**Whitley House, Four Ash Hill, Baythorne End, Birdbrook. Essex.**

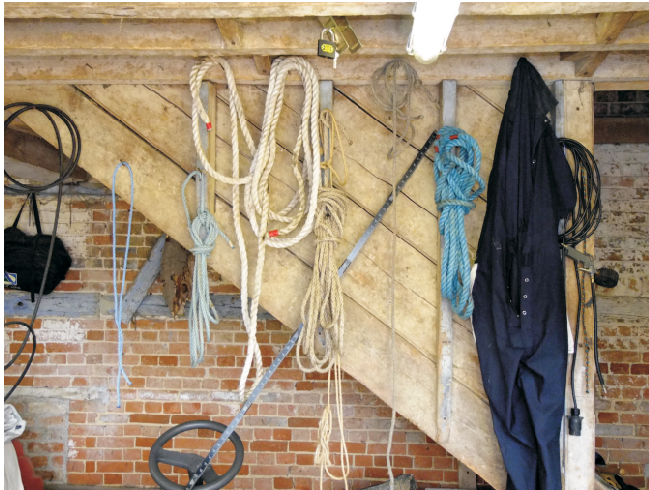
Inserted staircase at rear of main opening. Framed at same time as floor inserted over this area.

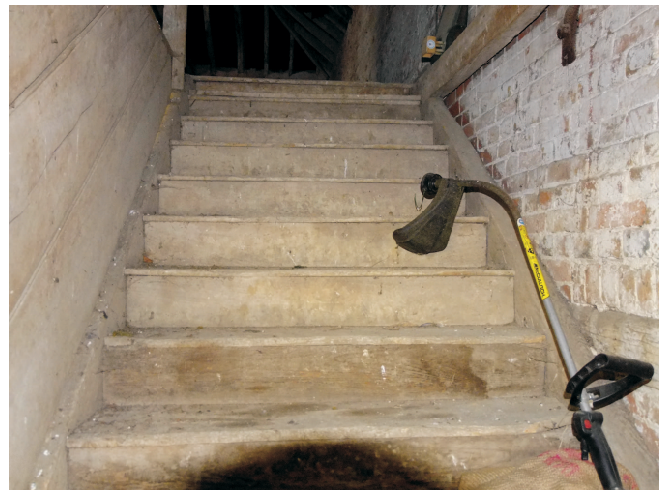
View up staircase show the width and well constructed detail.

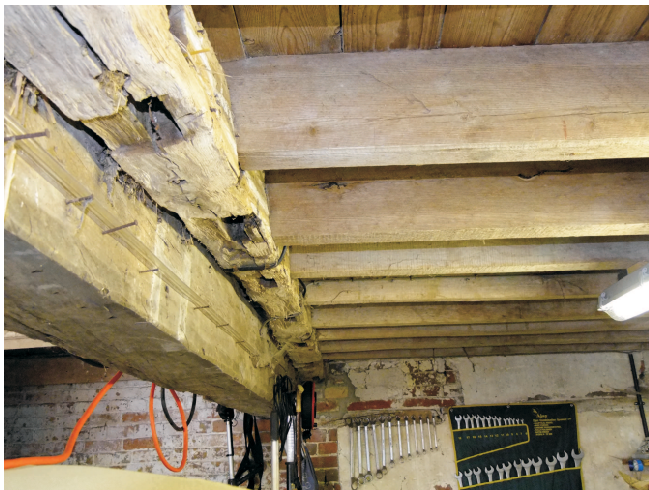
Head beam for lower floor partition to side of central carriage area. This side (to right of opening) is on the opposite side of the main beam. On the other side it is fitted to the inside of the main beam suggesting that the floors to this side went in later. Note elm joists.

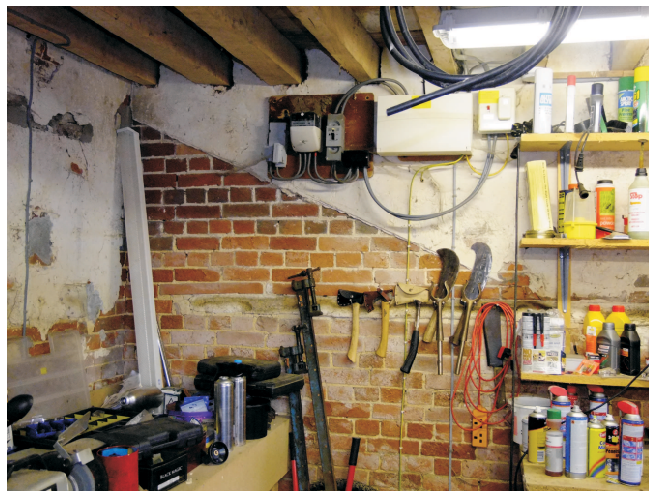
Example of filled in mucking out hole in north west wall. These are situated to either side of the central bay.

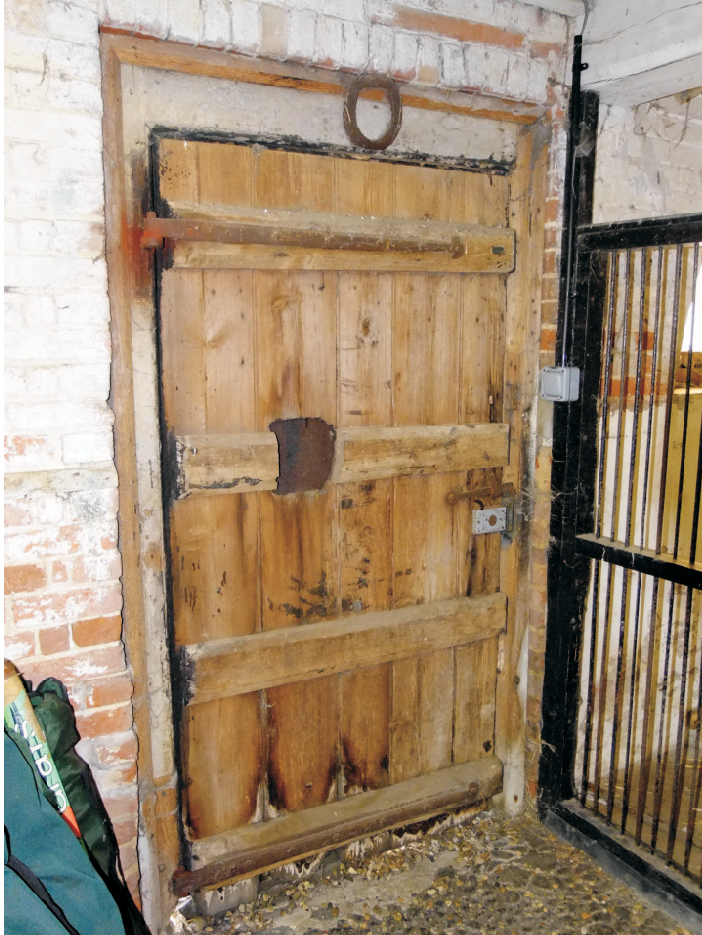
Inside of the doors, wide boards, 4 ledges & good iron work. The very long hinges do much to support the door.

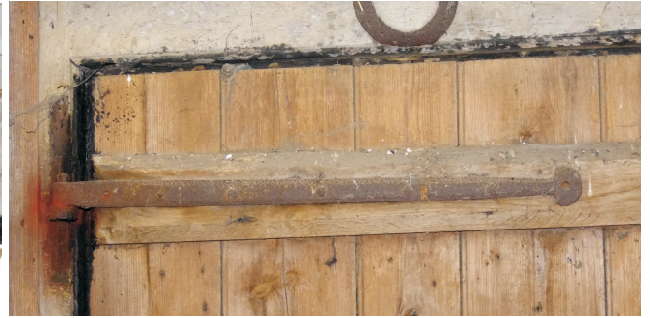
Example of one door hinge. They are clenched nailed to the door.

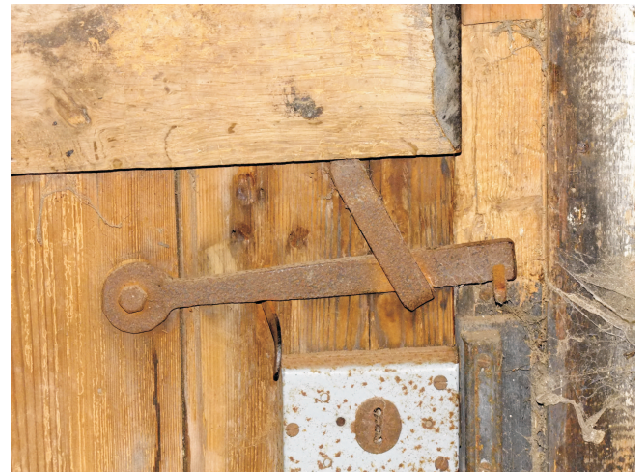
Example of door catch.

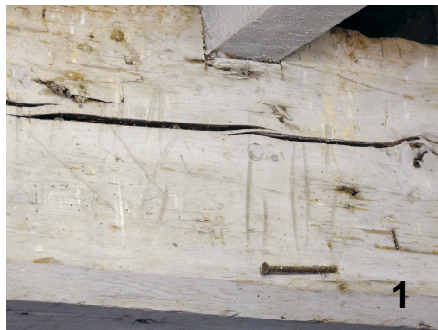
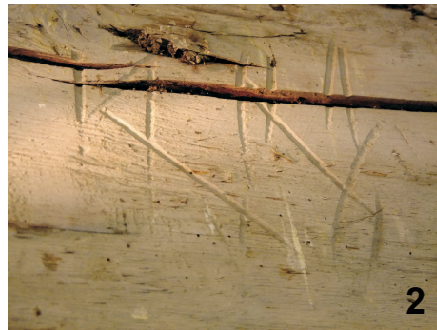
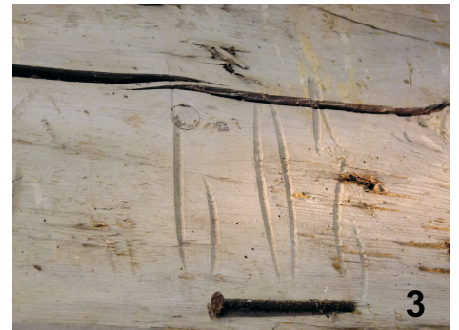
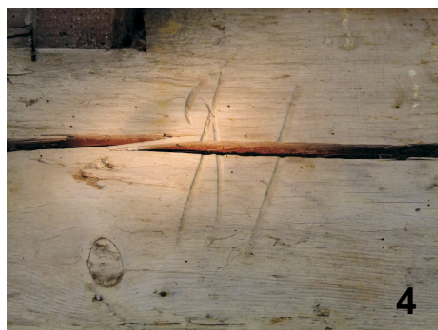
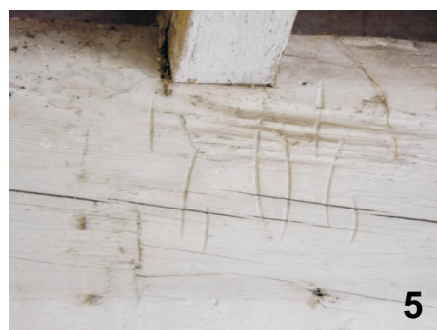
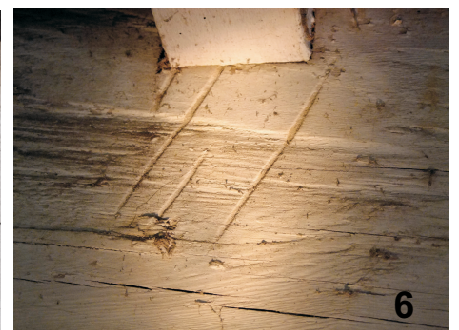
Examples of 'bracking' marks, or Scandinavian shipping marks on softwood floor beams. These marks made with a race knife here show some recognisable similarities between the various marks.

2 & 3 are the details from 1 but the various shapes can be recognised in 5 where the detail at 3 is repeated. Similarly 4 & 6 show distinct similarities.
