**Whitley House, Four Ash Hill, Baythorne End, Birdbrook. Essex.**

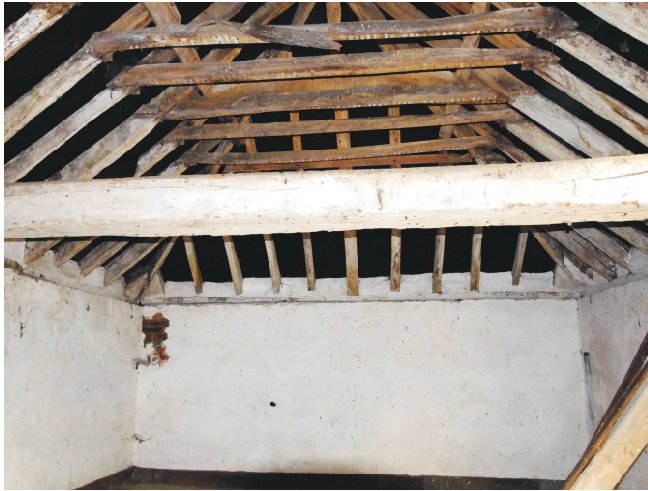
First floor view to north east showing granary end with fully plastered walls. Ceiling joists nailed to each rafter pair for plaster with undersides in line with lower face of collars.

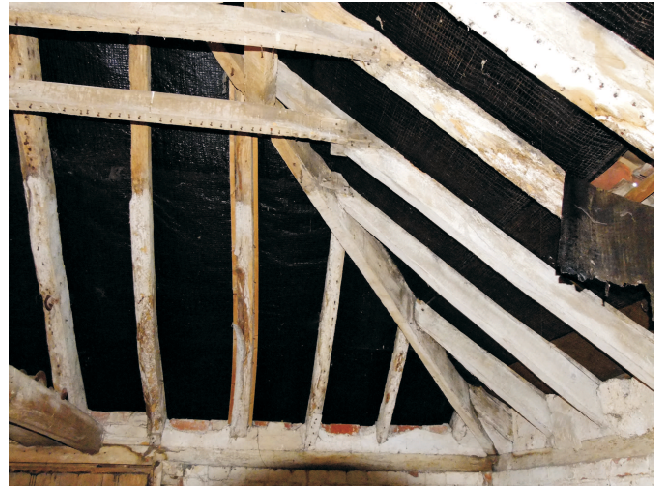
Typical hip construction. Lime wash stain shows original plaster level to under collars.

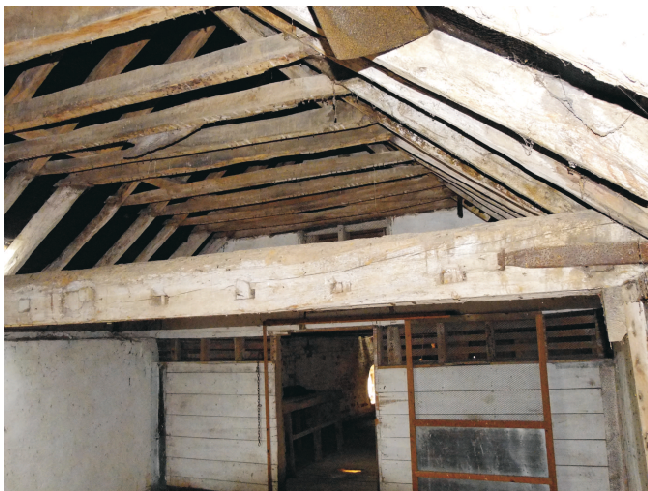
View from granary to division wall showing wide boards and vented area under tiebeam. Typical reused tiebeam in foreground with original iron ties to plate.

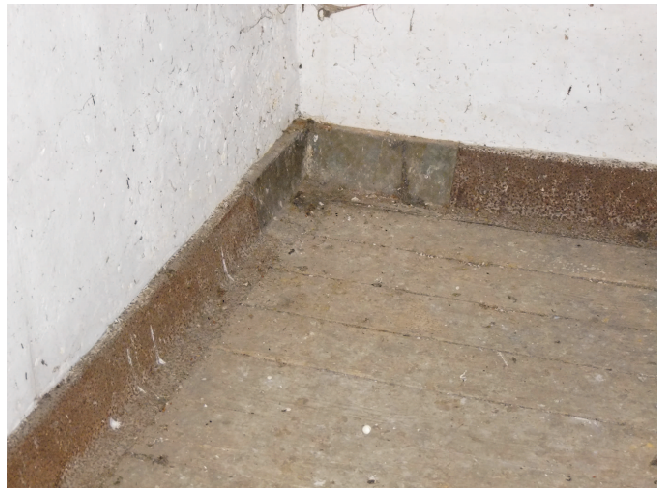
Granary floor area showing plastered walls and wooden floor junction sealed with sheet iron edging.

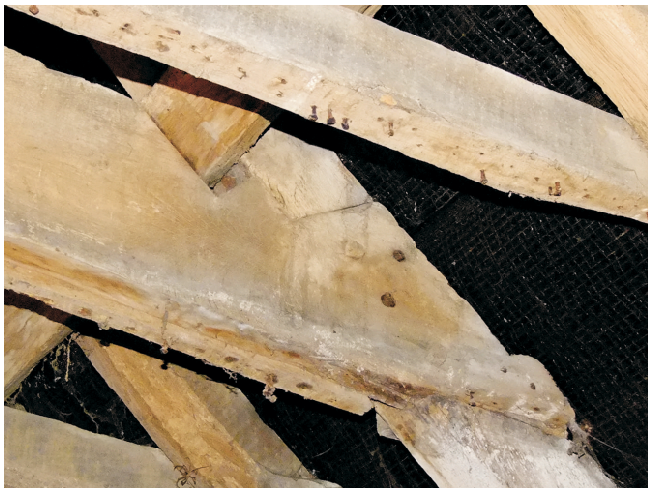
Collar detail with two wooden pegs and two nails to each end. Purlin clasped by rafter and collar.

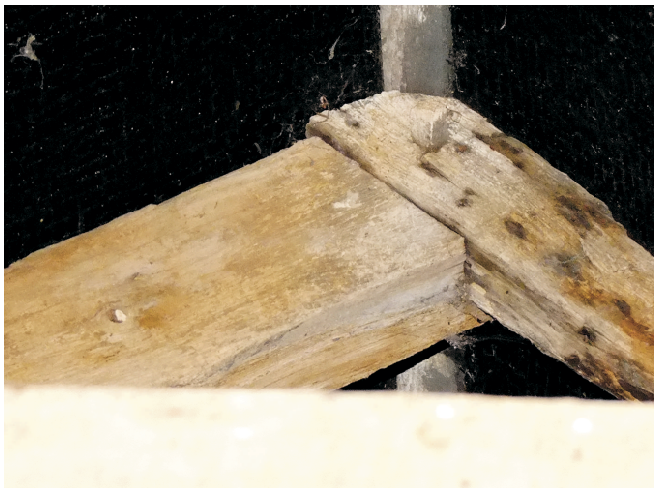
Typical apex detail for all rafter pairs. Fastened with one wooden peg. Each rafter is halved but rafter sections vary through the building.

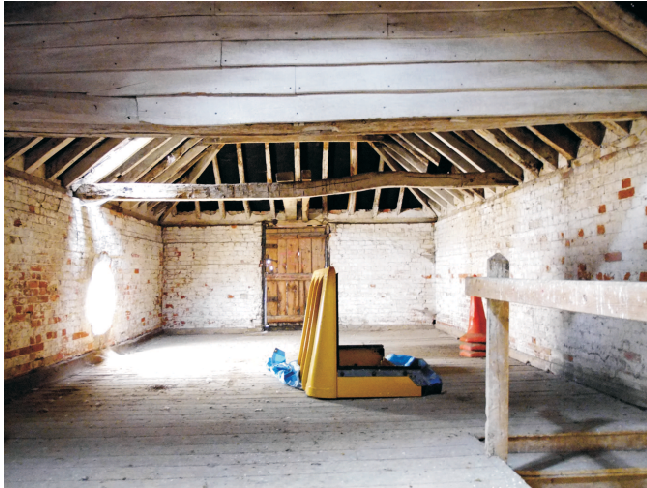
View to south west end and upper loading door. Note bay infill surviving above tiebeam to south west side of centre bay.

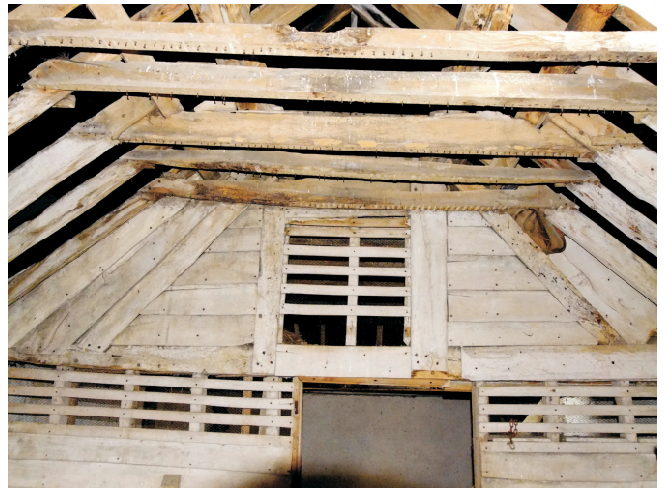
View to north east from south showing ventilated wall division to granary on line of north east side of central bay.

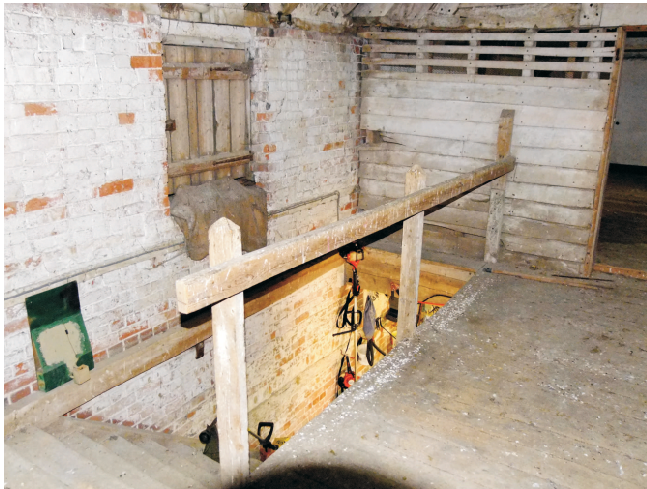
Inserted staircase and floor to central bay with handrail. 'Pitching' door is in the centre of this area.

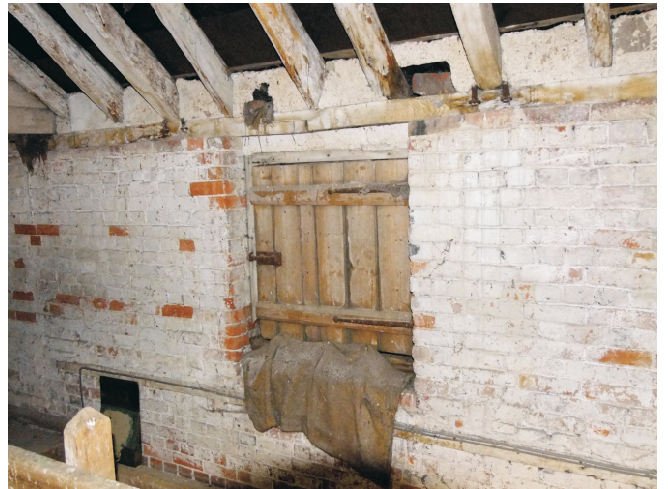
Detail of 'Pitching' door showing boarded construction with two ledges and lighter hinges than those on the main doors. Brickwork shows wear areas to the lower sections of the opening.

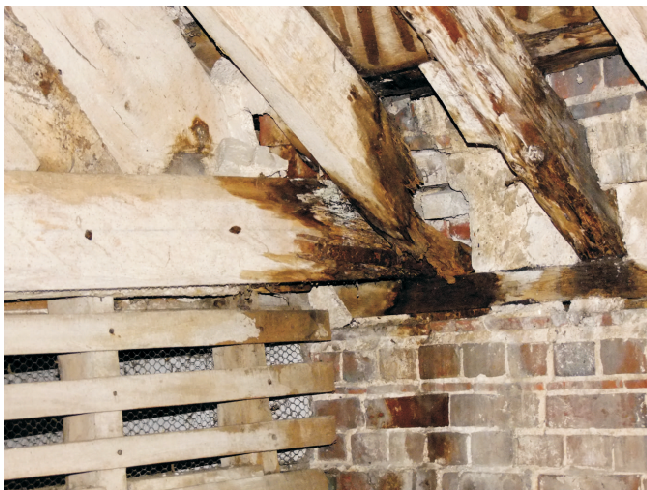
One centre bay tiebeam that has the pediment structure above. Failure of the roof detail at this point has led to much water ingress over time.

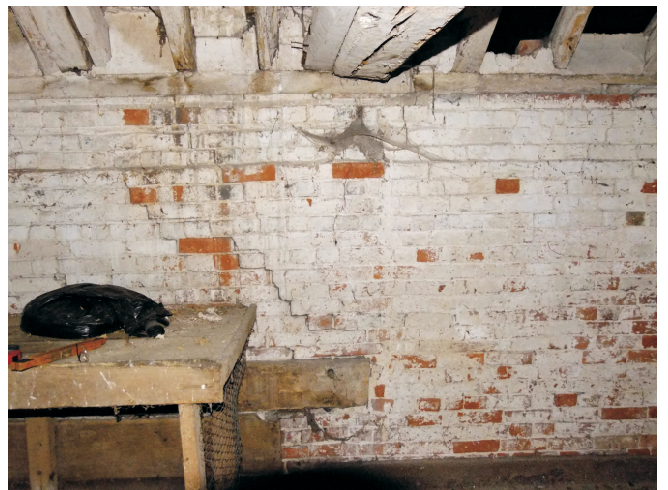
View to front showing south side of main door opening. Main opening lintol is just below table with infill boarding under to close area to floor level.
