Moss House Farm, Cockerham, Lancashire

Archaeological Building Investigation

Oxford Archaeology North

September 2009

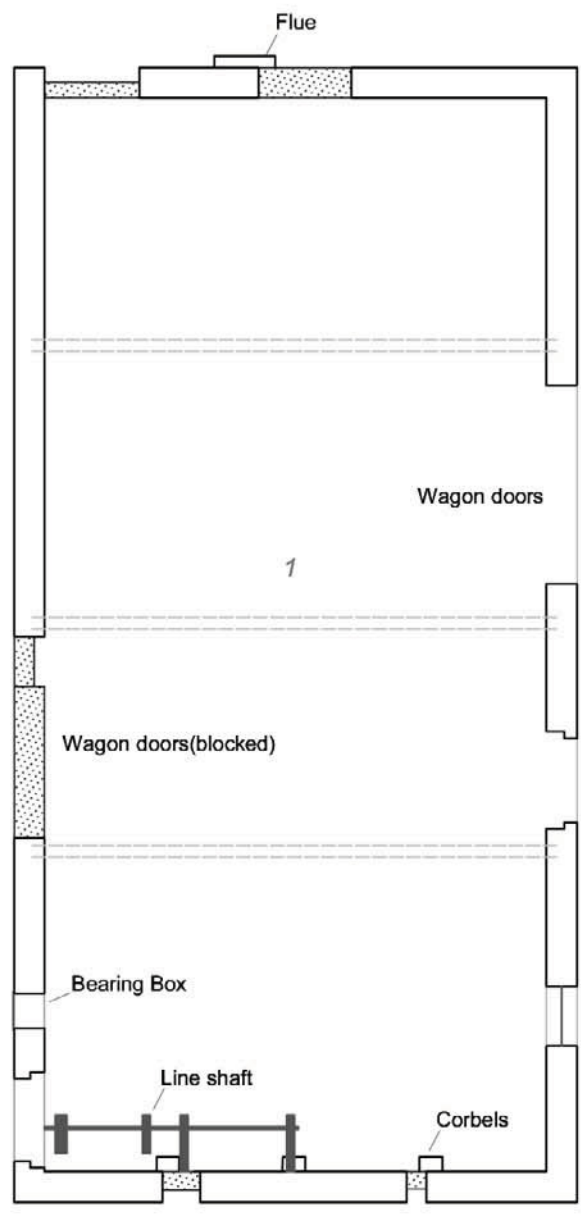
Figure 7: Ground floor plan of Barn A

- 4.3.3 Of particular interest is the lineshaft, complete with two pulley wheels, on the upper reaches of the south wall (Fig 7). This is secured by means of a bearing box within the west wall, and a pair of brackets on the south wall. Apart from the bearing box to the right of the door on the west elevation, there is no other

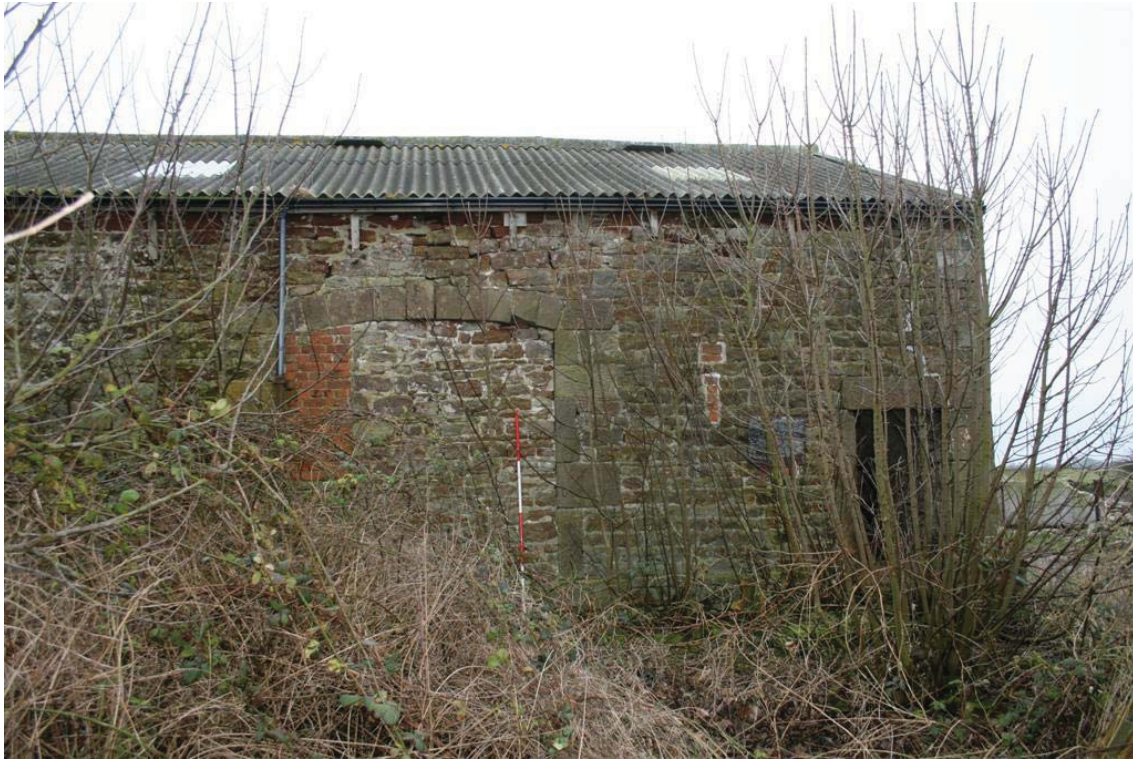
4.2.1 The barn is constructed from squared red sandstone, which is roughly coursed, and which is bonded with lime mortar, and dressed with roughly fashioned quoins (Plate 1). The stone is, for the most part, bare, but the north end of the east elevation shows substantial evidence of an earlier lime wash, whilst the corner itself has been heavily repaired with cement (Plate 2). The reason for this becomes apparent on the adjacent north elevation, where the corner is similarly rendered with the same cement. In addition, the upper section of the corner is rendered with a second patch of cement, but brick repairs are partially visible below the eaves. Similarly, on the corner to the right of this elevation, there is a crude rebuild of brick at ground floor height, with a cement render beneath the eaves.

Plate 1: West-facing elevation of Barn A and the farmhouse

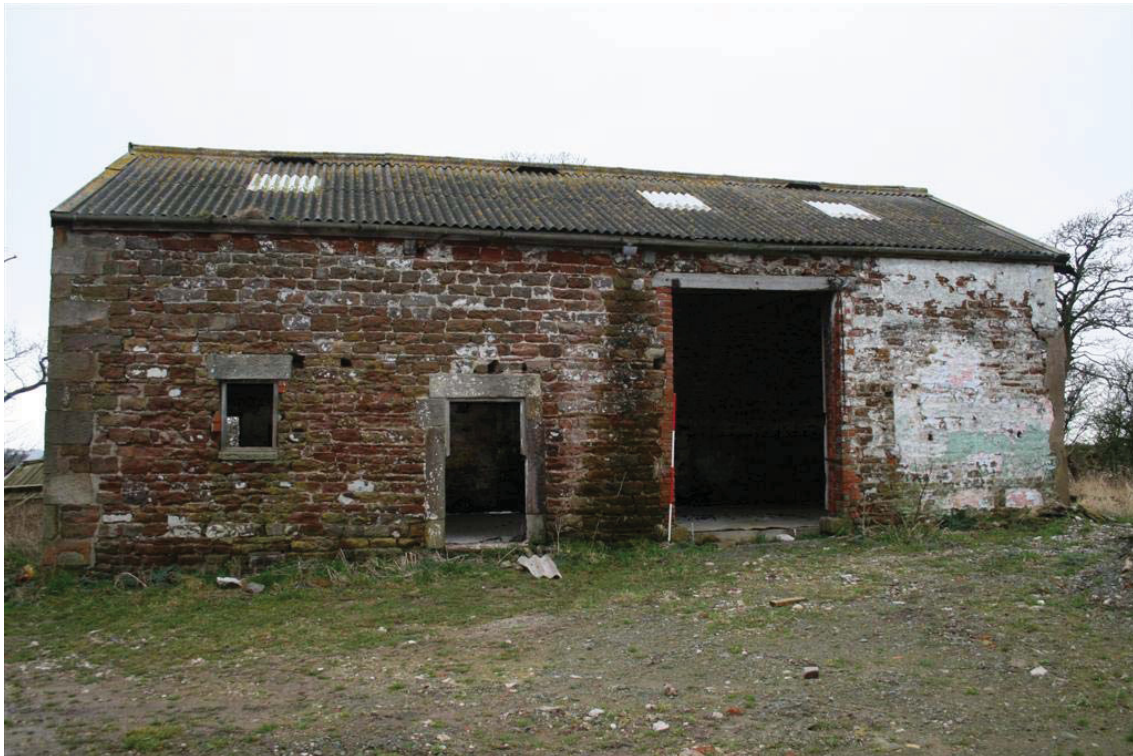
- 4.2.5 The window on the east elevation is a plain open aperture, which has a roughly fashioned stone lintel, projecting sill and timber frame (Plate 2). No quoins are present, but several of the stones in the jambs have evidently come loose and have been crudely replaced with inserted red brick (Plate 5). On the rear of the barn, the inserted window within the former wagon door has been blocked with brick, and judging by the similarity in brick, it would appear that this window was blocked at a similar time to the repairs on the north elevation.

Plate 2: East-facing elevation of Barn A

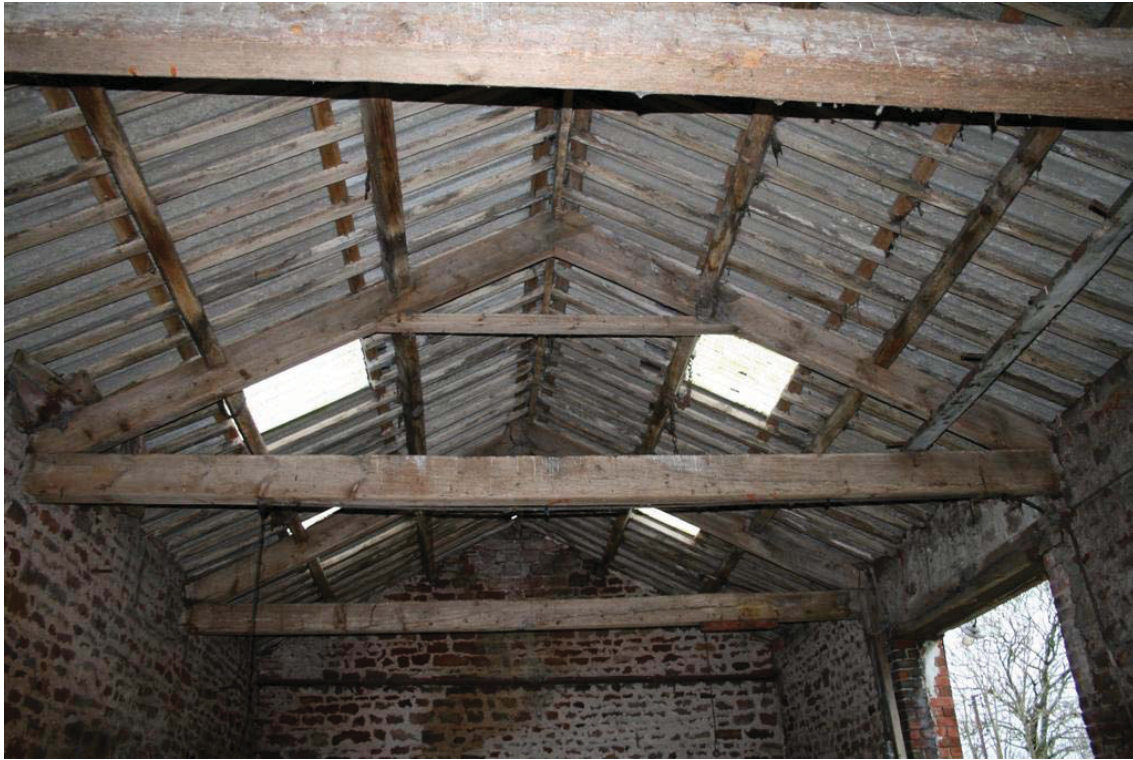
- 4.3.2 The roof is supported by a series of three roof trusses, each comprising a tie-beam and collar brace (Plate 3). The tie-beams are housed within sockets set in the walls. A pair of trenched purlins is present on each slope of the roof. The rafters and slates above are visible, and there are also a number of skylights.

Plate 3: Roof truss in Barn A

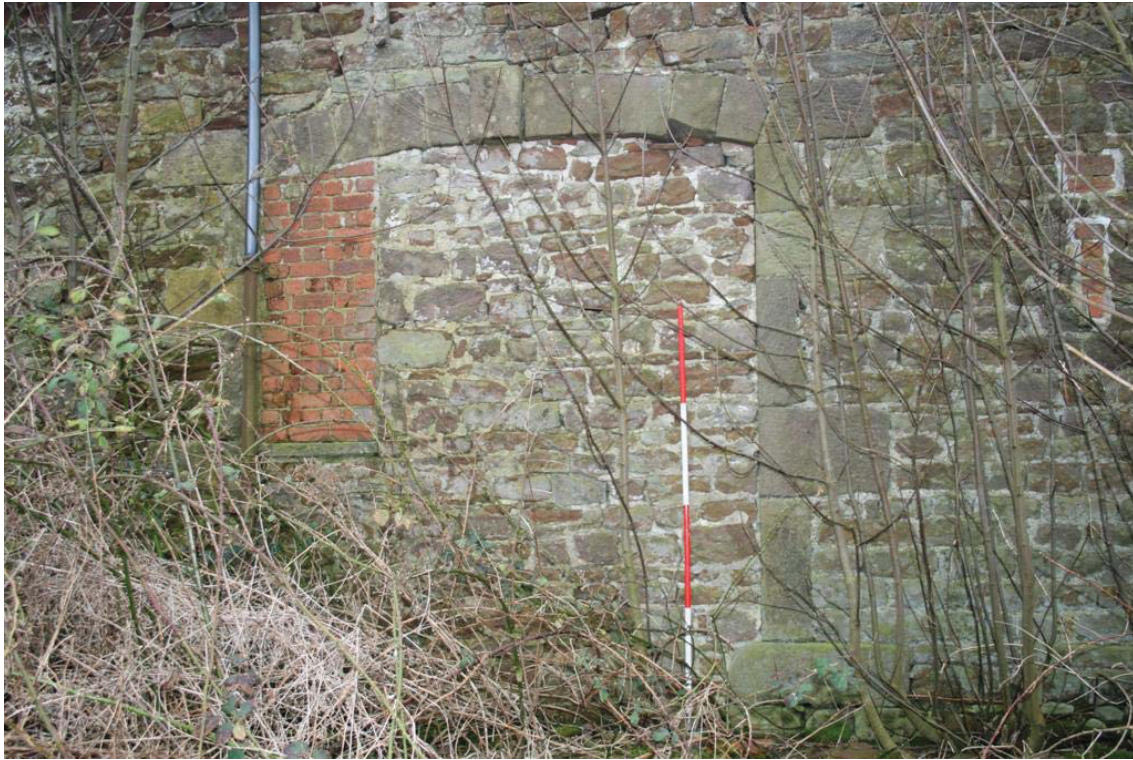
Plate 5: Blocked door and window on the west facing elevation of Barn A

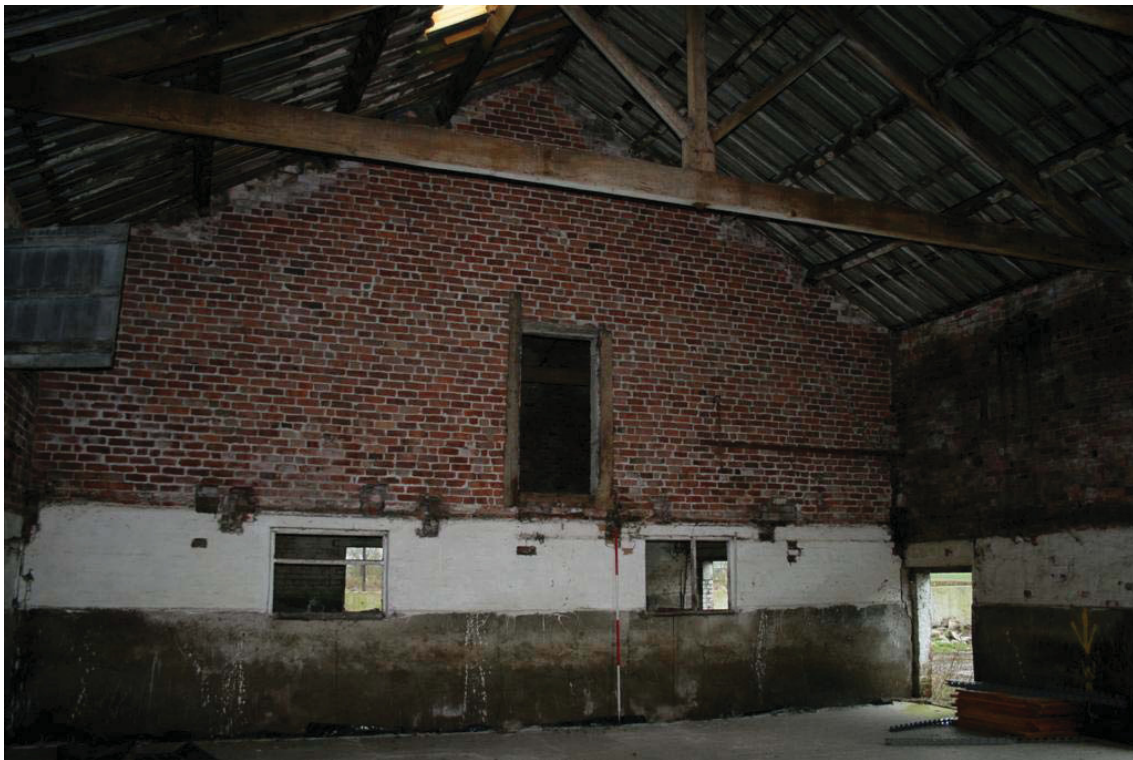
- 4.5.2 At first floor height within *Area 1*, there are pair of hayloft doors (Plate 6). The door on the east elevation is a small ledged matchboard door (Plate 8), which overlies the cattle stalls in *Area 3*, whilst the door on the south elevation is a full-sized doorway with timber lintel, which would have originally provided access to the hayloft in *Area 2* (Plate 7).

Plate 6: Area *I* of Barn B

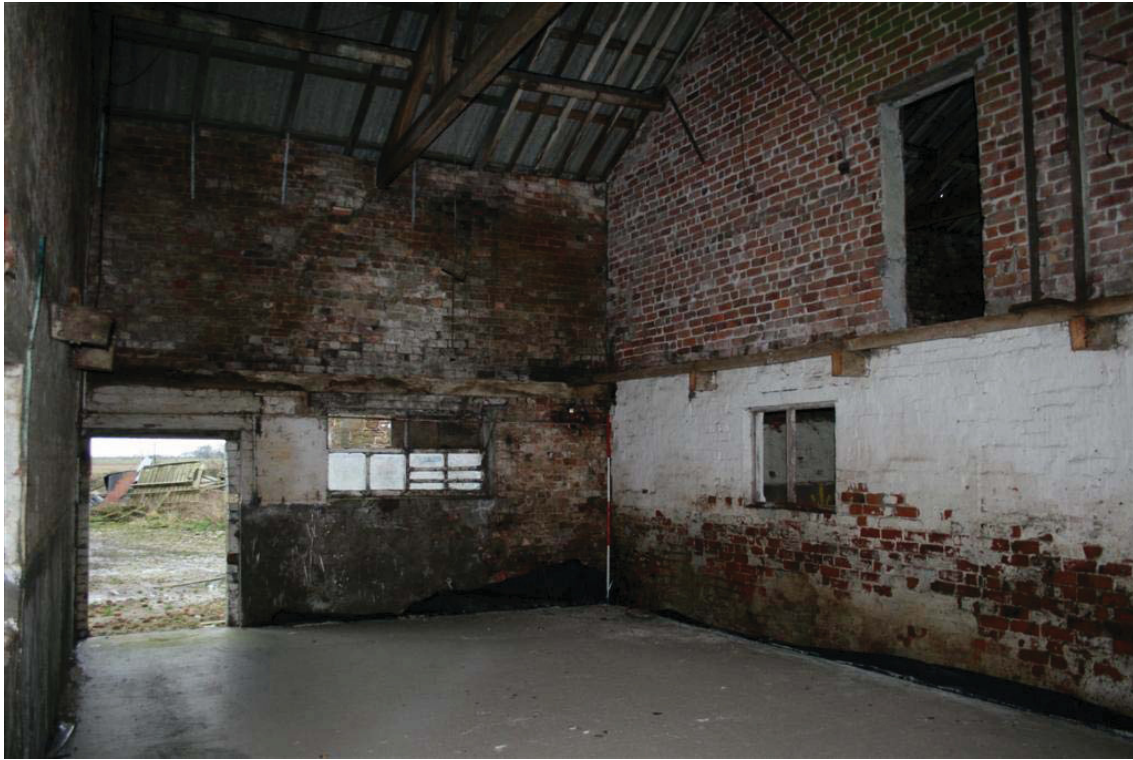
Plate 7: Area 2 of Barn B

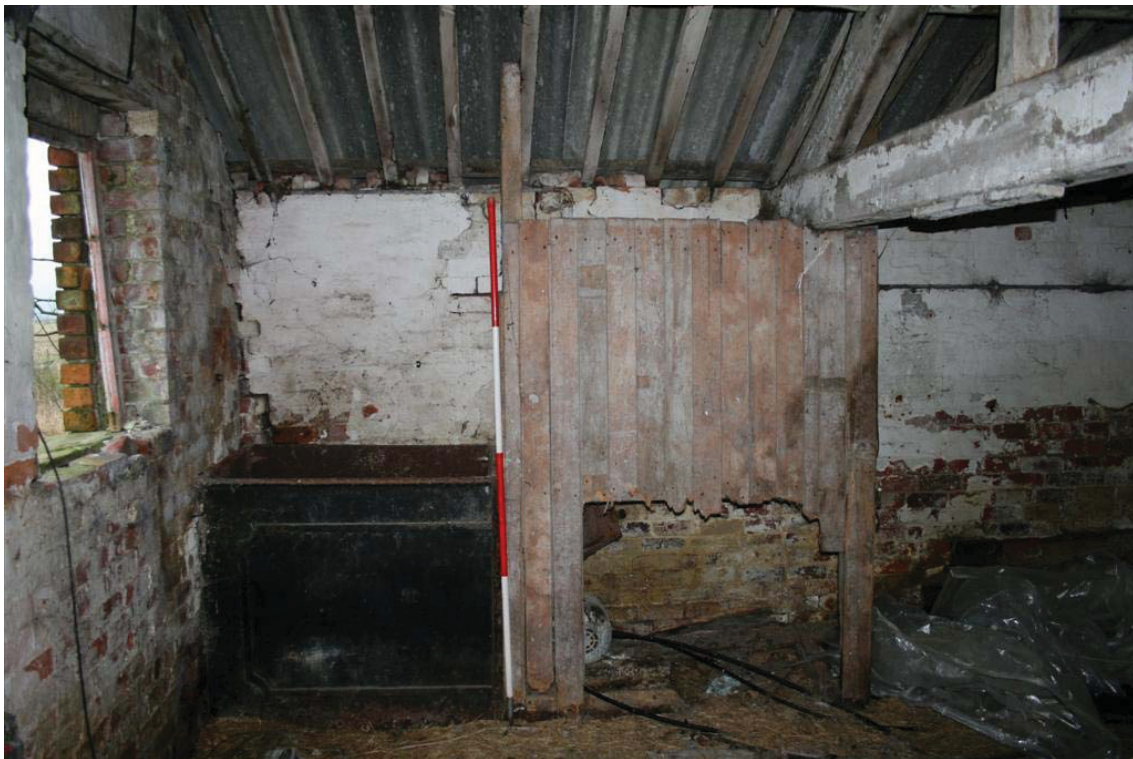
Plate 8: Area 3 of Barn B

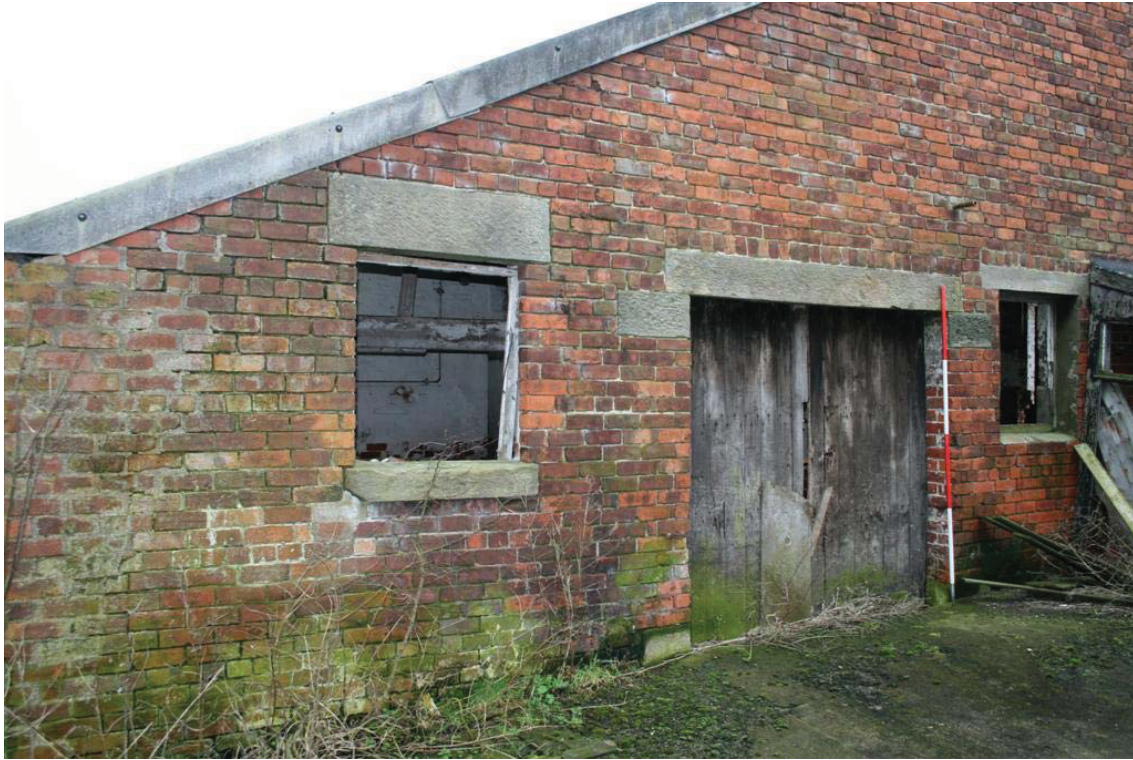
- 4.4.4 The casement window on the west elevation appears to be inserted, since the lintel and the projecting sloping sill are made of concrete, whilst the jambs of the window have been sealed with cement (Plate 9). Similarly, the casement to the right of the double doors on the north elevation would also appear to be a later insertion, as the lintel and sill are again of concrete, whilst the jambs have also be rendered with cement (Plate 10). Moreover, the pair of casements to the right of the north elevation again have concrete lintels, whilst the repairs to the surround are of the same pinkish brick used in the rebuild of the south gable. Although the casement on the south gable is within this apparent rebuild of pinkish-red brick, its lintel and sill are made of stone (Plate 11), which would suggest that the stonework of a comparable casement was retained and reused when the gable was rebuilt. The five light casements on the east elevation have narrow timber lintels and small projecting sills (Plate 12), and would appear to be original features of the barn.

Plate 9: North end of the west elevation of Barn B

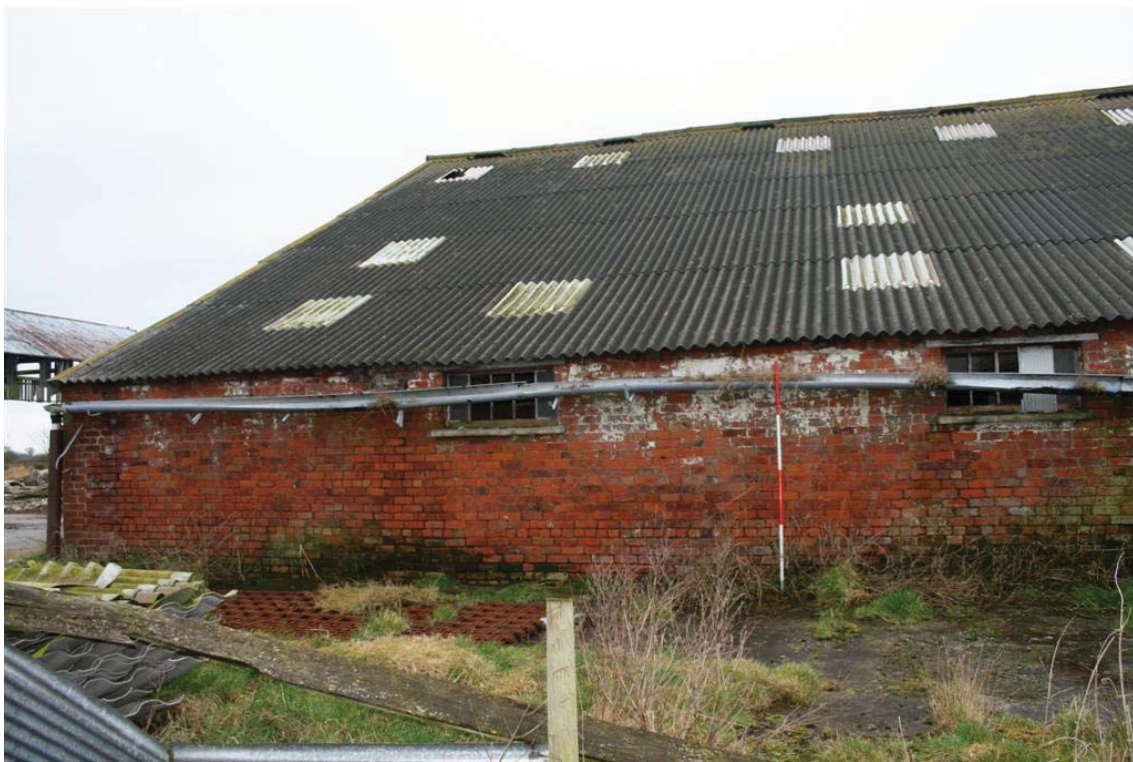
- 4.4.2 The roof is again constructed from corrugated asbestos sheeting (Plate 12), which is supported by a pair of machine-cut King-post trusses and seven trenched purlins, within the main section of the barn (Fig 10). The pitched roof to the east of the barn, is supported by a tie beam, principal rafter and pairs of angled braces. At the south end of the barn, the roof is supported by a composite truss, which is essentially a King-post, with an additional collar, queen struts, and paired truss rods (Plate 6). The seven purlins are not trenched and are affixed to the principal rafters with a series of cleats. At both the north and south ends of the building, there are a series of steel brackets, which secure the purlins to the gables, whilst a series of timber battens beneath the eaves of the west and east elevations provide additional anchorage.

Plate 12: East elevation of Barn B
