The Dye House, Hallthwaites, Millom, Cumbria

Archaeological Building Investigation

Oxford Archaeology North

November 2005

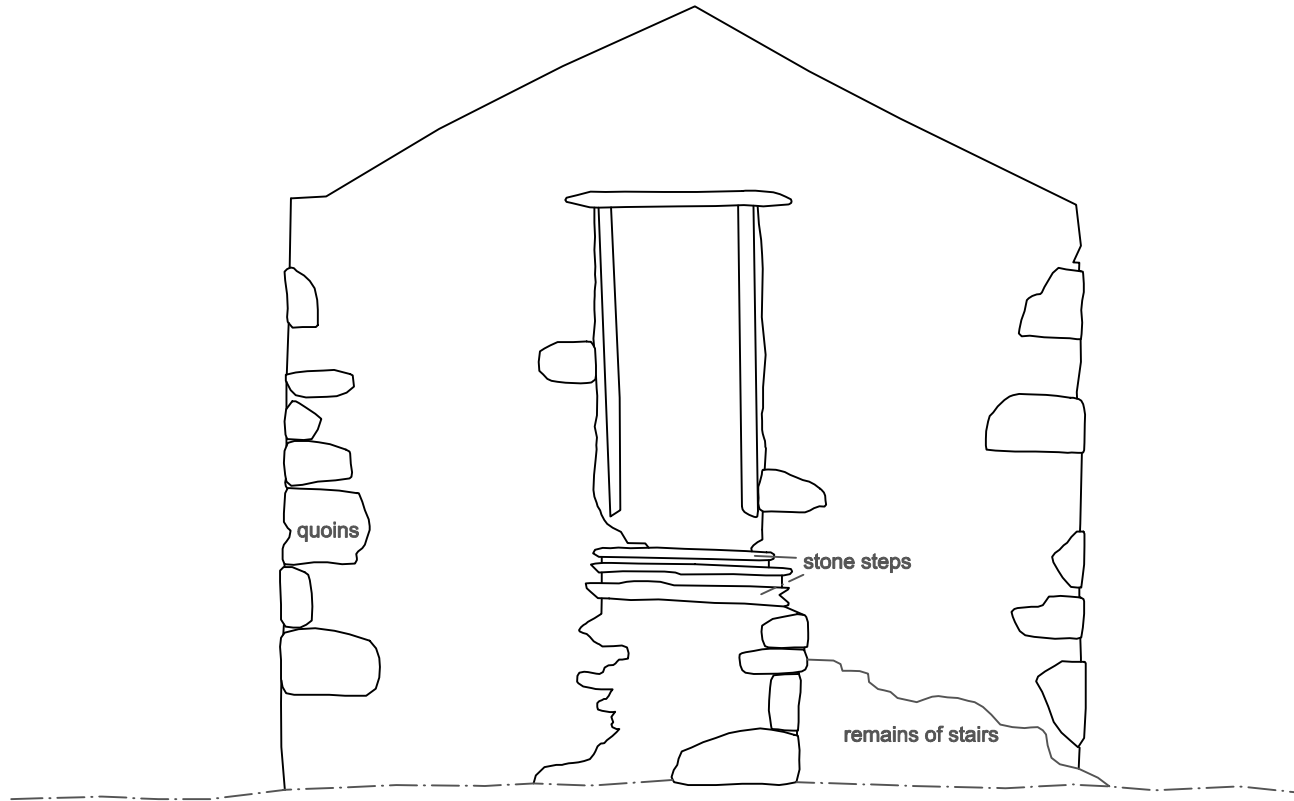
Figure 15: Elevation 9

4.4.11 **External Elevation 9:** (Fig 15; Plate 11) this forms the east-facing gable elevation of Rooms 1 and 3. It is constructed from a mixture of varying stone types and sizes which were probably collected locally and has large quoins. A single door with a stone lintel and missing threshold is the only access into Room 3, and is reached via a flight of semi-collapsed stone steps (similar to those described in *Section 4.1.1*). There is a small flagged landing at the top of the steps and, unlike those steps described in *Section 4.4.1*, there is a storage space beneath. The steps contain possible evidence of a handrail in the form of leaded holes in the steps (R Newman *pers comm*). The door is side-hung and of battened construction similar to that in Room 1. There is a simple timber surround and the whole assembly is in very poor condition. Above the door is a slate drip course below which are two square holes that may have held a timber for a porch (one of which still contains a timber).

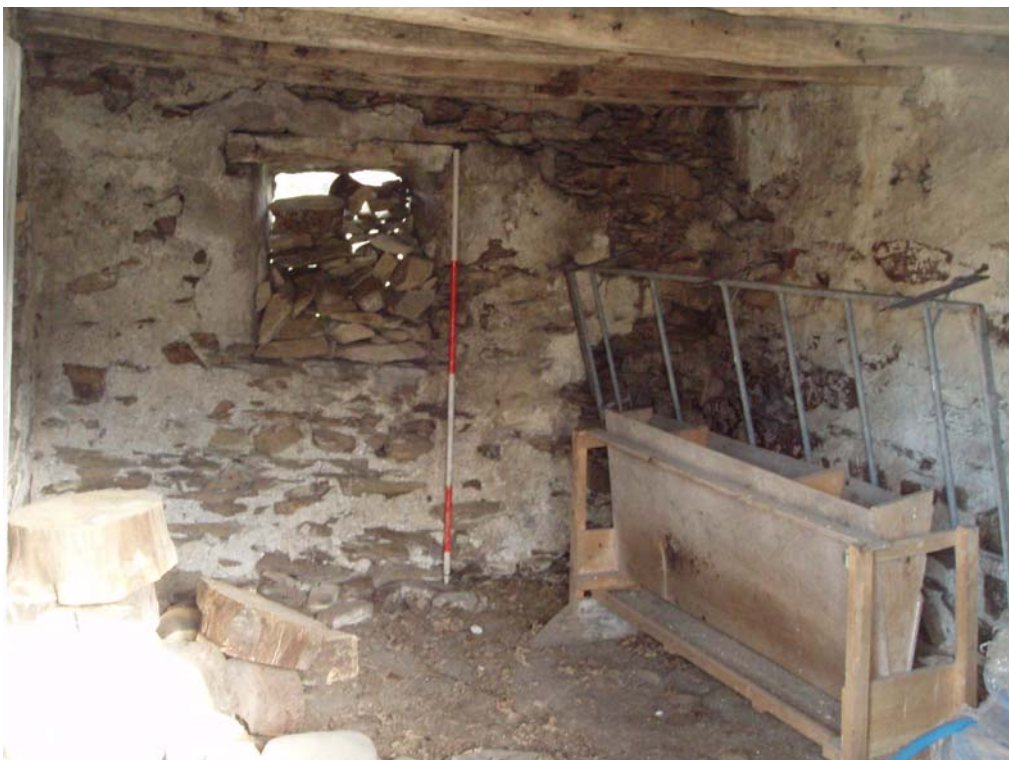
Plate 13: North-facing view of Room 2

- 4.5.4 **Room 2:** (Fig 3; Plate 13) (Fig 13 Elevation 7; Fig 16 Elevation 10; Fig 25 Elevation 20 and Fig 28 Elevation 23) east of Room 1, this room is of similar appearance and is also being used as a general store room. It is accessed via a single door located in Elevation 8 (Fig 14 *Section 4.4.9*). In common with Room 1, the walls have the remains of lime plaster/limewash present and are constructed from coursed small-to medium-sized sub-angular and sub-rounded stones. Larger ‘pad stones’ are to be found at the base of each wall.
