# 61 King Street, Blackburn, Lancashire

## Archaeological Building Recording

Issue No: 2013-14/1417

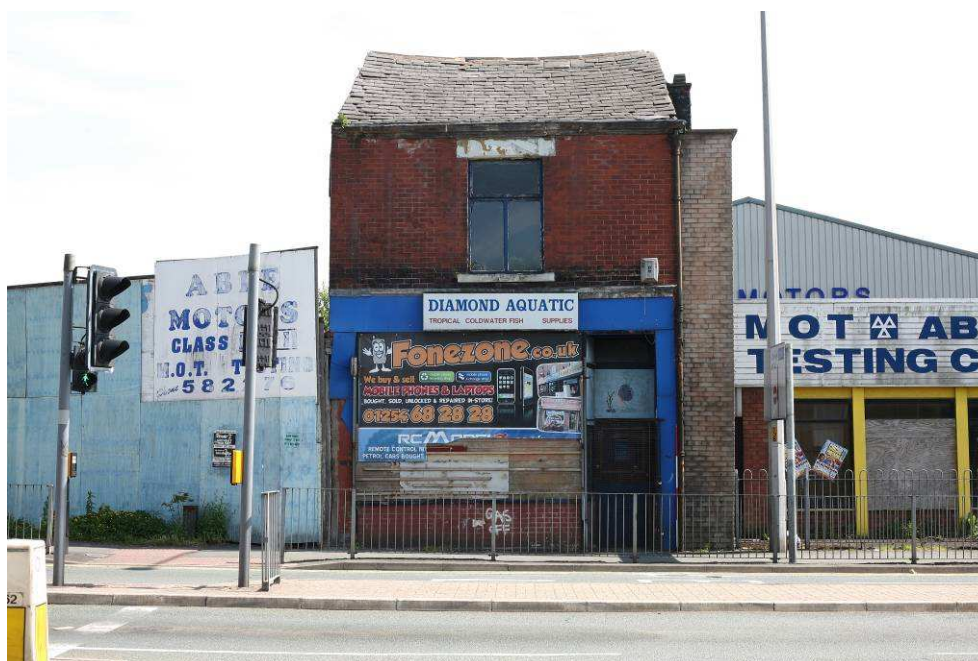
Plate 1: 61 King Street, the main elevation

- 3.2.6 **External Description:** the main elevation is plain in appearance (Plate 1) and consists of a late twentieth century shop front on the ground floor comprising a large glazed single window (currently boarded) with a recessed doorway to the right. The left side of the ground floor, together with the area below the window, have been rebuilt using bricks of recent manufacture. The shop sign is also of recent origin. The upper storey of the elevation contains a centrally-placed window opening that contains a timber casement window, probably dating to the late twentieth century. The window has a projecting sill and flush lintel with a chamfered arris. The most interesting feature of the elevation is a lead-lined stone gutter, which drains to the right into a cast-iron hopper and downpipe. The gutter is in three sections, and exhibits ovolo mouldings. Although, only able to be inspected from the ground, it appears to be built into the top of the elevation. There is a modern grey brick buttress supporting the left side of the elevation.

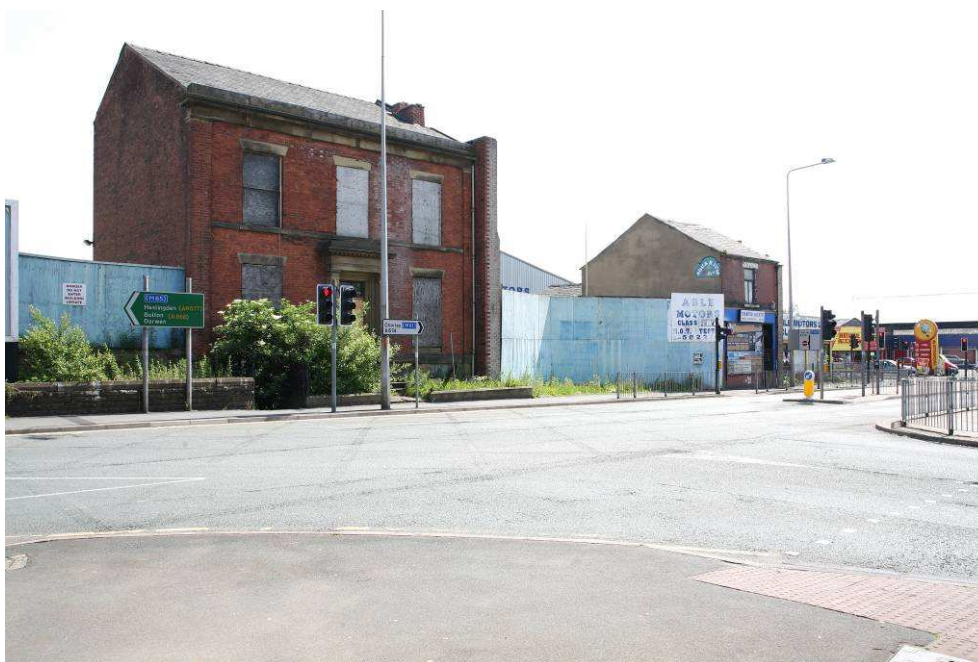
Plate 2: 53 King Street (in the foreground) and 61 King Street beyond

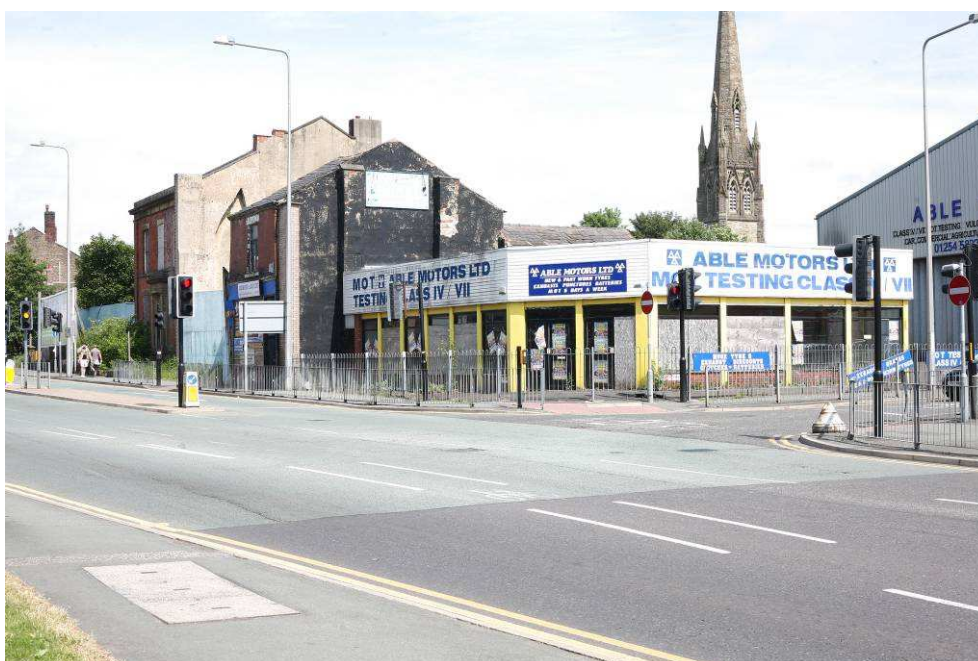
Plate 3: General view of the corner of King Street and Byrom Street

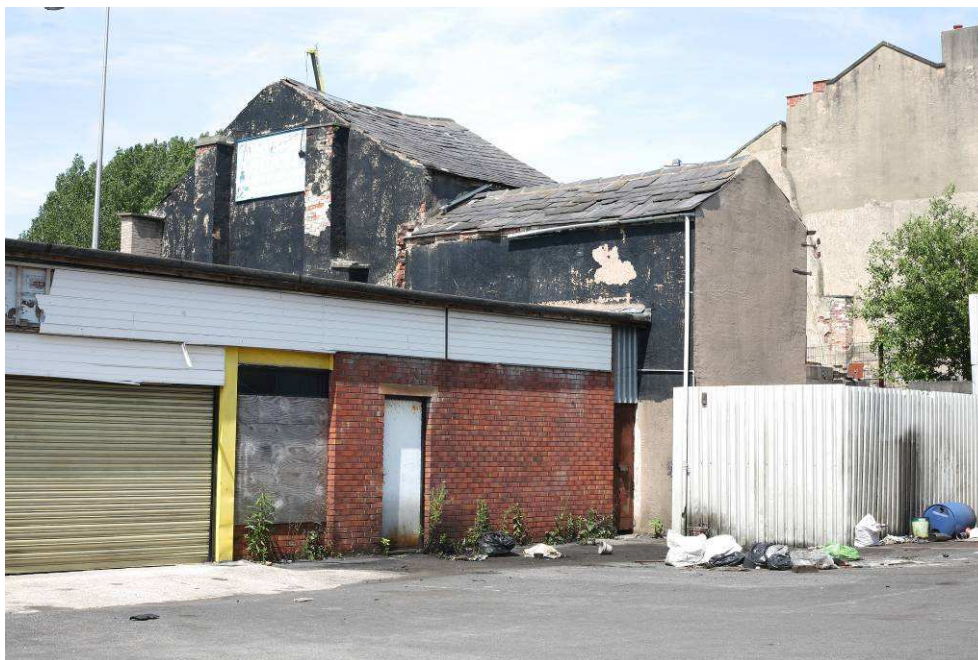
- 3.2.7 All of the rear elevations of the main building and the extension are covered by thick, patterned cement render (Plate 4). Only small parts of the rear elevations were able to be inspected directly, the remainder being visible from outside of locked compounds. The rear elevation of the main building is, for

Plate 4: Rear view of 61 King Street

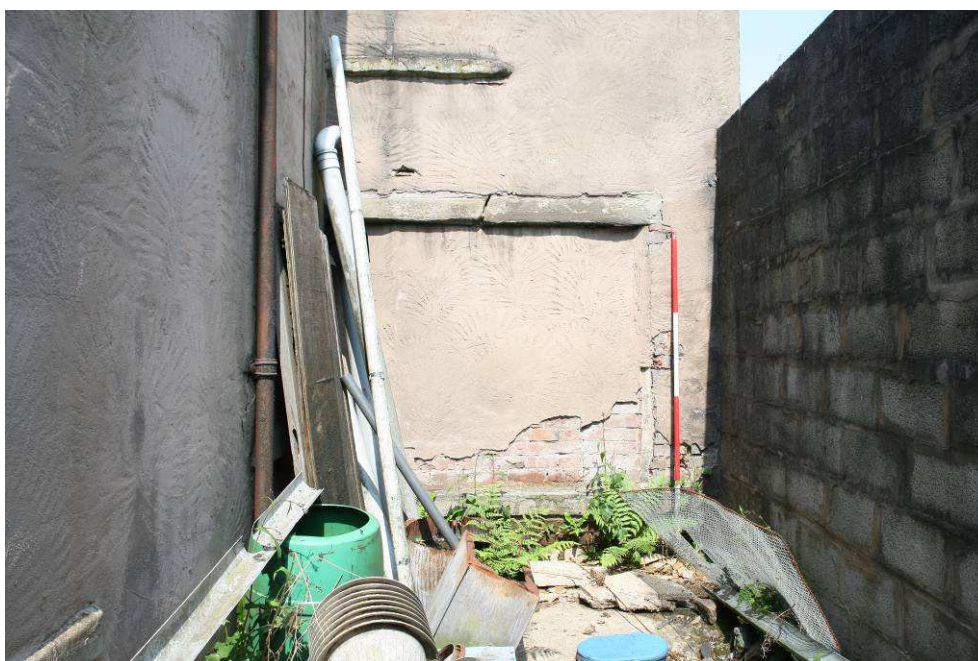
the most part plain render but there are three blocked windows visible on both the ground, first and second floors (once lighting Rooms 2, 6 and 10; Figs 2, 3 and 4, Plate 5). The ground floor window is wide and exhibits a projecting stone sill and lintel (much weathered). Some of the render has detached allowing a mixture of brick types to be visible. Some of the brick is similar to that used in the upper floor of the front elevation, whilst other brick is coarser, probably hand made. Only a projecting stone sill of the narrower first floor window was visible. The second floor window is blocked with cinder blocks.

Plate 5: Blocked windows in the rear elevation of the two-storey part of the building

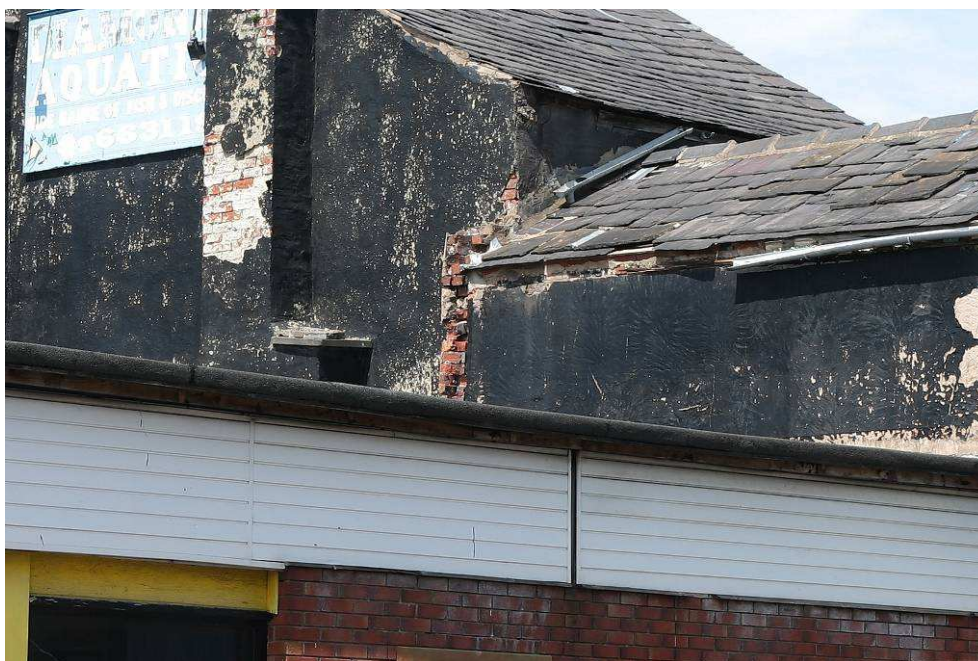
- 3.2.9 The west-facing elevations of both the main part of the building and rear extension are, again, only visible from afar, the lower portions of both being obscured by the adjacent garage building (Plates 3 and 4). The main part of the building exhibits the grey brick buttress, described in *Section 3.2.3* together with two brick projecting flues that possibly served fireplaces in an adjacent building. Although evidence of these flues is visible internally, there are no obvious fireplaces. Both of the flues are capped with concrete paving slabs. The visible portion of the west-facing elevation of the rear extension is plain with no evidence for any features such as flues or blocked windows (Plate 4). The rain water goods are plastic. The join between the extension and the main building is partly visible, there being evidence of a former wall that probably continued to the west (Plate 6). The offset of the rear extension is clearly visible.

Plate 6: View of the join between the main building and rear elevation

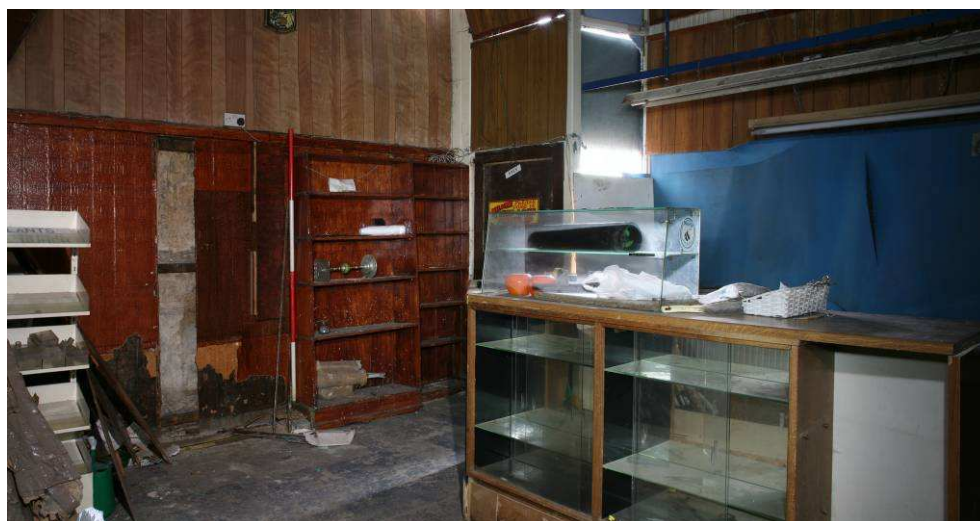
- 3.2.12 **Room 1:** upon accessing the building from the front, Room 1 is entered (Fig 2). This room obviously was last used for retail purposes, there being several display cabinets and shelving units present (Plate 7). The walls are lined with both real and fake timber panelling obscuring nearly all of the walls below. Some of the timber panelling was covered with embossed wallpaper. The floor is laid down to concrete and the ceiling (which is 3.4m high) is lined with matchboard. A steel 'I-beam' crosses the ceiling, which probably provided support due to the removal of an original brick wall dividing this room from Room 2 (*see Section 3.2.15*). There is a chimney breast in the middle of the east wall, to which a shelving unit was firmly attached. No evidence of a fireplace was visible.

Plate 7: General appearance of Room 1

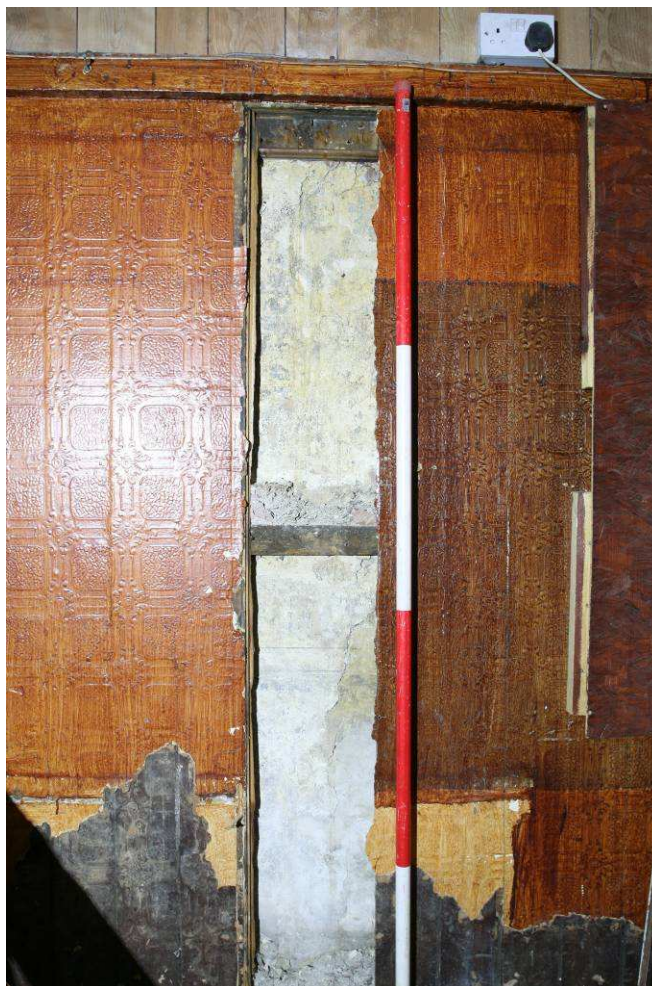
- 3.2.13 In the centre of the west wall, a narrow section of timber panelling had been removed revealing the bare (distemper covered) plaster of the wall below (Plate 8). Also revealed was the nature of the construction of the timber panelling, which was found to comprise two horizontal rails to which vertical matchboarding had been attached. Moulding could be seen on the upper rail. The panelling reached approximately 2m in height.

Plate 8: Construction of panelling in Room 1

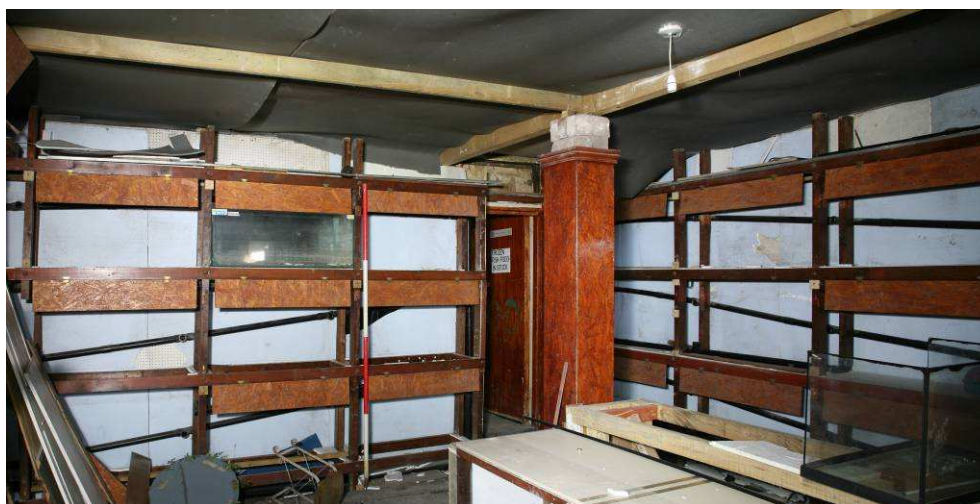
- 3.2.15 **Room 2:** this room is of a similar appearance to Room 1 and is almost wholly clad with plasterboard and fibreboard sheeting. To this, shelving units once housing fish tanks are fitted. The floor is laid down to concrete that appears to be a continuation of the floor from Room 1. The ceiling of this room is lower than that in Room 1, being approximately 2.4m high. It is lined with foam insulation material and much of it has a softwood timber frame indicating a lower suspended ceiling was once present. The east side of the room contains two chipboard-covered brick columns that support part of the timber frame. These are probably not part of the original fabric of the building and appear to have been inserted in order to support the ceiling (Plate 9). This is probably due to the removal of the dividing wall between Rooms 1 and 2. Two stubs at each side of the room probably relate to the former wall (Fig 2).

Plate 9: General appearance of Room 2

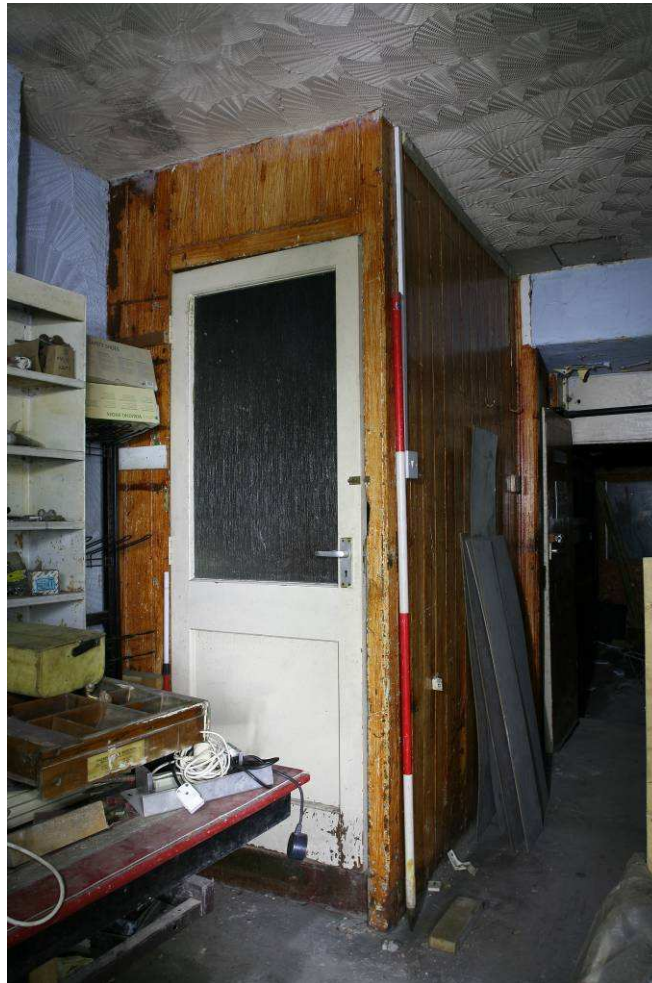
- 3.2.17 **Room 3:** a doorway in the south-west corner of Room 2 leads to Room 3 which covers the ground floor of the rear extension (Fig 2). There is a slight step up in to this room, and the floor is concrete. At the time of the survey, this room was being used as a storage area and, as such, much of the internal fabric was obscured. The walls are covered by a thick layer of decorative plaster which further obscures the original fabric. The ceiling in this room is approximately 2.6m high. This room contains two staircases, allowing access to both the basement and the first floor (Fig 6). The staircase leading to the first floor is a straight flight timber staircase, whilst that leading to the basement is of stone. A matchboard partition with door separates the stairs from the room, this feature may date to the nineteenth century (Plate 10).

Plate 10: Matchboard partition containing stairs in Room 3

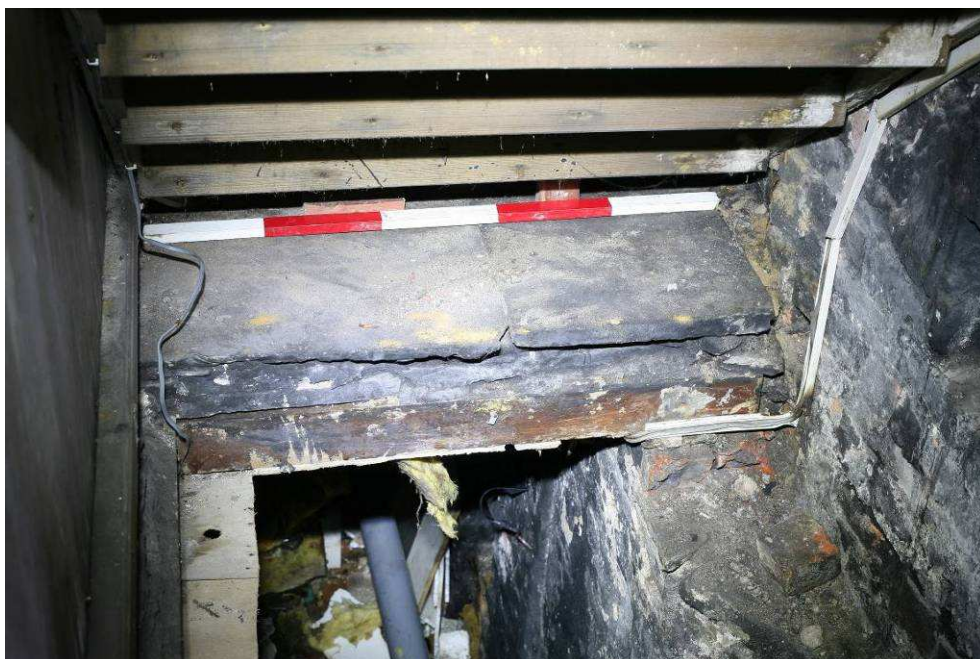
- 3.2.19 **Room 4 (Cellar):** the cellar is accessed via a flight of stone steps situated below the staircase from the ground to first floors (Fig 6). Stone flags are visible at ground floor level suggesting that the Room 3 had a stone floor, subsequently covered with concrete (Plate 11). Most of the surfaces of the cellar are obscured by foam insulating panels and glass fibre loft insulation (Plate 12). This limited the scope of the inspection in this room.

Plate 11: Flags visible above the steps leading to the basement

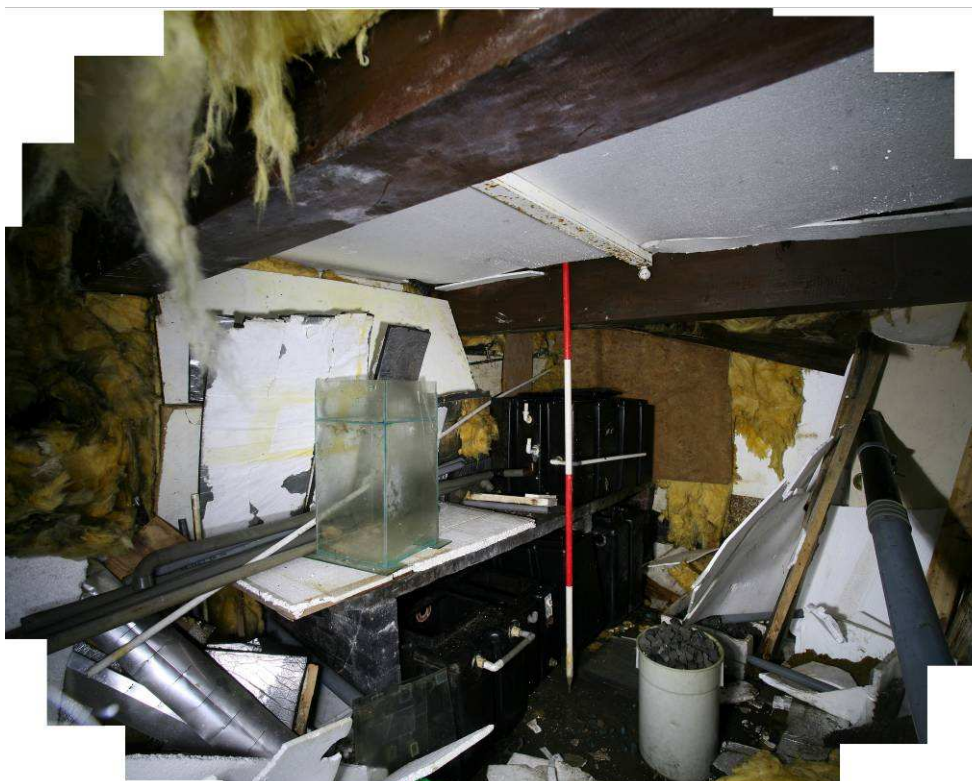
Plate 12: Composite view of the cellar (Room 4), showing clutter and lined walls

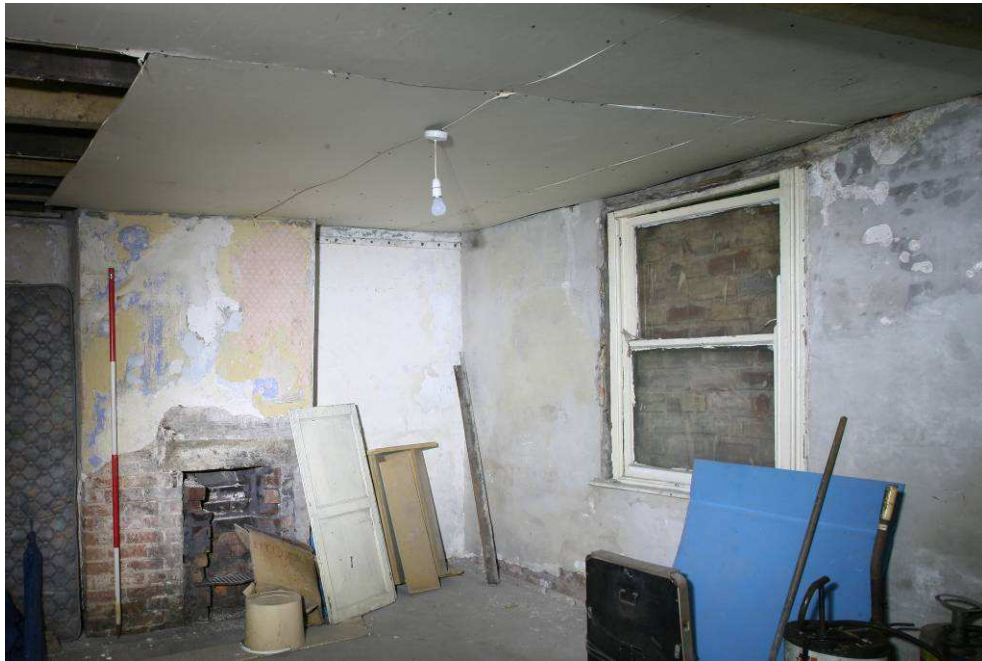
3.2.21 **Room 5:** this room is immediately accessed upon climbing the stairs from Room 3 (Fig 4). It is via this room that Rooms 6, 7 and 8 are accessible (Fig 6). The room once probably formed a bedroom, and appears to have once been a room and corridor, as there is evidence for a dividing wall (possibly brick) in both the north and south walls and crossing the floor at the west side (Fig 4). There is a fireplace set within a chimney breast at the east side of the room, the remains of a grate being visible. The brick fabric is clearly visible here. A window is present in the south wall of the room, which is of sliding sash (with horns) construction the aperture is blocked from the outside with brick. This has subsequently been rendered over externally, only a projecting sandstone sill being visible (*Section 3.2.7*).

Plate 13: General view of Room 5 facing east

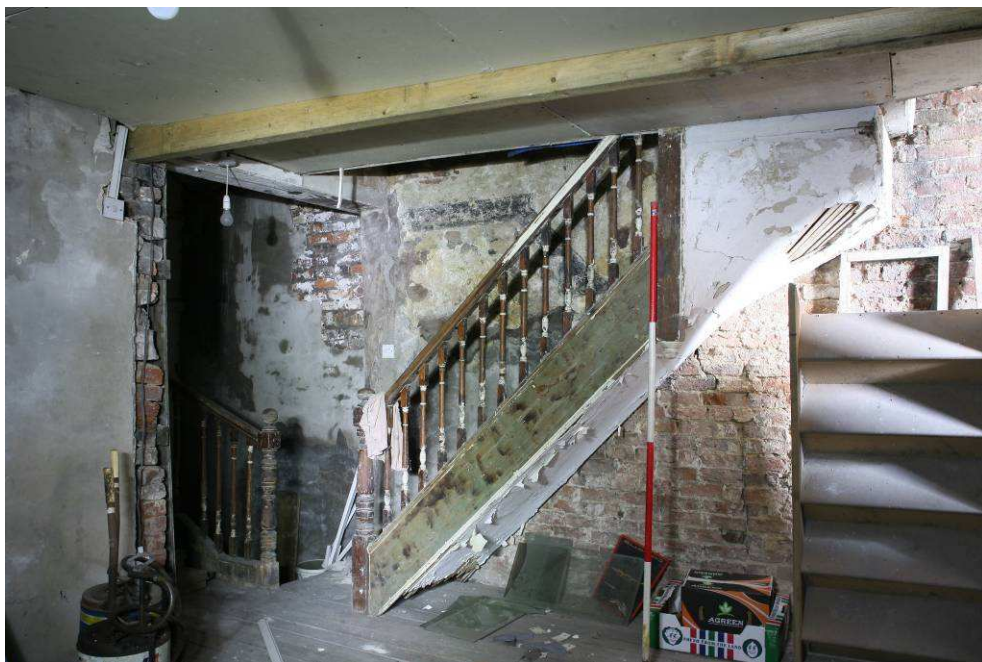
Plate 14: General view of Room 5, facing west, showing staircases and former wall scar on the left

3.2.22 The west side of the room contains the stairs allowing access up to the second floor, as well as the only access to Room 7 (Plate 14). The stairs are a straight flight with half turn at the top, the soffit being covered with lath and plaster. The balusters are simple and turned, as is the newel post. A further balustrade is present where a short flight of three steps allows access to Room 7 (Plate 14). The west and north walls have been stripped of their plaster covering, revealing the brick below which is of stretcher bond. Access to Room 6 is available via a doorway in the north-west corner of the room which is above

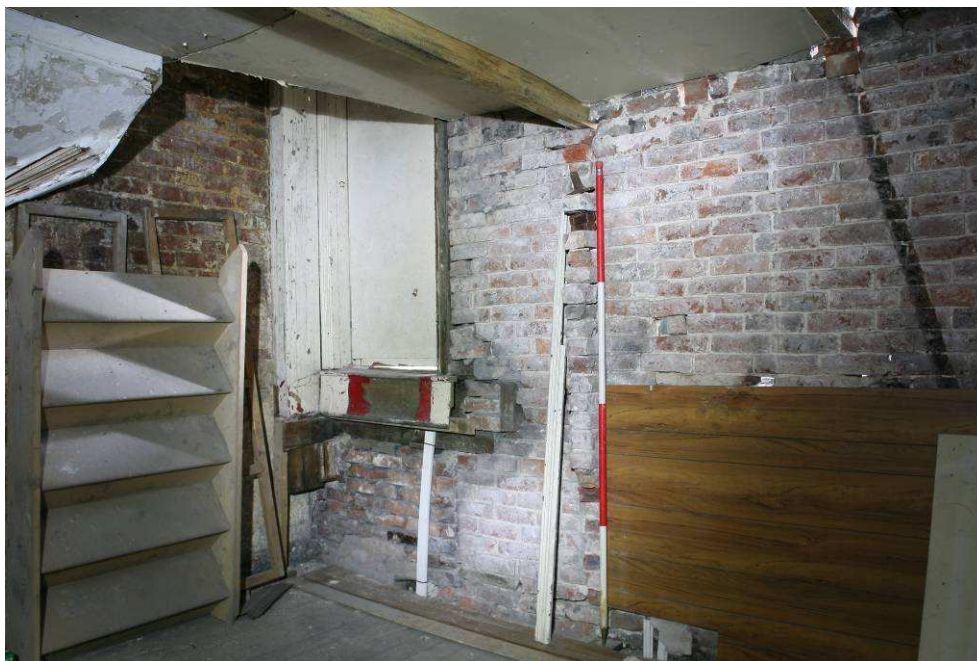
the level of the floor in this room (Plate 15). A flight of fibreboard (MDF) steps were once attached. To the left of the doorway is a vertical timber chute that extends to the second floor (Fig 4). The ends of the floor joists of Room 6 are visible at approximately 1m height in the north wall. Access to Room 7 is via a further short flight of steps, as the floor level in that room is slightly above the level of the floor in Room 5 (Fig 6).

Plate 15: Access from Room 5 into Room 6 showing the difference in floor levels.

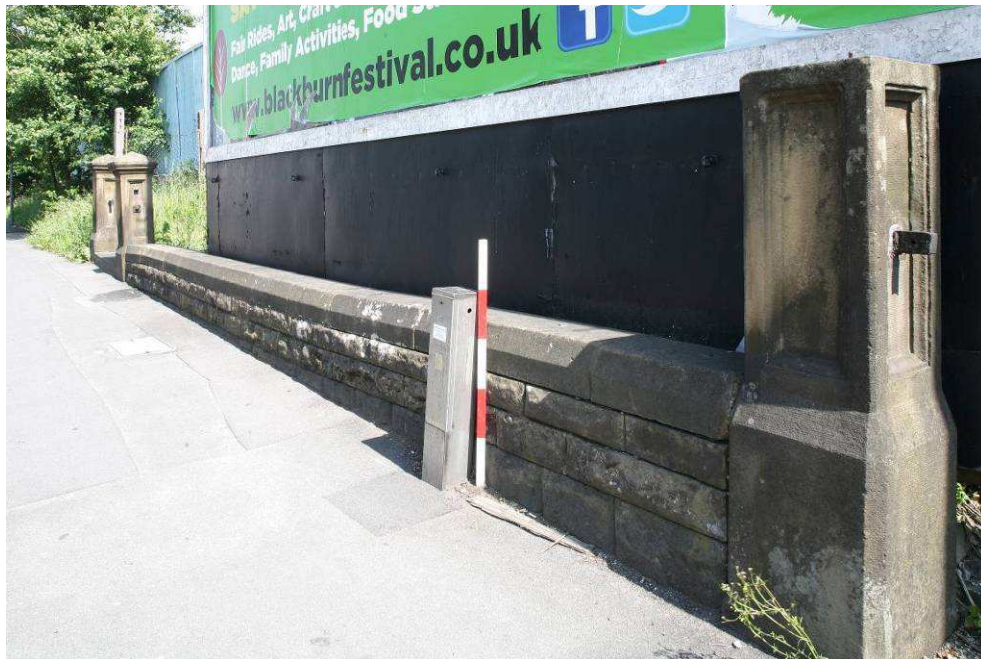
- 3.2.30 **The frontage to the former Police Station:** visible to the east of 53 King Street, is a section of low sandstone wall (Plate 16) with two entrances flanked by taller sandstone gateposts (Plates 17 and 18). The wall is no higher than approximately 1m and is constructed from coursed rock-faced sandstone with finer sandstone coping. The wall survives to a length of approximately 20m. The surviving gateposts form the two entrances to the Police Station, the left to the public offices, the right to passageway to the rear. There is evidence on each of the gate posts for former gates in the form of iron hinge brackets. Each of the gateposts has a recessed panel on each face and two pyramidal copings survive.

Plate 16: Low sandstone wall forming part of the frontage to the former Police Station next to 53 King Street

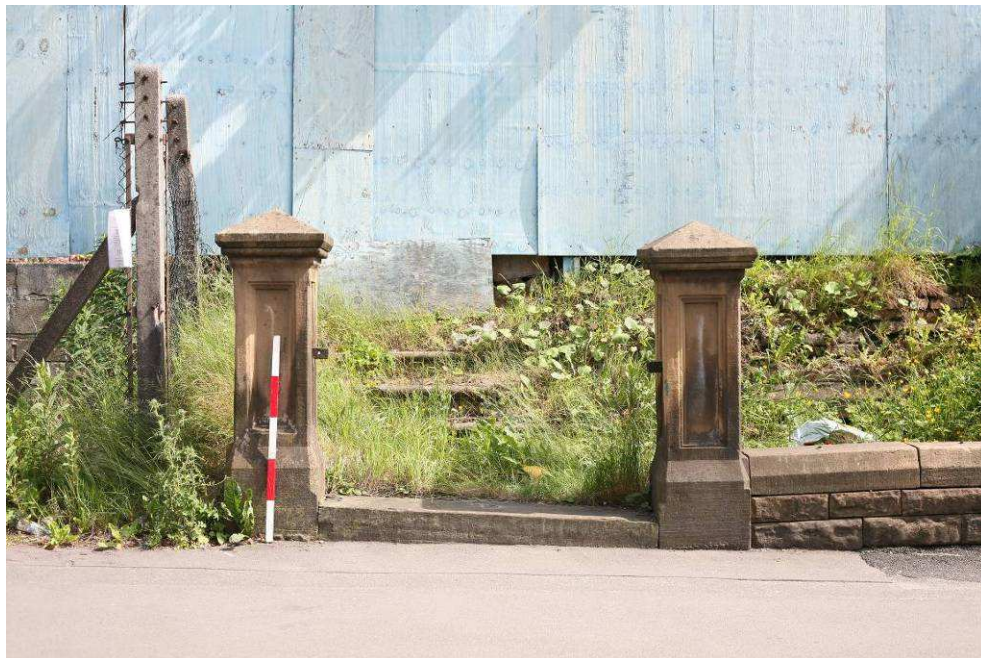
Plate 17: Gateposts forming the former public entrance to the Police Station.

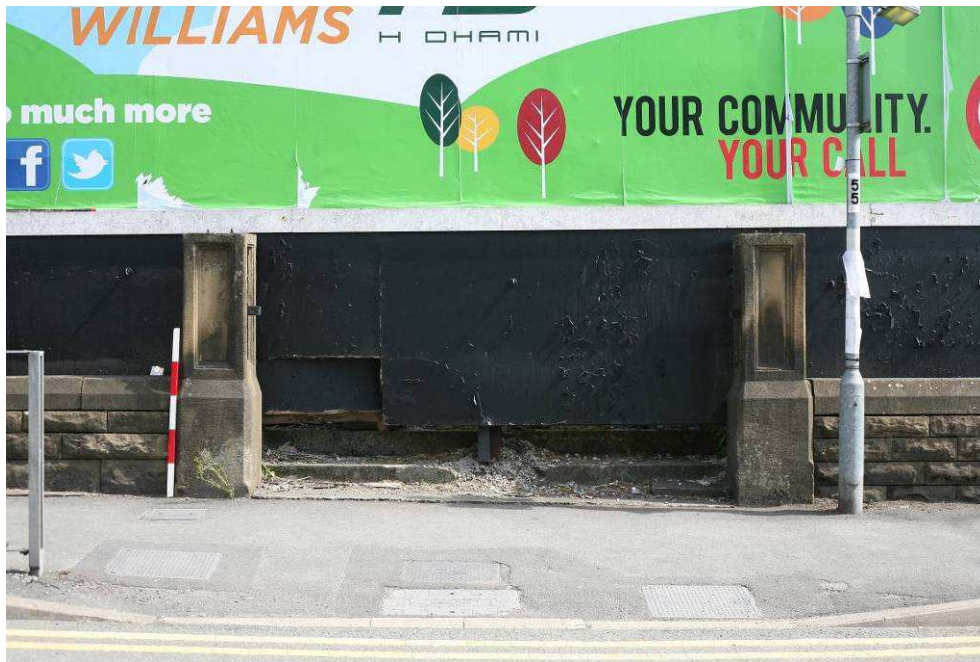
Plate 18: Gateposts forming the former entrance to the central passage of the former Police Station

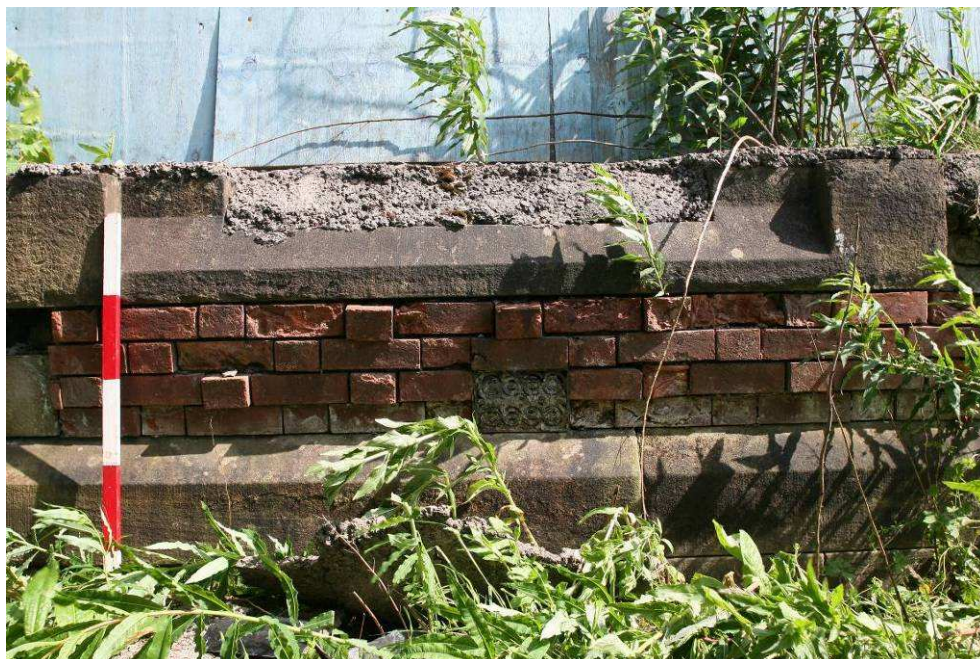
- 3.2.31 To the rear of the wall, and partially obscured by vegetation, part of the front of the actual building survive. This comprises parts of the lower front elevation, including a bay window together with a flight of steps. The surviving parts of the elevation, are constructed of red brick, below which is a

sandstone plinth (Plate 19). The sills of some of the windows are present, and these are substantial sandstone elements with sloping sills. Several decorative cast iron ventilation grilles are still present (Plate 19).

Plate 19: Surviving lower part of the front elevation of the former Police Station

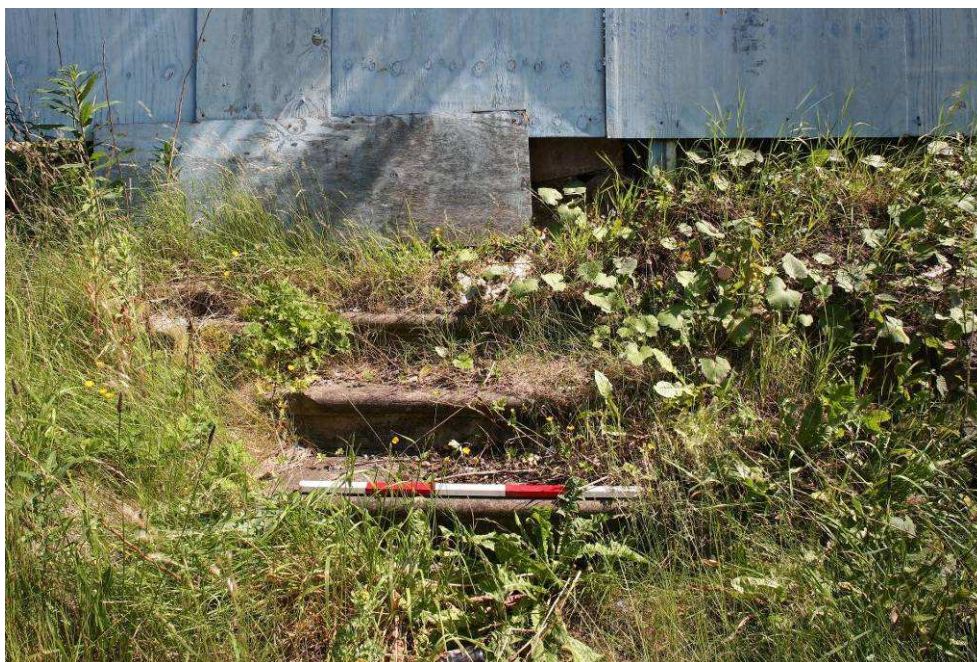
- 3.2.32 The base of a bay window survives, together with two flights of steps, one of which is of stone with moulded steps (Plates 20 and 21). The stone steps are situated behind the left entrance and the other steps (which are modern concrete and may have been inserted) are situated behind the other entrance. Much of this area is overgrown and further remains may survive.

Plate 20: Surviving sandstone steps behind the left entrance

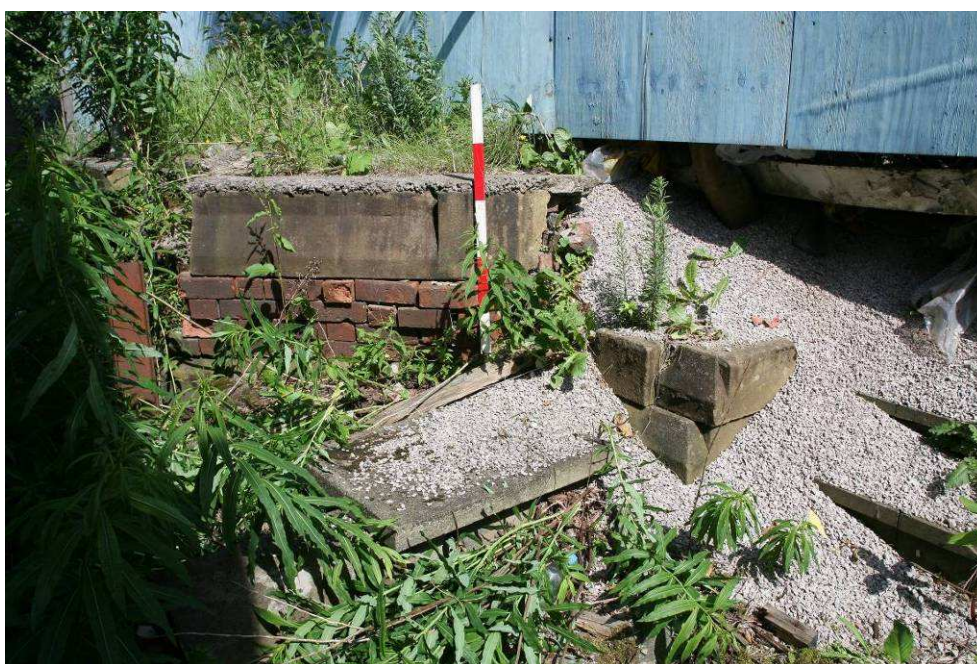
Plate 21: Part of the surviving bay window and steps behind the right entrance.
