# **Two Lions Public House, Great Dockray, Penrith, Cumbria**

## **Archaeological Building Investigation**

**Oxford Archaeology North**

March 2013

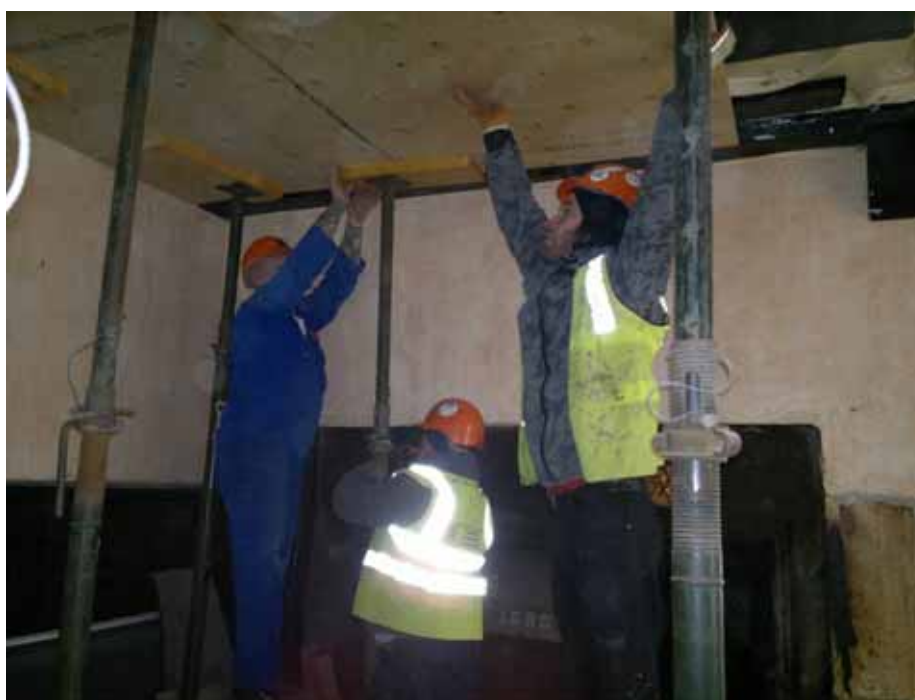
- 4.2.1 At the commencement of the redevelopment of the Two Lions, a protective cover was fitted below the plaster ceiling in order to shield the ceiling from any potential damage. This comprised a layer of foam covered by plywood sheets supported by acro props. Prior to recording of the plaster ceiling, the removal of props supporting the protective foam was required. During this, a watching brief was maintained, as outlined in *Section 2.4*. Each prop and plywood board was taken down and the foam then removed (Plate 5).

Plate 5: Removal of the protective covering on the plaster ceiling

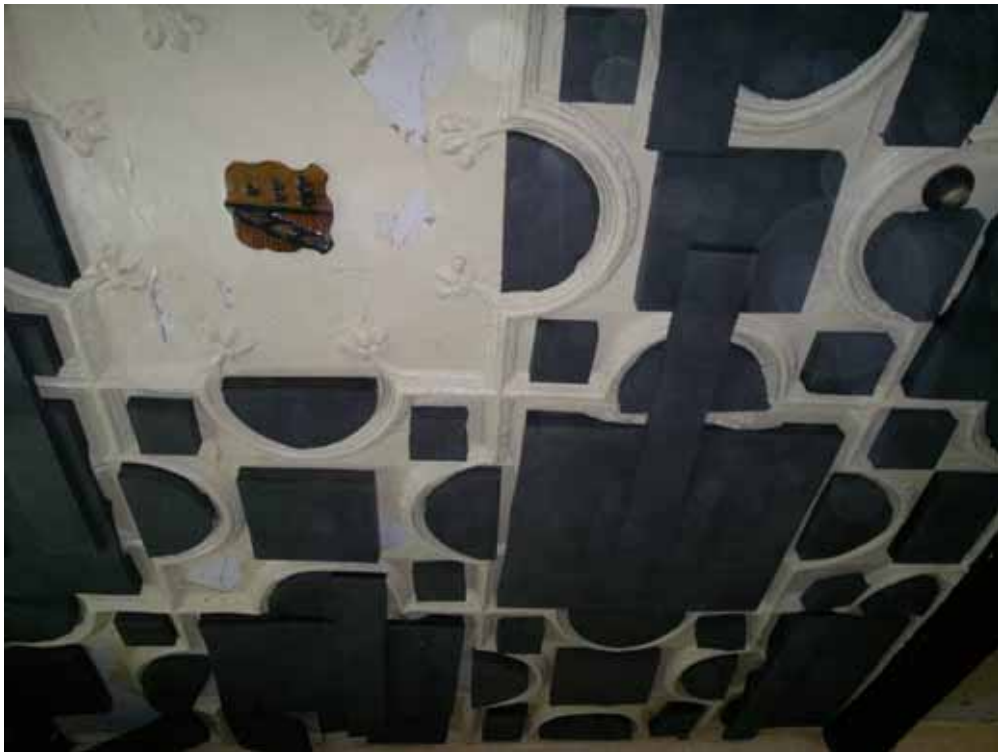
- 4.2.2 Following the removal of the plywood sheets, it became apparent that the protective foam pieces were fixed to the ceiling with black, cloth-backed adhesive tape. (Plate 6). Removal of the foam pieces led to the adhesive tape removing the paint from the plaster ceiling (Plate 7).

Plate 6: Protective foam *in situ*

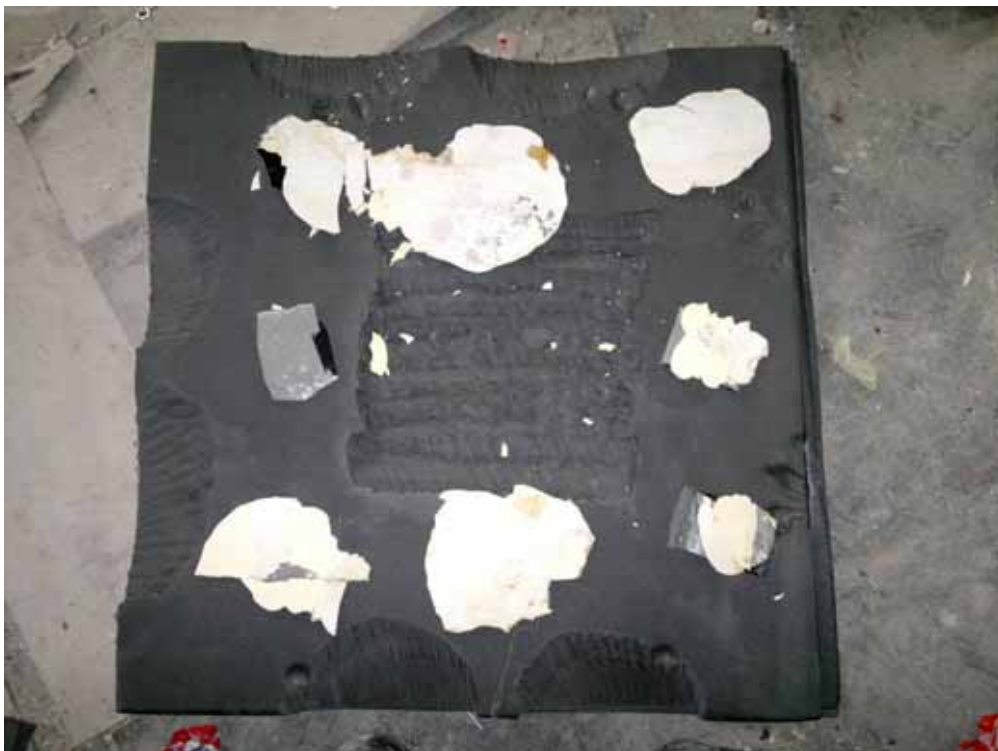
Plate 7: Removed foam piece showing adhered paint and self adhesive tape

- 4.2.3 Consequently, further removal of the pieces was halted, and the ceiling was inspected by the OA North buildings archaeologist. The inspection revealed that there was no resultant damage to the plasterwork where the paint had been removed, and the paint was found to be a modern 'gloss' type, which was not very well adhered to the ceiling. Removal of the foam blocks therefore continued, with no apparent structural damage, although many areas of paint had come away.

5.2.3 The recording work revealed that the ceiling was still covered with extensive areas of modern paint which, during removal of the protective foam, was pulled or flaked off relatively easily due to the strong adhesive tape used to stick the protective foam to the ceiling. A number of recommendations were made following the 2008 inspection (*Appendix 3*), and the implementation of each one is essential if the ceiling is to be preserved and conserved.

6.2.2 ***Plaster Ceiling and Decorated Joists:*** before any further building work, a number of measures should be carried out which are outlined in the recommendations section of *Appendix 3*. If the protective covering on the plaster ceiling needs to be re-instated, it should not be fixed to the ceiling using adhesive tape. There should be a layer of acid-free tissue between the ceiling and supportive material. Both the flat panels and mouldings need to be protected and supported, unlike the previous protective covering which did not support the panel mouldings.

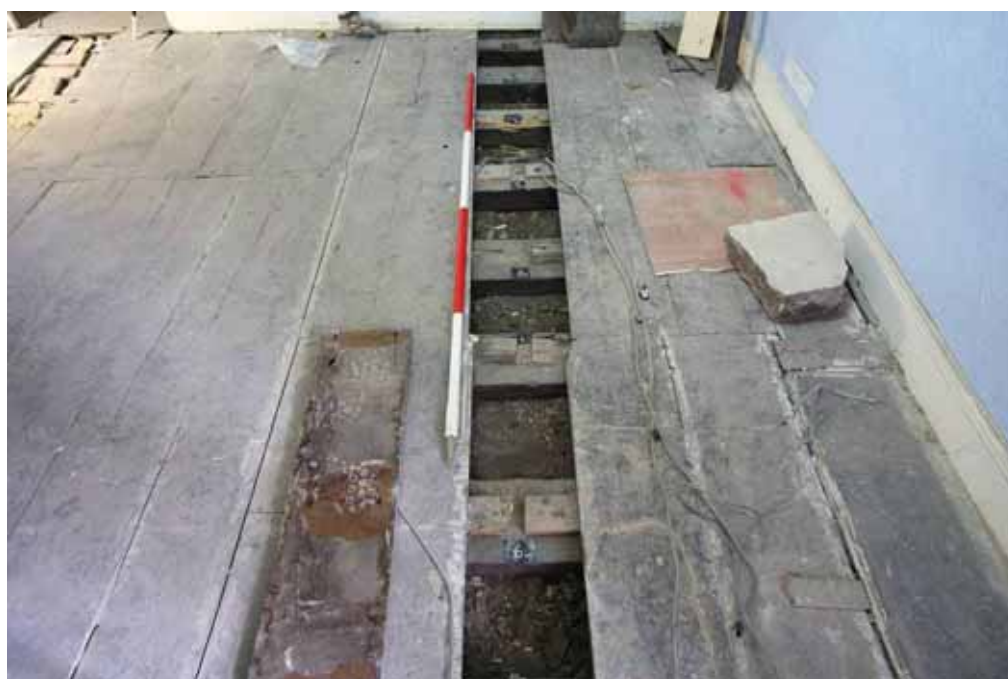
Plate 13: Removal of a floorboard revealed several decorated joists

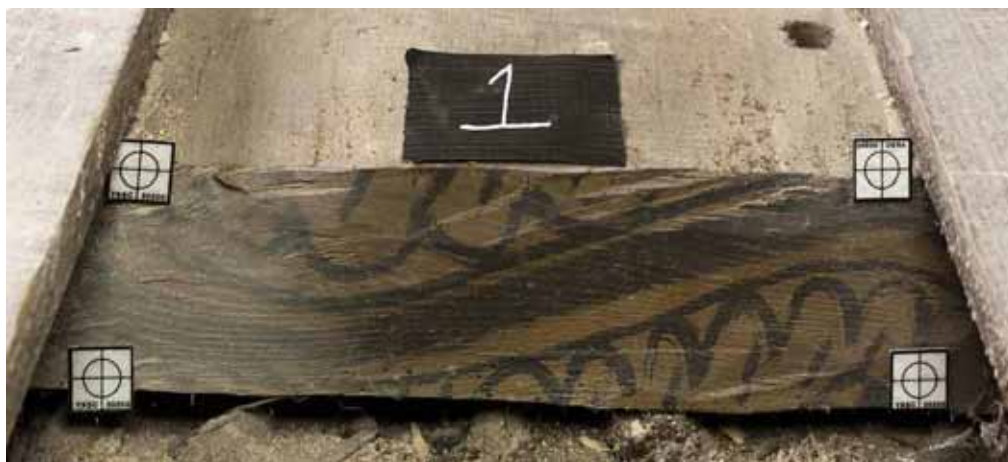
Plate 14: Example of a decorated joist below the floorboards in Room 24

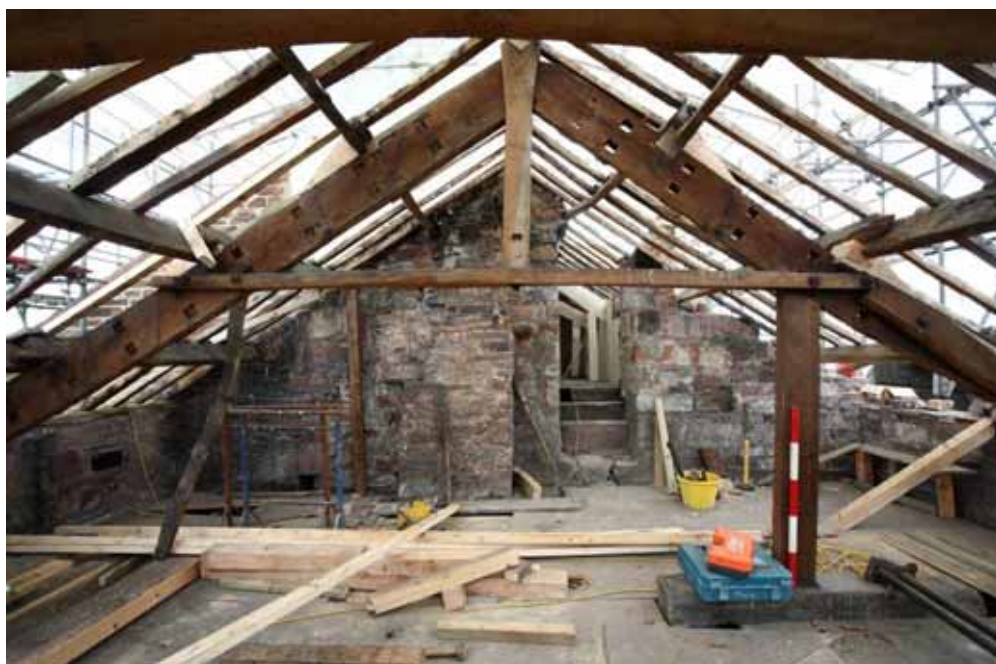
- 4.5.15 This section of roof contains two trusses, both of which were in the process of being repaired at the time of the survey (Plate 30). Both trusses are similar in their construction, each being a king post truss, the king posts being bolted to a collar that is itself bolted to the principal rafters at each end. The foot of each of the principal rafters is set within the wall on each side. There are three rows of purlins on each side of the trusses that rest on new cleats. It is apparent that the purlins were formerly trenched into the foot of each of the principal rafters, as there are visible notches. A single queen post supports the north rafter of the

Plate 30: East roof section showing the truss construction

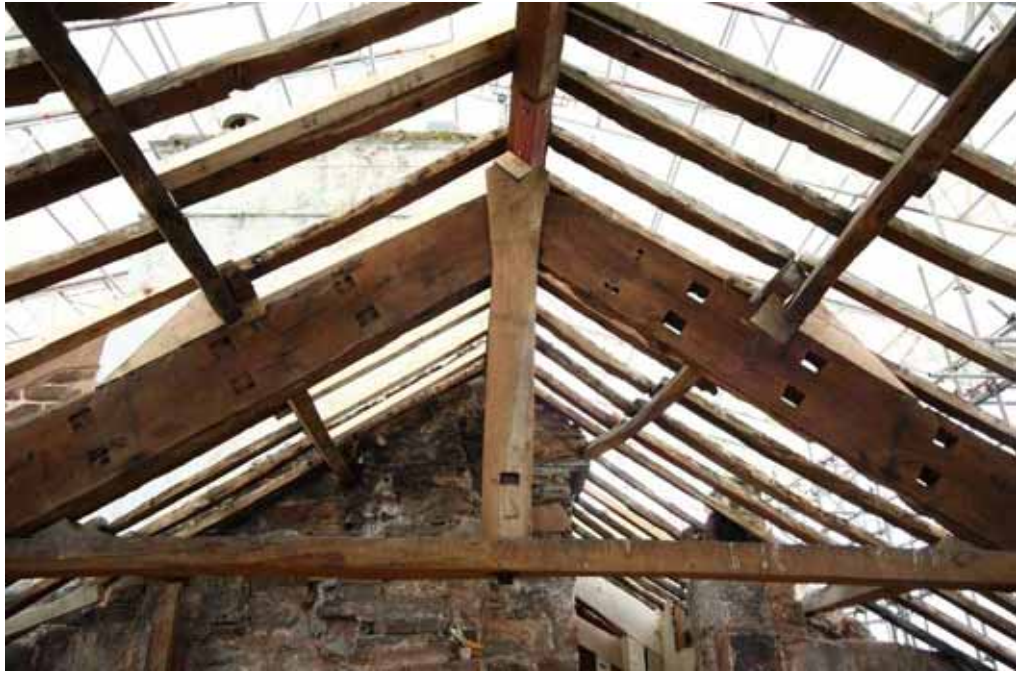
Plate 31: The west truss with holes clearly visible in the principal rafters

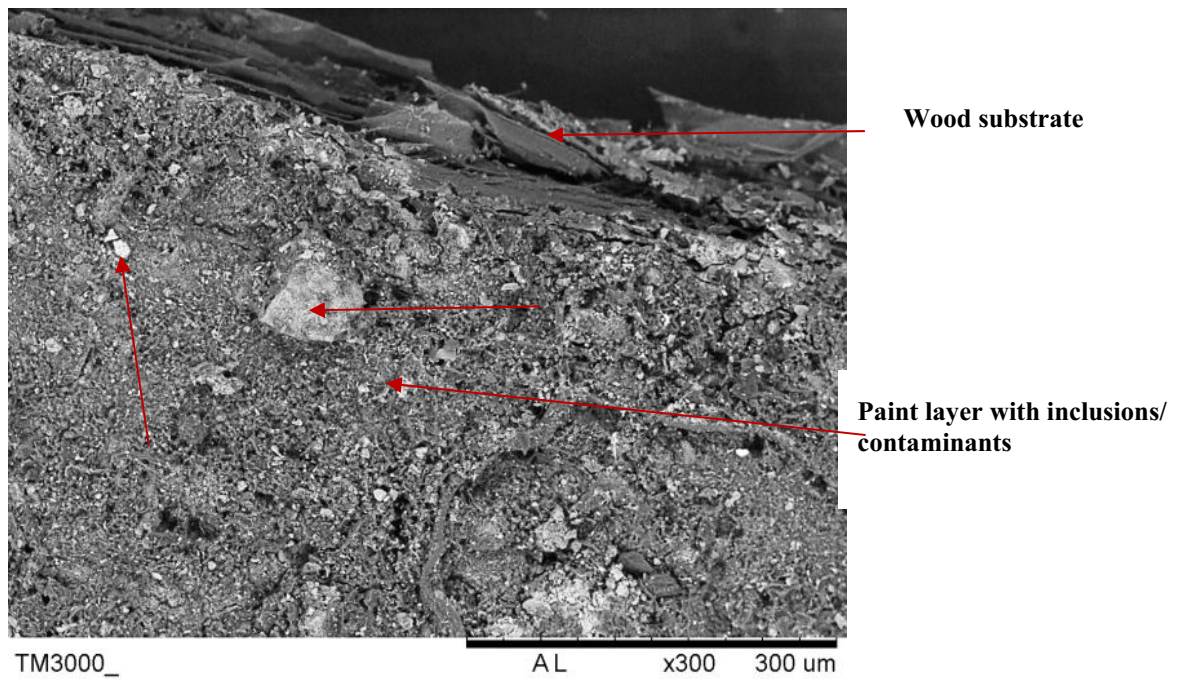
The SEM images below, taken at magnifications of x300 and x800 show the uneven surface of the paint layer, together with evidence of the surface contamination which remains after solvent cleaning. It is likely that the uneven surface of the paint has helped to attract and retain contaminants throughout its life.

SEM image (x300) of paint and wood substrate from beam 13E

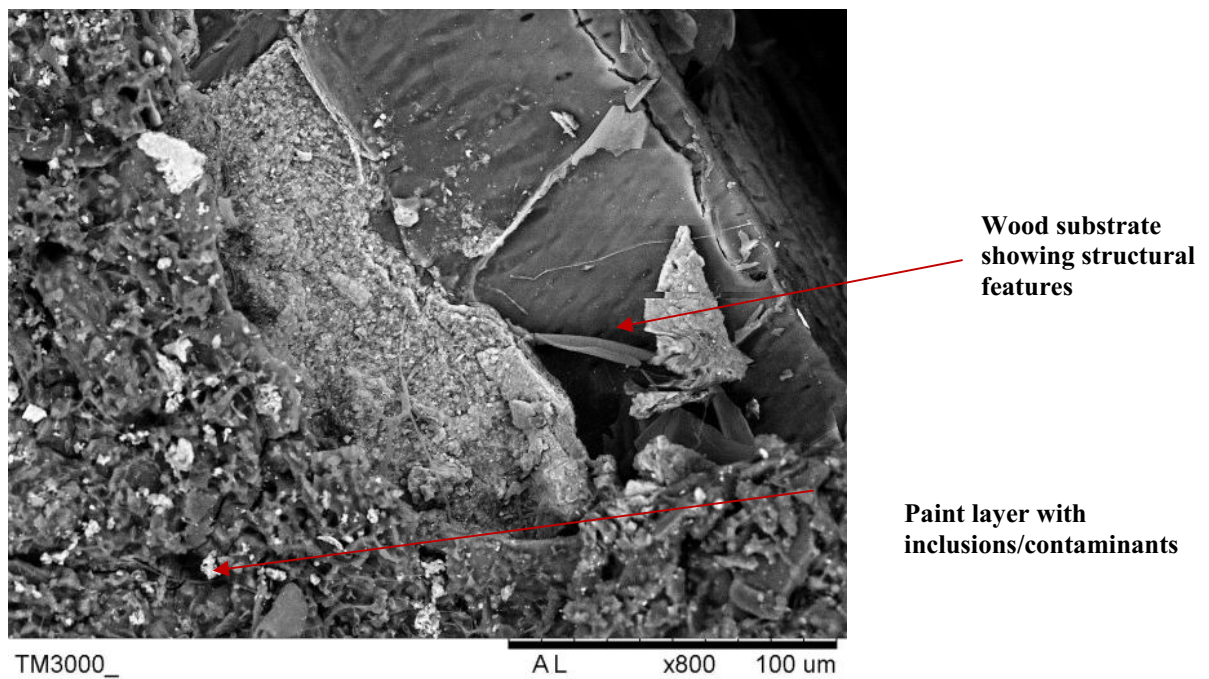
SEM image (x800) of paint and wood substrate from beam 8W
