ORDSALL HALL REFURBISHMENT, SALFORD

Archaeological Watching Brief and Excavation Report

Oxford Archaeology North

March 2012

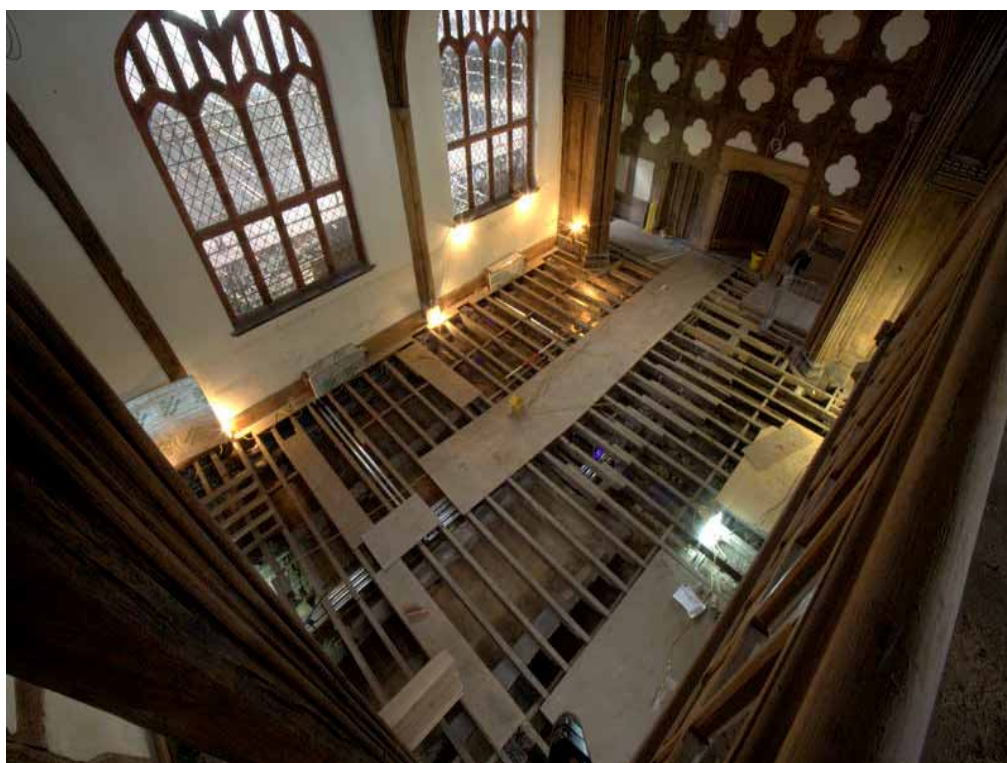
Plate 4: General view of the Great Hall (G4), showing floor construction

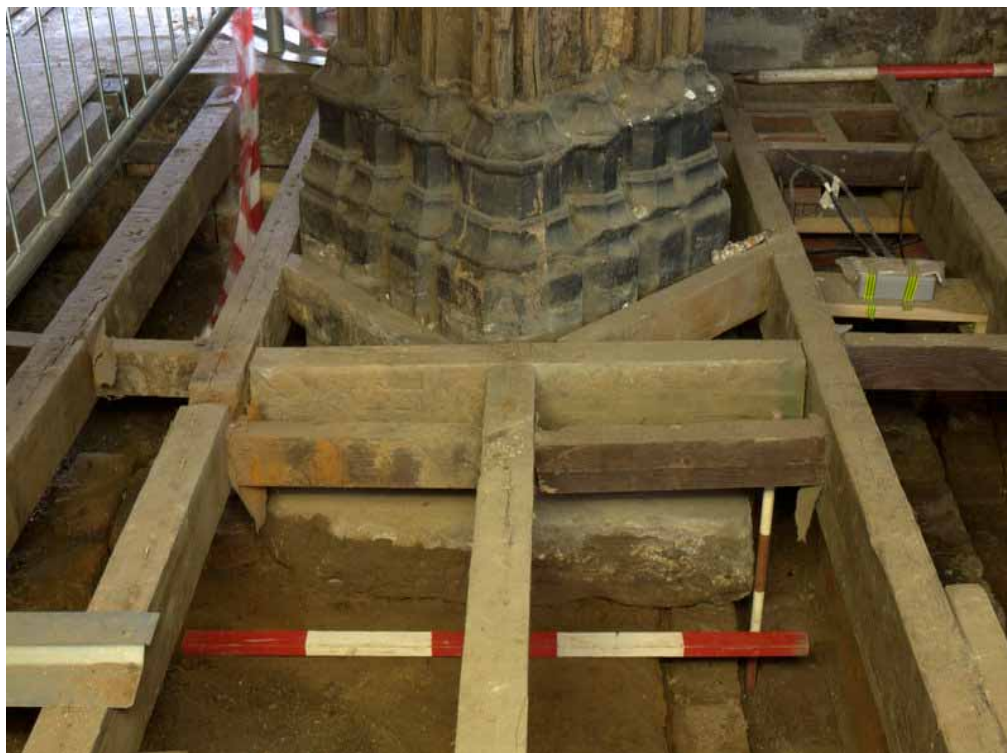
- 4.2.3 The decorated base of the spere post was diamond-shaped in section, although with a flattened southern side at the point where the wall-frame was joined to the post (Fig 9). The post was supported on a 6” (0.15m) deep, pale-coloured padstone. This was 3’(0.91m) square in plan (Plate 5), and comprised two approximately equally-sized sandstone blocks. This padstone was set on compacted orangey-brown natural sand (**I00**). A single-skin brick wall (**I03**) underlying the western side of the padstone, formed part of an undercut and later feature (see *Section 5*, below).

Plate 5: Detail of the Spere Post, with sandstone pad below

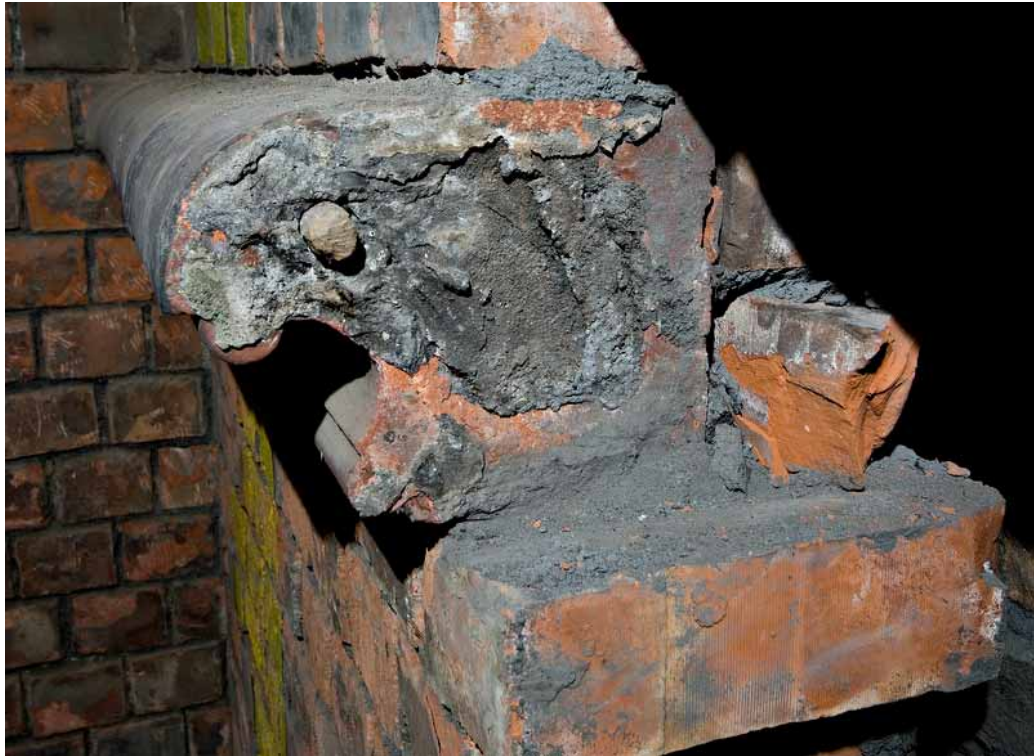
- 4.2.6 A terracotta string-course was incorporated into the external face of the wall. It was of *ogee cyma recta* style, being positioned at mid-floor level, and matching a similar string-course positioned between the ground and first floors. The individual sections of the string-course were jointed together with timber dowels and liberally bonded with a black sooty mortar (Plate 8). Each section was stamped on the reverse face with the makers mark “JABEZ THOMPSON TERRACOTTA WORKS MANCHESTER”, accompanied by the letters “OH”, suggesting that the mould was specifically made for Ordsall Hall (Plate 9).

Plate 8: Detail of the Great Hall (G4) string-course

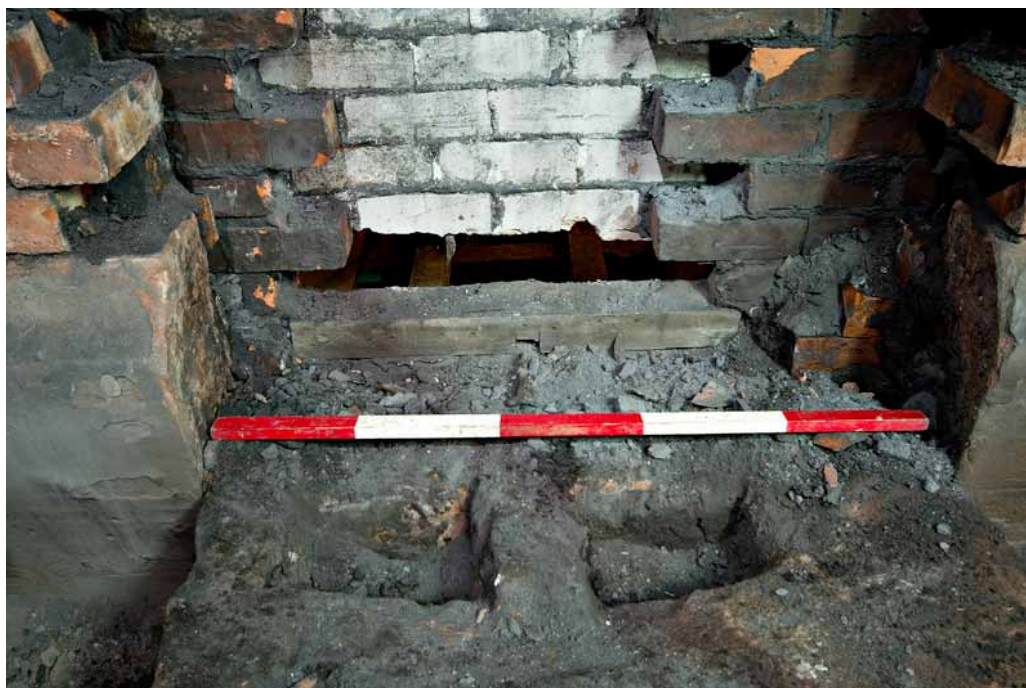
- 4.2.7 A red sandstone plinth projected slightly from the base of the external face of the wall. It comprised large sandstone blocks 3' x 2' x 9" (910 x 610 x 229mm), narrowing to a chamfer of half that thickness at the top (Plate 10). Removal of a section of the plinth exposed a timber rail, the purpose of which was unclear, although it appeared to be aligned with two rectangular-shaped apertures in the back of the plinth (Plate 10).

Plate 10: Removed section of Plinth, external south wall of Great Hall (G4)

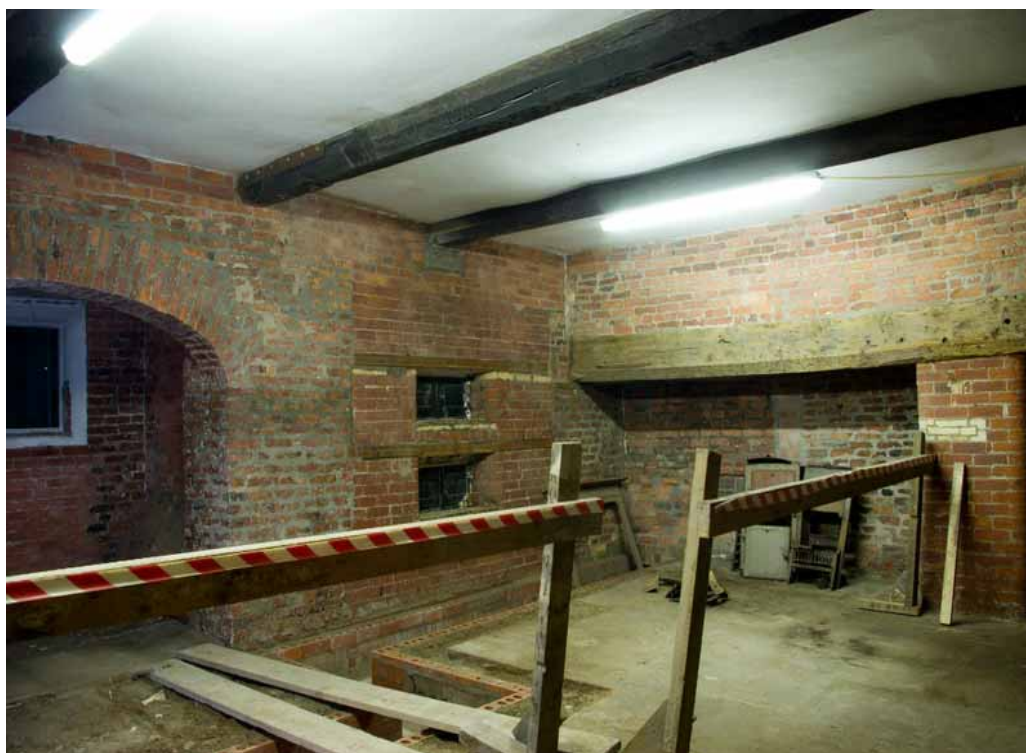
- 4.2.10 All of the walls are of brick construction, and extensive patching and repairs were visible, most of which appears to have been carried out relatively recently using cement-based mortar and a variety of brick types. The earliest fabric was constructed in English Garden Wall bond, typically comprising three courses of stretchers between those of headers, with thin hand-made bricks measuring approximately 9" x 4¼" x 2" (229 x 108 x 50mm), and bonded in a pale lime and sand mortar (Plate 11).

Plate 11: General aspect of the Kitchen (G10), with large inglenook fireplace and bread ovens

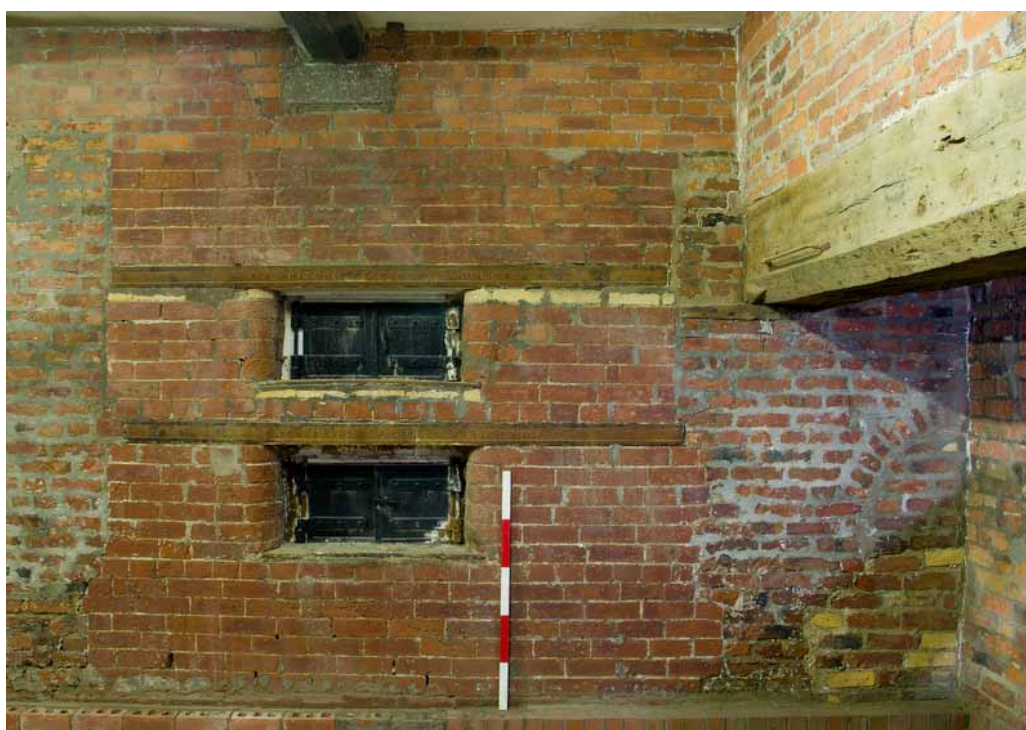
4.2.14 To the north, the wall had a 3.4m wide rebuild in similar machine-made brick to that to the south. It was straight-sided in the centre, becoming more ragged towards the base and the ceiling (Plates 11 and 14). The rebuild houses two cast-iron oven double-doors (Plate 14), each below a cast-iron lintel, stamped 'J JENNISON^S PATENT MANCHESTER'. These are almost certainly bread ovens, and appear to have been inserted in the late-nineteenth century. There was no direct evidence for the ovens on the external face of the wall, although it had been rebuilt in a different sequence of English Garden Wall bond from the original wall to the north. In addition, results from both the watching brief (See wall **23** in *Section 4.5.16*, below) and the more extensive excavations undertaken by UMAU in 1991 (GMAU 1991), revealed a possible structure placed adjacent to the west wing, which would almost certainly have incorporated the ovens.

Plate 14: Detail of inserted bread ovens

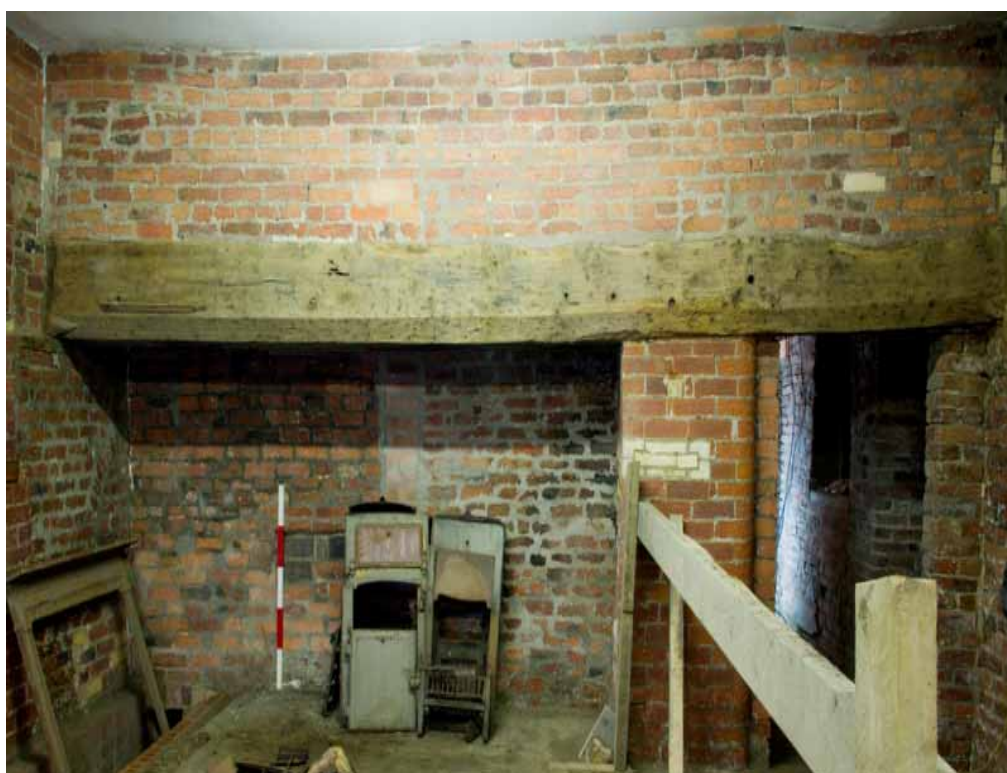
4.2.15 Immediately to the north of the bread ovens, the return of the north wall was incorporated into a large inglenook fireplace. This had been modified on at least one occasion, and comprised the majority of the north elevation, the full brick-thickness firehood being carried on a large-scantling, flat-chamfered bressumer, with decorative broach stops (Plate 15). This spans the full elevation, forming a lintel to a heck passage on the eastern side of the fireplace (Plate 15). This passage had been extensively remodelled, showing evidence for at least three phases, having originally been open into the room to the north, and blocked and re-opened, subsequently.

Plate 15: Inglenook fireplace in the Kitchen (G10)

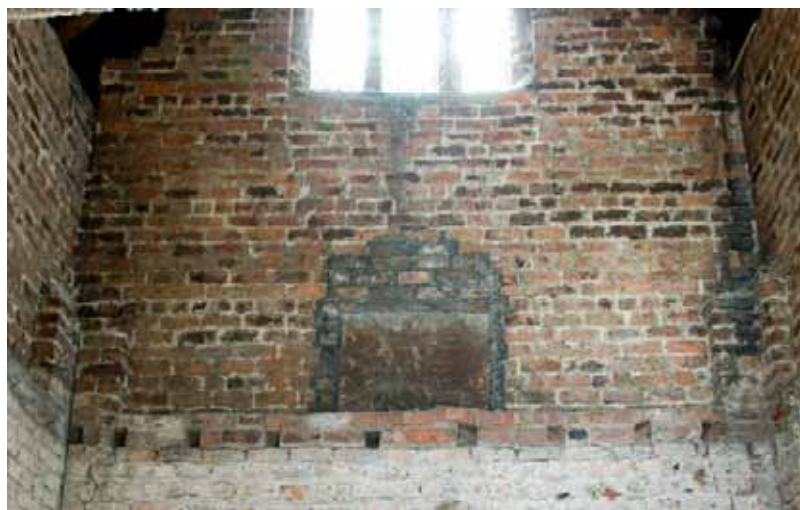
each mullion being quite degraded (Plate 29). The glazing within this window also differed from those below, comprising diagonal leaded comes, rather than the larger squares below, suggesting it represented an earlier survival. A blank sandstone panel immediately below the window on the external face, was not visible internally, however, the rear of the terracotta wall plaque, dated to 1898, was clearly visible within an area of rebuilding, and was bonded in black sooty mortar (Plate 29). Evidence for a blocked horizontal aperture at eaves level in the south elevation was also observed, but given the lack of access within the tower it could not be examined in detail, although it possibly represented a blocked small window.

Plate 29: Inserted wall plaque, and window in Stair Tower gable

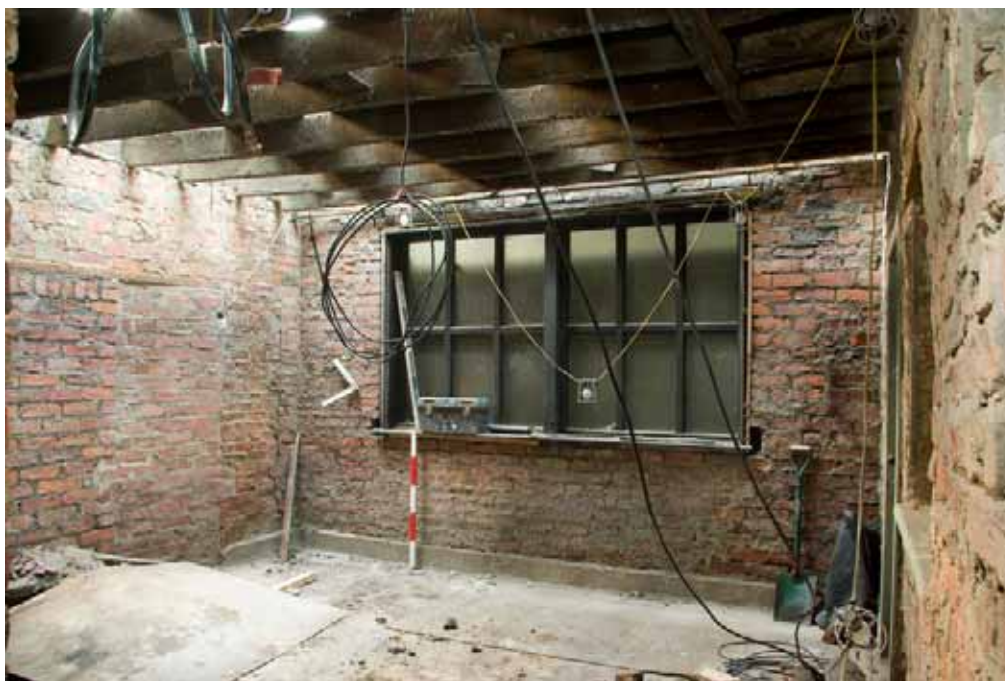
4.2.29 The large horizontal 12-light window in the north elevation (Plate 30) represented a replacement of an apparently similar earlier example. This appeared to be contemporary with the rebuilding of the north wall (Plate 30). This presumably dated to the reduction of the extension to single-storey height, quite probably undertaken during the major remodelling of the property at the turn of the twentieth century.

Plate 30: Rebuilt north wall of the Gardener's Office

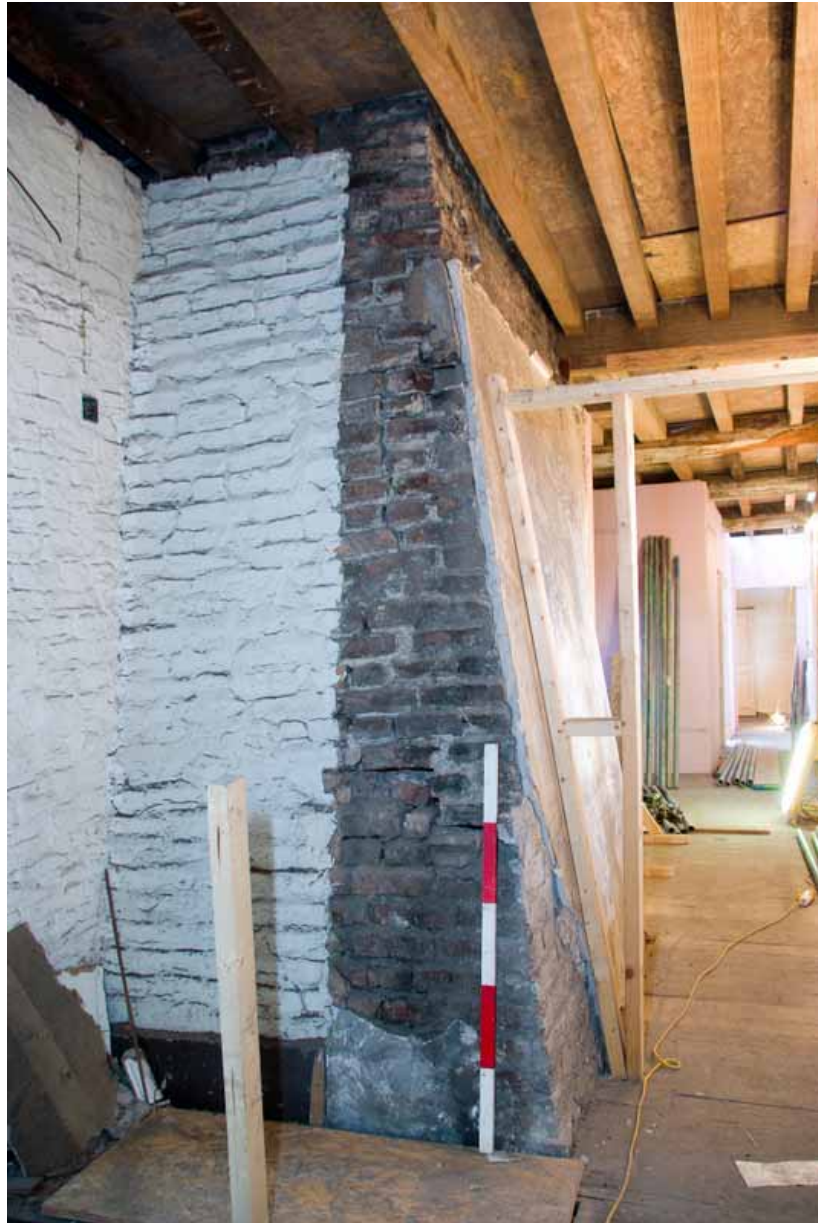
continuation of the brickwork of the stack around its south-eastern corner, where it was constructed in three-stretcher English Garden Wall bond. A small section of plaster, which predated the L-shaped wall, survived at the base of the chimney-stack (Plate 32).

Plate 32: Chimney-stack revealed by removal of a later wall in the Egerton Gallery

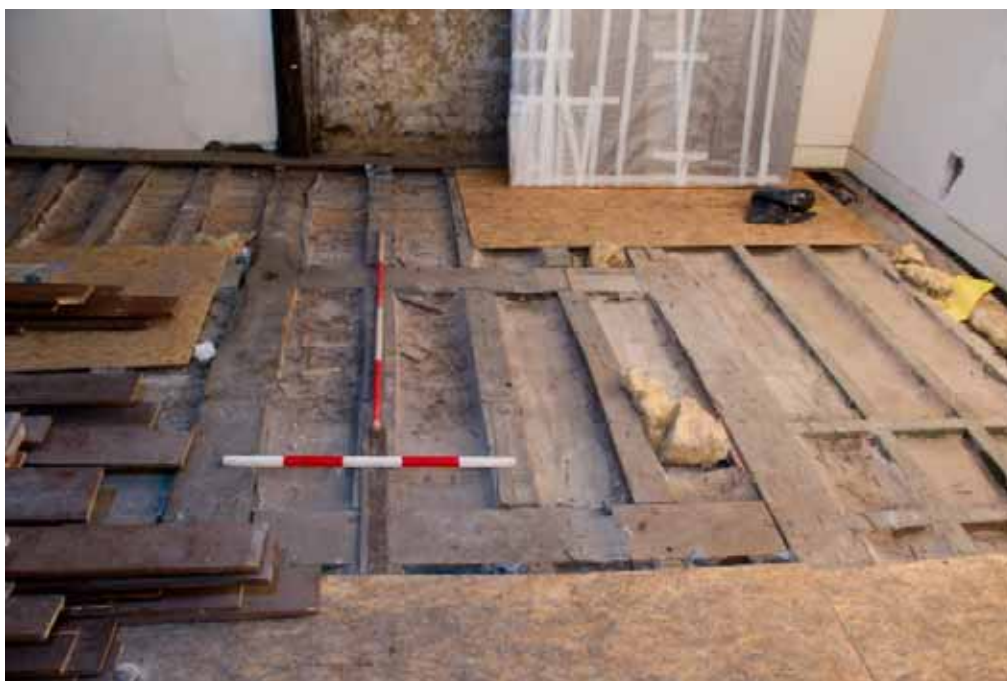
4.2.35 **The Lord's or Great Chamber Floor (F3):** the floor in this room was partly revealed by the removal of much of the existing floor boards (Plate 33). The specification for the refurbishment of the building required that the floor in this room be strengthened, and previous interventions were to be left *in situ* by the contractors. The floor remained in the same condition as when drawn by the GMAU survey of 1993 (GMAU 1995, Fig 9).

Plate 33: Area of floor structure exposed in the Lord's Chamber

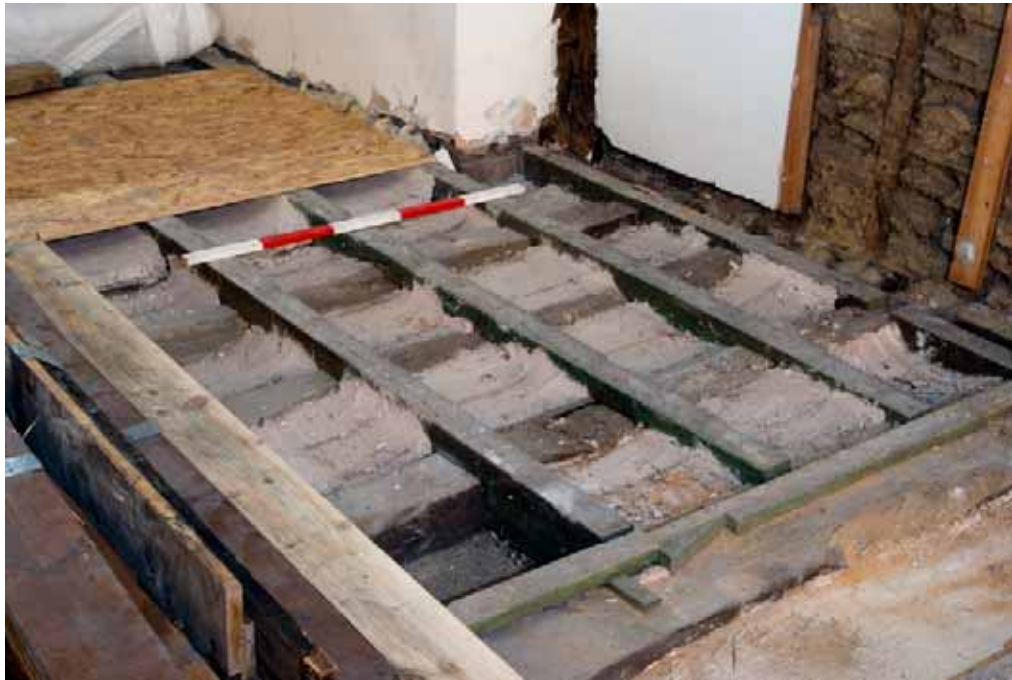
- 4.2.37 The floor structure also had been subjected to various phases of minor repairs. Some modern L-shaped brackets had been added to supplement the timber jointing in several places. Notches also had been cut into some of the beams and joists for the insertion of cables and wires. Steel-mesh reinforced mortar had been applied to the spaces between the main structural members, obscuring the nature of the upper face of the Star Chamber Ceiling, which appeared to be of lime. The entire floor was sealed by 8" (0.20m) wide square-edged floorboards (Plate 33), with an array of packing pieces used to level the floor.

Plate 34: Later joists associated with an extension to the south of the Great Chamber, notched over the earlier fabric

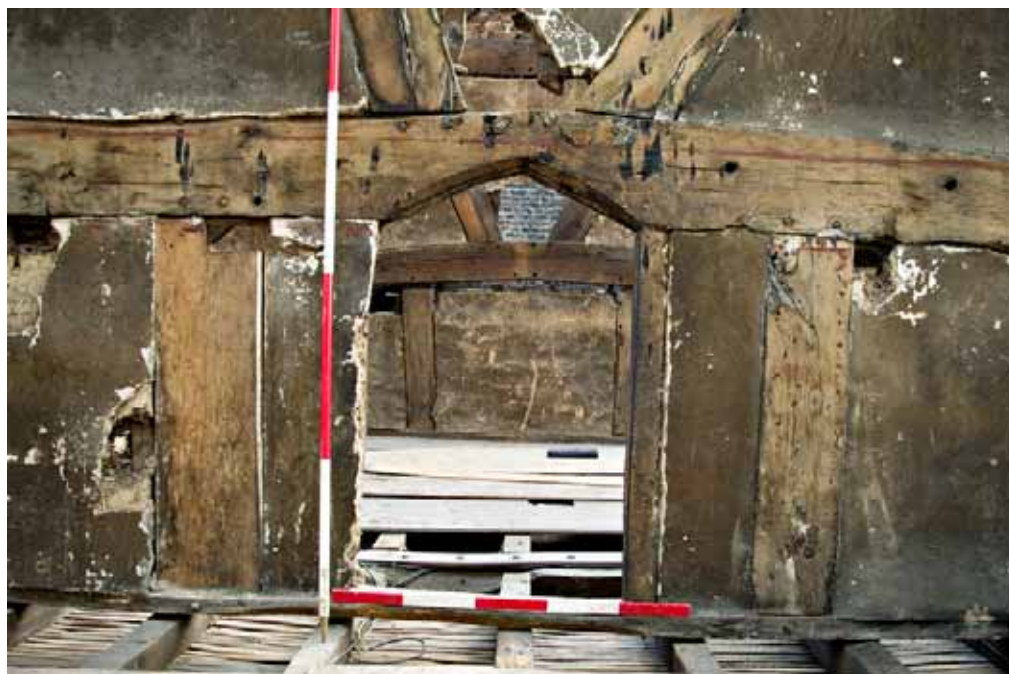
double-pegged within mortices in the tie-beam, and with only single pegs into the much lower-scantling rail at floor level (Plate 37). This rail was almost certainly a replacement, and redundant third peg-holes within the mortices on the soffits of the tie beams suggest that the posts may have also been replaced (Plate 37).

Plate 37: Detail of truss within Room S9, showing pegged assembly

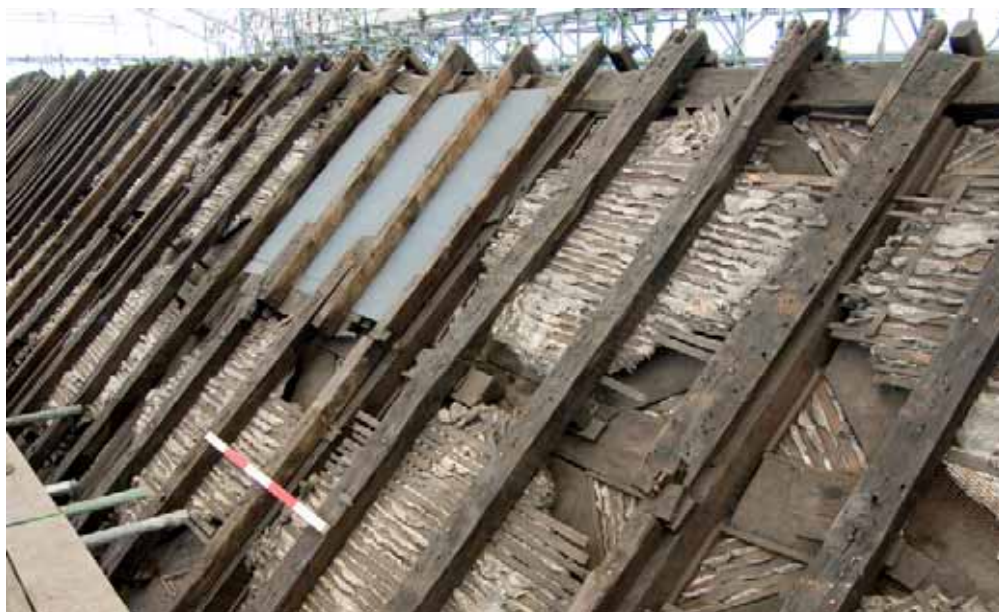
4.4.16 Incised carpenter's assembly marks were observed on many of the joints, comprising Roman numerals and tags (Plate 54). The ceiling below was formed onto riven oak laths (Plates 53 and 54), laid above the decorative panels and purlins, but beneath the rectangular-section common rafters. These were set in opposing pairs, the northern member being bridled, and clasped and pegged into the southern rafter (Plates 55 and 56). Several replacement rafters of similar scantling had squared ends, and were nailed to the ridge (Plates 53 and 56). On the southern pitch, the rafters were sprocketed onto the later parapet (Plate 53). The third bay from the eastern end of the lath and plaster ceiling contained a steel sheet between the upper and ridge purlin on each pitch, which was held in position by short re-used jack rafters (Plate 56). This represents the infilling of the original open louvre of the Great Hall (G4),

with the ceiling below the steel sheets having been infilled with plaster. Whilst of apparently relatively modern date, the sheets almost certainly represent the replacement of an earlier blocking, which may have failed to maintain a waterproof membrane to the ceiling.

Plate 56: Blocked louvre, southern pitch, Roof D

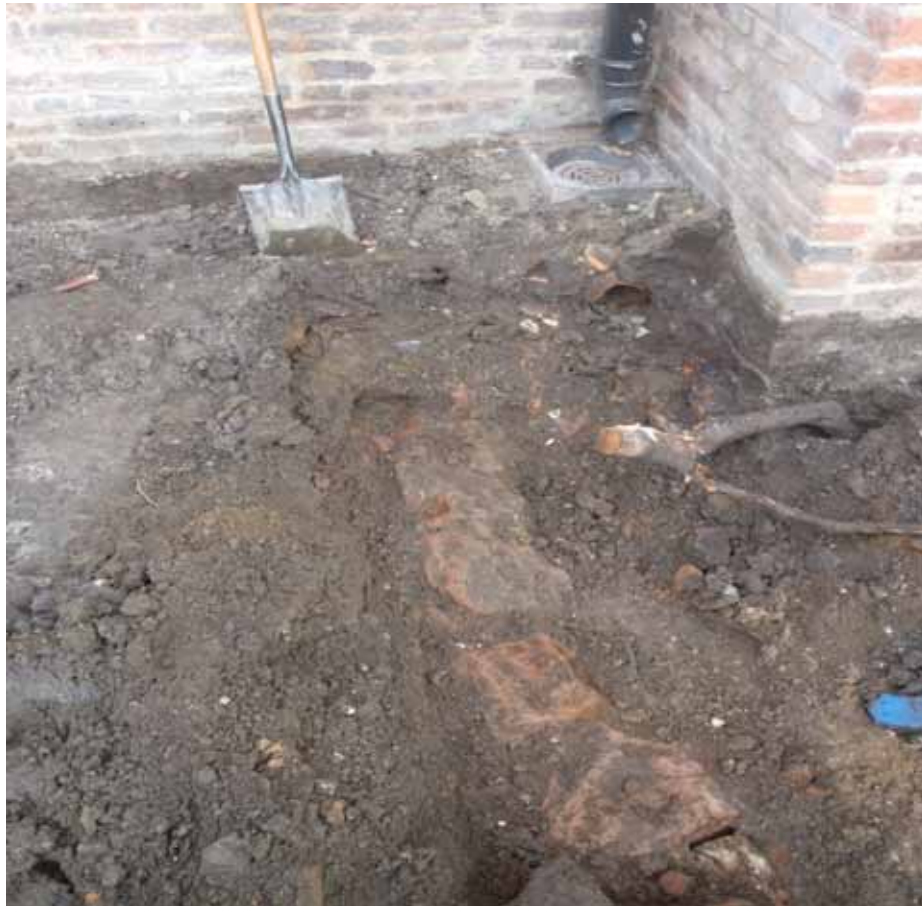
- 4.6.3 Two stone walls (**29** and **37**) and a stone culvert (**30**) were partially exposed. Wall **29** (Plates 79 and 80) followed a vague east/west alignment, and appeared to be truncated by the northern end of the west wall of the hall. It comprised a single course of unbonded, worn, yellow sandstone blocks, surviving for a length of 0.75m. These were set on red sandy-clay, which was exposed 1m beneath the modern ground level. A large block, measuring 0.8 x 0.6 x 0.4m was removed from loose deposits above the wall, and was likely to have formed part of an upper course. The projected approximate length of the wall measured 3.30m. It would certainly appear that this wall pre-dates the northern annexe to the west wing

Plate 79: Eastern extent of Wall 29

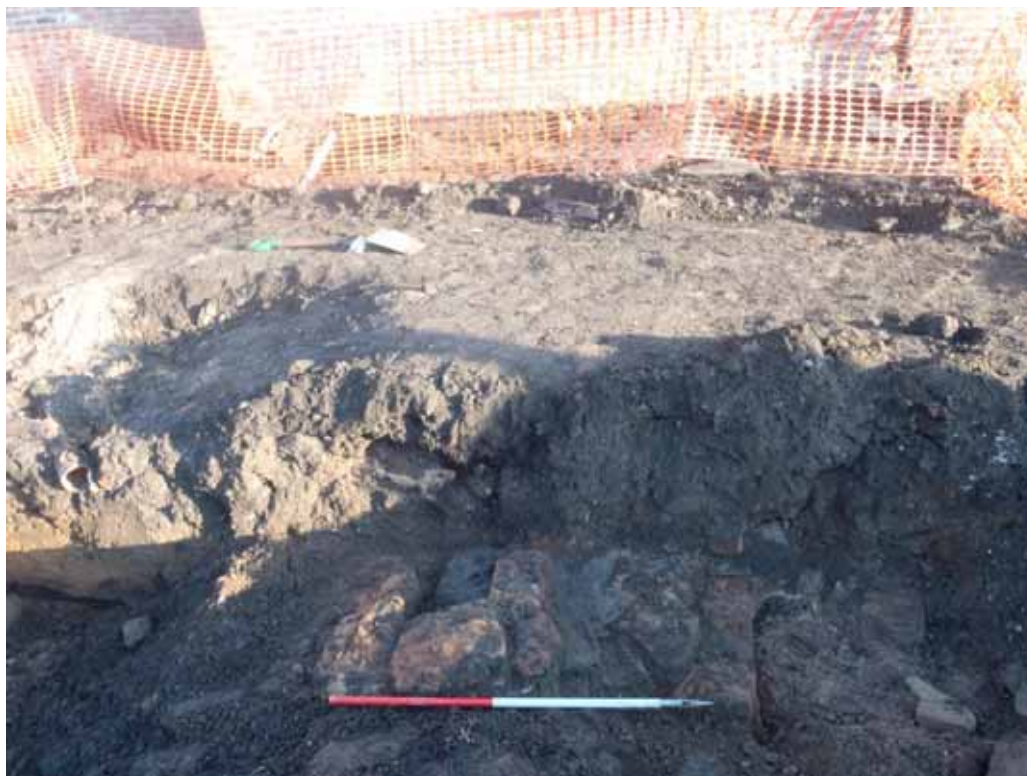
- 4.6.6 An arrangement of irregular-sized stone blocks and slabs (25; Plate 83) was exposed 5.8m to the west of the hall. It was aligned north/south for a distance of 2.1m, and was 1m wide. The stones are almost certainly the foundations for a wall. The wall overlay a 0.4m thick clay and gravel levelling layer, which in

turn overlay a horizon of red sandy-clay (28). The clay (28) yielded pottery dating no later than the late-seventeenth century. The stone blocks (25) were sealed by a dump of demolition debris (27) containing charred building material, and domestic refuse, including eighteenth-century blackware pottery. This tentatively limits the date of construction of the wall to between the late seventeenth century and eighteenth century, and suggests that the structure it relates to burnt down.

Plate 83: Foundation 25

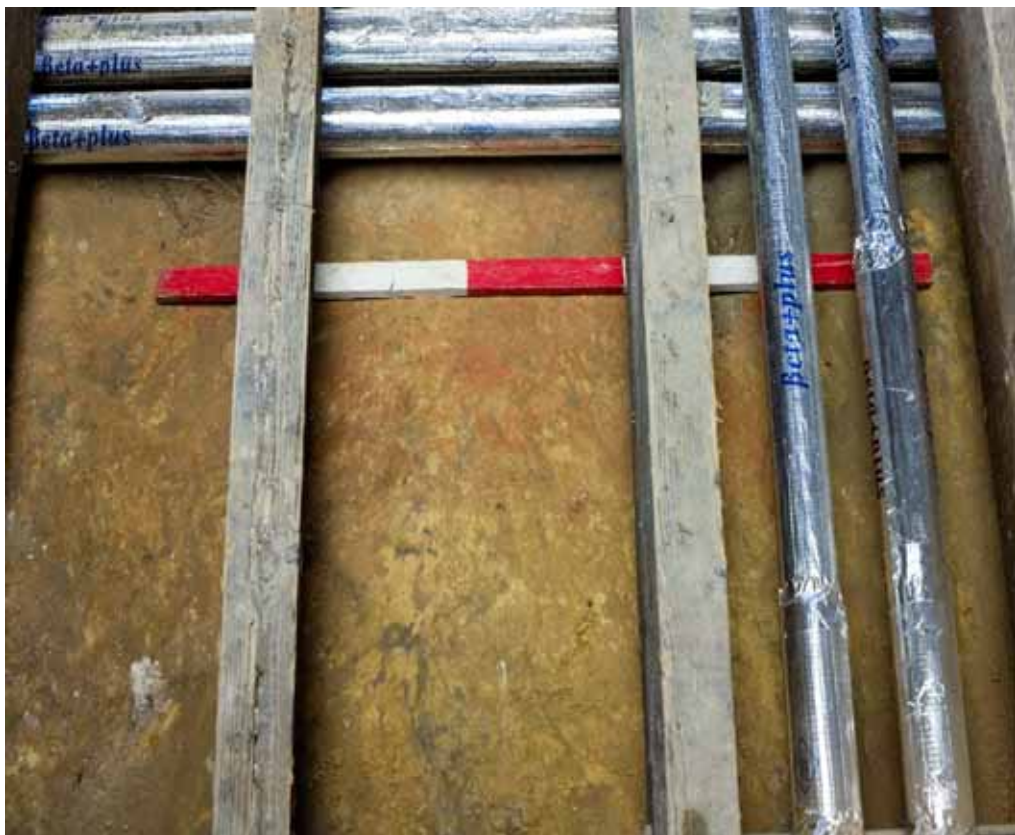
Plate 94: Area of burnt sand (101) resulting from the former presence of a hearth
