Redisher Works, Holcombe Brook, Bury, Greater Manchester Archaeological Investigation

December 2018

Client: CgMs Heritage

Client Name: CgMs Heritage
Document Title: Redisher Mill, Bury
Document Type: Archaeological Investigation Final Report
Grid Reference: SD 7778 1542
Planning Reference: 59 715
Site Code: RSM18
Invoice Code: L11161

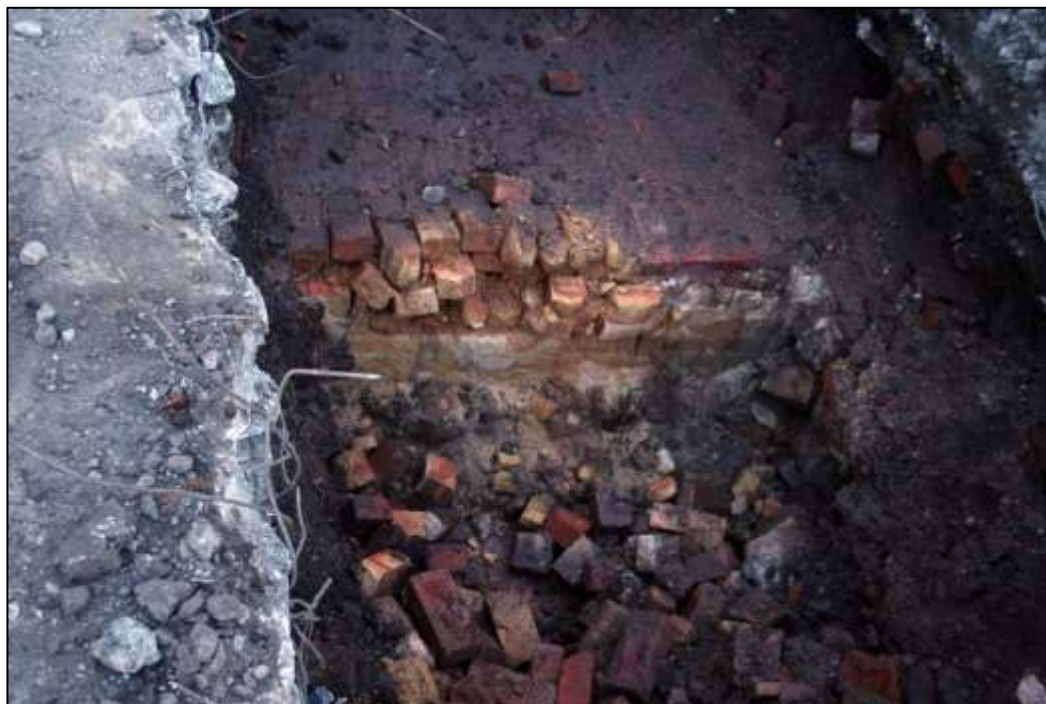
- 3.2.1 **Trench 4:** this trench was orientated north-east/south-west (Fig 2) and lay within the footprint of an earlier twentieth-century boiler house (see Section 1.4.17 above), being positioned in its north-eastern quadrant, running parallel with its eastern side wall.
- 3.2.2 The trench measured 8 x 2m and was excavated to a maximum depth of 0.3m (Fig 3). The excavated area was dominated by a brick surface (**403/404**), composed of heat-affected machine-made bricks and refractory bricks, either side of a 1.75m-wide brick-lined channel, which was aligned east/west (Plate 7). During the machine excavation of this later feature, asbestos was visible and hence excavation ceased and the trench was backfilled.

Plate 7: The heat-affected brick base and brick-lined channel (flue) in Trench 4

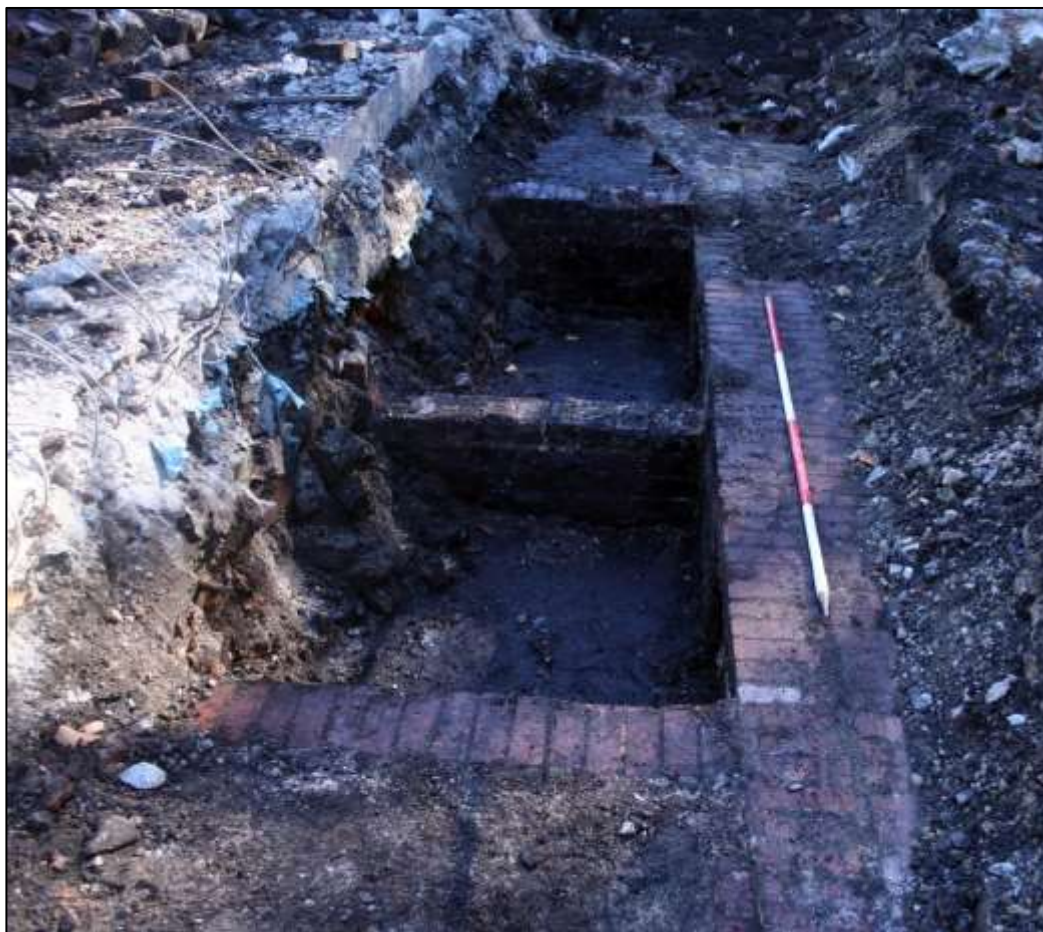
Plate 8: The brick-built tank in Trench 5

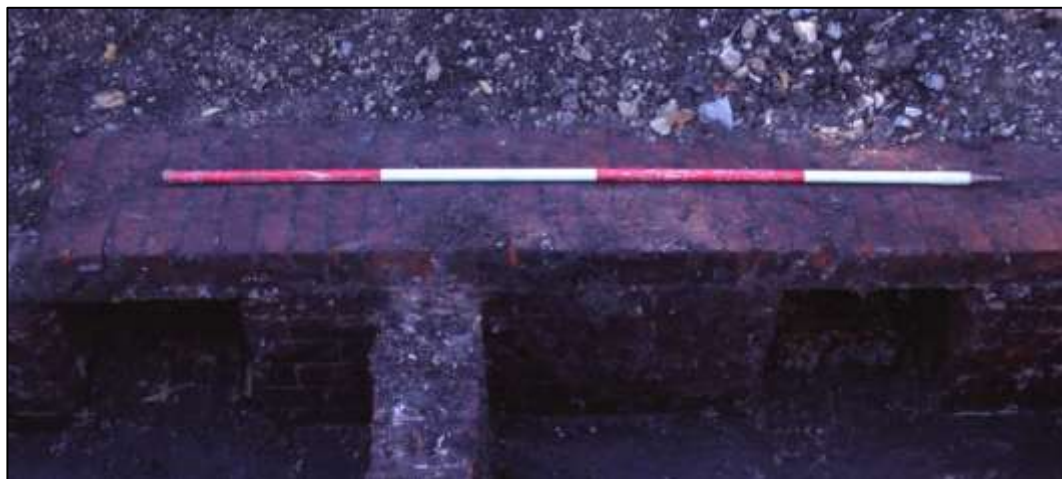
- 3.2.6 The southern elevation of the tank had two c 0.5m-wide openings, which relate to the mouths of two culverts that channelled water into/out of the two separate chambers within the tank (Plate 9). Each of the culvert mouths were also provisioned with a metal sluice gate, of which the partial remains survived, allowing for the control of water into/out of the tank. The line of a brick-built culvert (**506**) was also visible running from the eastern end of the tank, outside of the evaluation trench, and this was almost certainly the culvert that served the tank. At this end of the trench a brick surface (**505**) was also present, whilst at the western end of the trench a short length of walling (**503**) was visible. This wall was composed of machine-made frogged bricks and ran parallel with the tank side walls.

Plate 9: The openings on the southern elevation of the tank in Trench 5

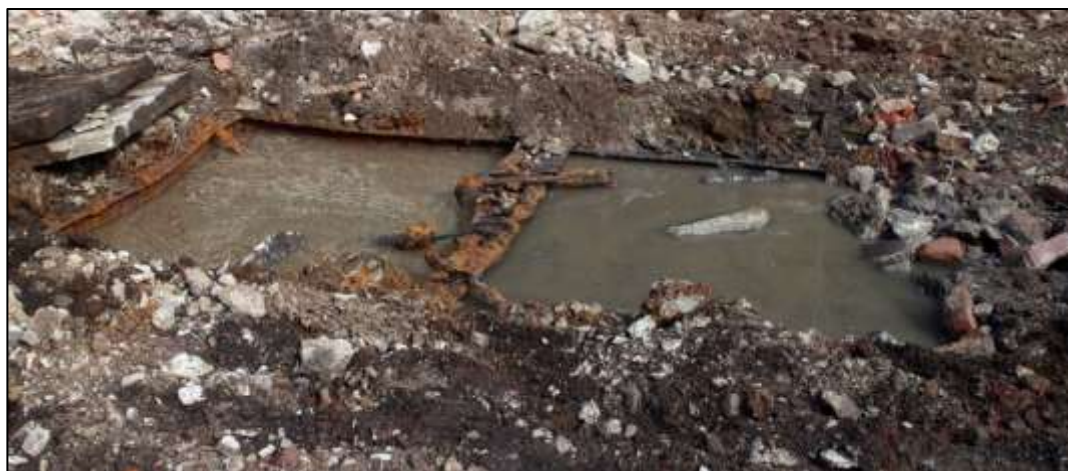
3.2.7 **Trench 6:** this trench (Fig 2) was positioned across the site of a large rectangular building that formed an element of the late nineteenth-century brickworks (see Section 1.4.13 above). At the start of the excavation of this trench, a large open-topped metal tank was exposed, that was filled with potentially contaminated water (Plate 10). Given the Health and Safety implications, including the exposure to and the release of potentially harmful substances, excavations within this area were abandoned and no further investigation of the tank was undertaken

Plate 10: The tank exposed in Trench 6

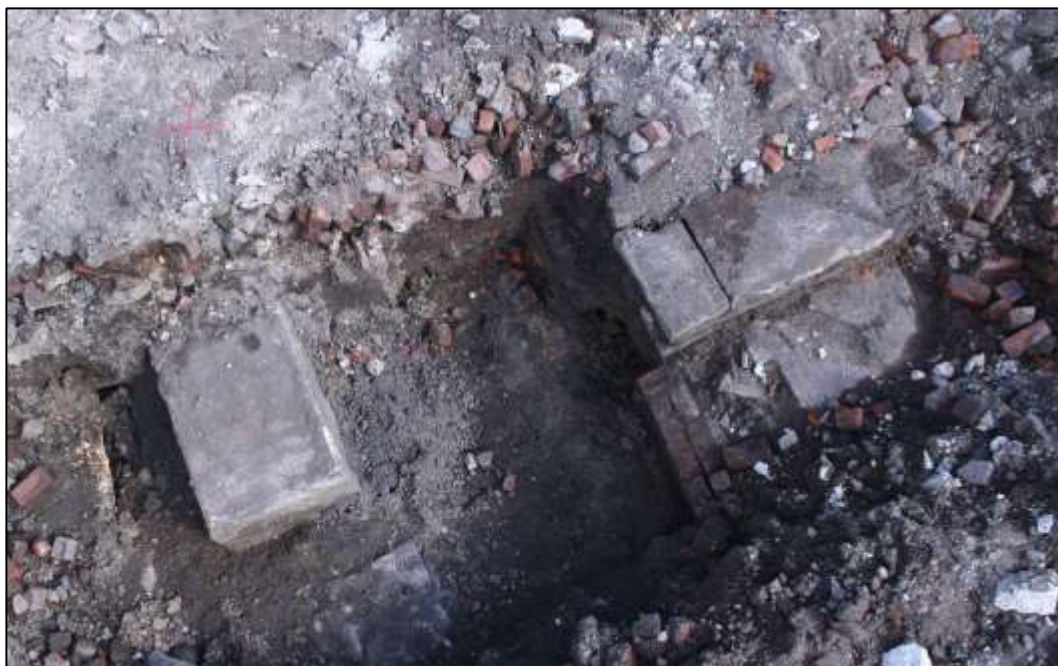
Plate 11: Wall **706** (left) and structure **708** (right), adjacent to wall **707** and surface **709**, in Trench 6

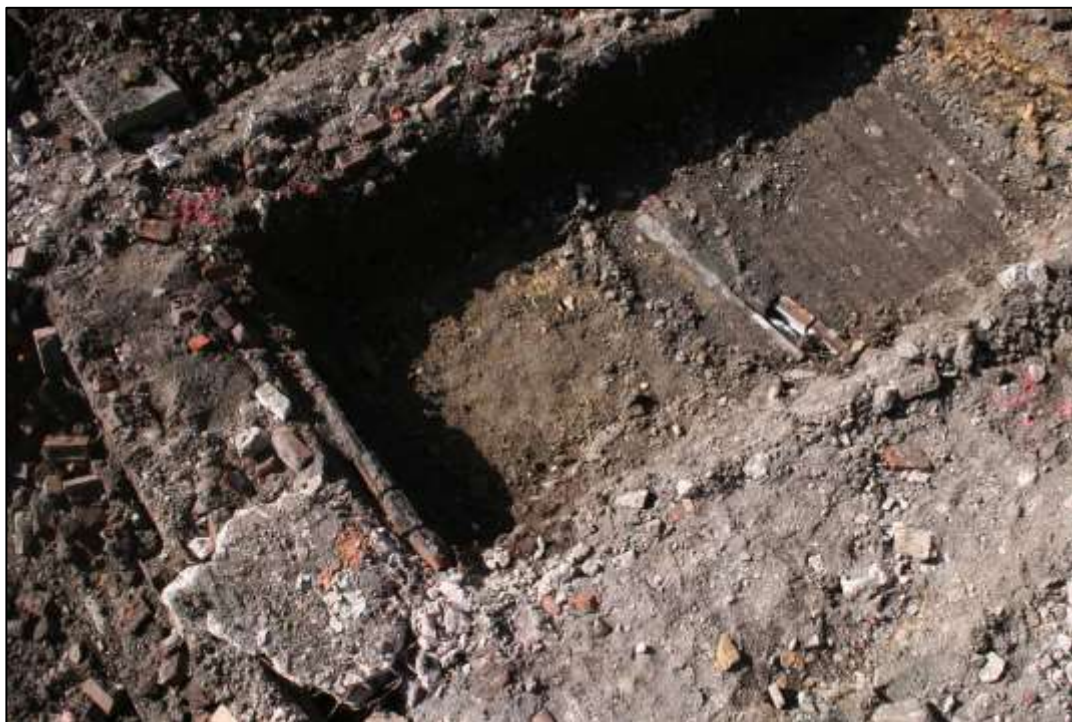
3.2.10 Several later walls and structures were also present in the trench. These included a wall composed of machine-made bricks (**707**) and a concrete surface (**709**) that lay adjacent to structure **708** (see Section 3.2.9 above; Plate 11). It is possible that these were created when the late nineteenth-century building was incorporated into the design of the early twentieth-century bleach works' ancillary building. In the western half of the trench were also two machine-made brick walls (**703** and **704**) of twentieth-century date (Plate 12). The more westerly of these (**703**) was a two-skin thick wall, which seems to correspond with the outline of the works building as depicted on mapping dating to 1963/4 (see Section 1.4.19 above). The other wall, however, was much more substantial, measuring c 1.2m wide; although it is not clear precisely what this section of walling relates to, it too probably formed an element of the mid-twentieth-century works.

Plate 12: Walls 703 (right) and 704 (left), in Trench 6

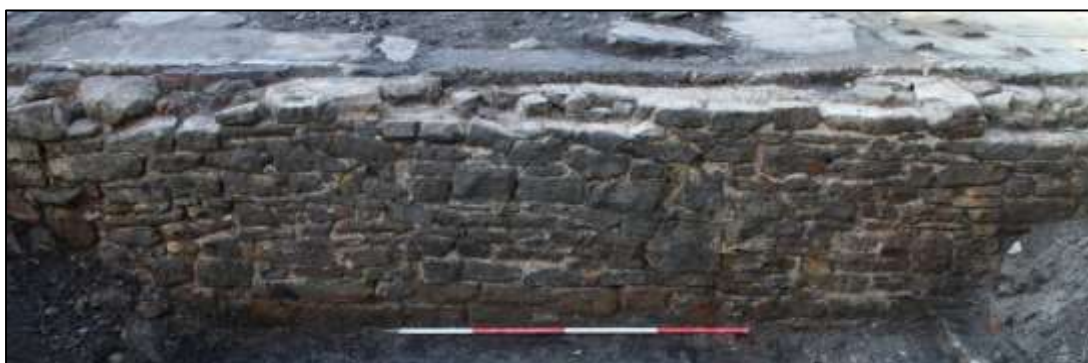
- 3.3.4 The other length of Phase 1 walling lay to the south-west and ran parallel with the south-western side of **Room 1017**, being set some 3m distant, with the area between the two walls being designated as **Room 1009**. This wall was also 0.5m thick, constructed of similar roughly square sandstone and mudstone blocks, bonded with lime-based mortar (Plate 15), and probably formed the northern side of the southern bay of the original mill/bleach works.

Plate 15: The north-eastern exterior elevation of the Phase 1 wall defining the southern bay of the mill/bleach works

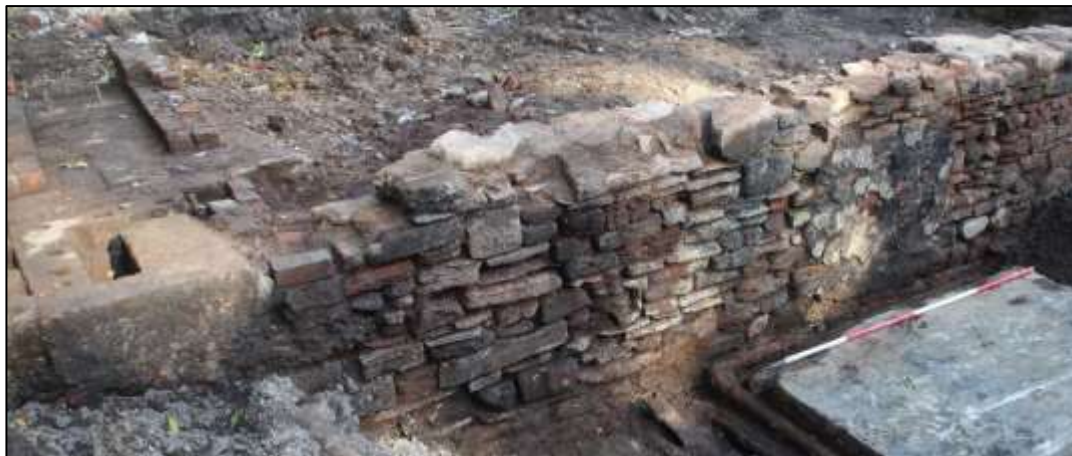
16). This block measured 1.07 x 0.71m and contained an L-shaped slot, surrounded by six circular smaller rectangular and circular slots, marking the position of bolt holes. This block had also been encased in handmade brick on its eastern and western sides (Plate 17).

Plate 16: The large sandstone block (left) incorporated into the Phase 1 wall defining the northern bay of the mill/bleach works

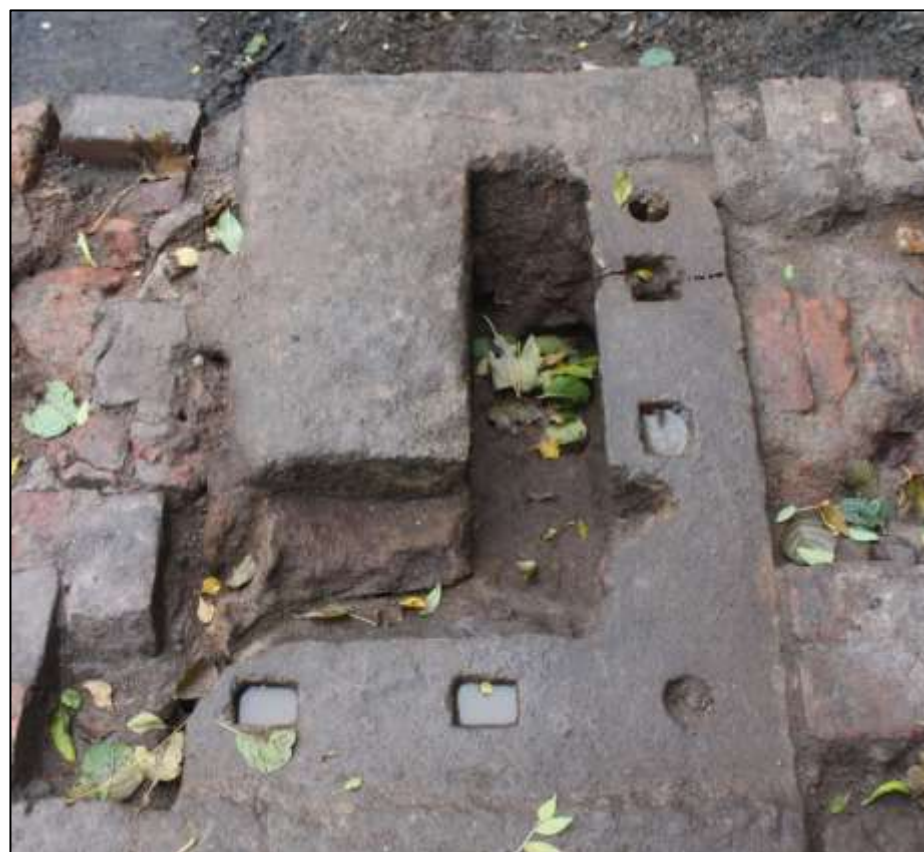
Plate 17: Detail of the large sandstone block incorporated into the Phase 1 walling

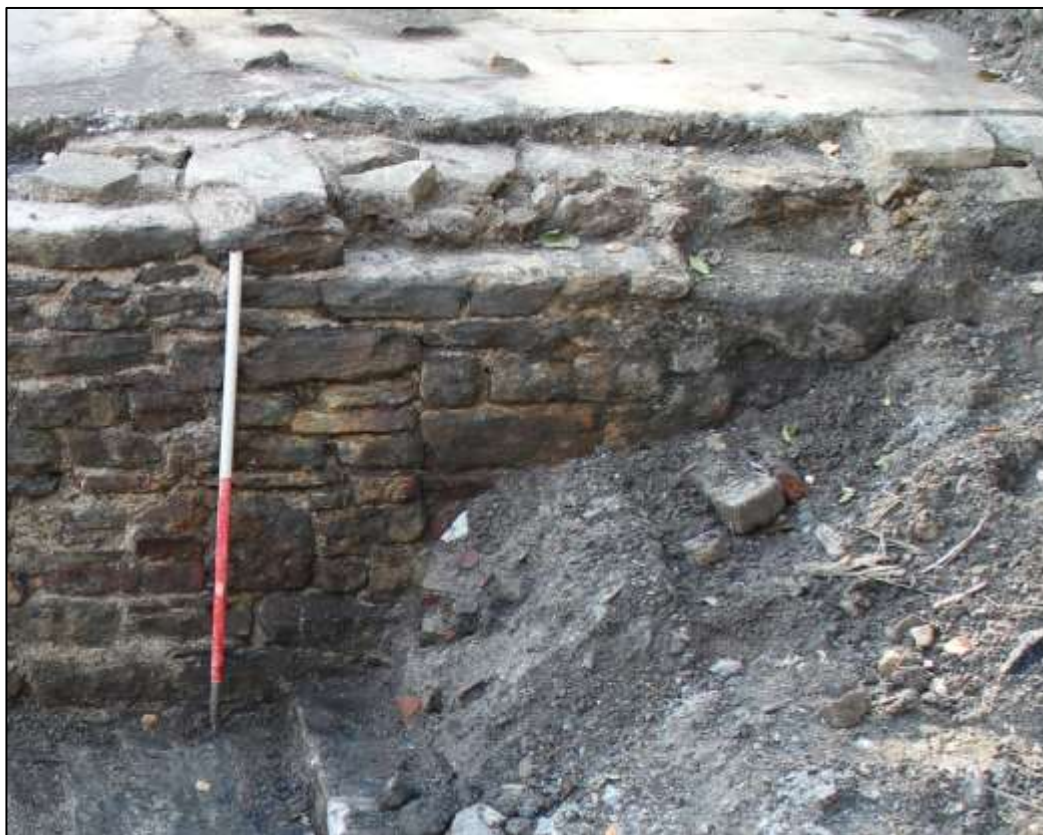
Plate 18: Infilled masonry (right) in the Phase 1 wall defining the southern bay of the mill/bleach works

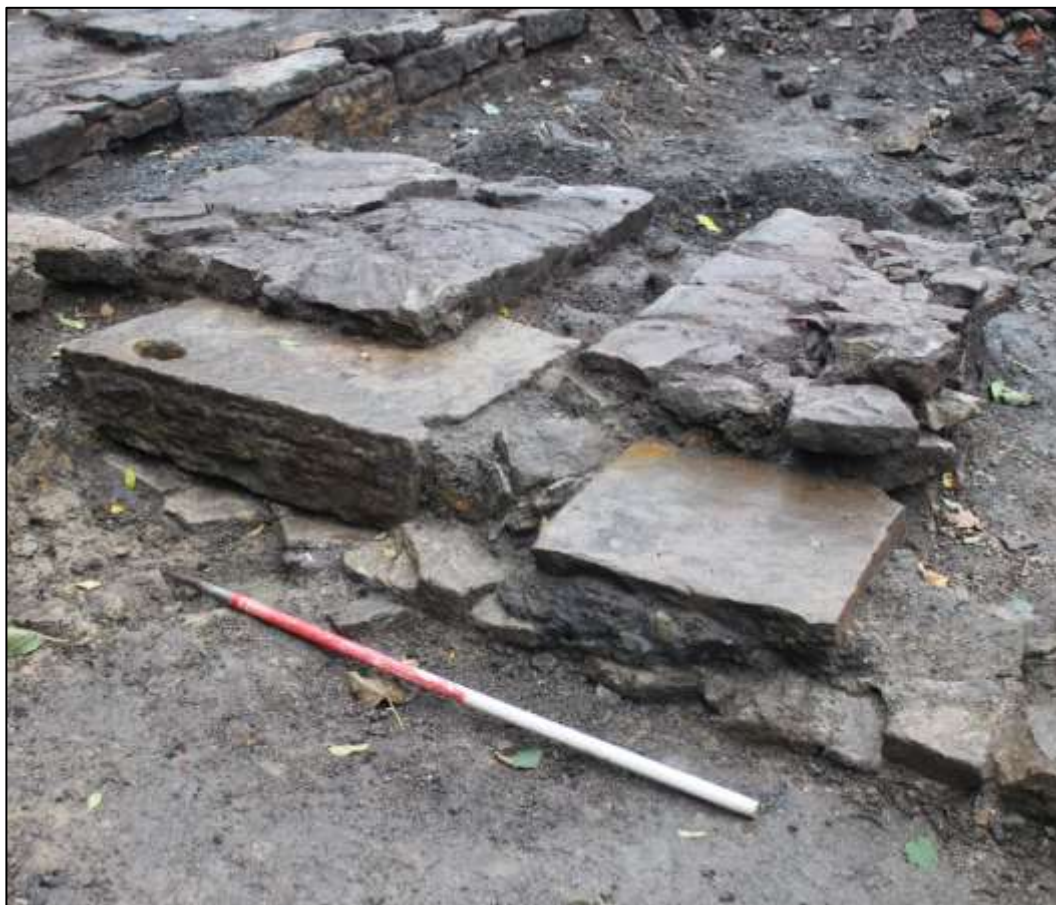
3.3.10 Although no floor surfaces survived in either of the rooms, **Room 1012** did contain two, late nineteenth-century structures, which truncated the Phase 1 wall defining **Room 1017** (Figs 7 and 8). Both structures were composed of stone rubble, bonded with mauve coloured lime-based mortar, and each was also partially set on a stone block and partially on a levelling deposit of shale (**1018**). The stone-rubble structures were set 0.36m apart and the more southerly measured 1.25 x 0.65m, whilst the northerly base measured 1.25 x 1.10m (Plate 22). Within the gap separating the bases three ‘holding down’ bolts were also present, whilst the stone slab that supported the northern structure also had a cut circular hole and arcing notch denoting the position of two additional bolts. This evidence clearly indicates that the structures and bolts represent a machine base, which secured a machine that lay within this part of the bleach works.

Plate 22: The Phase 2 stone machine base in Room 1013

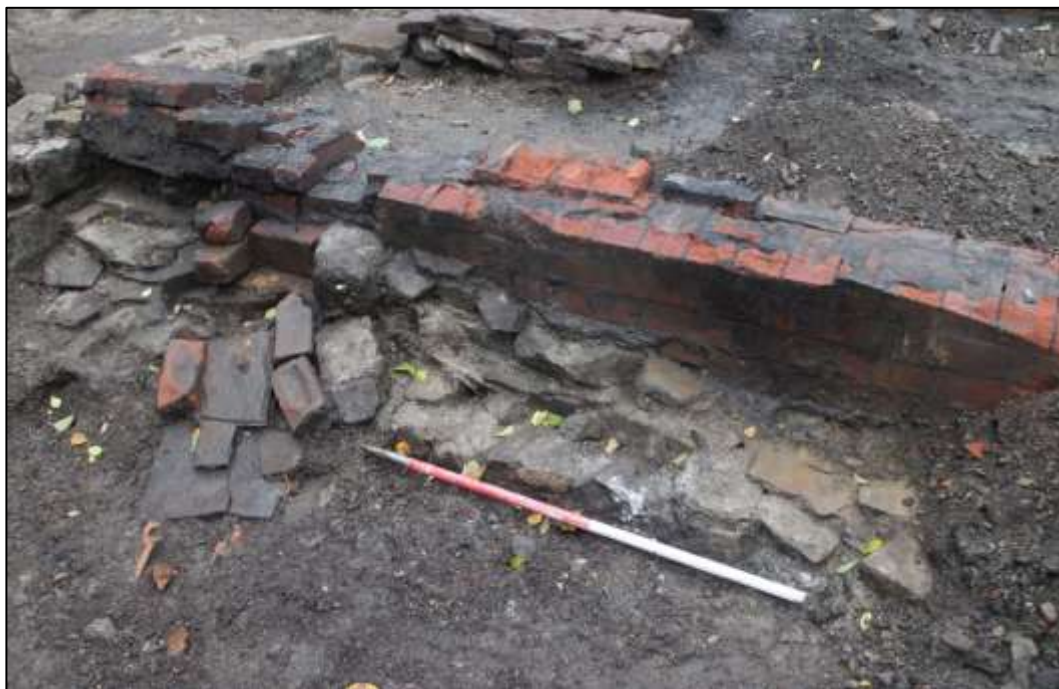
Plate 25: The Phase 3 brick wall positioned separating **Rooms 1008** and **1009** and the Phase 3 drain (left). These overlie a Phase 2 stone wall

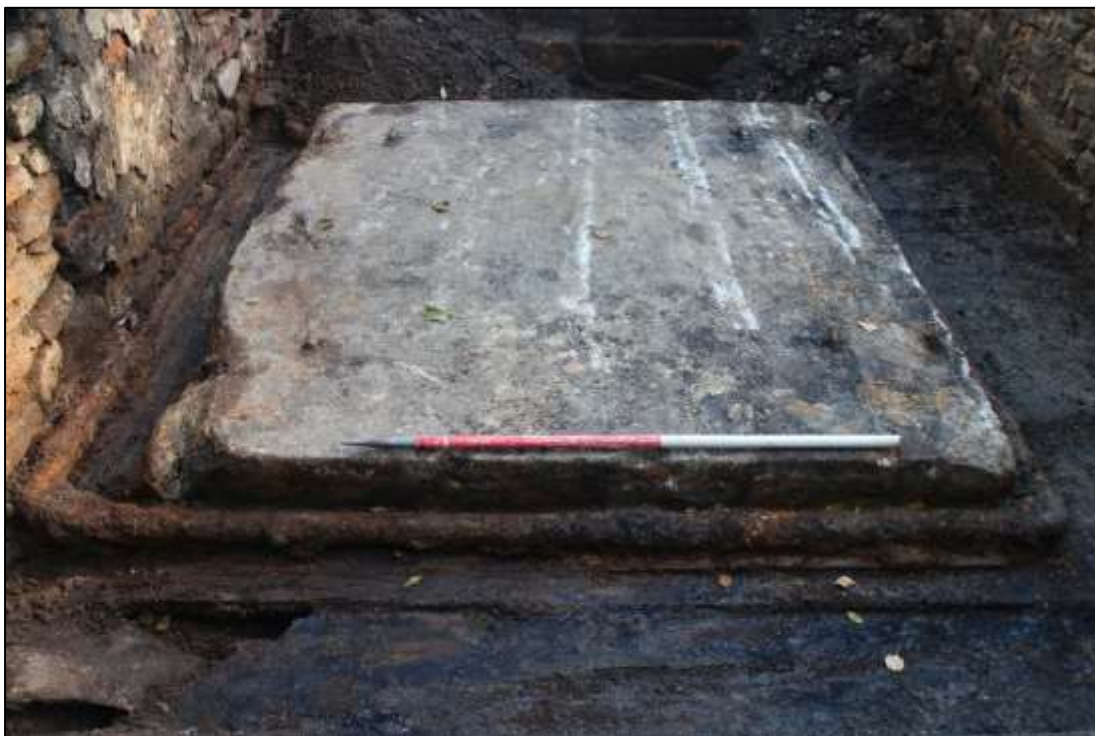
Plate 26: The sandstone base in **Room 1009**

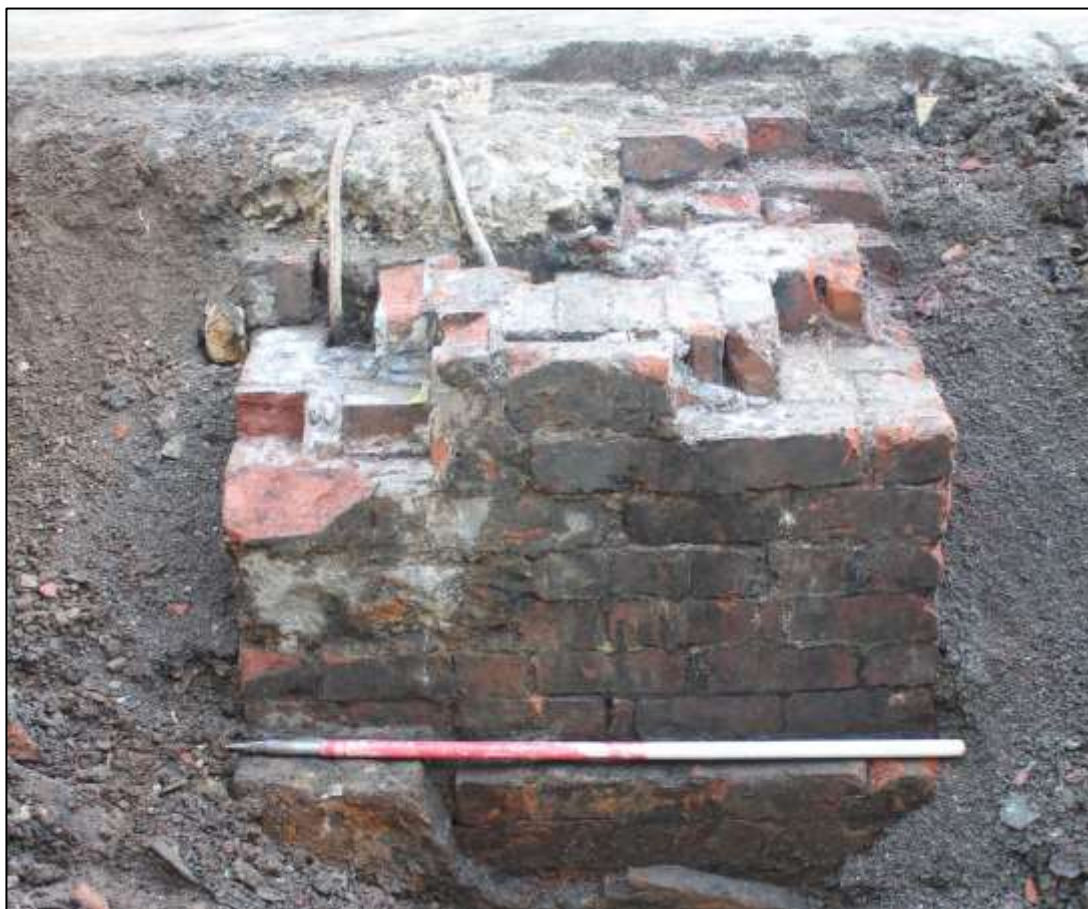
Plate 27: The brick and stone base in **Room 1009**

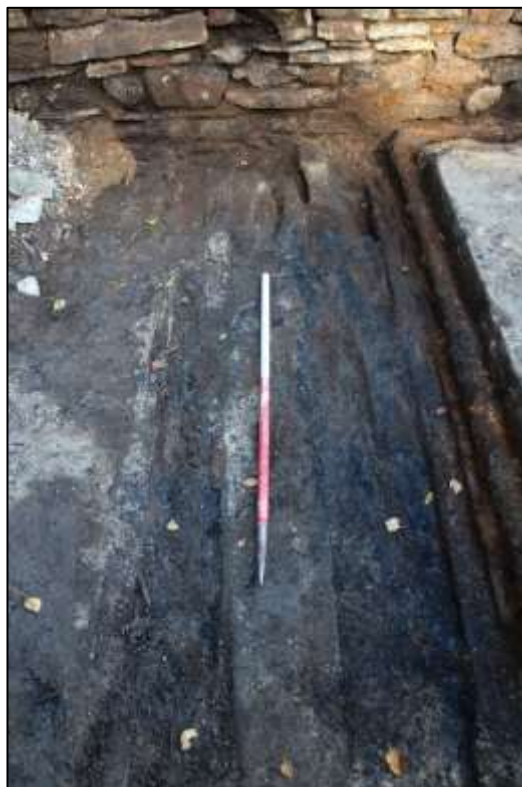
Plate 28: Detail of the wooden floor in Room 1009

- 3.3.15 Following recording, the wooden floor was removed and additional excavations were undertaken beneath it, to a depth of c 2.5m. Immediately beneath the floor a 0.2m deposit of black clay silt contaminated with a bright orange residue (possibly iron) was encountered and this sealed a 0.2m layer of concrete, which overlay redeposited material. At the lowest level of the excavation an early twentieth-century brick wall was observed, which was aligned parallel with the Phase 1 stone walls defining **Room 1009**. This wall was 0.8m high and sat upon clay deposits; however, it was not possible to determine its extent as during excavation at this depth there was continuous ingress of water from the clay deposits below and from surrounding contaminated deposits.

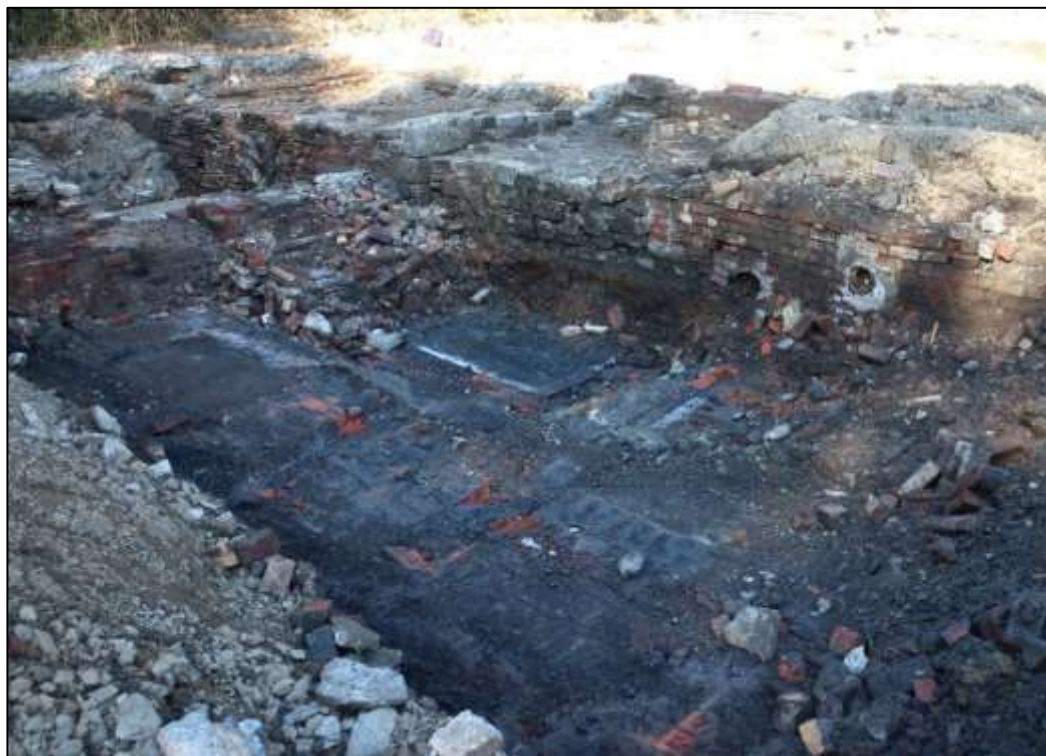
- 3.3.16 Excavation in **Room 1008**, to the south-east of the more easterly of the bases in **Room 1009** (see Section 3.3.14 above) also revealed several additional Phase 3 structures (Fig 8). Unfortunately, these had been heavily contaminated by hydrocarbons, which meant that the excavation was halted in this area, and their extent and form could not be fully determined (Plate 29). However, it was evident, following initial mechanical excavation, that these structures comprised an additional brick-built base, measuring c 1.95 wide, which extended for a least 3m and that contained a large sandstone slab. This base also lay adjacent to a c 1.9m-wide brick-built platform positioned in the southern part of **Room 1008**.

Plate 29: The structures in Room 1008 as seen following initial machine excavation

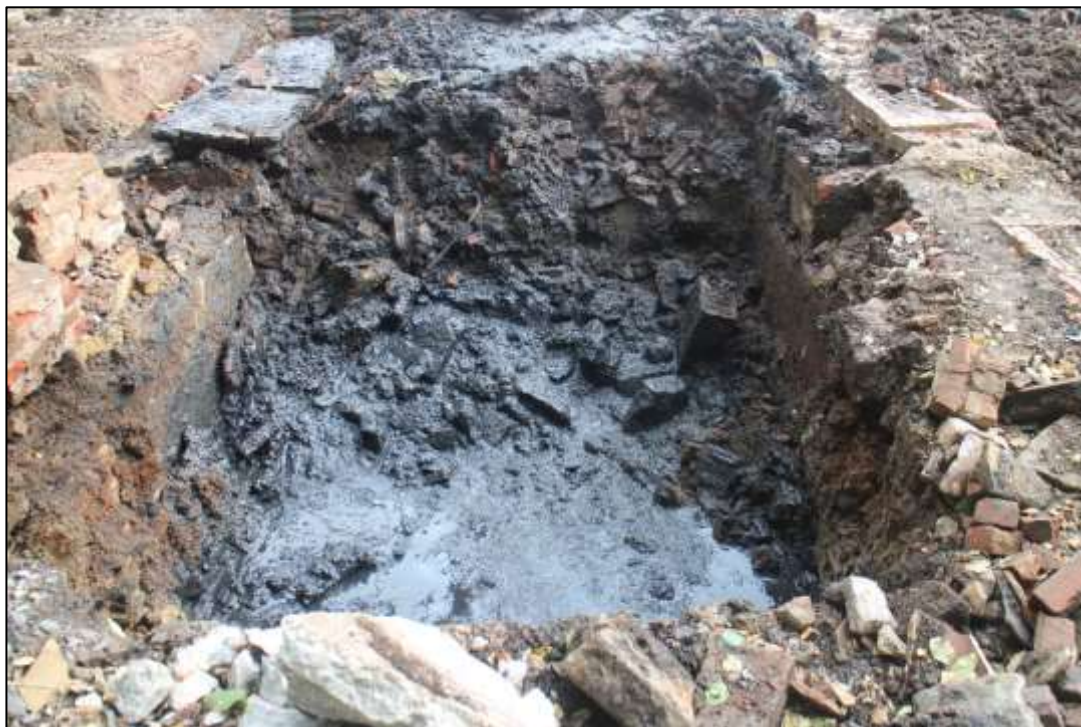
3.3.18 Other Phase 3 remains were also encountered in the northern corner of Area 1 (Plate 24). In this part of the trench, a series of Phase 4 dyeing vats/cisterns were present (see Section 3.3.21 below), and excavation beneath one uncovered the remains of an earlier dyeing vat, which presumably dates to the earlier part of the twentieth century. Excavation of this structure was, however, hampered due to the ingress of contaminated liquids, and so its full extent could not be determined, but it was evident that the vat had a stone base and stone-slab sides (Plate 31).

Plate 31: The partially exposed Phase 3 dyeing vat, heavily contaminated with hydrocarbons

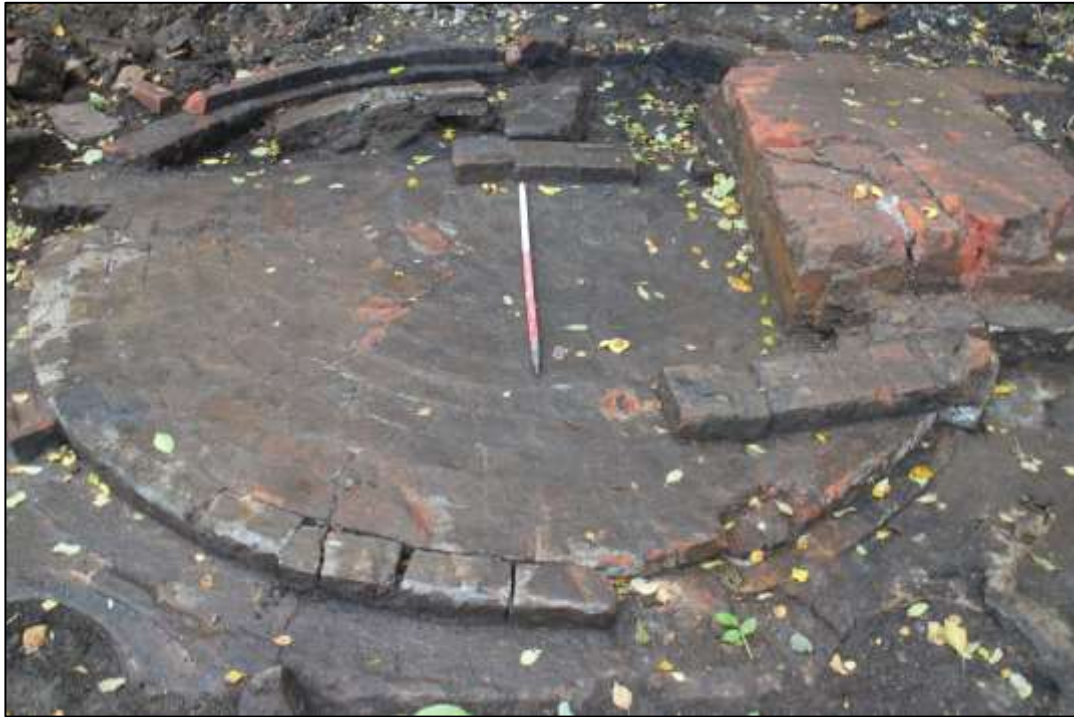
Plate 35: The base of the dyeing vat (1015)

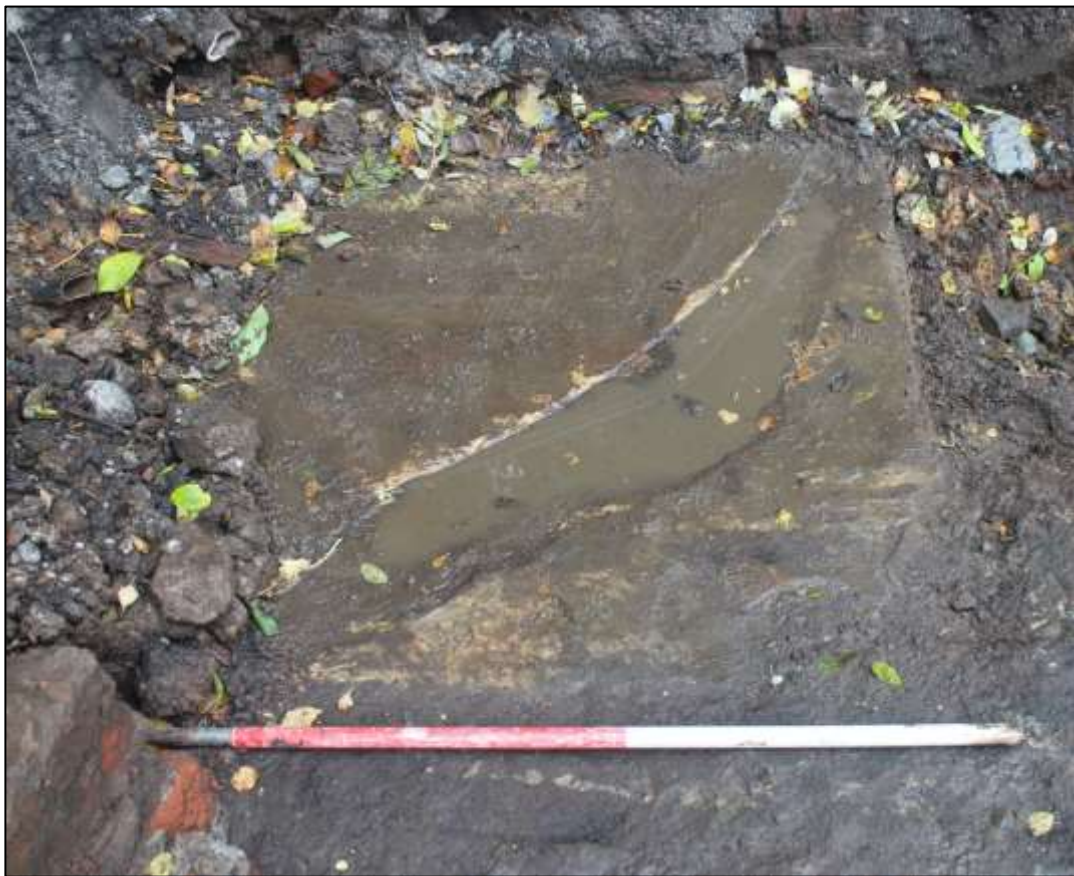
Plate 36: The circular recess defining the base of a circular dyeing vat

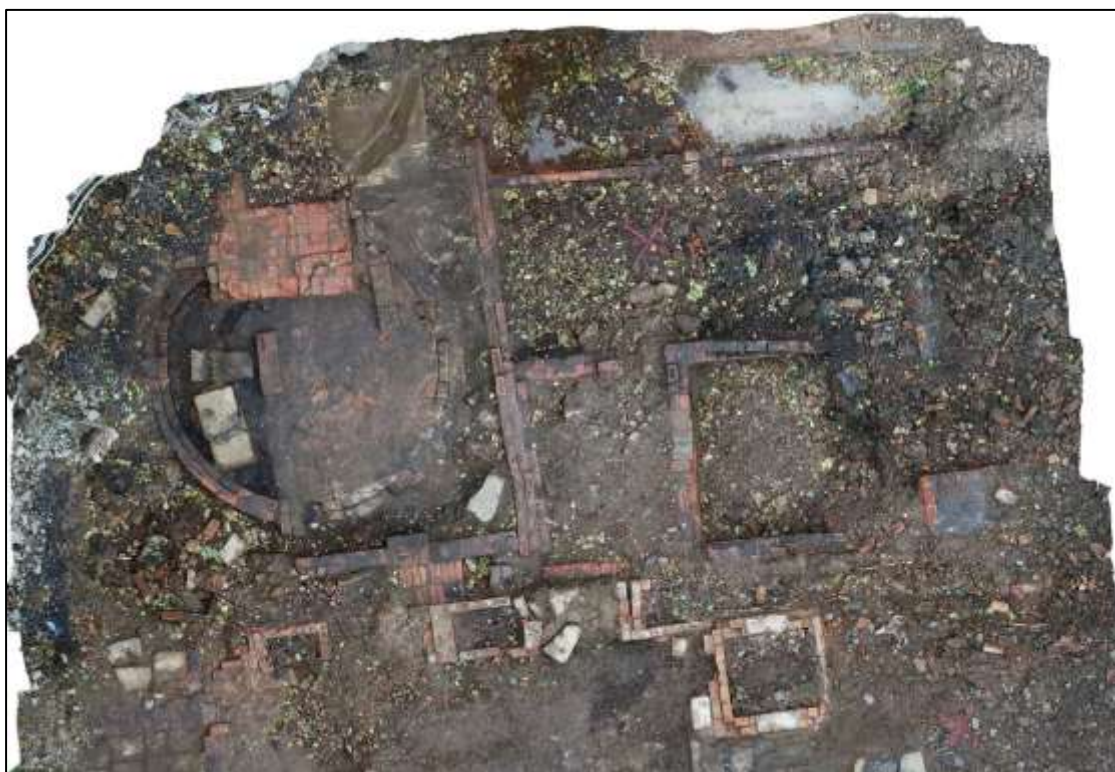
3.3.22 The life of these two circular vats seems, however, to have been short-lived, as they were subsequently replaced, in the mid-twentieth century, by a bank of rectangular/square dyeing tanks. The larger of these had been built directly over the circular dyeing vats (Plate 37), and although portions of this lay beyond Area 1, it was evident that it was defined by a double-skin brick wall and was 2.5m wide. Adjoining this tank, was a rectangular grid of twentieth-century brick walling that defining four additional square tanks (**1016**) covering c 3.50m², though an additional length of twentieth-century walling was observed to the immediate north east suggesting the presence of two more tanks that lay just outside Area 1. One of the tanks was excavated and this contained a thick, silty-clay deposit, which was heavily contaminated with a blue-coloured dye identical to that noted in the base of the circular dyeing vat (*see Section 3.3.21 above*). Its brick-built base was also encountered at a depth of 1m. At a later date, probably in the mid-twentieth century, the large rectangular tank was then replaced, by a brick plinth that was built over its western side, which measured c 1 x 1.7m (Plate 38).

Plate 37: The bank of rectangular dyeing vats and adjacent drains

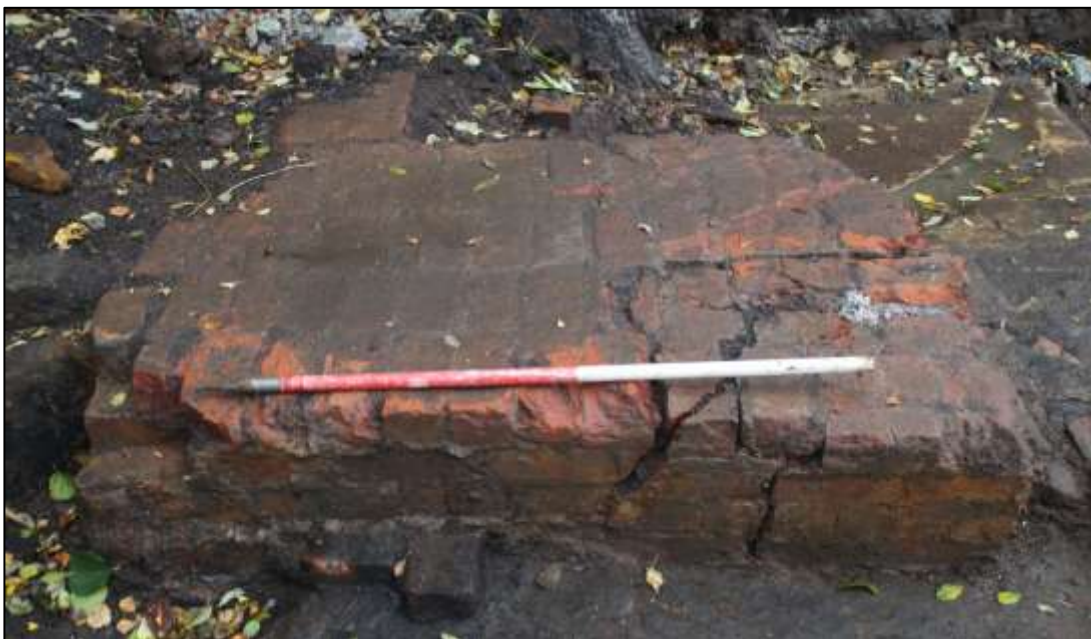
Plate 38: The brick-built plinth

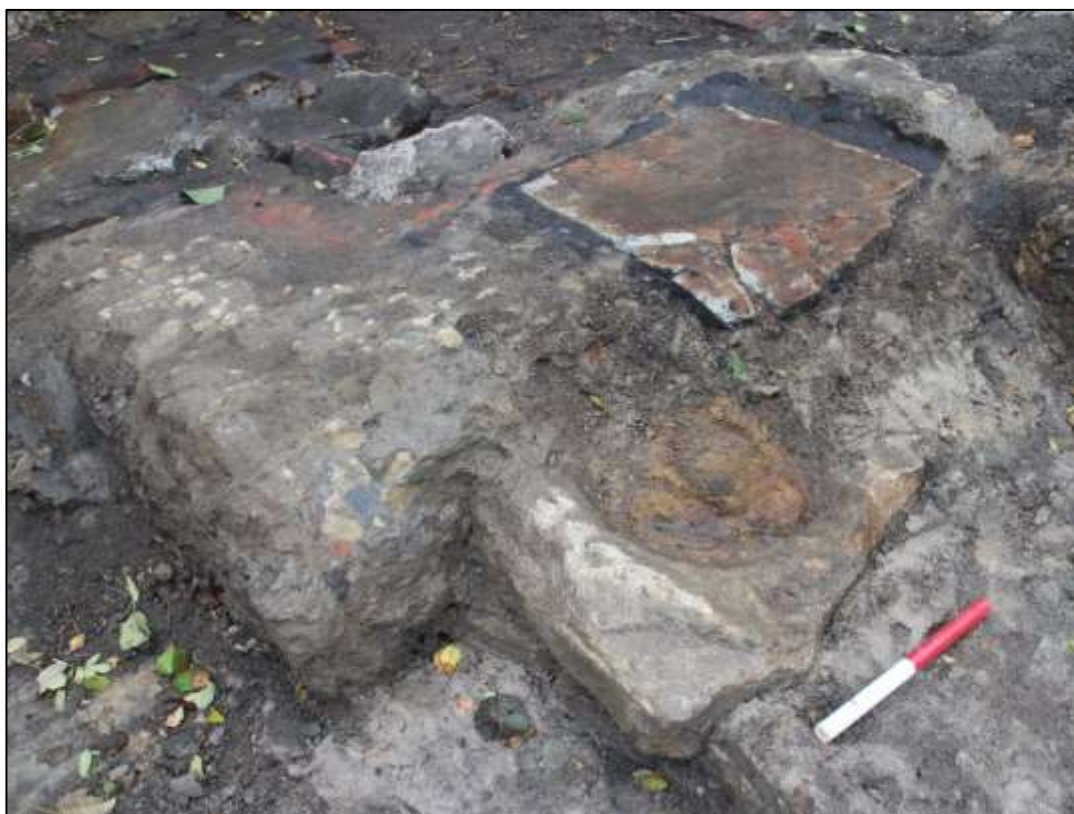
Plate 40: The column base with the remains of the in-situ cast-iron column

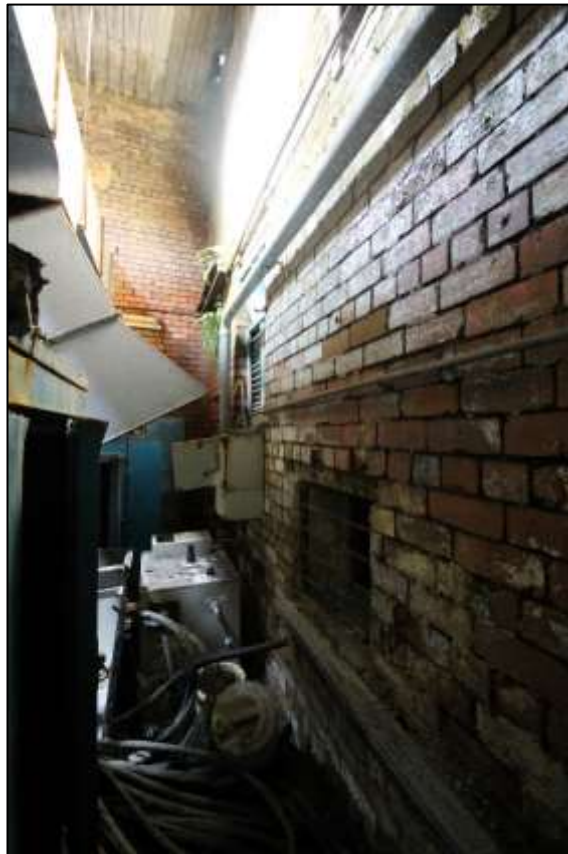
western side with concrete blockwork. On the same wall, a second and slightly larger window to the south of the first, was fitted with a louvre vent below a two-light glazed hopper (Plate 50).

Plate 50: Western wall of the larger cell, showing blocked windows

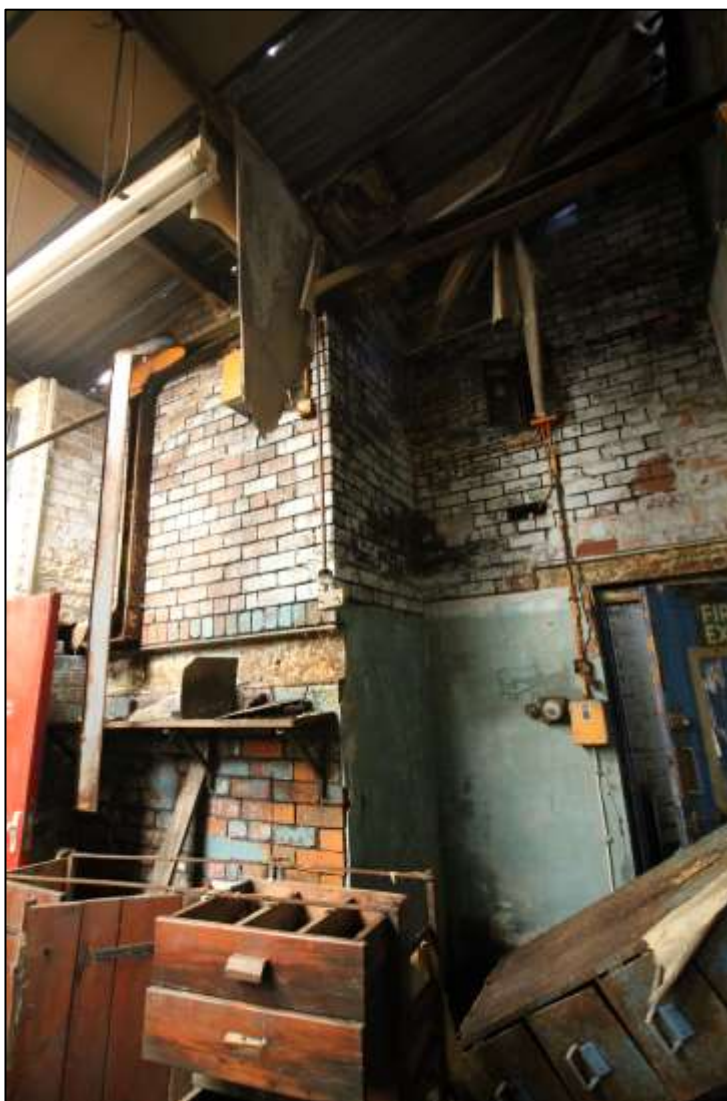
- 4.2.9 From the interior of the lean-to range to the east, it was possible to inspect the lower portions of the building's eastern wall. The horizontal steel lintel identified on the opposing face was again observed and traces of paint indicated that the lower half of the wall had been painted blue, with white above (Plate 51). Additionally, the internal angle formed by the dog-leg wall had been plastered to half-height and the southern end of the wall was obscured by a bank of steel cabinets associated with managing electricity generation (Plate 52).

Plate 51: Lower half of the eastern wall of the larger cell, facing west

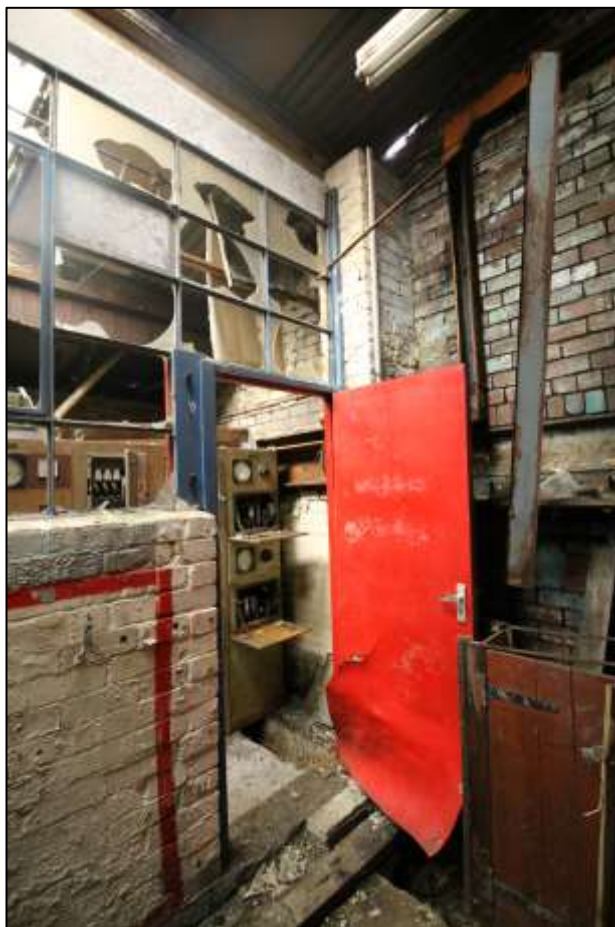
Plate 52: Electrical generation equipment at southern end of the eastern wall of the larger cell, facing south-west

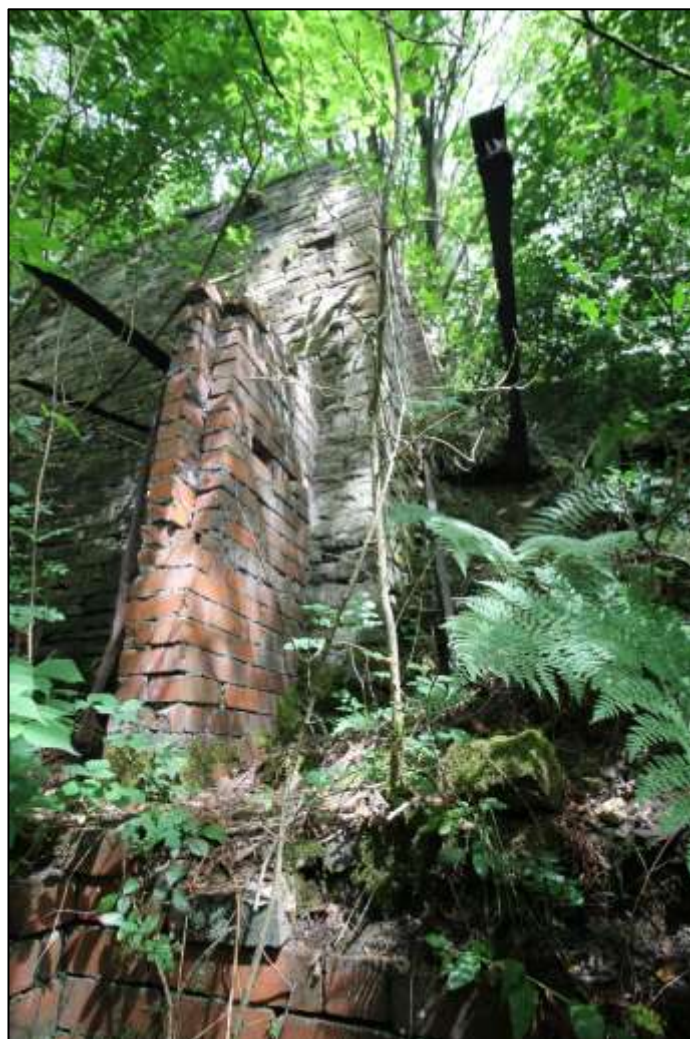
Plate 57: Corner of stone-built revetment wall, with redundant roof beam extend to right of centre

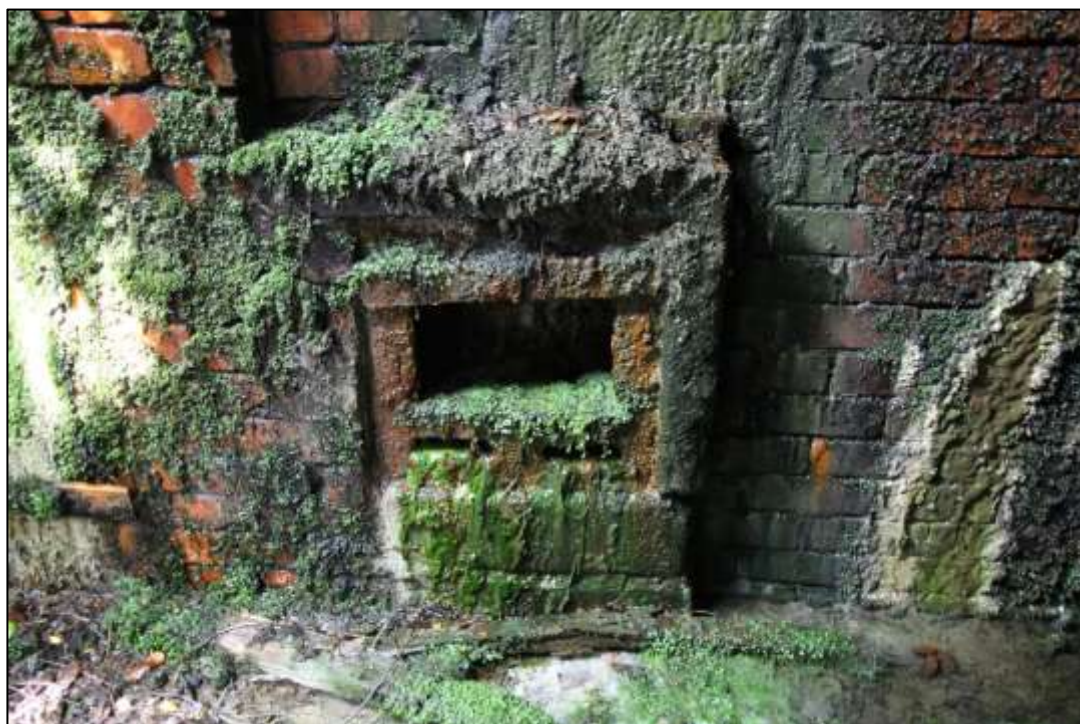
Plate 59: End bearing box on north-western wall of open-sided building
