# **KINGSWAY BATHS AND BRIDGE HOUSES, LANCASTER**

## **Archaeological Building Investigation**

**Oxford Archaeology North**

March 2005

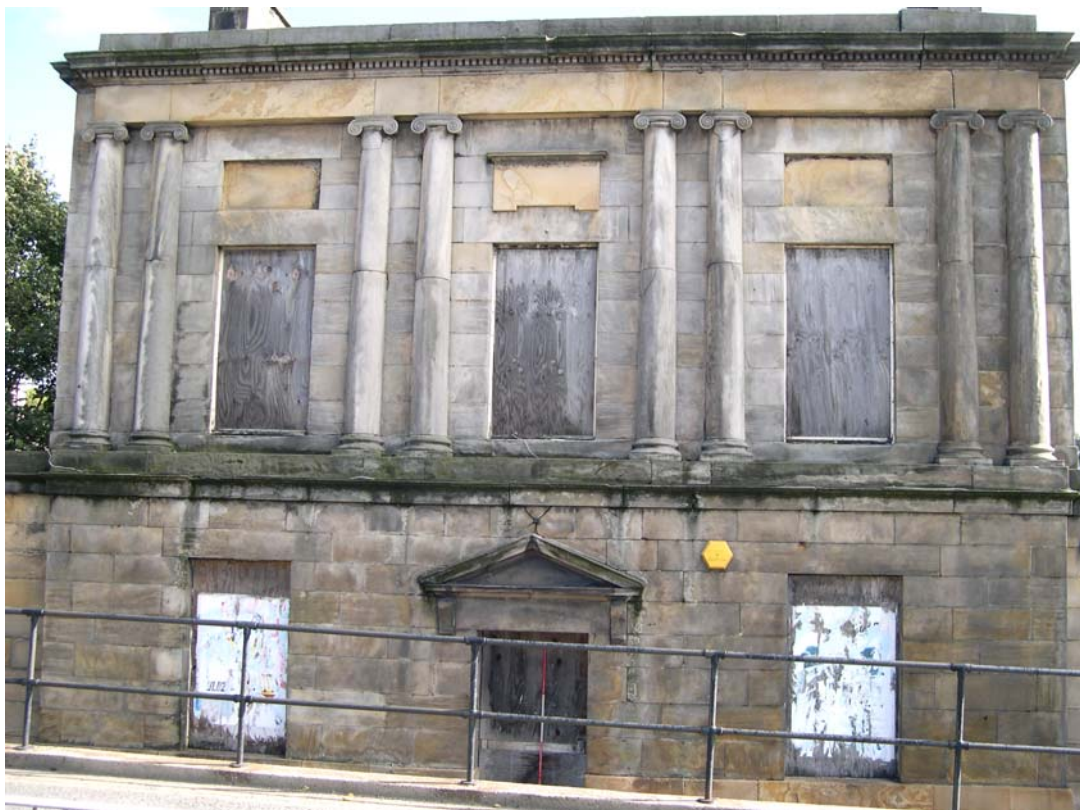
- 4.2.5 **Fabric:** all of the three bridge houses and the link walls are constructed from local yellow sandstone (Plates 7-9) which is in relatively good condition. The walls and decorative elements forming the main façade and entrance porches are compound walls faced with square cut flush-faced ashlar. The visible elevations of the east and west Bridge Houses are constructed from coursed, squared and tooled random stonework (Plate 6) and the rear elevations are a mixture of coursed and uncoursed random rubblework with large sandstone quoins. The majority of the roof covering has been removed leaving only modern roofing felt, although this was originally probably slate (stacks of roof slates are present in the modern restaurant).

Plate 7: Front (north) external elevation of the central Bridge House

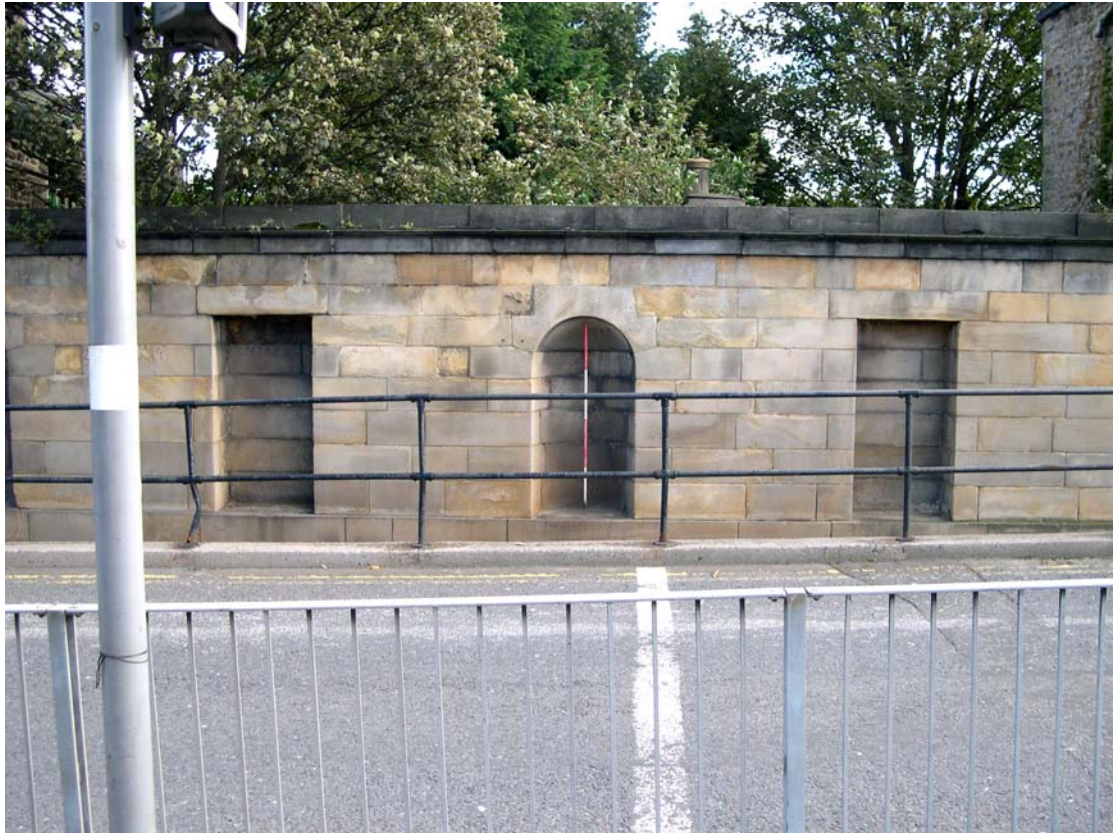
Plate 8: Detail of the front (north) elevation of the east link wall

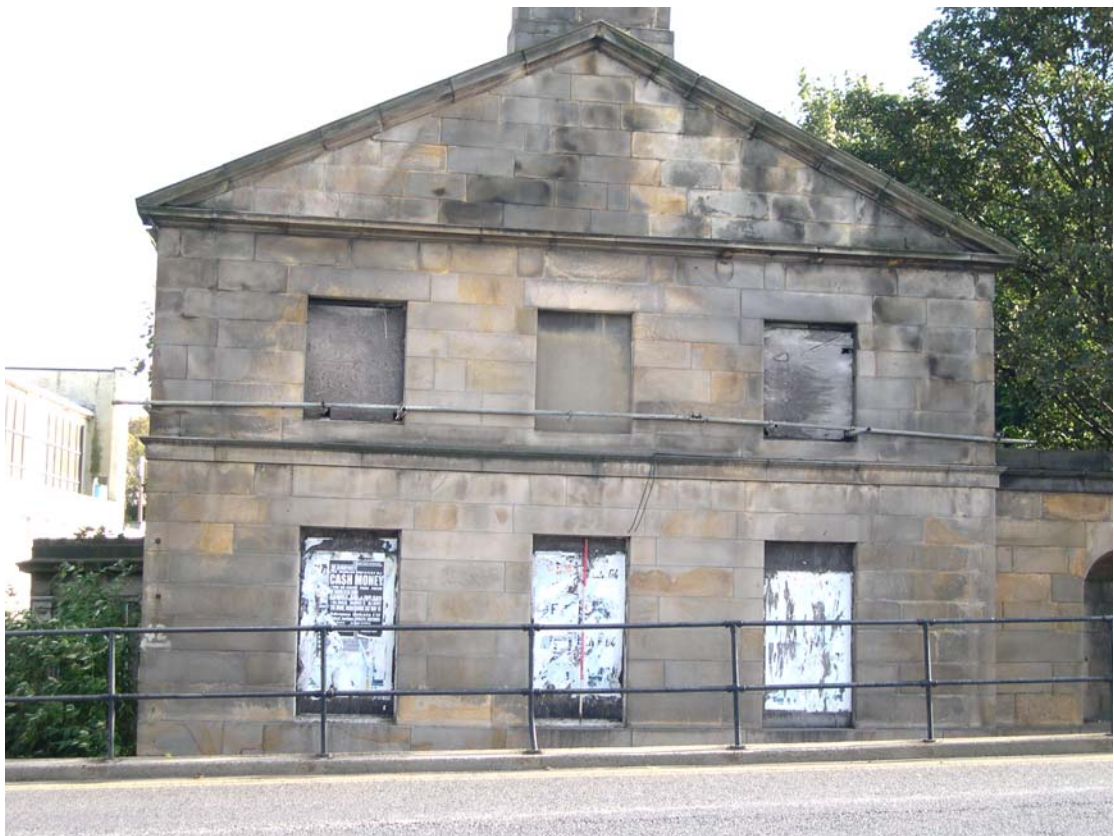
Plate 9: Gable (north) external elevation of the east Bridge House

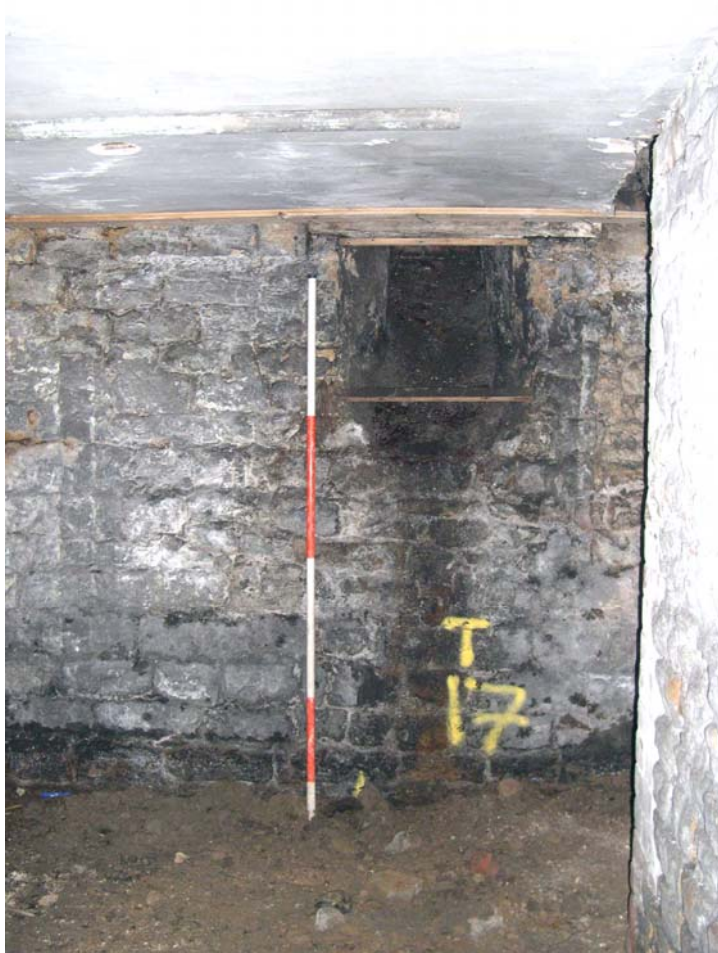
Plate 11: Coal chute in Room 1, east Bridge House

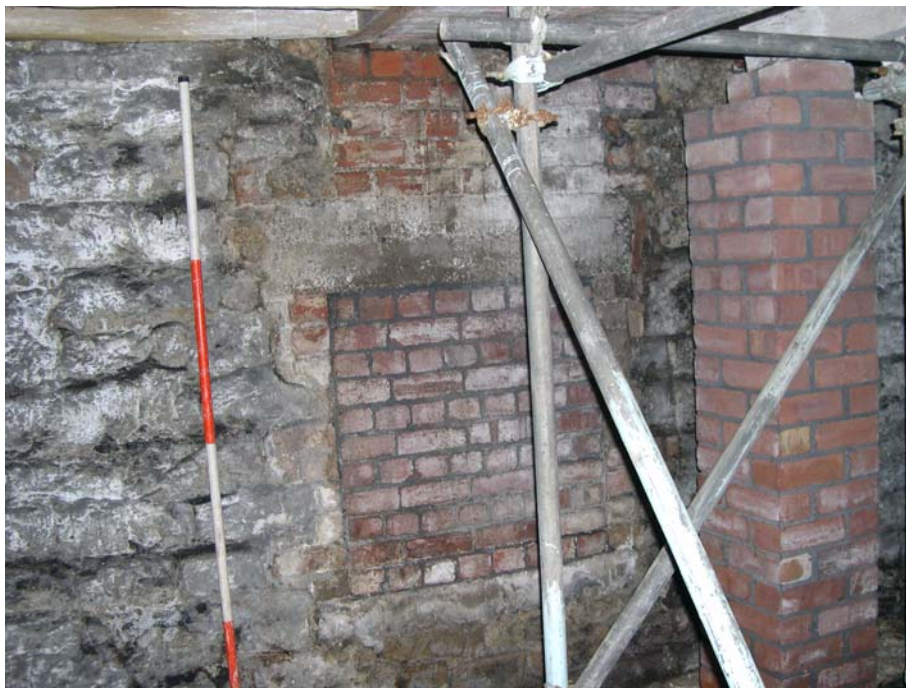
5.2.12 In the east Bridge House the damage was not as extensive, although some fireplaces were blocked and cosmetic alterations were made. In particular apertures were inserted into the east elevation of the basement and then blocked with brick. It is not clear what function these served.

Plate 12: Blocked apertures and inserted brick pillar in Room 2, east Bridge House

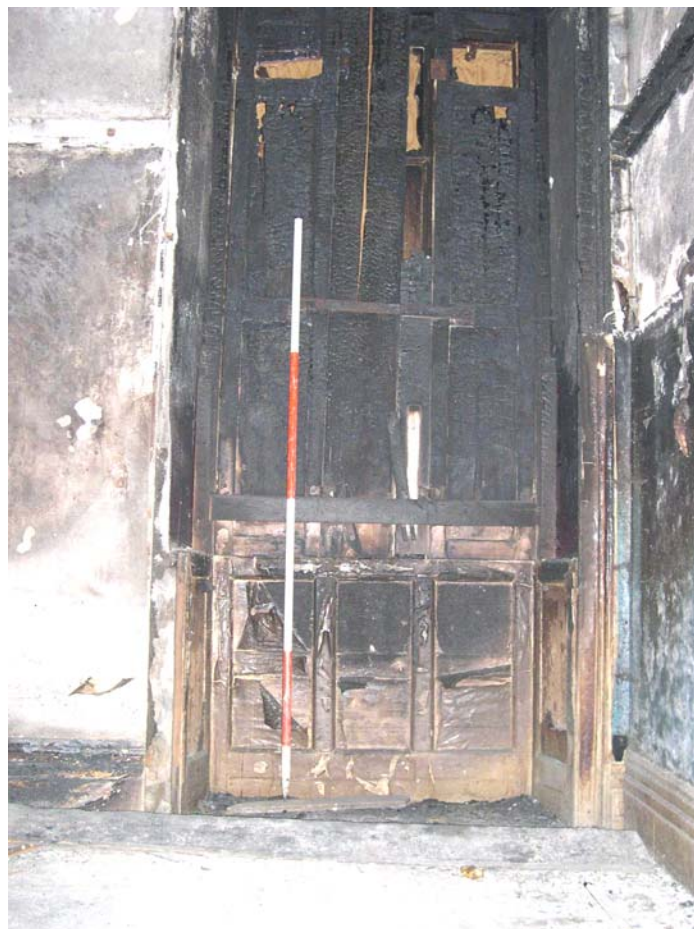
- 4.3.16 **Room 7:** the entire room is decorated with a skirting board and dado/picture rail (although much of this has been lost due to fire damage). A simple moulded cornice, or its remains, is also present throughout. There are two large windows in the north elevation with splayed jambs and a relatively late sliding sash window. The easterly window of the two has the badly fire-damaged remains of panelling and shutters *in situ* (Plate 14). The west elevation has a central chimney-breast, 0.16m deep, in the centre of which is a fireplace with a relatively modern tile surround, which has been blocked with brick. The south elevation is a stud partition and has a doorway on the east side into the hall, and a radiator attached on the west side. The east elevation is also a stud partition but is otherwise plain. The floor comprises floorboards and the ceiling is lath and plaster.

Plate 14: Window in Room 7 of east Bridge House, showing remains of badly damaged shutters and surrounds

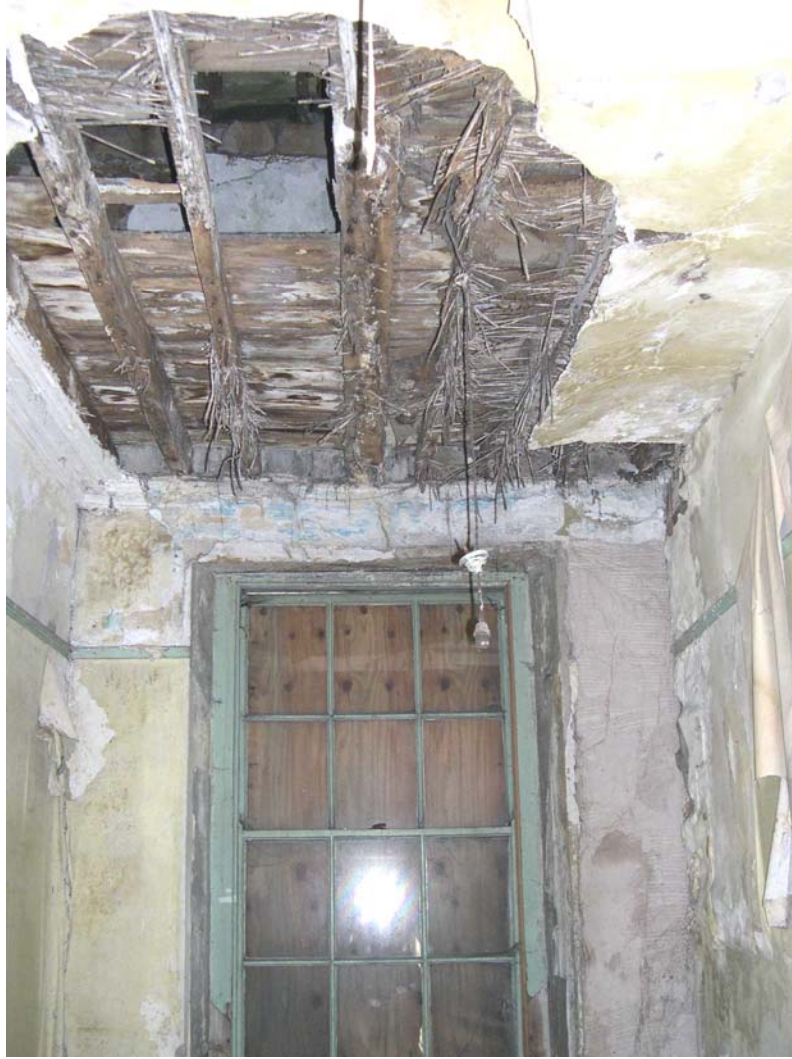
- 4.4.18 **Room 11:** between Rooms **10** and **12** is a smaller room. This too is very plain, although there is a dado/picture rail and the remains of a cornice. In the north elevation there is a window with splayed jambs (Plate 19), which is missing its surround. All of the walls apart from the north are stud partitions and there is a door in the south.

Plate 19: Exposed reed-plaster ceiling and window in Room **11**, central Bridge House

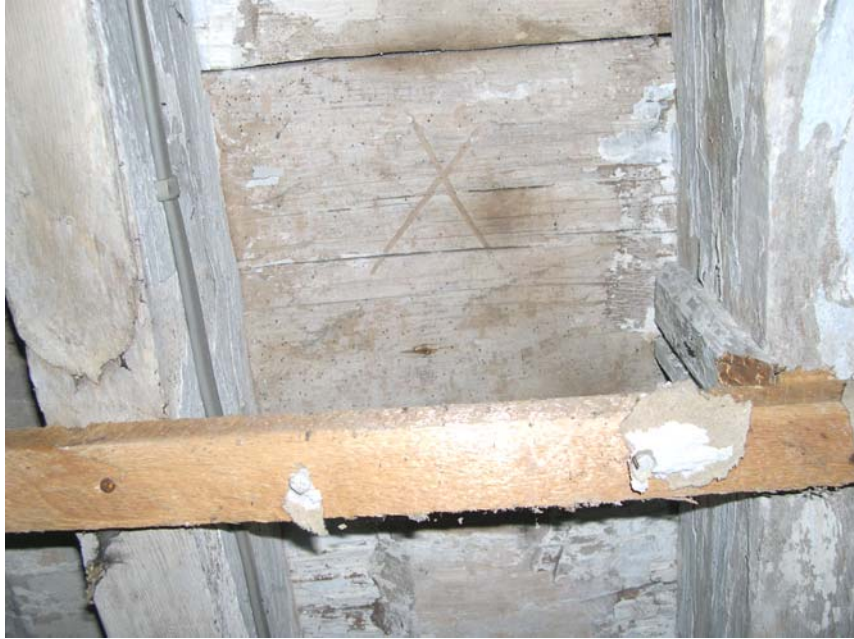
- 4.5.7 **Room 2:** this is the north-east room. This is particularly large, probably due to the removal of an original wall on the south side. There is a small vent in the north elevation, utilising a former coal chute. The walls are all tiled and there is a large modern pizza oven in the south-east corner, partially inserted through the wall. There is a large aperture to the north of this in the east elevation leading into the restaurant, with iron lintels. The ceiling is mostly a later replacement on the north side and there is a further iron beam supporting it to the south, probably marking the position of a former wall. The ceiling to the south of these retains many original thick floorboards, which are hand-finished. Most have had rough soffits cut to fit the beams, perhaps suggesting that they were re-used, and there are at least four Baltic timber visible on them including rows of scored lines, an 'X' (Plate 21) and a '7'.

Plate 21: Timber mark in floorboards, Room 2, west Bridge House

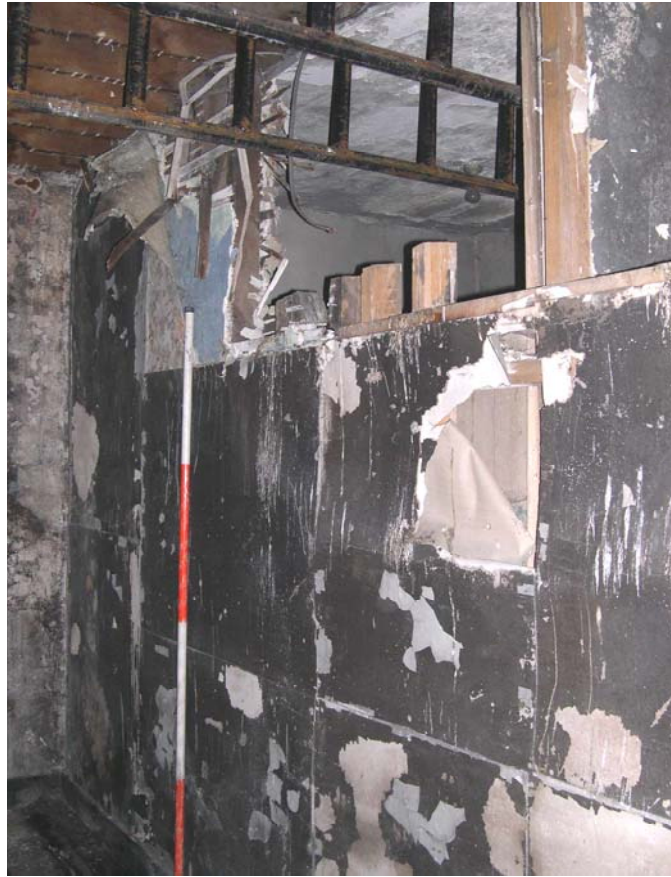
- 4.5.21 **Room 14:** this is a large room in the north-east corner. There is a window in the north elevation with splayed jambs and a fireplace in the east. This has been blocked with concrete blocks, although a small hole has been broken through. The west and most of the south elevations are modern stud partition walls, although the first 2.16m projecting from the east elevation are apparently original (Plate 24).

Plate 24: Junction of modern and early partitions between Rooms **14** and **18**, west Bridge House

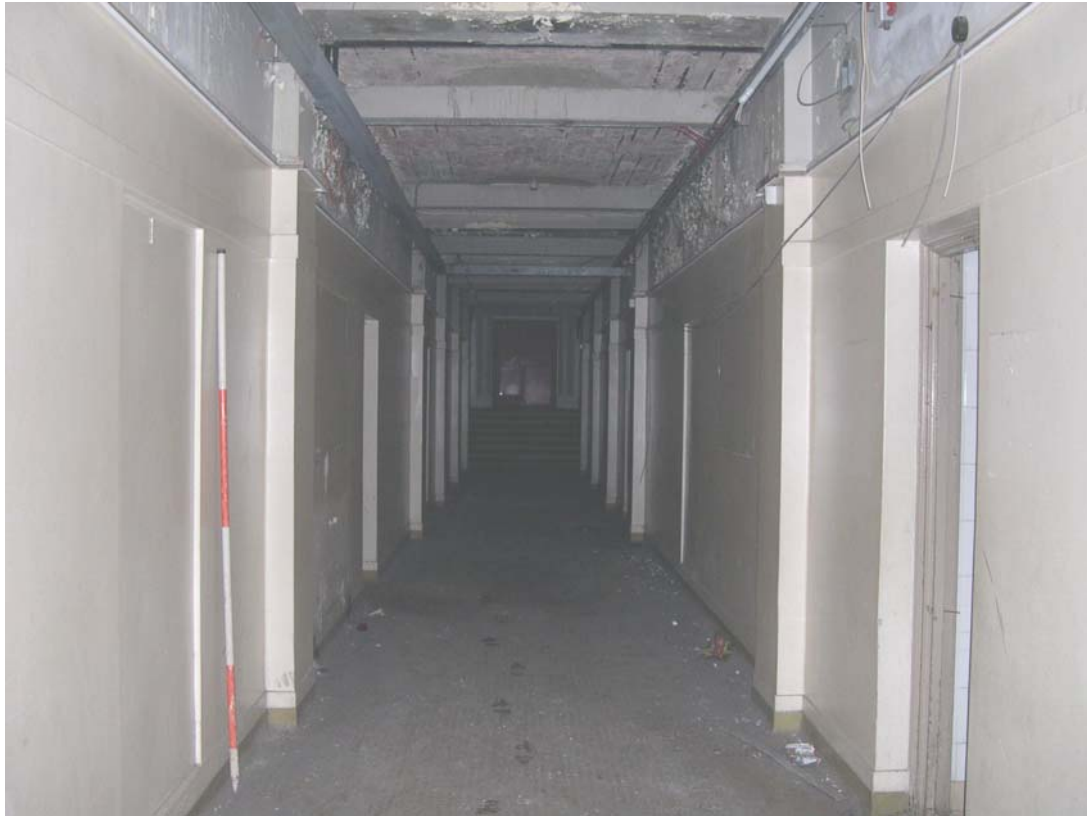
Plate 30: Spinal corridor (Room 5) looking south showing detail of ceiling and blocked doorway, baths

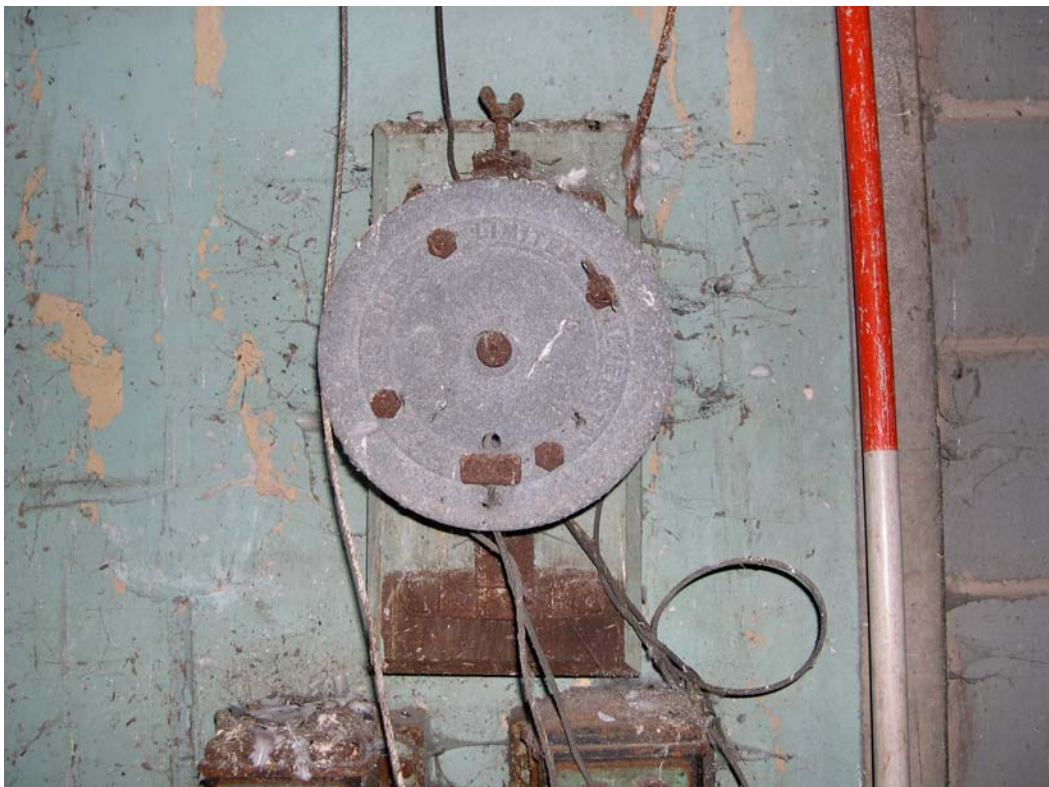
- 4.7.35 **Internal Detail, Room 26:** this is a large room to the north-west of Room 25, which originally formed a stage overlooking the main pool. It is tall, extending to first floor height, with nine-light windows in the east and west elevations at first floor level and two larger blocked windows in the north elevation at the same level. The ceiling is original but plain, and supported by three concrete beams. The floor is finished with badly damaged timber blocks and there are the remains of a skirting board along most of the walls. There are blocked doorways in the north sides of the east and west elevations and an inserted doorway in the south side of the east. The ground floor level of the north elevation mostly comprises a single large aperture filled with concrete blocks. Within the blocking three smaller apertures have been left, but these have subsequently been covered by timber boards (which are finished with tiles on the pool side). Above the original large aperture is the remains of a mechanised curtain and long strip-light, and on the west side the electric drum for the curtain remains *in situ* and is marked 'STONES LIMITED ULVERSTON' (Plate 37).

Plate 37: Cable drum for stage shutters marked 'STONES LIMITED ULVERSTON', Room 26, baths
