HOLLIES FARM, SCHOOL LANE, HARTFORD,

**CHESHIRE WEST AND
CHESTER**

Archaeological Building Investigation

June 2010

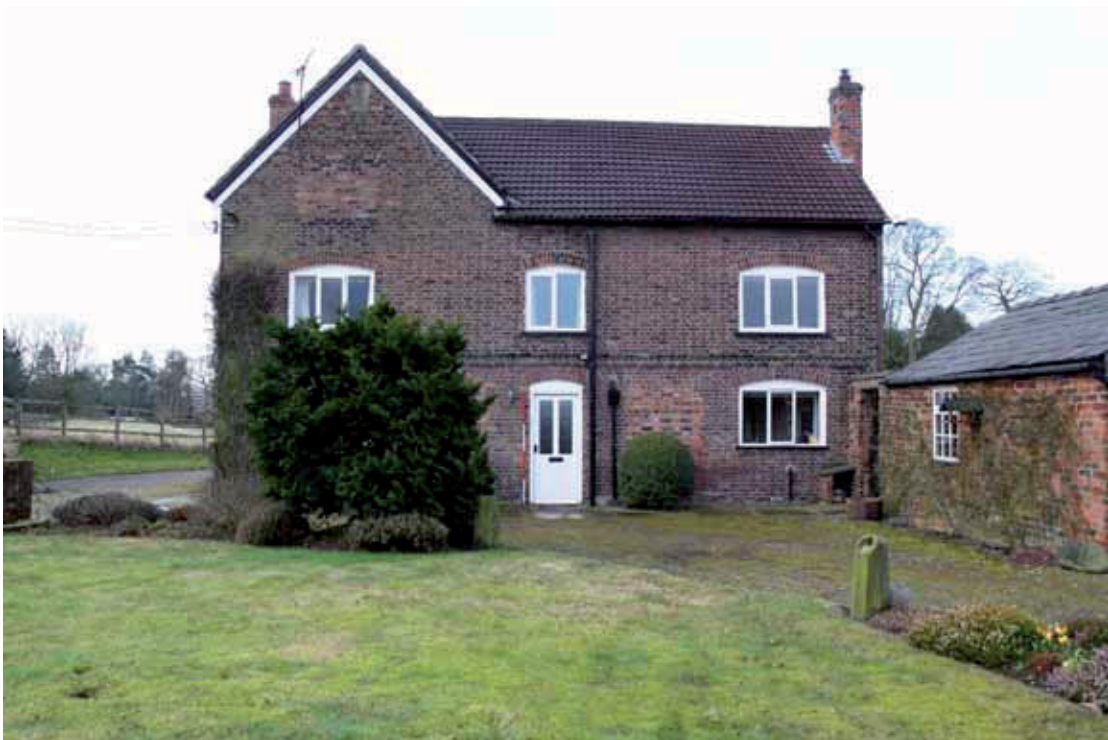
According to the datestone present in the eaves of the gable, the farmhouse was constructed in *c* 1761. At this time it was probably at two dwellings, as suggested by the blocked doorways in the front elevation.

Plate 2: Front elevation of the farmhouse, one of the blocked doorways is evident, as is the blocked window at attic floor level, and the datestone

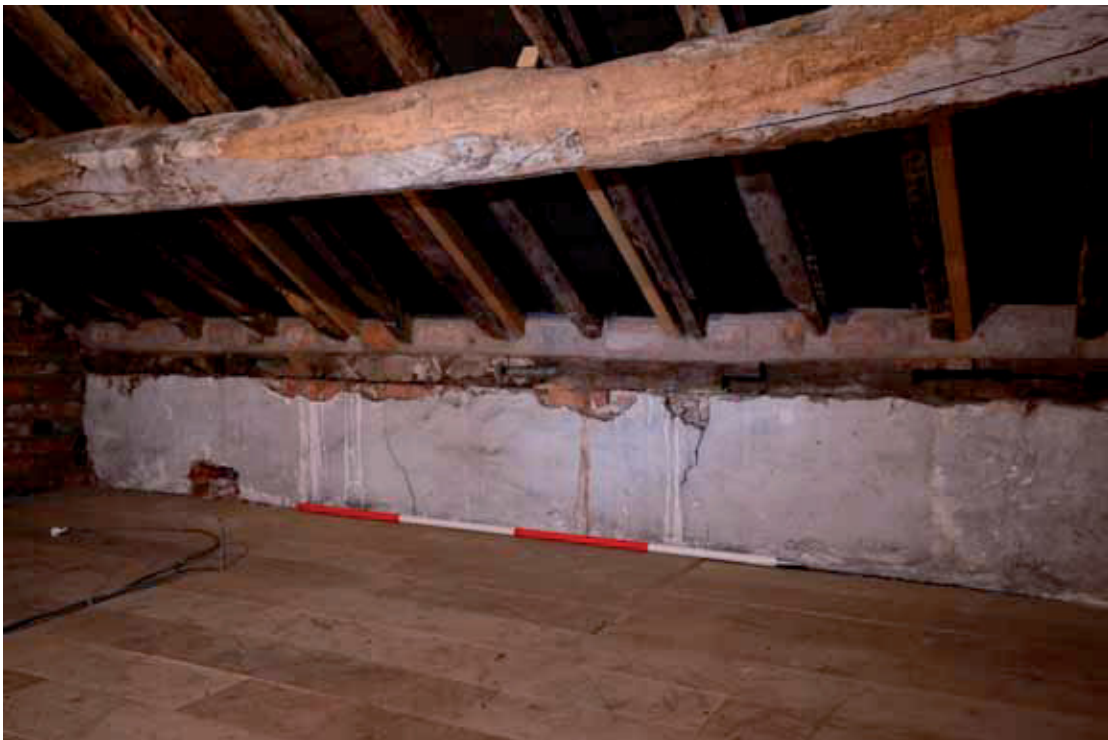
Plate 12: Detail of wall plate with edge-halved, scarf joints, and new brickwork above

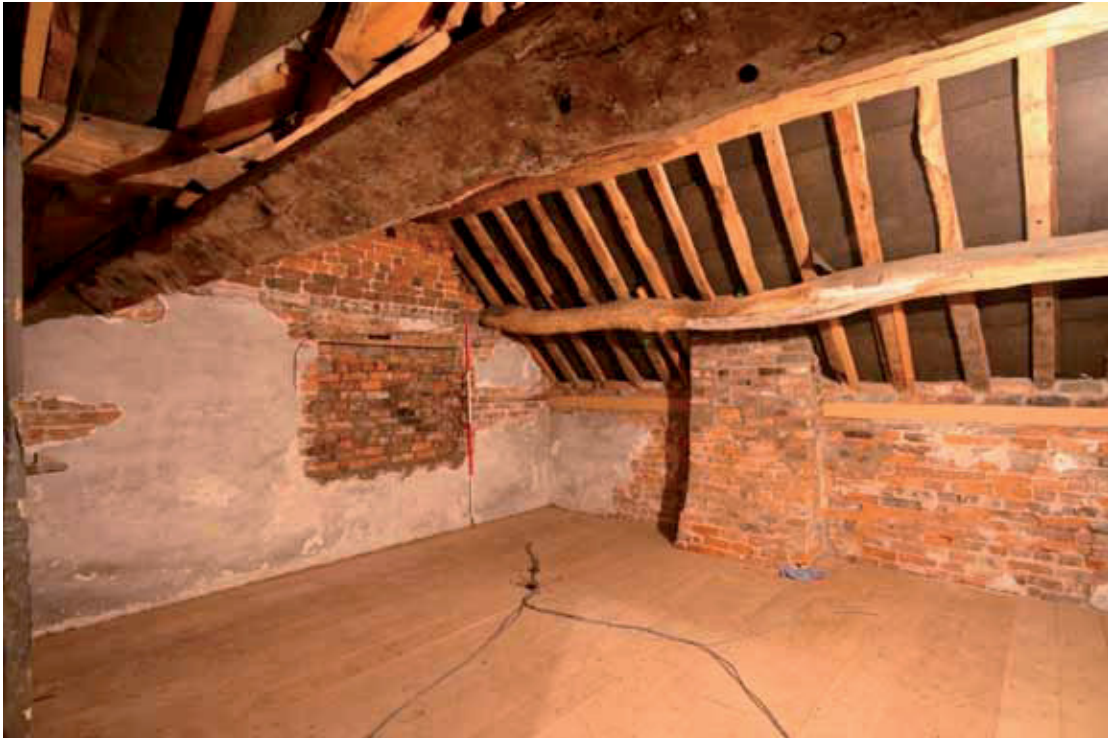
- 4.3.19 **Room 3:** this is the front room within the wing of the house. The blocked window is clearly evident from this perspective, and has a large timber lintel (Plate 13). The chimney breast seen on the previous two floors is also present here, although narrows in a stepped-formation, and the change in brickwork, where the new stack has been added can be clearly observed.

Plate 13: Blocked window within the attic, and partially re-built flue

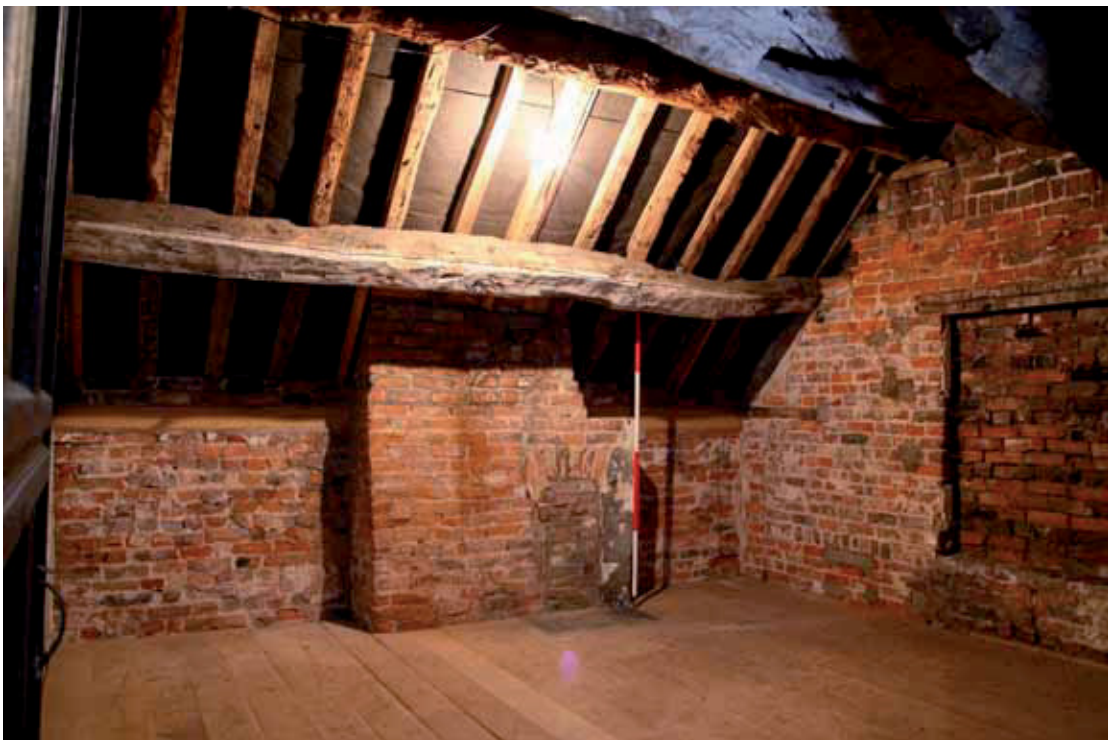
Plate 14: Blocked fireplace and blocked window in the attic

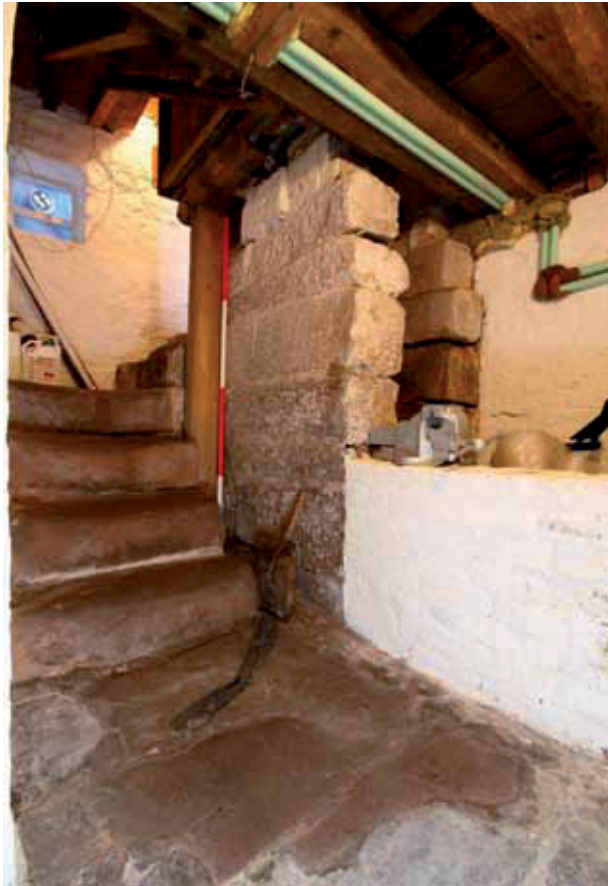
4.3.23 **Cellar:** the cellar is entered via a well worn half-turn sandstone staircase. The upper flight of which is supported by an open sandstone ashlar block construction (Plate 16). This leads into a single cell brick-vaulted cellar with a brick and cobblestone floor (Plate 17). A partially blocked cellar light or coal chute is evident on the front cellar wall. The timber joists from the floor above can be seen within the stairwell, and it appears the stairs above have also undergone some modern renovation or strengthening with plywood.

Plate 16: Detail of staircase in the cellar

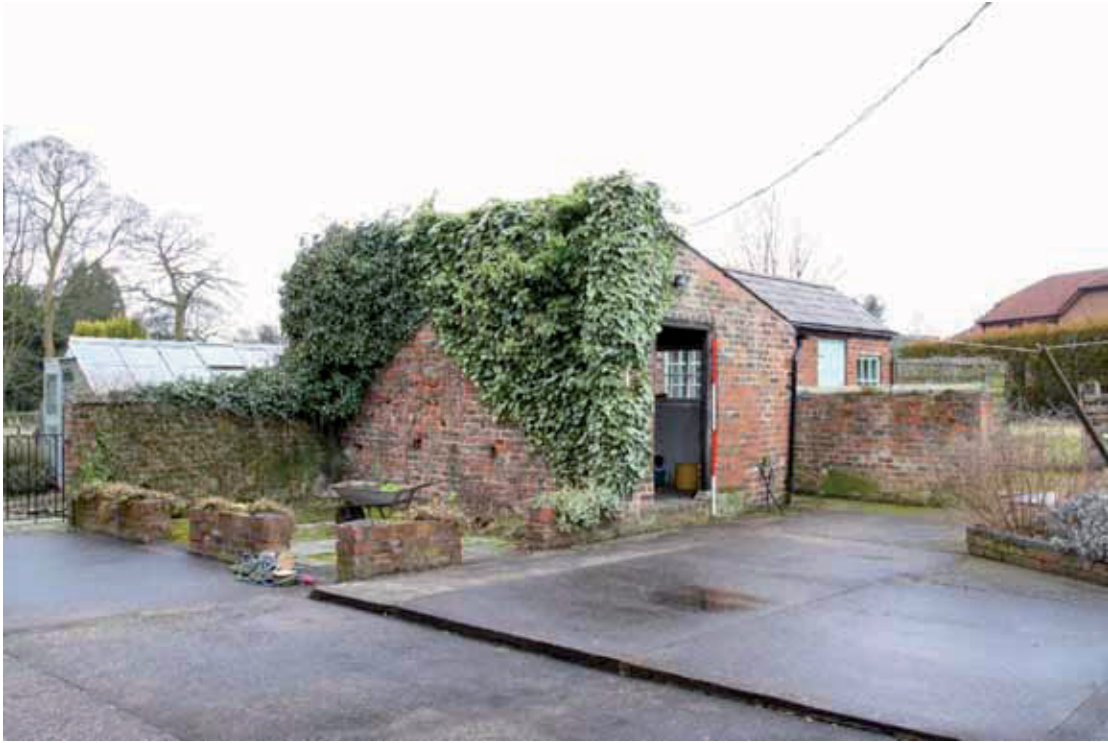
4.4.4 **Storage Shed:** a small building with a single pitch roof of open slate, which appears to have been adapted from the structure of the original house (Fig 2; Plate 18). Although most of the exterior is overgrown with vegetation, it is clear that the side elevation of the building extends above the roofline and a single casement window is present to the other side elevation with the entrance being on the gable end. Internally, the building has a partial chequer board pattern red and black tiled floor, although this has been repaired or replaced in part with a brick floor.

Plate 18: The brick outbuilding formerly attached to the farmhouse

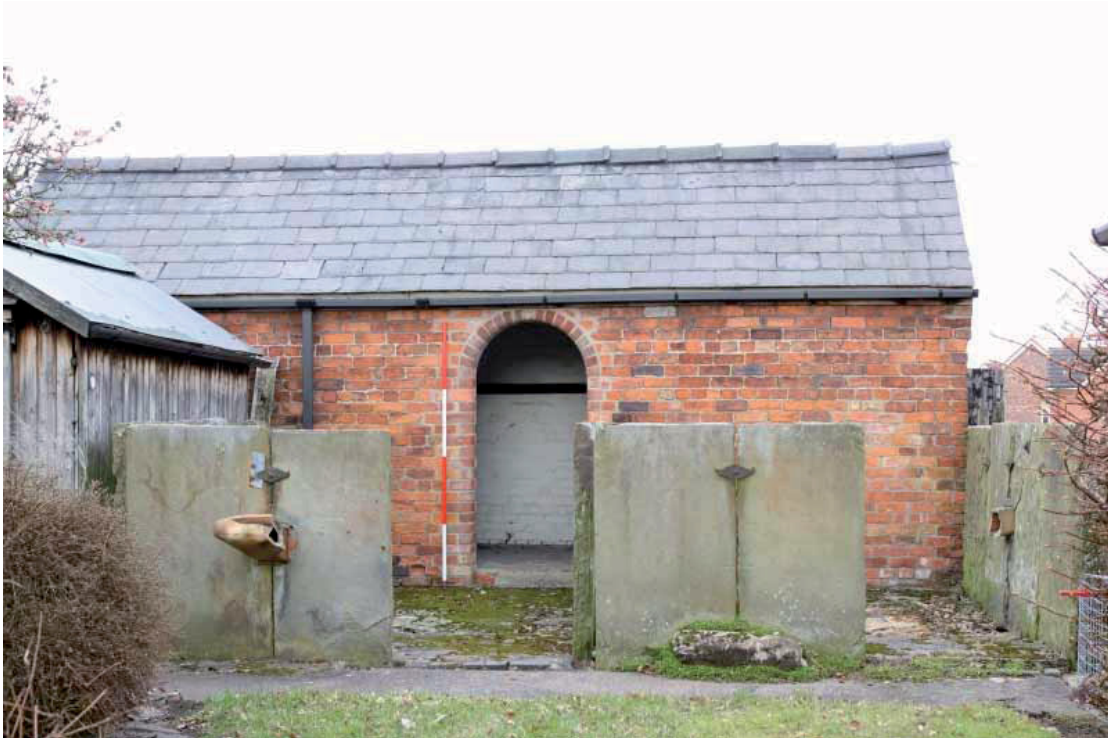
4.4.2 **Pigsty:** the pigsty, although single storey, had a poultry loft (Fig 2; Plate 19). It was constructed from handmade bricks in an English Garden Wall bond with an open timber and slate roof. It would originally have had three external pens, only two of which remain. These were constructed from large flagstones set on end. A glazed ceramic feeding chute for the two remaining pens is present. The entrance into the covered portion of the sty was through small arches with double bull-nosed brick surrounds. The two end arches remain, although these are now blocked, and have been replaced with a central tall doorway. The half-height floor which separated the pigs from the poultry has been removed, presumably to allow easier access. Poultry holes can be seen in both end elevations.

Plate 19: Pigsty with original ceramic feed hoppers in external pen walls

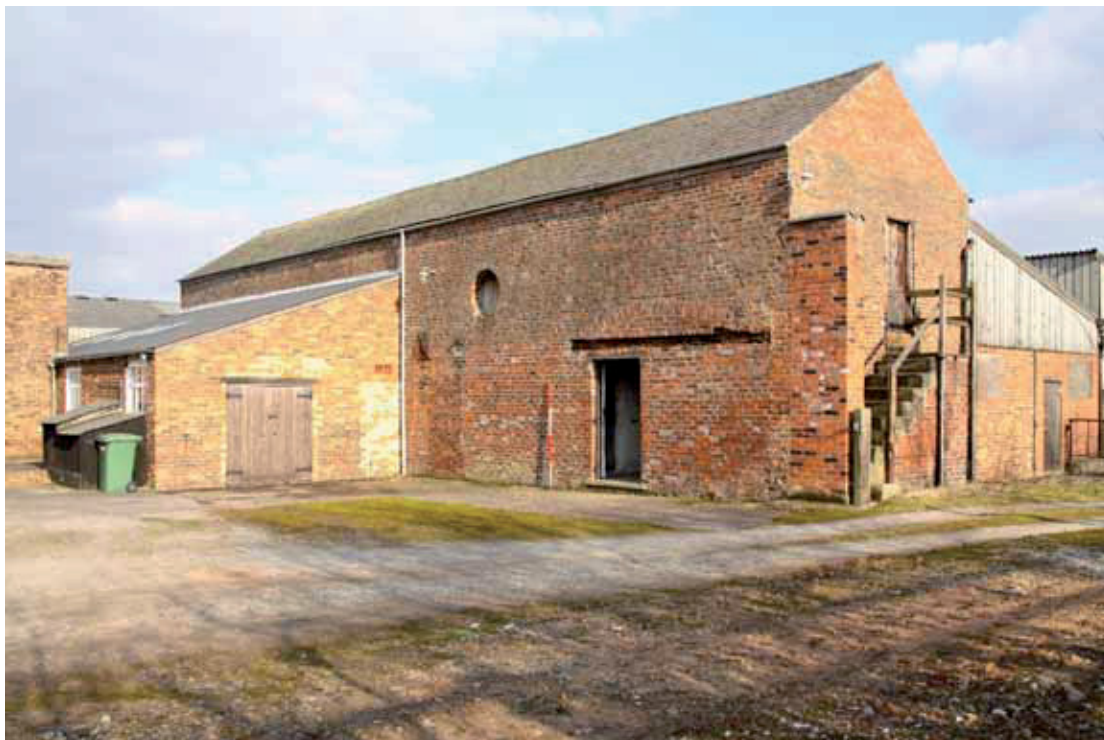
Plate 22: The front elevation of the barn. The relieving arch for the wagon door is evident above the timber lintel

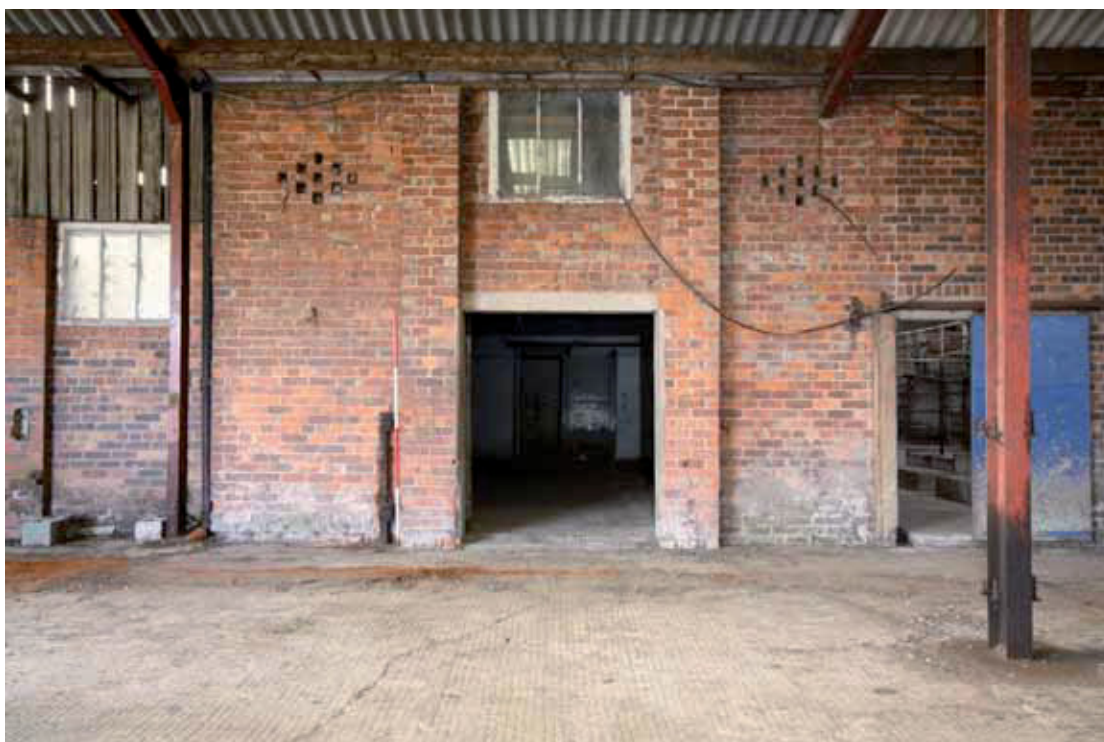
Plate 23: Gable end of the barn (Building 1), now internal, showing re-built face with Building 3 keyed in on the right

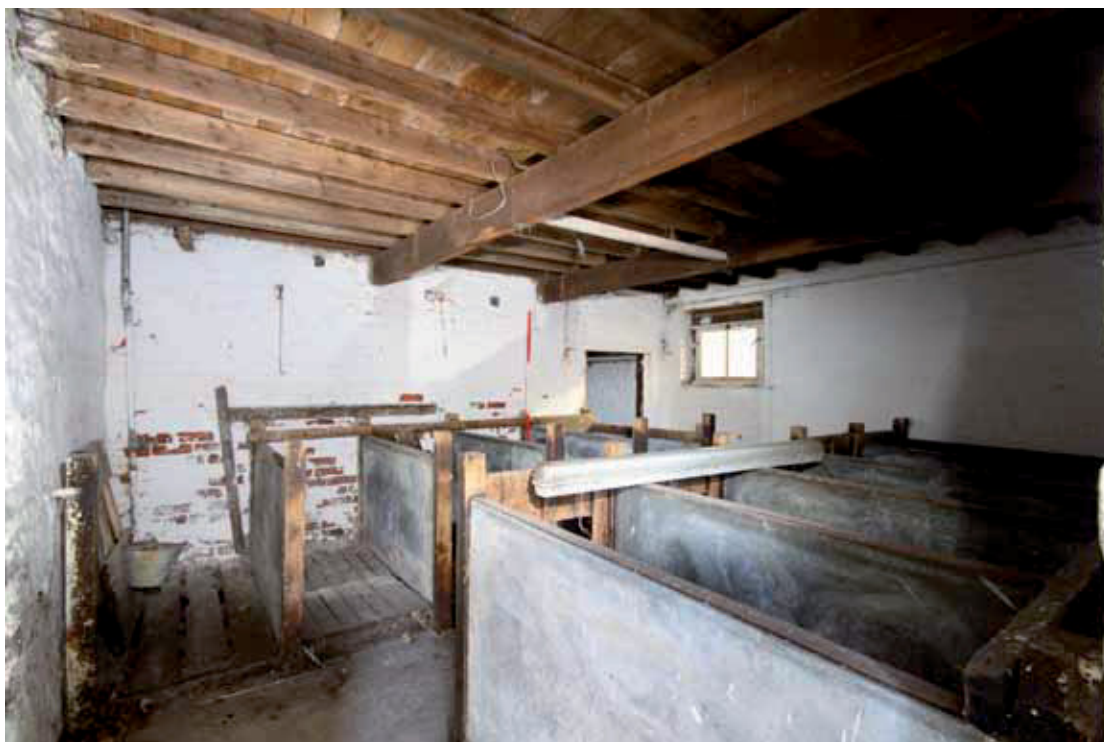
- 4.5.8 The doorway into the next room does not appear to be the original access as it has been cut quite crudely through the wall. The subsequent bay contains 10 stalls for calves, five on each wall (Plate 27). This room has a concrete floor and the new timbers to the ceiling suggest that the floor above has been replaced recently. The door through to the central bay is diagonally opposite. The only remarkable feature in this bay being a blocked air vent to the wall that divides this building and Building 3. The floor above is constructed of modern timber joists and timber panelling floor. An impressed concrete floor continues into the room beyond. The far wall of the bay is a modern addition, being roughly keyed in to the side walls. It has a centrally-placed sliding wooden door, with a large concrete lintel. It does not extend to the full height of the barn, continuing to the base of the new truss as brick buttresses. The fourth and fifth bays at the northern end of the barn comprise a room of two stories in height being open to the roof. Two buttresses also supporting a truss (Plate 28) sub-divide the bays. The walls in these bays have an additional skin of bricks up to first floor height and have been rendered up to a height of 1.9m.

Plate 27: Calf shed with modern beams over

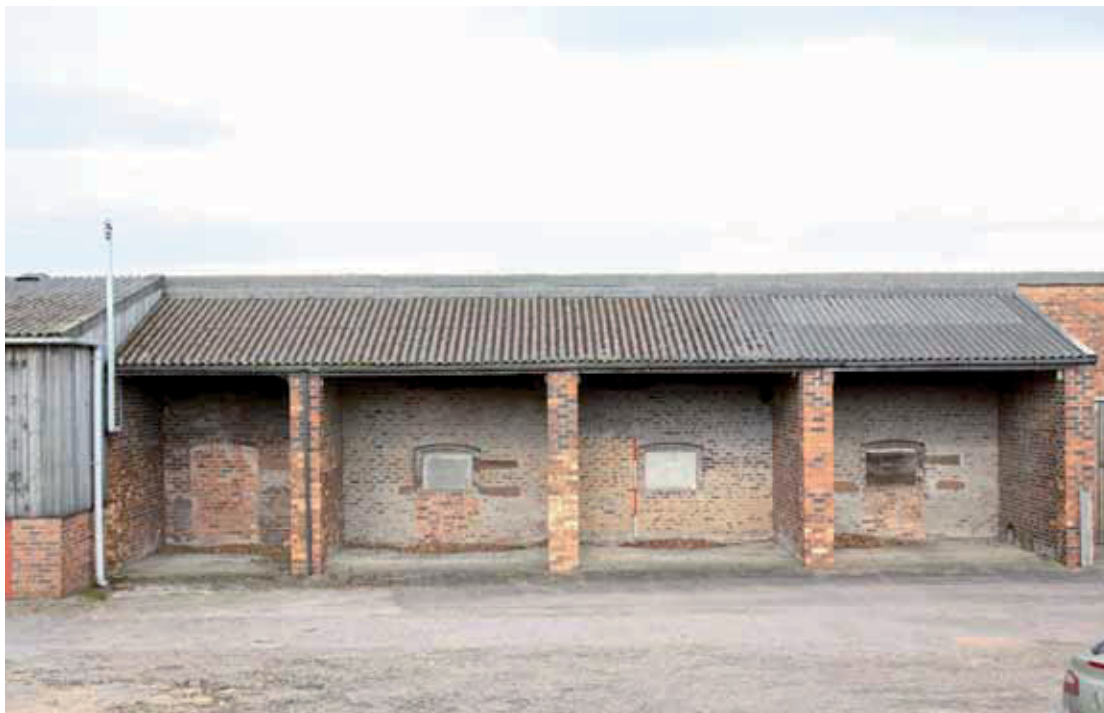
- 4.5.16 **Building 5:** is an open-fronted four-bay storage area. It was originally constructed to support the failing wall of Building 2 (Plate 30). Five one-brick wide walls were constructed to act as buttresses to prevent the collapse of the cow shed (*pers comm* John Eaton), and followed with a single pitch asbestos and timber roof. Within each bay a blocked up doorway is evident; these appear to originally have had bull-nosed reveals and sandstone pads in the jambs, prior to being bricked up to form windows, which have also since been covered. Every other bay also contains a circular brick pitching eye of the same style as noted in Building 1. Several brick air vents are present and these have mostly been blocked or are now behind the projecting walls.

Plate 30: Building 2 incorporated into Building 5, showing a series of blocked doorways

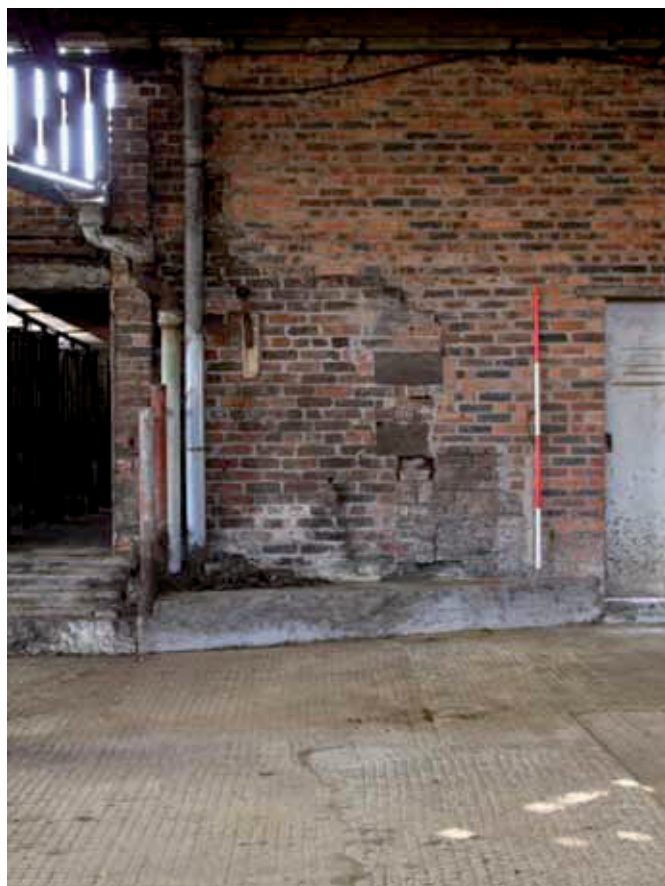
Plate 31: Rear elevation of Building 4, showing the short section of Building 2, and the sandstone pads for an original door jamb
