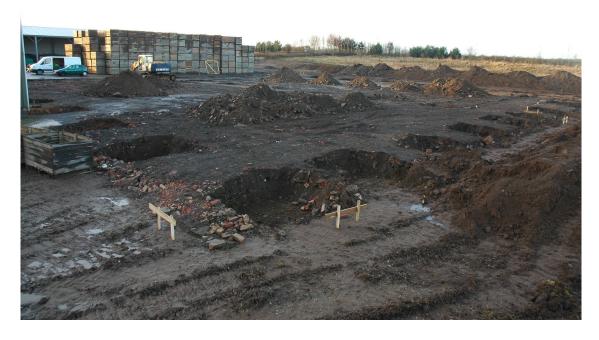
Photo No.1: Development site facing southeast

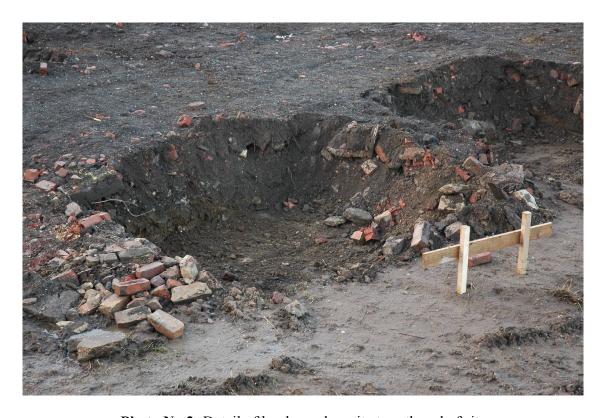
Photo No.2: Detail of hardcore deposit at north end of site
