**REPORT ON THE ARCHAEOLOGICAL MITIGATION WORK:**

**PRIORY CHURCH OF ST. MARY AND ST. MARTIN,  
BLYTH, NOTTS.**

Site Code: BSMM10

February 2011

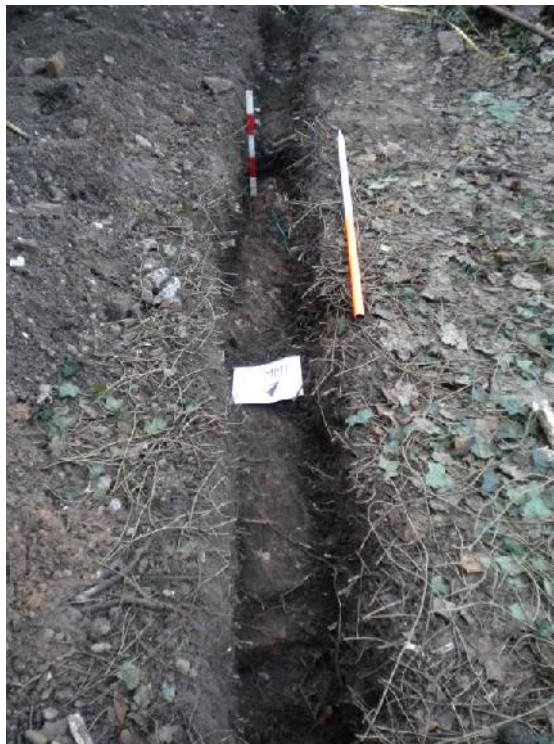
Part of a convex brick surface, probably representing the upper (external) surface of a brick burial vault (12) was encountered during monitoring of the new drainage trench (Fig. 3, plates 1-4). The vault, located c. 0.30m below existing ground level and exposed for c. 3m, was preserved in situ (Appendix 2). A quantity of 19<sup>th</sup> and 20<sup>th</sup> century pottery and tile; and a hand-made brick was recovered from topsoil (10) above the vault (Appendix 3).

2. Drainage trench with brick burial vault (13), looking northwest

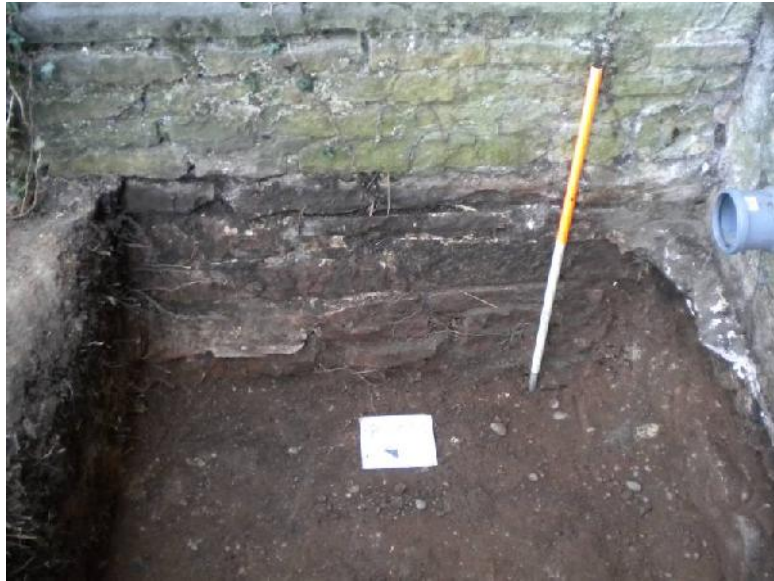
A large pump chamber pit was excavated at the eastern end of the drainage trench against the north aisle (Fig. 4, plates 5 & 6). The pit was approximately 1.5m<sup>2</sup> and 1.3m deep. It contained two deposits. The earliest was a sand and mortar demolition deposit (11) containing fragments of roof tile and vessel glass, including the base of an early 18<sup>th</sup>-century 'Onion' bottle (see Appendix 3). Above layer 11 was 0.35m of dark brownish-black topsoil (10) containing 19<sup>th</sup> / 20<sup>th</sup> century pottery. The west-facing elevation of the church's easternmost buttress (14) was recorded within the eastern pit section (Fig. 5). Part of the lower north aisle wall (13) was recorded within the southern pit section (Fig. 6).

5. Buttress (14) within west-facing section of pump chamber pit

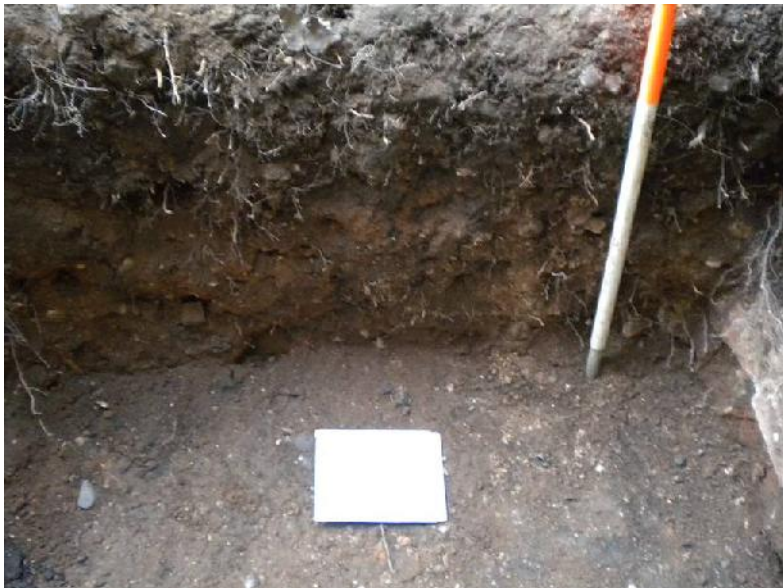
6. South-facing section of pump chamber pit

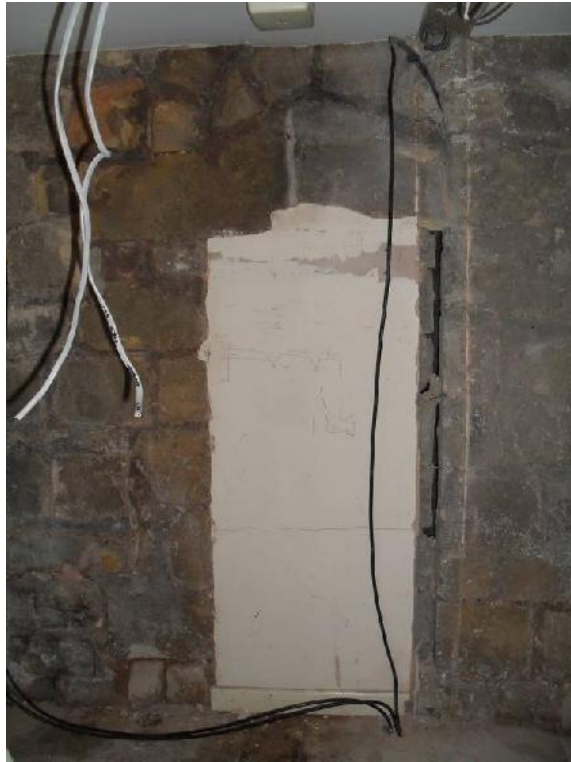
Monitoring conducted during alterations to the kitchen and vestry recorded a blocked doorway with a stone arch located in the west wall of the north aisle (kitchen area) (see Figure 3 and Appendix 1, plates 9 & 10). The door originally led outside to the west of the church. It had been blocked relatively recently with 20<sup>th</sup> century plasterboard and covered.

9. Blocked doorway in the west wall of the north aisle, looking west
