College Farm, Creaton South Northamptonshire

Level 2 Historic Building Recording

Report Number: 16611

CA Project: 660806

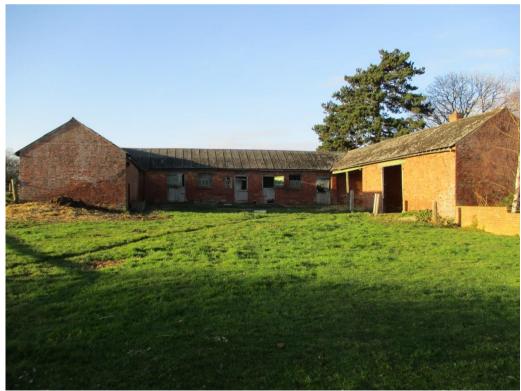
Photo 1: View of the building looking west.

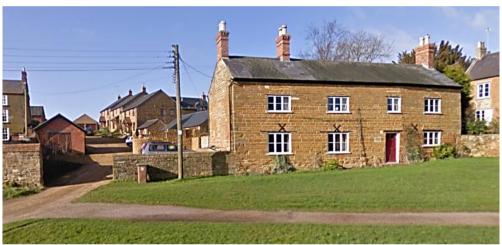
Photo 2: College Farm's farmhouse viewed from The Green, with the cow house hidden behind the terrace of three houses at centre-left. The Georgian farmhouse is partly visible at far-left.

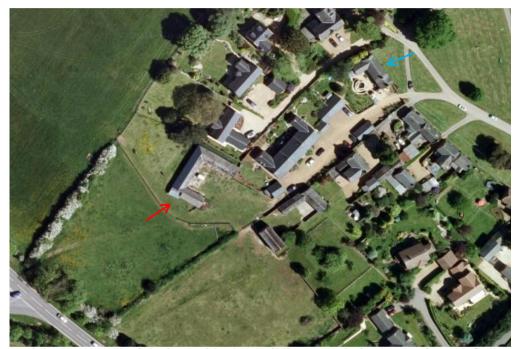
Aerial photo 1: Aerial view with the building at left (red arrow), and College Farm farmhouse (blue arrow). Comparison with the 1885 OS map (Fig. 3) confirms the extent of later infilling between the two. The paddock to the building's south-west is also part of the earlier farm.

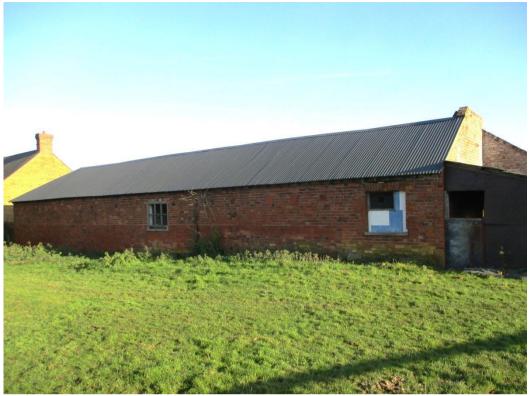
Photo 3: Rear elevation of cow house, looking south-east. The metal roof is later.

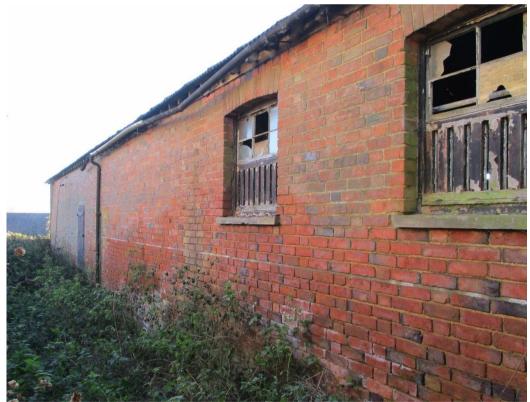
7.15. The double-pitched roofing is unlined throughout and open to the rafters, some timber-work appearing to be later. Because of re-roofing there is no earlier evidence of roofing insulation, such as straw, which was a quite common solution during winter months. Roofing materials are predominantly of corrugated asbestos, with one pitch of more recent corrugated metal. The original roofing was probably of Welsh-slate. Whilst some later 19th-century rainwater goods survive including a cast-iron hopper-head, asbestos guttering was fitted as a later replacement.

Photo 4: North-east facing elevation facing. Note the ventilation slits to windows. Note the mix of guttering and downpipes: cast-iron and asbestos.

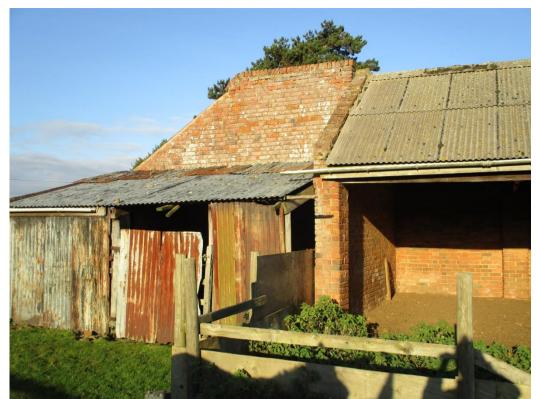
Photo 5: Corrugated-iron lean-to at south-western corner of the building.

- 7.16. Room 1 Open cow shelter of earthen floor, with two posts placed on former staddle-stones (Photos 5 and 6). A relatively-recent roughly-hewn tree-trunk has been inserted to provide additional structural support. The earlier posts include mortices for now-removed upper partitions. There are no features within the shelter. The roof is a later replacement of the original, the whole structure resting directly onto the wall-plate, the ends of common rafters projecting over slightly at the eaves (Photo 7). The king post truss used here better supports the roof across the expanse of the shelter itself. Here, the central king post rises from the horizontal tie-beam, two struts set diagonally rising from the base of the king post itself. These are set into the principal rafters to each side, which in turn supports purlins upon which rest common rafters. Tie-beams rest upon piers projecting forwards into the room. This is a common roofing structure.

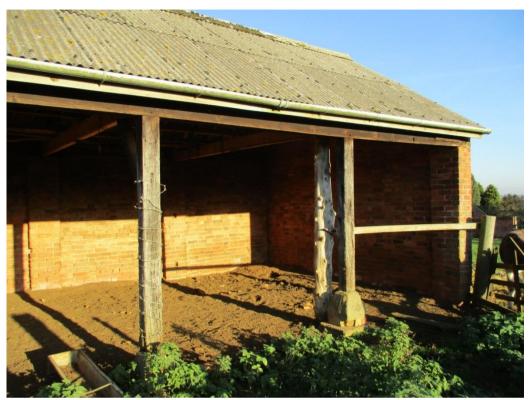
Photo 6: Room 2, cow shelter. Later asbestos roofing.

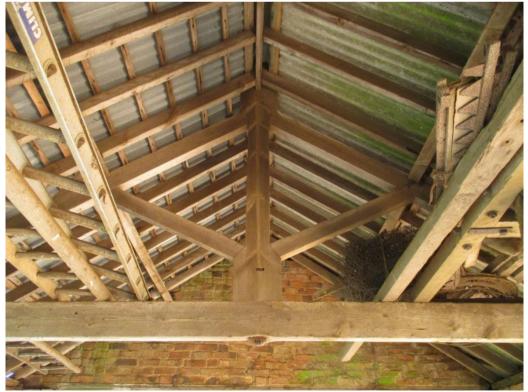
Photo 7: Roof structure to room 2. This appears more recent in date.

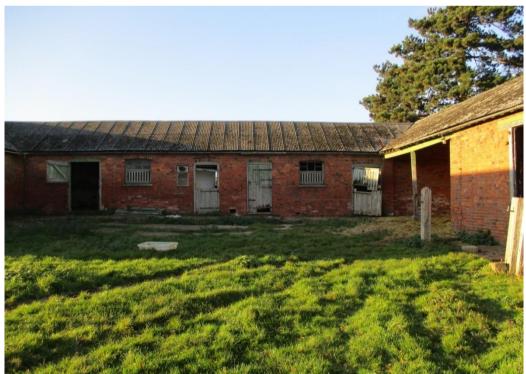
Photo 8: Cattle yard and south-east facing elevation of central range. The surface area nearest to this range is laid with concrete, which has since broken up.

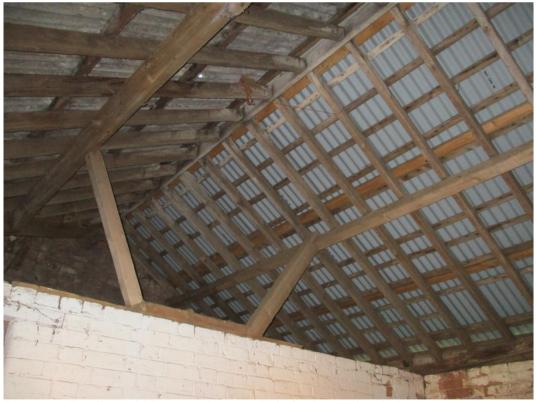
Photo 10: Roofing within central range. This is the earlier timber structure as first constructed. The struts support purlins, which in turn carry common rafters.

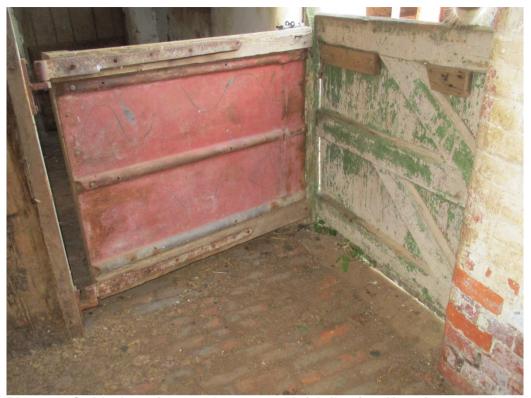
Photo 11: Stable doors in central range, and brick-flooring. Note the rounded edge to the brick-walling at right.

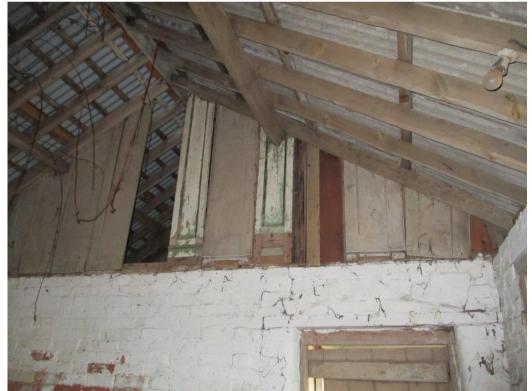
Photo 12: Improvised partition in central range between rooms 3 and 4.

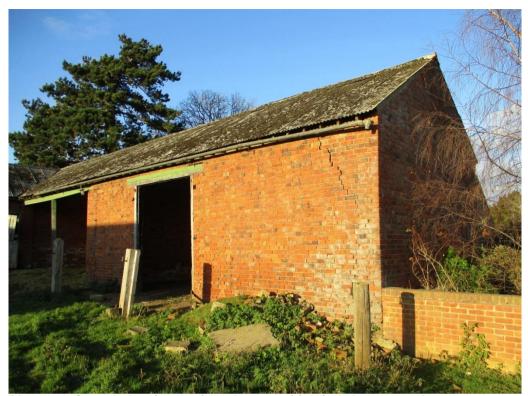
- 7.20. Rooms 7 and 8 Room 7 is a second cow shelter facing into the cattle yard, and the roof structure itself appears to be a later replacement (Photos 8 and 13). The walling to the gable between rooms 6 and 7 appears to be later infilling, or has been re-pointed at a different time to that below. The flooring to both rooms is earthen. A king post truss again supports the roof across this span, purlins at either end set into brick gabling. The double-door entry into room 8 confirms the need for wide access but there are no interior features to suggest function. A ledged plank door allows access into the room from the north-east.

Photo 13: Cow shelter (room 7), and room 8 (right). Asbestos roof.

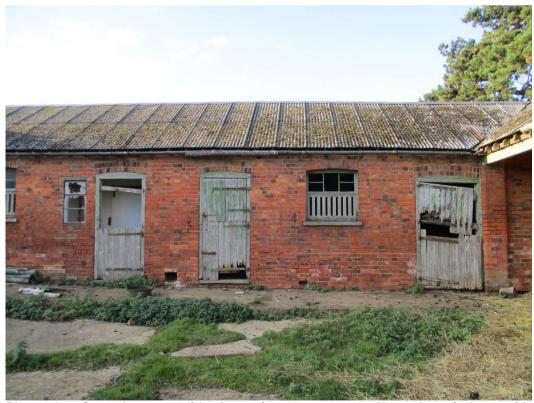
Photo 14: Central range with doors into rooms 4-6. Note the window, with ventilation slits to the lower part and what was originally six-light glazing to the upper. These have been repaired and reworked. Guttering is asbestos.

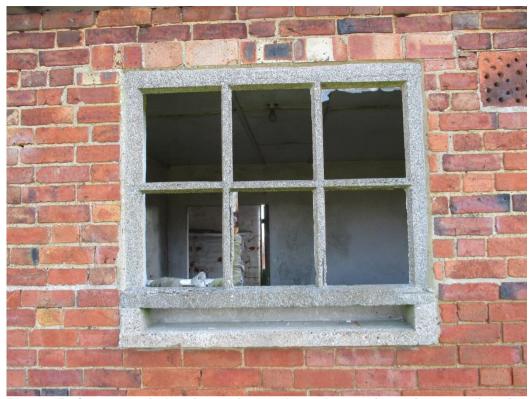
shaped so as to create curved jambs, or quoins to avoid harm to livestock or horses. A later concrete window-frame provides light to room 4 (Photo 15).

Photo 15: Concrete window-frame, inserted at a later point to increase light into the building. Note also the earlier clay ventilation panel at upper-right.

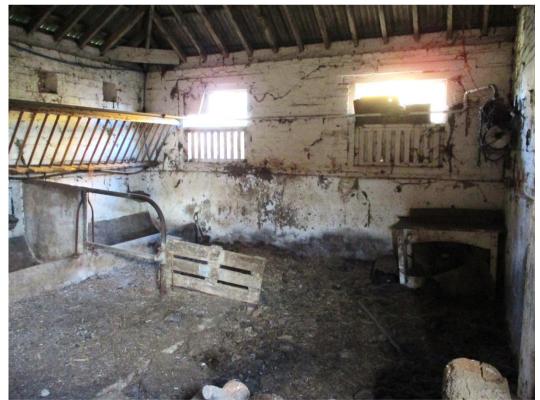
Photo 18: Room 6, the milking parlour.

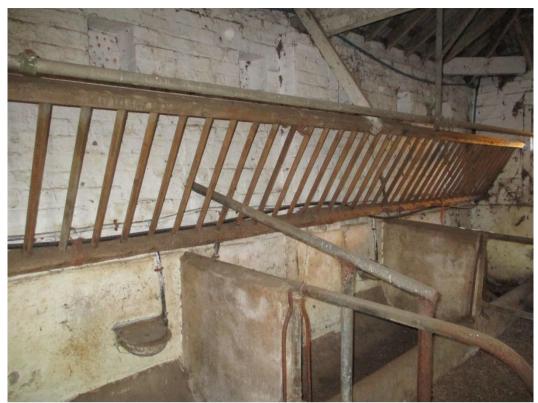
Photo 19: Hay-rack and milking stall in room 6.

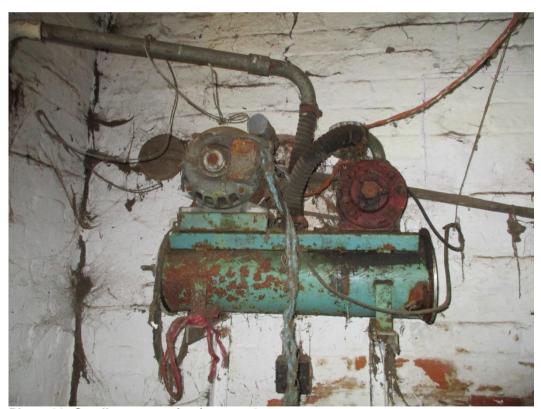
Photo 20: Small pump engine in room 6.

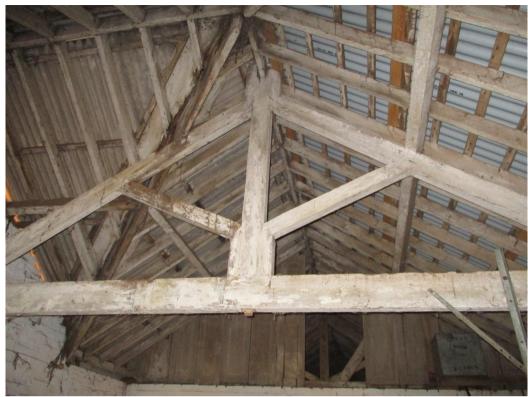
Photo 21: Roof-structure over room 6.
