**Zouch Manor  
Tidworth  
Wiltshire**

Historic Building Recording

CA Project: 770047  
CA Report: 14058

prepared by	Peter Davenport, Historic Buildings Consultant
date	25 February 2014
checked by	Mark Collard, Head of Contracts
date	4 April 2014
approved by	Simon Cox, Head of Fieldwork
signed

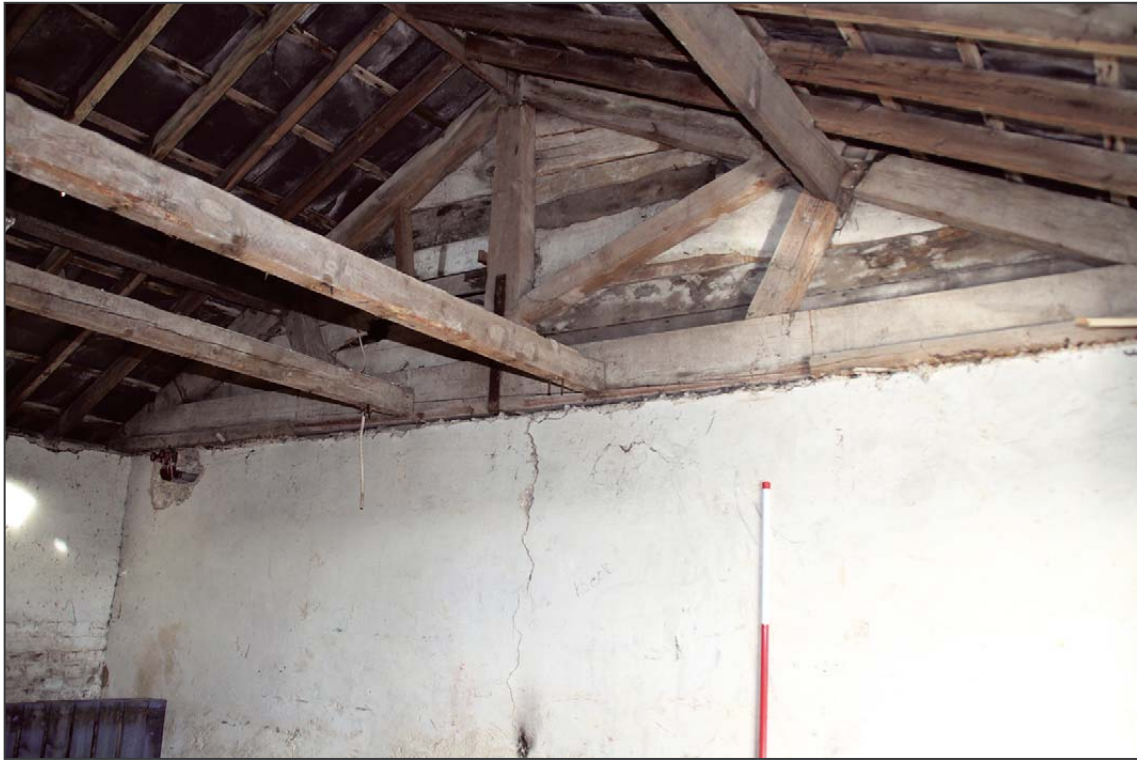
11

- 5.7 The trusses were all identical and were of shallow-pitched king-post design (Fig. 11). The joints of the diagonal braces from king post to principals were haunched, but the head of the king post was not jowled. The base of the king post was tenoned to the tie beam and the joint reinforced with a bolted U bracket. The chamfer on the tie beam stopped either side of this strap. The apex of the principals was reinforced by a curving iron tie. The common rafters met at a vertical ridge board held in a slot in the head of the king post.

- 5.9 The southern bay, adjacent to Building C (Bay 1), was divided from the others by a cob cross-wall up the tiebeam of the roof truss and horizontal planking above (Fig. 11). It had a double door closing off the wide doorway in the east side, the cob jambs being rounded, although the brick base wall was not.

**11 Truss 1 in Building D, over north wall of Bay 1 (scale 0.5 divisions)**

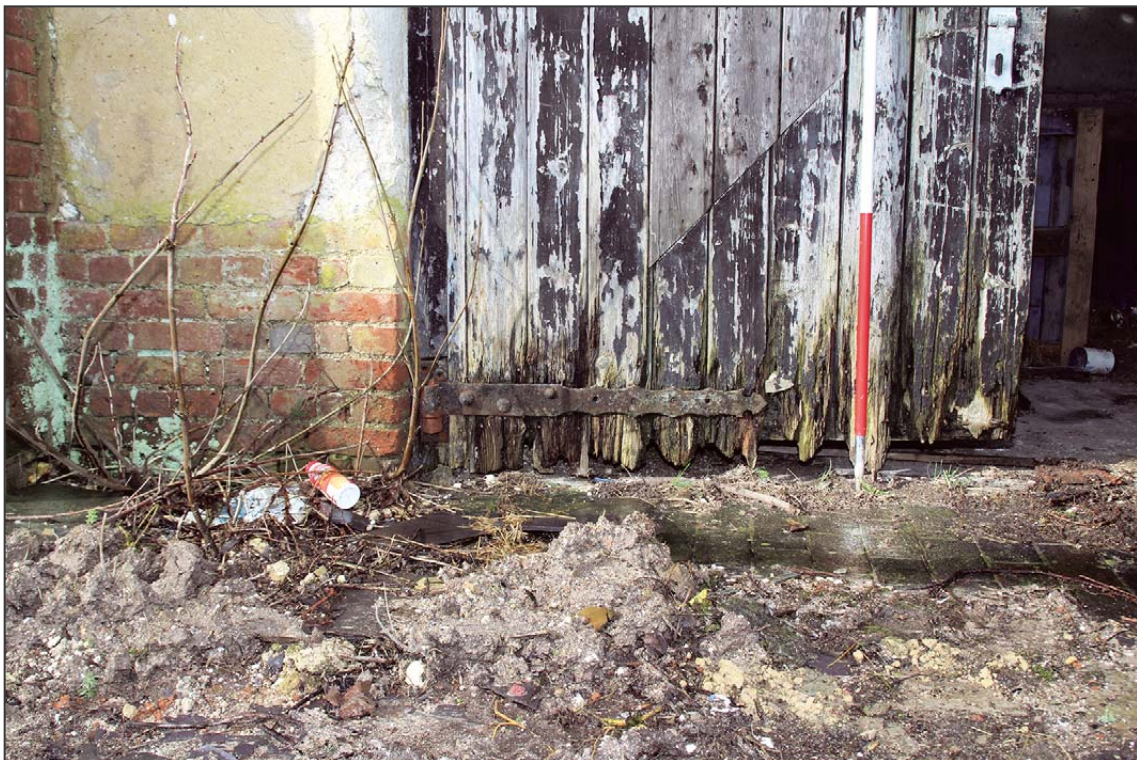
- Fig. 12 The decorative hinges on the doors to Bay 1, Building D. This also shows the abutment of the lower wall to that of Building C (scale 0.5m divisions)

- 5.10 The framed, vertically-planked door was hung on decorative, scalloped-edged, wrought-iron strap hinges swinging on pintles (Fig. 12).
- 5.11 The floor was of plain, red brick paviments, 9" x 4½" (230mm x 115mm) internally and there was an apron of similarly sized plain, black pavement bricks outside the door.

- 5.14 The low brick wall on the east, either side of the doorway was eight courses (seven internally) of thin bricks  $8\frac{1}{2}'' \times 4\frac{1}{8}'' \times 2\frac{1}{4}''$  (216mm x 105mm x 57mm) laid in a slightly irregular English bond (Fig. 12).

- 5.18 This is a similar building to Building D and may be close in date. It is not structurally contemporary, as the brick base and cob walling of Building D clearly abut it (Fig. 12). It has a low brick base of similar style (and brick size), is cob-built and has a roof structure that is very similar indeed (Figs 15, 16 and 17). Rain ingress has caused the collapse of parts of the cob walling and the roof trusses in these areas; access to the interior was therefore very limited and the first floor completely inaccessible.
- 5.19 Apart from a recent repaired patch at the north-east corner, the building had no brick quoins. It seems to have the same render history as Building D, but the cementitious

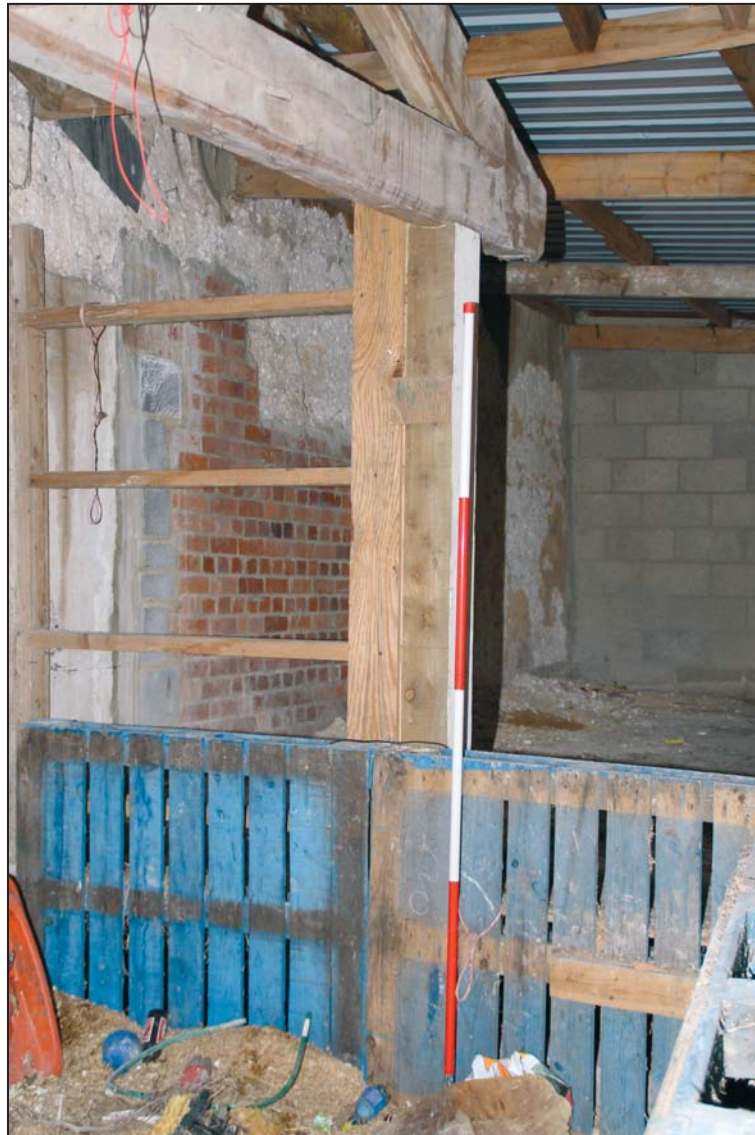
- 5.12 Most of the west wall of this bay had been removed to give access to eastern end of the lean-to against Building C at a higher floor level (Fig. 13). Consequently, the west end of the truss was supported on an inserted post. The roof south of the truss continued to meet the north wall of Building C, the purlins being supported in pockets in the cob.

**13** The post supporting Truss 1 in Building D after the removal of the cob wall here and the repair and construction work related to the lean-to, looking west-south-west (scale 2m)

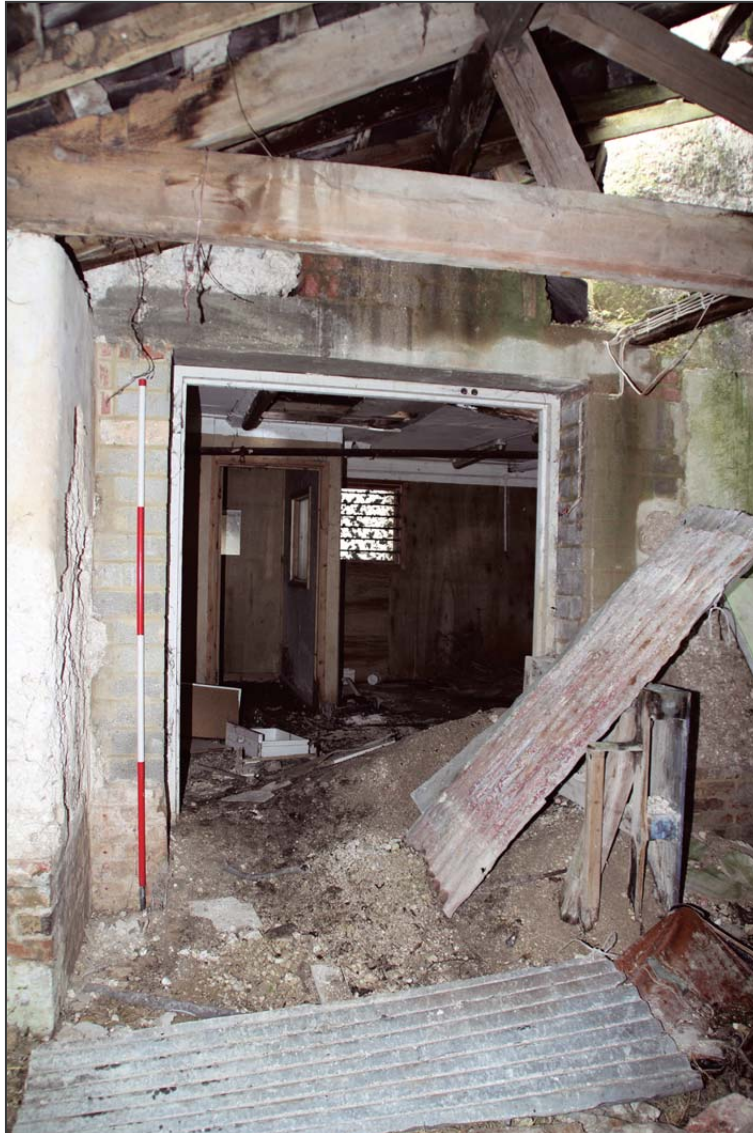
- 5.13 A door had also been cut through the south wall into Building C. This was recent and the jambs were of concrete blocks and the lintel was a reinforced concrete beam. Missing cob above the lintel had been replaced in concrete block and brick (Fig. 14). The wall at first floor level above the door had completely collapsed.

**14** The door in the south end of Building D cut through the north wall of Building C (scale 2m)

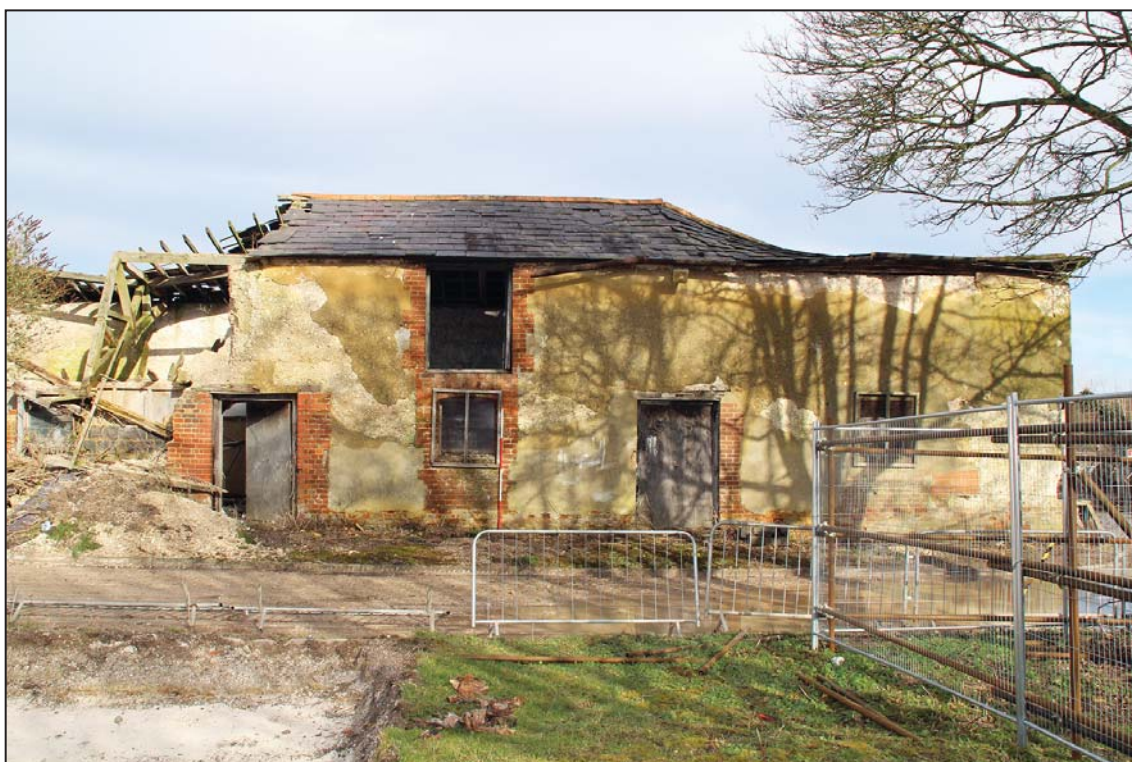
- coat is confined to areas around inserted/repared doors and windows on the ground floor, south elevation (Fig. 16).
- 5.20 The east wall is blank, and the south wall has two doors and three windows on the ground floor and a loading window in the first floor (Fig. 16). The collapse of the west end of the wall has removed evidence for any further first floor windows. No brick is evident in the pile of disintegrated cob in front of this collapsed section (Fig. 18).

- 5.21 The openings are of various phases. In the absence of any other certainly early door to the ground floor, the eastern door is thought to be the oldest (Fig. 16). The other door has jambs of bull-nosed face bricks and is clearly either an insertion or has been rebuilt (Figs 16 and 18). Even the early door has had its eastern jamb rebuilt, using the same bricks as the reinforced north-east corner and post-dating the last render coat. Its western jamb, only a small portion of which could be seen, seemed to pre-date all render coats and be made of bricks similar to the base wall (Fig. 16).

**16 South elevation of Building C (scale 2m)**

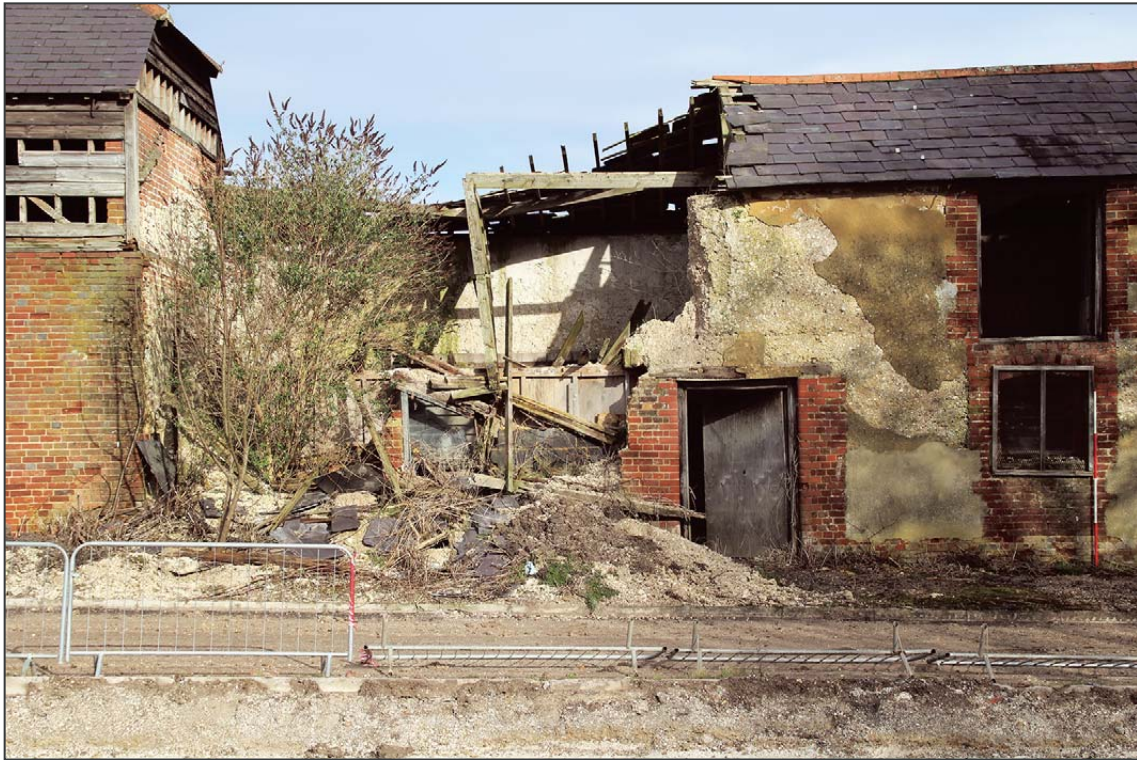
- Fig. 18 The mostly collapsed west end of the south elevation of Building C. The different brick types are evident. The third ground floor window is just visible left of centre, blocked internally by the concrete block wall

- 5.24 The ground floor window openings, two of which survived intact with a segmentally-arched head, are also framed in brick, but of a darker hue and of a different size, 9" x 4 $\frac{1}{8}$ " x 2 $\frac{1}{2}$ " (230mm x 105mm x 64mm), and set in a very different mortar with gravel aggregate up to 10mm diameter. The brick extends in an apron to rest on the top of the base wall (Fig. 16). The third window retained only its western jamb and was largely buried in debris (Fig. 18).

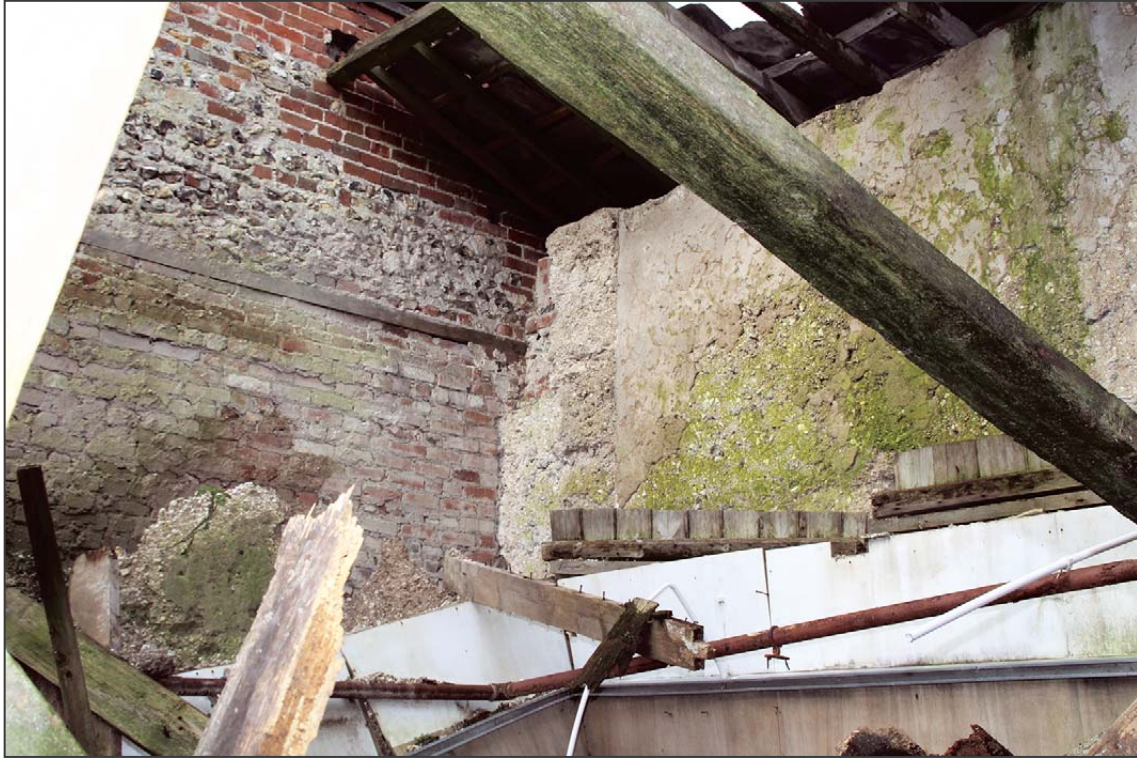
- 5.26 The western end of the building had suffered most from collapse, but it is evident, nonetheless, that there was a cob wall across the western end of the building. A large fragment of this wall survived at ground level (with a doorway through it into

Building B, see below para. 5.54) and the scar of its junction with the north wall was still visible to eaves level (Fig. 19).

19 The walls at the west end of Building C/junction with Building B, looking north-west (scale 2m)

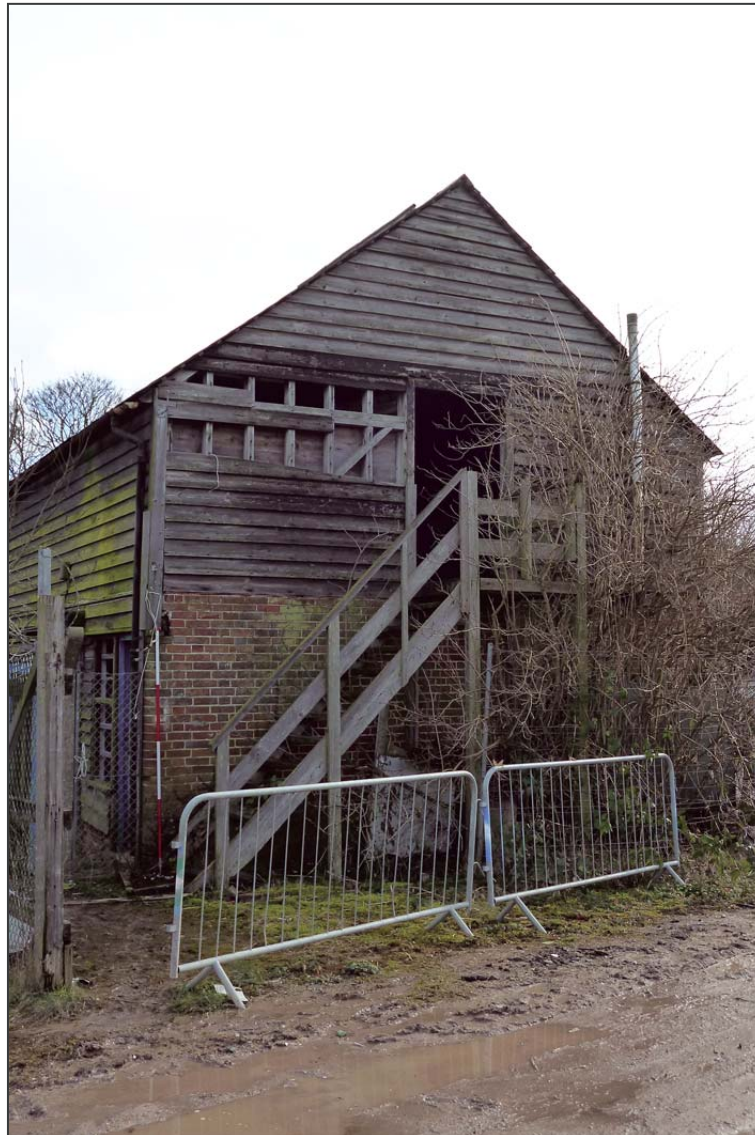
- 5.40 The north range is shown on historic mapping (1885, 1902) to have extended further west and a covered waggon way is indicated passing through it at the position of the west gable end of Building B. It is possible that access was from the room over the covered way and from the adjacent, now demolished building. However, there was no sign in the present north end of the former existence of such a waggon way or building, unless the gabled west end is a carefully repaired remnant of a through-roof.

**24 The west gable end of Building B, looking south-east (scale 2m)**
