**Steer Bank Farm
Harworth
Nottinghamshire**

Historic Building Record (Level 3)

CA Project: MK0926

CA Report: MK0926_1

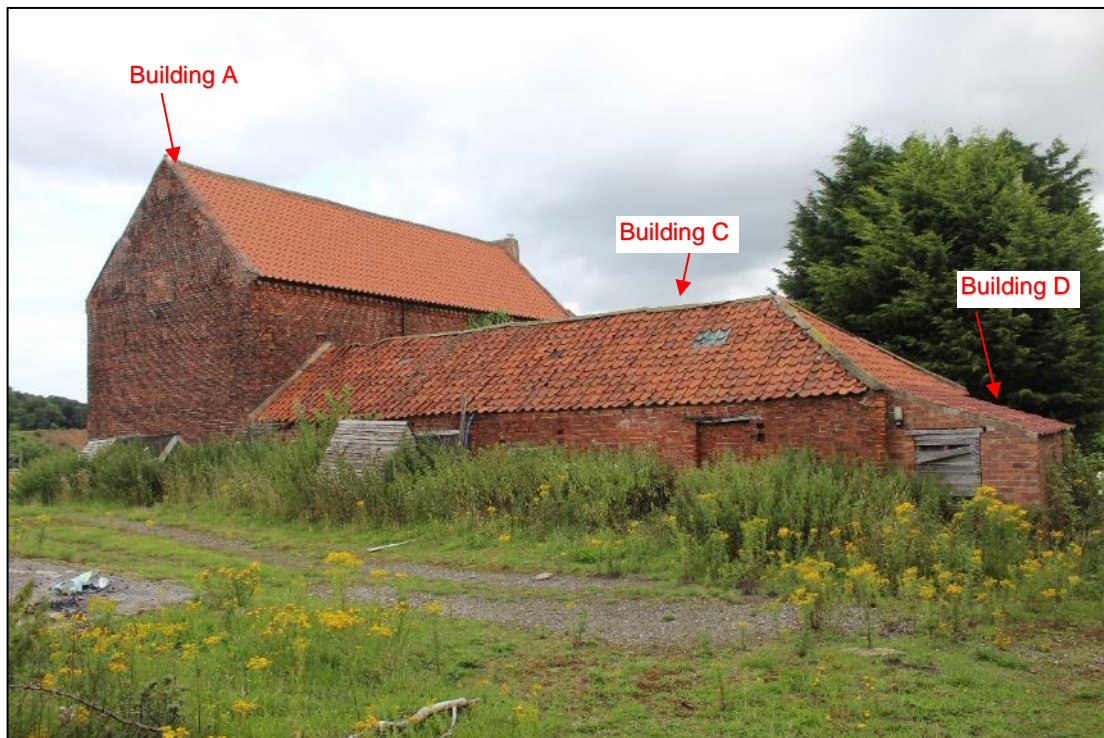
- 4.4. Building A comprises a former threshing barn that represents the earliest (Phase A) building on the farm. The outline of a building that first appeared on the 1806 Enclosure map is very likely to constitute the present Building A due to its orientation and footprint. The exterior of the building conveys a clear distinction in form and scale from the surrounding, later buildings on the farm (Photo 1).

Photo 1: Overview of Farm building, looking north-east

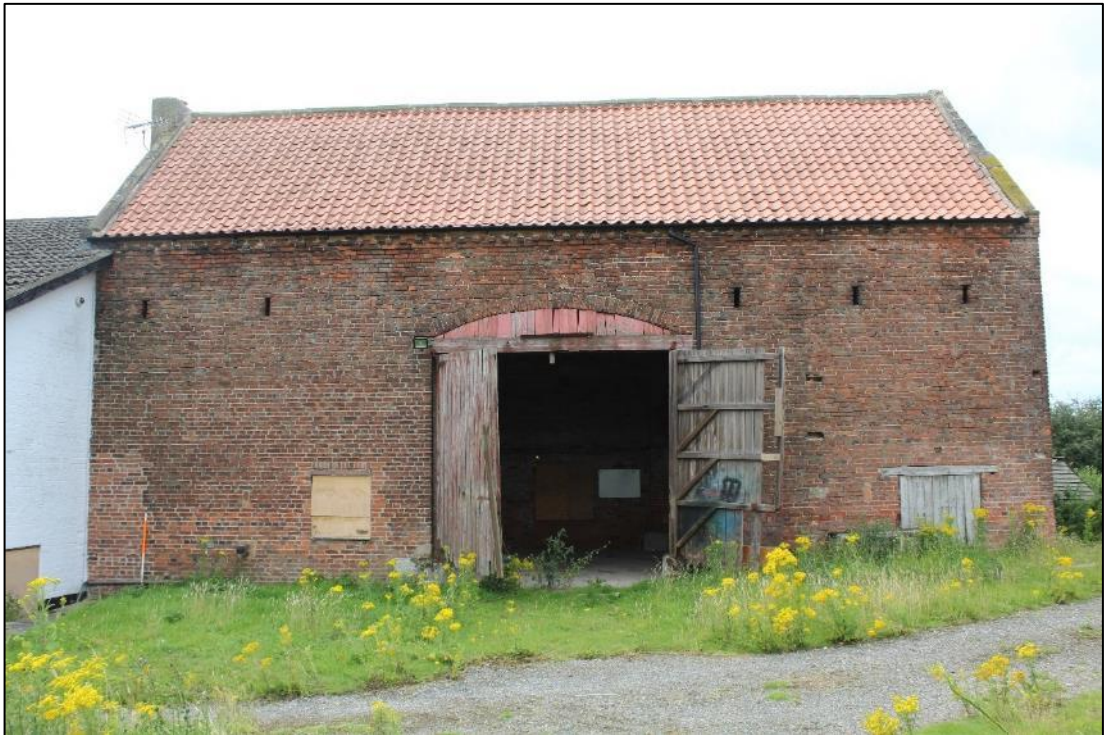
- 4.5. The building incorporates an entirely red brick construction (Photo 2), laid predominantly in English Garden Wall bond (Photo 3), except for areas of infill and alteration, although the prevailing brick bond has been carried through in certain areas of later alteration in an apparent attempt for aesthetic cohesion, or else for ease of continuity. The number of rows of stretchers also varies, with three between rows of headers on the northern and southern elevations whilst the western gable elevation incorporates four and five rows between rows of headers, for reasons unknown. Beneath the eaves of the building is a continuous row of simple brick dentils (Photo 4), however, it appears that an additional course of bricks may have been installed above the dentils, possibly during a programme of roof replacement/renewal. A modern window unit has been installed at ground floor level and formerly served Room B7 of Building B (Photo 2).

Photo 2: Building A, northern elevation

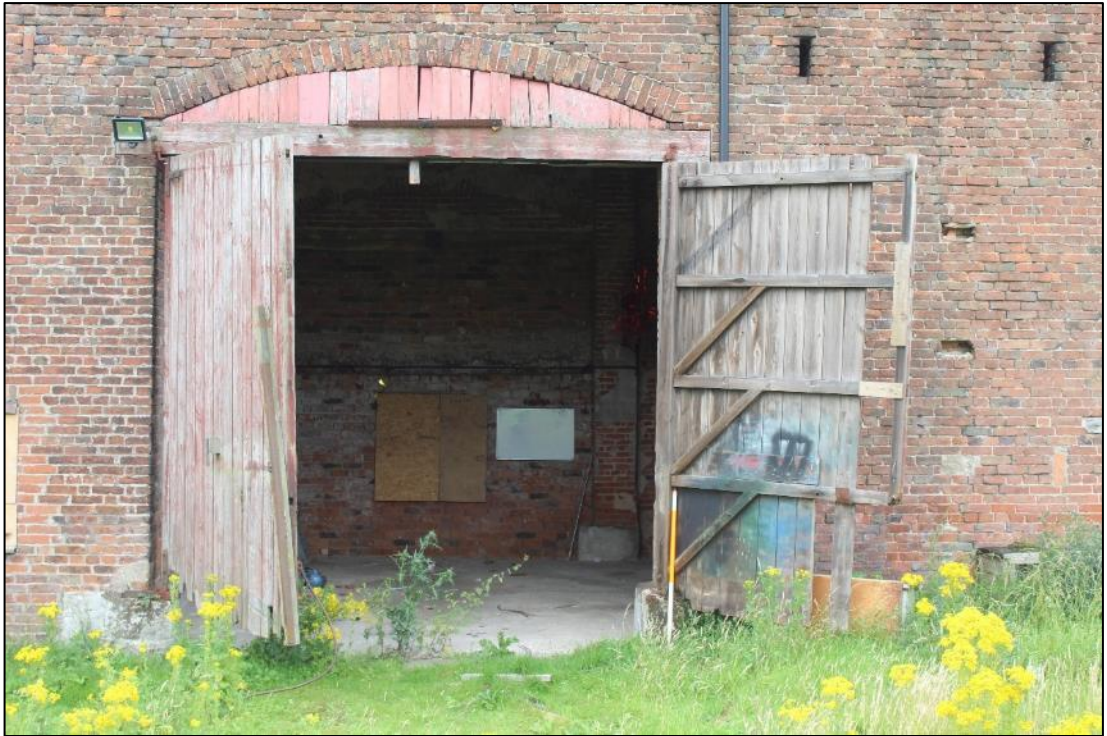
- 4.6. The surviving ledge and brace threshing doors within the northern elevation (Photo 5) are timber in construction and sit beneath a wide segmental brick arch. The doors sit above the ground level, allowing for the incorporation of a pair of large stone bases with grooves that would have housed a plank (Photo 6). The plank would have allowed the doors to remain open during threshing (thus allowing more light in) whilst the *in situ* plank would have prevented chickens entering the barn to eat up the corn whilst also ensuring that the crop was not at risk of being blown out of the barn by the wind (Brunskill 1987). The gap at the bottom of the doors also prevented the doors from encountering the wet ground and thus better preserved them from rot (*ibid*). A plank of just over 11ft long remains inside the barn and corresponds to the width of the doorway (including the depth of the stone grooves). The plank is in remarkably good condition and may represent a later replacement (Photo 7).

Photo 5: Threshing doors within northern elevation of Building A

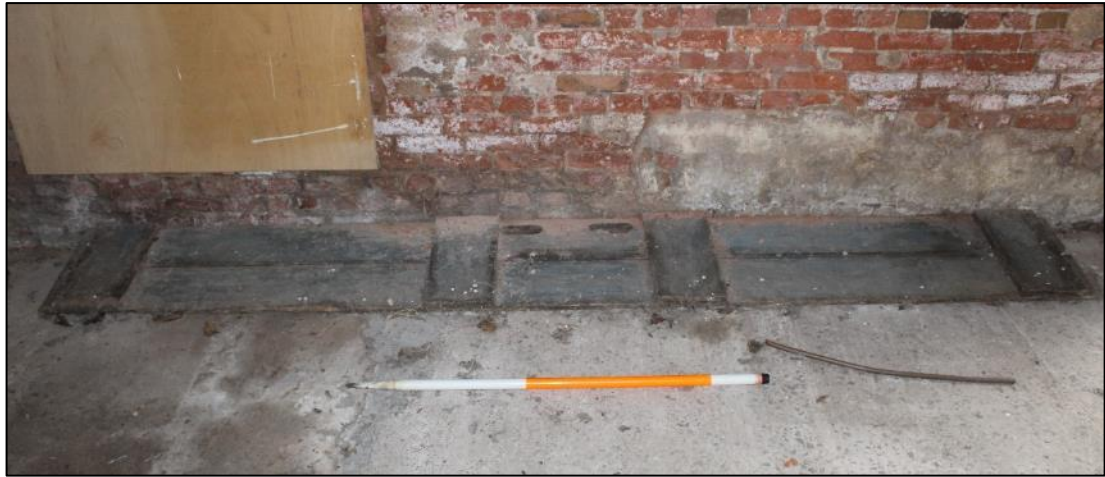
Photo 7: Threshing door plank

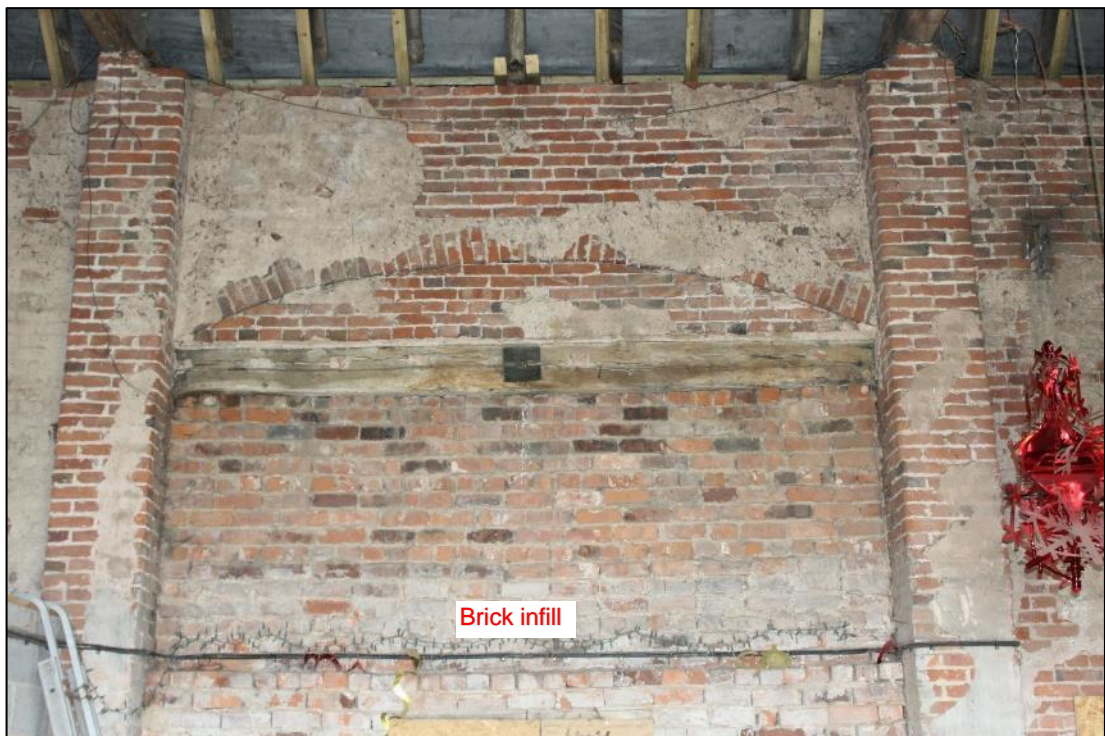
Photo 14: Detail of infilled southern threshing door, upper portion

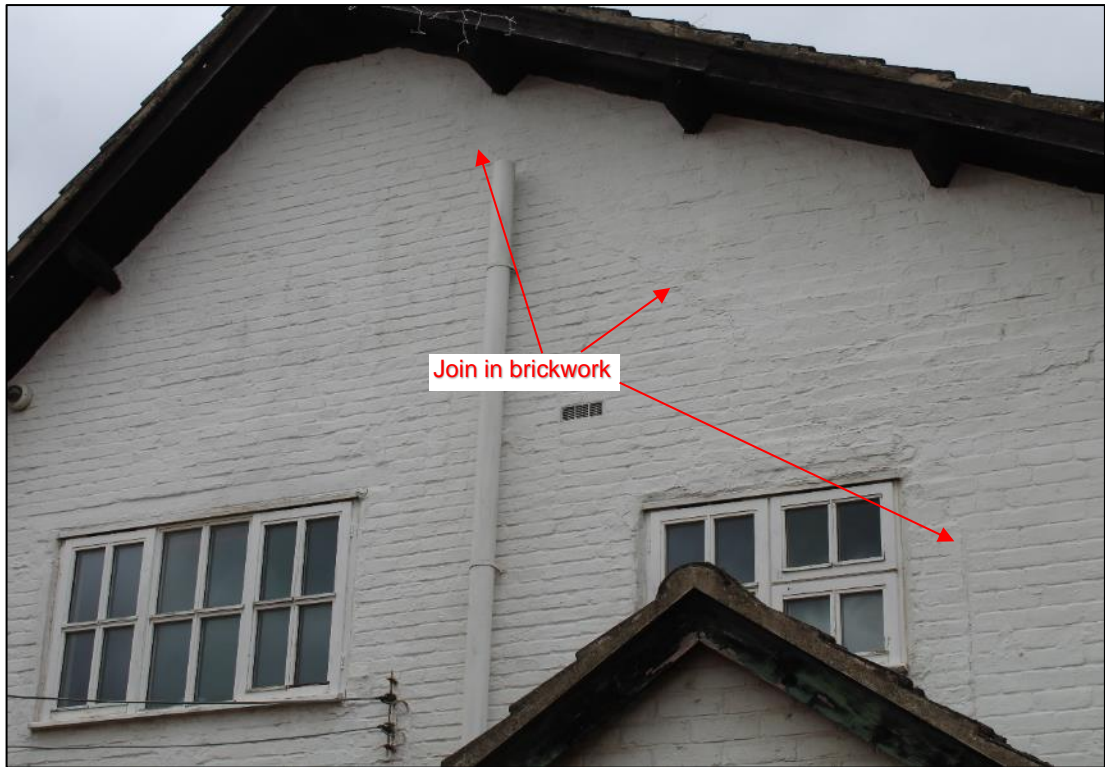
- 4.21. Perhaps reflecting the considerable alteration to the configuration of the farmhouse, the fenestration arrangement is inconsistent and conveys a sense of iterative development rather than conscious design. Overall, the apertures and units appear to be mid to late 20th century in date. A porch has been constructed broadly to the centre of the eastern elevation. The porch is a later addition, as evidenced by the junction of brickwork with the principal elevation where brickwork is misaligned and butted against rather than knitted in.

Photo 23: Detail of phased brickwork on eastern elevation

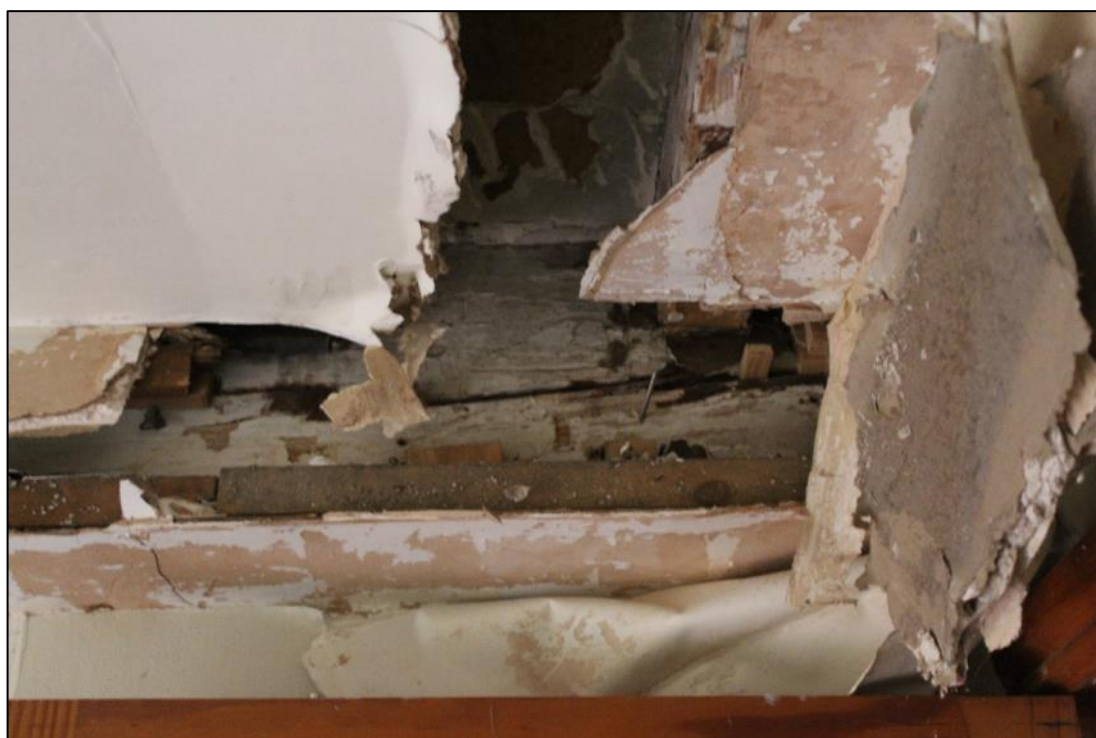
- 4.23. The building is entered through the later porch (Room B1) and into a central lobby area, Room B2. The ceiling of the lobby is partially collapsed, revealing elements of a historical timber beam (Photo 25). The beam appears to date to at least the 19th century and may have been incorporated into the building either as an original component or else reused for the building's reconfiguration.

Photo 25: Detail of timber beam within ceiling of Room B2

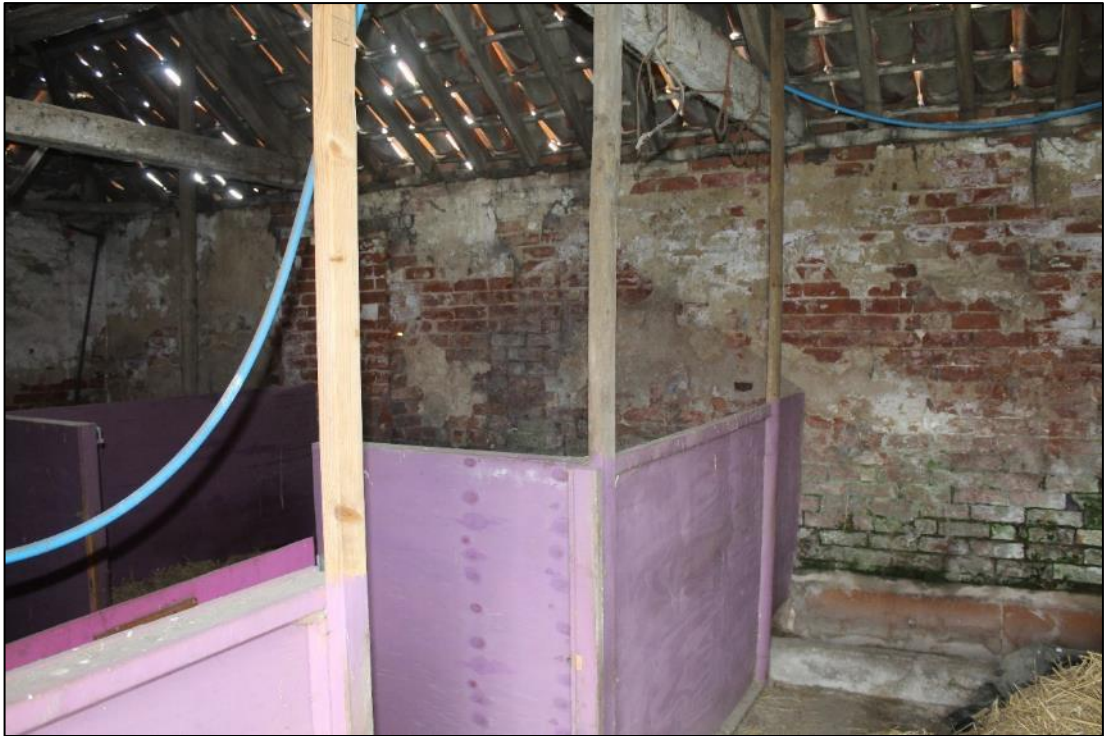
- 4.34. Internally, the southern extent of the building (Room C1) is presently configured to house horses, incorporating modern stall partitions (Photo 35). However, the former cow house configuration can still be identified. A clay tile manger routes along the western wall of the interior whilst a drainage channel is still present along the centre of the room, aligned north to south. The roof comprises a simple construction of two king-post trusses, rafters and purlins, characteristic of the building's early 19th-century construction date (Photo 36).

Photo 35: Overview of Room C1, looking west

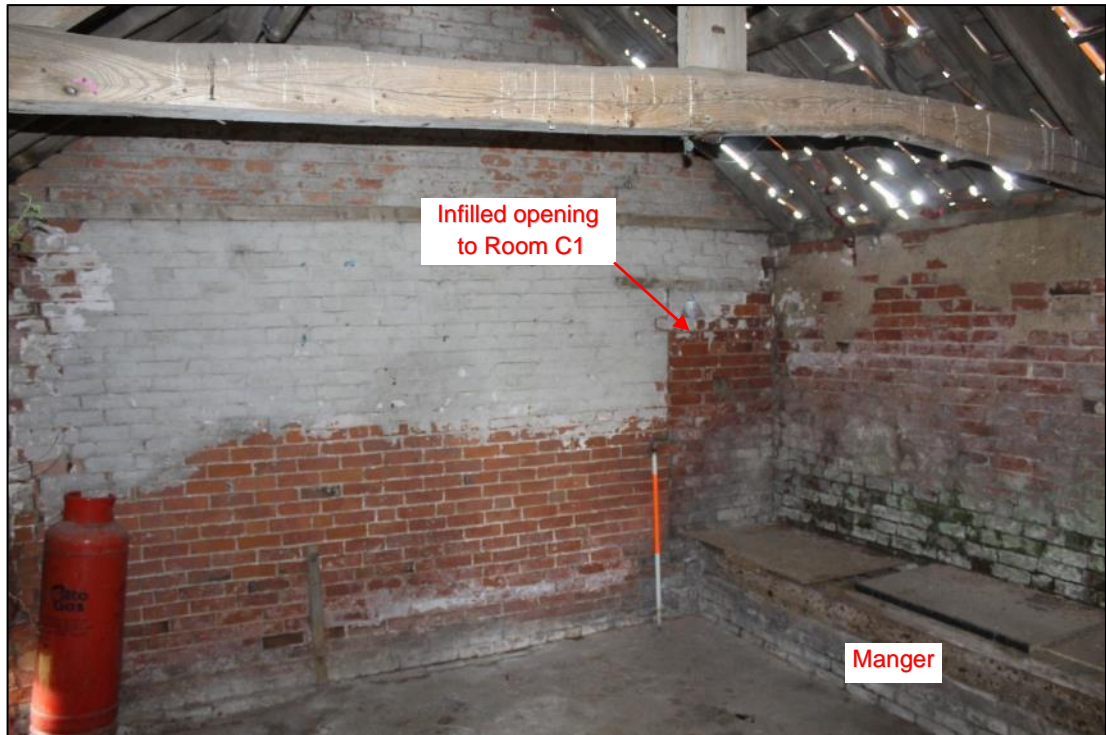
4.37. The manger within Room C2 is clay tile and concrete, and unlike the example in Room C1, sits atop a brick plinth (Photo 38). A drainage channel routes north to south through room, returning a 90 degrees to an exit point within the eastern wall, as with the example in Room C1. The roof construction in Room C2 mirrors that in Room C1, employing a single king-post truss.

Photo 38: Room C2, looking south-west

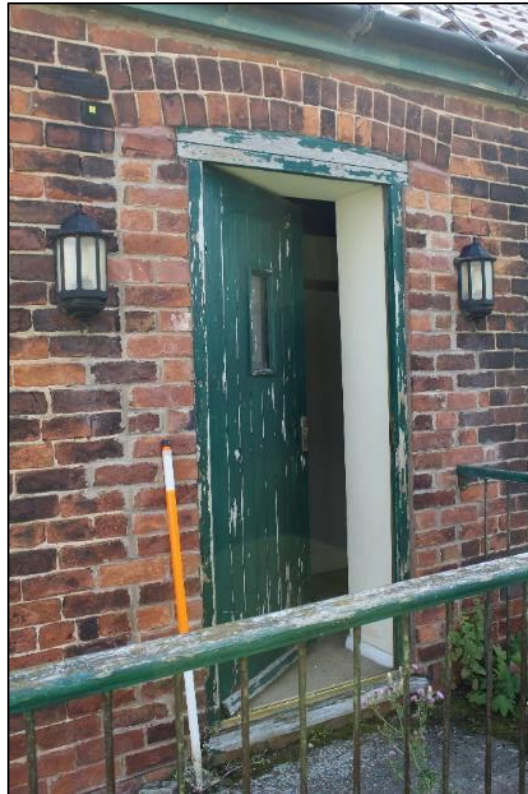
Photo 50: Detail of doorway alterations

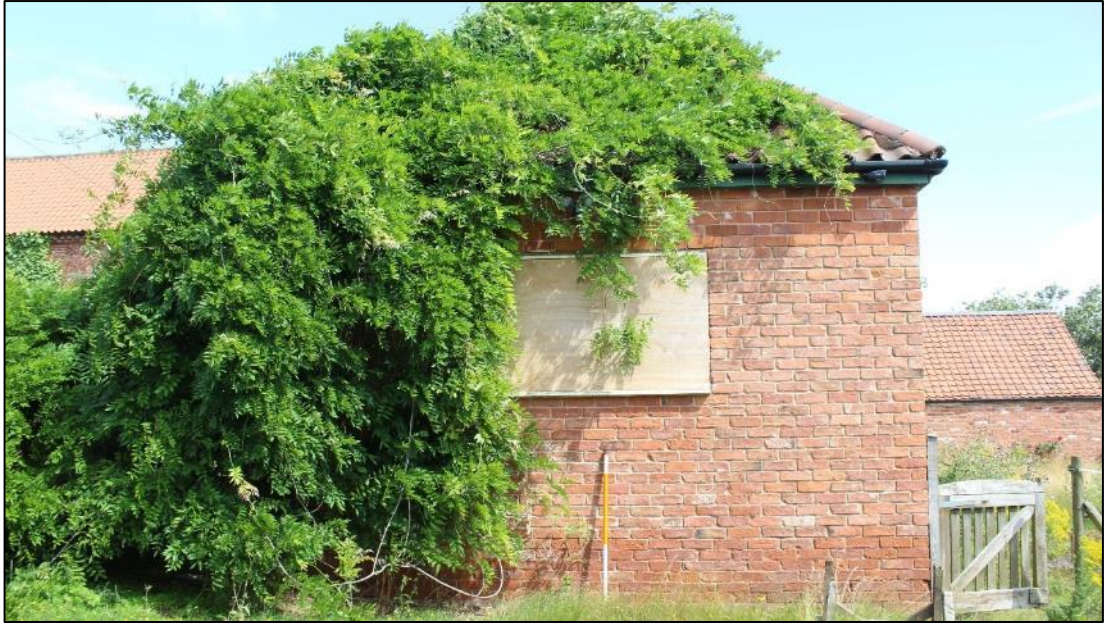
- 4.49. The southern elevation is partially obscured by vegetation but incorporates a modern window unit and modern (i.e. Phase E) brickwork, laid in stretcher bond, at the eastern extent (Photo 51). This modern brickwork extends around the southern extent of the eastern elevation (Photo 52), suggesting a considerable instance of repair and rebuilding of this part of the building. A clear change in the brickwork illustrates the junction between Phases B and E (Photo 53). The clay pantile roof is straight and consistent in its appearance, implying that it was renewed during the mid to late 20th century (Phase E) or later still.

Photo 51: Building F, southern elevation

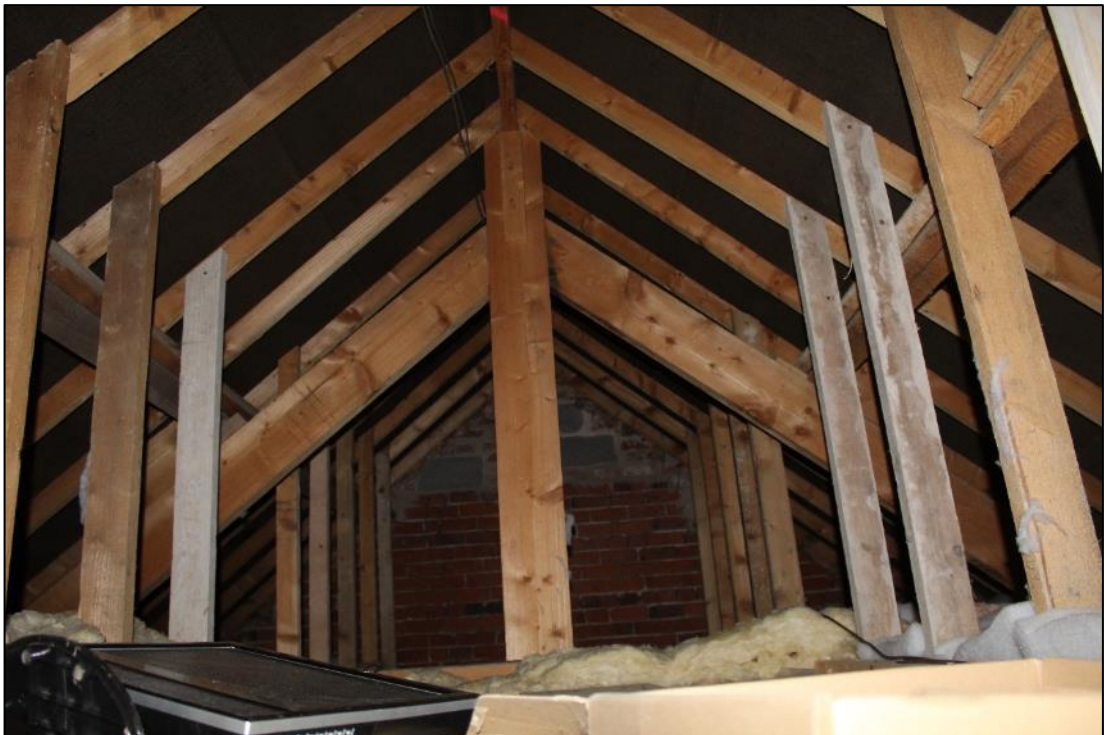
- 4.50. Internally, the building most recently functioned as a residence. This is evidenced by the comprehensive partitioning of the building and character of its rooms. Rooms F1 to F5 comprise a series of standard living room (F1), kitchen (F2), bathroom (F3) and bedrooms (Rooms F4 and F5) (Photos 54 and 55), incorporating no historical features. The roof structure was visible through a loft hatch and incorporates entirely modern machine cut timbers (Photo 56).

Photo 56: Detail of roof structure within Building F
