The Grand Western Canal Halberton Devon

Interpretative earthwork survey, photographic
survey and watching brief

CA Project: 4408
CA Report: 13481

January 2014

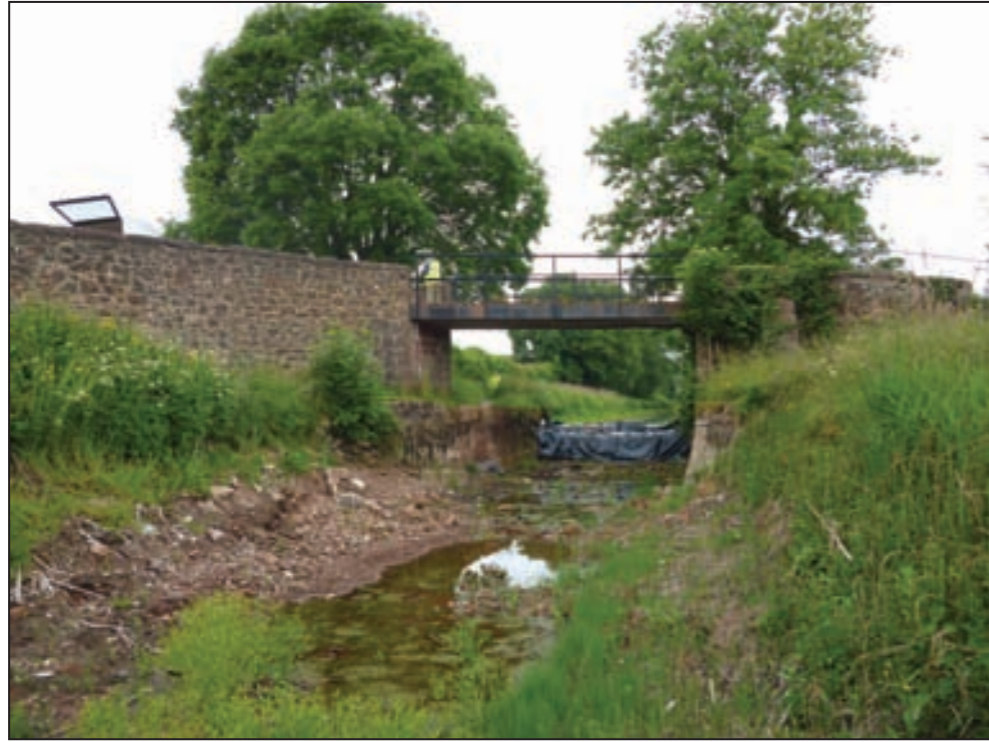
- 4.9 The Swing Bridge as it exists today is a high level fixed crossing, allowing boats to pass under (Fig. 7). The deck was 3.48m above the water level in the canal on 1 July 2013 compared to a recorded clearance of 2.57m on the 1889 engineer's notes. If accurate, this means the canal was full to the bottom of the kerbing course under the bridge in 1889.

6 Swing Bridge, east elevation, looking west; the canal drained, dam in black plastic (scale 2m)

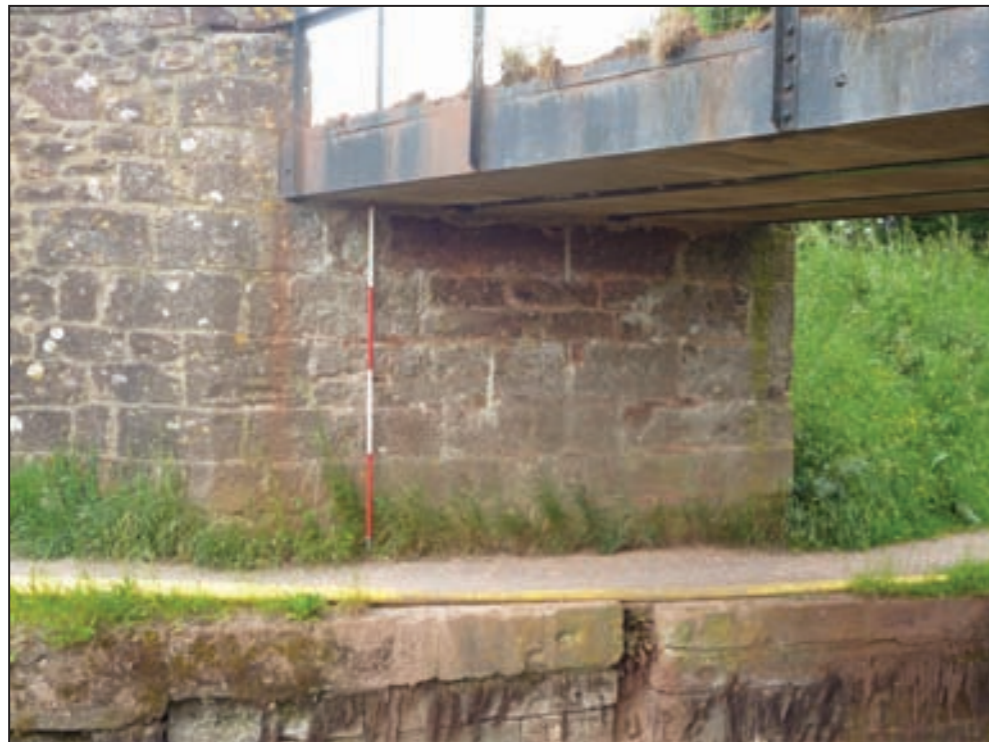
- 4.10 The face of each abutment is constructed of large ashlar blocks, identified as sandstone breccia (Fig. 8). These return a short distance into key into the flanking walls, which are constructed of rubble (Figs 4, 5 and 9). The northern abutment has a continuous ledge or corbel supporting the end of the road deck which was not apparent on the south. The corbel is shown on the 1889 engineer's notes at its present level, suggesting no alterations. The blocks were originally laid in a reddish lime mortar, but this is mostly obscured by a variety of lime and cementitious re-pointings but there is no underlying suggestion of multiple phases of construction.

- 4.11 The northern abutment rises directly from the tow path level (Fig. 4), but on the south the abutment is set back to allow the tow path to pass in front of it and under the bridge (Fig. 8 and 9).

8 The southern abutment of the bridge, to the south-west (scale 2m)

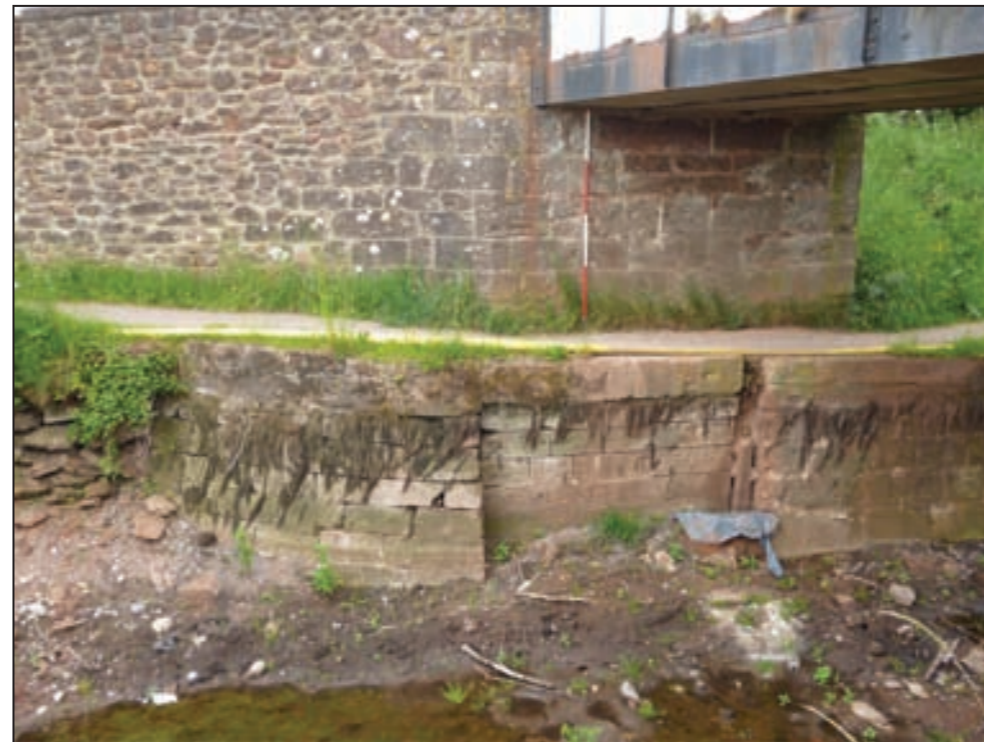
- 4.15 Each recess has a channel in its inner end which held a timber post, traces of which remained (Fig. 10). This was braced back into the wall by a horizontal beam which

9 The western stop lock gate housing on the south side, abutment and flanking wall; note timber hinge post in stop lock for gate (scale 2m)

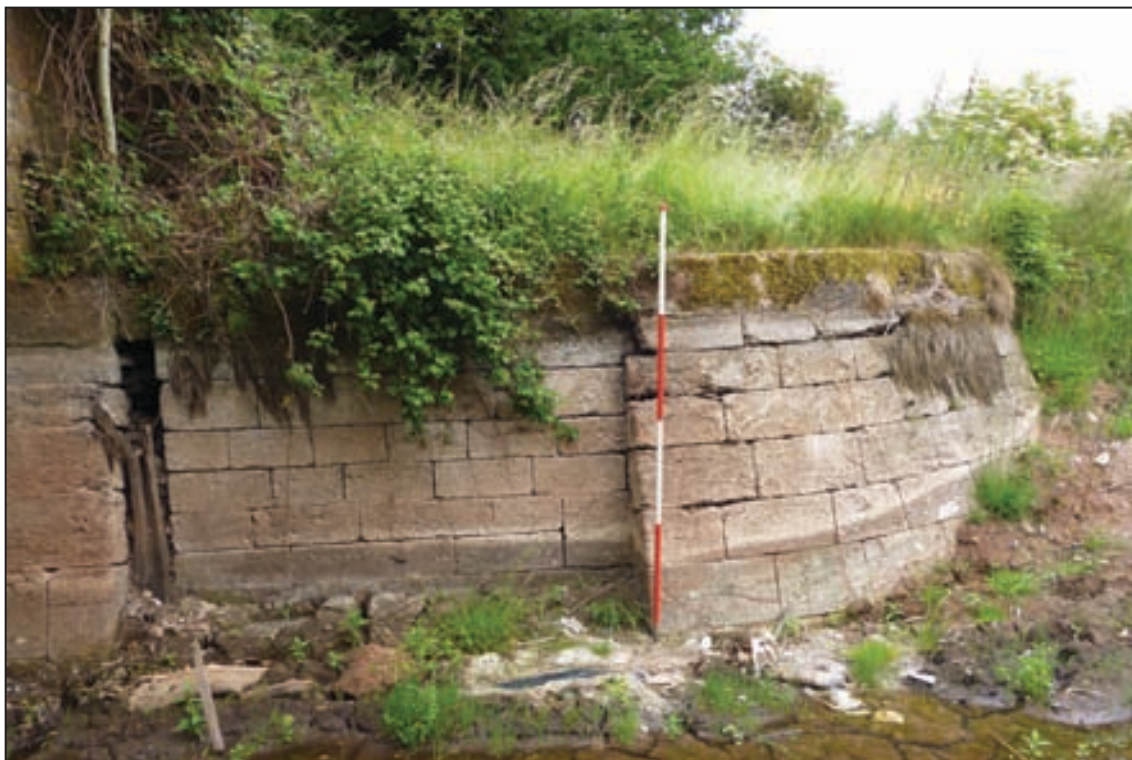
- 4.12 The abutments rise from a lower structure forming a stone-built channel (Fig. 10). The sides of this channel are slightly battered and built of large ashlar blocks. The coursing consistently diminishes upwards and then is capped with a deeper capping or kerbing course. The eastern and western ends are splayed and curved as they meet the canal.

- 4.13 The abutment stone-work is paler and less red than the upper parts, but this is presumably due to it being submerged for its working life and weathering differently. The bedding is different as it appears to be a pale grey, hydraulic lime mortar, again re-pointed at different times, most recently in a pale grey, cementitious mortar. Much more of this stonework has lost its pointing, especially on the curved entrance walls.

10 Lower structure of stone-built channel (scale 2m)

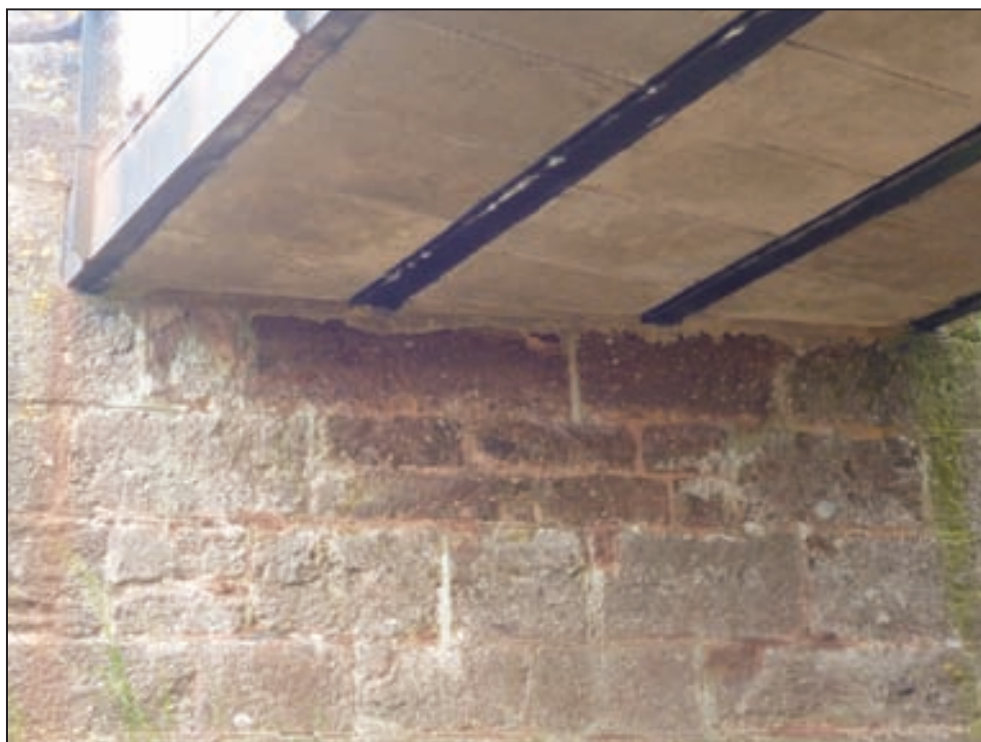
- 4.16 A small area in the top centre of the southern abutment seems to have had stone blocks removed and replaced: this substitution was clear because of the use of extremely coarse-textured breccia blocks, set in a red mortar (Figs 11). This replacement was not affected by cementitious pointing. There is no sign of such alteration on the northern abutment.
- 4.17 While it is possible that the alteration to the southern abutment and the existence of a corbel on the north side indicates that the bridge did swing, there is no sign in the present structure that a low level horizontally-pivoted Swing Bridge ever existed. The bridge deck is of modern steel beam and concrete panel construction (Fig. 11), with simple angle-iron hand rails and posts bolted to it and each other.

11 The underside of the modern concrete and steel bridge deck and the replacement blocks in the southern abutment, to the south-west

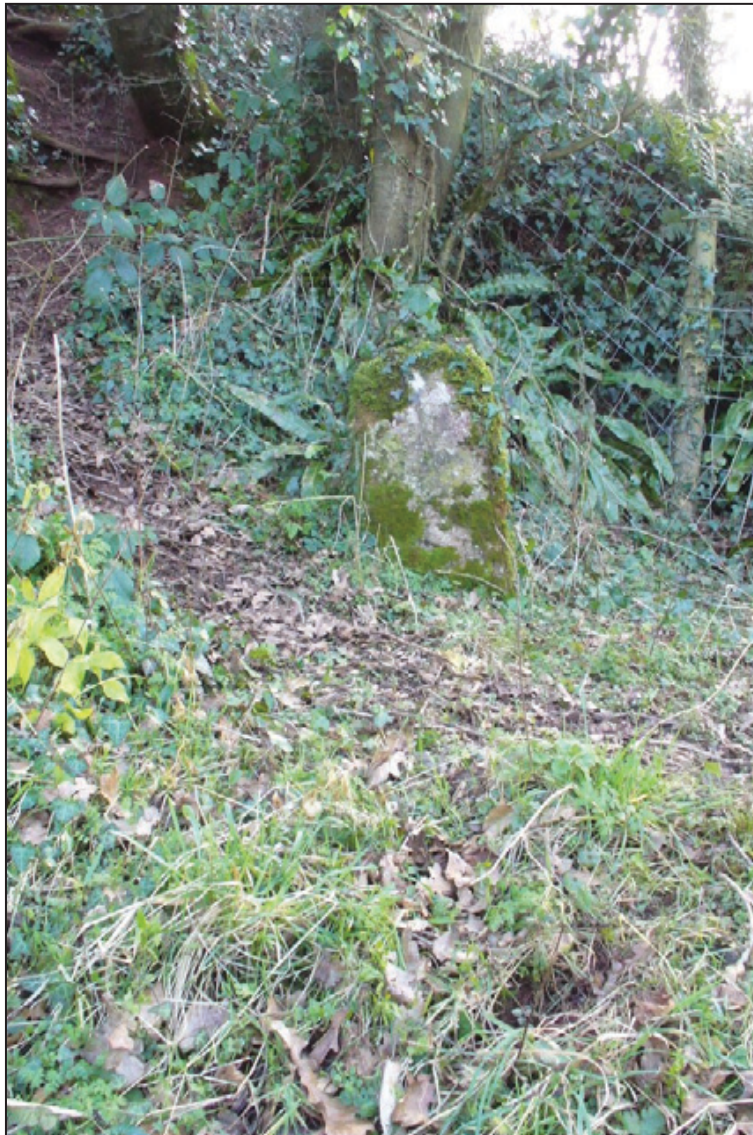
- 4.18 The extant milestone is probably original to the canal. It is a plain, round-topped stone pier with a simple capital V carved on the face towards the canal. It is drawn on the sketch map made of this part of the canal in August 1889 by the Canal Engineer in his note book, labelled '5 mile' (Fig. 12).
- 4.19 The boundary markers delimited the edge of the GWR's property on the northern side of the canal west of Swing Bridge (Fig. 2). The cast-iron, disc-shaped heads are marked with "Grand Western Railway Cos" around the edge of the flat top with "Boundary 1897" in the central zone surrounded by a raised rib (Fig. 13).
- 4.20 The discs are mounted horizontally on posts made of sections of broad-gauge rail (the lightweight 'bridge rail'). This would have been freely available after the final abandonment of broad gauge in 1892.

12 The five mile milestone on the southern bank of the Canal, towards Rock Bridge

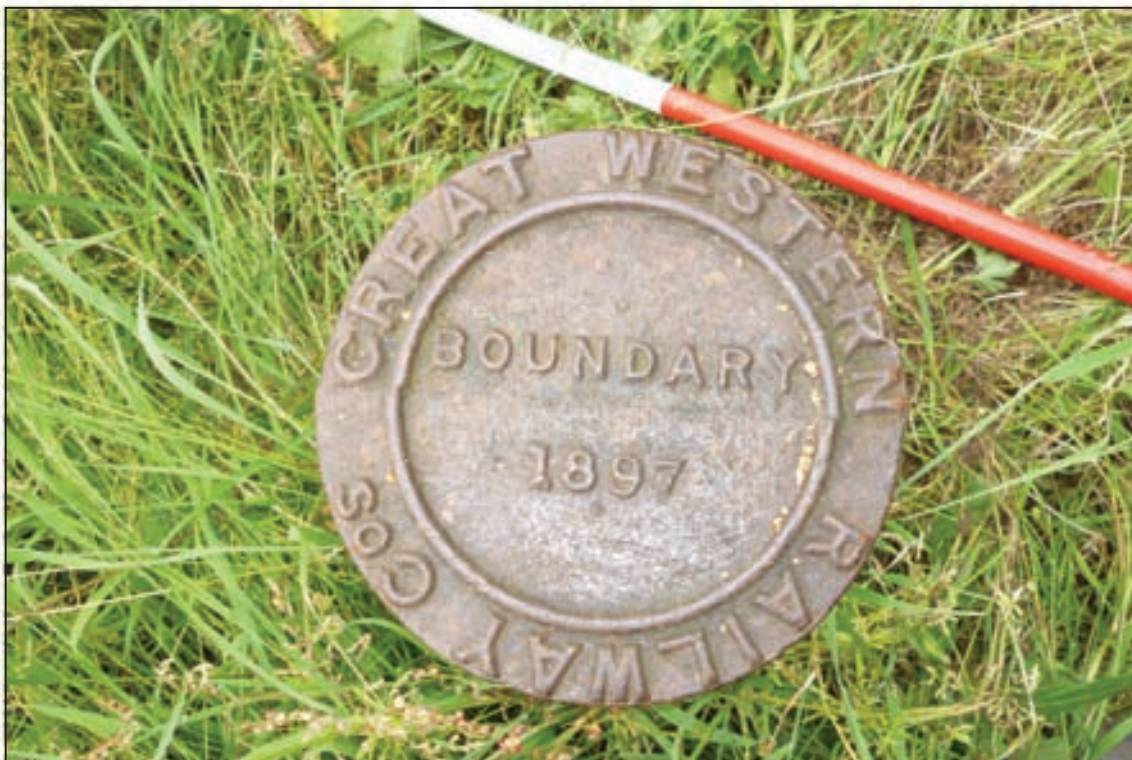
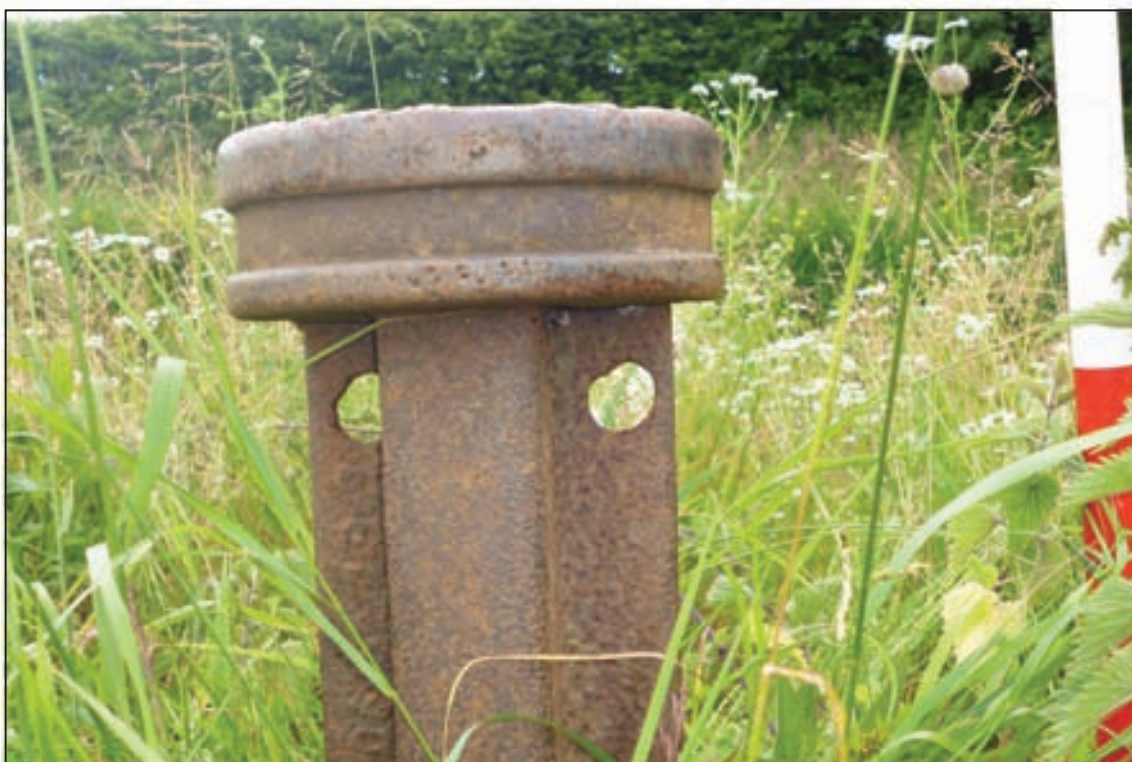
13 One of the GWR boundary markers on the west of Swing Bridge, top and side views

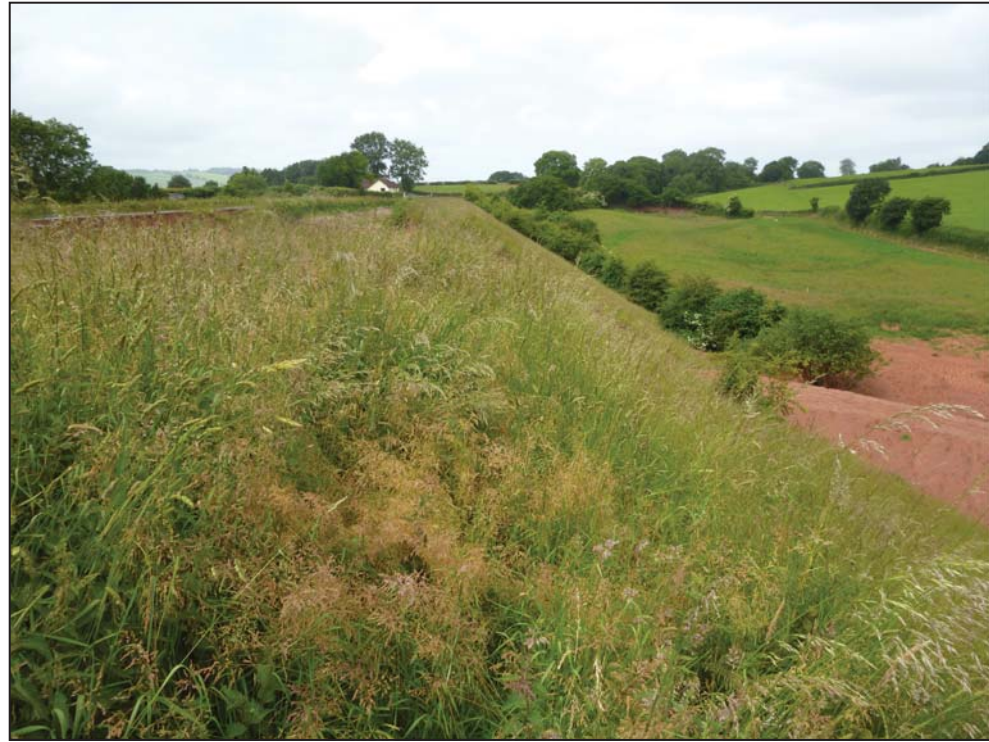
- 4.21 In an attempt to reduce the number of locks and therefore the amount of water required, Rennie re-routed the canal on a lower line, but one that required more cutting and embanking than originally envisaged (Jacobs 2013a). To cross the valley between Swing Bridge and Rock Bridge required a massive embankment, 15m high, and at its base up to 77m across (Fig. 14). The local source material was the sandy

- 14 The canal embankment looking along the top of the northern side, to the west
- 15 The dump construction of local materials revealed in the breached embankment, looking east
- 16 The dump construction of local materials revealed in the breached embankment, view from north
- 17 The dump construction of local materials revealed in the breached embankment, looking west

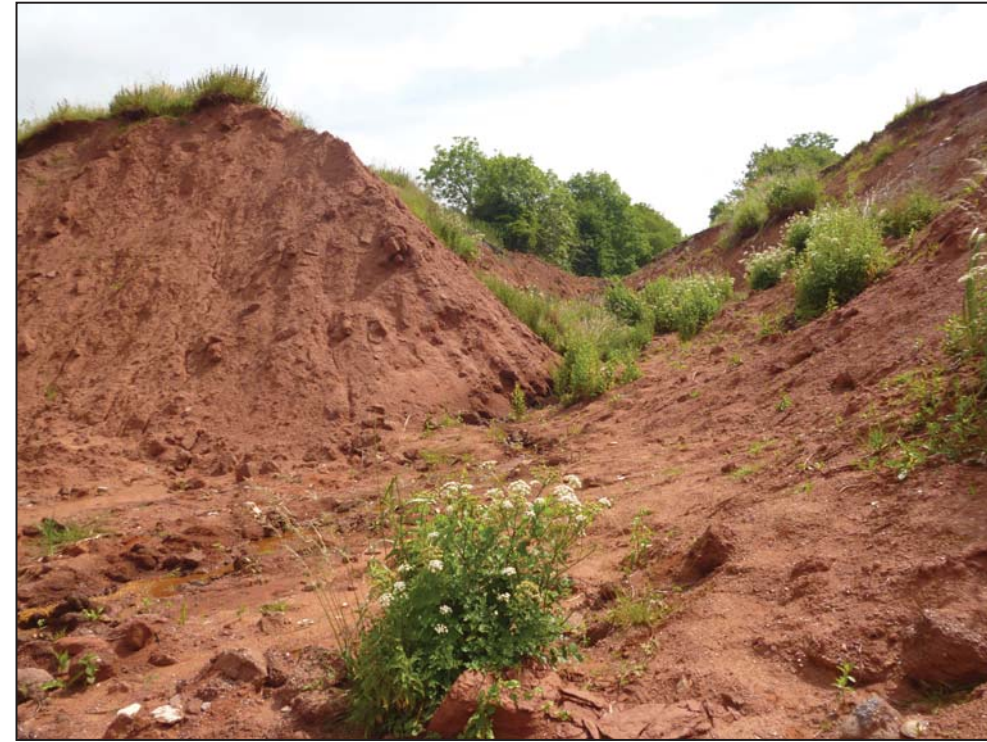
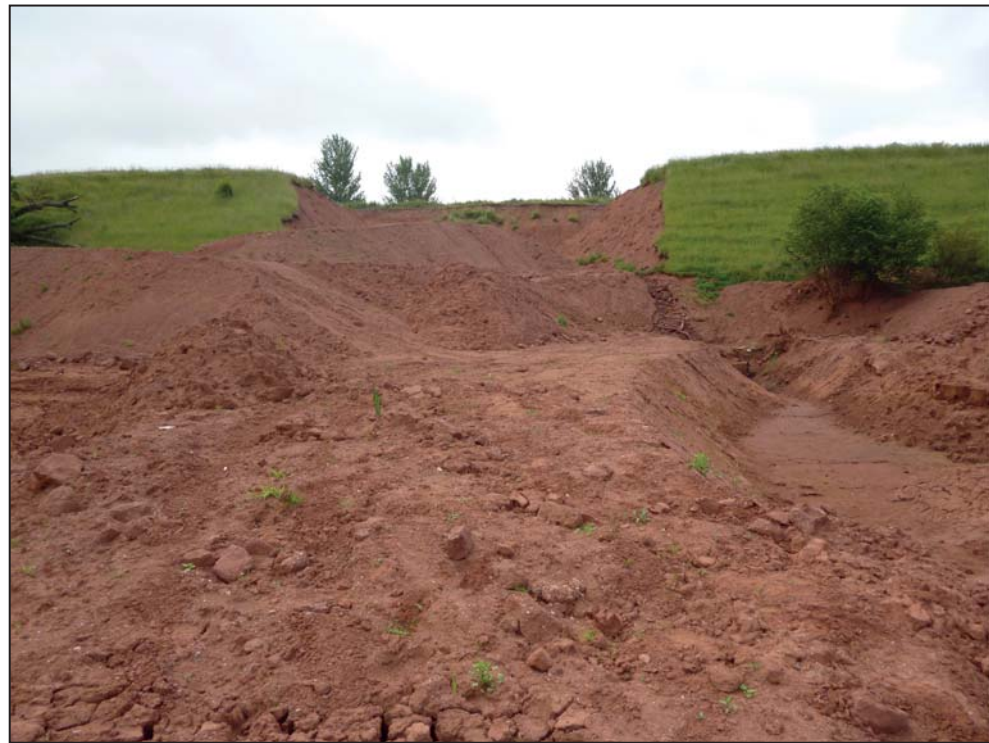
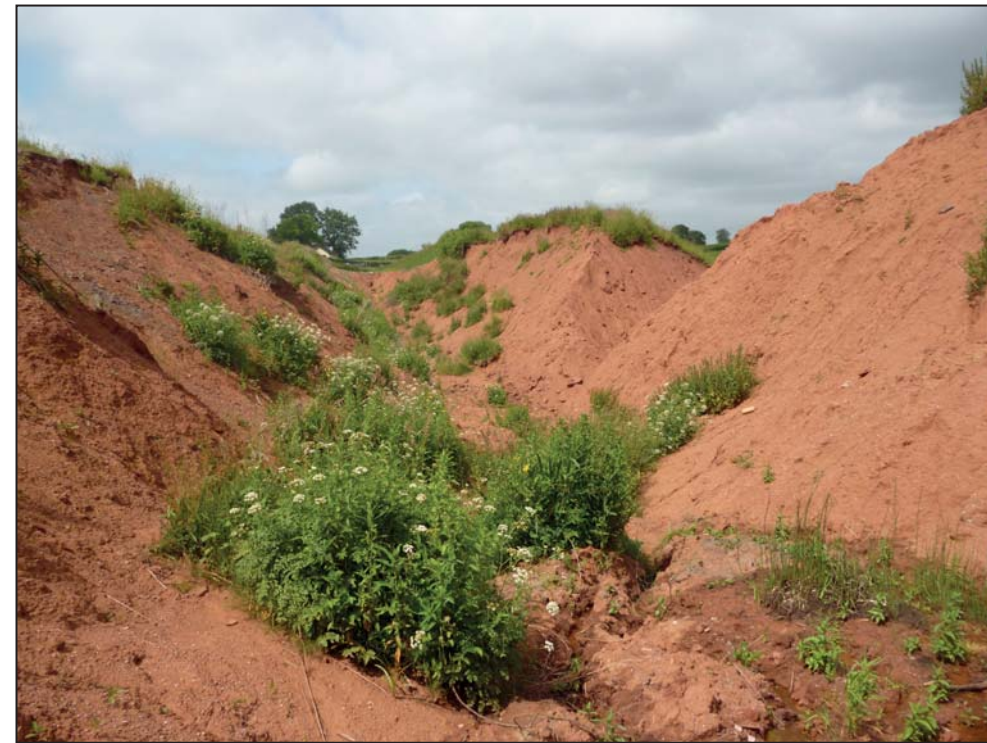
soil derived from the bedrock and the bedrock itself, as was exposed as a result of the breach (Fig. 15-17).

- 4.22 Observations at the site of the breach indicated that no structure is apparent in the body of the embankment, which appears to be of simple dump construction (see particularly Fig. 15). The recorded section of the embankment runs for c.350m. The foot of the embankment has a low dry-stone rubble wall, dilapidated in places, but not more than c. 1.2m high (Fig. 18). It is now referred to as a toe wall. In terms of purpose it is too small to have been designed as a retaining wall, but may have helped keep dumped material in place and/or mark out the area to be raised. Very little of the toe wall was visible during the course of this element of the survey.

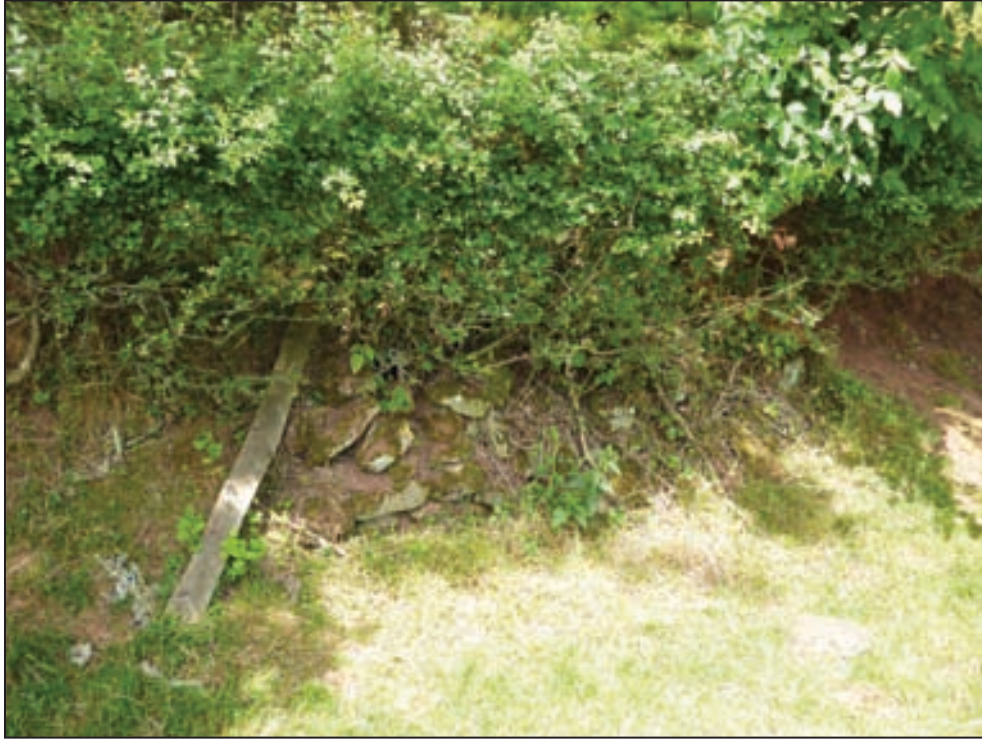
18 The low dry-stone wall at the southern foot of the embankment

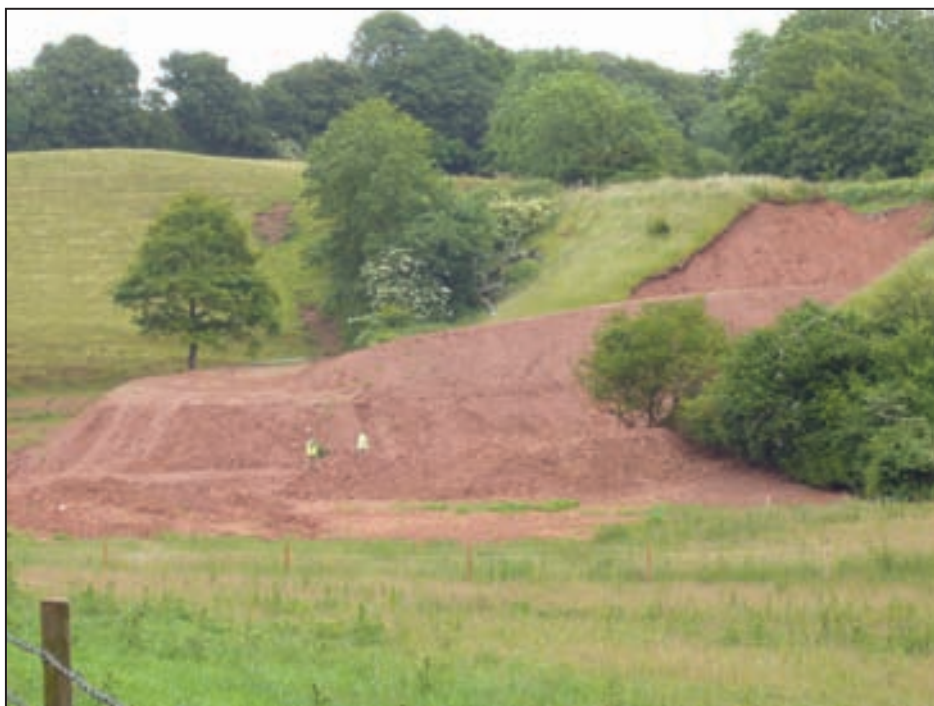
19 Extent of clay flow north of the embankment breach

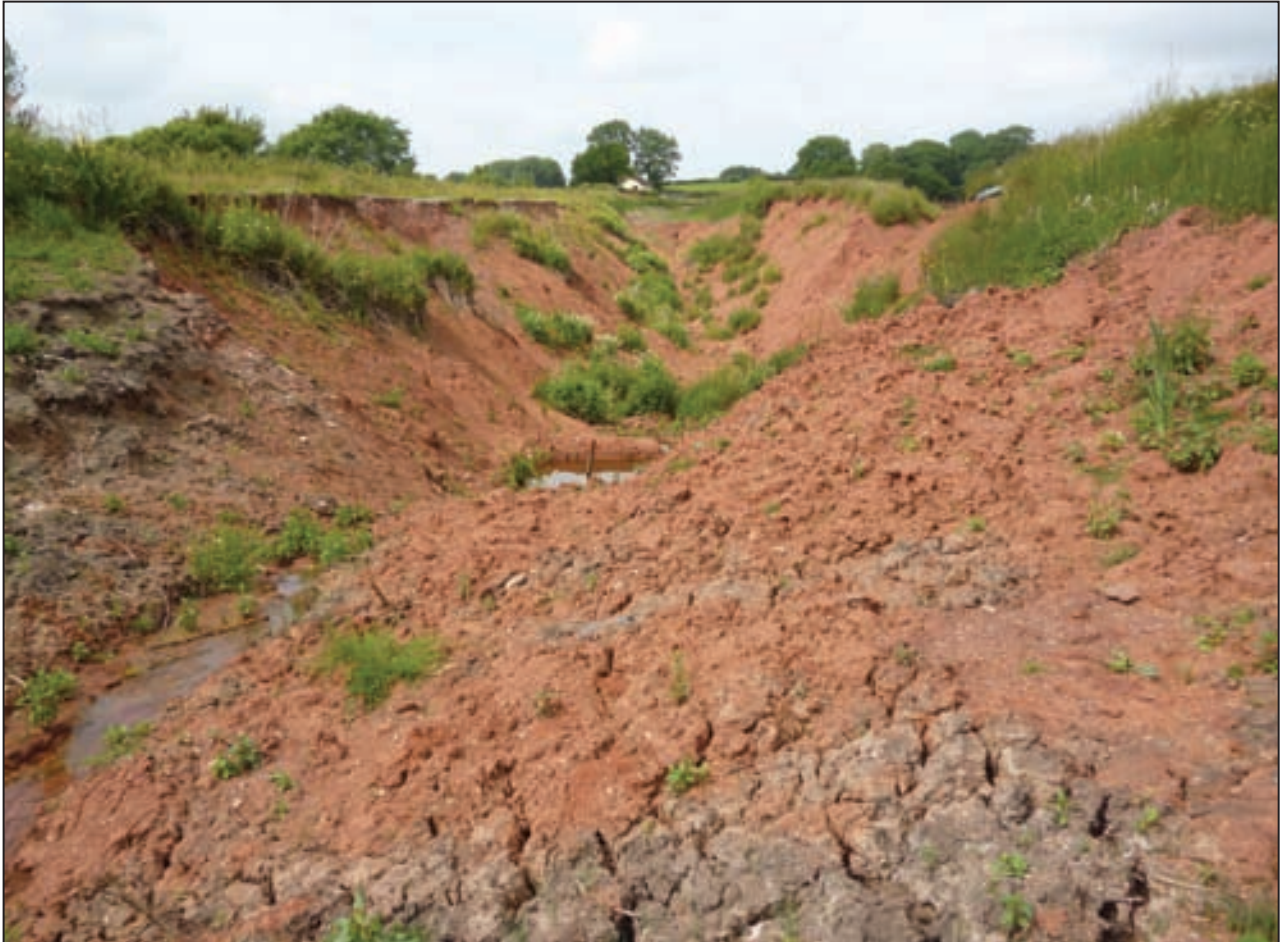
- 4.25 The canal itself was formed by a channel 2.4m to 2.6m deep (from top of bank to base of canal) with sloping clay lined sides (Fig. 20 and 21). The bank material was subject to routine repairs, leaks are mentioned in the 1889 Canal Engineer's notebook. What appears to have been clay lining (but was possibly clayey sediment) was visible as a dark greyish-brown clay at the east and west ends of the scoured-out base of the canal either side of the breach itself, and around the empty cut at Swing Bridge (Fig. 22).

22 Visible elements of canal lining

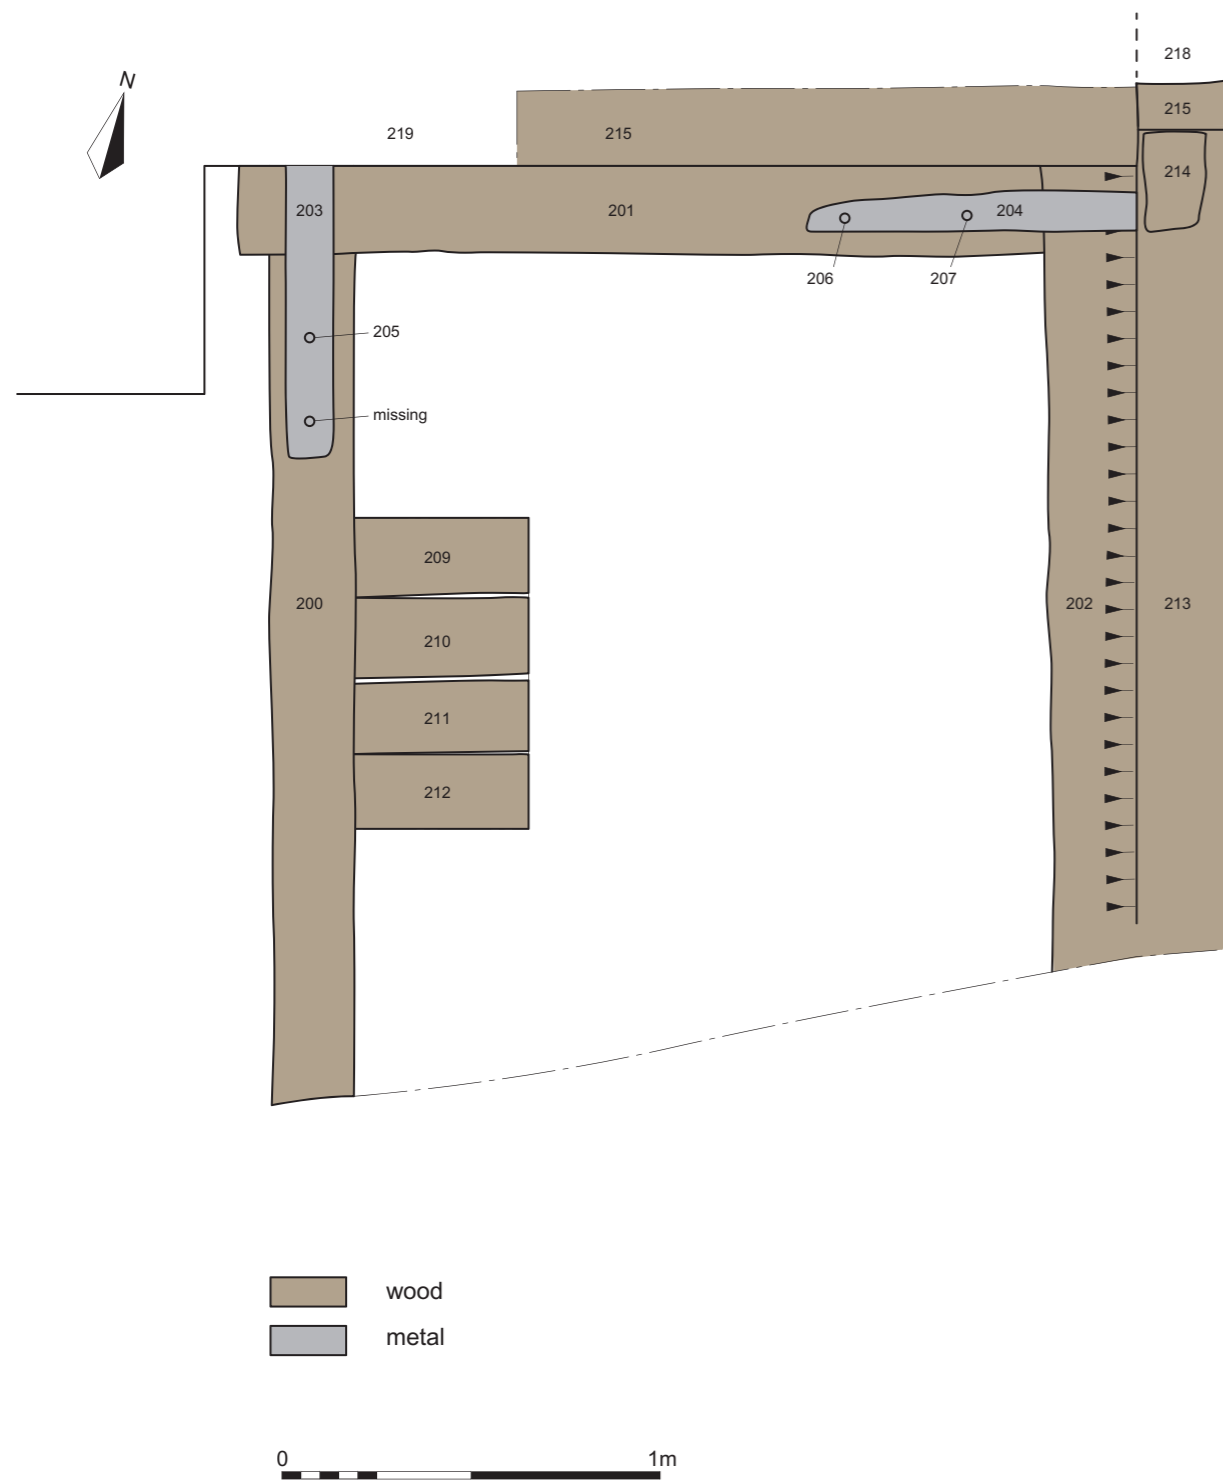
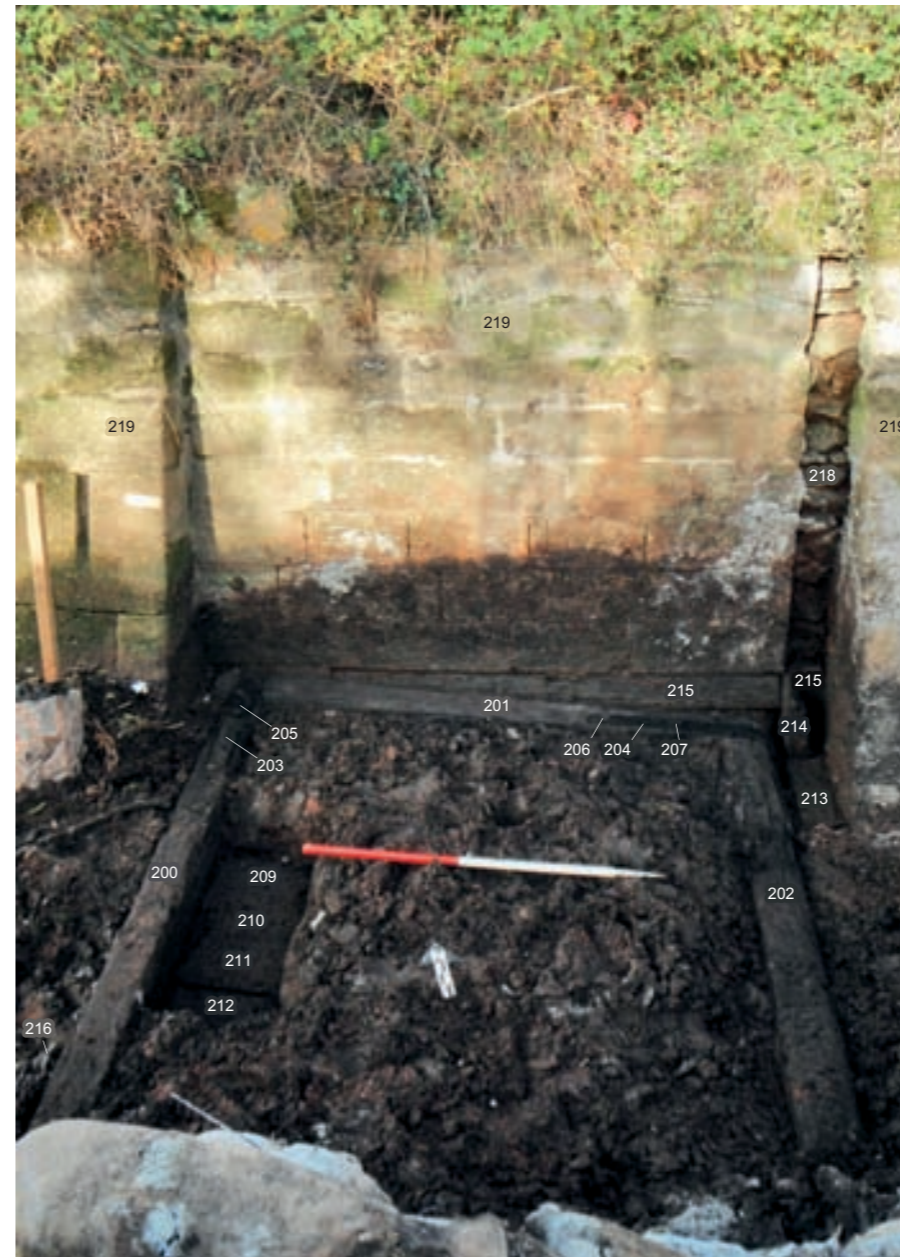
- 4.30 The remains of the stop gate lay at the western side of Swing Bridge (Fig. 23), and comprised elements of the gate frame and door (Fig. 19). The stone abutments for Swing Bridge were constructed with four purpose built H recesses within which the stop gates operated. Elements of the wooden framework (particularly timber 214) were identified, indicating the gate rotated around a point at the eastern extent of the recess. The frame, particularly timber 215, extended under the stone fabric of the bridge abutment within the recess. Timber 214 ran alongside frame timber 215 and sat on top of a horizontal timber beam, 213, itself visible across the width of the canal.

- 4.31 The stop gate door was positioned horizontally on the base of the canal floor, equating to its open position. Three of the timber beams forming the edge of the gate door were exposed: the top 200, bottom 202, and northern side 201. These were joined together with iron fixings (203 – 207 inclusive as illustrated on Fig. 3). Timber planks 209 – 212 were partially exposed, but the gate as a whole is presumed to measure approximately 2.30m x 5.30m (7 feet 10 inches x 17 feet 5 inches). Timber 202 was rounded on its eastern side presumably to facilitate rotation to the upright, closed position against timbers 213 and 214.

Stop gate remains, western side of swing bridge, looking north (1m scale)
