Barn at Church Farm Besford Worcestershire

Historic Building Recording

CA Project: 5452

CA Report: 15537

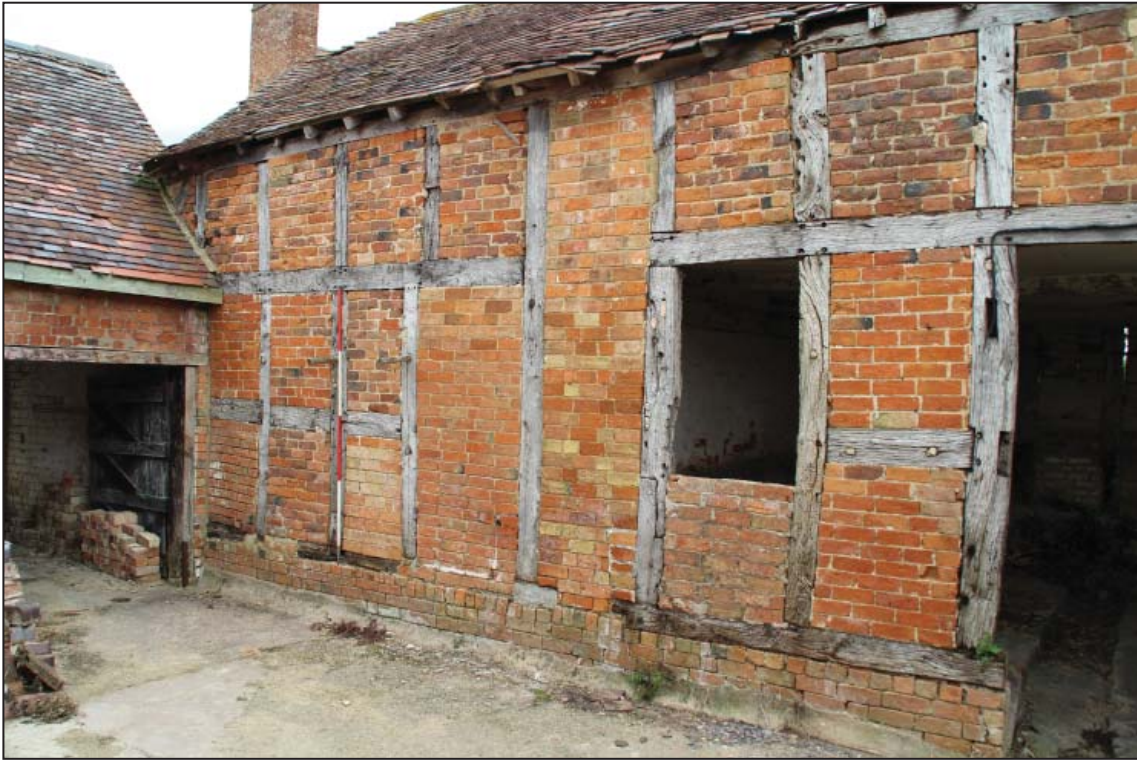
as the soleplate is also missing here and the bricks in the plinth are arranged as if to provide a threshold (Figs. 4 and 7).

7 The western elevation, looking north-east (scale 2m)

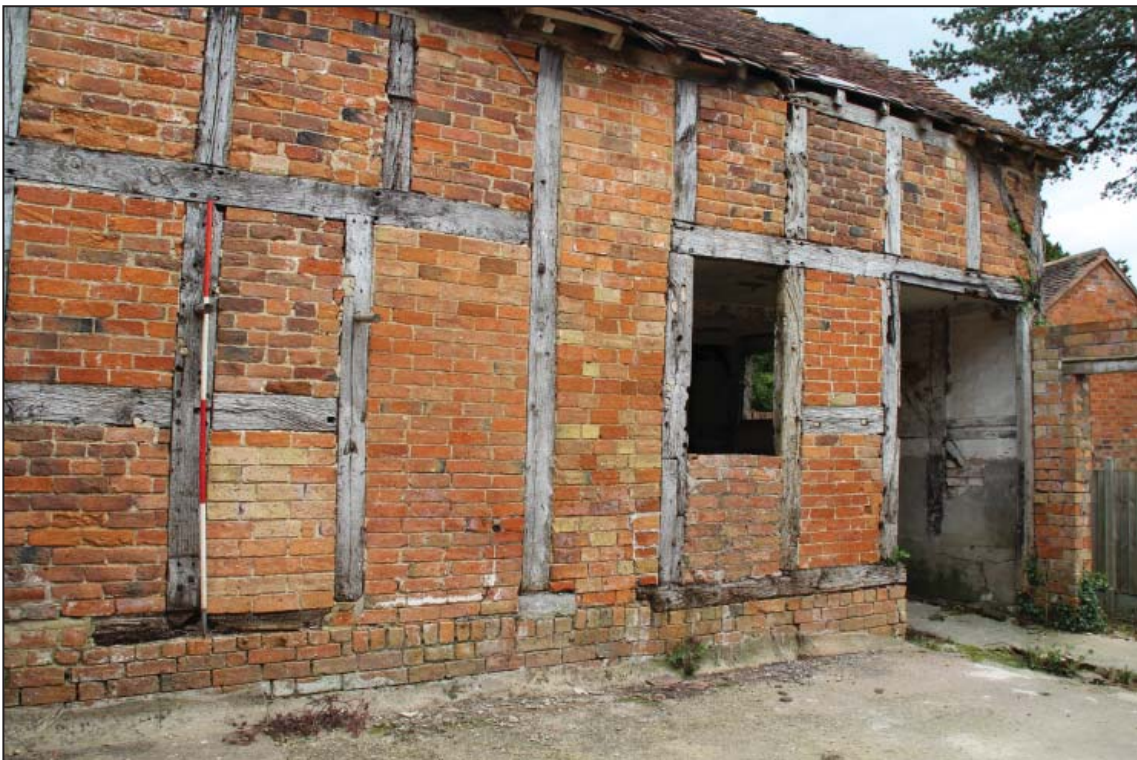
8

- 4.11 South of the central truss the next bay has lost both its rails. The lower section of the next bay is open from below half height and the timber between it and the previous bay has been replaced with a slightly over-sized timber jointed to the stub of the original with a face-halved scarf (Figs. 4 and 8).

- 4.33 These are also the bricks used in infilling the tall panel in the west elevation south of the truss post and the upper part of the one next to it, which may have been a door (Figs 4 and 8).

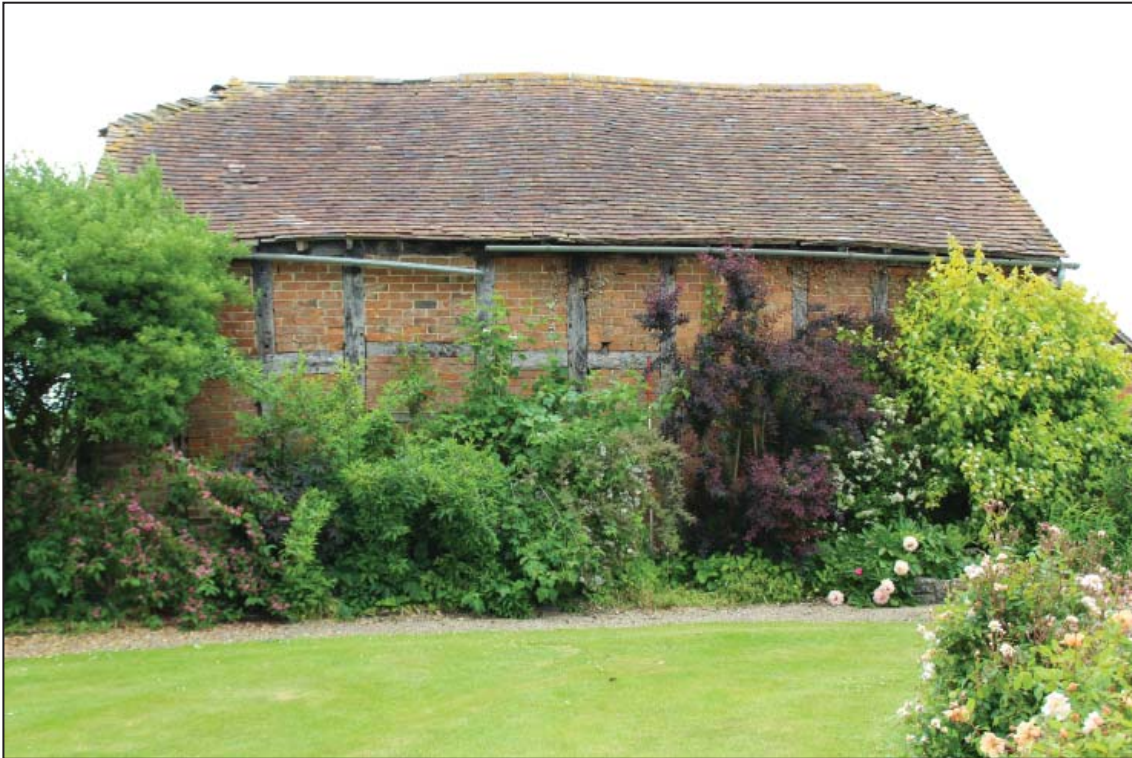
9 The eastern elevation, much obscured by vegetation (scale 2m)

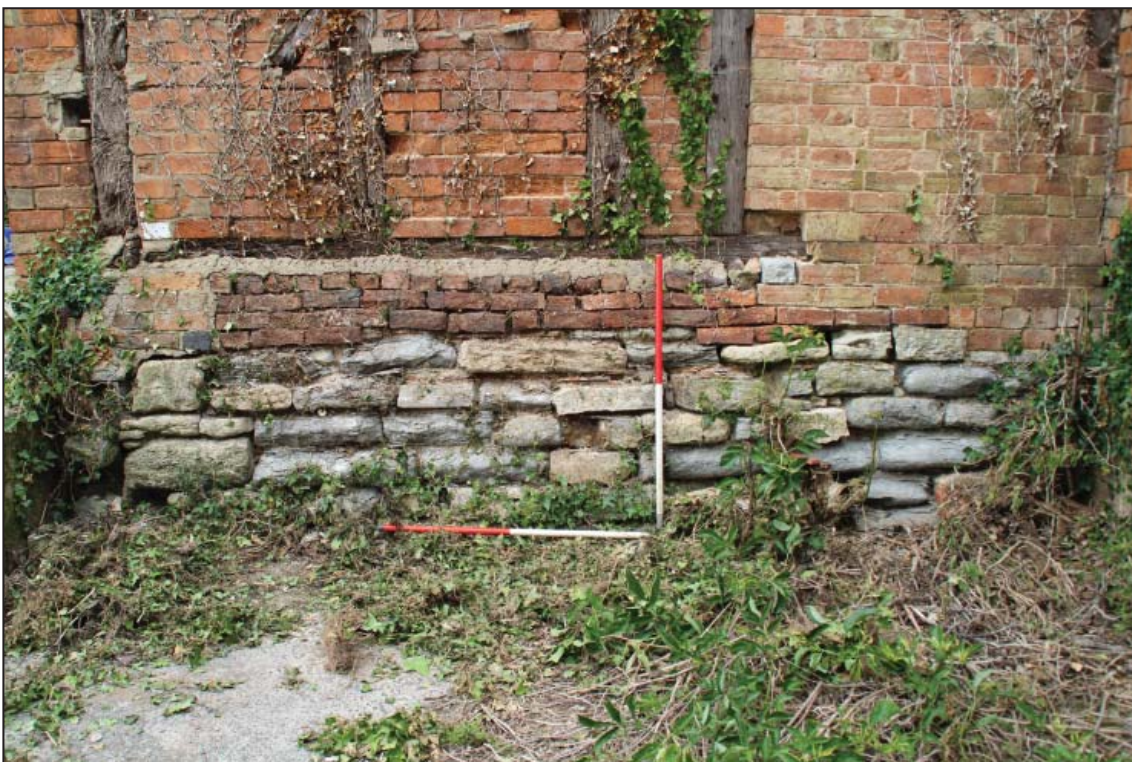
10 The brick (type F) and stone plinth of the south gable end; note common pressed bricks upper right (type E) (scales 1m)

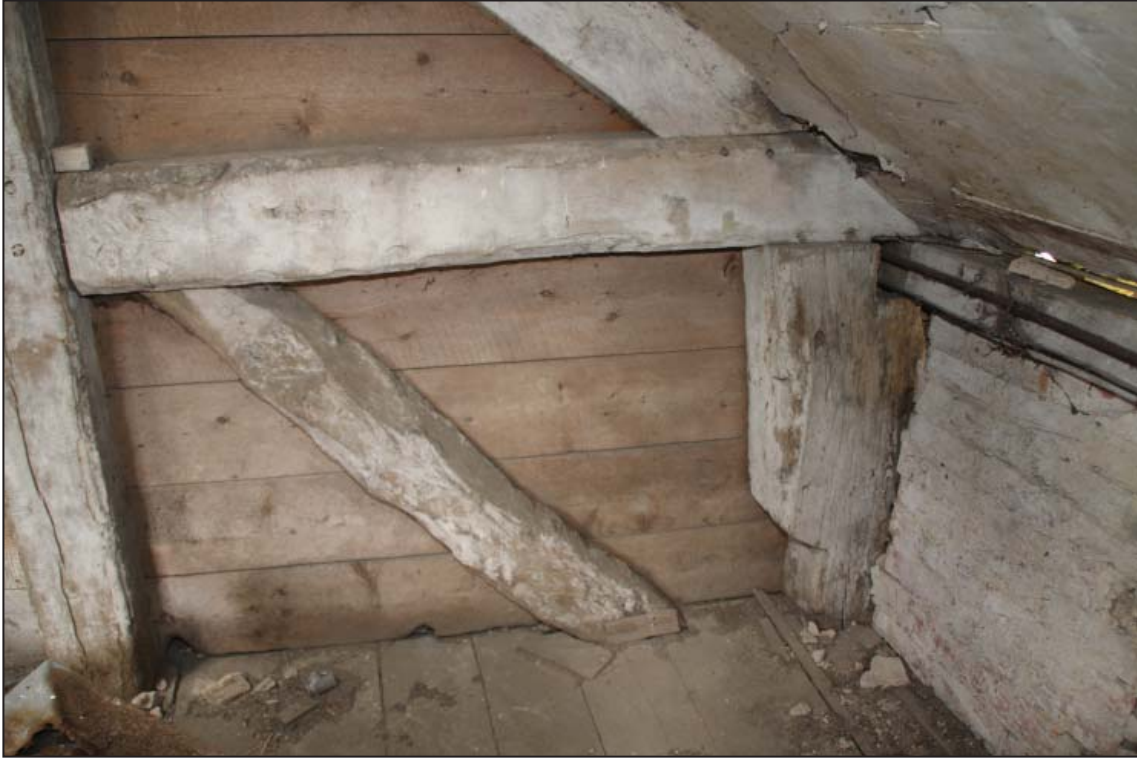
- 4.8 The gunstock-jowled corner and truss posts all have the standard housed tenon joint to the wall plate and open tenon to the tiebeam (Fig. 11). The latter is presumed to have the standard dovetail lap to the wall plate. The ends of the other posts are all mortised into the wallplate and soleplate with a single peg. The wallplate each side is in two pieces jointed with a pegged bridled or tongued splayed scarf.

11 The gunstock jowl of the eastern truss post showing the tiebeam and wallplate joint and the later alterations to the frame

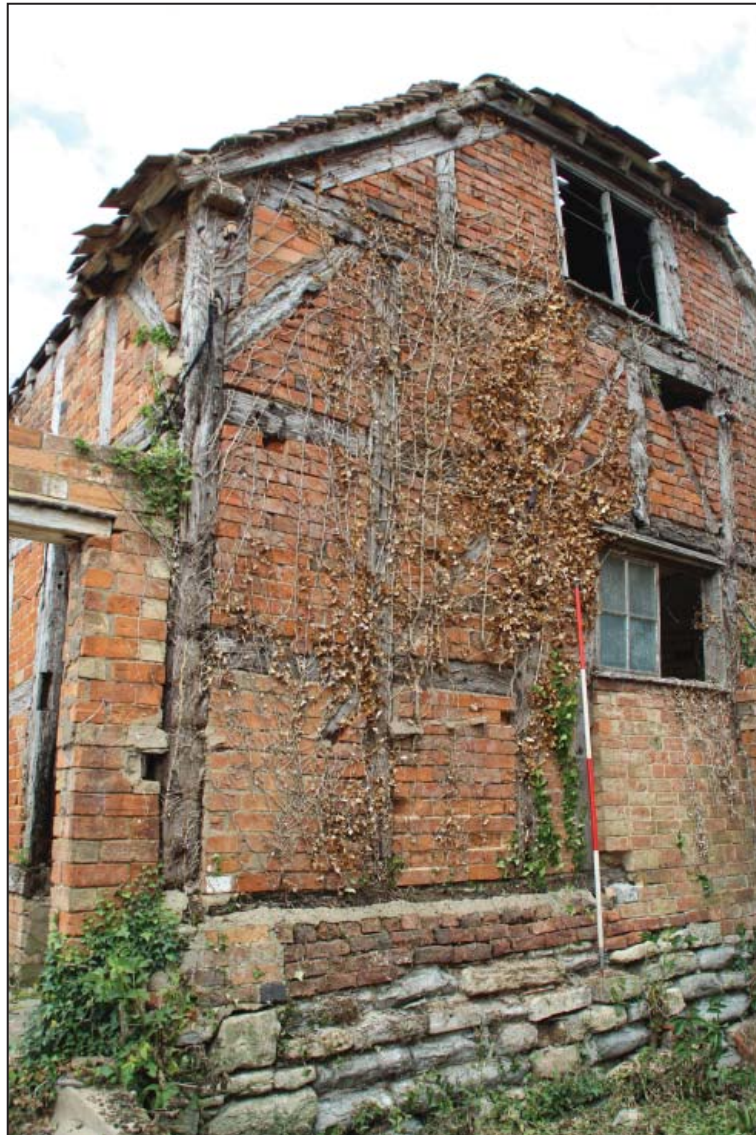
- 4.13 The south gable end is basically of similar construction (Figs. 5, 12 and 13). There are five storey posts roughly equally spaced, between the gunstock-jowled corner posts, the straight up-braces to the tiebeam fitting neatly under the angle of the jowl. The tiebeam thickens to its centre, giving a slightly cranked effect. Straight down-braces run from the centre of the underside of the tiebeam to the feet of the corner posts: or they did. The eastern side has rotted away at the base and the western side had been removed by the insertion of the door on this end of the elevation.

12 The south gable end, looking up and to the north-east (scale 2m)

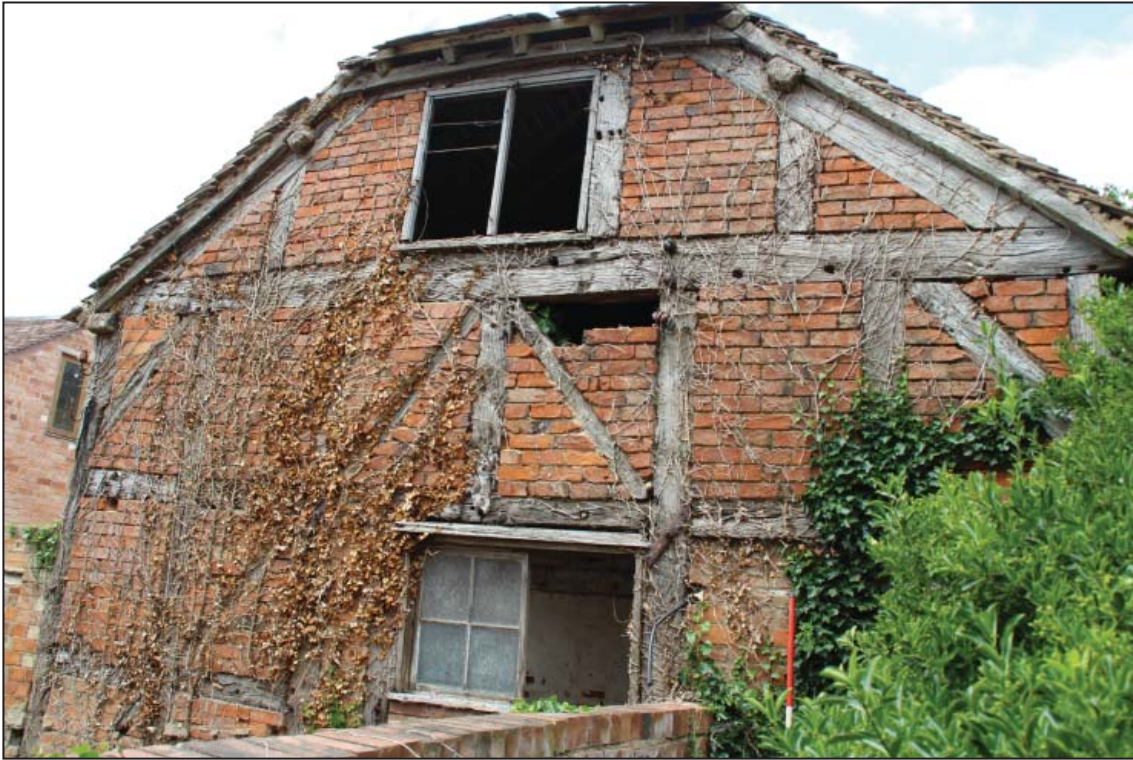
- 4.17 Above the tiebeam, the principals are truncated to the collar as the gable is hipped (Fig. 13). Four studs rise up from the tiebeam, two to the principals under the purlins and two to the collar. One has been removed to allow the fitting of the window. The purlin ends are visible, being halved over the back of the principals. The common

- 4.27 This brick is clearly associated with changes to the frame. It post-dates the alterations to the north elevation above the tie beam and the insertion of the window above the tie beam in the south elevation (Figs 5 and 13).

13 The upper part of the south gable end, looking to the north-west (scale 0.5m divisions)

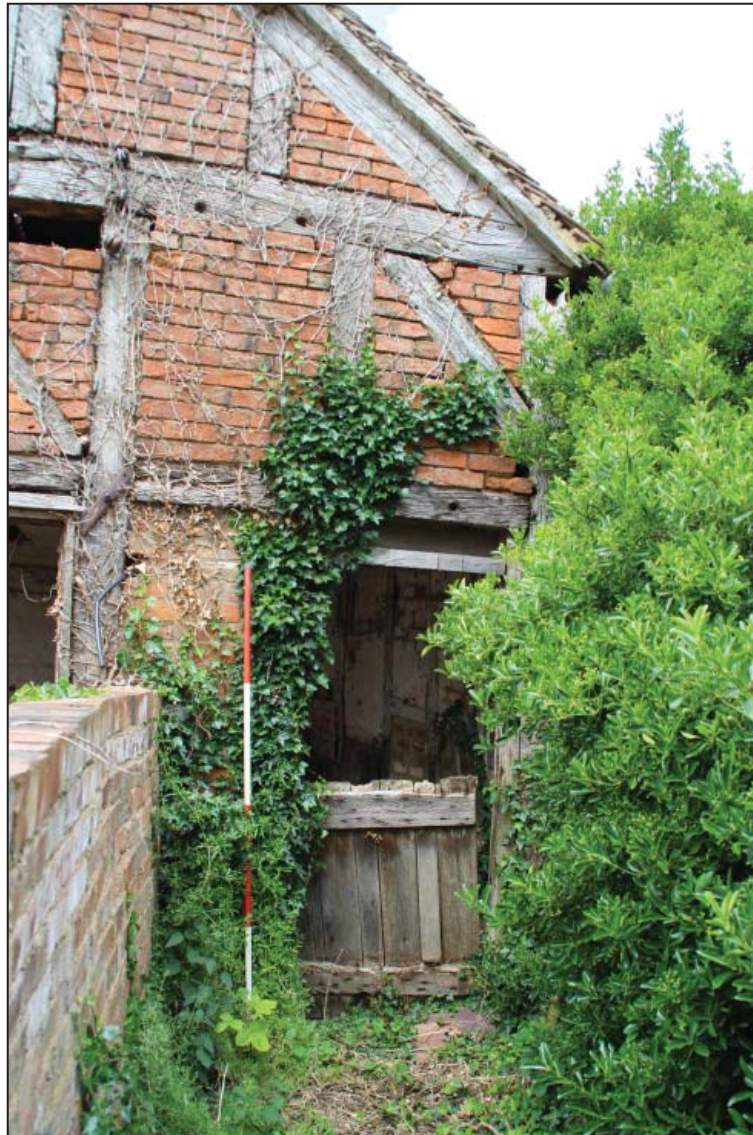
- 4.15 The post has presumably been re-used to provide the west side of the window, but is obscured by vegetation so this could not be confirmed.
- 4.16 The next post to the east has also had its lower section replaced by this brick which is also the infill of the end two bays where the last storey post has been cut away to allow the insertion of a doorway (Figs. 4 and 14).

14 The inserted doorway at the south-east corner of the barn, looking north (scale 2m)

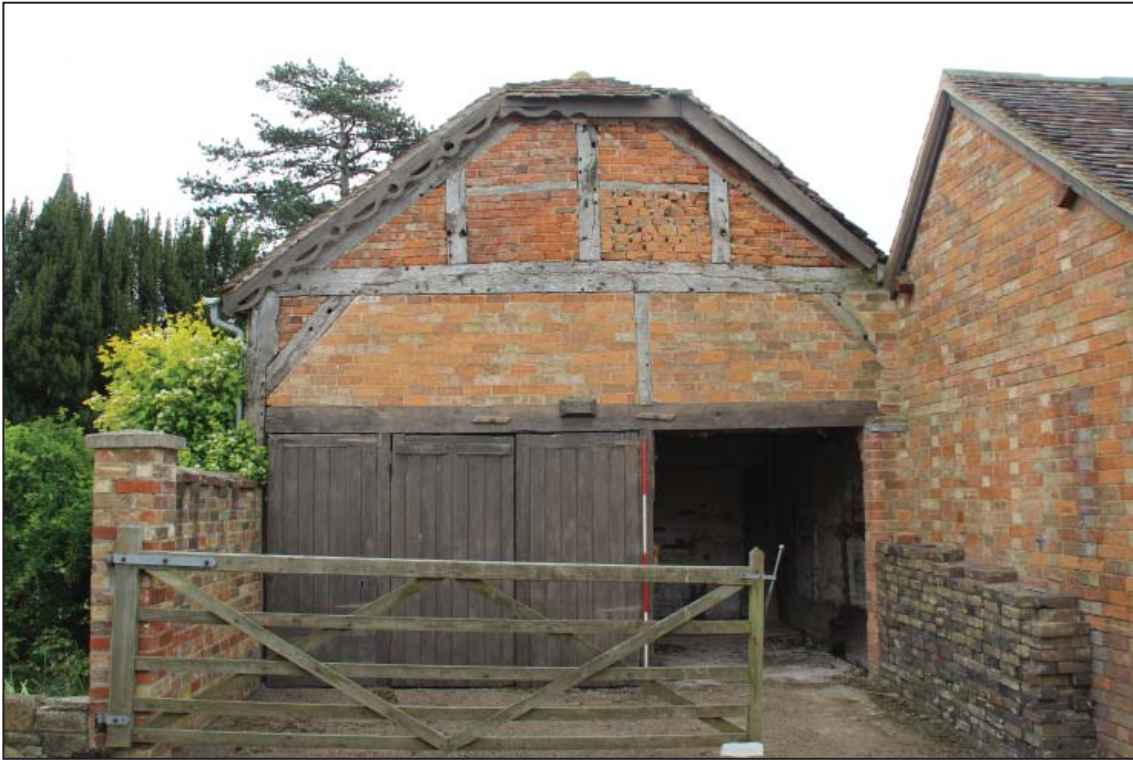
- 4.19 The north elevation has been much altered but the position of empty peg holes allows the earlier disposition of timbers to be understood, and it is clear that it was very similar to the south elevation when first built (Figs. 4 and 15).

- 4.32 More traditionally made bricks, but certainly used later than these pressed brick repairs, are the pale-coloured (including almost white) bricks that fill in the north elevation between tiebeam and upper rail (type C, Fig. 15). They also replace the corner post. They are very similar to those used in the adjacent shed (probably Victorian or Edwardian and with gable recently rebuilt, using the old bricks).

15 The north elevation of the barn (scale 2m)

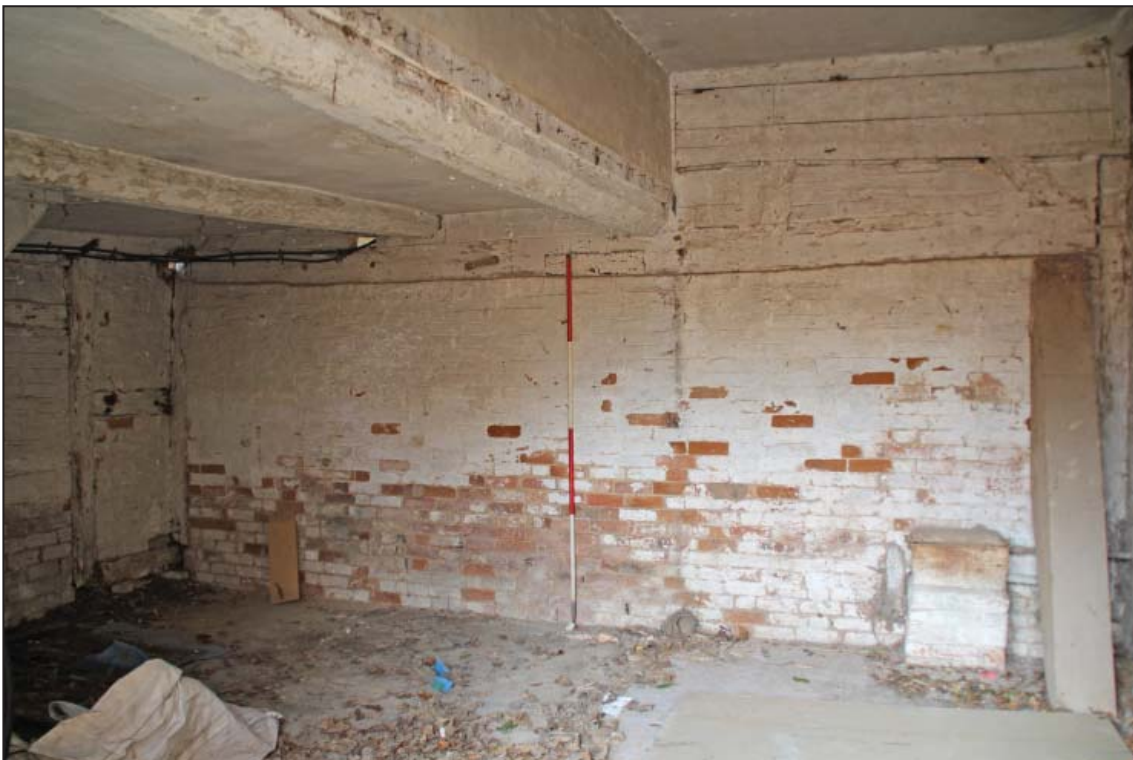
16

- 4.38 The ceiling is supported on two north/south joists resting on the new upper rail on the north and a wooden beam atop the brick wall dividing the room from its southern counterpart. The ceiling west of the western of these beams is raised 0.76m above the rest of the ceiling (Fig. 16).

- 4.39 The wooden beam appears to be jointed into the truss posts and the brick wall has been underbuilt in B type brick (Fig. 16).
- 4.40 The timber frame is exposed internally. On the east, the large doorway (para 4.3) is seen to interrupt the soleplate (Fig. 17). Its inserted lintel can be seen to respect the ceiling.

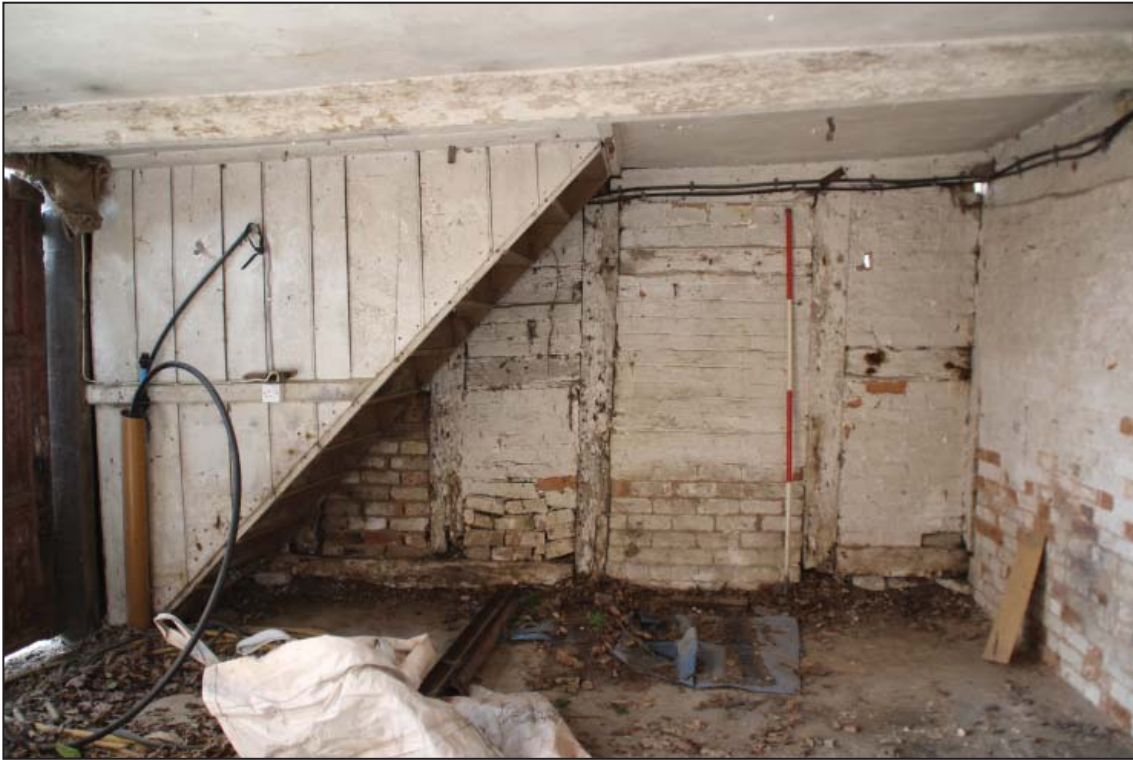
17 The east side of the ground floor north room; stair enclosure and blocked doorway (scale 2m)

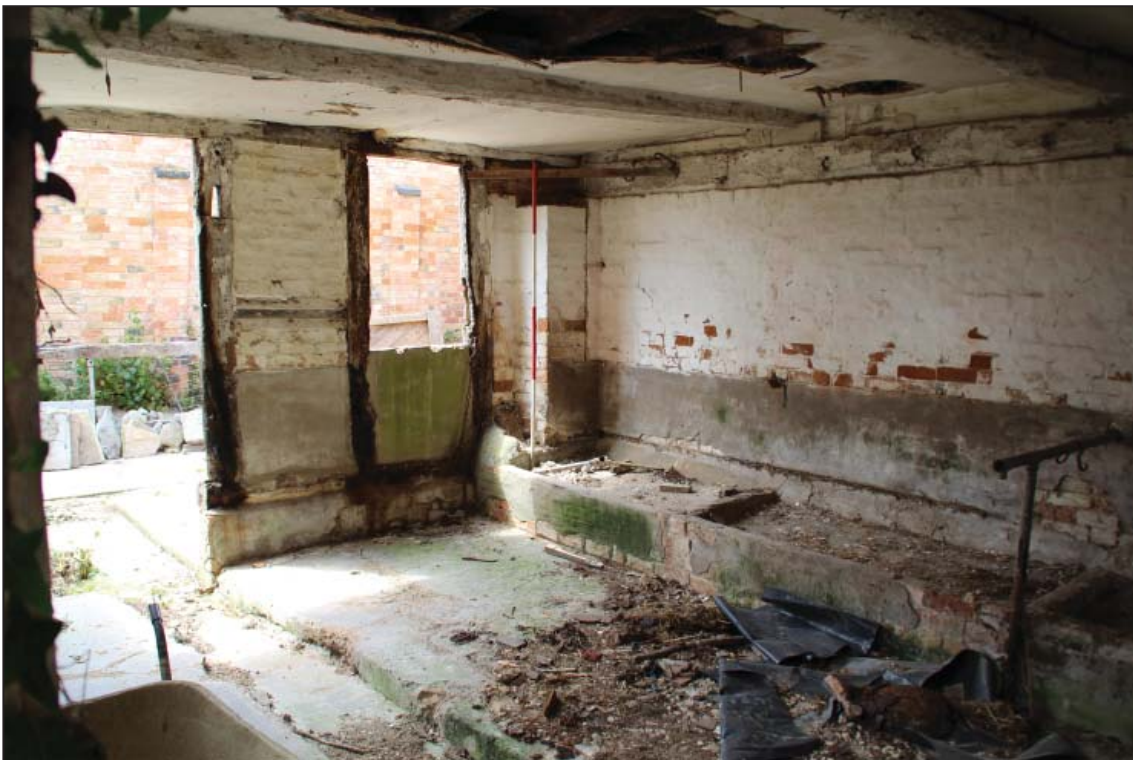
18

- 4.43 As in the northern room, the blocked tall door in the east side interrupted the soleplate and is now blocked up (Fig. 19).
- 4.44 The ceiling is carried on two joists that run from brackets nailed on to the south wall posts (Fig. 20) to blocks on the central cross beam (Fig. 18).

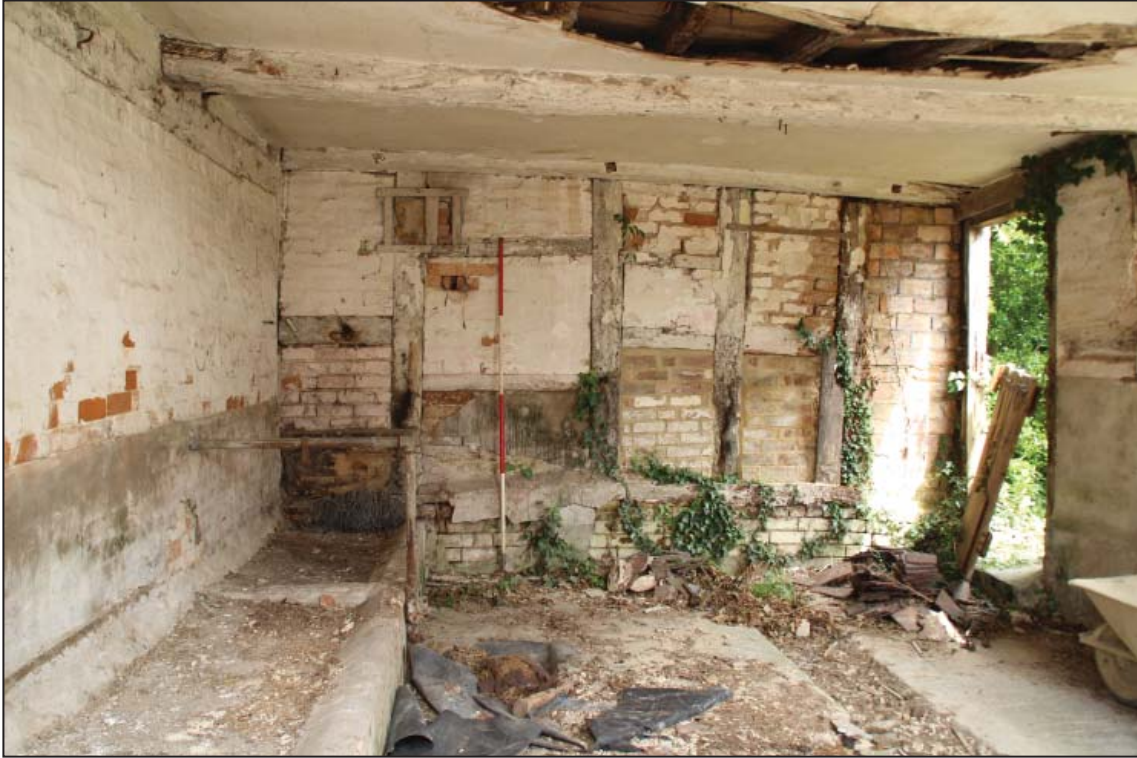
19 The south ground floor room, looking east

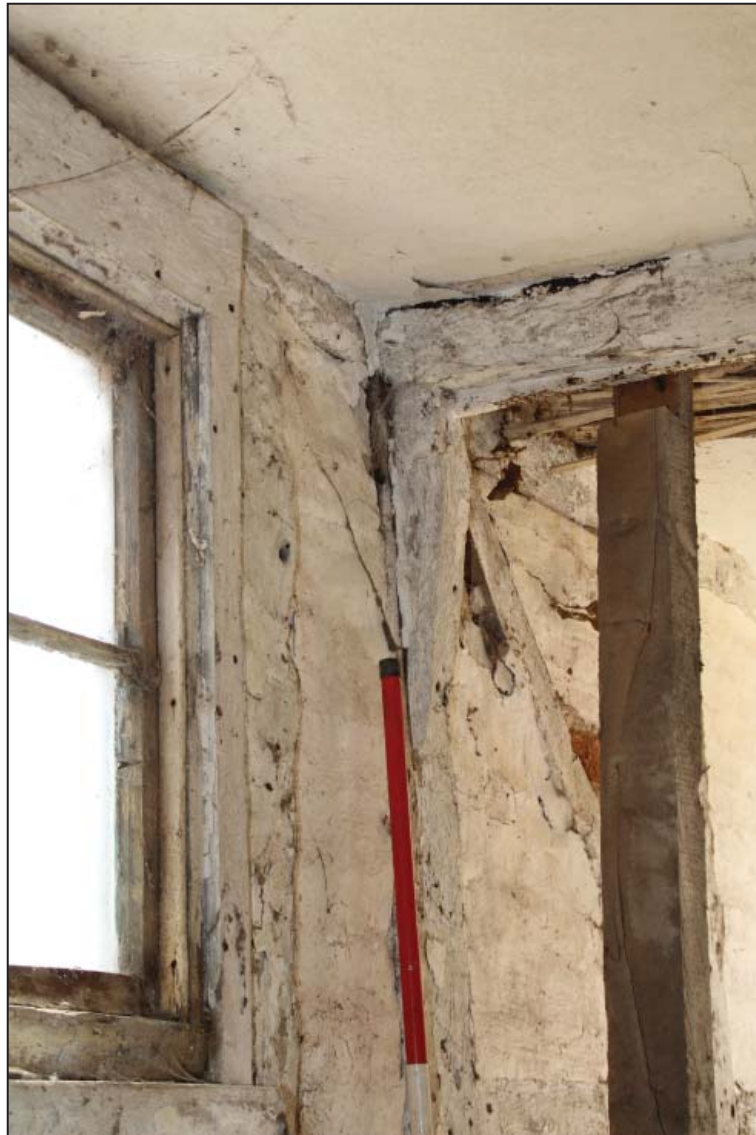
20 Nailed-on bracket to support the western inserted ceiling beam in the south ground floor room (scale 0.5m division)

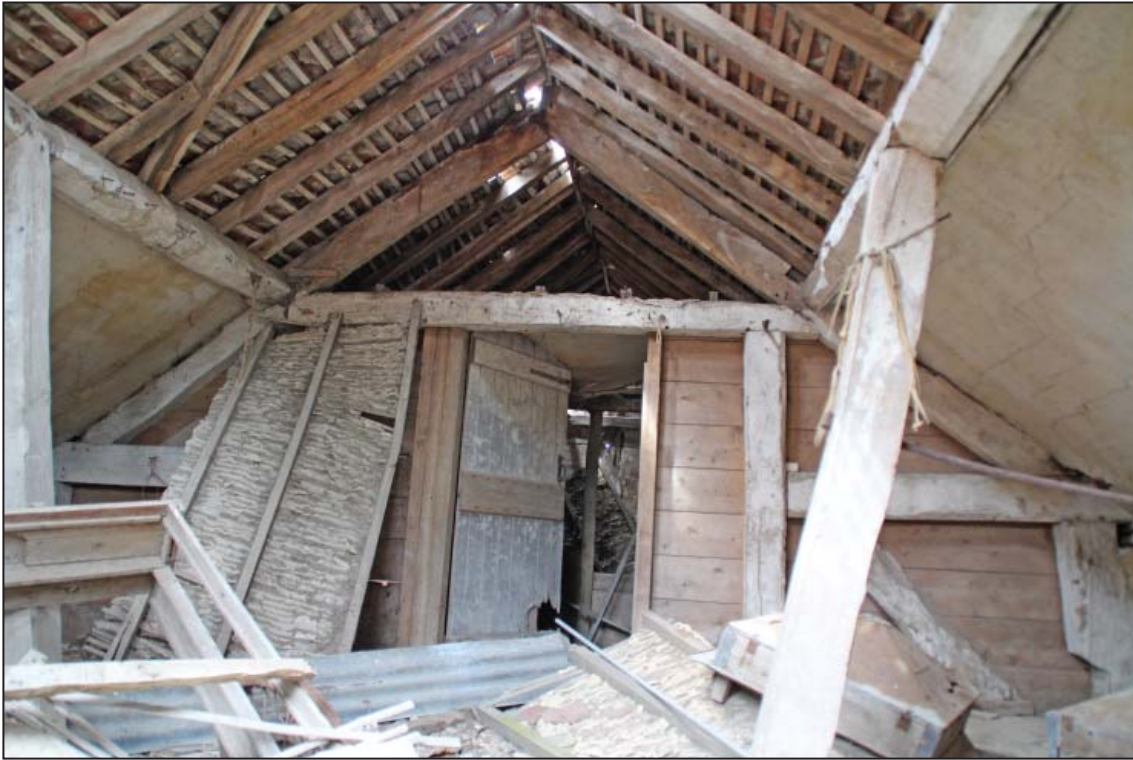
- 4.48 However, although all is pegged in place, the timber work above this upper rail appears to be secondary. The two posts (Fig. 21), appear to be additions, as they cut the tiebeam in two, removing its structural sense (and do not quite line up with the mortises in the collar), and the new tenons cut into the truncated ends of the tiebeam are full depth and occupy through mortises in the uprights, an unusual feature. Again the fit is poor. The up-braces are rather rough and waney, are not pegged into the tie beam, and are jointed, not into the truss post, but into the upper rail.

- 4.53 Both the main rooms have sloping struts resting on the inserted ground floor ceiling beams and, roughly nailed into place, supporting the purlins (Figs. 21 and 22). The eastern purlin in the southern room has sagged or warped considerably and has a new timber on its back to provide a level seating for the (replaced) common rafters.
- 4.54 It is thought that these struts post-date the ceiling on the first floor as the northern ones are cut to fit around a collar (of re-used timber) that appears to have been fitted between the purlins to support the ceiling. The boarded bins also post-date the struts, strictly speaking, but may well be part of the same phase of works.

21 The central truss at first floor level, looking north; note collapsed ceiling, replacement rafters and later raking struts (no scale due to access problems)

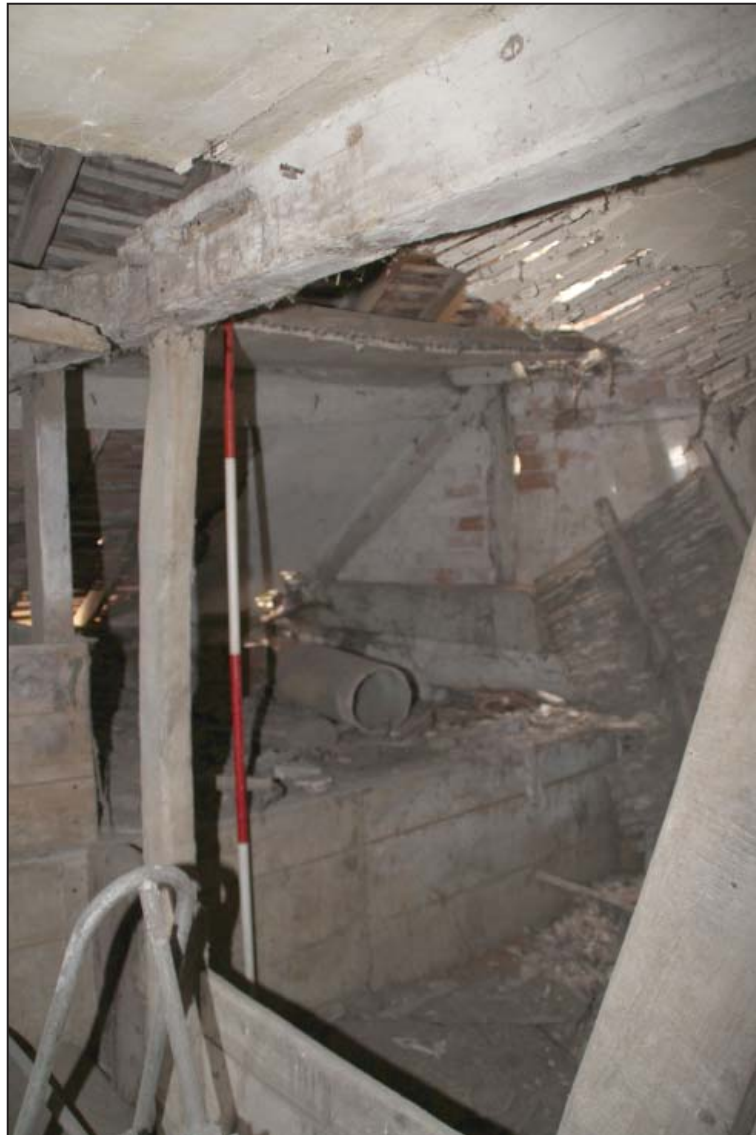
section. The southern end of this also has boarded sides to create another (but raised) bin (Figs 6 and 22).

22 The bins, raking struts, and inserted collar at the north end of the first floor, looking north-west (scale 2m)
