Chevithorne Barton Tiverton Devon

Historic Building Watching Brief

CA Project: 880169 CA Report: 17091

March 2017

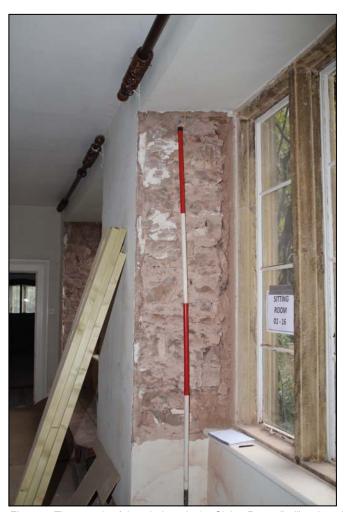
- 5.5 The presumed and unseen timber lintels over the window recesses seem to have sat on timber pads in the top of the reveals (Fig. 7)
- 5.6 It was noted that the lintels and cills of the windows on the ground floor all had filled and patched settings for diagonally set, vertical, iron security bars, two per light (just visible top of Fig. 6).

Figure 6: The reveals of the windows in the Sitting Room (hall) stripped plaster, looking east (scale in 0.5m divisions)

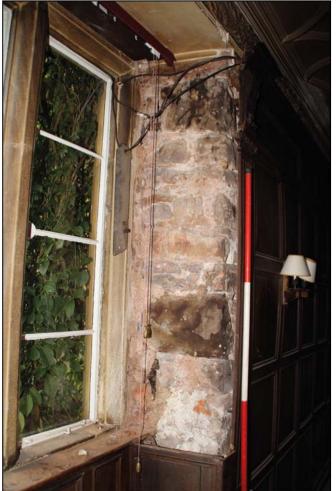
Figure 8: The northern reveal of the west-facing window in the Drawing Room (Oak Room) showing plaster behind panelling (scale in 0.5m divisions)

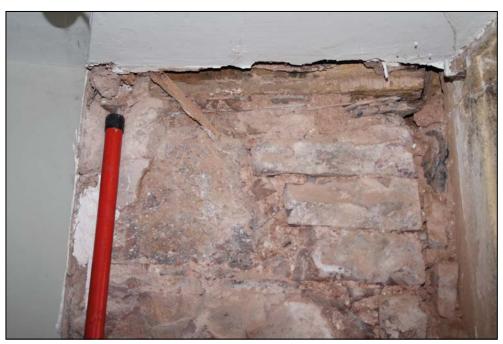
Figure 7: Timber pad at the top of the reveals in the mullioned windows (here in the Sitting Room (hall) eastern window, looking east

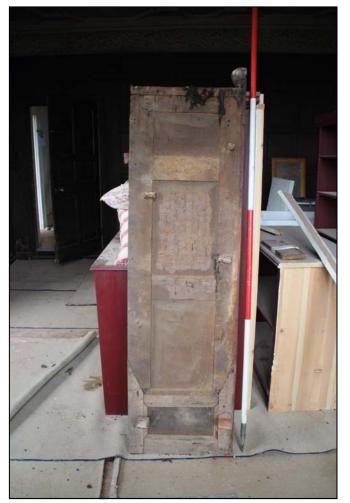
- 5.8 The panel removed had been repaired in the past with a new timber base-muntin and timber pieced in to the bottom of the stiles (Fig. 9).
- The plaster was also removed from the reveals in the windows in the Games Room.

Figure 9: The rear face of the panel removed from the reveal in the Drawing Room; note repair (scale in 0.5m divisions)

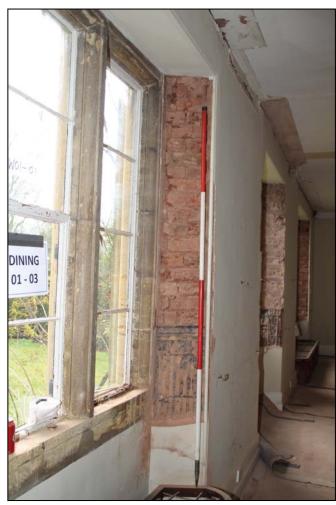
Figure 10: The brick reveals of the Games Room windows and the probably re-used windows, looking W (scale 2m)

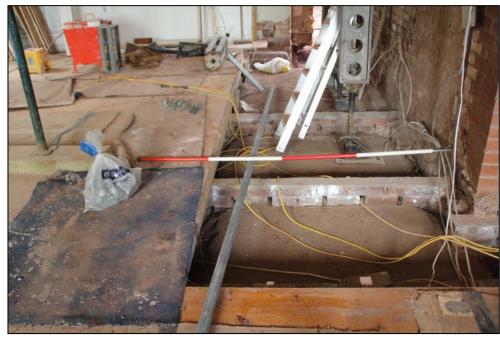
Figure 12: The possible barrel-vault extrados under the rear part of the Games Room, looking north (scale in 0.5m divisions)

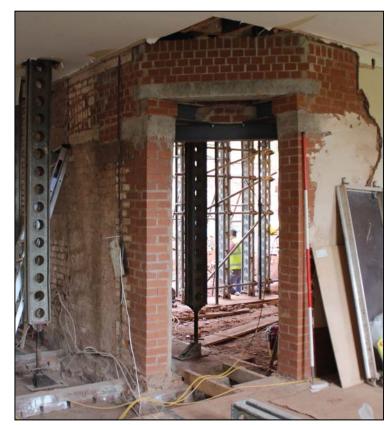
Figure 11: The wall between the rear part of the Games Room and the Kitchen, on left, looking north-east; note blocked doorway with half an arched head. 2017 doorway in centre (scale 2m)

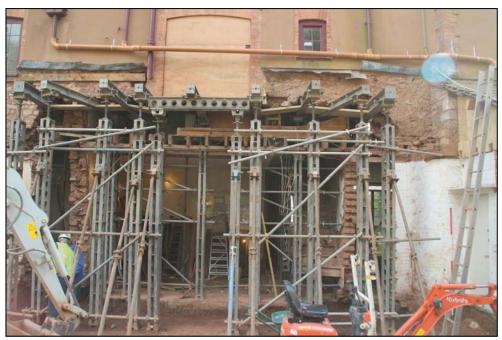
Figure 14: The rear wall of the west wing after demolition of the rear ranges and the lower part of the wall. Note stack quoins on right (scale 2m)

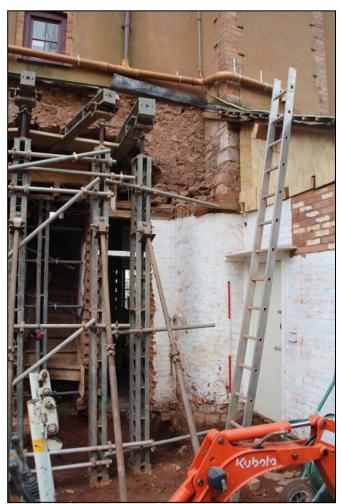
- 5.20 It has already been noted that the ground floor stack near the north-west corner was a survivor from the 17th-century house (Keystone 2011, 25) and this masonry is of a piece with the stack (Fig. 16). The brickwork of the quoins of the rebuilt stack above it is identical to the window surrounds of the rear range.

Figure 16: The stack at the north end of the west wing, continuous with the older masonry of the north wall, to south-west from within the demolished western utility room.

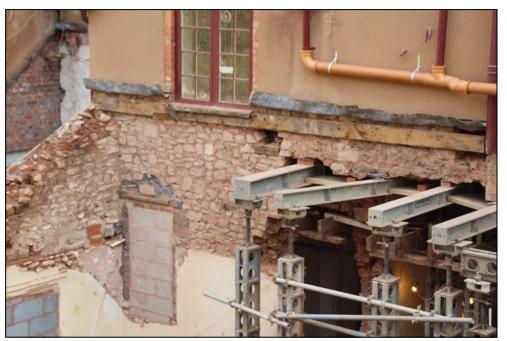
Figure 15: The junction of the older masonry at the rear of the west wing (over the needles) with the rubble walling of the 19th-century rear range (bathroom and central larder), looking south-east

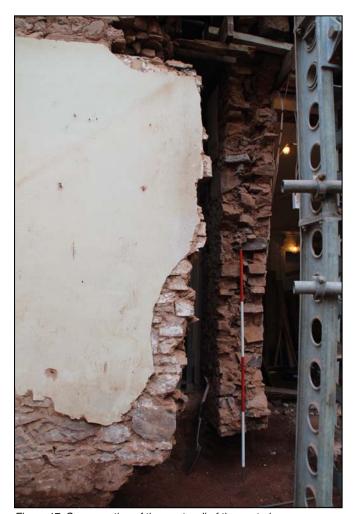
Figure 17: Cross-section of the west wall of the central range, no footings and relatively regular construction, looking south-south-west, 19th-century wall in front (scale 2m). The concrete scraps are the remains of the silver safe

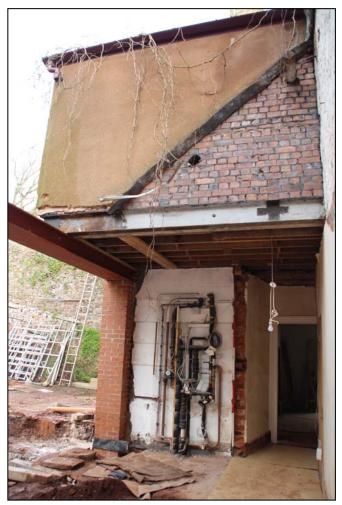
Figure 18: The first floor bathroom after demolition of the eastern utility room and rear corridor and the insertion of the modern steel and brickwork to support the old steel and brick, looking east, (scale 2m)

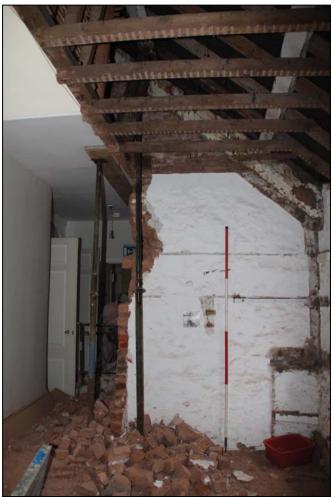
Figure 20: The eastern utility room looking west after the demolition of the brick wall forming the rear corridor: inserted 1930 ceiling joists below the 19th-century roof timbers

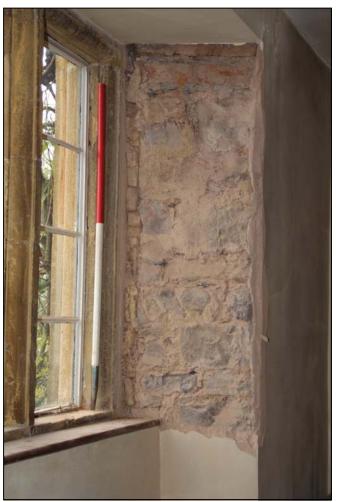
- 5.40 It is presumed that when the old plaster was replaced with the present material, the brick repairs visible in the top of both splays of the west window in Bedroom 1 and the east splay of the window in the Drawing Room were made. These were inserted under the wood pad for the presumed lintel (Fig. 24).

Figure 24: The stripped west splay of the south window in Bedroom 1, showing brick repair and modern plaster (scale 1m)

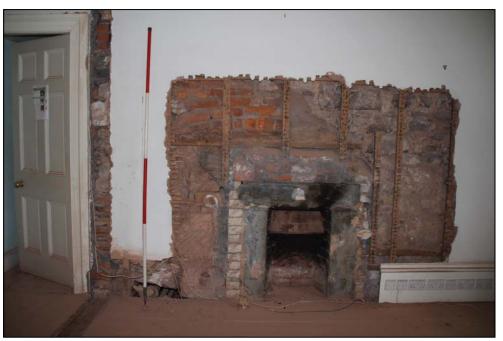
Figure 23: The blocked fireplace in the north wall of the office after removal of lath and plaster covering (scale 2m)

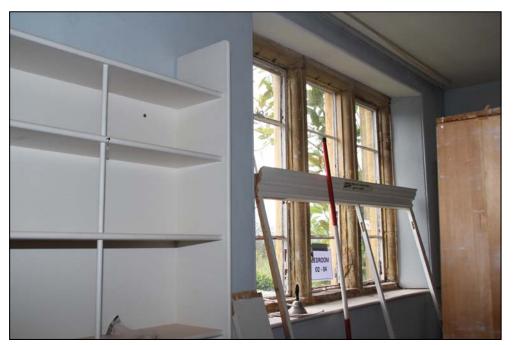
- 5.41 It was noted above that the mullioned windows in the ground floor had evidence for the former existence of vertical security bars. None of the windows in the upper floors of the 17th-century wing show these scars. However, all of the mullioned windows in the 19th-century wing on the ground and first floors exhibit them (Fig. 25).

Figure 25: The western window in the south side of Bedroom 5, showing probably re-used mullions, cills and lintels with filled bar-settings visible in the lintels (scale in 0.5m divisions)

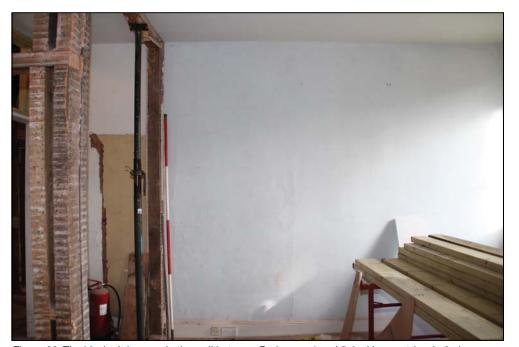
Figure 29: The blocked doorway in the wall between Bedrooms 4 and 5, looking east (scale 2m)

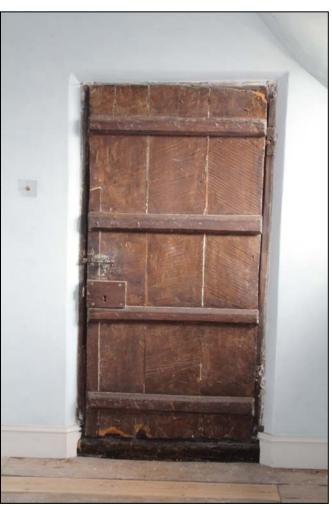
- The door in the partition between the bedrooms is 17th-century and the frame, although given an extra lining in recent times in polished dark wood, also appears to be of that date. The threshold is worn hardwood. This partition might well be early if not original. It is thicker than the corridor walls and its overlapping of the window jamb seems to be the result of a later thickening of this end of the partition. In the absence of a corridor it is more probable than not that this door is *in situ* in an early partition (Fig. 36).

Figure 36: The door and doorframe between Bedrooms 7 and 8

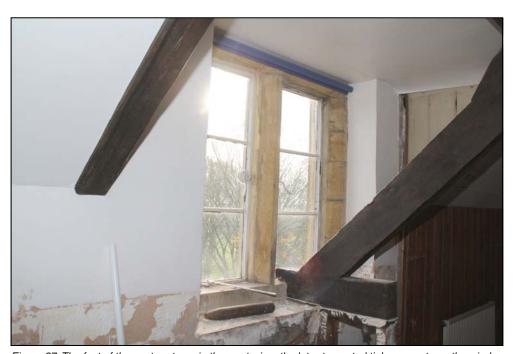
- 5.73 The removal of the tie beam to the south of the stack (Fig. 37), again replaced by an inserted higher beam, allowed the creation of a couple of rooms here, the kitchen and store room and a ceiling (Fig. 5).

Figure 37: The foot of the eastern truss in the west wing, the later-truncated tiebeam rests on the window cill. Note simplified profile of mullions

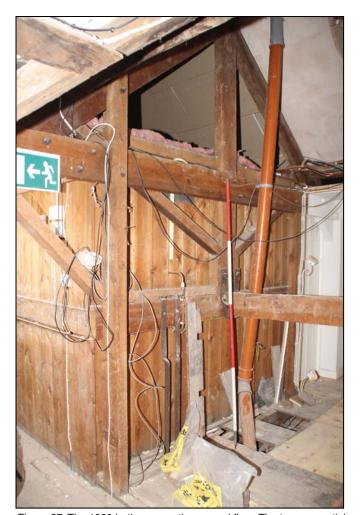
Figure 37: The 1930 bathroom on the second floor. The transverse tiebeam of the rear roof is truncated at both ends and the main tiebeam (on right) is minus the principal rafter. New timbers are bolted on to provide replacement support (scale 2m)

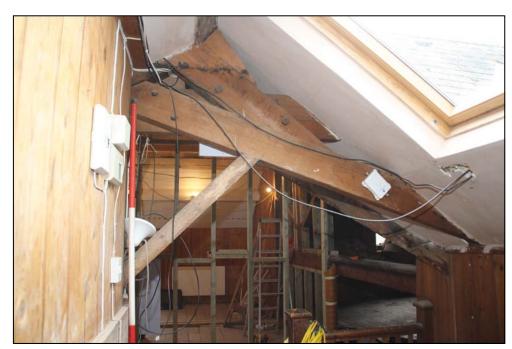
Figure 42: Timbers inserted in 1930 to replace and support removed and truncated timbers, from the top of the back stairs, looking south (scale in 0.5m divisions)

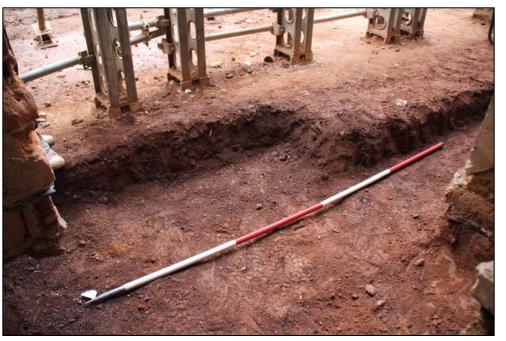
- 8.8 The demolition of the rear ranges showed that the walls of all dates had almost no foundation trenches and were set on the surface of the bedrock. The area for the new structures was excavated to a depth of approximately 0.3m and then another 0.25 to 0.3m along the line of the demolished rear wall of the west wing during the writer's last visit. All that was revealed was the degraded sandstone bedrock (Fig. 43).
- 8.9 The rear wall of the west wing and the west wall of the main range were also without substantial footings. There was no sign of the rear extensions indicated on the Tithe Map, and it seems probable that they were also without significant footings, and all traces were swept away when they were replaced.

Figure 43: Excavations at the rear of the west wing, looking north-east. The level supporting the props has been reduced by 300mm and the deeper area by another 250-300mm, exposing only degraded sandstone natural (scale 2m)
