Plot C2 Millbay Plymouth

Archaeological Watching Brief

CA Project: 880071
CA Report: 17355

June 2017

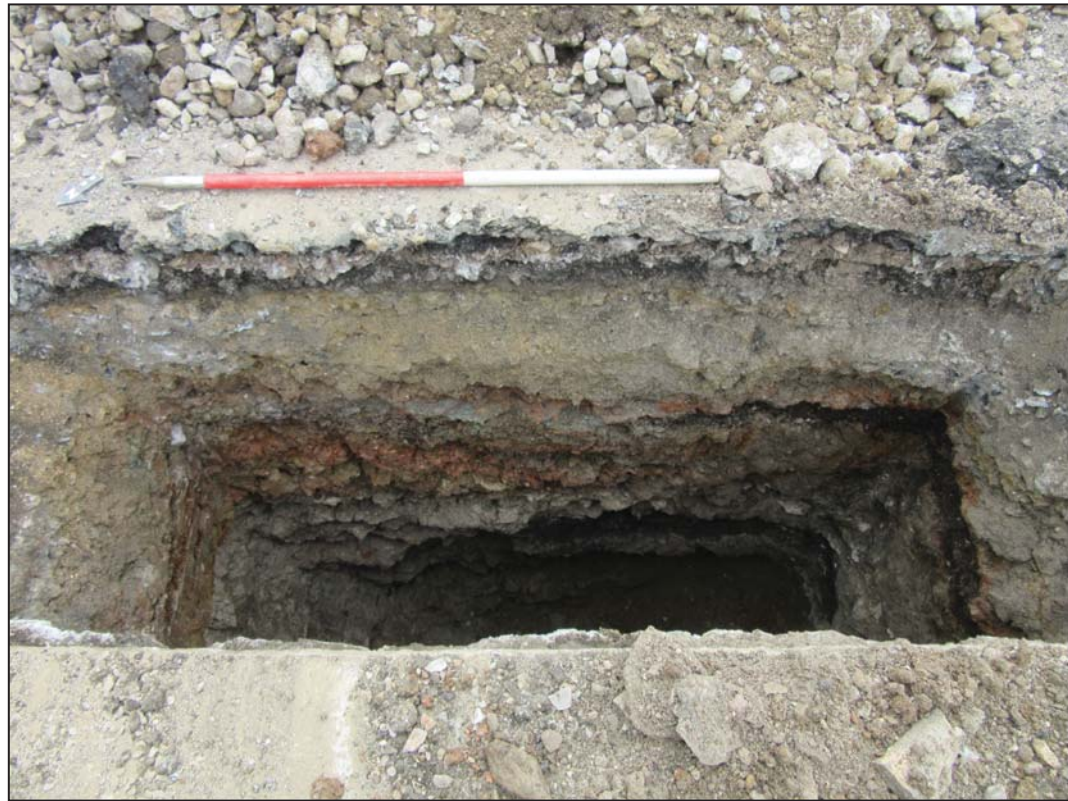
Test Pit 2, looking south-east (1m scale)

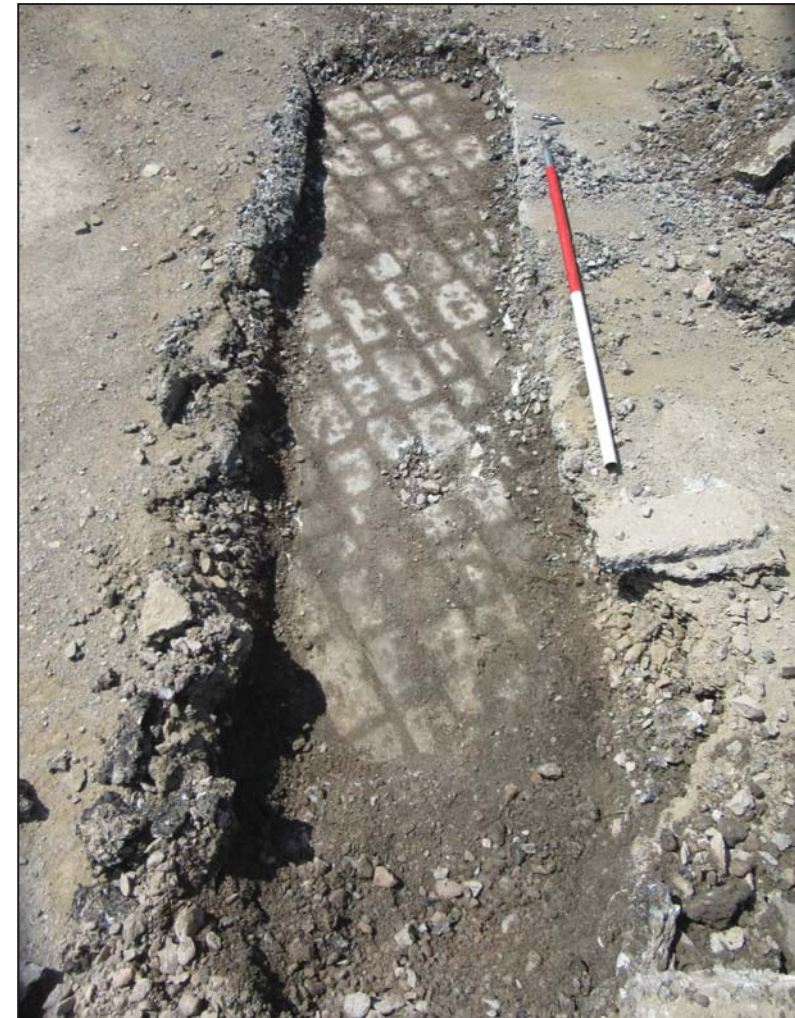
Part of a concrete structure was exposed at the base of the test pit (2.6m bpgl). It was apparently sealed by redeposited natural layer 405. The upper surface of this redeposited natural layer (0.5m bpgl) was cut by the fragmentary remains of red brick wall 404.

Test Pit 4 showing cobbled surface 400, looking east (1m scale)

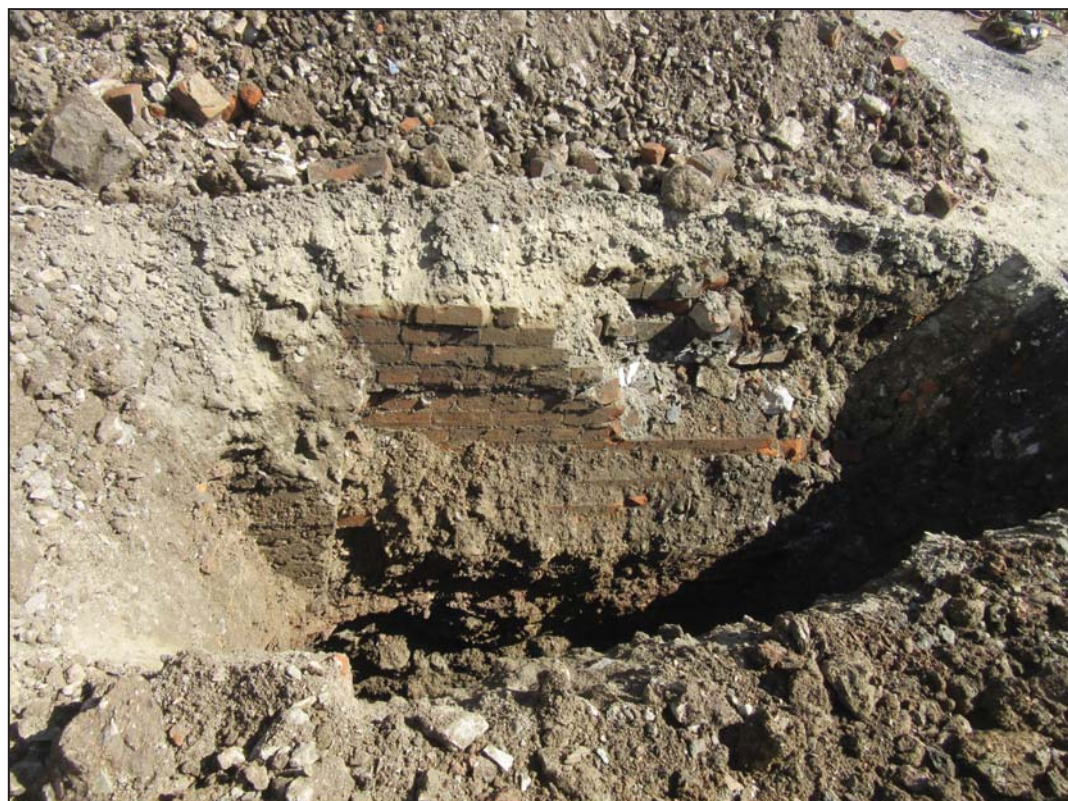
Test Pit 11 showing brick wall 1101, looking south-east

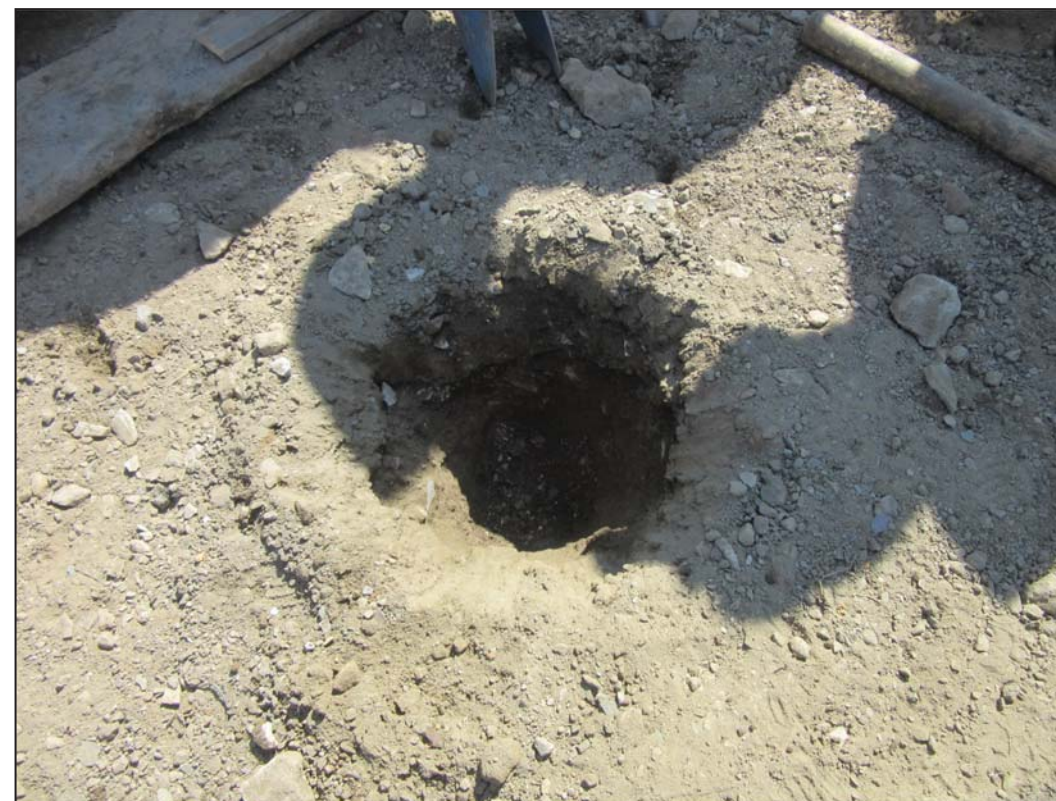
Borehole Test Pit 7

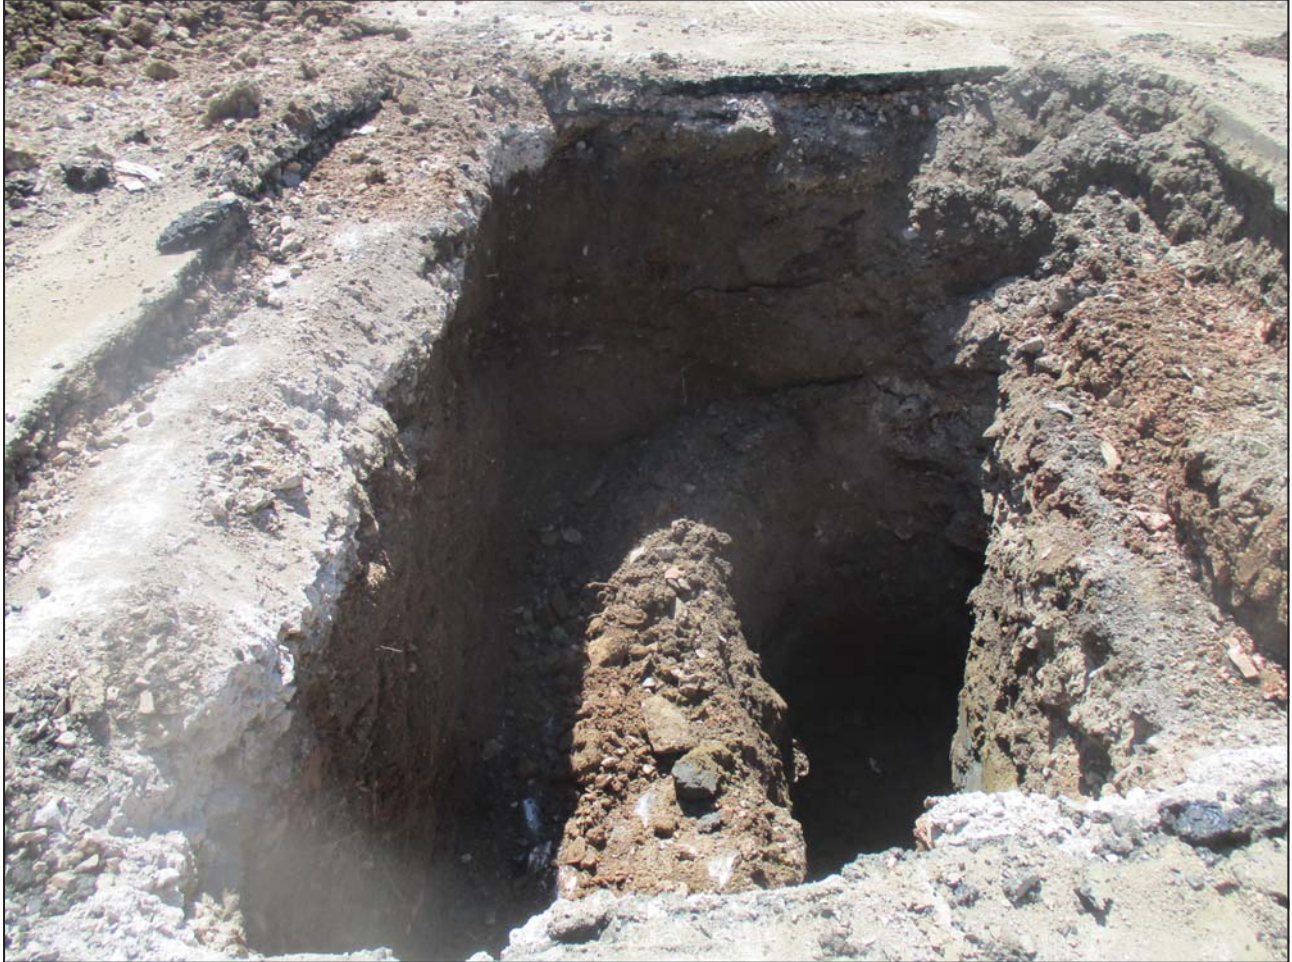
- 5.4 A culvert was exposed in TPs 13, 14 and 17. This culvert was aligned north-east/south-west. The top of this structure was exposed 2.4m bpgl in the north-eastern part of the site (T13 and T17), deepening to 3.1m bpgl as it moved south-westwards (T14). It was not possible to investigate the culvert in detail due to the deep and unstable nature of the groundworks. A CCTV inspection of the culvert was

- 6.4 The alignment of the culvert exposed in TPs 13, 14 and 17 suggests that it is unlikely to be a later expression of the 16th-century Drake's Leat, although it may have fed into the leat. The culvert had been much rebuilt/repared, with sections of the structure being built of masonry, brick, cast iron and concrete.

Test Pit 17, showing culvert 1700

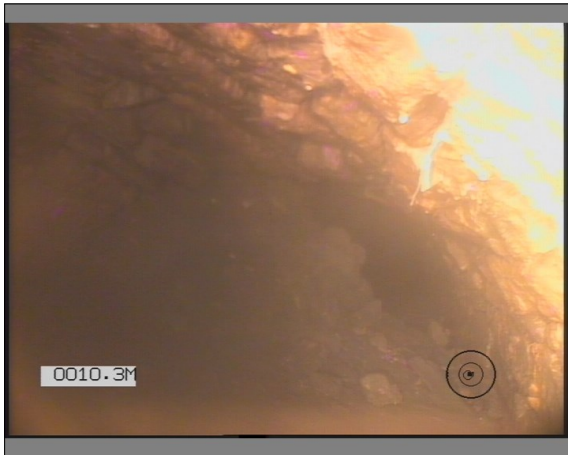
Photo: 1_4A, 00:02:51
10.3m, Survey abandoned

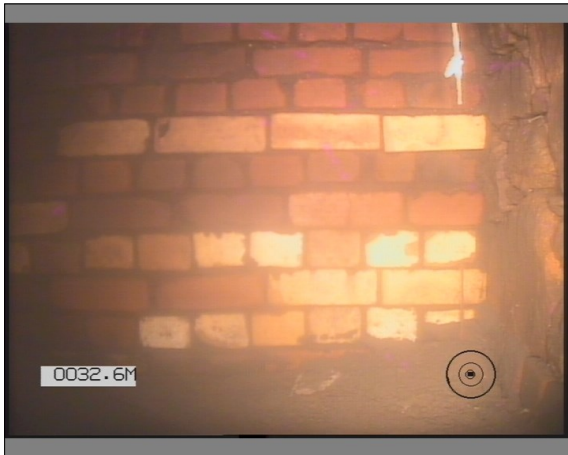
Photo: 2_3A, 00:02:52
32.6m, Finish node type, manhole reference number: CAP END

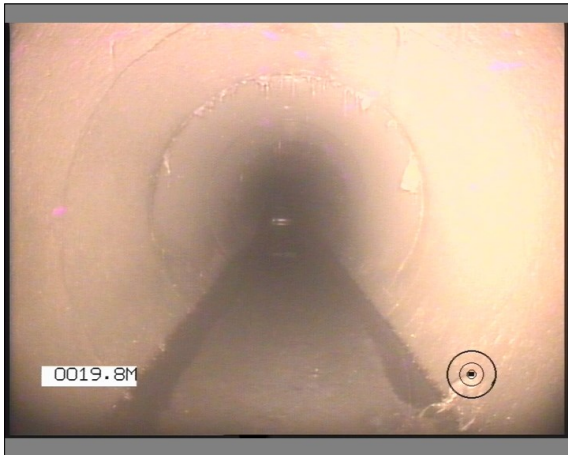
19.80	MC	Material changes, concrete	00:01:15	4_3A	(Misc) 0
	19.80	FC	Fracture, circumferential, from 7 to 5 o'clock	00:01:21		(Struct) 3
	20.80	FCJ	Fracture, circumferential at joint, from 2 to 5 o'clock	00:01:47	4_5A	(Struct) 3

Photo: 4_3A, 00:01:15
 19.8m, Material changes, concrete

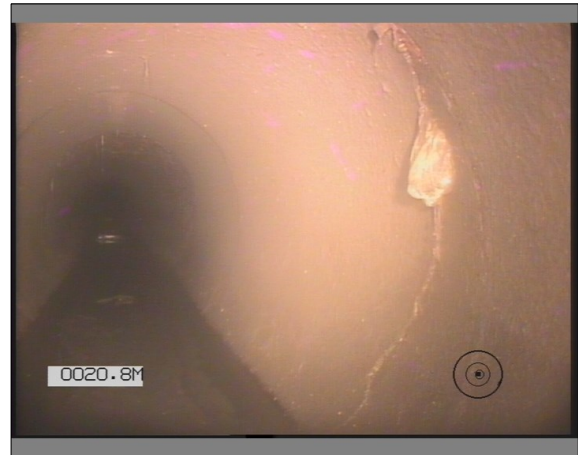
Photo: 4_5A, 00:01:47
 20.8m, Fracture, circumferential at joint, from 2 to 5 o'clock

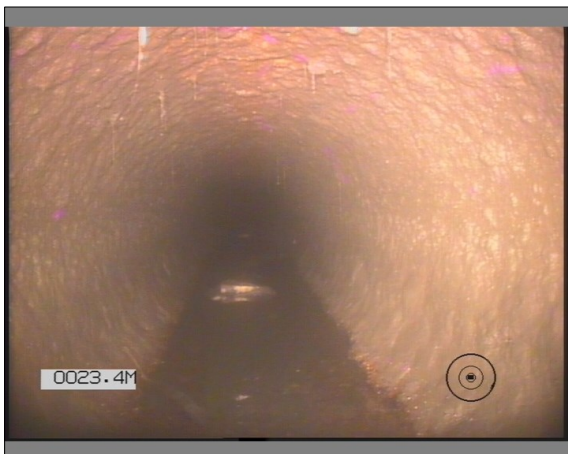
Photo: 4_7A, 00:02:21
 23.4m, Material changes, cast iron

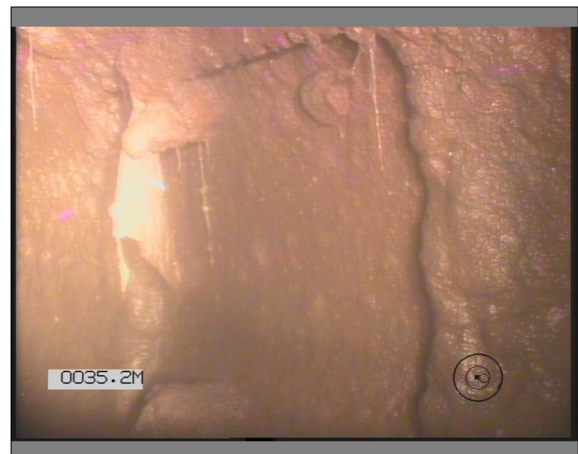
35.20	REM	General remark Remarks: THIS LINE IS RUNNING THROUGH MANHOLE 1 CORRODED HATCHBOX PRESENT	00:03:36	4_9A	(Misc) 0
	35.20	F01	DES Settled deposits, fine, 10% cross-sectional area loss, End	00:06:27		(Serv) 3

Photo: 4_9A, 00:03:36
 35.2m, General remark

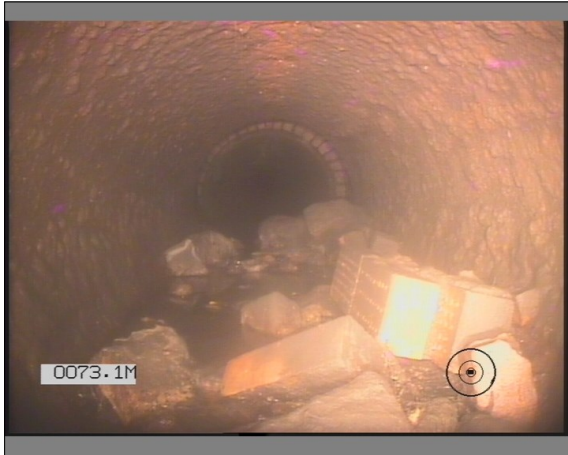
Photo: 4_18A, 00:06:53
 73.1m, Settled deposits, coarse, 40% cross-sectional area
 loss

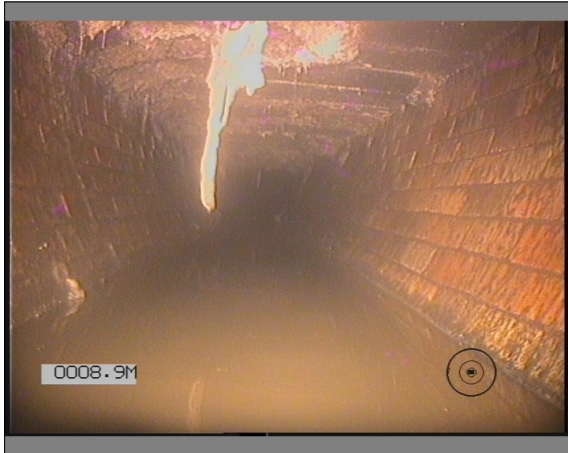
8.90	REM	General remark Remarks: CONCRETE REPAIR TO THE TOP OF THE PIPE	00:01:08	5_3A	(Misc) 0
8.90	SC	Dimension changes, 900mm high, 900mm wide	00:01:17		0

Photo: 5_3A, 00:01:08
8.9m, General remark
