**Beanie Building
3 George Street
Teignmouth
Devon**

Historic Building Watching Brief

CA Project: EX0071

April 2020

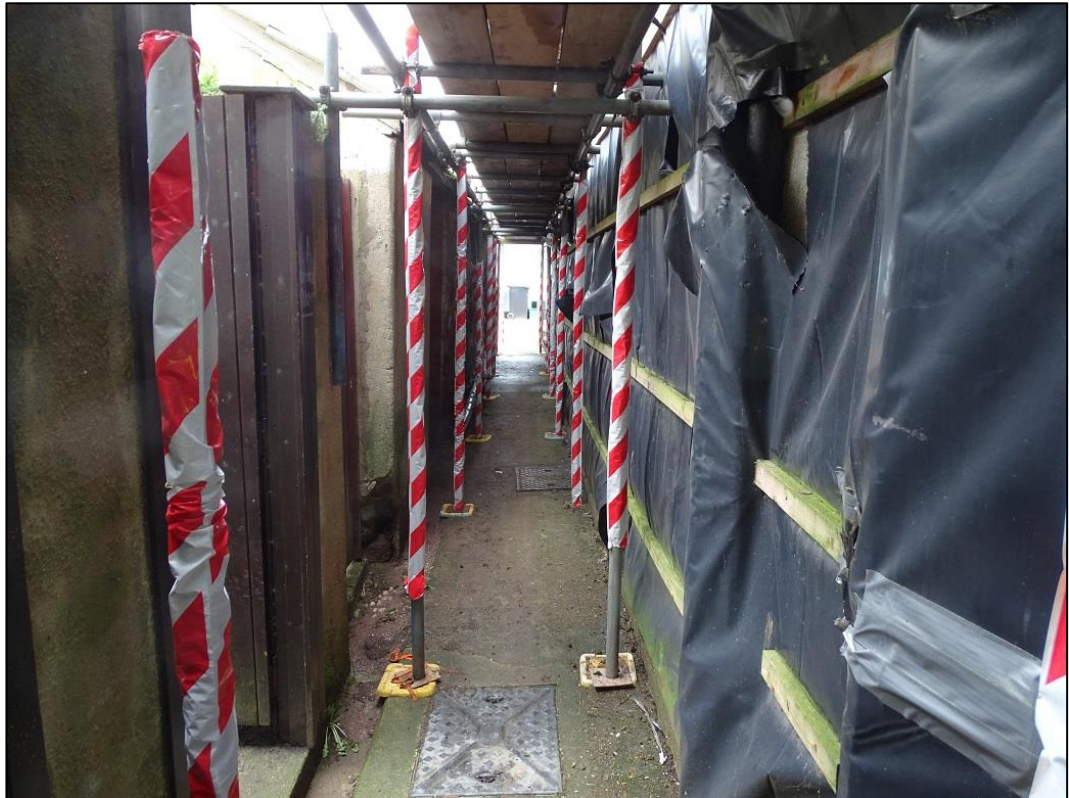
- 3.1. The west elevation of the Building (Photo 1), fronts onto a narrow alleyway that separates it from the group of buildings to its west that have frontages onto both George Street and Somerset/Northumberland Place. This elevation of the Building was sheeted and battened as a protective measure and is scaffolded for access across the first and second floors (Photo 2), and at roof level.

Photo 1: Exterior of the Building at its west elevation at ground floor looking north

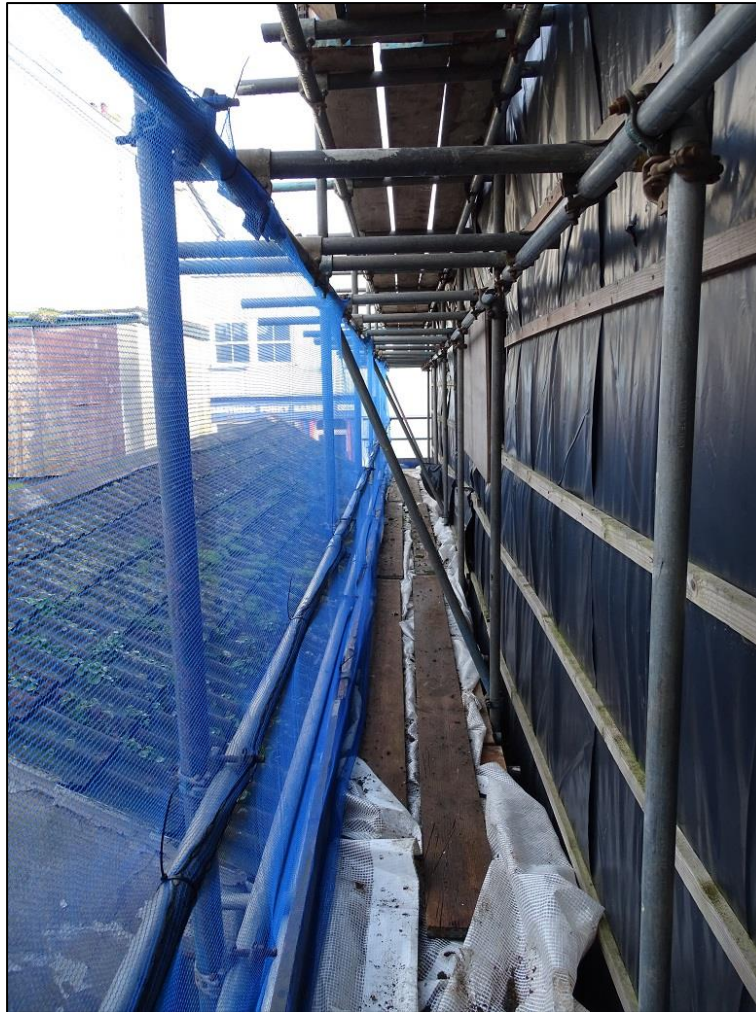
Photo 2: Exterior of the Building at its west elevation at first floor level looking north

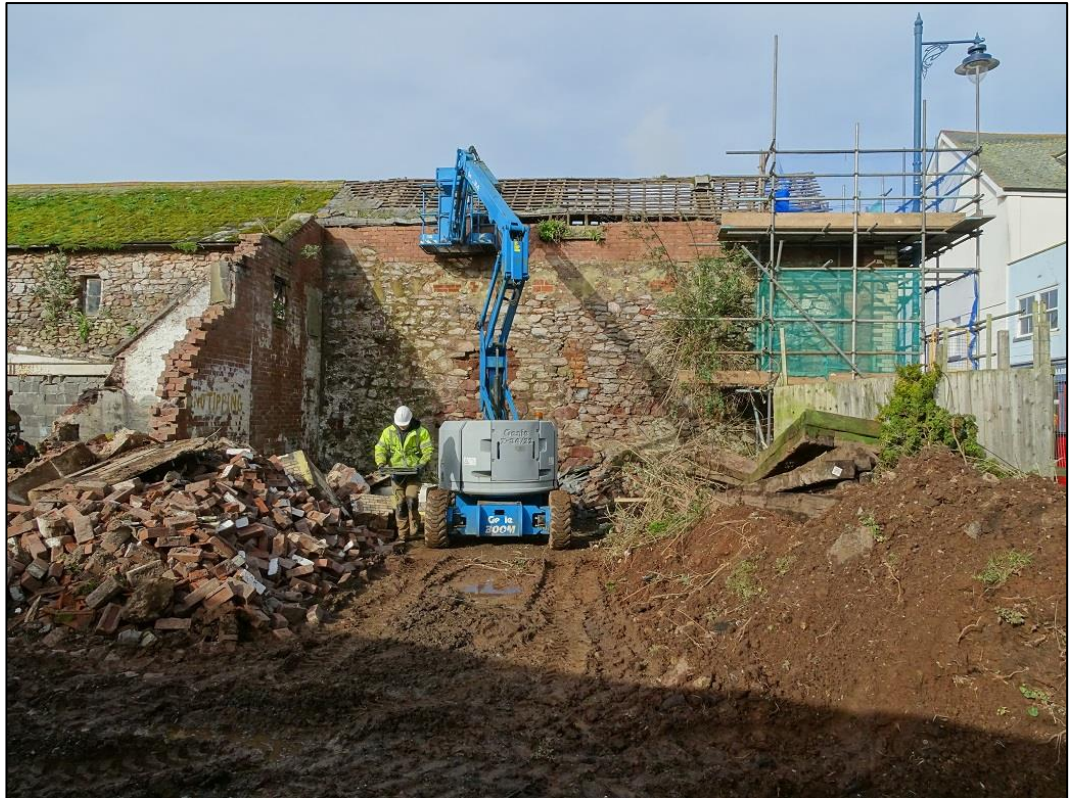
- 3.2. The former Swanson's Workshop structure had been largely demolished, leaving the eastern elevation of the Building exposed (Photo 3 and Photo 4). At the north aspect of the elevation (Photo 3), the randomly coursed stone wall of the structure was visible. Above the stone wall at this aspect 9 courses of brick, laid in a Flemish Bond have been inserted. This was likely done to raise the roof height; directly below the brick superstructure there are brick inserts along the length of the wall that suggest infill to post holes. A small return wall element of the Swanson building remained to be demolished.

Photo 3: Exterior of the Building at its east elevation at ground floor north aspect looking west

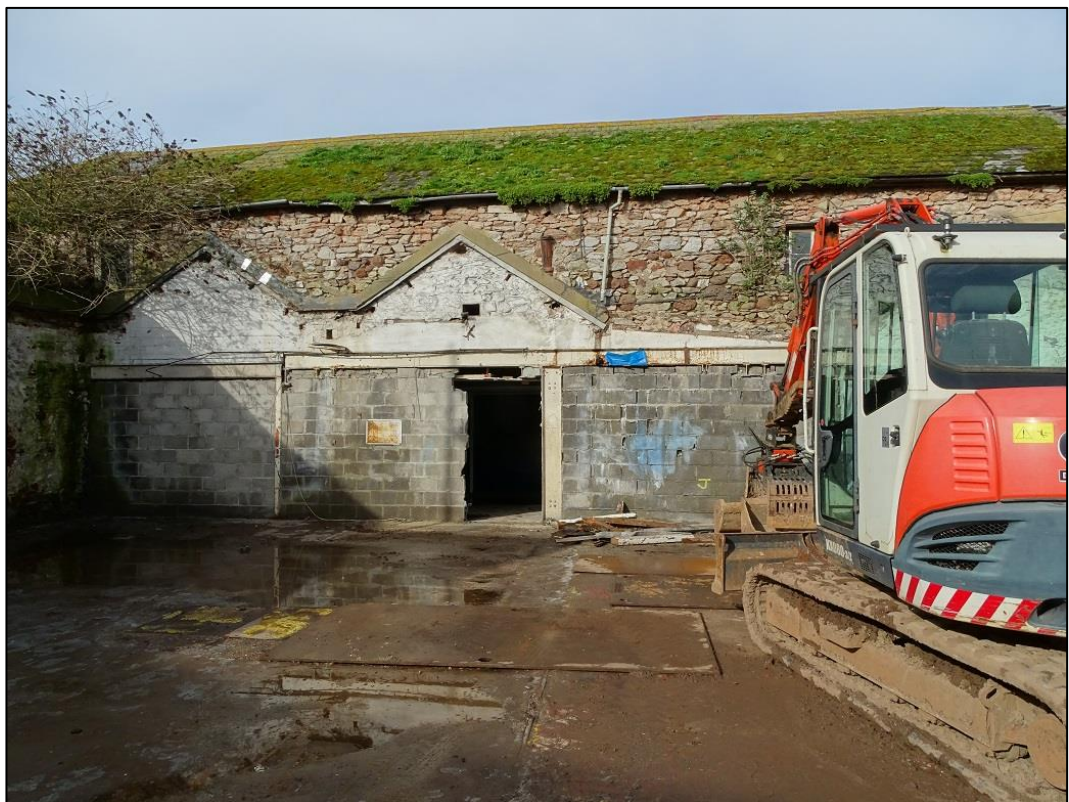
Photo 4: Exterior of the Building at its east elevation at ground floor south aspect looking west

-
- 3.3. The south aspect (Photo 4), illustrates the much-modified nature of the elevation. The random stone wall is in evidence below a roof colonised by vegetative growth. The roof covering in this area is of asbestos cement tiles and works to remove these asbestos tiles was in progress during the survey. Below the wall, the form of the Swanson's Workshop was visible in the double gable arrangement carried on inserted steels. The infill to the steels is of modern breeze block, an aperture into the breeze block wall has been crudely inserted to allow access to the interior of the Building.

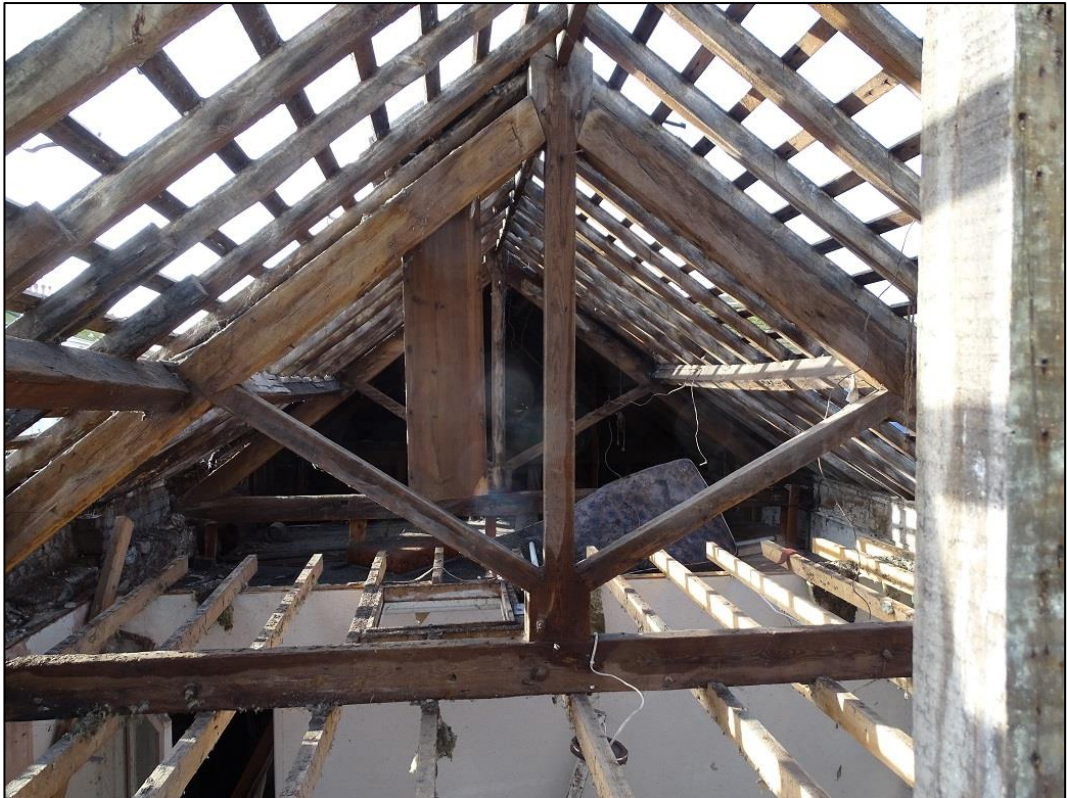
- 3.5. The demolition works at the north elevation of the Building revealed the roof structure in this area (Photo 5), formed of King posts, principal rafters and common rafters. The King posts are bolted at the tie beam; however, dowels are also in evidence at the jointing suggesting that the bolts were a later addition; likely to have been carried when the roof was raised and the new rafters in evidence were inserted.

Photo 5: Exterior of the Building at its north elevation at roof level looking into the roof space

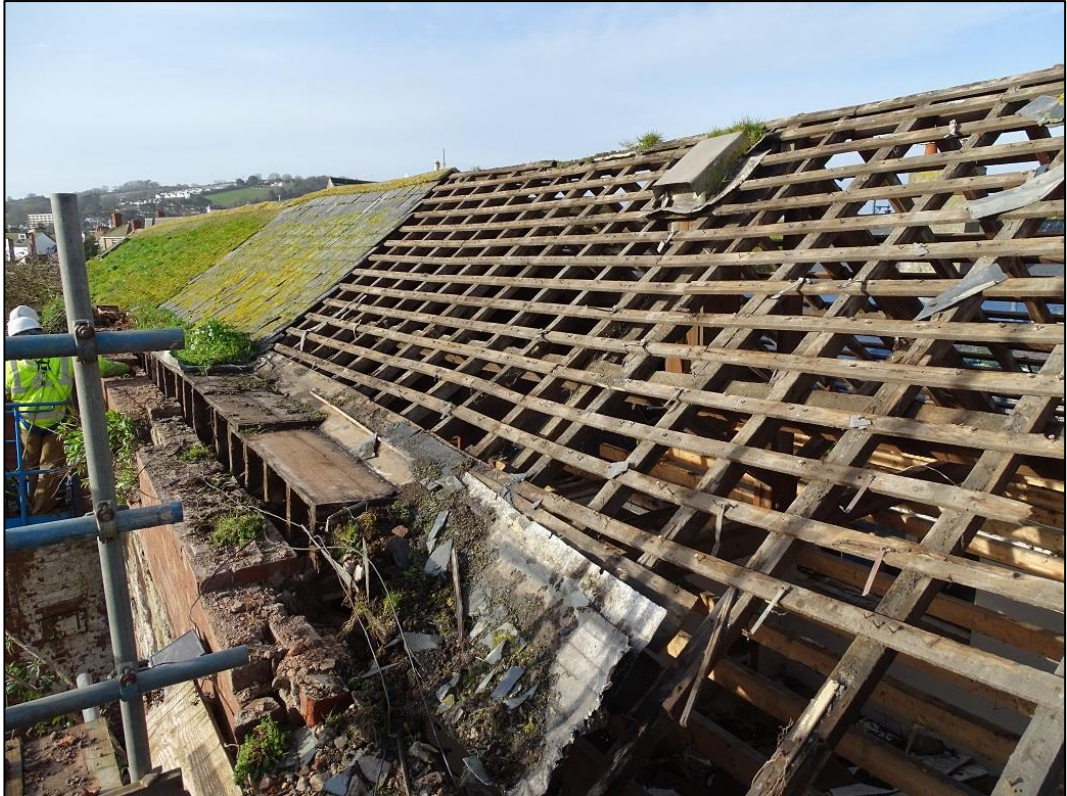
- 3.6. The exterior of the roof at the east (Photo 6), and west (Photo 7) elevations had been partly stripped of their roof covering to reveal the batten and common rafter detail. The roof covering at this north aspect of the Building was of grey slate fixed to wide battens set on the common rafters. Evidence of delamination, vegetative growth and the 'spongy' texture of the roof slates suggest that this was likely the original roofing material of the Building.

Photo 6: Exterior of the Building at its east elevation at roof level looking south

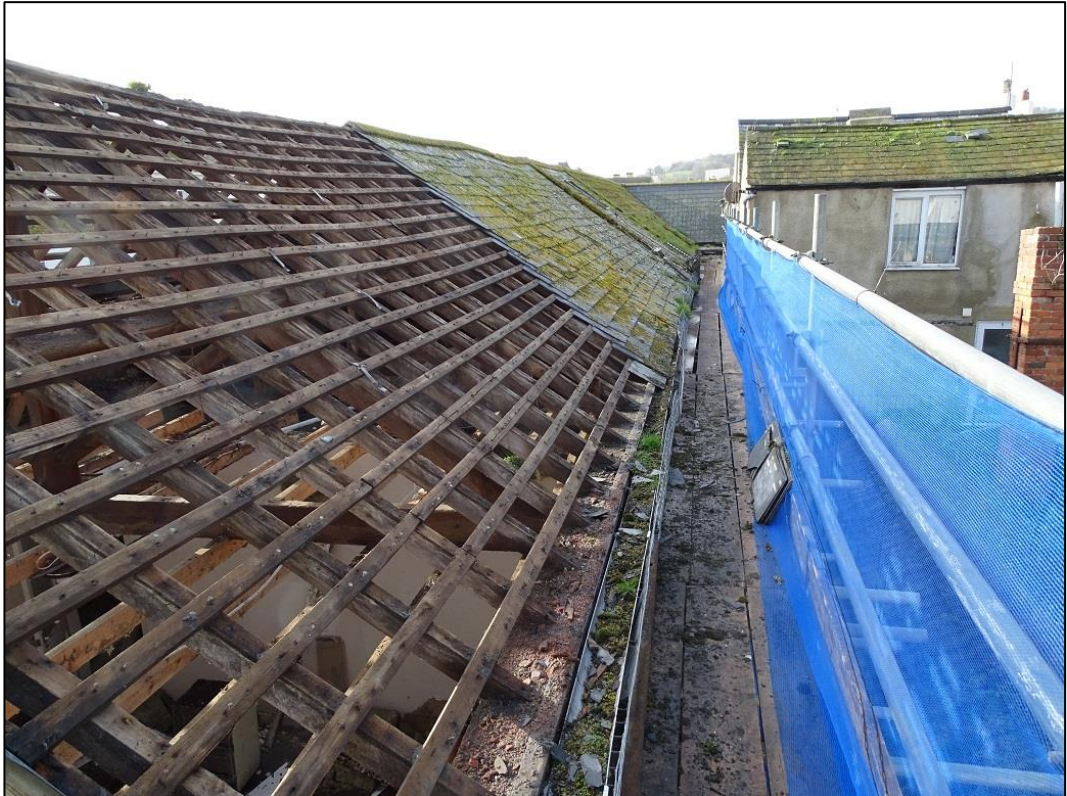
Photo 7: Exterior of the Building at its west elevation at roof level looking south

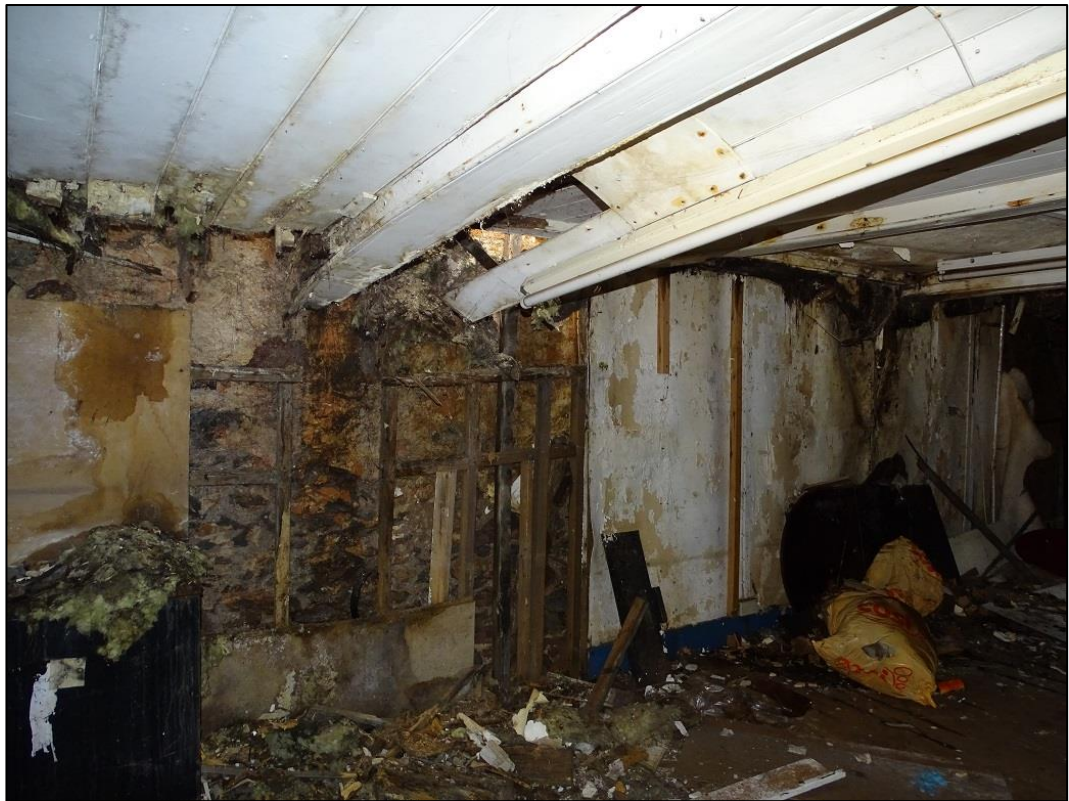
- 3.7. At its interior, the Building is constructed across two floors, and is divided into two roughly equal sections orientated north south.
- 3.8. At the ground floor, the north aspect of the Building was in a much dilapidated and unsafe condition (Photo 8 and Photo 9); with evidence of sustained historic water ingress. Due to the historic water ingress the end of a principal beam has rotted and failed at the wall, rendering the floor above extremely unsafe. The random stone wall has been battened and at the east aspect, a mid to late 20th century fibreboard wall covering introduced. At the west aspect vertical timber cladding has been used as a wall covering has been used and a stud partition introduced. From the visual inspection the flooring appeared to be concrete and screed.

Photo 8: Interior of the Building at its ground floor north aspect looking east

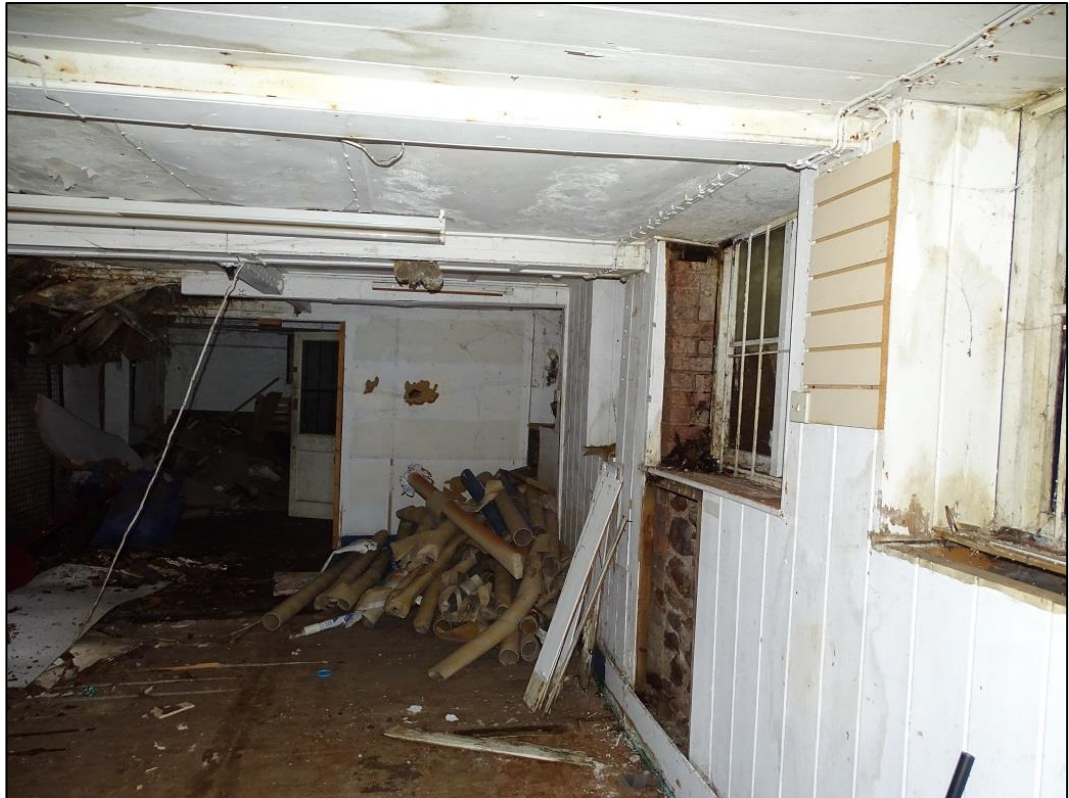
Photo 9: Interior of the Building at its ground floor north aspect looking south

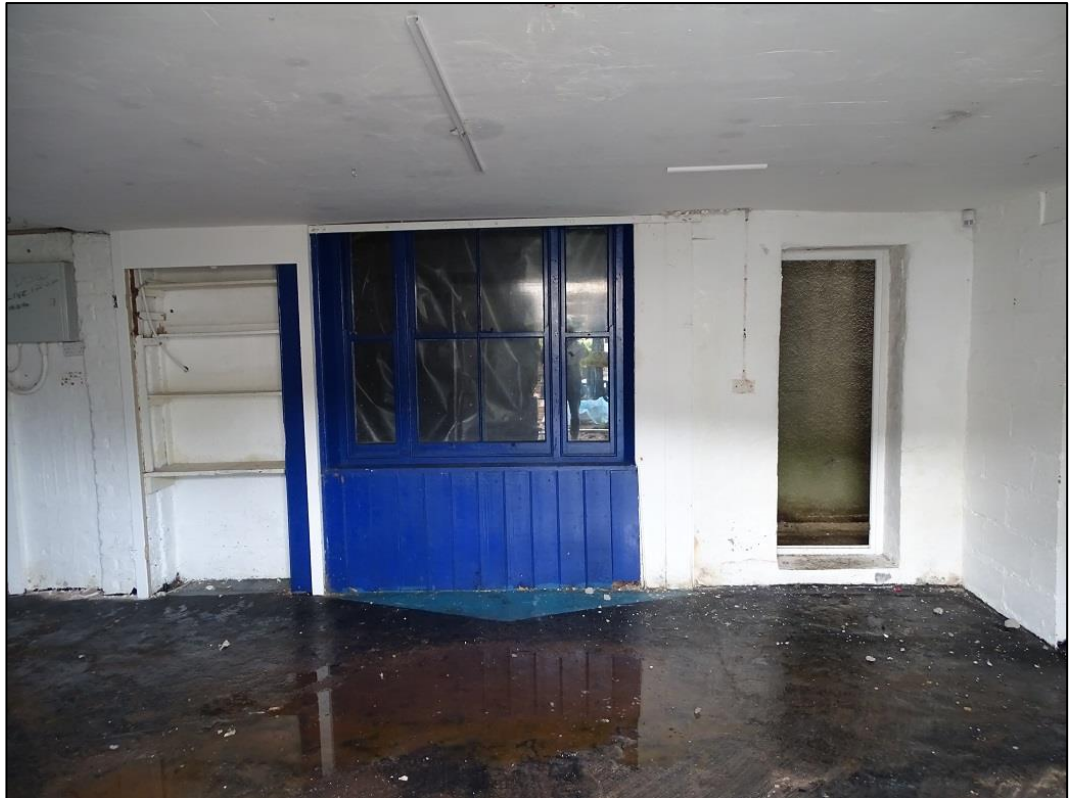
- 3.9. At its ground floor south aspect, the Building appeared much altered, at its west elevation (Photo 10), a window and door provided views and access into the west elevation alleyway. Looking south (Photo 11) there were views towards the access into the adjacent Teignmouth Arts Action Group (TAAG) building. Looking north (Photo 12), evidenced a blockwork aperture constructed below a concrete lintel than effectively divides the south aspect space of the Building. The north element of the divide evidenced two further windows and another door access into the alleyway at the west elevation (Photo 13). The walls in this area of the Building were of uncoursed stone, painted white in contrast to the painted brick and block of the remainder of the south aspect.

Photo 10: Interior of the Building at its ground floor south aspect looking west

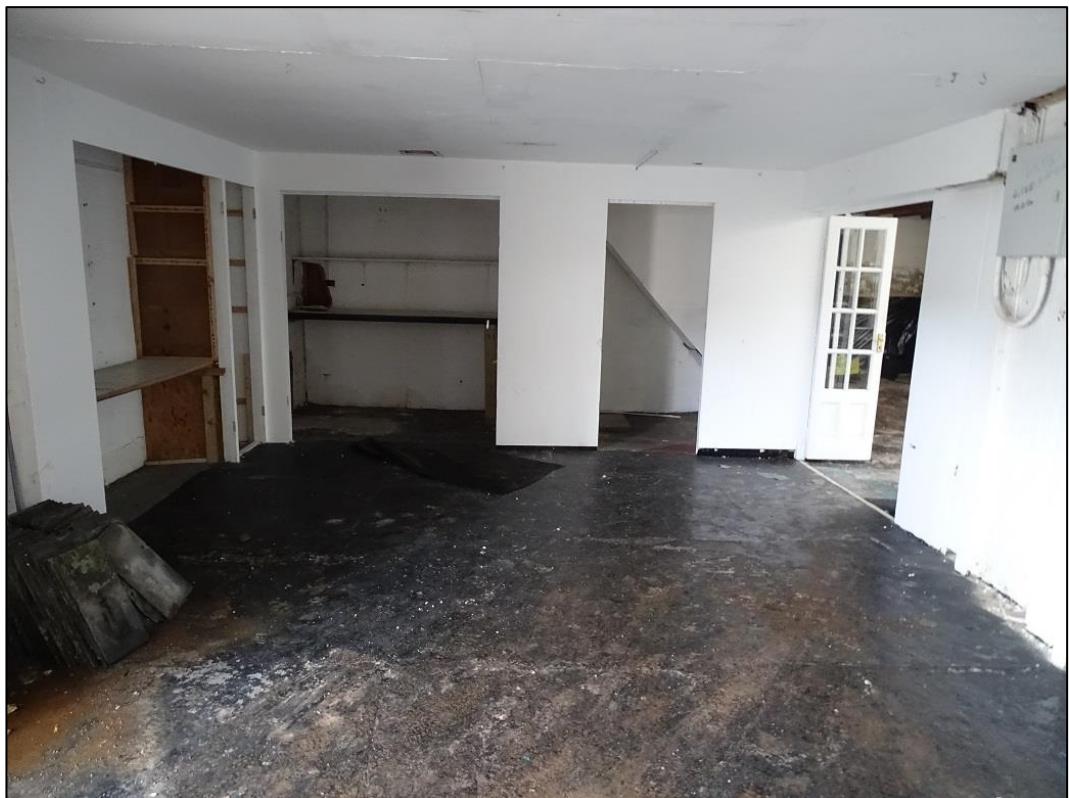
Photo 11: Interior of the Building at its ground floor south aspect looking south

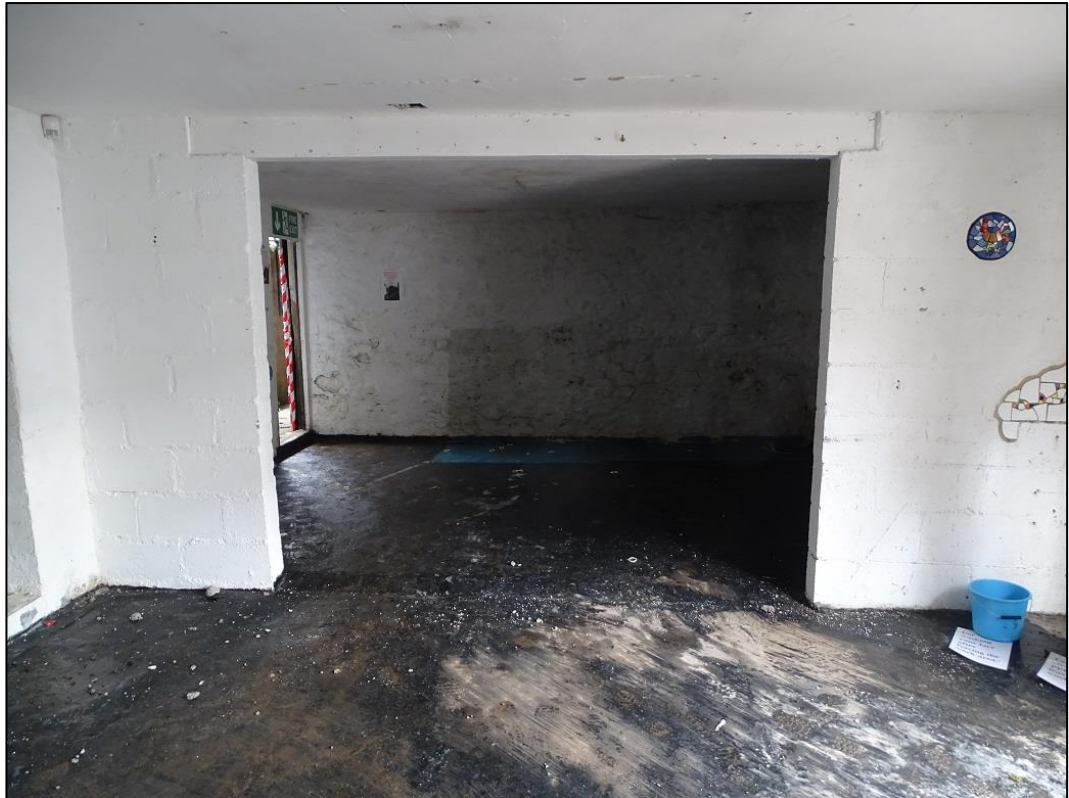
Photo 12: Interior of the Building at its ground floor south aspect looking north

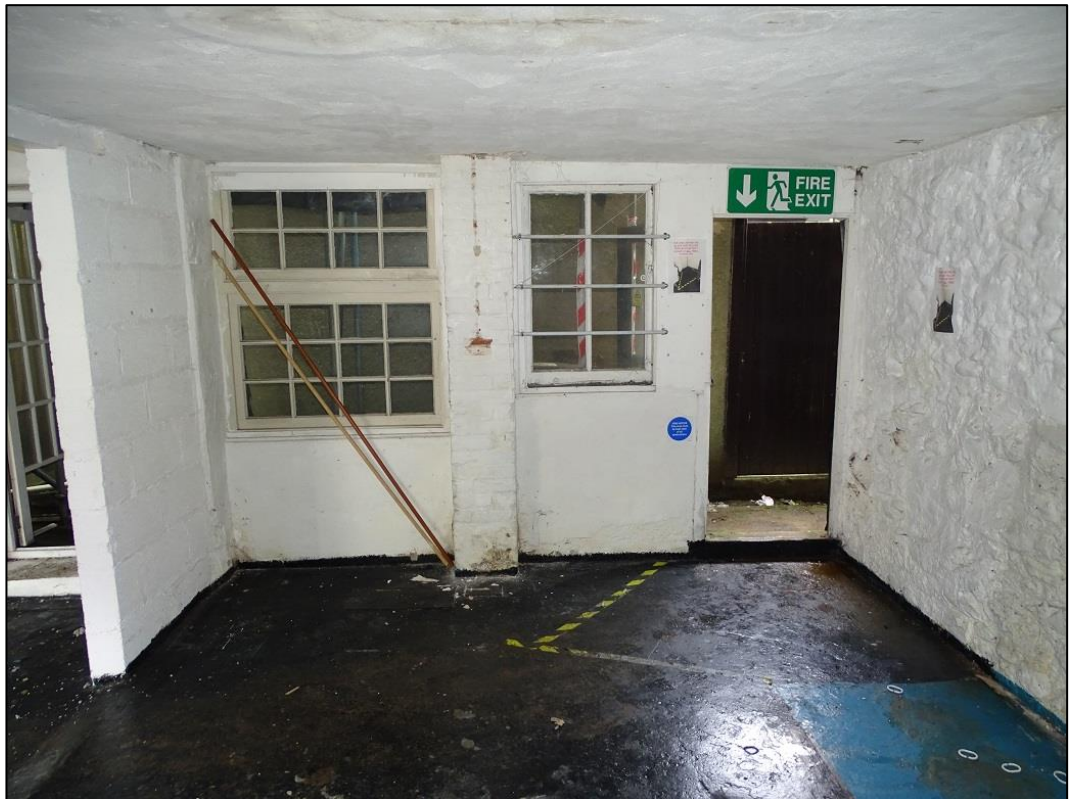
Photo 13: Interior of the Building at its ground floor south aspect looking west

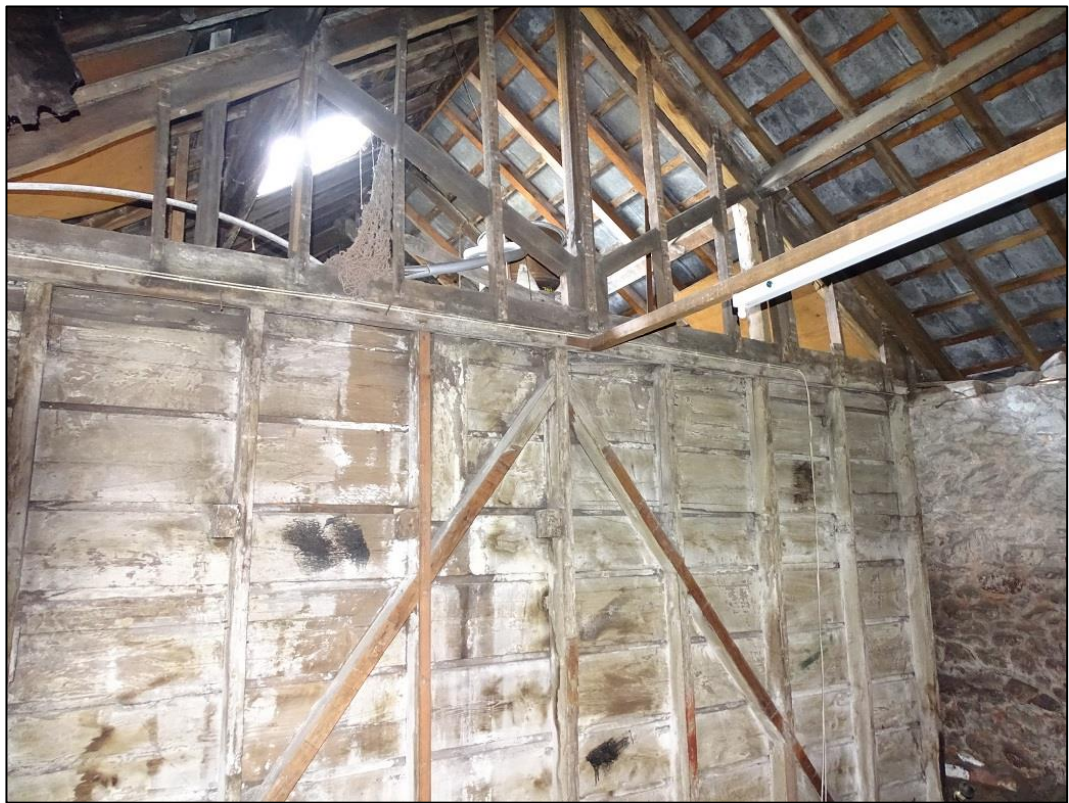
3.10. The first-floor north aspect of the Building was characterised by timber partition that divides the space (Photo 14). The partition was constructed of small profile scantling and wide, horizontal timber cladding. No access was available to the room beyond. Joist ends set in the horizontal cladding suggest a platform of floor in the adjacent space. Markings on the timbers above the cladding suggest that there was once a lath and plaster arrangement in this area. The underside of the asbestos roof tiles were in evidence, carried on modern, machine cut common rafters. The wall structure at the east aspect was of the random stone type (Photo 15), with evidence of some brick insertions/repairs at floor level. At the west aspect of the space was a door aperture with an associated timber wall element that evidences a lath & plaster construction. The lath used appears mill sawn, a lath not generally available until c. 1825-1835.

Photo 14: Interior of the Building at its first-floor north aspect looking north

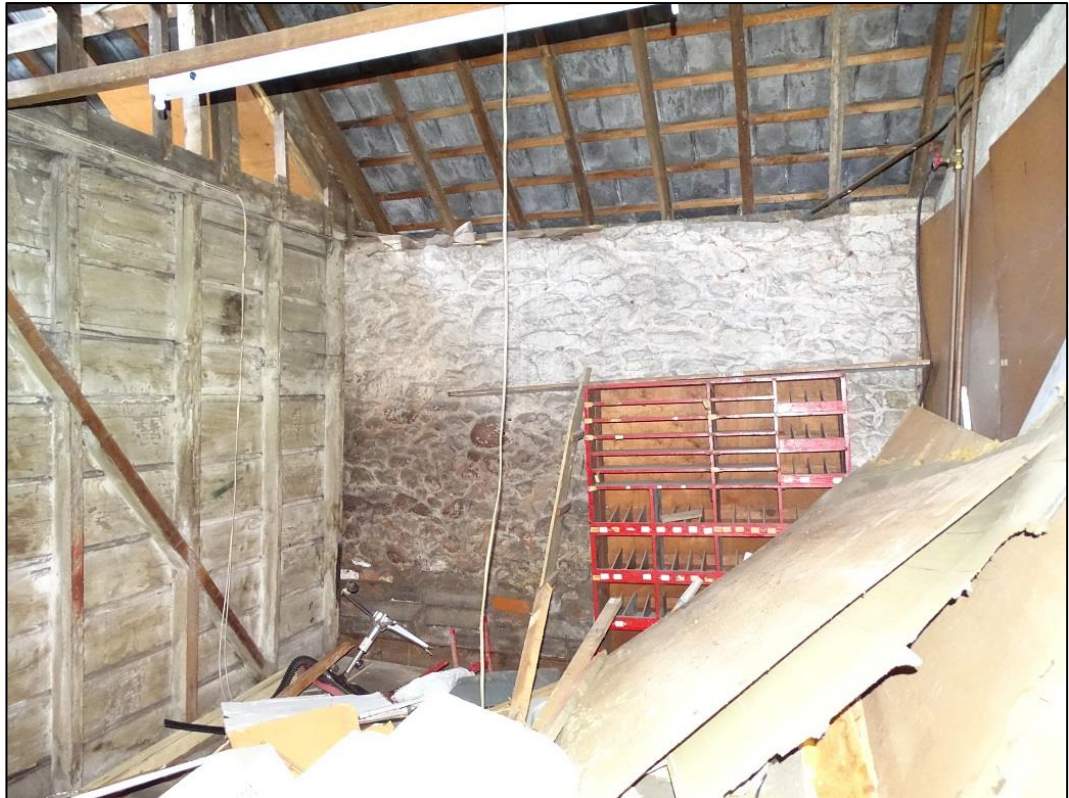
Photo 15: Interior of the Building at its first-floor north aspect looking east

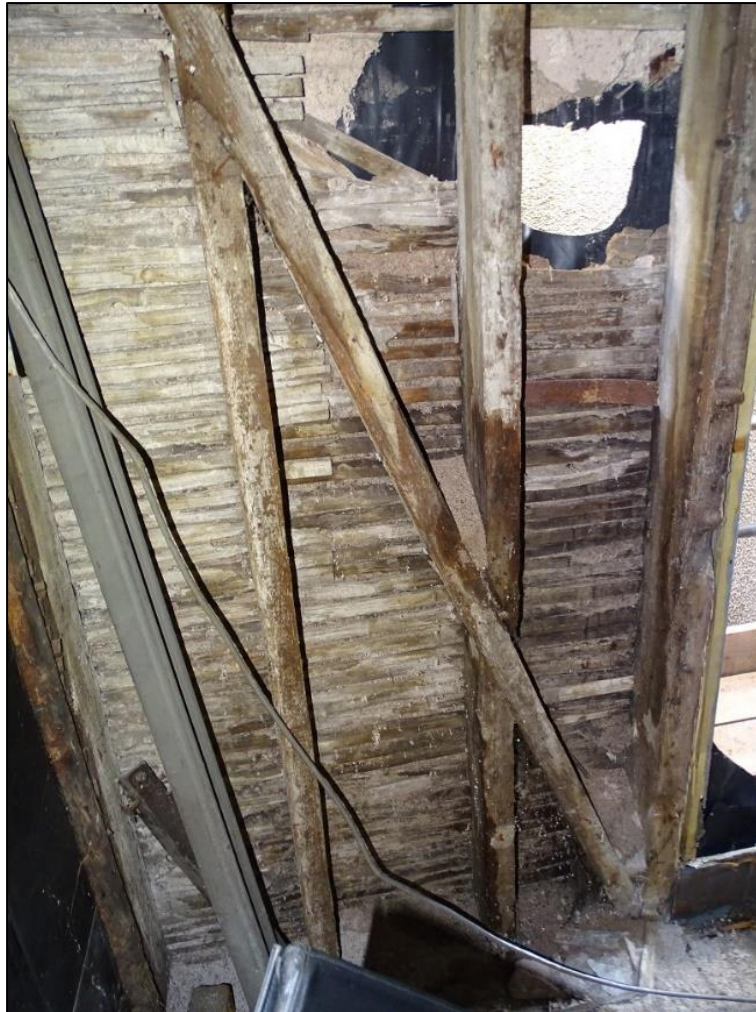
Photo 16: Interior of the Building at its first-floor north aspect looking west

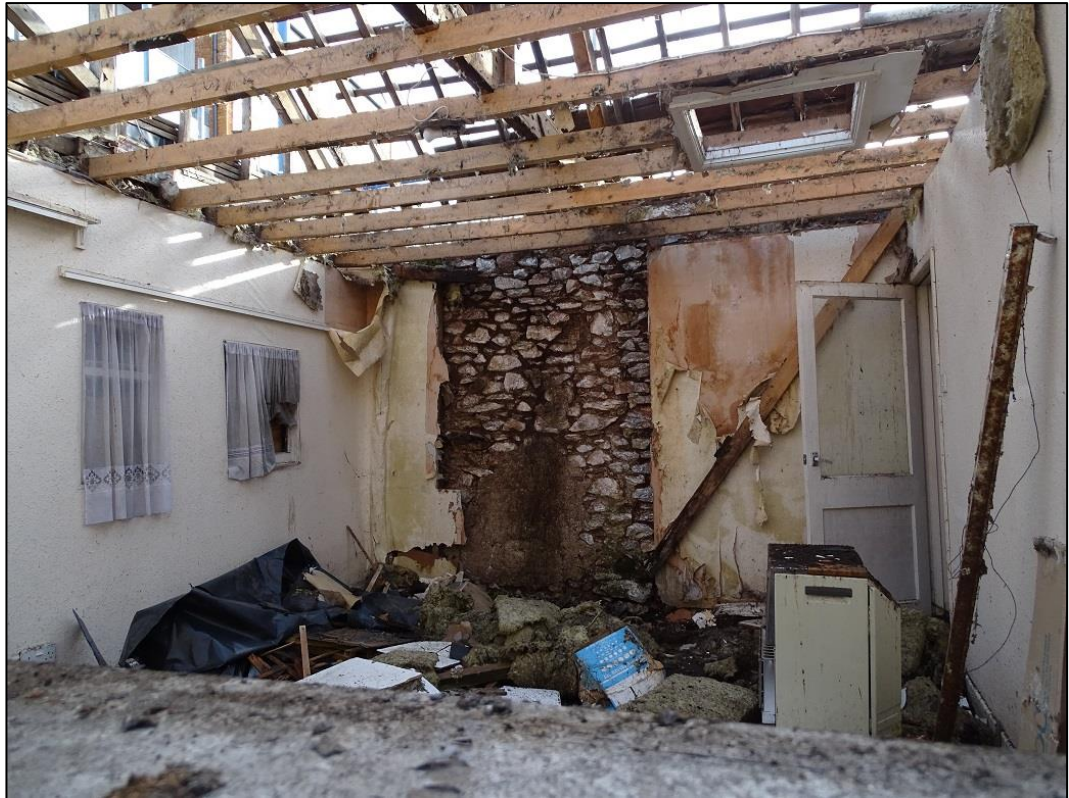
- 3.11. At the first-floor north aspect of the Building, there was evidence of a room converted for, or brought into residential use at some point in its history (Photo 17). The room was in a very dilapidated condition, directly above the failed beam at ground floor level and could not be safely entered. The room reflects the modern fibreboard covering over the random stone wall that was in evidence in the space below. The roof joists in the room were of modern, machine sawn timber.

Photo 17: Interior of the Building at its first-floor north aspect looking south

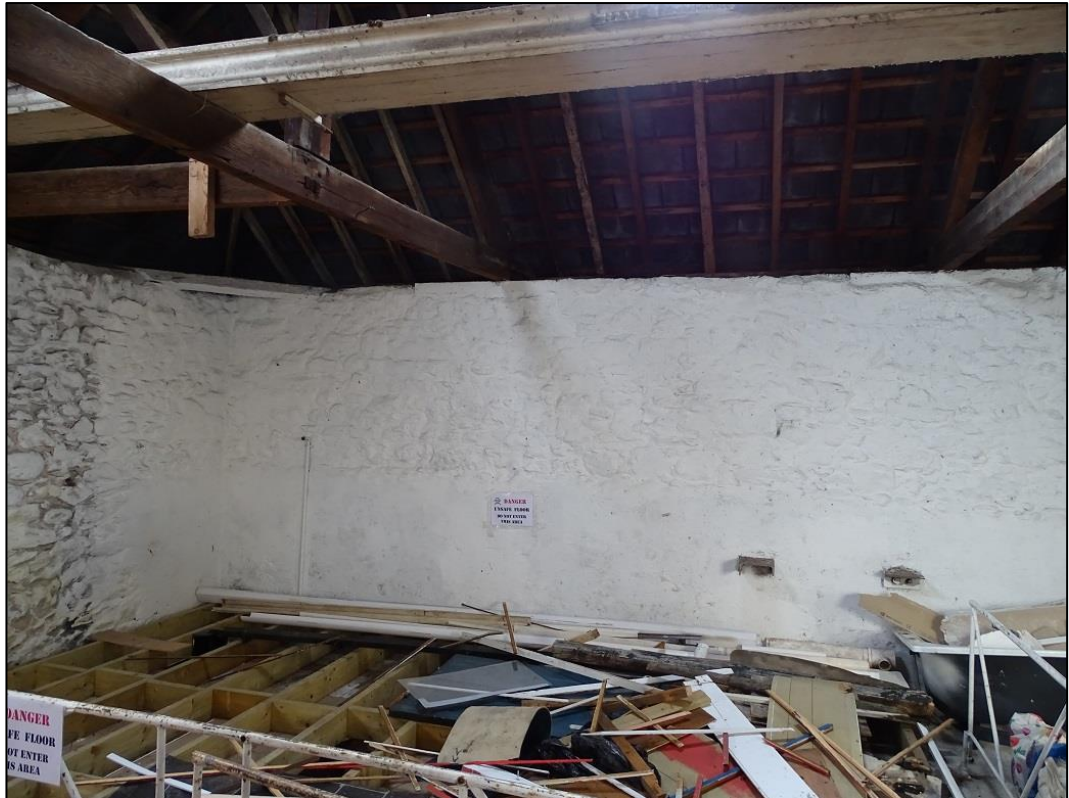
- 3.12. At the first-floor south aspect of the Building, the uncoursed stone walls were in evidence, as at ground level this aspect of the building appeared much altered. A modern floor had been inserted with new machine sawn timbers used in the joist arrangement, at the time of the survey the floor in this area had failed and was in an unsafe condition. The roof structure appeared to have changed orientation; a corner tie appears at the extreme south-east aspect of the room, but the failed floor structure in the area precluded a closer inspection to determine if this is an original feature or a later insertion. A half-joist appears at mid-span orientated east - west; the half-joint of which appeared tenoned into the full span north - south orientated joist and is likely an original feature.

Photo 18: Interior of the Building at its first-floor south aspect looking south

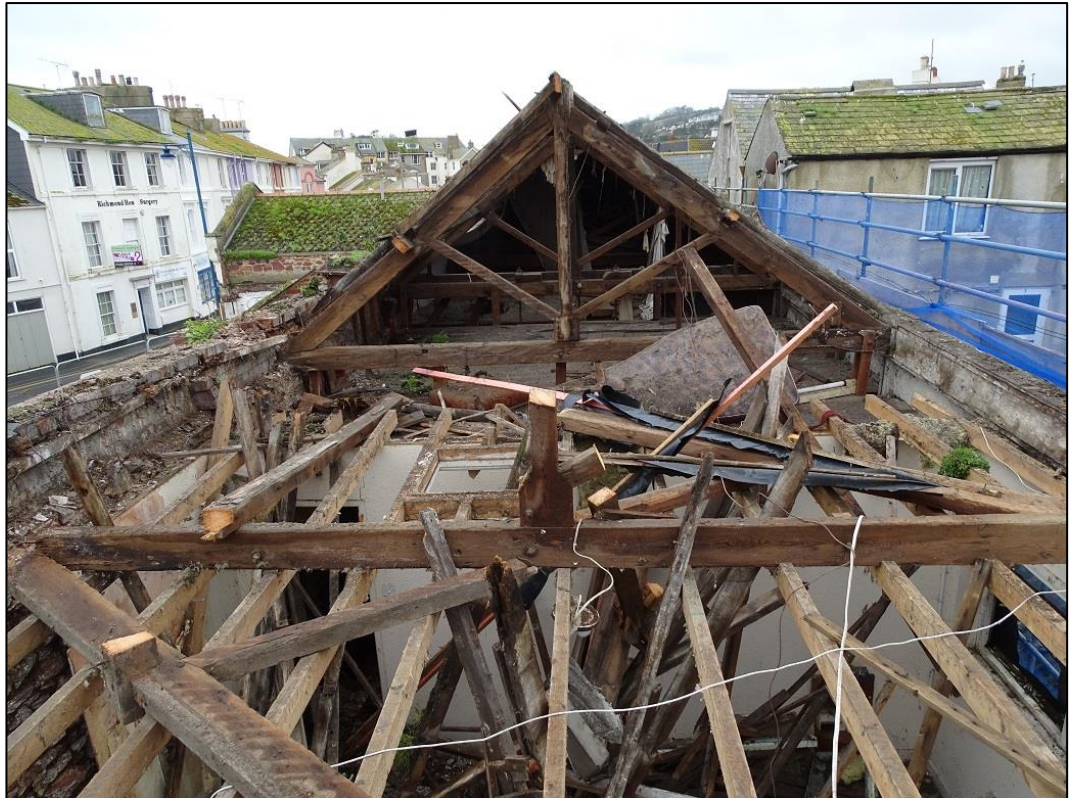
- 3.13. At the time of the survey, the roof structure at the north aspect of the Building was being taken down by hand as the slate roof covering was being removed. The King posts, principal and common rafters were being cut out and removed (Photo 19 and Photo 20), and the tie beam and joist structure was being further exposed, revealing the rough working of the tie beams. A steel brace was revealed at the west aspect of the remaining tie beam; bolted through the tie beam the brace was likely supporting a feature below. A loft hatch intrusion was in evidence and a mattress had been revealed in what was presumably the attic space. No new historic fabric was revealed as a result of the partial removal of the roof structure.

Photo 19: Demolition of the roof from the north elevation of the Building

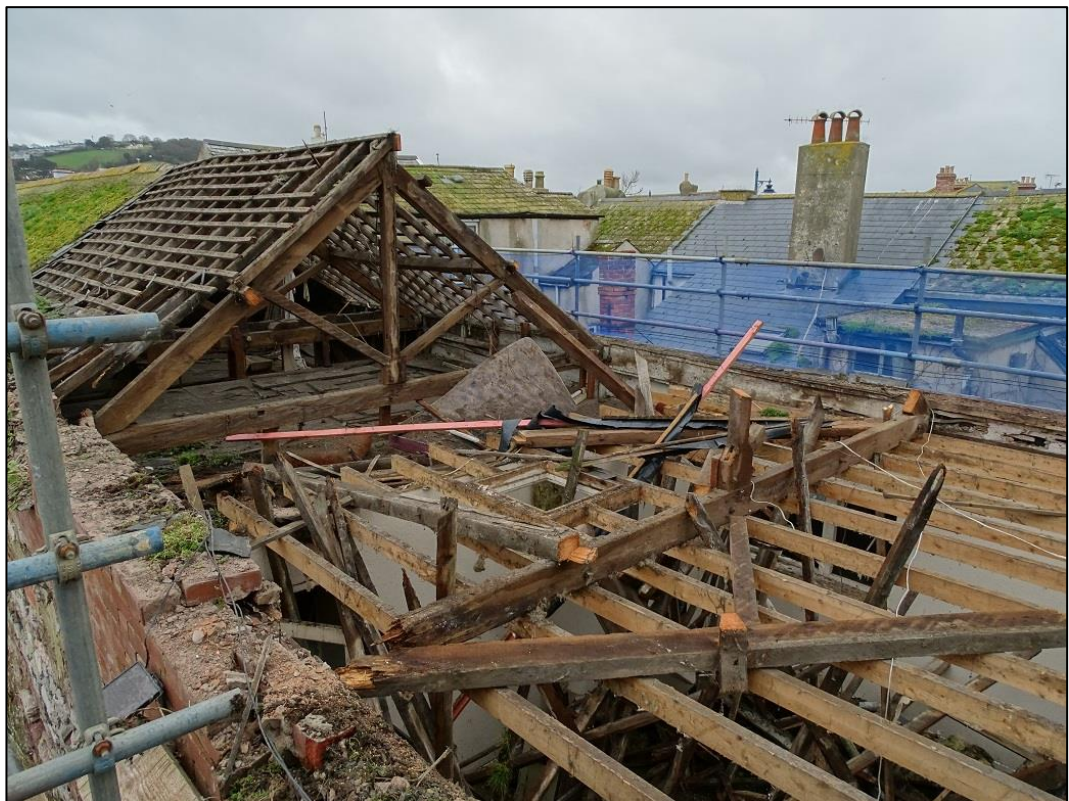
Photo 20: Demolition of the roof from the north elevation of the Building looking south west
