# Catherine Dalley House Scalford Road Melton Mowbray Leicestershire

Historic Building Recording

CA Project: MK0090 CA Report: MK0090\_1

August 2019

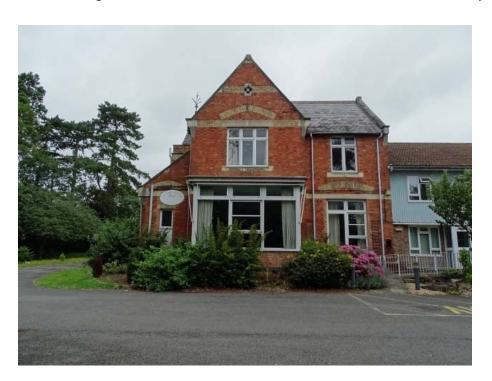
- 4.2. The House is accessed and approached via a driveway entrance situated at the southern extent of the Site. This approach presents the south elevation of the House as its primary elevation (Photo 1, 2 and 3). This aspect presents a clear illustration of the original form of the House in its late Victorian Gothic revival style.

Photo 1: South elevation of the House

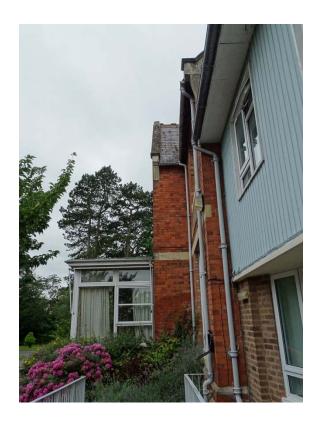
4.3. The south elevation has a prominent bay extension (Photo 4 and 5) that would appear to be a replacement for the earlier more modest bay arrangement indicated on the historic cartographic sources. The south elevation features a lean to extension at its west aspect (Photo 6) and employs the same Neo-Gothic character which suggests it was constructed as part of the original plan form or not long after.

Photo 4: South elevation of the House looking west at the 20th century porch extension

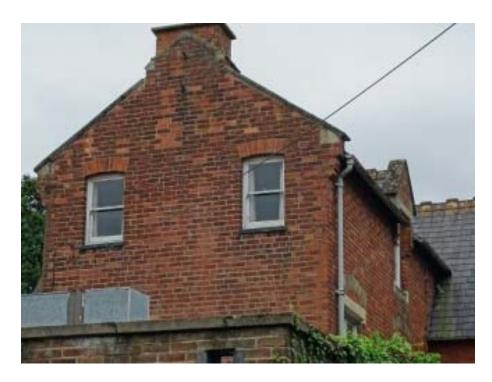
4.5. The north elevation of the House is completely obscured by the late 20th century extension (Photo 12) at ground floor level. The elevation is of red brick and contains two small one-over-one horned sash windows below a gable chimney stack.

Photo 12: North elevation of the House

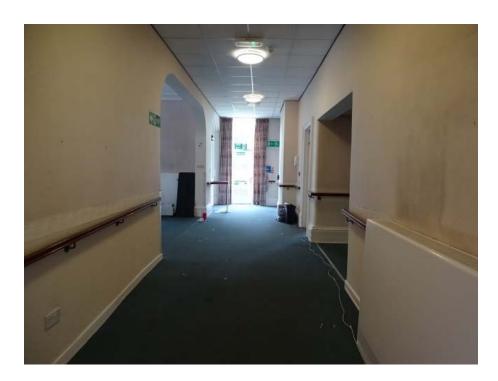
4.11. The east west orientated corridor (Photo 19) that runs through the ground floor of the house gives access to the central area of the ground floor and a modern fire exit below a modern suspended ceiling.

Photo 19: Ground floor east/west corridor of the House looking west

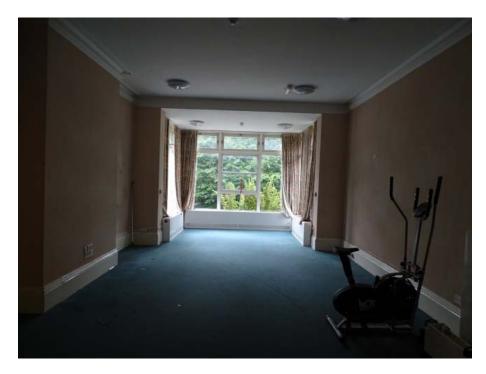
4.12. Room 2 (Fig 2) is the principal room at the south aspect of the ground floor of the House and has a modern projecting bay facing south through a large window (Photo 20). This modern bay would have replaced the more modest bay arrangement indicated on the historic cartographic sources. The room contains the reverse of the fireplace/chimney arrangement evidenced in room 1 (Photo 21).

Photo 20: Ground floor room 2 of the House looking south

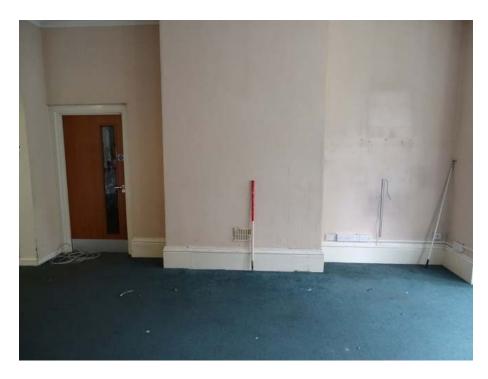
Photo 21: Ground floor room 2 of the House looking east

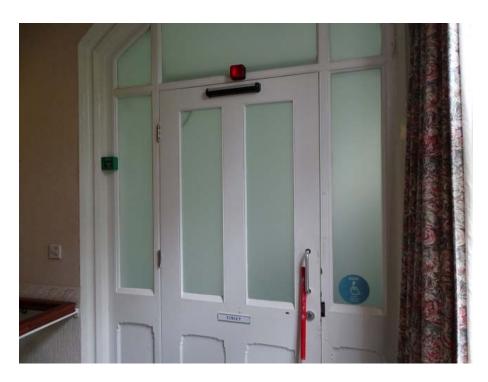
4.13. The ground floor room 3 of the house is now used as a modern disabled toilet facility. What sets this room apart from the other rooms at the House is the ornate decorated door and door surround (Photo 22 and 23) with Gothic arch, features not found elsewhere in the House. Fig. 2 indicates a void space behind the modern toilet area, with the ceiling cornice stopping abruptly before the toilet facing unit (Photo 24). The reason for the decorative entrance to this room is unclear, but the ornate features of the entrance, if original, would suggest that the room had some special significance.

Photo 22: Ornate door at entrance to room 3

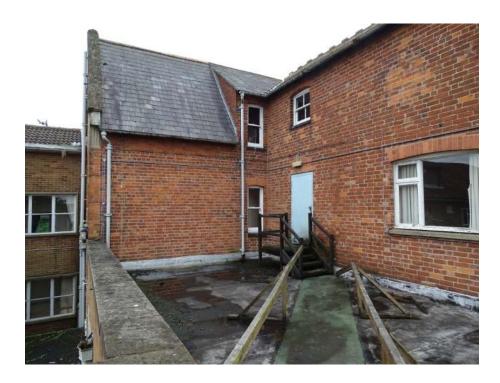
the first floor extension (Photo 42 and 43), illustrates a fire escape intruded into the east elevation. The modified arch above the door suggests that this may have once been a window.

Photo 42: East elevation of the House from the flat roof of the north east 20th century extension

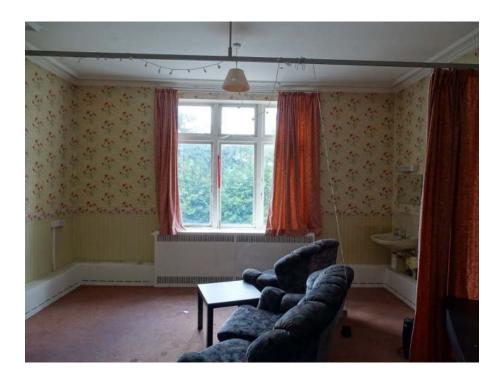
contains a south-facing modern uPVC window unit (Photo 50) and the reverse of the chimney breast from room 8 (Photo 51), the ventilation grill suggests a void that would have in all probability have been the location of a fireplace.

Photo 50: First floor room 9 of the House looking south

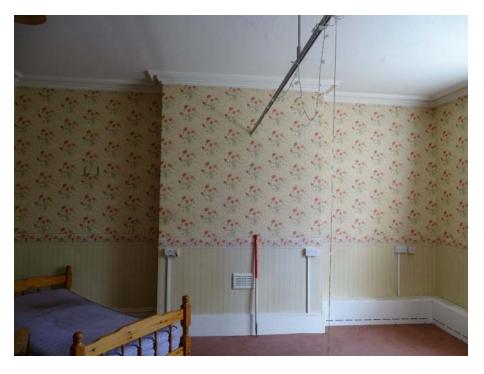
Photo 51: First floor room 9 of the House looking east

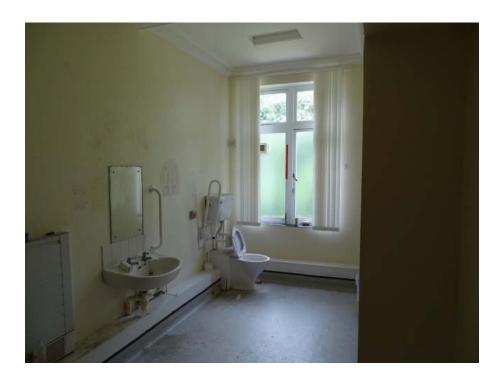
4.24. Room 10 has been converted into a modern disabled toilet unit with a west-facing uPVC window arrangement (Photo 52). The room has a detailed cornice profile throughout and contains a chimney breast (Photo 53) that reflects that found in the east/west orientated corridor at ground level (Fig. 2).

Photo 52: First floor room 10 of the House looking west

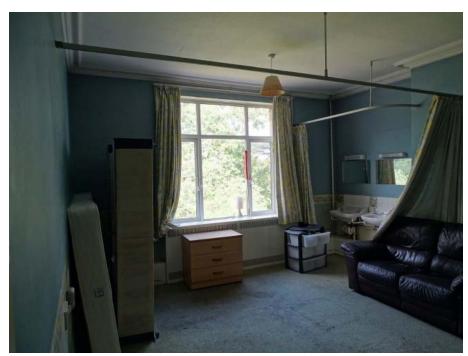
4.25. Room 11 is the largest extant room at first floor level; it has a modern west-facing uPVC window unit (Photo 54). The north aspect wall has the now disused chimney breast (Photo 55) that is reflected in room 4 at ground level (Fig 2), and has the same detailed cornice profile as that found in rooms 8, 9 and 10.

Photo 54: First floor room 11 of the House looking west

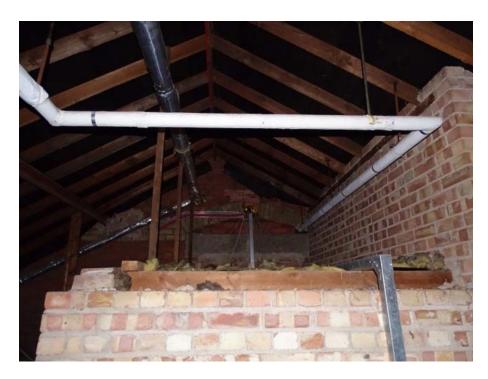
4.30. An attic access hatch in the first floor east aspect extension provides a view onto a section of the original second floor east elevation. The view (Photo 66 and 67), provides evidence of the clumsy execution of the extension and the crude nature of the intrusion of services into the original House.

Photo 66: Looking west in attic space of 20th-century extension towards east elevation of the House

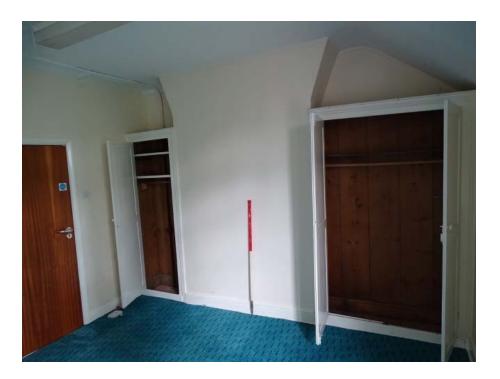
4.32. Room 16 has a chimney breast (Photo 70), that reflects that in the first floor room 14 and is flanked by two cupboard spaces. Room 17 has a chimney breast that reflects the north gable stack that is flanked by a pair of one-over-one timber sash windows (Photo 71).

Photo 70: Second floor room 16 in the House looking south

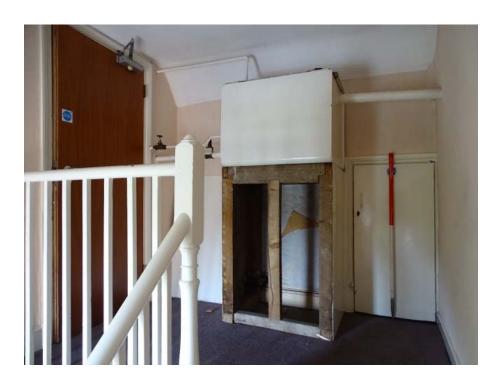
4.33. The south aspect of the second floor (Photo 72) has a door that leads into an attic space with a substantial purlin arrangement (Photo 73), that contains modern pipe work and water tanks. There is a small 'cupboard' type door that leads into a second attic space that is not marked on the plans (Photo 74); the attic space also contains substantial purlins and a roof truss for the attic space roof structure.

Photo 72: Second floor landing in the House looking south

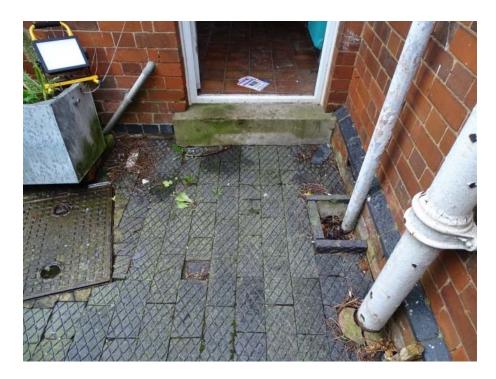
4.37. The entrance to the ground floor of the Cottages at the west aspect is via a small patterned blue brick courtyard arrangement (Photo 84), that leads, via a modern uPVC door, into a ground floor kitchen space (room 1, Photo 85). Looking east from this kitchen space (Photo 86) affords views of the staircase leading to the first floor and the entrances to the ground floor room 2 and room 3.

Photo 84: Entrance to Cottages at the west elevation

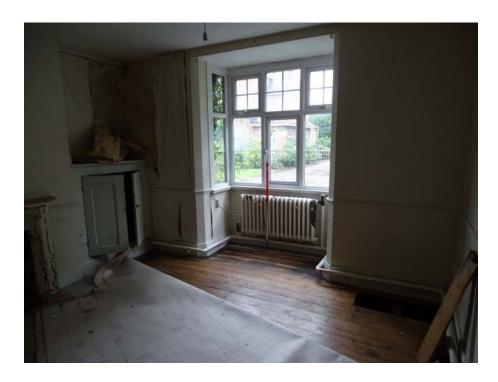
4.38. Room 2 has a south-facing bay window arrangement (Photo 87), a modern UPVC unit. The room is boarded beneath the carpet suggesting a suspended timber floor. The room contains a chimney breast, fireplace and cupboard arrangement (Photo 88), from which the fireplace surround has been removed.

Photo 87: Cottages ground floor room 2 looking south

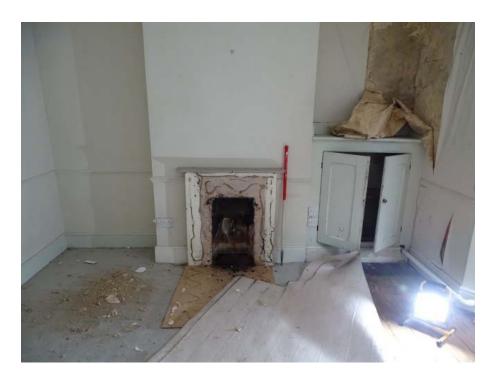
Photo 88: Cottages ground floor room 2 fireplace detail

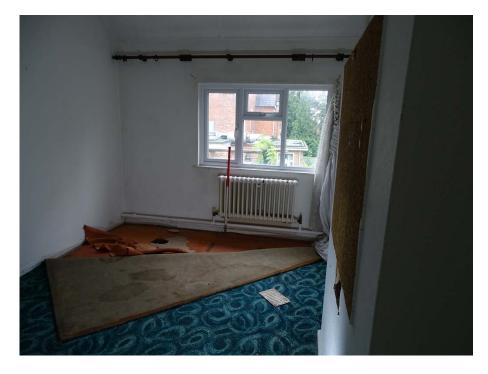
4.46. Room 11 appears to have been used as a living space and contains a modern uPVC window unit facing south and the reverse of the chimney breast found in room 10 (Photo 111).

Photo 111: Cottages first floor room 11 looking south

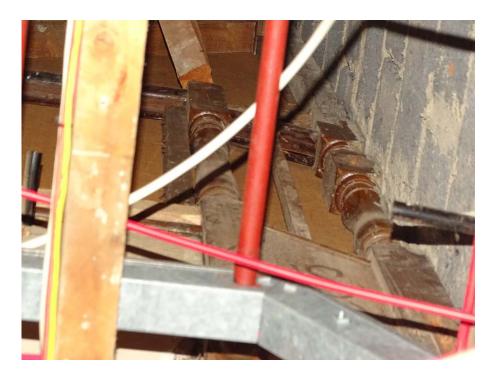
- 5.3. The central space of the original House, at the intersection of the corridor arrangement would have been the most likely location for the ground to first floor connecting staircase. Missing panels from the modern suspended ceiling in this area (Fig. 5), reveal the evidence for the staircase having once existed in this area (Photo 117).

Photo 117: Staircase behind suspended ceiling in the ground floor of the House
