# The Garages, Temple Guiting Manor

*Level 2 Historic Building Recording*

CA Project:CR0132

August 2019

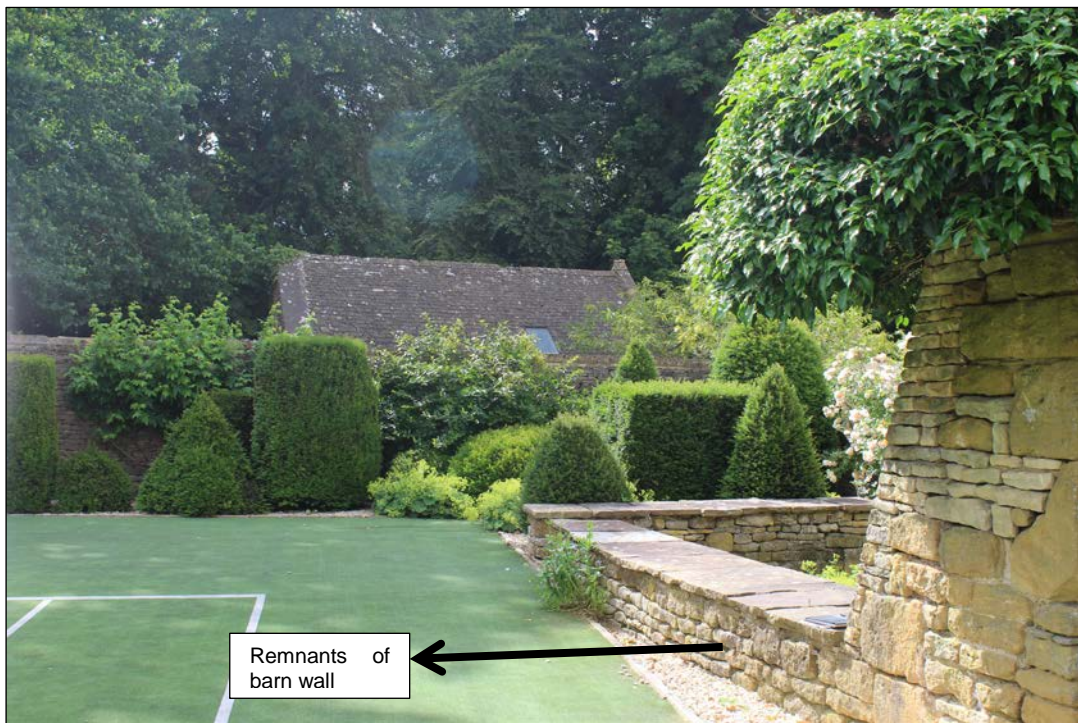
alterations to drainage systems. The walls associated with the barn represented on the 1804 map were uncovered as part of the works and the report concluded that the garages (called building A) were ‘probably part of the original structure’<sup>1</sup>, not least because the alignment is correct. Standing remains of the barn are visible in the tennis court area of the estate (Fig. 8). It was not possible during this fieldwork to retrieve any dating evidence to confirm the construction of the barn though as above it can be narrowed to be of 17th or 18th century origin; likely mid to late 18th century.

**Fig. 8** View of remains of barn wall, view looking east towards the garages

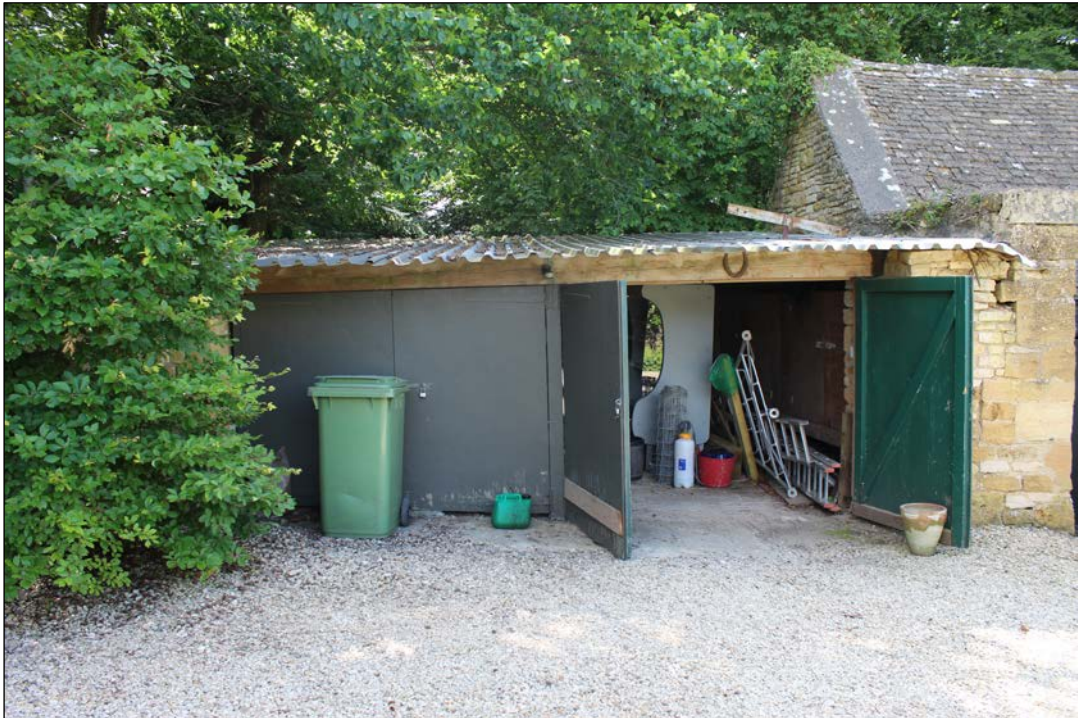
- 3.9. The north garage is a single story building currently housing gardener's equipment. It is roughly rectangular in plan form, measuring c.6m by c.5m and it is understood that it is formed of the easternmost remains of the large barn illustrated in the 1804, 1818 and 1840 maps of the estate. The building is shallow in height, roofed with corrugated metal material and has wide painted plywood garage doors opening outwards into the drive (Fig. 11).

**Fig. 11** View east to the northern garage

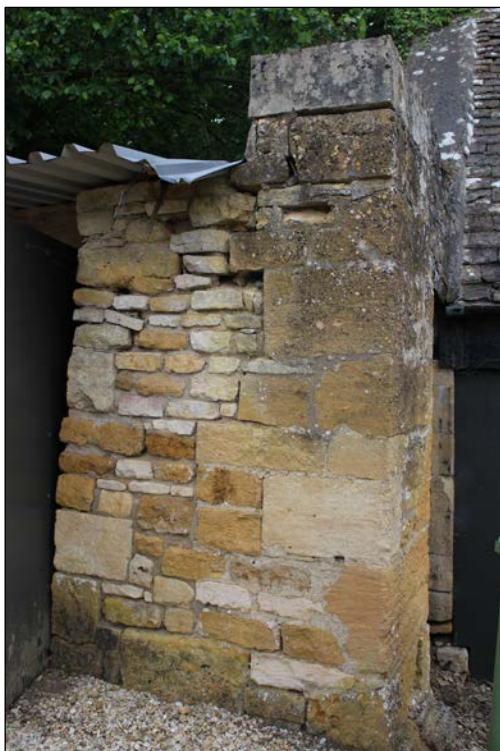
- 3.10. The building gives clues of its former self in the fine coursed rubble walling of each elevation and ashlar quoins which are visible on all four corners. The north-west and south west corners are somewhat compromised by the insertion of rubble stone infill which is of inferior quality and is degrading due to cement pointing (Fig. 12 and 13); it is assumed this were inserted to form piers to support the roof and complete the garage when it was created sometime in the 20th century. The presence of quoins at these corners suggests that they may have marked a wide opposing through doorway, possibly a threshing bay. Opposing doors are a feature of threshing barns where the harvested crop was beaten out by hand on the threshing floor before the grain was separated from the chaff in the cross draught, known as 'winnowing'. A chaff house would usually be located adjacent to this function (National Farm Building Types 2013).

**Fig.12 South-west quoins of northern garage**

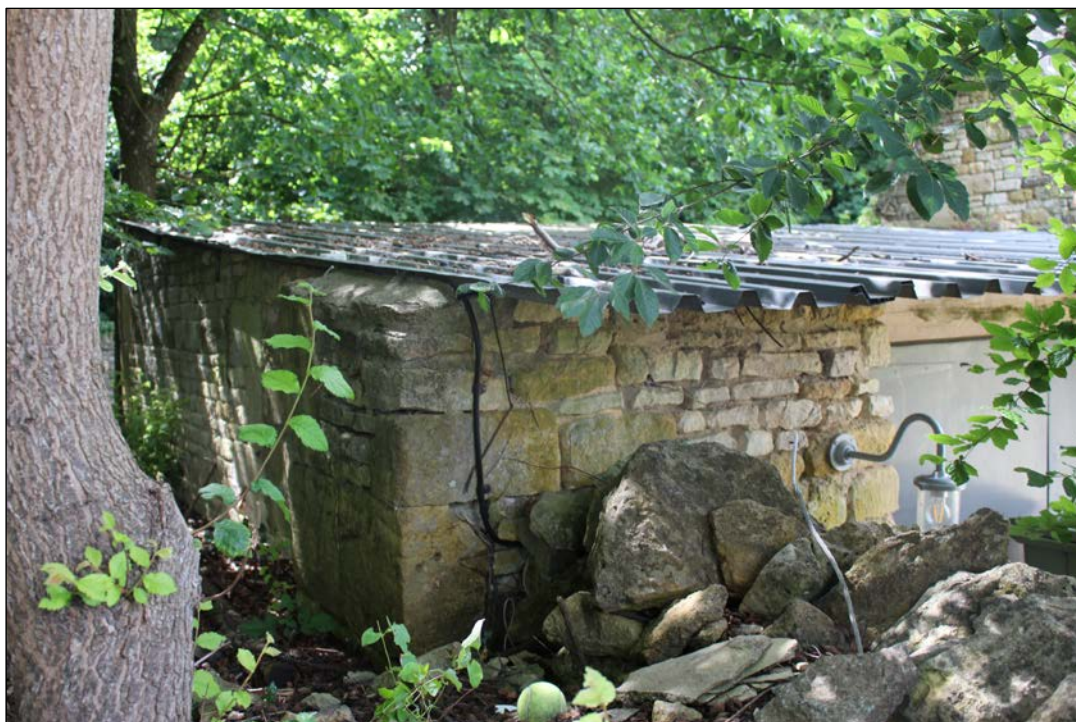
**Fig.13 North-west quoins of northern garage**

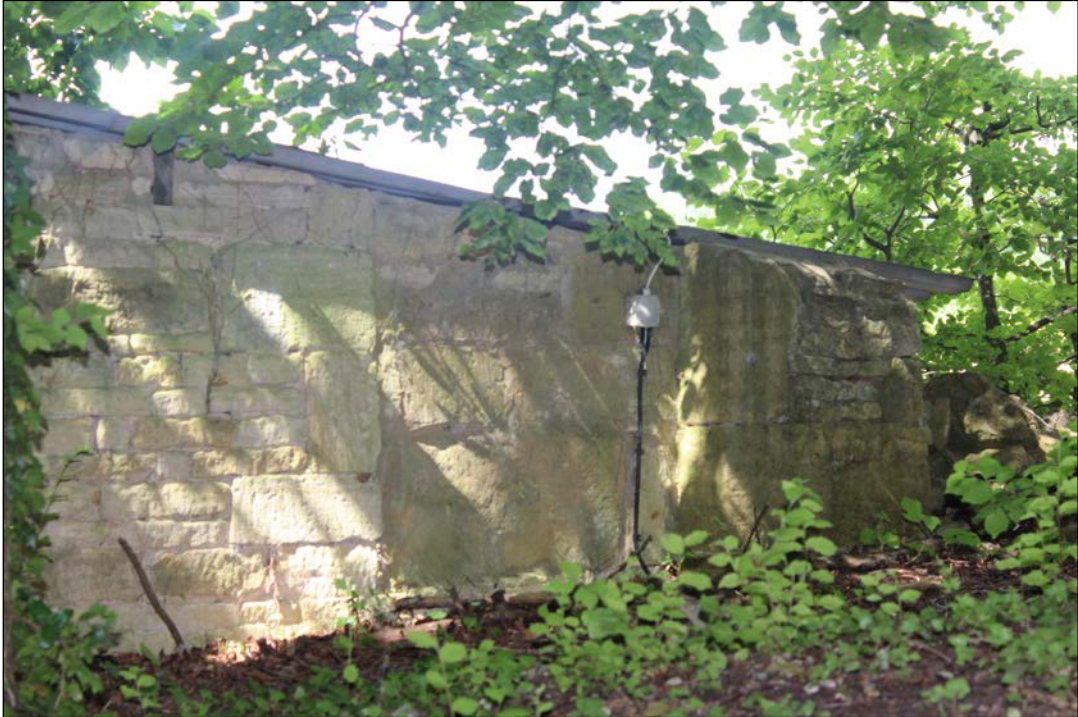
3.11. The north wall abutting the lane bank shows part of a blocked-up doorway evidenced by large ashlar quoins and inset rubble infill (Fig. 14) and the east wall viewed from the lane has what looks to be an ashlar stone cill which is clearly a truncated window (Fig. 15). Both of these features are entirely consistent with the theory that this building is formed from the truncated eastern range of the large barn.

**Fig.14** Filled-in doorway on north elevation

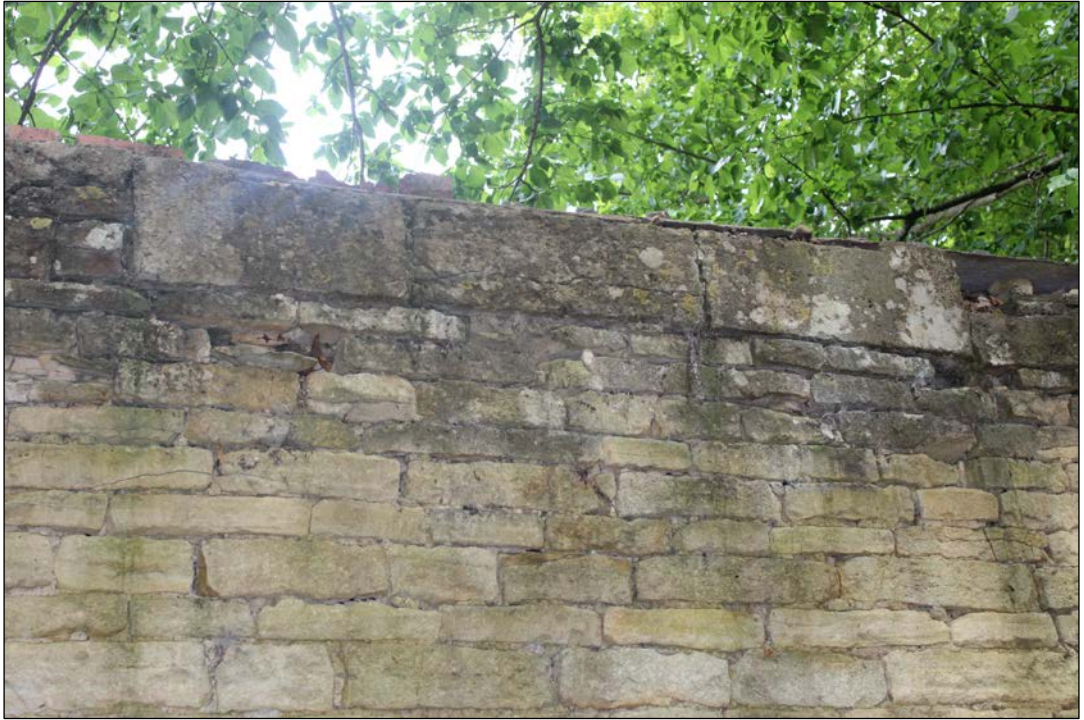
**Fig.15** Truncated cill of window in the east elevation of the barn (now northern garage)

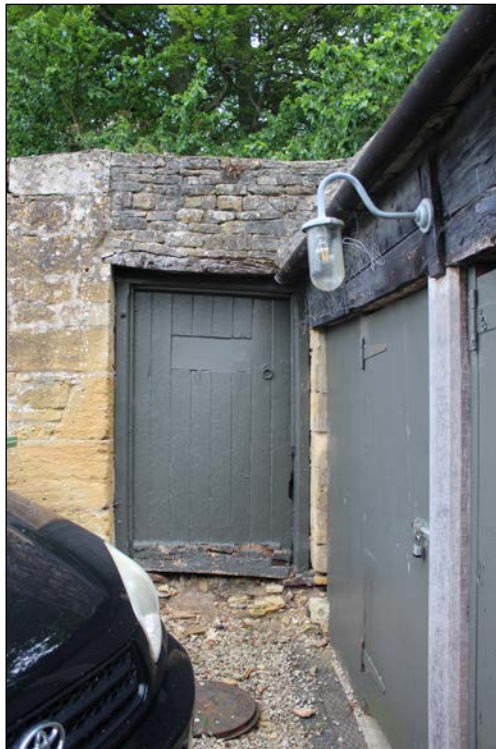
3.12. A doorway is located on the southern return wall (Fig. 16). It has a weathered oak lintel topped with incongruous infill rubble walling. There is a c.19th century timber boarded door and door frame with a chamfered outer frame with run out stop, typical of late 19th century Arts and Crafts detailing. This door may be a later opening in the barn wall, due to the juxtaposition of this doorway close to the large quoins (north and south-west corners of the northern garage) which appear to mark a through opening in the barn, and that the timber door and frame are clearly of a later date.

**Fig.16 Doorway to north garage**

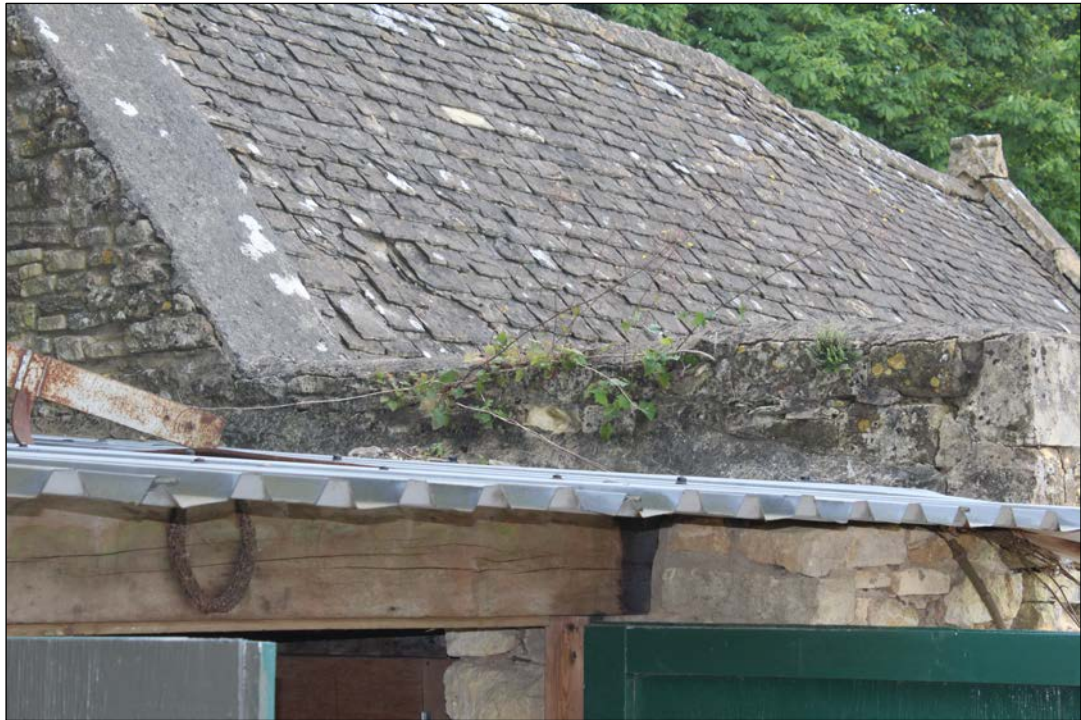
3.13. The south wall of the north garage is topped with what looks to be a cementitious mortar capping that runs along the top of south wall and up and over the north gable end of the south garage (Fig. 17).

**Fig.17 West gable capped in mortar**

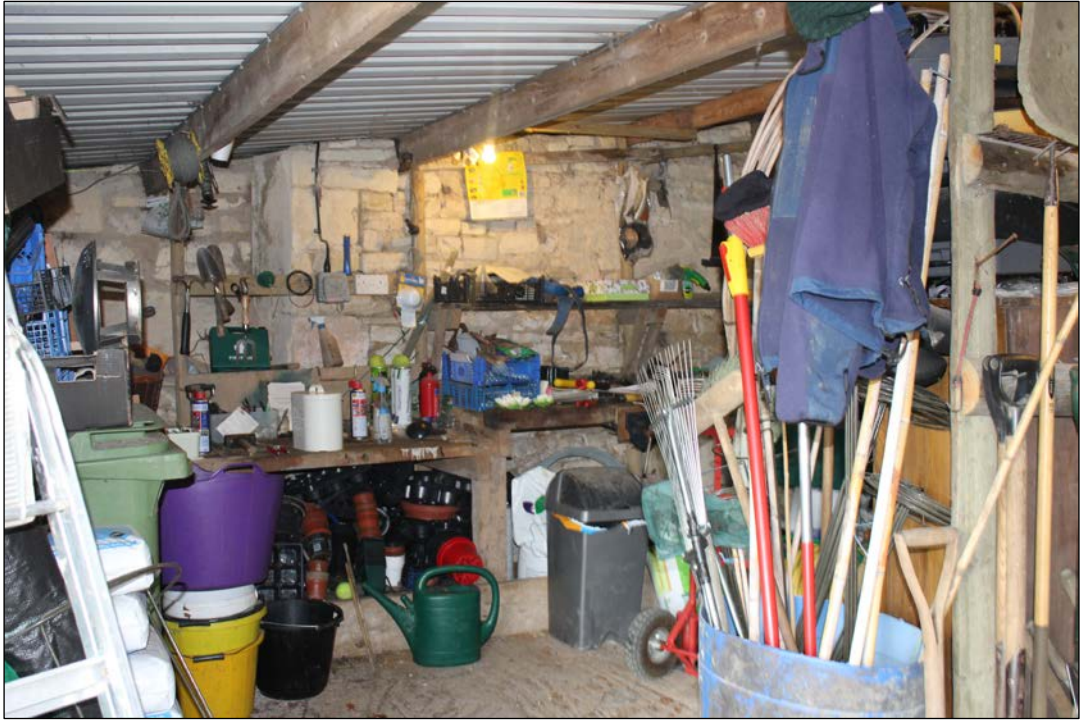
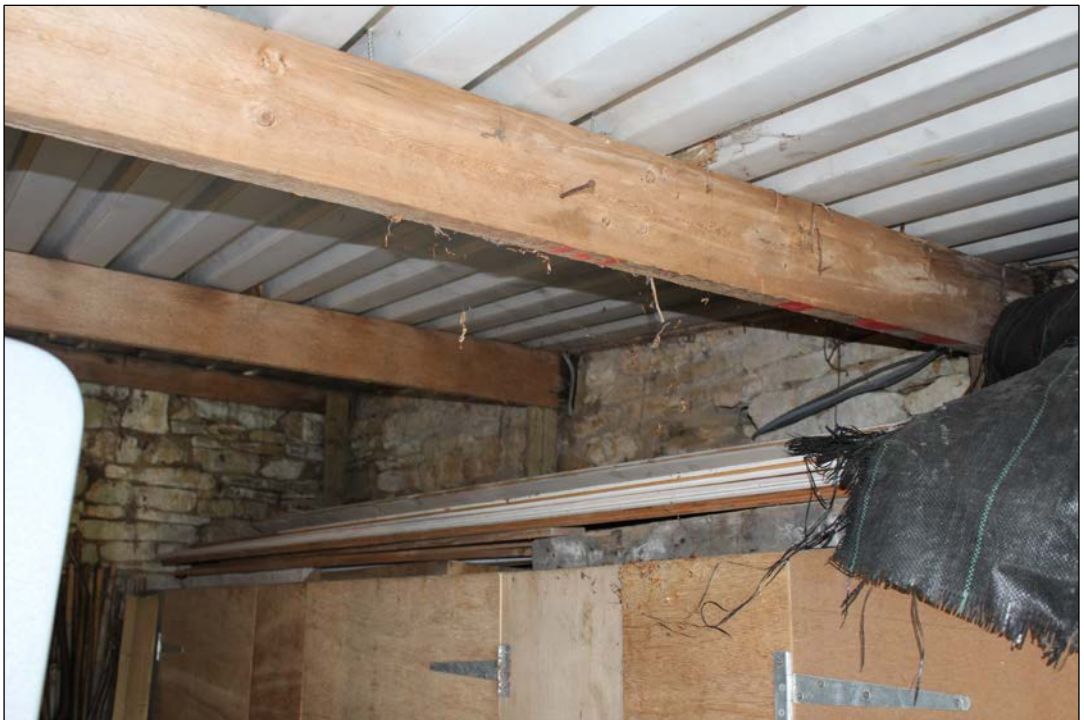
- 3.14. The interior of the northern garage (Figs 18 and 19) was inspected. The floor is levelled with concrete and no remarkable or inconsistent features were recorded. The blocked doorway on the north wall was evident internally, as it is a thin single skin rubble infill inset visible within the substantial thickness of the original barn walls. The roof is set flat on machine tooled beams pieced into the northern and southern walls.

**Fig.18** Interior of north garage, view to the north wall

**Fig.19** Interior of north garage, view to the south wall, obscured by storage cupboards

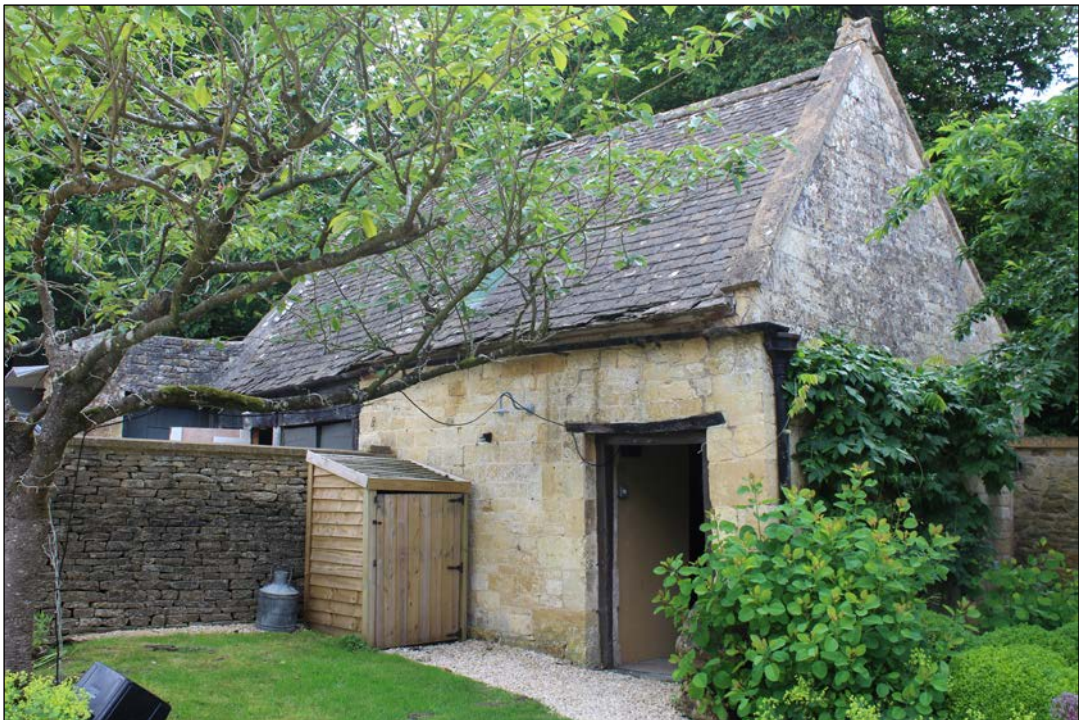
- 3.15. The southern garage is a separate structure to the northern garage although they abut one another. An evidence-based theory on the age and development of these two buildings follows in paragraph 3.27. The southern garage is a rectangular building lying north-south on the village lane (Fig. 20). It is c.8m by c.4m at its widest point. There are gables at the north and south elevations and the roof is ridged and roofed with Cotswold stone tiles, currently in a poor condition, particularly those lower on the roof, and some ridging caps. The south gable end ridge is capped in large rectangular stone tiles with a historic vernacular finial at the apex.

**Fig.20** Southern section of south garage

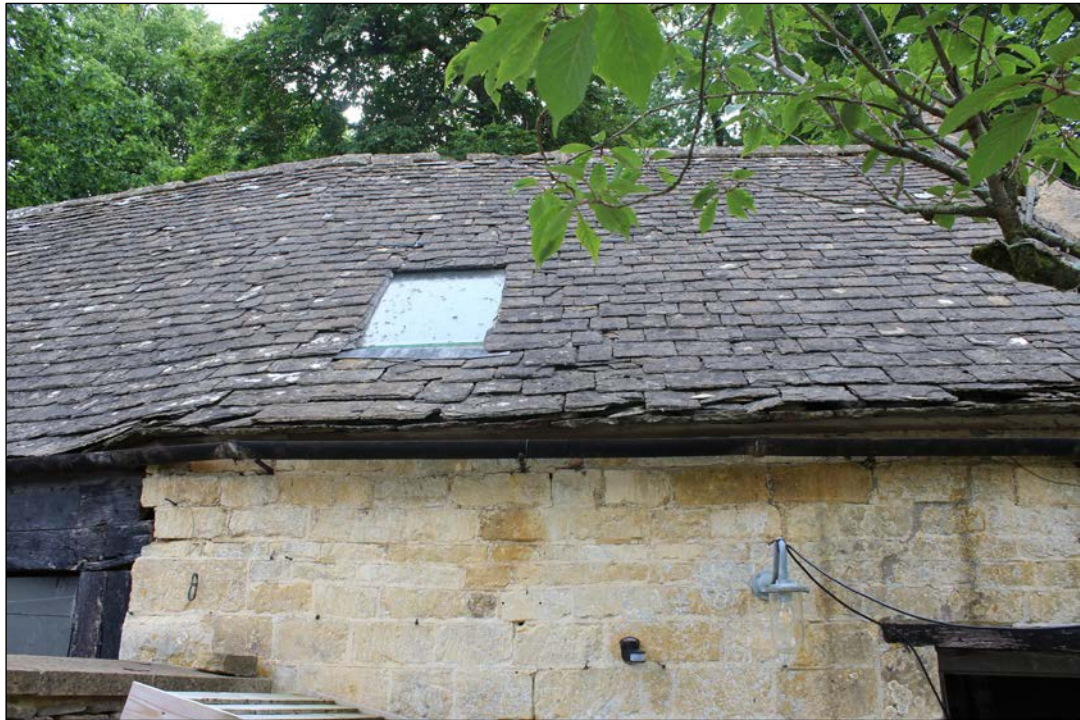
**Fig.21** Section of roof, south garage, illustrating poor condition

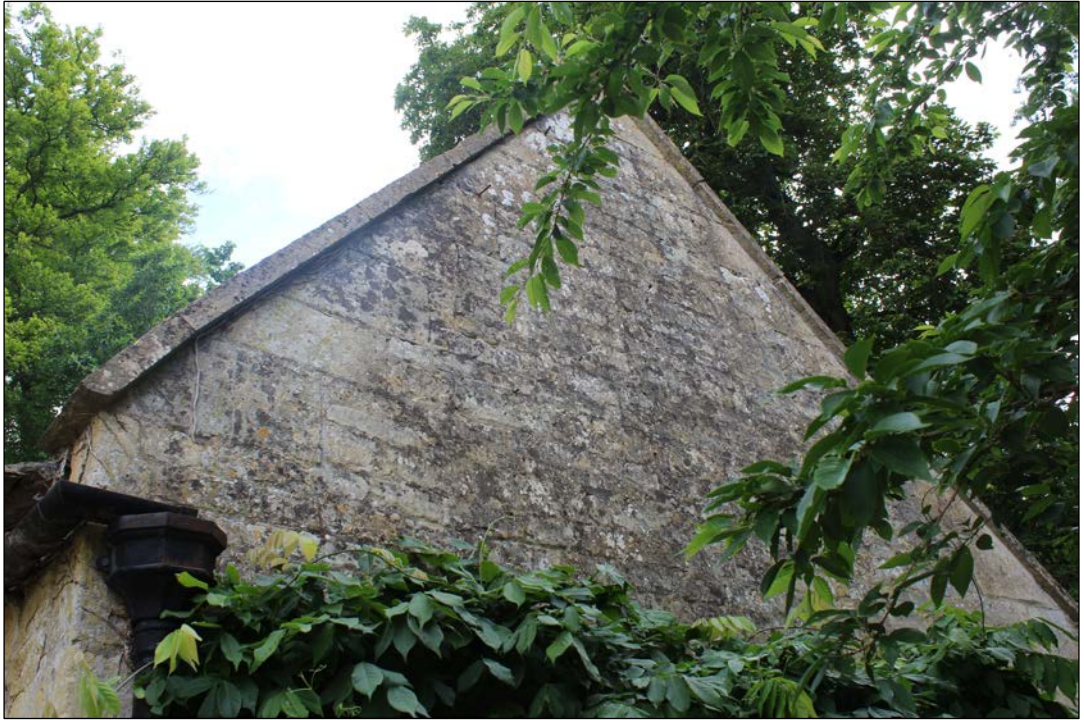
- 3.16. The building has been subdivided internally to create two spaces, both used for storage, for the purposes of this report they are called the northern and southern sections. Part of the northern space currently houses the oil tank though it is understood this is to be removed. The southern space was small and difficult to access, therefore photography opportunities were limited. It has a cement floor and has been boarded out in plaster board so there was limited view of the walls and roof areas. The south gable end wall (Fig. 22) was visible on both the exterior and interior; the exterior shows a well-built fine coursed rubble wall with flush pointing, assumed to be lime, and a possible aged patina of limewash. The interior wall is in a less satisfactory condition, with open joints and areas of what looks to be cementitious repairs. Several modern steel discs are bolted into the wall and these look to be ties, though they were not visible on the exterior elevation. If they are ties they are probably tying the interior rubble wall to the exterior layer of coursed stonework.

**Fig. 22** South gable wall of south garage

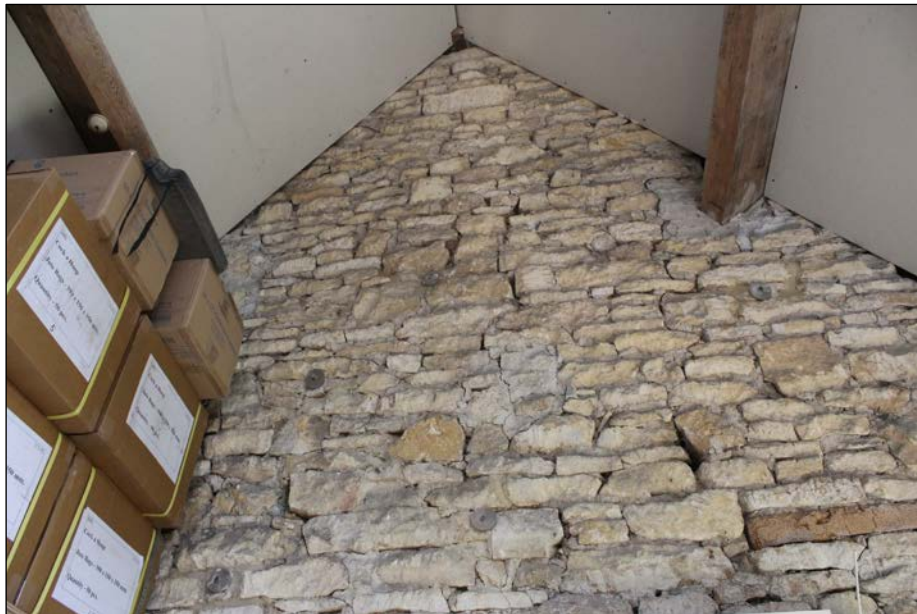
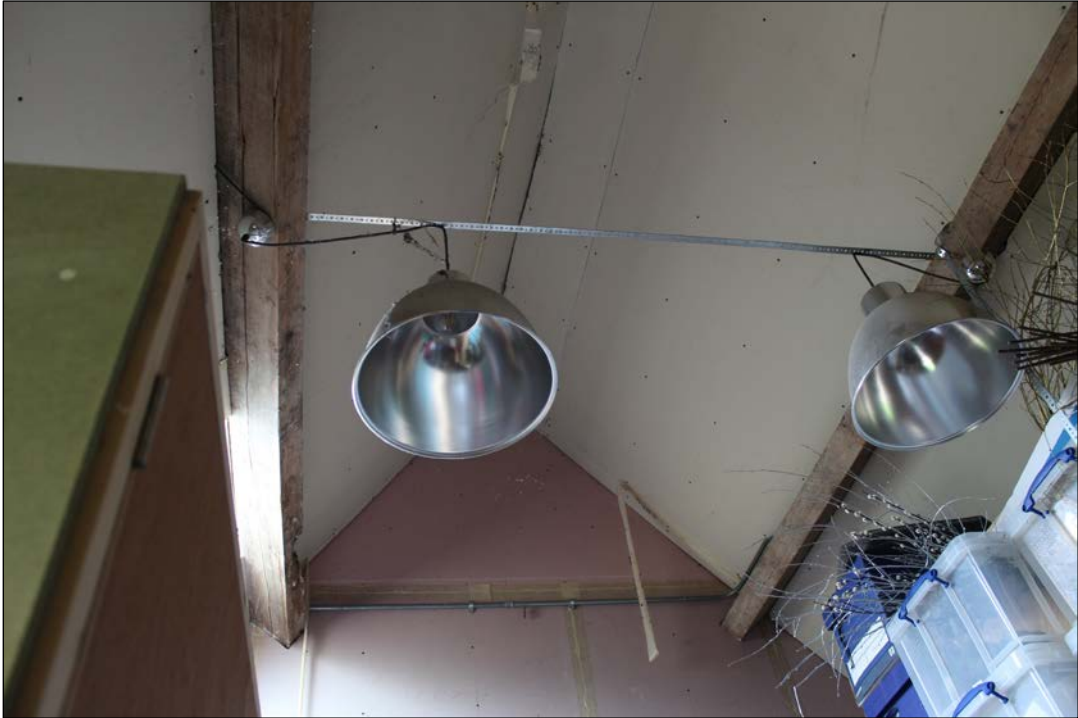
3.17. The roof truss was largely obscured by the boarding, but it was possible to see machine-tooled roof purlins inserted with cementitious pointing into the gable wall (Fig. 23). This and other evidence in the northern space suggests that the roof has been re-roofed with new timbers. A rooflight is located within the west roof slope (Fig. 24). A further discussion of the roof is provided below.

**Fig. 23** Internal south gable wall of south garage

**Fig. 24** Internal view of south garage, view to the north with window to the left

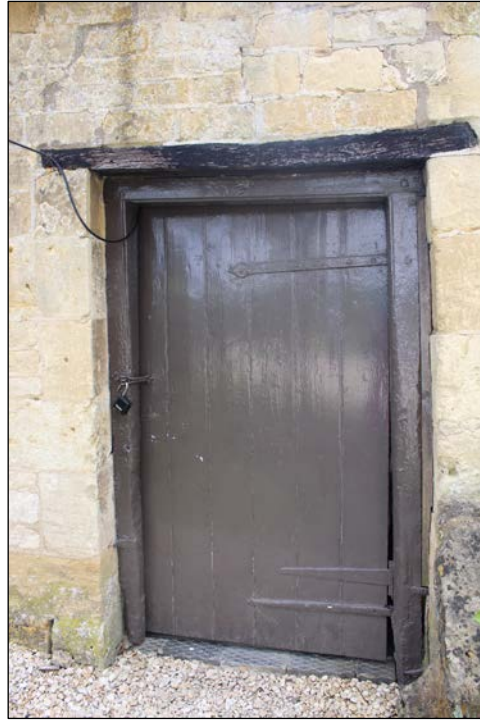
- 3.18. There is a doorway in the south-west corner of the southern garage (Fig. 25) with a weathered timber lintel above. The door jambs look to be hand-tooled, beaded at the top and jointed with pegs, which dates this door to be no later than the early 19<sup>th</sup> century. The wide boarded timber door has three strap hinges of differing dates, ranging from what appears to be the oldest, a crude, hand forged version (lowest on the door), a more ornate version with a lozenge end (top) and a 20th century triangular version. It is difficult to definitively date the older strapwork (as vernacular style iron work continued to be created throughout the 18<sup>th</sup> and 19<sup>th</sup> centuries) but their appearance suggests 17th or 18th century; it is possible this door could be reused from elsewhere on the estate or farmhouse. There is evidence of poor quality cementitious repointing above the door.

**Fig. 25**                      **View of doorway, south garage**

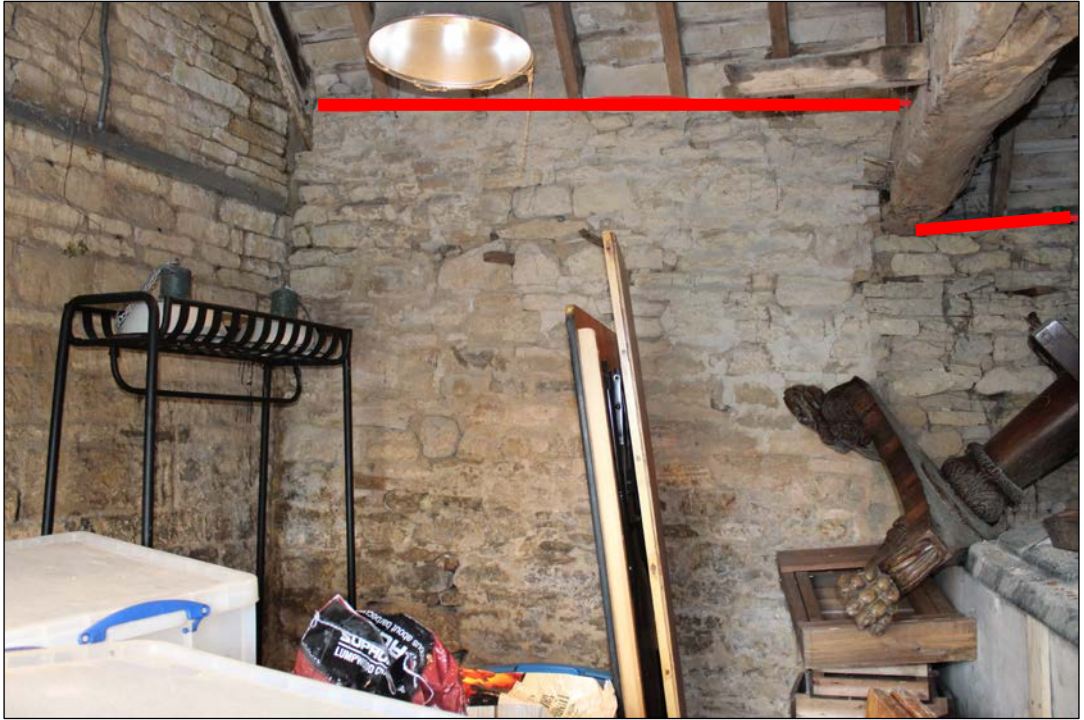
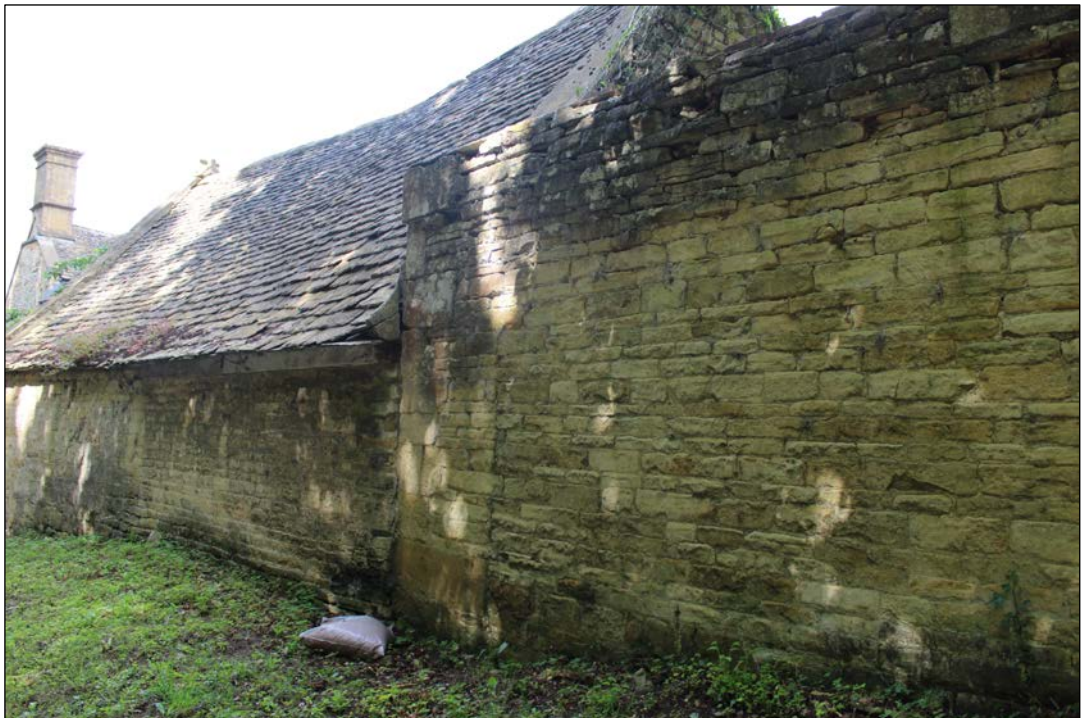
- 3.19. The north space of the southern garage afforded more views of the building fabric as it has not been boarded out, though access to this space was limited due to storage items. The boarding out of the south space is visible against the middle roof truss. The northern section of the east wall (starting from the junction with the corner of the gable end) is interesting in that it steps upwards (Fig. 26), the top of wall meeting the roof timbers higher on the roof slope; this is potentially a structural feature to accommodate the topographical slope on which it sits. On the external east facing side the roofslope juts slightly further out from the wall which is consistent with this internal feature (Fig. 27). There is again evidence of poor cementitious re-pointing.

**Fig. 26** Internal view of east wall, northern section of south garage

**Fig. 27** External view of east wall of south garage, view to the south

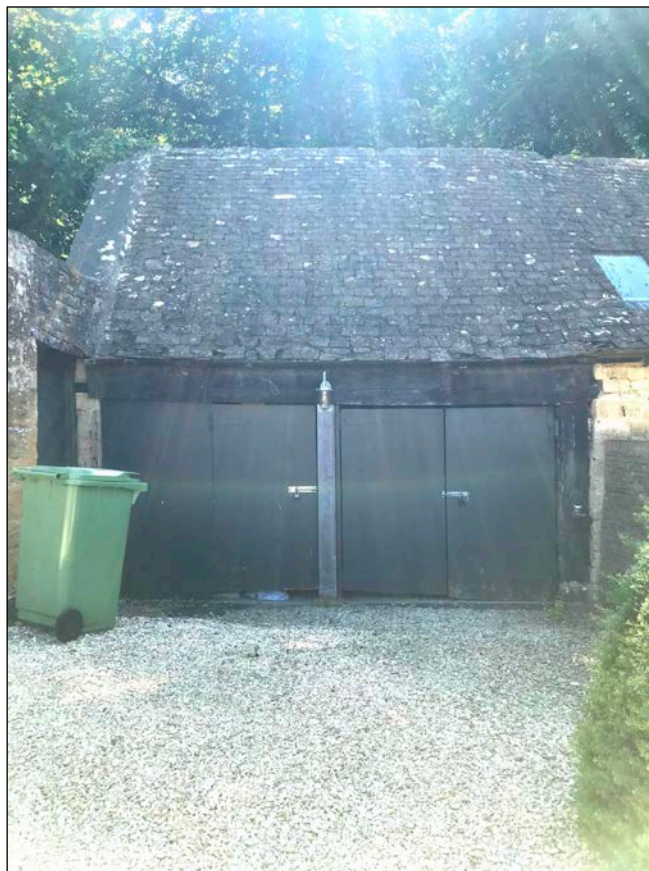
3.20. This space is accessed from two sets of wide plywood garage doors; the opening is supported by a thick oak lintel of some age, supported with a modern timber vertical post that looks to be weathered oak. This lintel is visible internally but has been covering in treated timber boarding on the external face (Fig. 28). The lintel is supported at each end by thick timber piers, again of some age. The interface with the stone walls to each side appears awkward and this combined with the absence of quoins, suggest that this wide garage door is a later insertion, the lintel perhaps re-using an older oak beam from the barn or elsewhere.

**Fig. 28** View of garage doors, northern section of south garage, view to the east

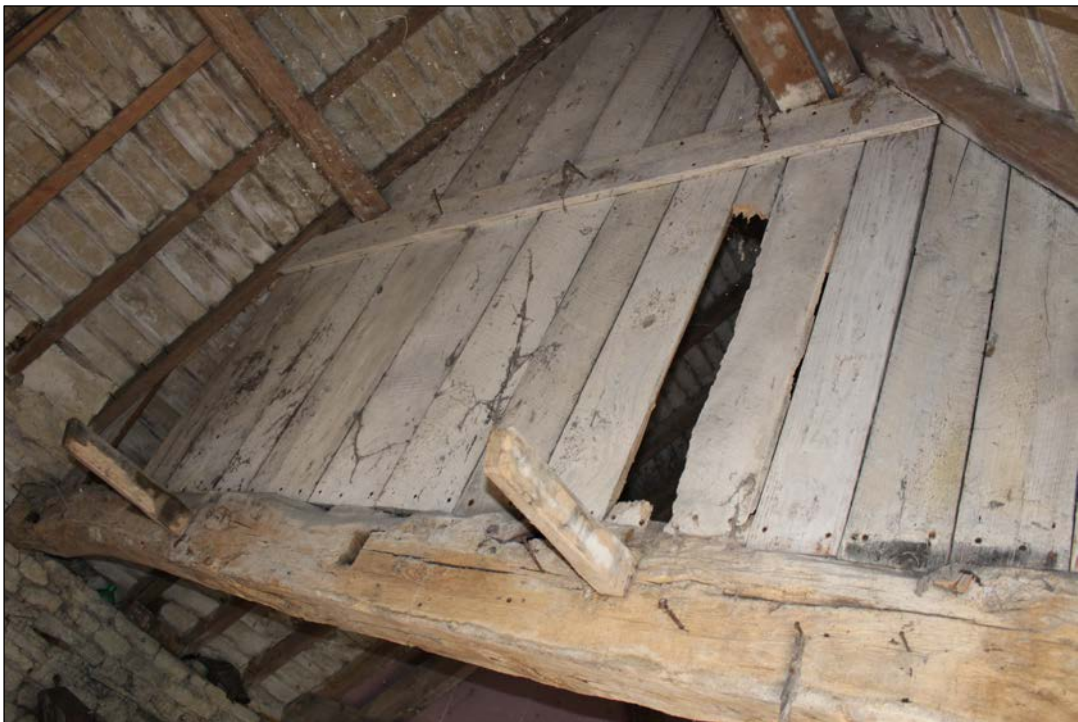
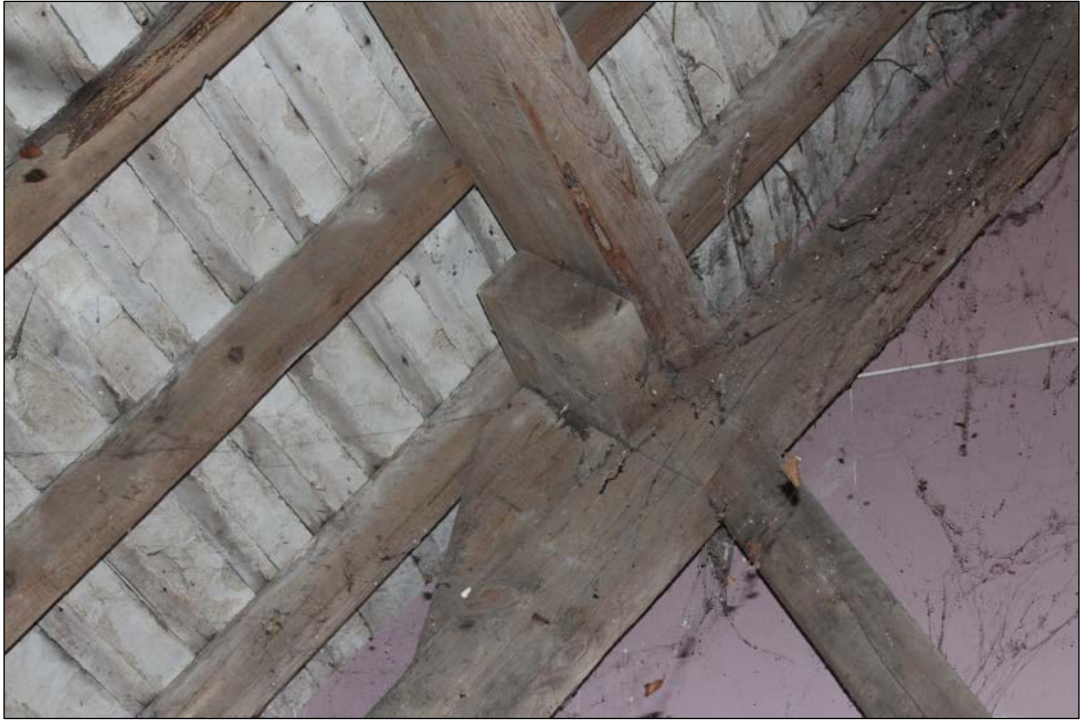
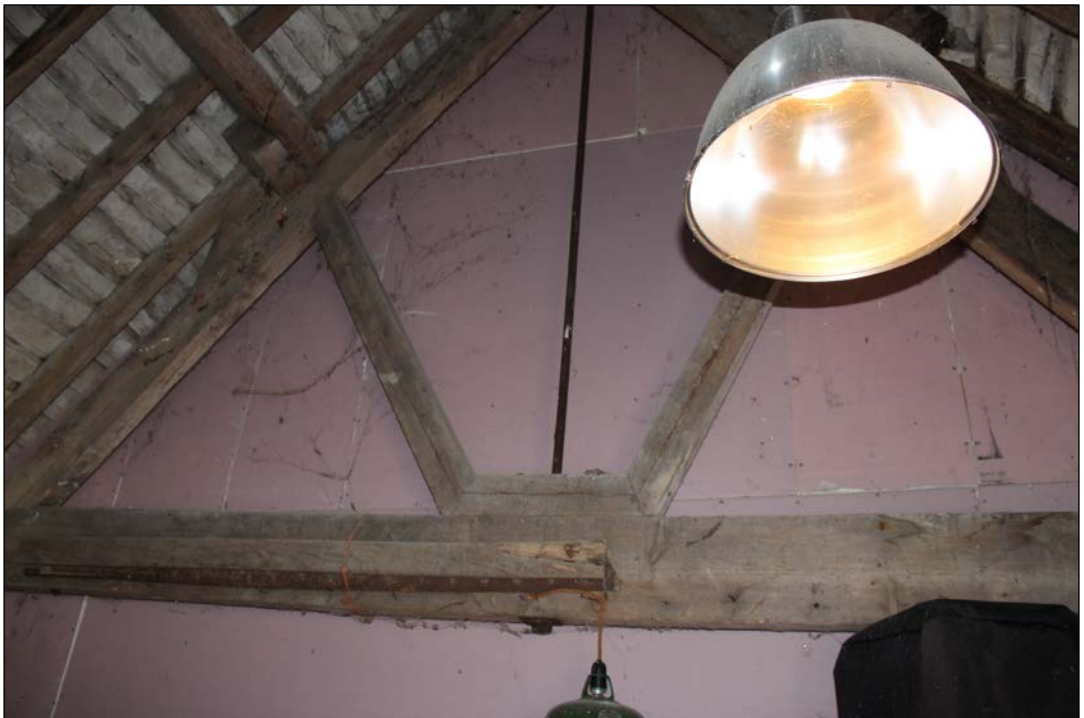
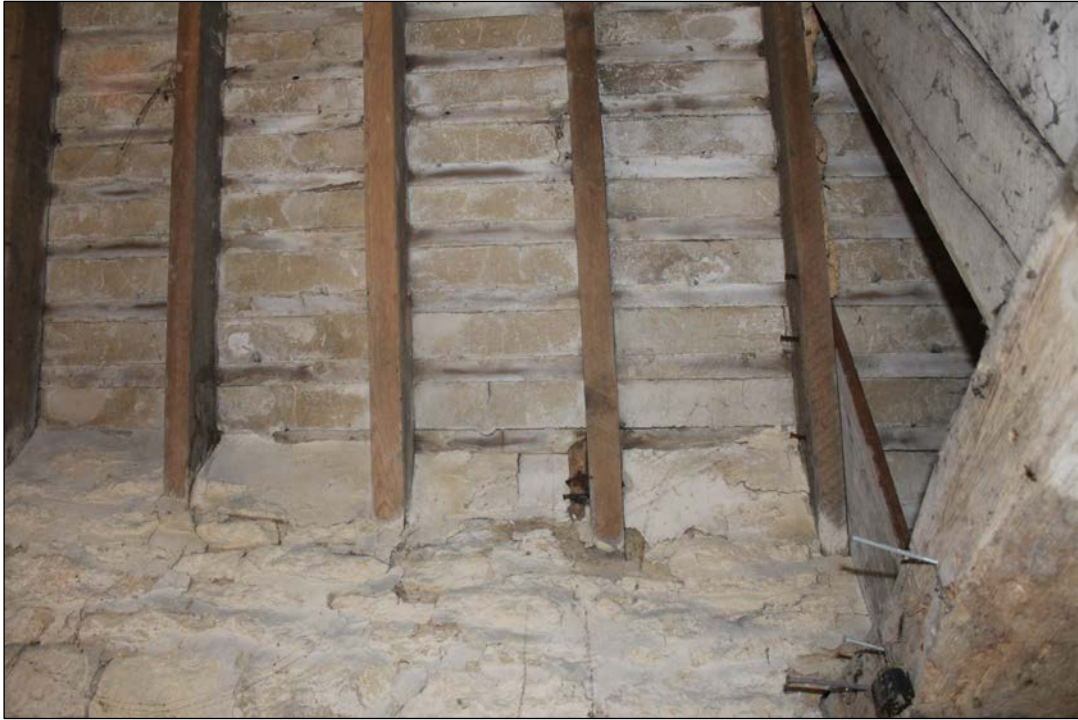
3.21. The interior of the north space gives a view of the roof truss and rafters. A substantial tie beam with pegging sits in the middle of the space (Fig. 29). This beam is hand tooled and of some age, possibly original to the barn as unused tenon holes may suggest it is re-used. A timber-boarded screen has been built up from the tie beam to subdivide the roof space. It is clear that this screen and the other timbers

(purlins, rafters and truss) of the roof structure are newer and that at some point in the past the building, or part of, has been re-roofed. The evidence for this is the nature of the timber members, all are machine tooled deal found in much roofing of the 1830's onwards. The back purlins sit atop each other and are supported by a cleat (Fig. 30) and the truss, visible in the centre section (Fig. 31), is an unusual version of a king post arrangement without the central post and instead bolted on the underside. There is torching between the rafters and battens, presumably some kind of a lime mortar mix (Fig. 32). It is assumed that this arrangement continues in the southern section underneath the plaster boarding.

**Fig. 29**                      **Old oak tie beam in northern section, with timber board screen above**

**Fig. 30**                    **Stacked back purlins with a cleat in the northern roof section**

**Fig. 31**                    **King post 'without the king post' truss, southern end of the northern section**

**Fig. 32**                      **Torching between rafters in northern section**

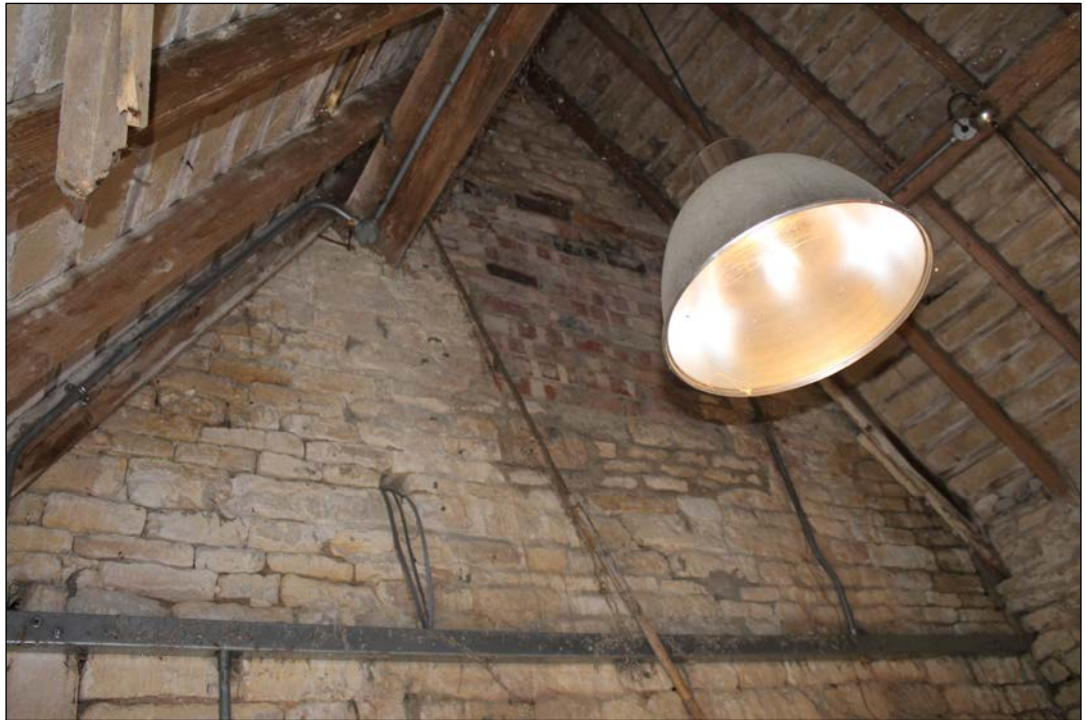
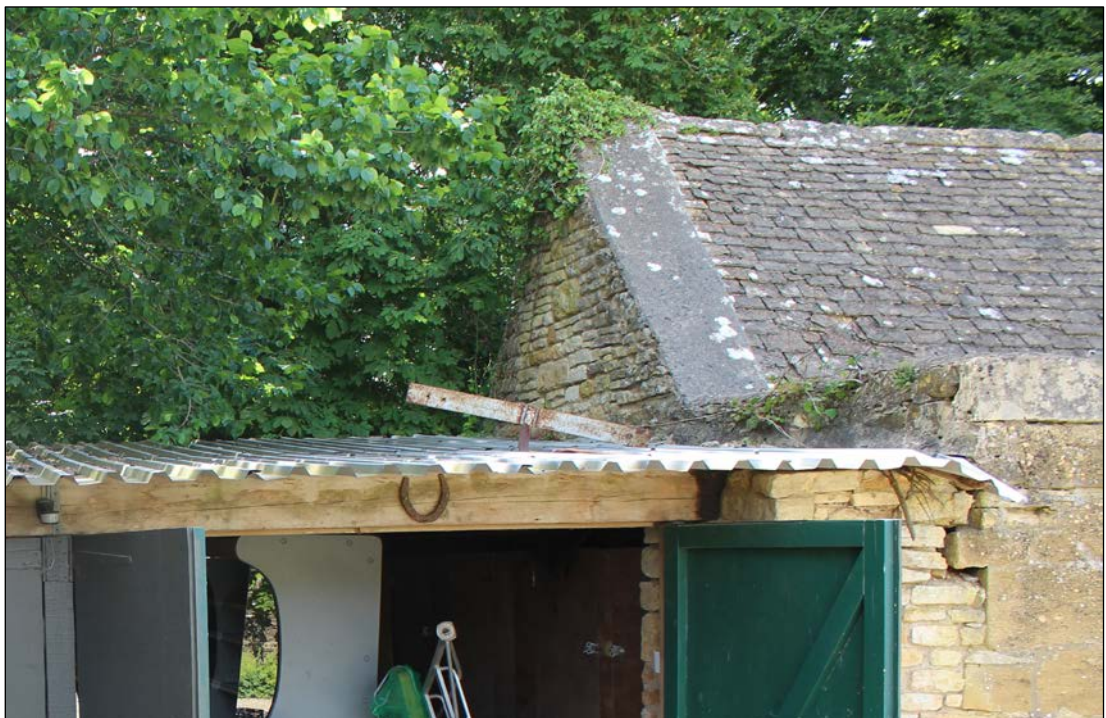
3.22. The northern gable wall is formed of solid well-built stone courses of varying width. The upper part of this wall is interesting in that there is evidence of brick infill (Fig. 33), which indicates an opening was filled in. There is no evidence of this on the external face of this gable wall (Fig. 34) though there are two incongruously large stone blocks within this section which may suggest re-used infill. This opening may have been a window in the south wall of the barn that was filled when the northern section of the south garage was constructed.

**Fig. 33**                    **Brick infill to the north gable wall of the south garage**

**Fig. 34**                    **External face of north gable wall to south garage**

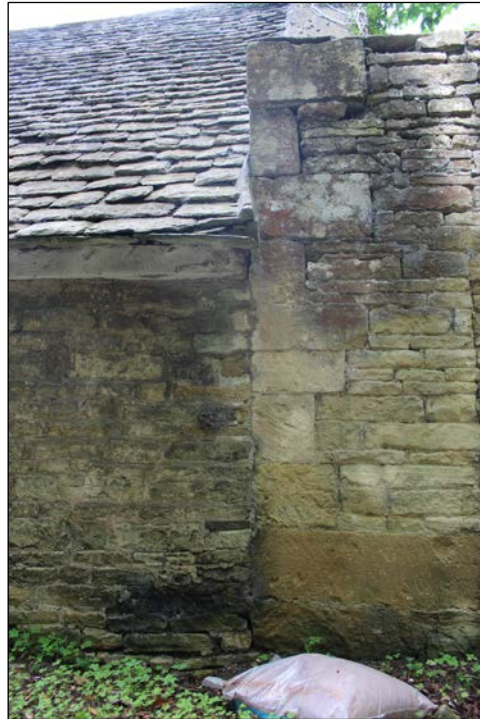
3.23. There is a distinct join (Fig. 35) between the walling of the south garage and quoined corners of the north garage which evidences that the two buildings are separate entities constructed at different times. The junction with the old barn walls is finished in a similar fashion to the west elevation; the gable end is capped in a mortar and the corner quoins of the barn walls jut above junction.

**Fig. 35** Joint between south and north garages, viewed to the west from roadside
