# The Garages, Temple Guiting Manor

*Level 2 Historic Building Recording*

CA Project:CR0132

August 2019

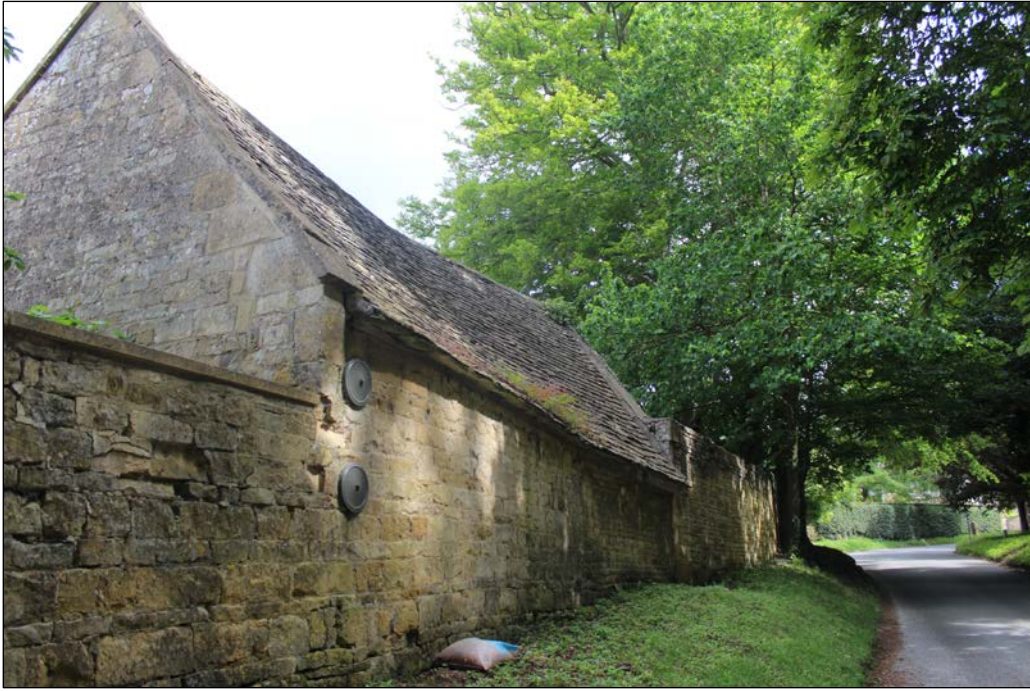
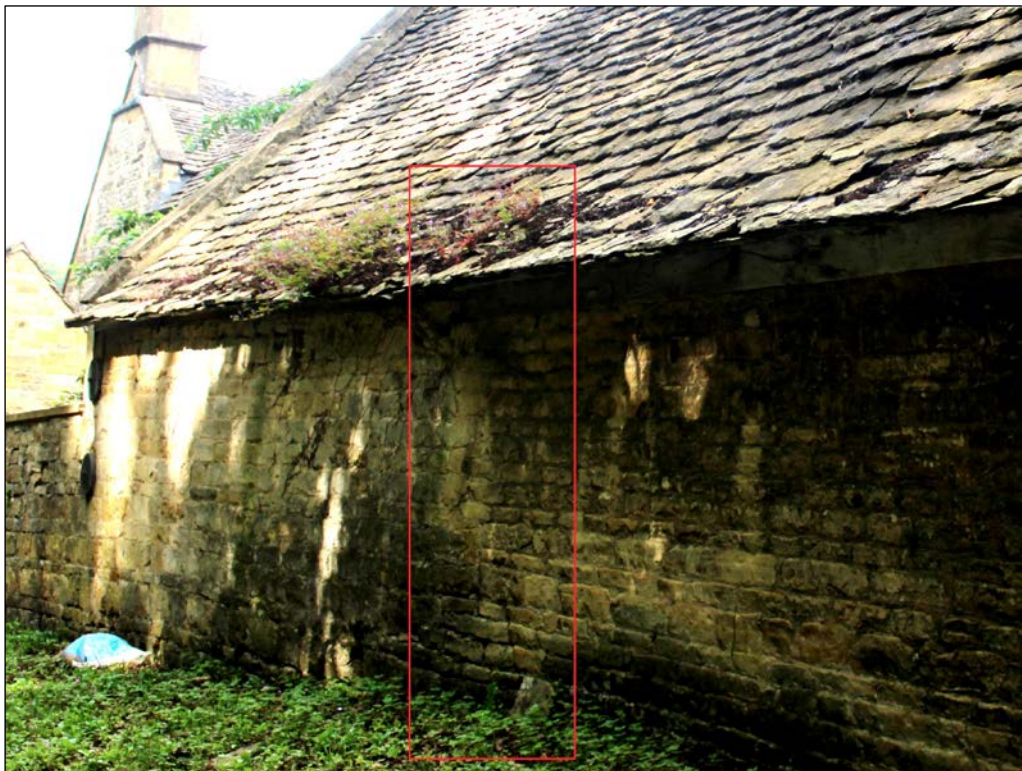
3.24. The east, roadside elevation of the south garage (Fig. 36) shows a well-built coursed rubble wall, though two circular wall ties are visible on the south-east corner, indicating structural issues. There is a slight change in character to the stonework between the northern and southern sections, and a visible stone joint, which suggests some rebuilding or filling in of this part of the elevation. The 1840 cartographic evidence shows a gap between the barn and a building to the south (likely the southern section of the south garage) that appears to corroborate this visual evidence that the northern section of the south garage was constructed or reconstructed at a different time to the southern section.

**Fig. 36** East elevation of south garage, view to the north, showing metal ties

**Fig. 37** Detail of east elevation, showing joint in stonework

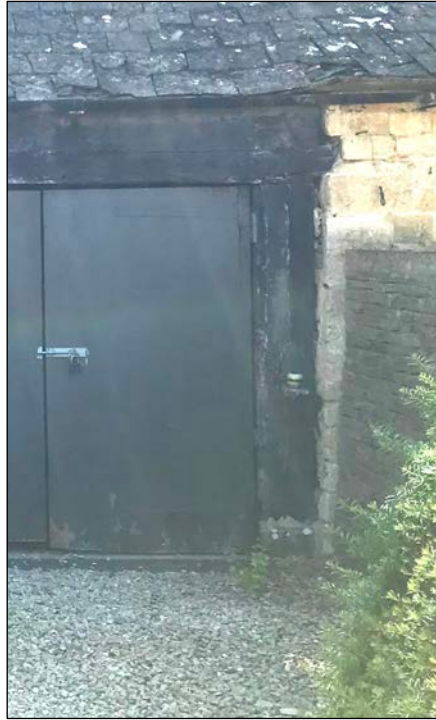
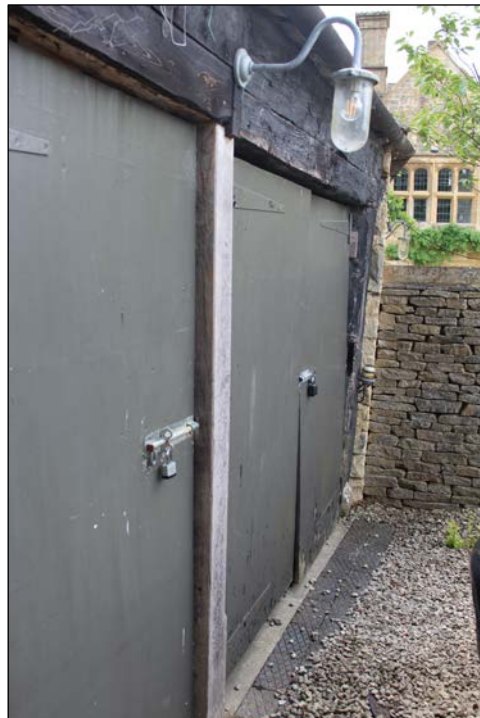
- 3.30. On site it was observed that the junction of the wall and the garage doors in the north section of the south garage is awkward and untidy (Fig. 40), and there is a slant to the wall when viewed to the side (Fig. 41). If this section of the south garage was a mid-19th century infill as described above in 3.27, with the northern section being 'knitted' together with the southern section, this would explain the awkward wall/post/beam junctions and also the 'new' roof with kink. Given the visual evidence of the roof timbers, which, aside from the older oak tie beam, look to be later 19<sup>th</sup> century, this infill could have occurred in the 1860's or 1870's, though it is possible the extant roof structure in the south garage range is a later version as the timbers and torching are in good condition.

**Fig. 40** View of junction between garage door and wall, south garage

**Fig. 41** Side view of northern section of south garage, view to the south
