# The Old George, High Street Stony Stratford Milton Keynes

*Historic Building Recording*

CA Project: MK0097

October 2019

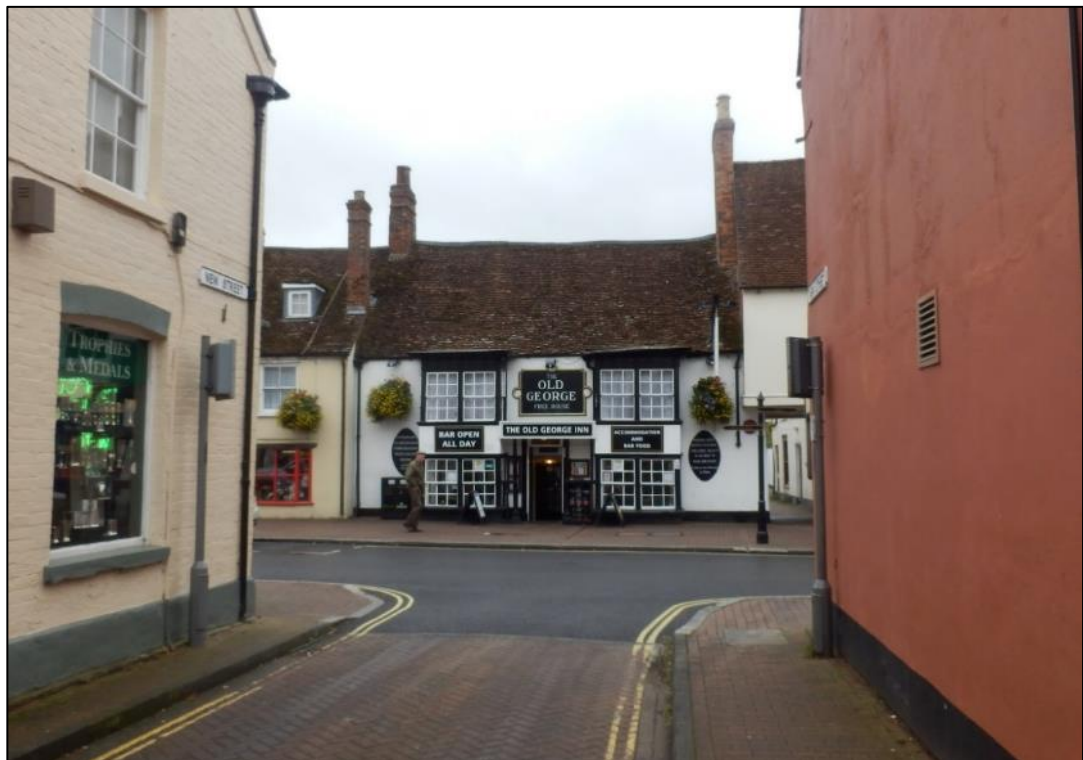
**Photo 1: The northern elevation of The Old George.**

- 3.7. The earliest part of the Building comprises the inverted 'L' shaped structure which fronts on to the High Street (Photo 1). This ranges dates to the 16th/17th century. This building fronting on to the street is a single pile structure sitting parallel to the

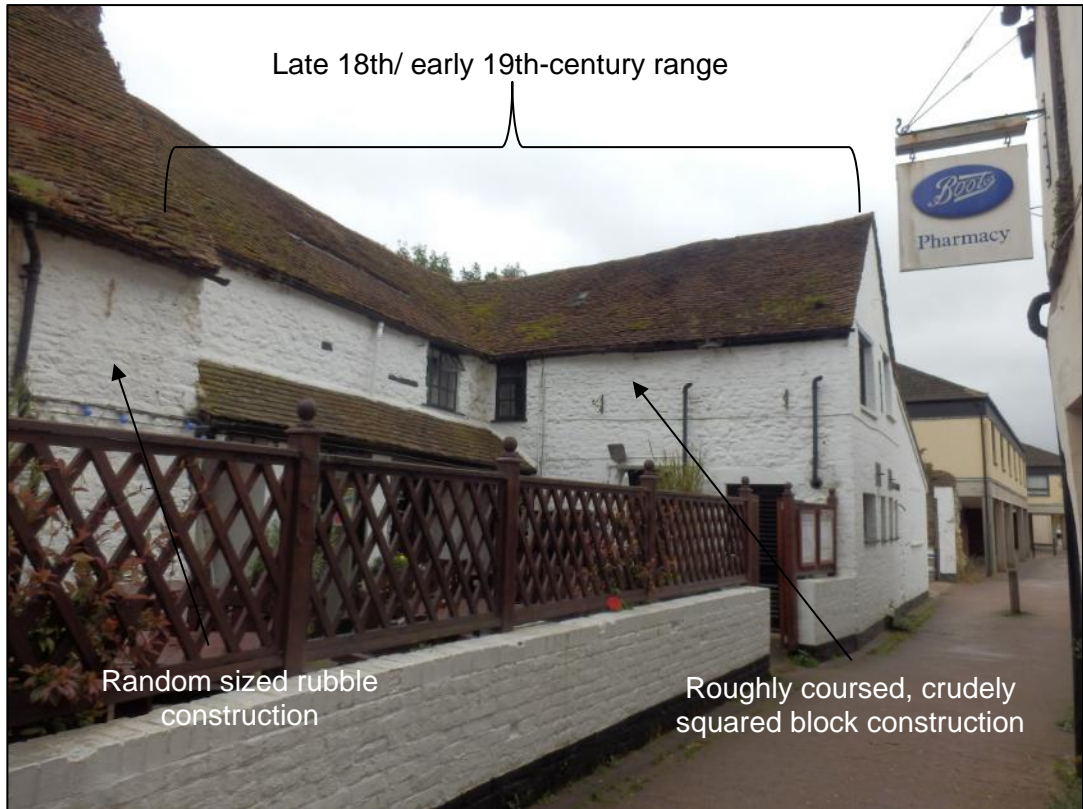
Photo 2: The north elevation of the rear range of The Old George.

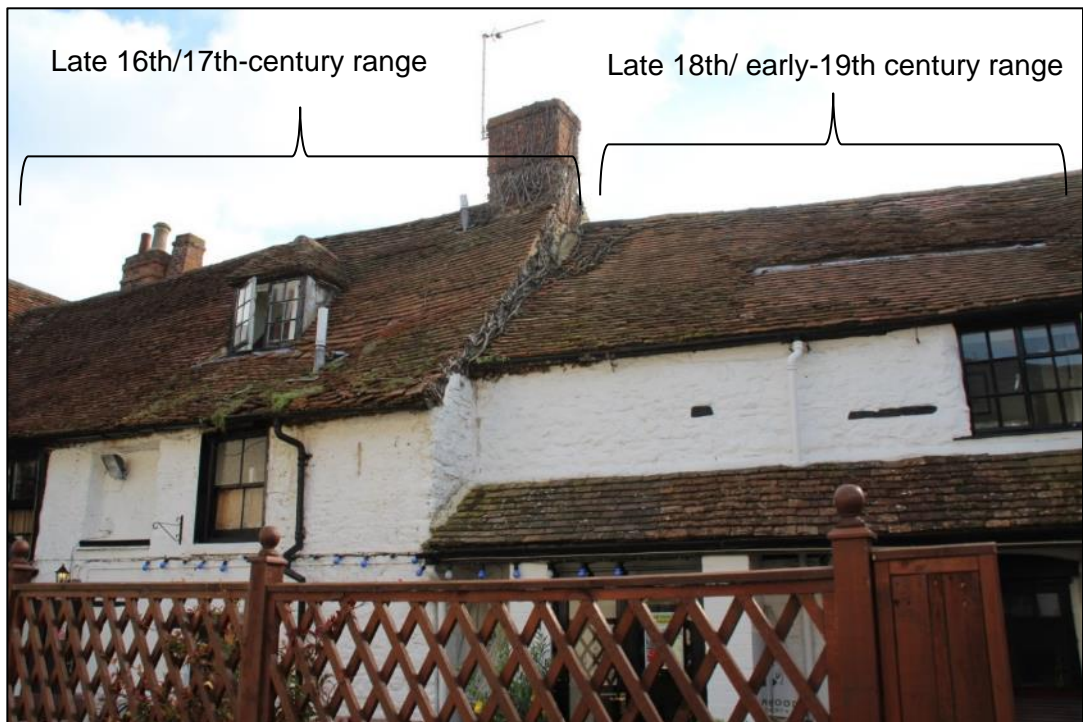
Photo 3: The western elevation of The Old George fronting into George Yard.

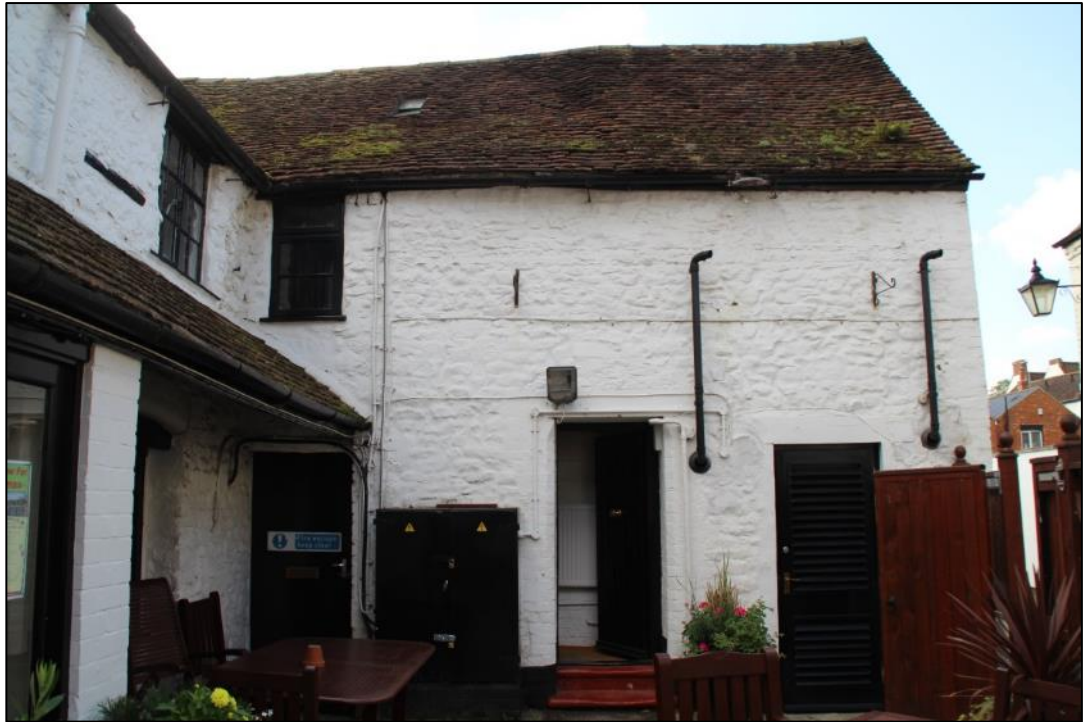
- 3.8.** To the south of the main building and clearly butted on to it, is a presumably later L-shaped block, slightly narrower and with a less steeply pitched roof. This structure is of late 18th or early 19th-century date (Photos 2 and 4). This is also rubble-built and, like the earlier range, white-painted. Unlike the earlier range, whose rubble is random, this block is very roughly coursed in crudely squared blocks close to a standard size. The ground-floor interior has been gutted. The upstairs was fitted with modern partitions and finishes to create guest and/or staff accommodation in the mid to late 20th century (Figure 3, Rooms 1-4). This range appears to be of one basic structural phase, except for the gable end facing on to George Yard which has been rebuilt in brick (Photos 7 to 10). All the visible windows in this block, except those in the brick gable end, are insertions, all very recent except for the first-floor window to the eastern extent of the northern elevation of the gable end range (late 18th/ early 19th- century structure), which, while inserted, appears to have woodwork of 19th to early 20th-century date (Photo 4). A doorway below may also be original or early.

Photo 4: Northern elevation of the late 18th/early 19th-century southern range.

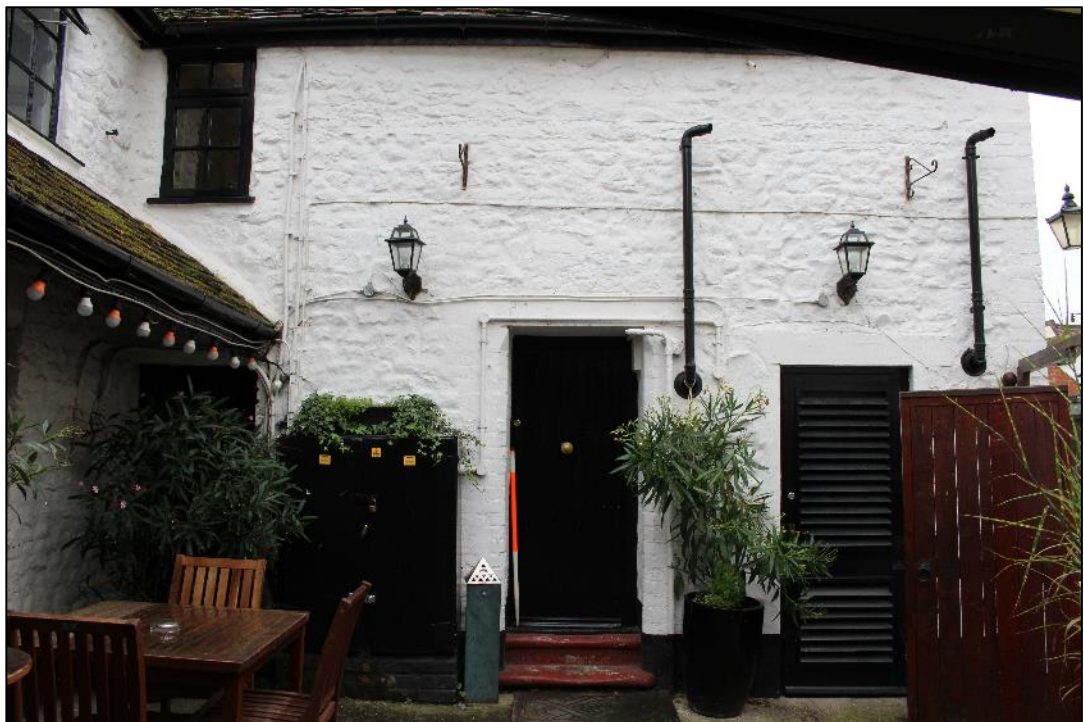
Photo 5: Detail of the northern elevation of the gable ended late 18th/ earl-19th century range.

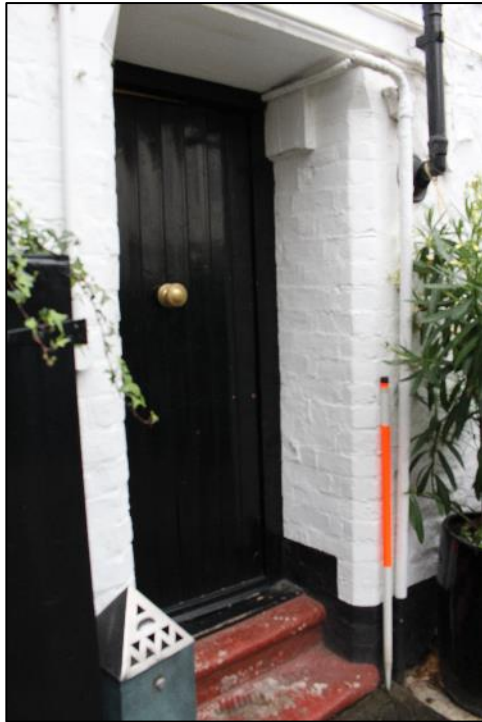
Photo 6: Detail of stop chamfer door opening within the 18th/early 19th century range.

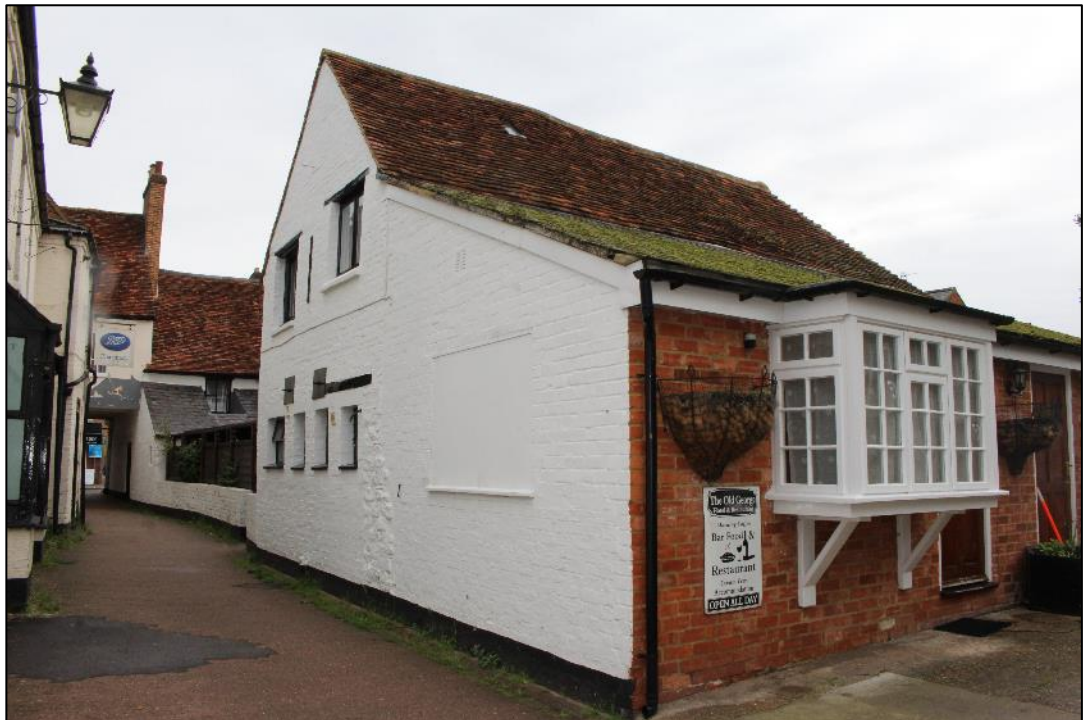
Photo 7: The eastern and southern elevations from the south-west.

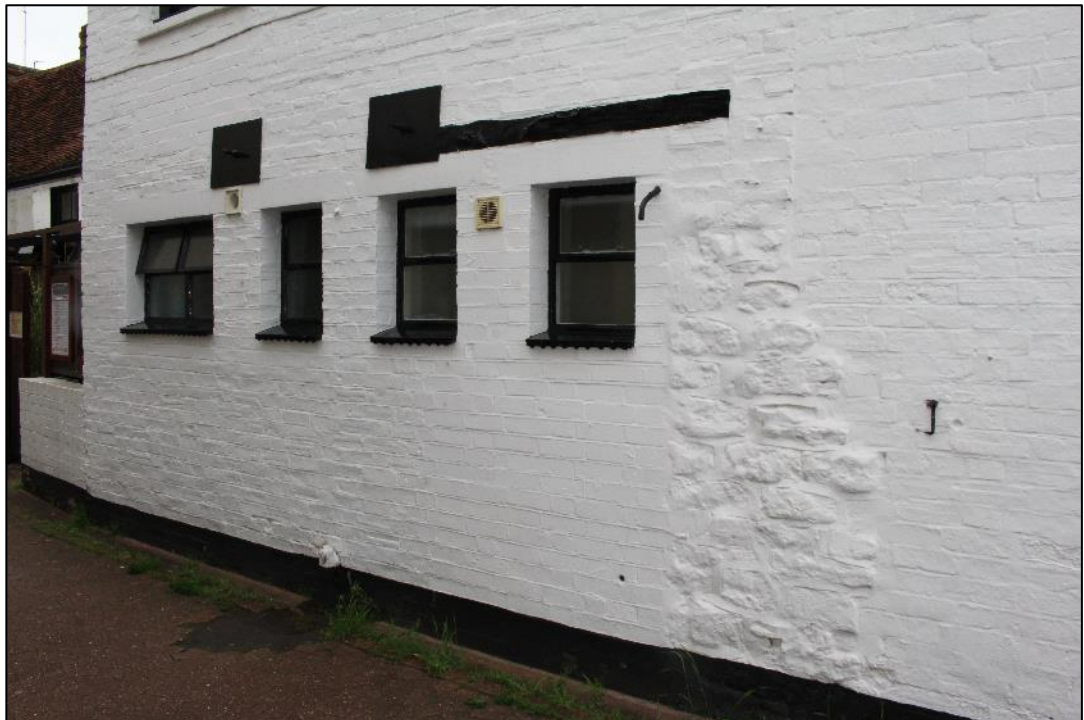
**Photo 9: Detail of metal framed window openings within the gable end of the late 18th/early 19th century range.**

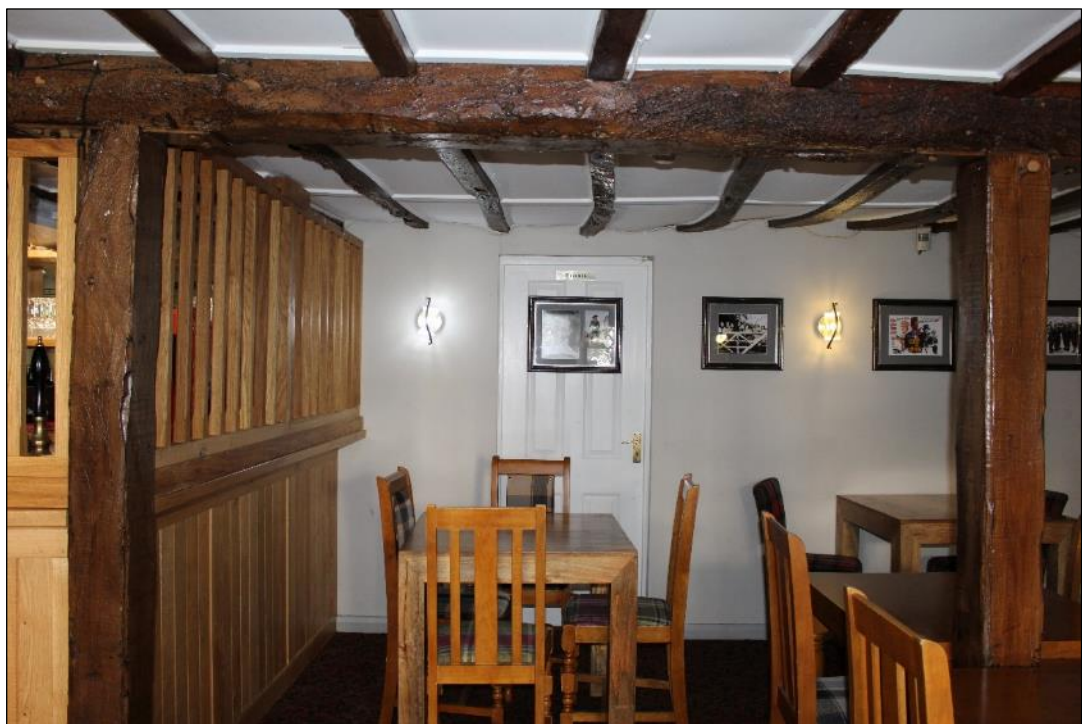
**Photo 12: The eastern wall of the northern dining room with access to the cellar.**

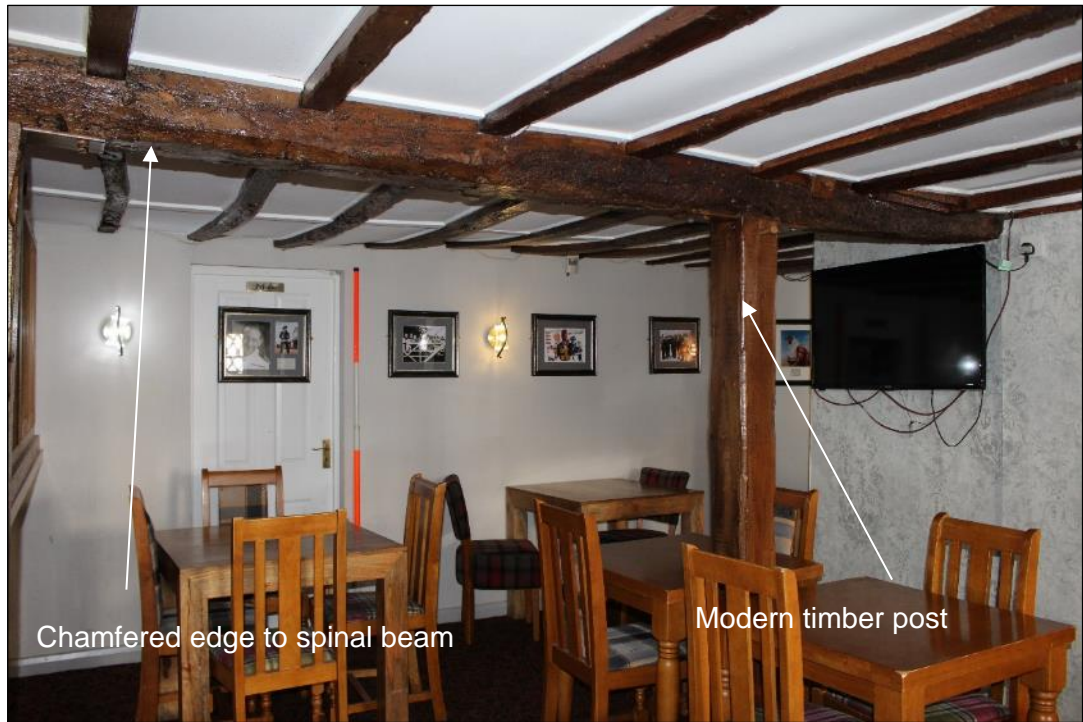
**Photo 13: The northern extent of the Dining Room from the north-west.**

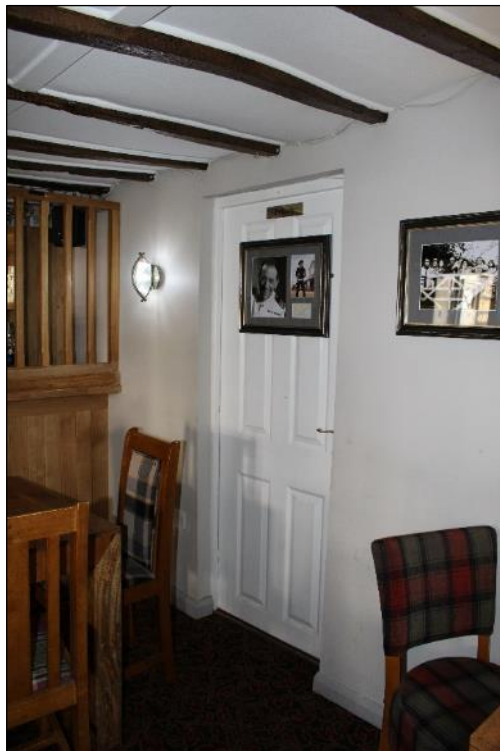
**Photo 14: Access from the Dining Room in to the 20th century cellar extension.**

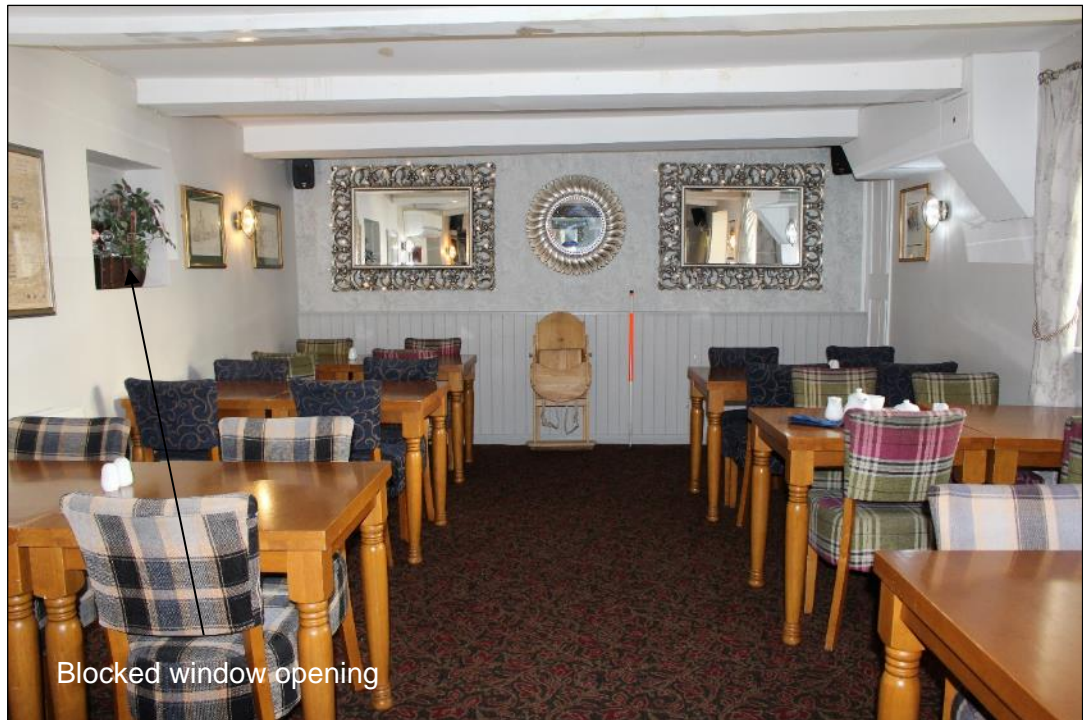
**Photo 15: The southern extent of the Dining Room from the north.**

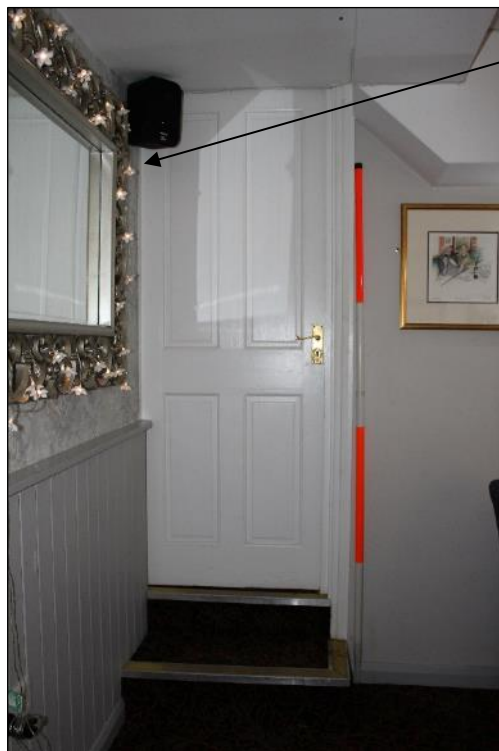
**Photo 16: Access between the southern extent of the Dining Room and the staff toilet within the gable end Building.**

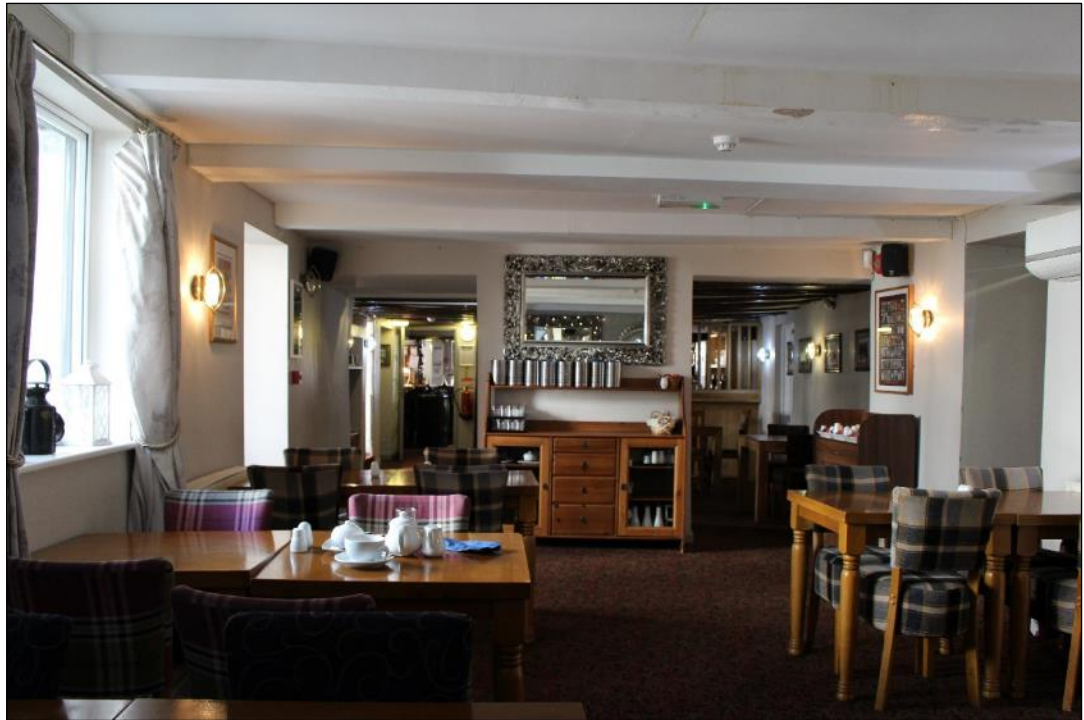
**Photo 17: An overview of the ground floor Dining Room from the south towards the High Street frontage.**

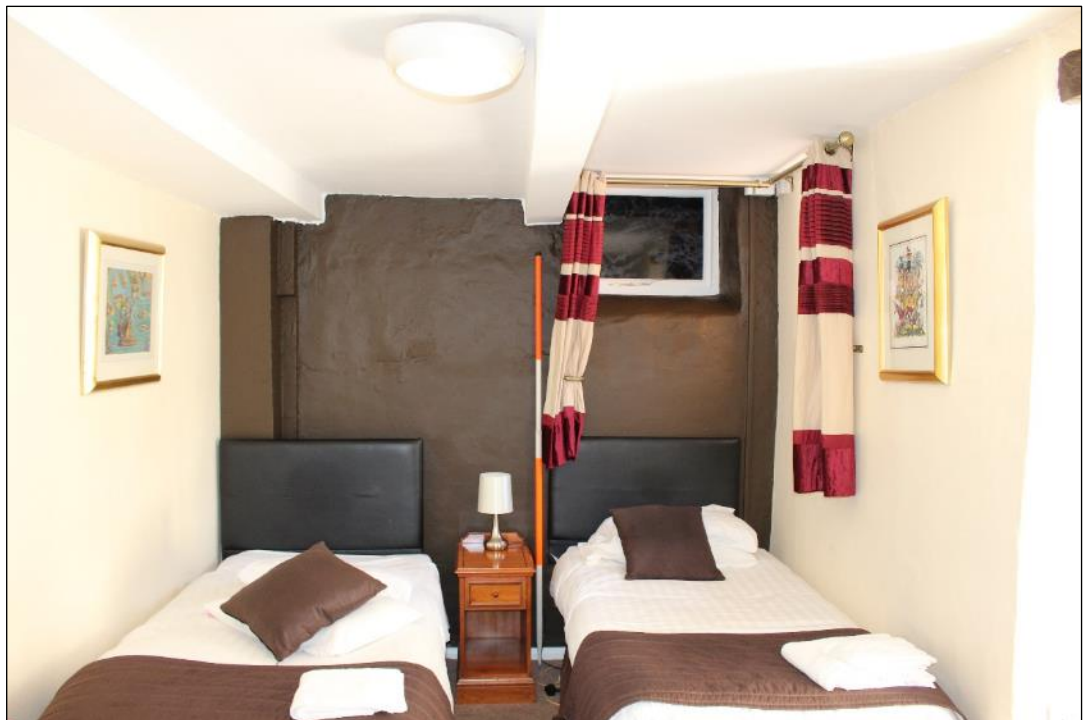
- 4.4. Its extant southern wall is an apparent later insertion, constructed to form Room 7 (Photos 18 to 20) when the single-storey lean to (Rooms 5 and 6) were constructed in the late 20th century to provide en-suite accommodation rooms. The opening in to the Staff WC from the south-western extent of the Dining Room appears to have been an earlier opening which was partially obscured following the construction of Room 7. The left door jamb has been obscured by the southern wall of the Dining Room (Photo 16).

**Photo 18: Room 7 from the east.**

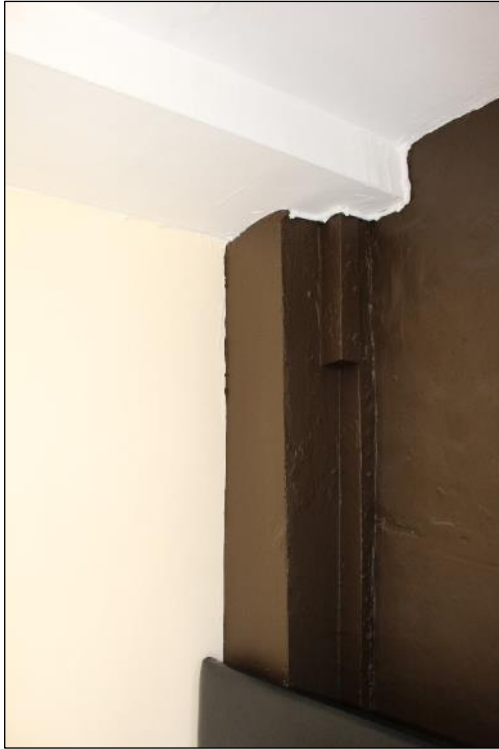
19), indicating that the beams and ceiling were inserted, prior to the construction of the southern wall of the Dining Room to form Room 7.

**Photo 19: Detail of beam and post within the north-eastern corner of Room 7.**

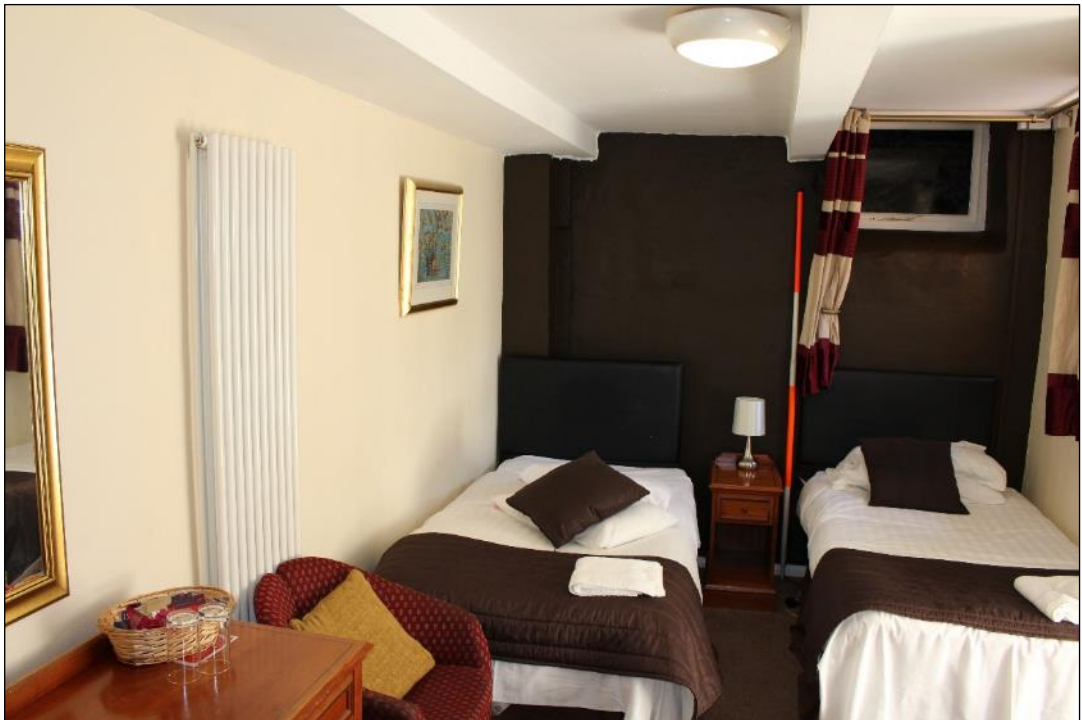
**Photo 20: An overview of the partition wall between Room 7 and the southern extent of the Dining Room.**

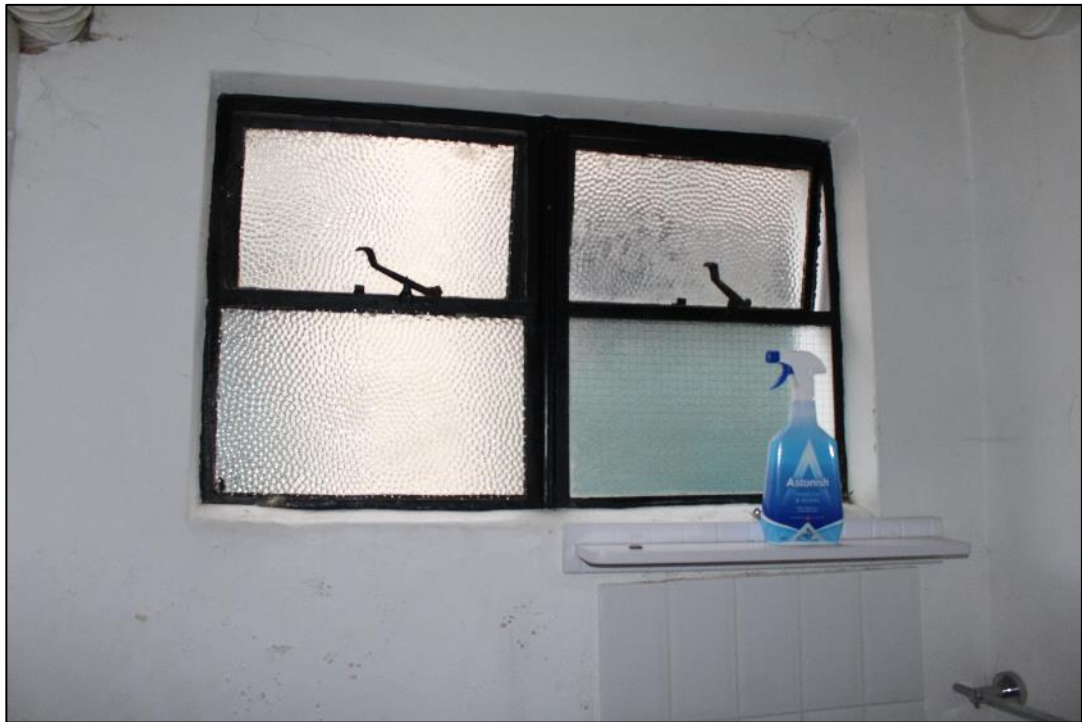
**Photo 24: Detail of window opening within the western elevation of the Boiler Room.**

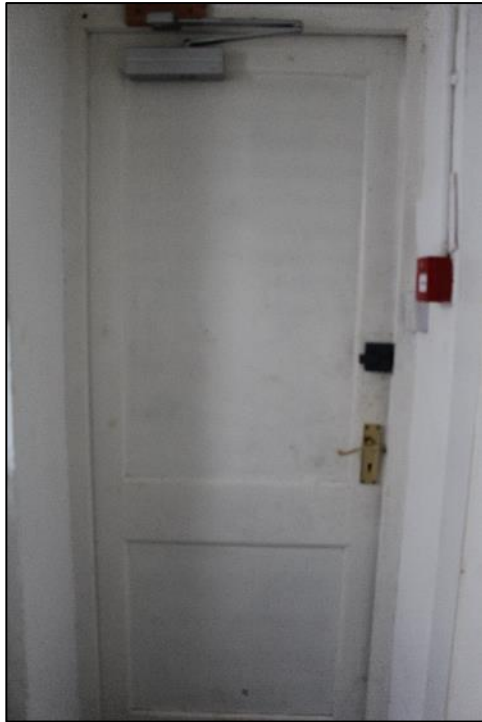
**Photo 25: Detail of door opening within the northern elevation of the Boiler Room.**

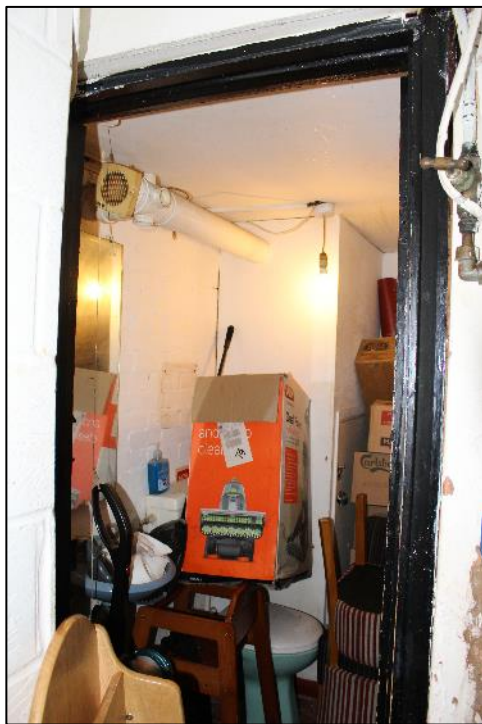
**Photo 29: Detail of timber door opening.**

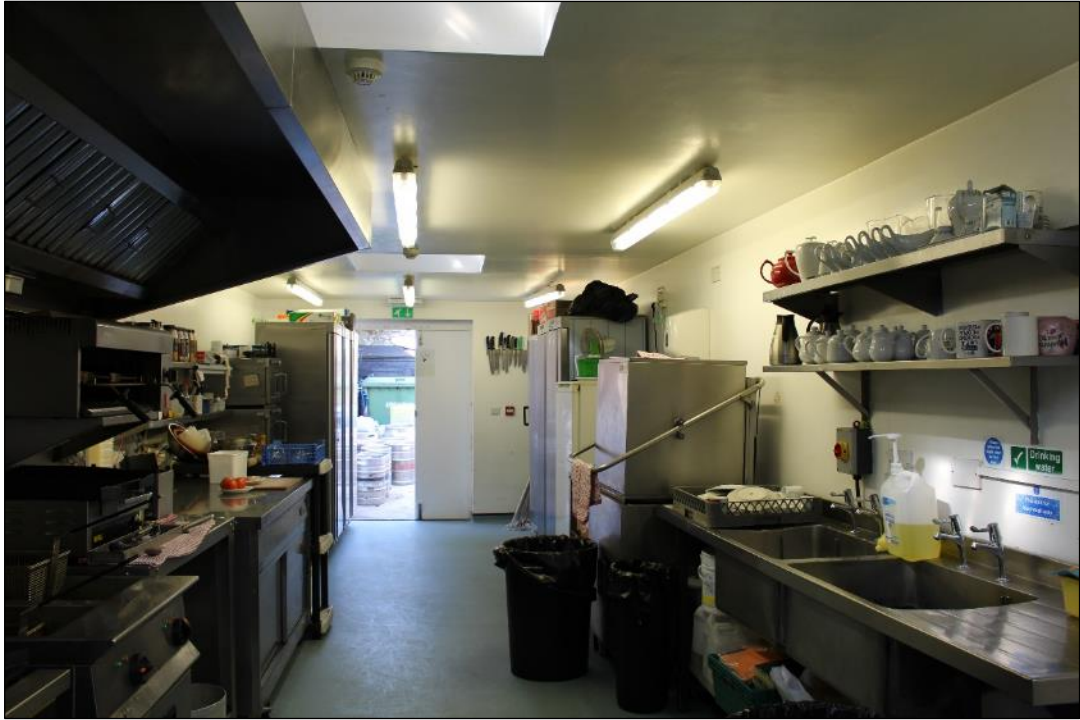
- 4.11. In the later 20th-century, a single-storey kitchen block (Photo 38) was constructed to the south of the stores and cellar which runs from the southern extent of the late 16th/17th-century range to the southern extent of the late 18th/ early 19th-century range. The kitchen is of single skin brick construction and a small gap, visible when looking at the southern elevation from the south (Figure 2, Photo 47), has been left between the late 20th century construction and the rubblestone wall of the late 18th/early 19th century range. There are two window openings visible within the eastern elevation of the late 18th to early 19th-century range and it is possible that the door between the kitchen and the Dining Room makes use of an earlier window opening (Photo 17).

**Photo 38: An overview of the late 20th century kitchen extension from the north.**

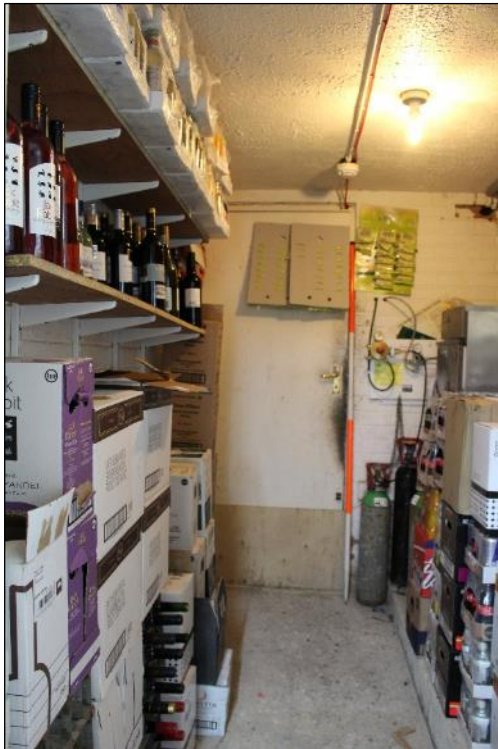
**Photo 39: Store 1 from the south.**

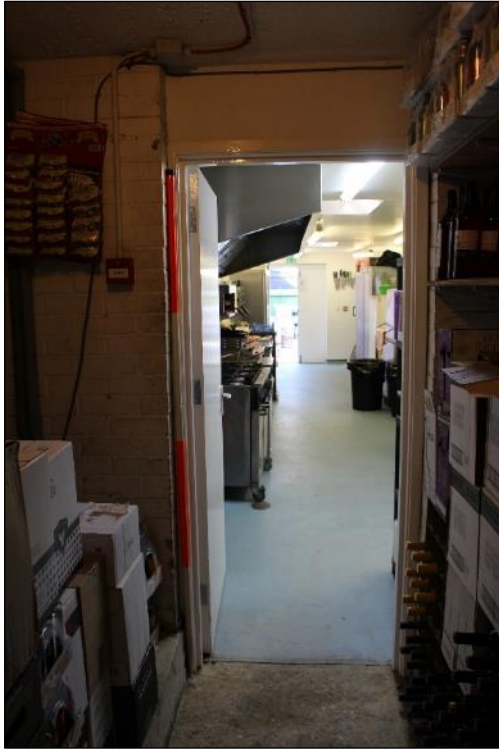
**Photo 40: Store 1 from the north.**

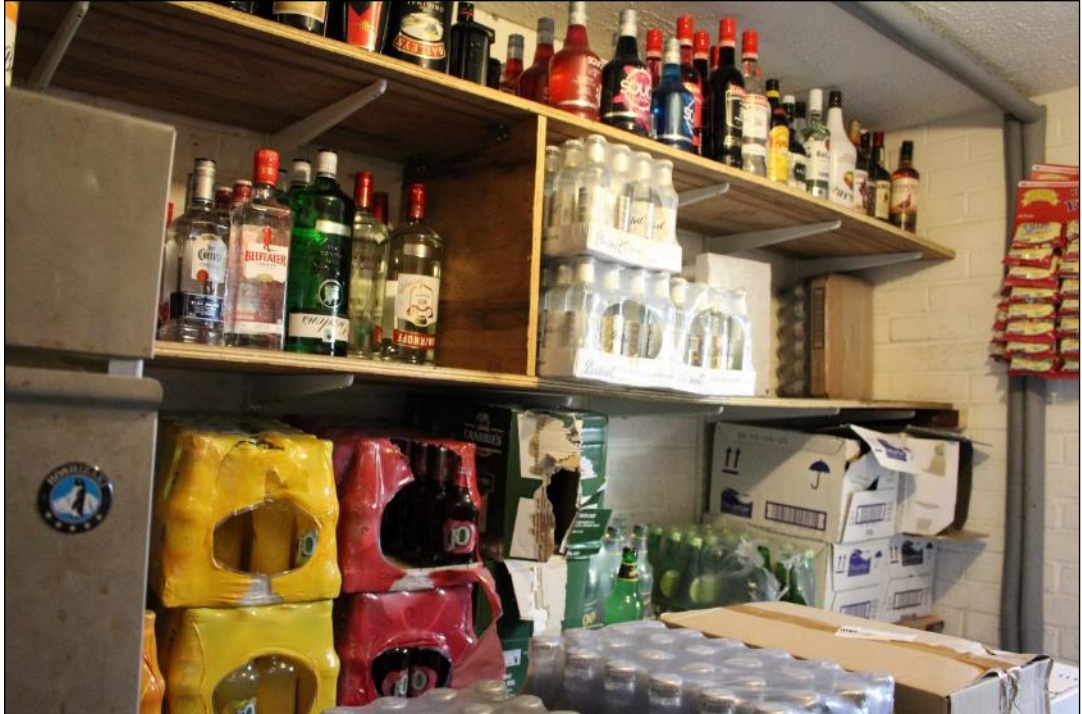
**Photo 41: Store 1 from the north-west.**

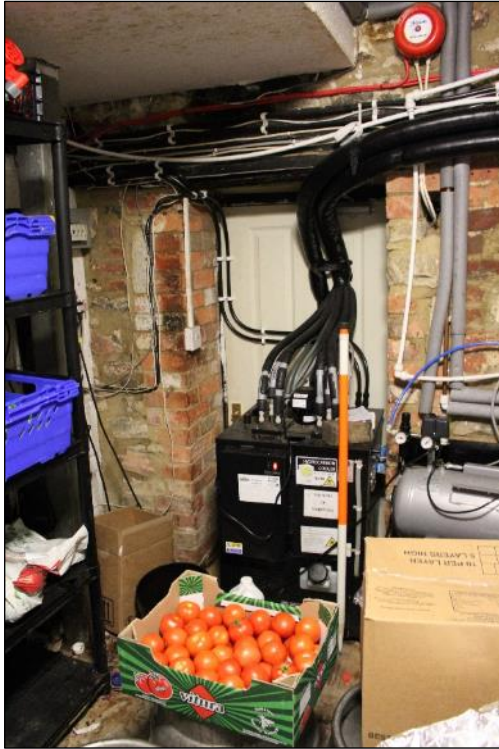
**Photo 42: Door opening between the early 20th-century cellar and the northern extent of the dining room.**

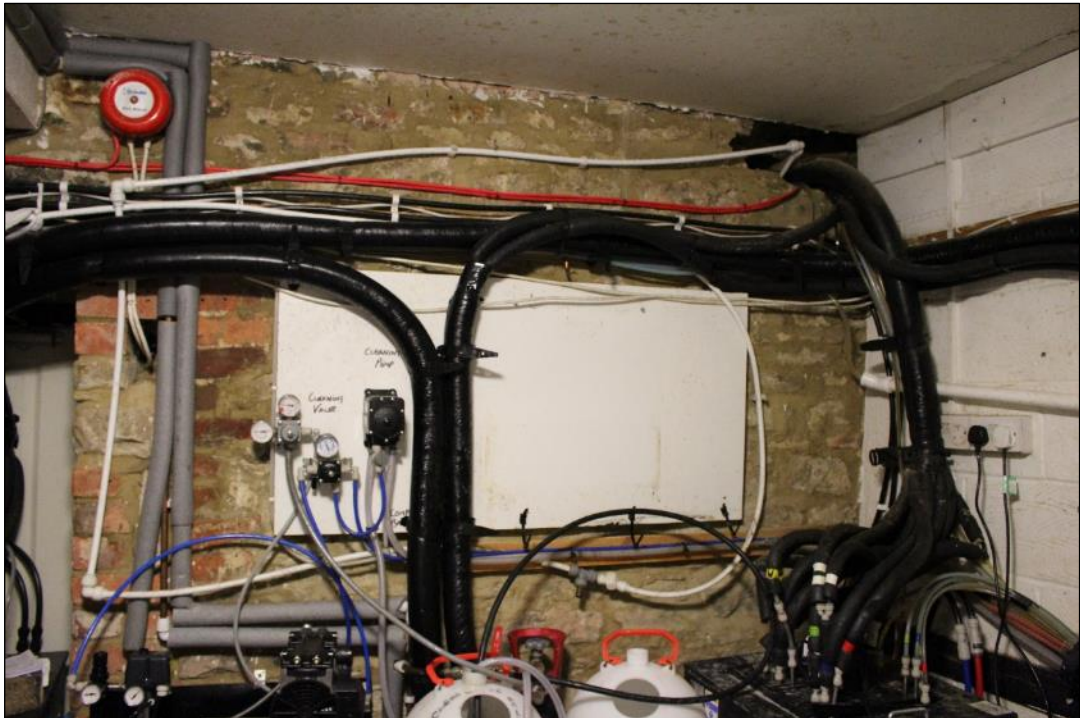
**Photo 43: The western wall of the cellar is of rubblestone construction.**

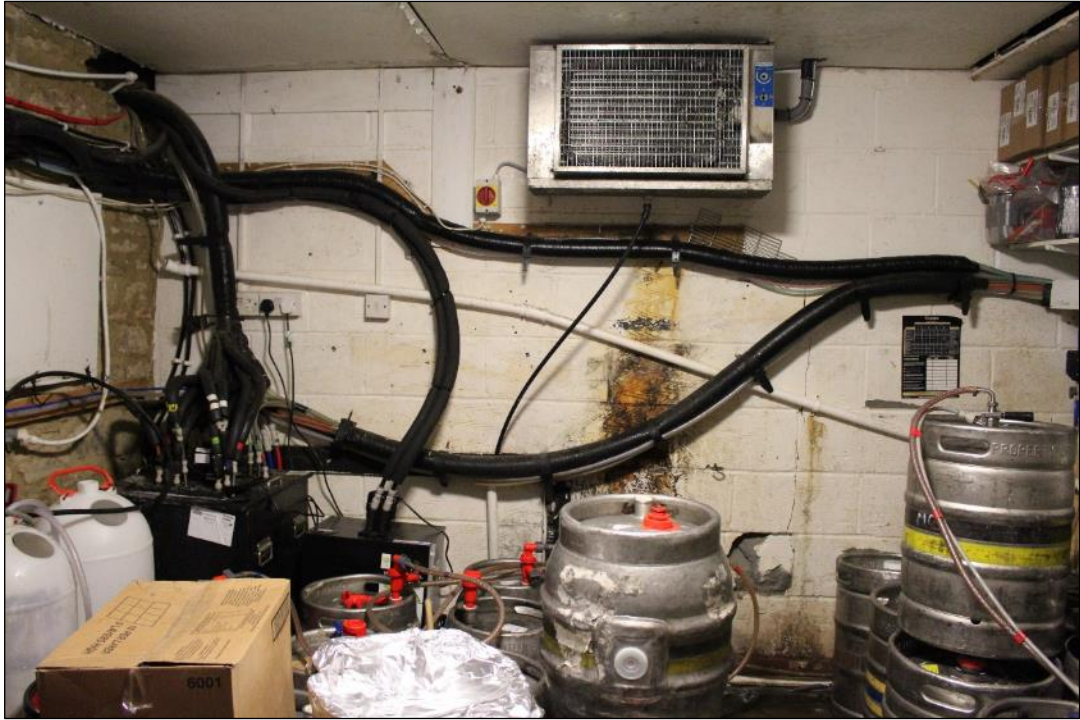
**Photo 44: The northern wall of the cellar is of breezeblock construction.**

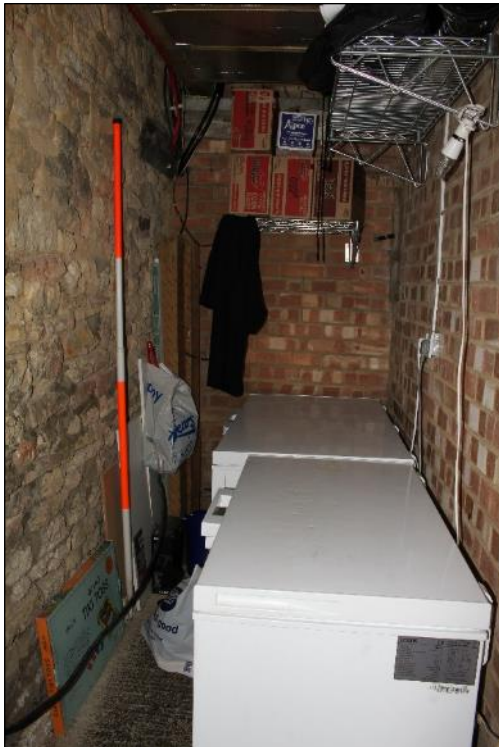
**Photo 45: Store 2 from the south.**

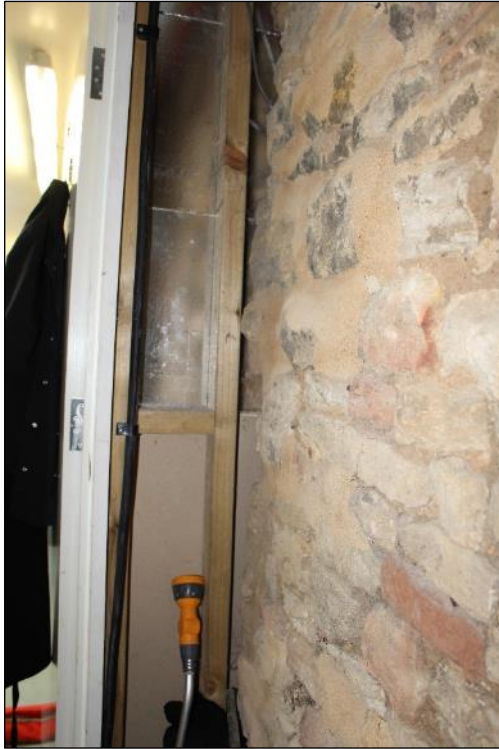
**Photo 46: The south-western extent of store 2.**

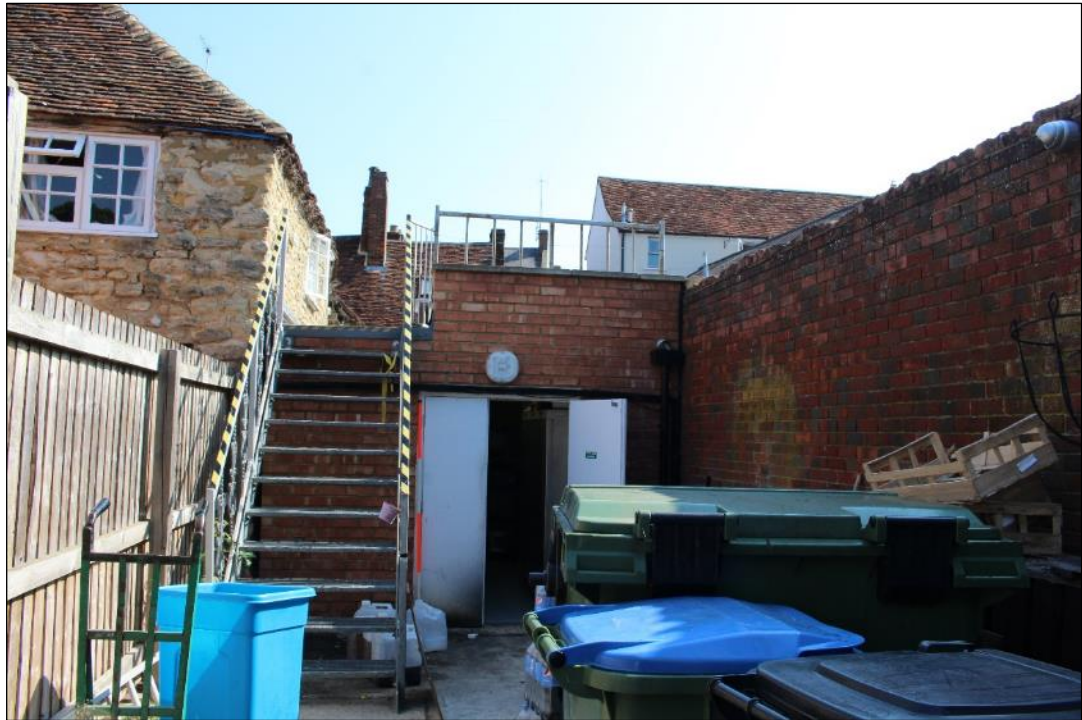
**Photo 47: The southern elevation of the late 20th century kitchen extension and the late 18th/early 19th century subsidiary building.**

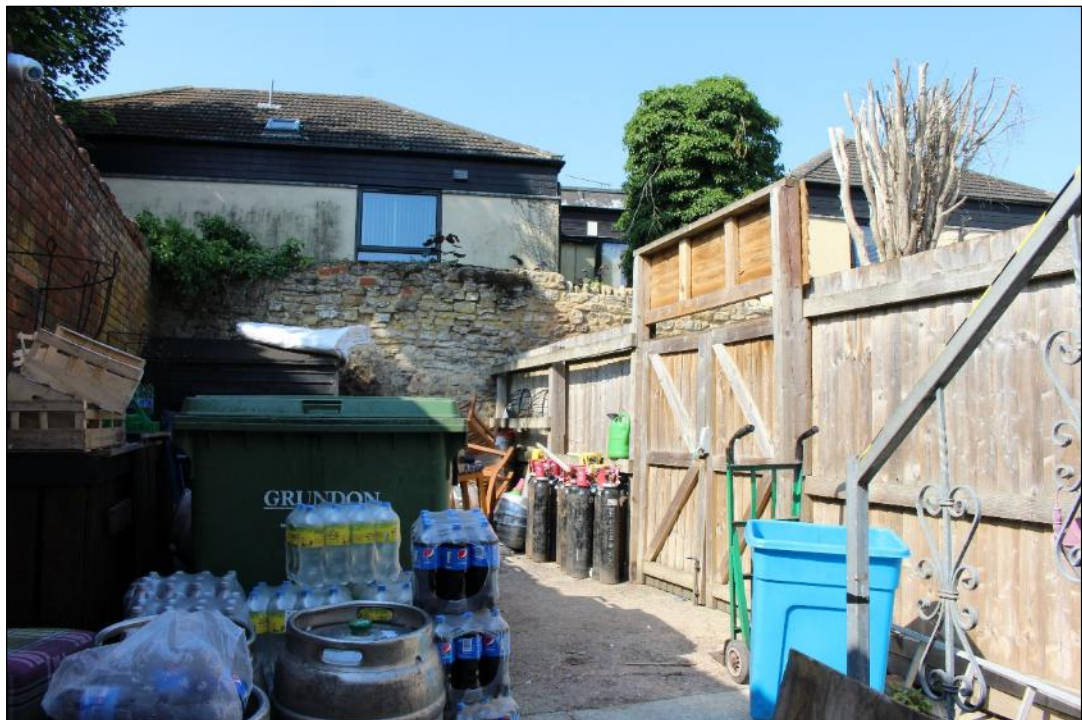
**Photo 48: An overview of the rear yard from the north-east.**

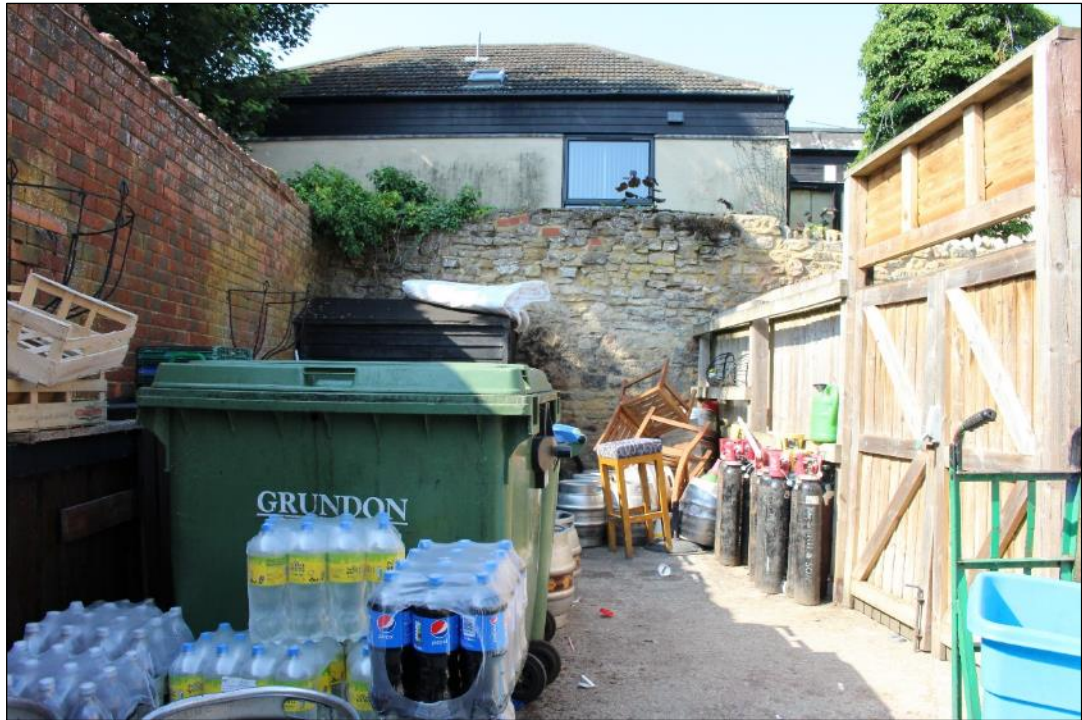
**Photo 49: An overview of the rear yard from the north.**

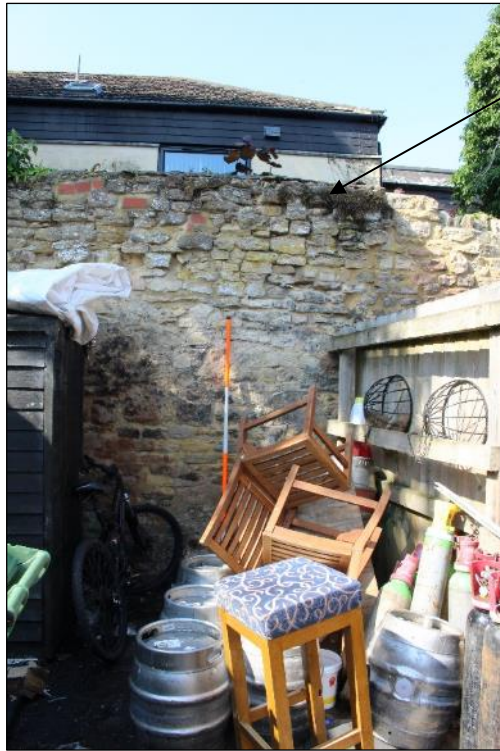
Capped rubblestone wall

Photo 50: Detail of the eastern extent of the southern boundary wall from the north.

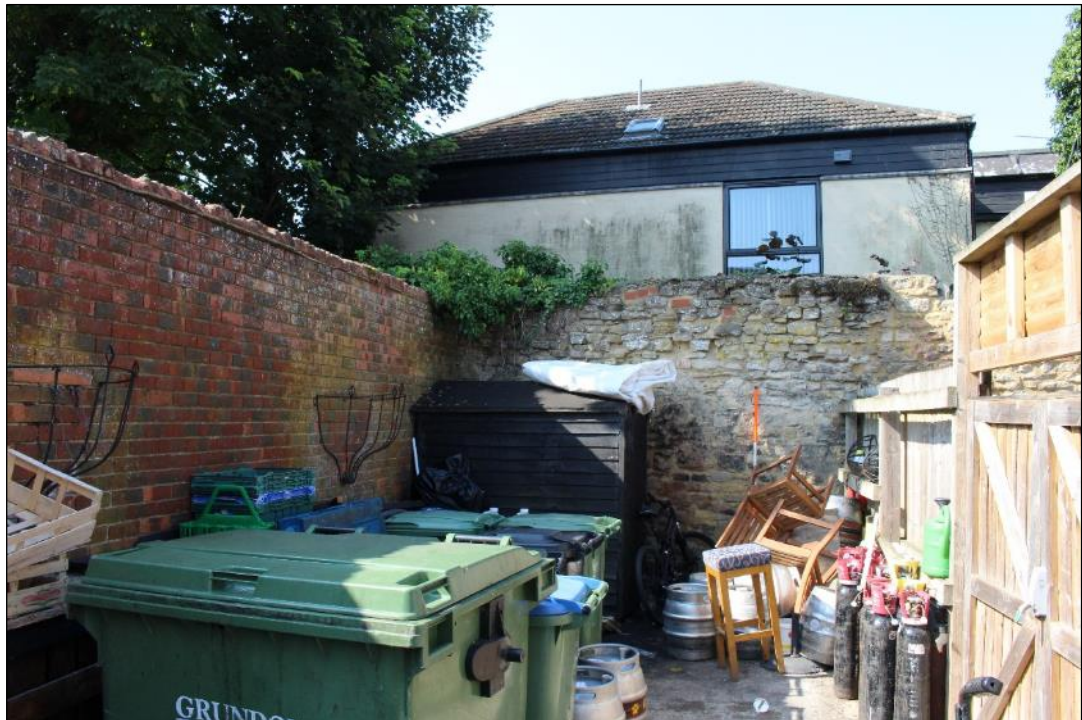
Photo 51: An overview of the brick eastern boundary wall and the southern stone boundary wall from the north-west.
