# The Old George, High Street Stony Stratford Milton Keynes

*Historic Building Recording*

CA Project: MK0097

October 2019

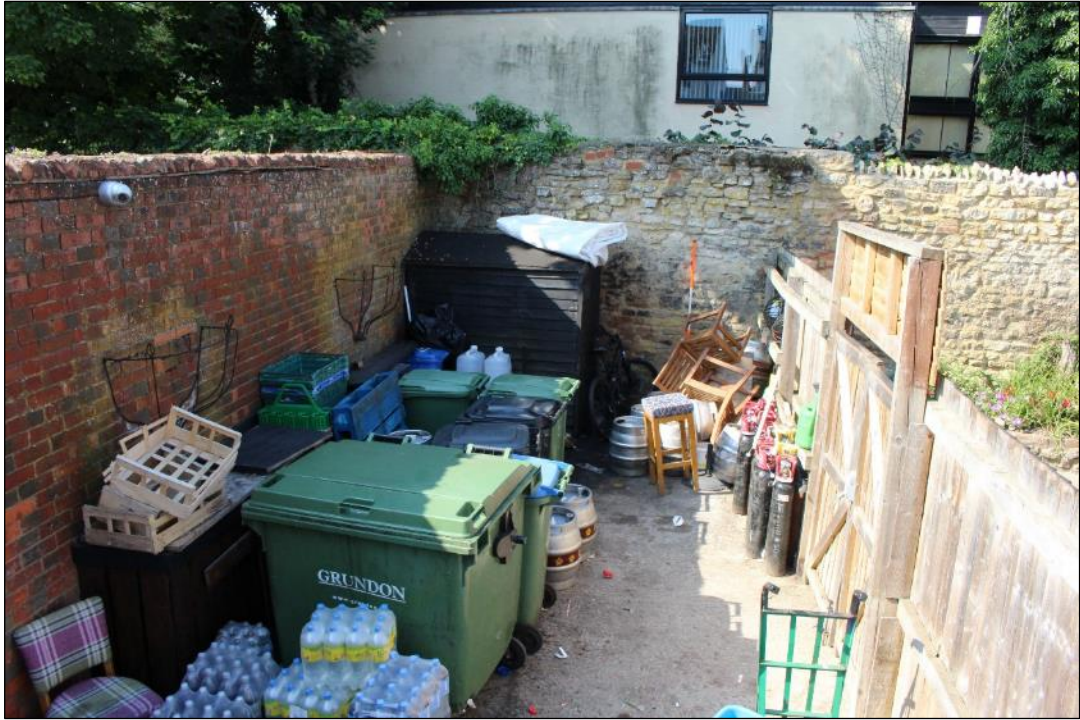
Photo 52: An overview of the rear yard from the late 20th-century staircase.

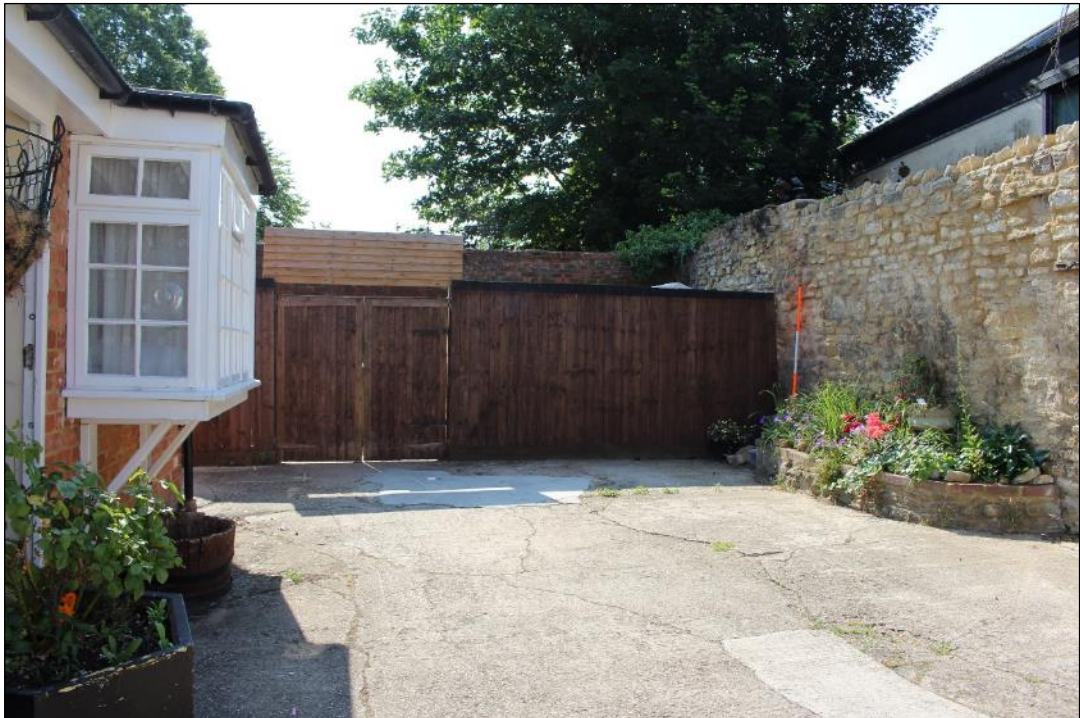
Photo 53: An overview of the rear yard and southern boundary wall from George Yard to the east.

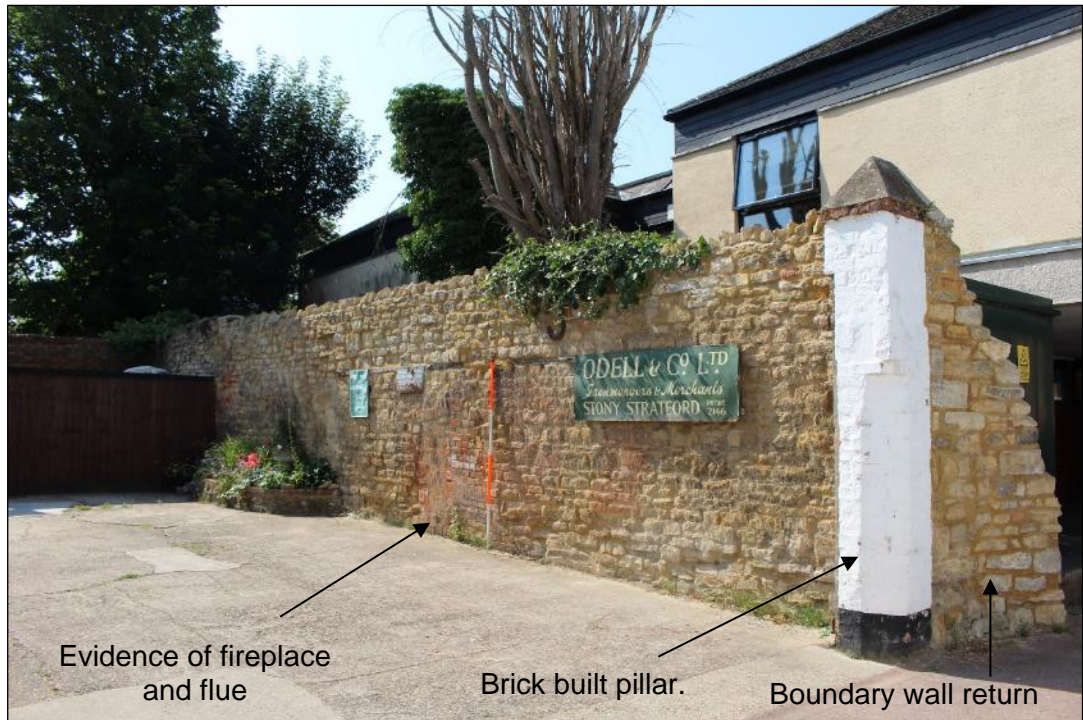
- 
- 4.14. The western extent of the wall contains an area of brickwork which appears to be the remains of a blocked brick fireplace and adjoining flue (Photos 54 and 55). A strong pink tinge to the stonework around the fireplace suggests that there was a serious fire around the fireplace, and that it was constrained to the west by a wall of some kind as it has a straight edge there. Further reddening and possible discontinuities where the present wooden fence joins the wall are visible (Photos 56-58). This wall represents an old boundary, probably related to changes in the land holdings to do with the market place.

**Photo 54:** The stone boundary at the southern extent of the Site with its return in to the plot south of The Old George.

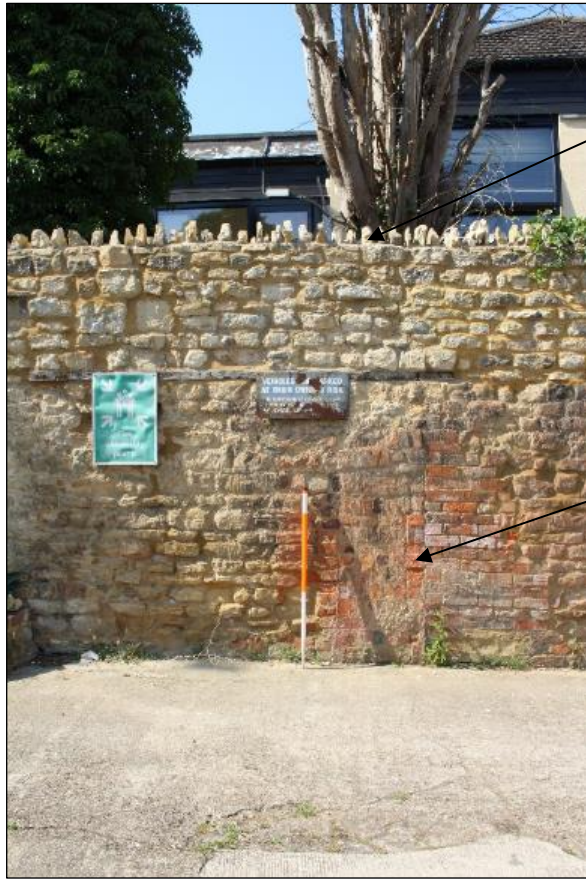
Upright coping stones

Evidence of fireplace  
and flue

**Photo 55: Evidence of a former brick fireplace and flue relating to a now demolished structure visible on the 1st edition Ordnance Survey map.**

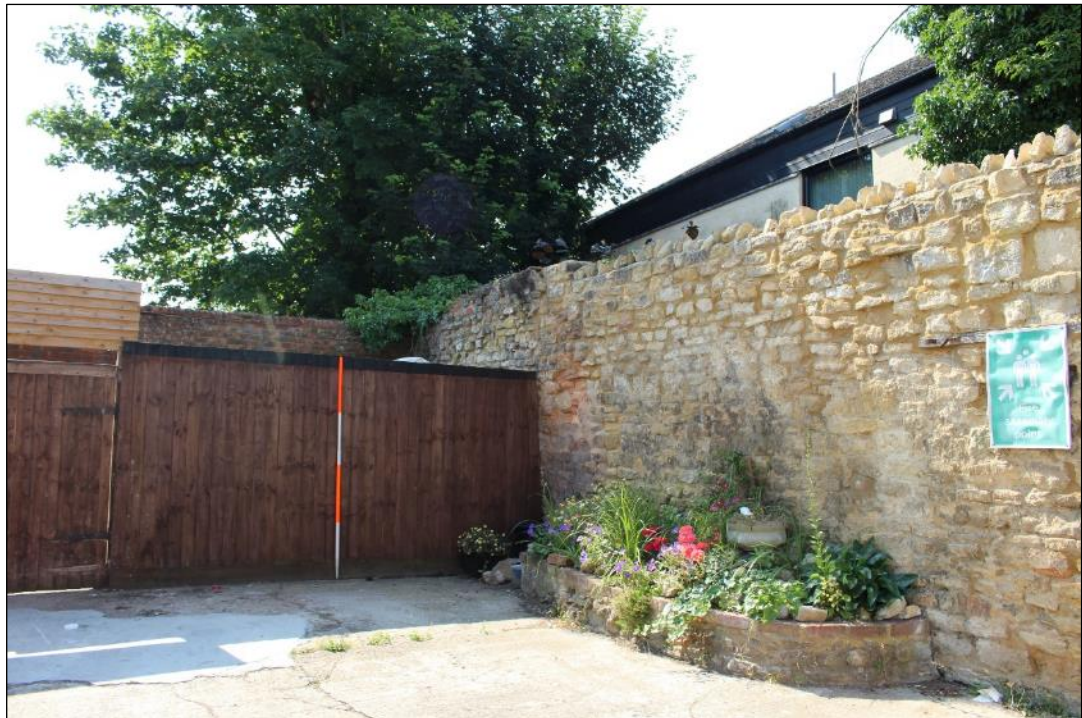
**Photo 56: The southern boundary wall form the north-west.**

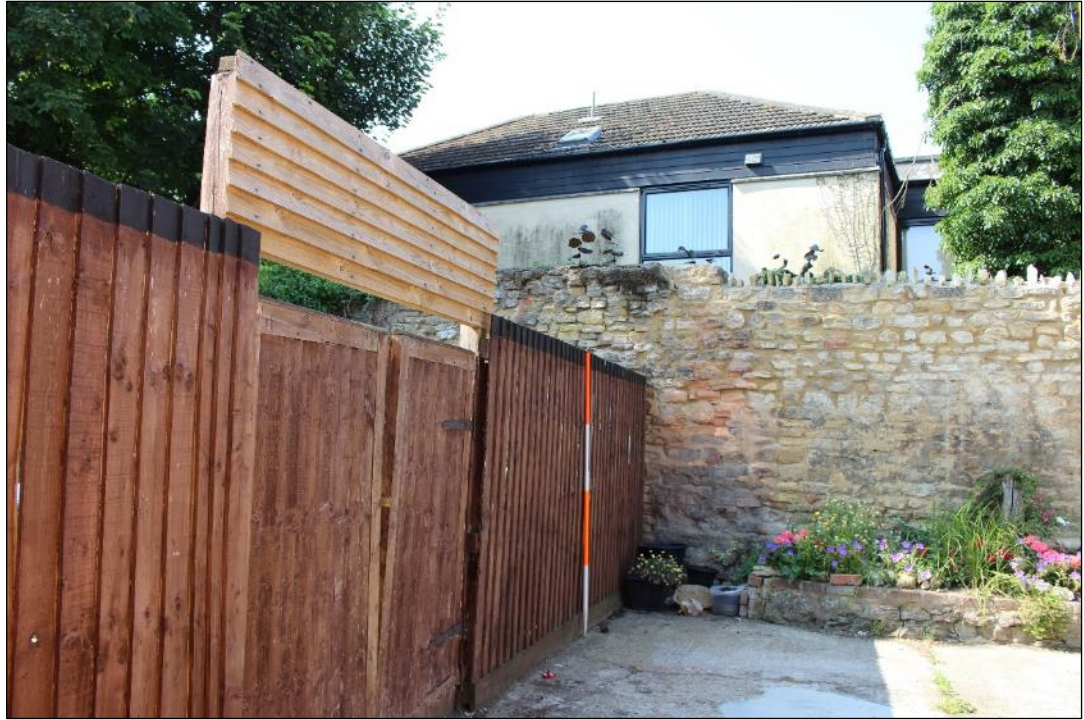
**Photo 57: The eastern extent of the boundary wall from the north.**

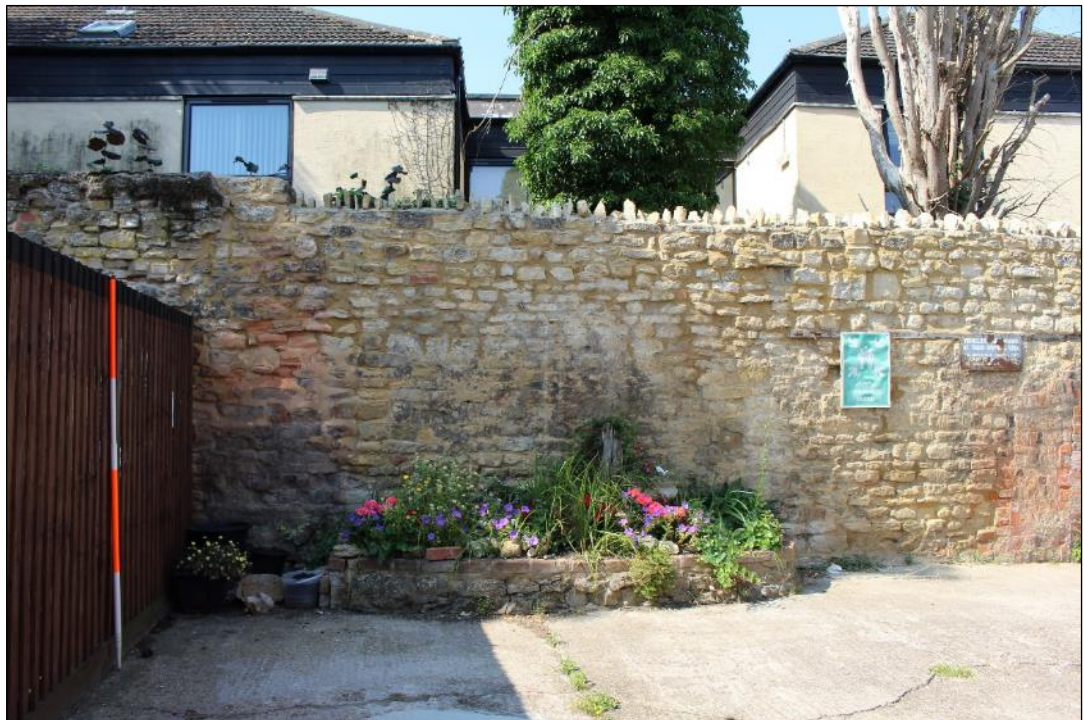
- 4.13. The southern side of the yard is bound by a stone rubble wall which dates to at least the late-19th century, as it is depicted on the 1881 25 inch Ordnance Survey map. A stub of the southern return of the wall survives but there is no sign of a return northwards (Photo 54). The gate pillar to the south of the entrance in to the rear yard from the west is a later brick-built addition which is likely to have been added in the late 19th or 20th century. The wall is entirely of rubble stone construction, its eastern extent has been capped neatly with rubble stone and is set slightly higher than the eastern extent of the wall which has been finished with random sized upright coping stones.

**Photo 58: The western extent of the southern boundary wall is finished with upright coping stones.**

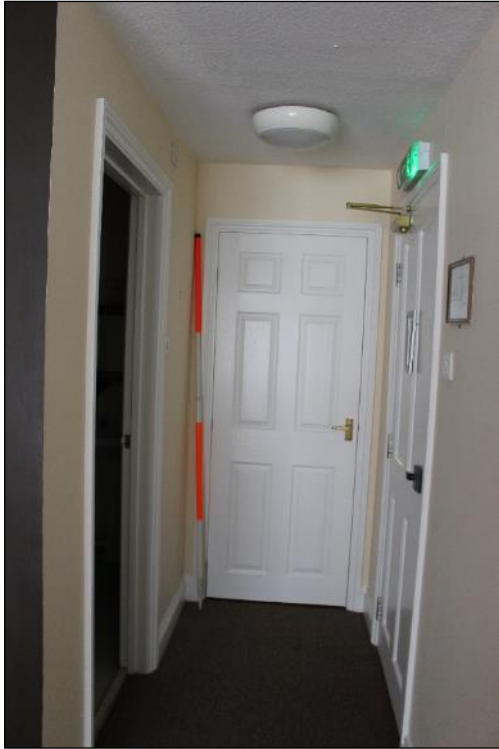
**Photo 59: An overview of the south-western extent of Room 10.**

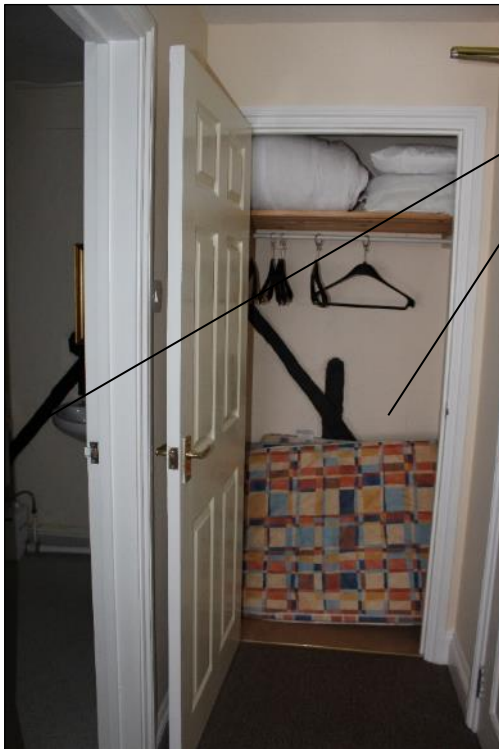
Exposed timber  
truss

**Photo 60: An overview of exposed timber framing within the cupboard of Room 10.**

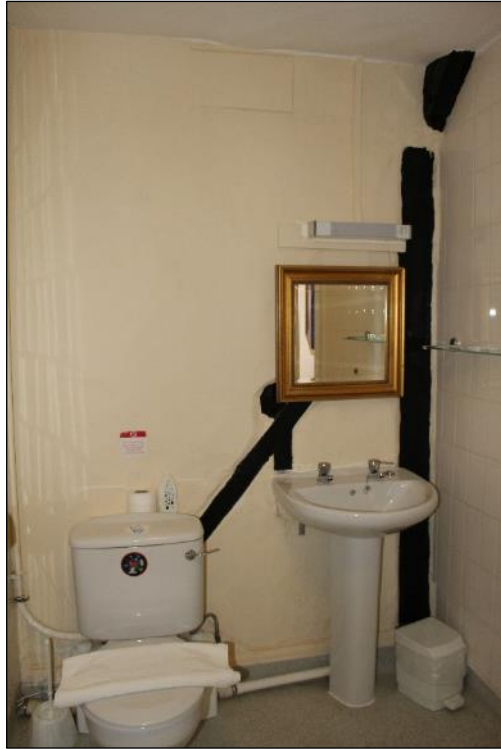
**Photo 61: An overview of the timber roof truss set within the southern wall of Room 10.**

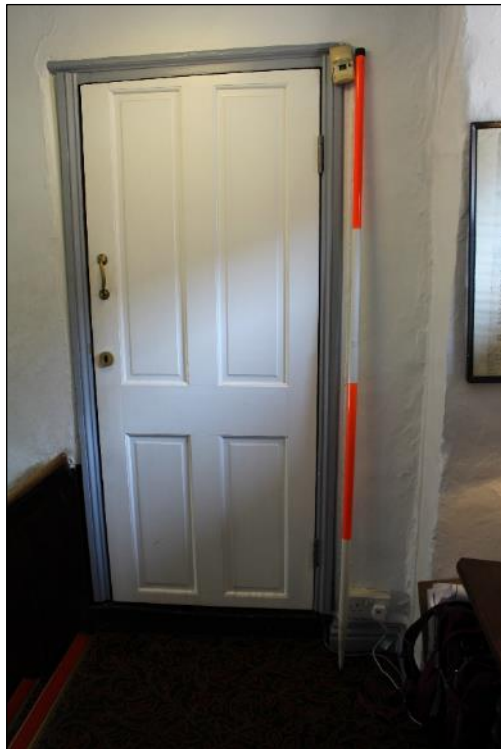
**Photo 62: Detail of four-panelled door to cupboard at the top of the stairwell.**

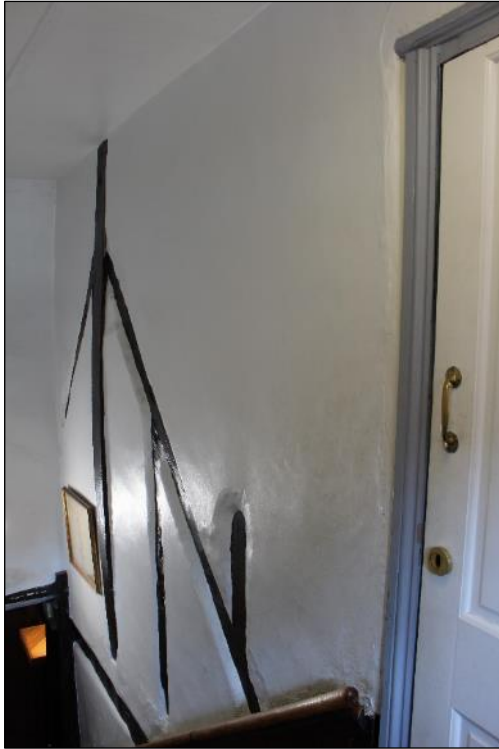
**Photo 63: Detail of exposed timber framing/ roof truss within the northern wall of the stairwell.**

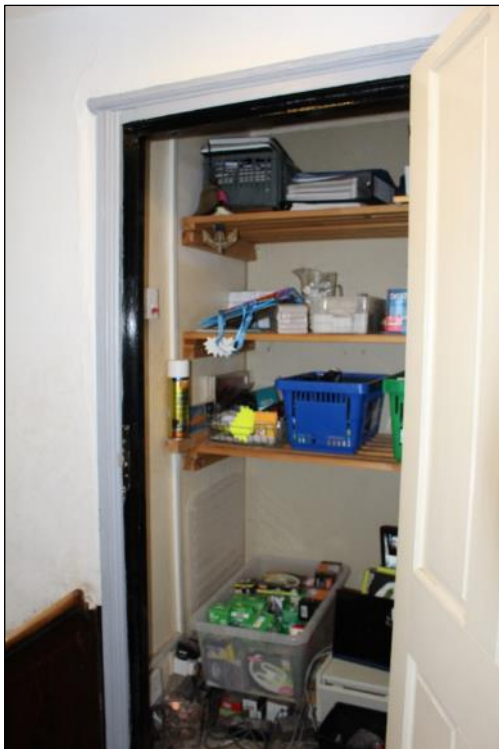
**Photo 64: Detail of the open cupboard at the top of the stairwell.**

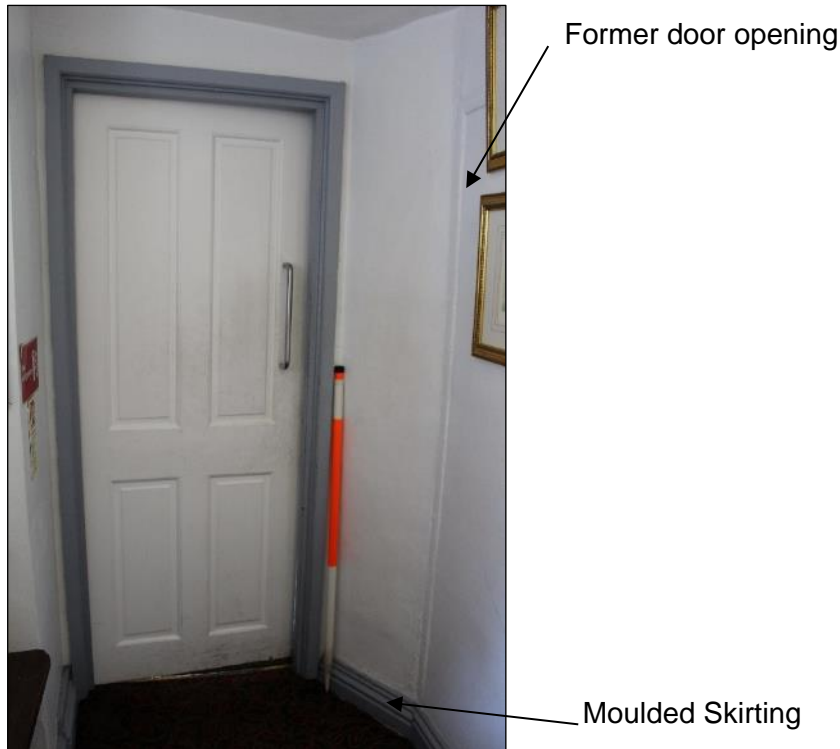
**Photo 65: Detail of four panelled door between the landing and eastern corridor.**

- 4.19. The landing at the top of the stairwell appears to have been remodelled and evidence of slight door jambs and lintels (Photo 65) within the eastern wall of the Linen Store suggests that the Linen Store was accessed by a now blocked door opening from this landing/corridor. The first-floor landings and C-shaped corridor retain fixtures and fittings of late 18th/ early 19th-century style including moulded timber skirting towards the southern extent of the eastern corridor (Photo 76). The section of corridor which runs on an east to west axis (Photo 66) has an alcove at its western extent with a moulded timber shelf (Photo 43 and 44). The function of this alcove is not known.

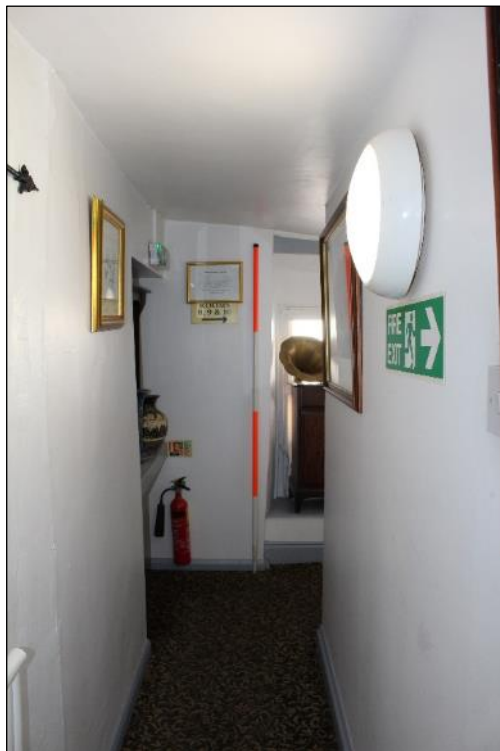
**Photo 66: The corridor between the first floor staircase and the Linen Store.**

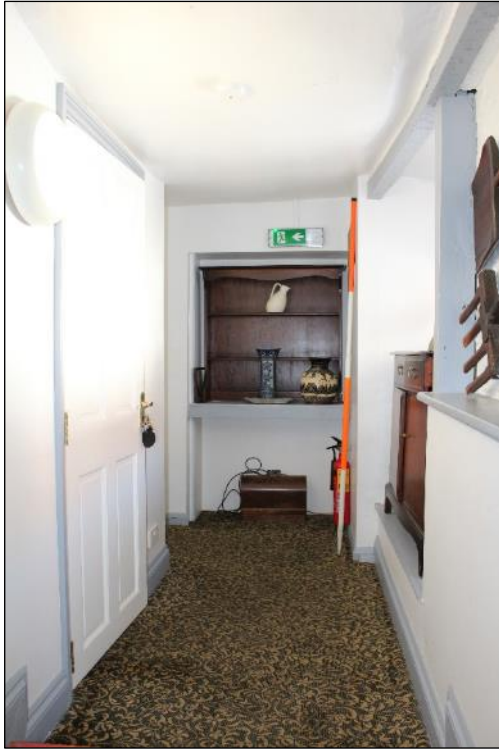
**Photo 67: The western corridor from the north.**

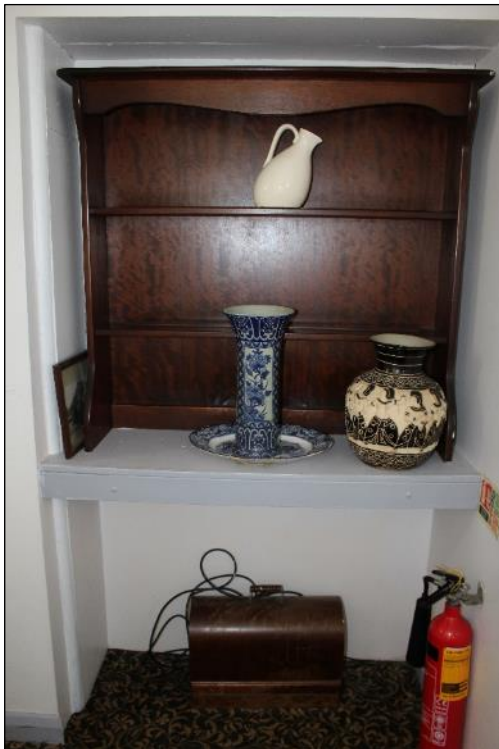
**Photo 68: An alcove with an in-built timber shelf within the south-western corner of the first floor corridor.**

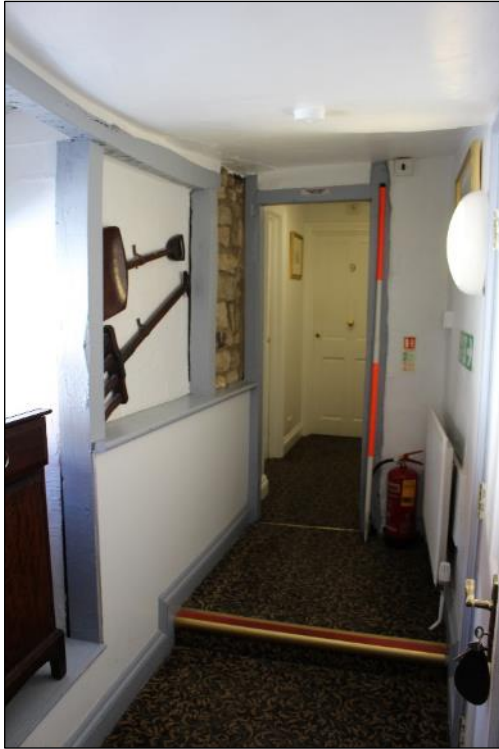
**Photo 69: An overview of the western corridor from the south.**

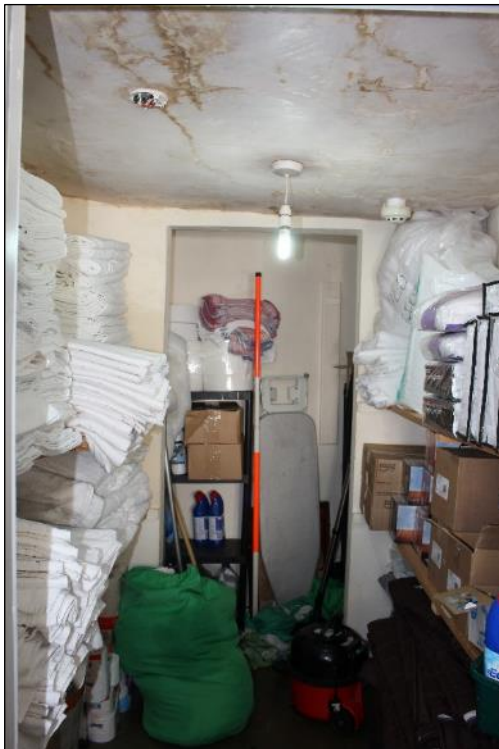
**Photo 70: An overview of the Linen Cupboard from the west.**

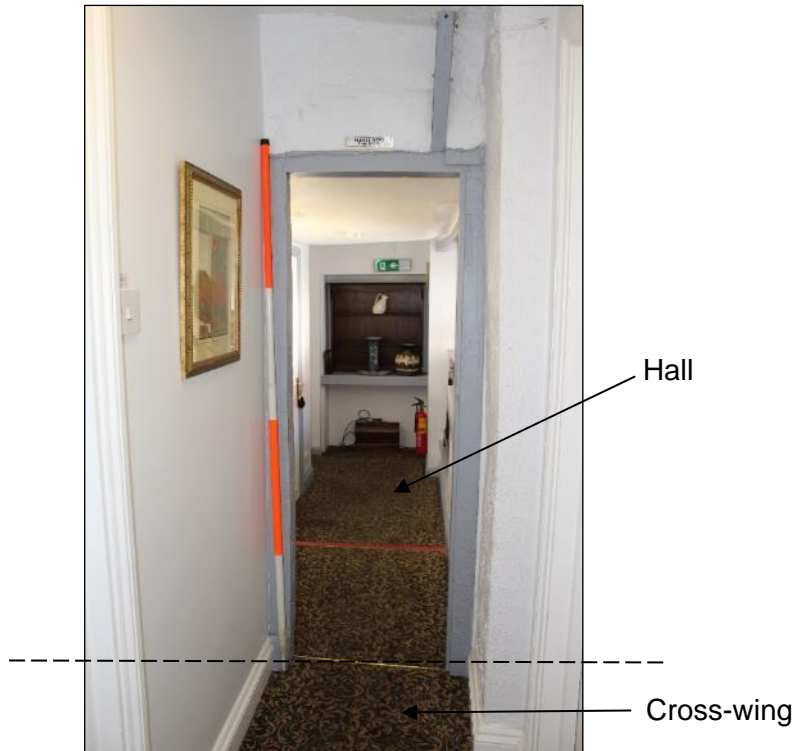
**Photo 71: An overview of the western corridor from the north.**

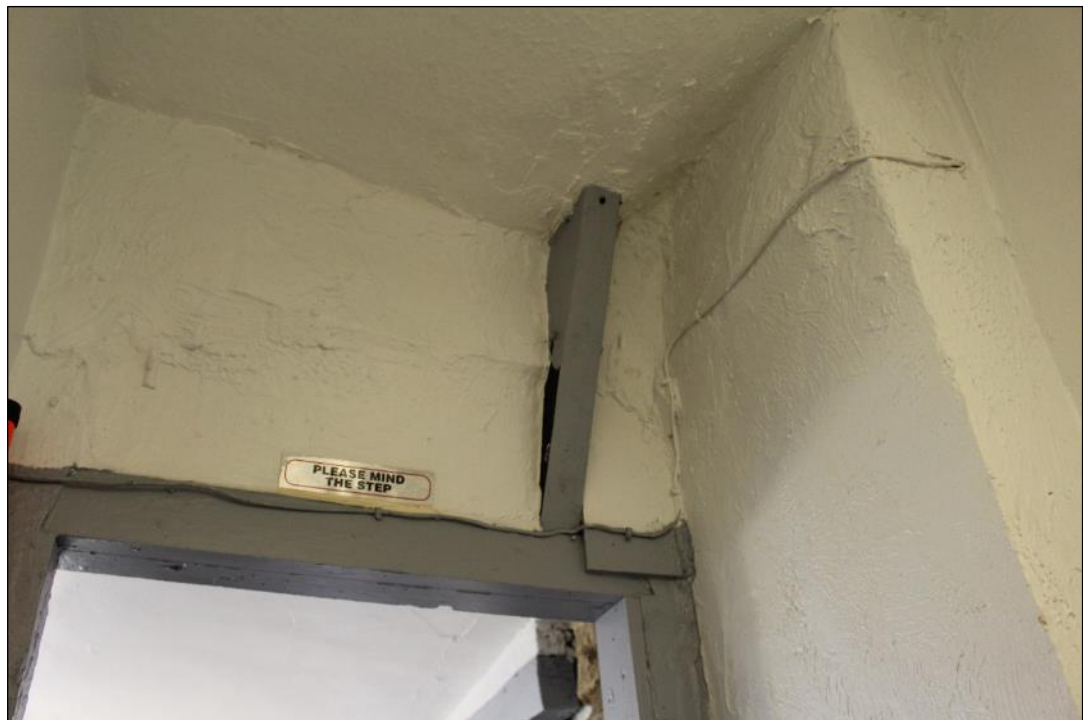
**Photo 72: Detail of bracket above door opening within the western corridor.**

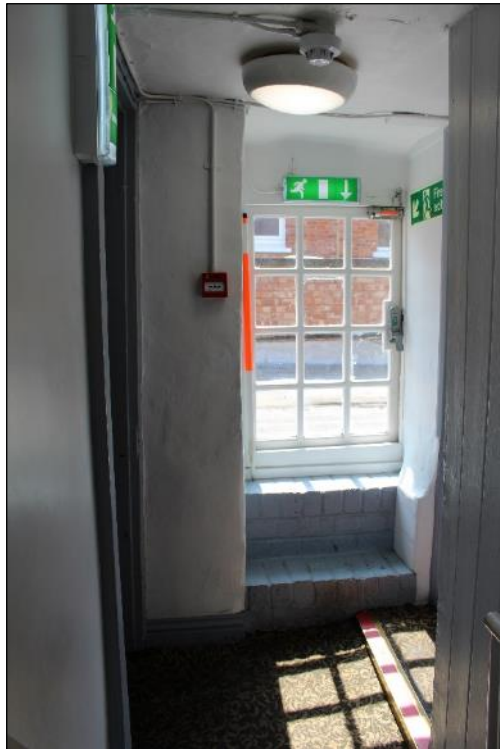
**Photo 73: External window/door opening leading on to the flat roof of the 20th-century building.**

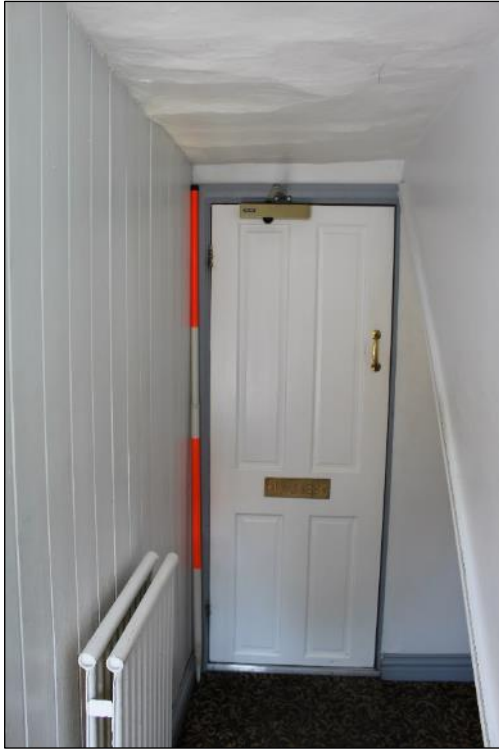
**Photo 74: Door to the Female Toilets.**

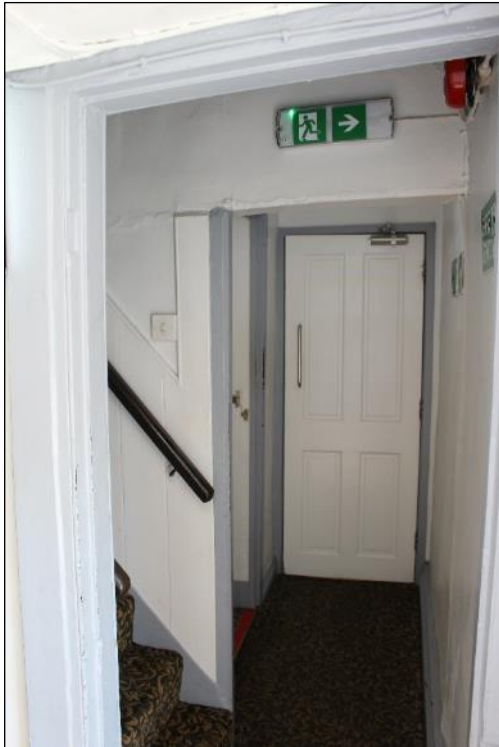
**Photo 75: An overview of the southern extent of the eastern corridor.**

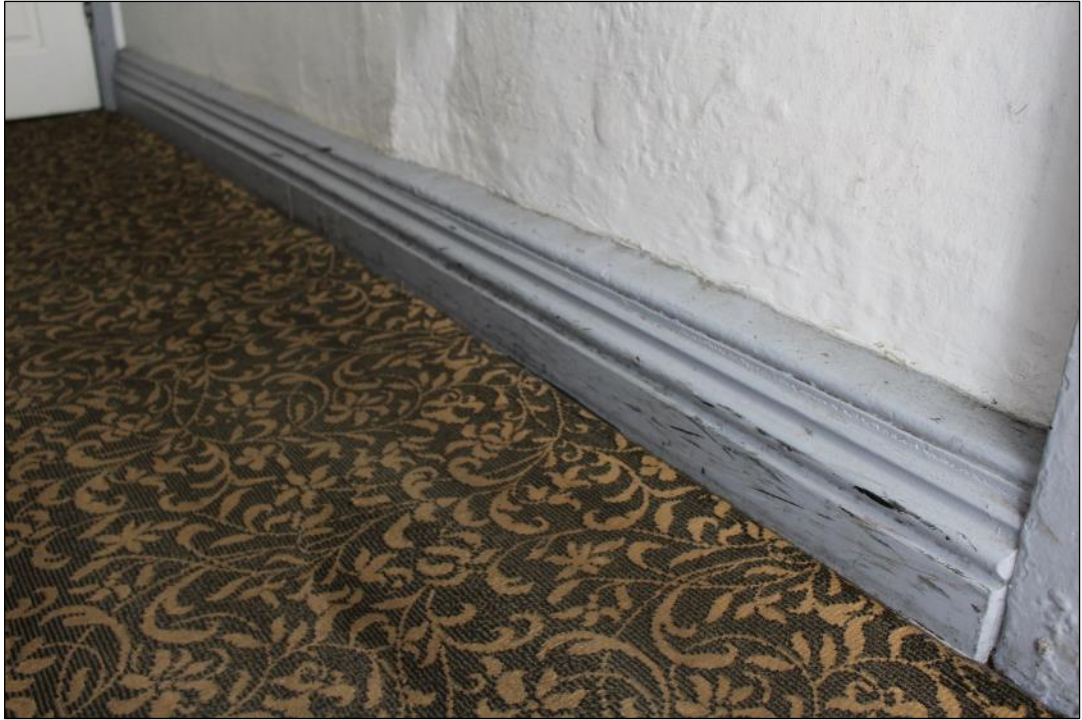
**Photo 76: Detail of moulded skirting against the eastern elevation of the eastern corridor.**

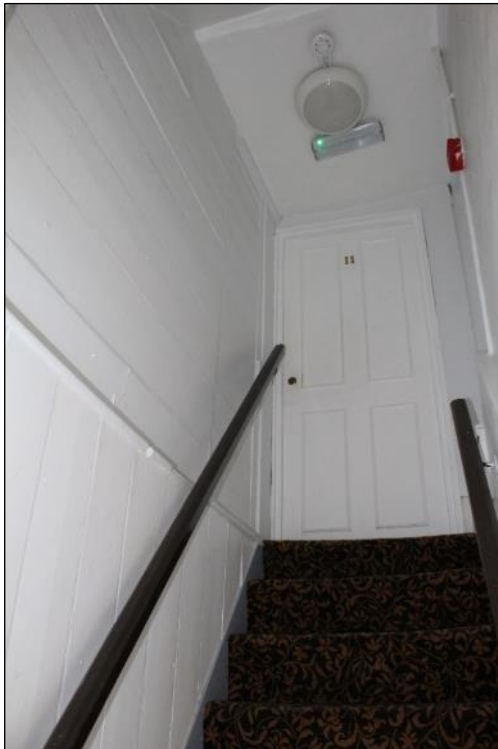
**Photo 77: Stairs between the southern extent of the first floor and the second floor.**

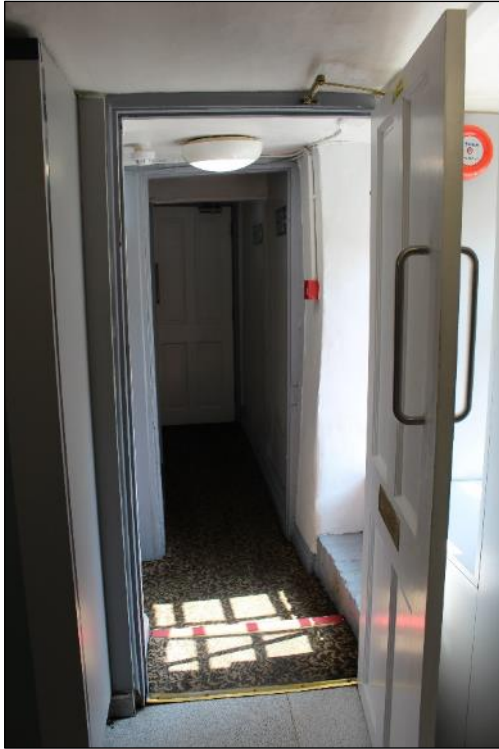
**Photo 78: An overview of the eastern corridor from the south.**

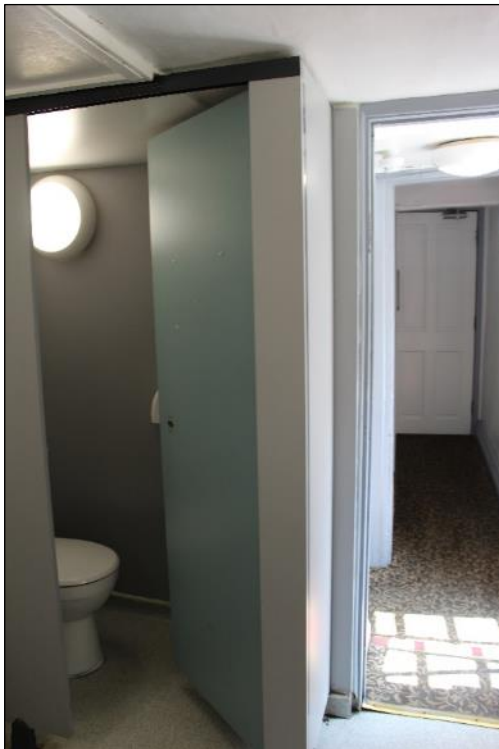
**Photo 79: An overview of the Male Toilets from the south.**

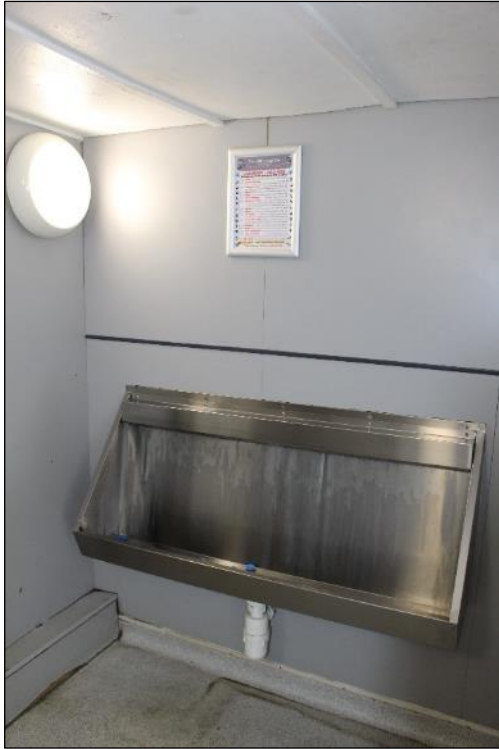
**Photo 80: An overview of the Male Toilets from the east.**

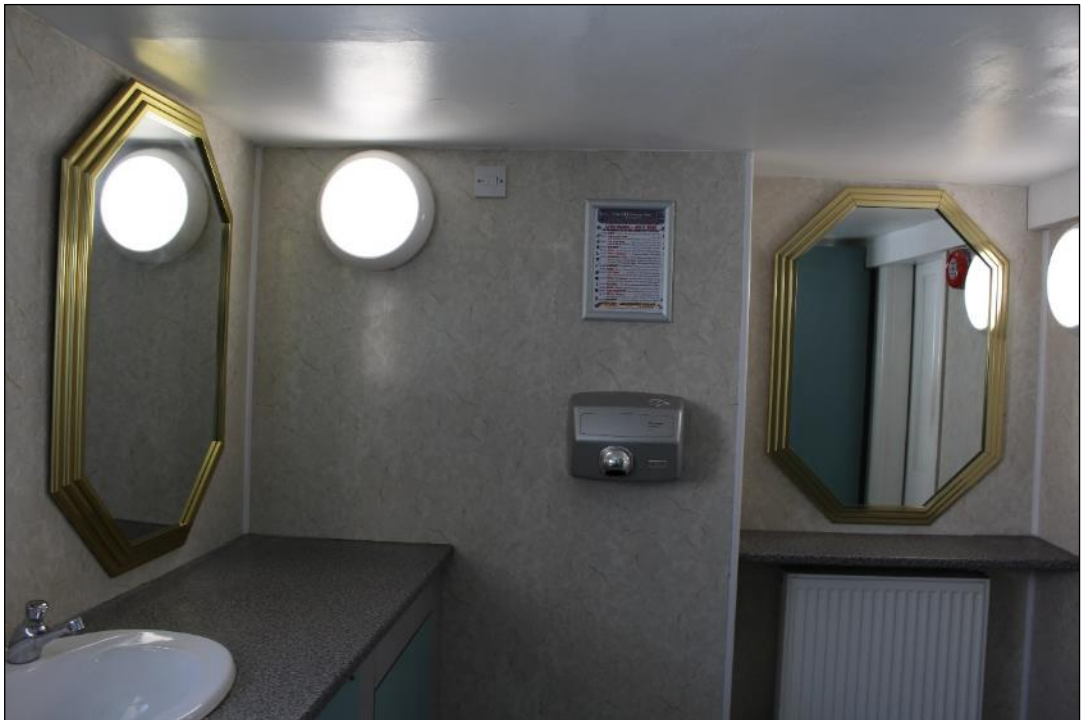
**Photo 81: The Female Toilets from the south.**

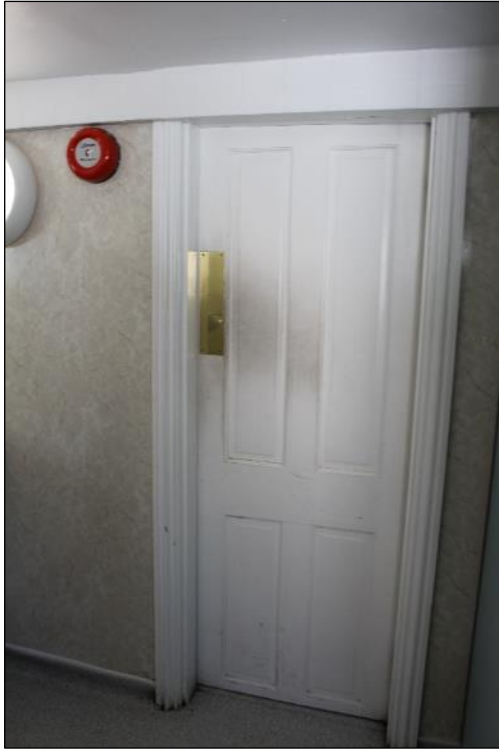
**Photo 82: Four panelled door within the eastern wall of the Female Toilets.**

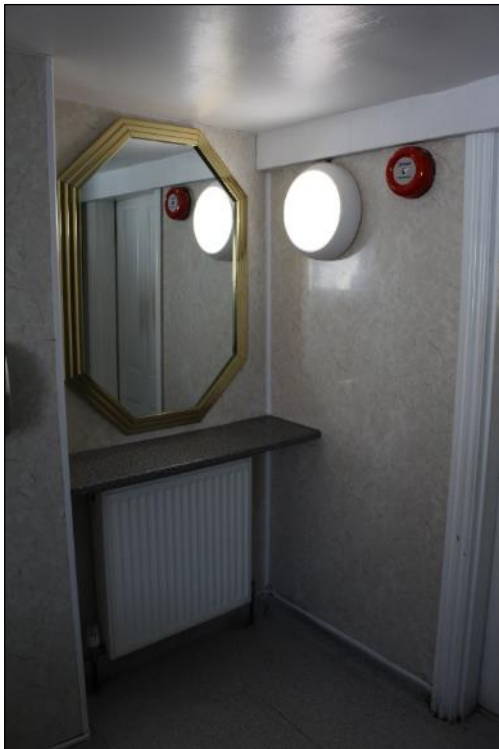
**Photo 83: The north-eastern extent of the Female Toilets.**
