Princess Royal Barracks Deepcut Surrey

41 Squadron Lines Buildings

HISTORIC BUILDING RECORDING

CA Report: AN0107_1

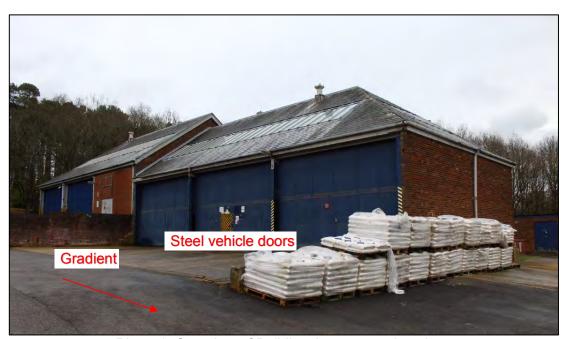
- 4.6. The western elevation (Photo 1) incorporates five large steel doors that allow for the ingress of vehicles to the building's interior. The doors are arranged such that they form the entirety of the western elevation, save for one bay where the door has been replaced with brick, laid in stretcher bond (Photo 2). A low brick wall, laid in English bond (Photo 3), provides an external boundary between the two parts of Building A and acts as a retaining structure where the northern area of hardstanding lies at a higher level.

Photo 1: Overview of Building A, western elevation

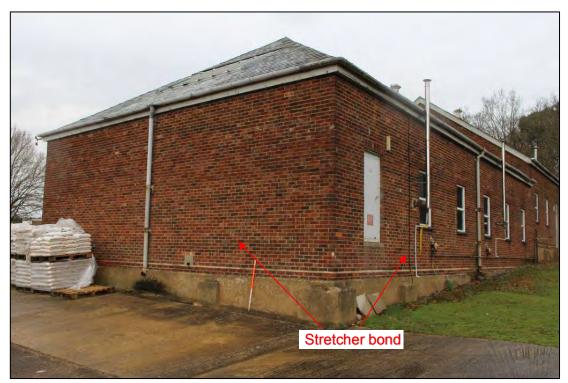
4.8. The eastern elevation of Building A (Photo 4) incorporates a regularly spaced row of windows. Bricks are laid in stretcher bond, interspersed with vertical lines of headers, generally positioned at the midpoint between windows and at the midpoint of the windows themselves. The eastern elevation evidences industrial activity through the presence of various ventilation chimneys and service pipes. The age and condition of visible services evidences a gradual accretion or replacement of these features over time as technology and requirements have advanced.

Photo 4: Southern and eastern elevations of Building A

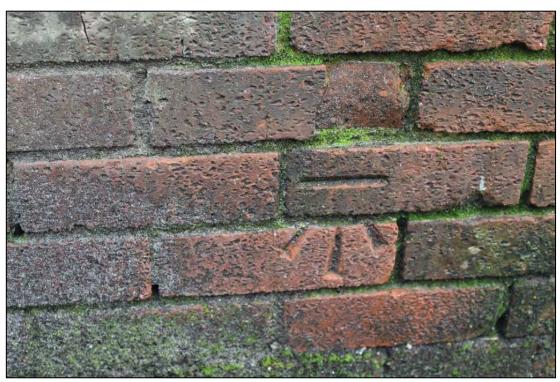
found on buildings and other semi-permanent structures.⁶ The arrow, or 'pheon' has historically been used to indicate government property, however, the presence of a horizontal line above the pheon suggest the more likely purpose as a Benchmark Locator.

Photo 6: OS Benchmark Locator at western extent of Northern elevation

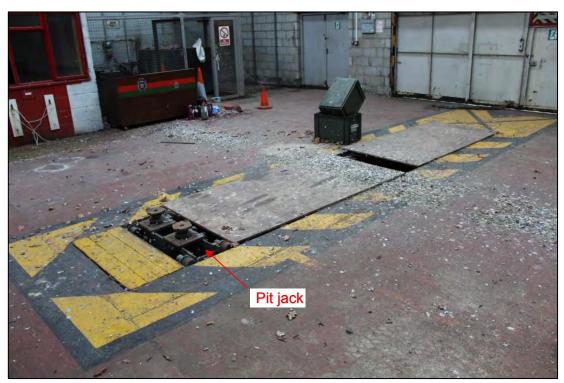
- 4.11. Room A1 incorporates two vehicle inspection pits (Photo 10), the southernmost of which retains a single pit jack, used for lifting vehicles. Whilst the room is generally clear of loose equipment and fittings, several fixtures remain, such as air compressor hoses, generator and chain hoists. The age of these fixtures is apparently varied, however, they generally appear to have been fitted subsequent to the building's initial construction in the late 1930s/1940s.
- 4.12. Room A2 (Photo 11) is formed of a breeze block construction at the south-eastern corner of Room A1. The room appears to have been built at an indeterminate point after the construction of the building and likely functioned as an office. To the west of Room A2 remains a timber desk bearing the coat of arms of the Royal Logistic Corps (RLC).

Photo 10: Vehicle inspection pit within Room A1, incorporating pit jack

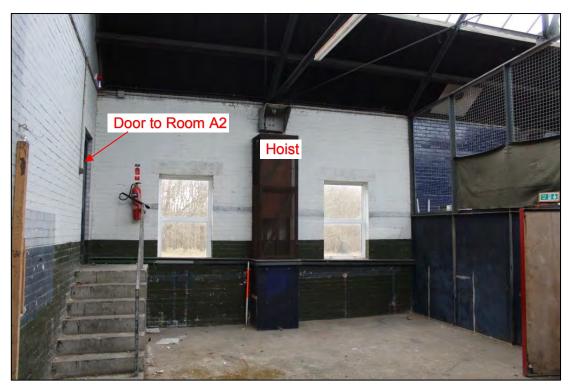
4.13. Through access is achievable via Room A2 to the southern part of Building A. A flight of concrete stairs leads into Room A3 (Photo 12). The room is devoid of features except for a single hoist mechanism. The eastern wall incorporates two windows whilst the western wall incorporates a single vehicle door. The northern wall of Room A3, separating it from Room A1, is laid in stretcher bond from the ground to approximately halfway up, before transitioning to English bond (Photo 13). This anomalous pattern is unusual and suggests either a degree of replacement or repair to the wall or that it was originally constructed in this way for a particular structural/aesthetic reason. A stretcher bond would normally relate to a half brick depth wall, often used as part of a cavity wall installation, whereas English bond is typically a full brick depth.

Photo 12: Overview of Room 11, looking east

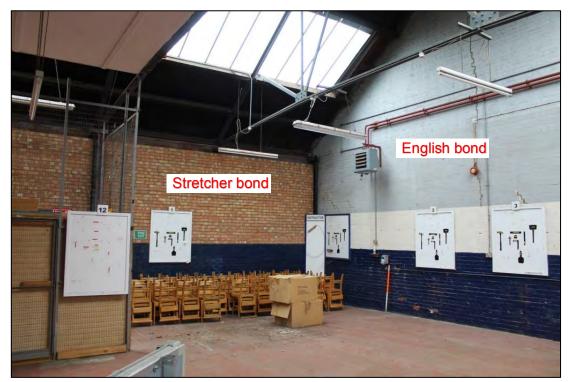
area to the northern extent of the space, separated from Rooms B6 and B7 by a stretcher bond brick wall and from Room B5 by a metal mesh partition. The north wall of the room, separating the northern half of the building from the southern half, consists of English bond brickwork (Photo 25).

Photo 25: Overview of Room B4, looking north-west

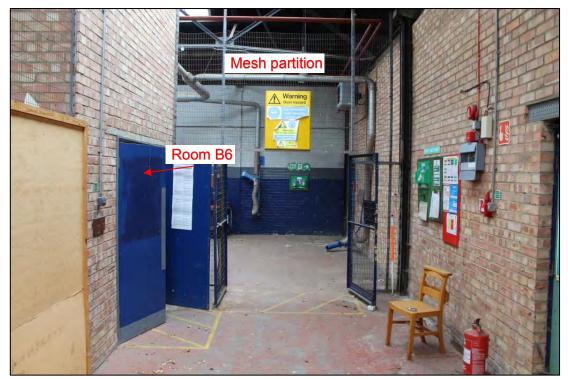
4.20. Room B5 (Photo 27) is accessed from Room B4 via a metal mesh partition and forms a lobby area in this part of the building. Rooms B6 and B7 (Photo 28) are located within the internal brick structure and appear to have functioned as a possible changing area or equipment storage area.

Photo 27: Overview of Room B5, looking south

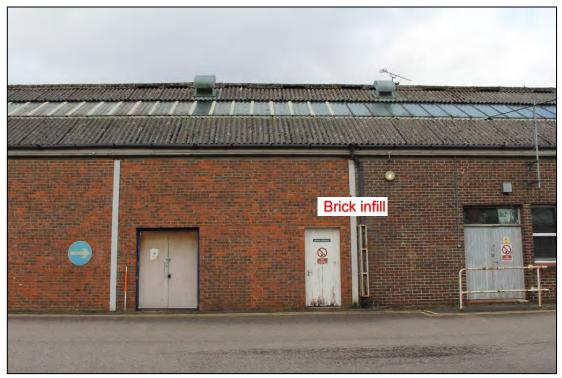
the southern elevation (such as those in Photos 31, 32 and 33) provide no structural support for the building and have been constructed to provide clerical or workshop space internally. The eight brick bays in the southern elevation may therefore represent a post-construction alteration of the building. The brick within the three westernmost bays of the southern elevation appears to contrast with that prevalent in the remaining elevations and within adjacent bays (Photo 36), adding credence that at least part of the southern elevation had been altered since the construction of the building.

Photo 36: Detail of infilled bays within southern elevation of Building C

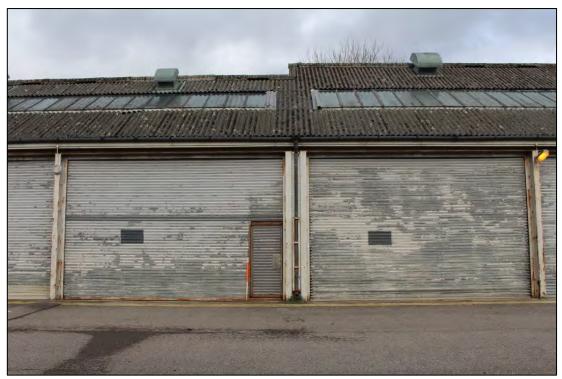
4.25. The remaining bays within the southern elevation each incorporate a single metal roller door (Photo 37), for the ingress of vehicles. Their design and form is different from the doors found in Buildings A and B and possibly represent later replacements of earlier doors. Fenestration to the northern elevation consists of regularly spaced windows, each comprising a one-over-one unit that were likely installed later (Photo 38). The eastern elevation encompasses a further roller door (Photos 33 and 34), of modern construction, which incorporates brick pilasters to either side, possibly a further later addition.

Photo 37: Overview of roller doors in southern elevation of Building C

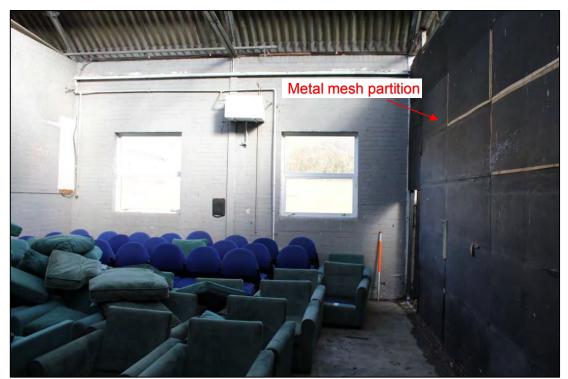
4.30. Room C12 (Photo 47) is a single bay wide and comprises a single vehicle roller door to the southern extent that incorporates a single wicket door. The room is sub-divided from Rooms C8 and C9 by a brick partition, laid in English bond (Photo 48) whilst the eastern wall of the room comprises a metal mesh partition, separating the room from Room C13. The room is open to the roof structure of the building where metal fan trusses are visible.

Photo 47: Overview of Room C12, looking north

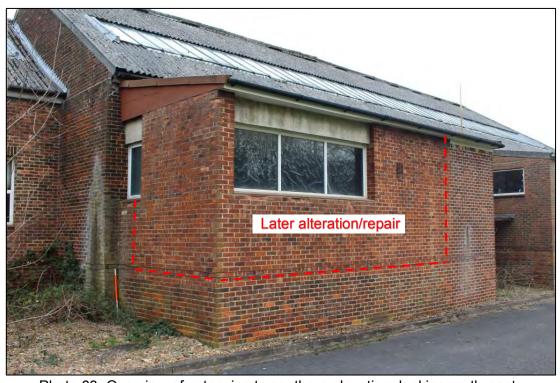
4.37. The southern elevation appears to have been altered to a greater degree than any other external elevation of Buildings A to D. The regular fenestration arrangement found to the northern elevation of Building C is replicated to the southern elevation of Building D but is much altered. There are a series of extensions, two of which (Photos 62 and 63) were constructed between 1965⁸ and 1971, according to aerial photograph (1965) and cartographic evidence (1971; Fig. 7). The extension incorporating Rooms D16 and D17 appears to have been further extended to the south (Photo 62; Fig. 16). The extension incorporating Rooms D9 and D10 appears to have been altered or repaired at a later date (Photo 63).

Photo 63: Overview of extension to southern elevation, looking north-east

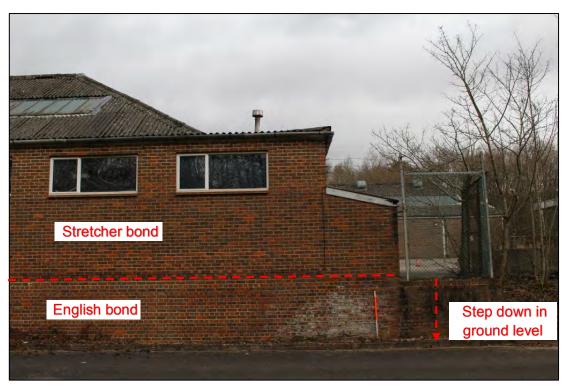
4.39. Building D is situated on sloping ground, falling from north to south. This is evident in Photos 60 and 65 where the lower brick courses of the southern elevation are in English bond and perform a retaining function below the floor level of the building.

Photo 65: Overview of easternmost extension of Building D, looking north

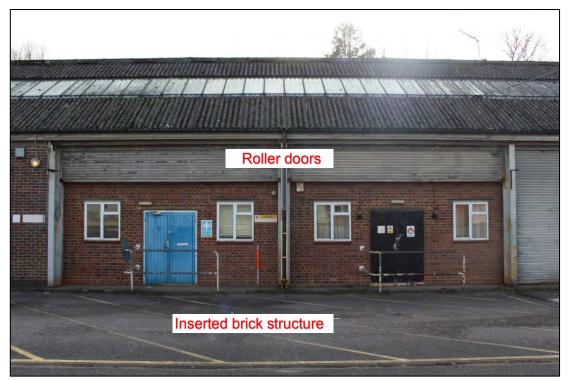
4.40. The northern elevation is functionally similar to the southern elevation of Building C, details of which are discussed in paragraphs 4.23 to 4.25. However, of note is the addition of an internal brick structure to Building D that is positioned behind the extant roller vehicle doors (Photo 66), in contrast to the prevalence for infilling the existing aperture. As a result, the roller doors within these two bays are still *in situ*, demonstrating the phased development of this part of the building.

Photo 66: Overview of brick structure within Building D

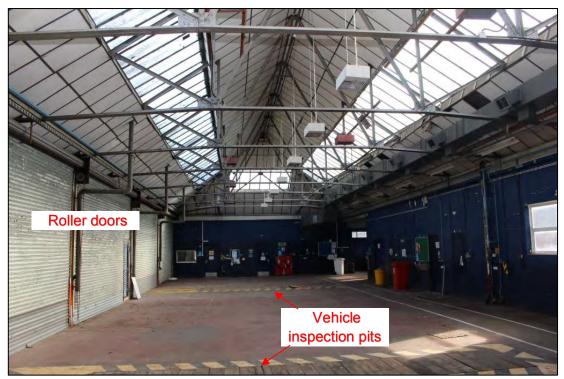
4.42. Room D1 (Photos 67 and 68) incorporates a large, open area, for the apparent maintenance of vehicles/ordnance. The room is similar in proportion to Room C14 in Building C but incorporates three vehicle inspection pits (Photo 69) and mechanical plant (Photo 70) that is more suggestive of a maintenance/workshop function more so than a storage function. The roof trusses are of a fan configuration and match the form of trusses found throughout Building C.

Photo 67: Overview of Room D1, looking east

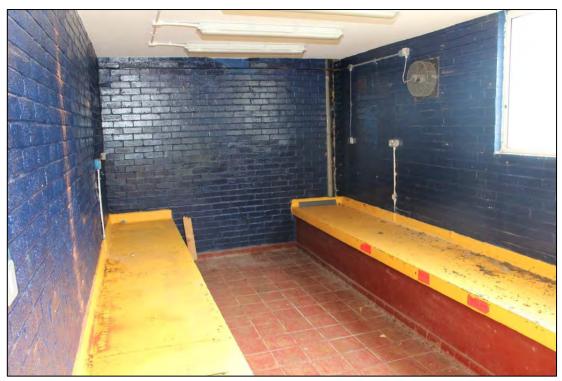
4.46. Rooms D9 and D10 are located within an extension to the southern extent of Building D and are both accessed via Room D1. Room D9 incorporates a WC whilst Room D10 (Photo 76) incorporates a pair of benches, with one labelled as 'spill kit', and a quarry tiled floor, suggesting that the Room was possibly formerly used for the handling of liquids.

Photo 76: Overview of Room D10, looking east

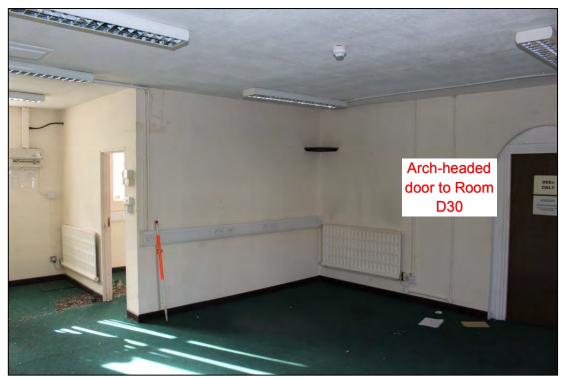
4.49. Room D27 (Photo 82) is located within the western half of the inserted brick structure and likely formerly incorporated a clerical function. Room D28 contains no features of note and forms a small corridor to Rooms D29 and D30. Room D29 incorporates a WC and occupies a small extension structure to the southern extent of the building whilst Room D30 (Photo 83) comprises a single room that exhibits no evidence of its former function. A doorway with arched head provides alternative access between Rooms D27 and D30 (Photo 84). The Area Plan (Fig. 17) records Room D27 as a 'Driver rest room' and Room D30 as a 'Driver Training Room'.

Photo 82: Overview of Room D27, looking south-west

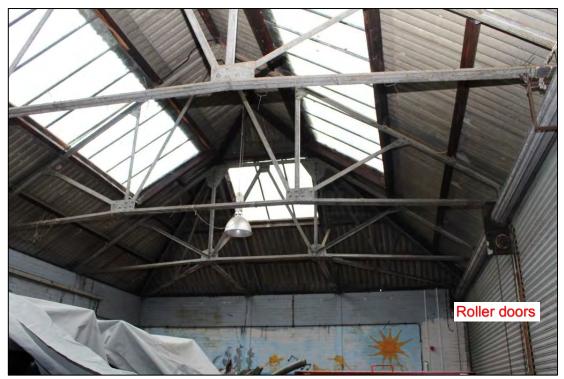
4.50. Room D31 (Photo 85) comprises a large, open plan space located to the western extent of the building. The Room is three bays wide and is open to the roof space where the steel fan truss arrangement is appreciable. The southern wall of the room incorporates a regular fenestration arrangement (Photo 86) that consists of modern units above bullnose brick window sills. The inserted brick structure containing Rooms D24 to D30 is visible to the eastern extent of Room D31 (Photo 87). The retention of the roller doors to the northern side of the structure evidence its later construction. The room is presently used for the storage of vintage carriages, however the Area Plan specifies a former use as staff car park (Fig. 17).

Photo 85: Overview of Room D31, looking west
