# Greendale Farm Clyst St. Mary, Devon

*Historic Building Recording (Demolition)*

CA Project: EX0074

April 2020

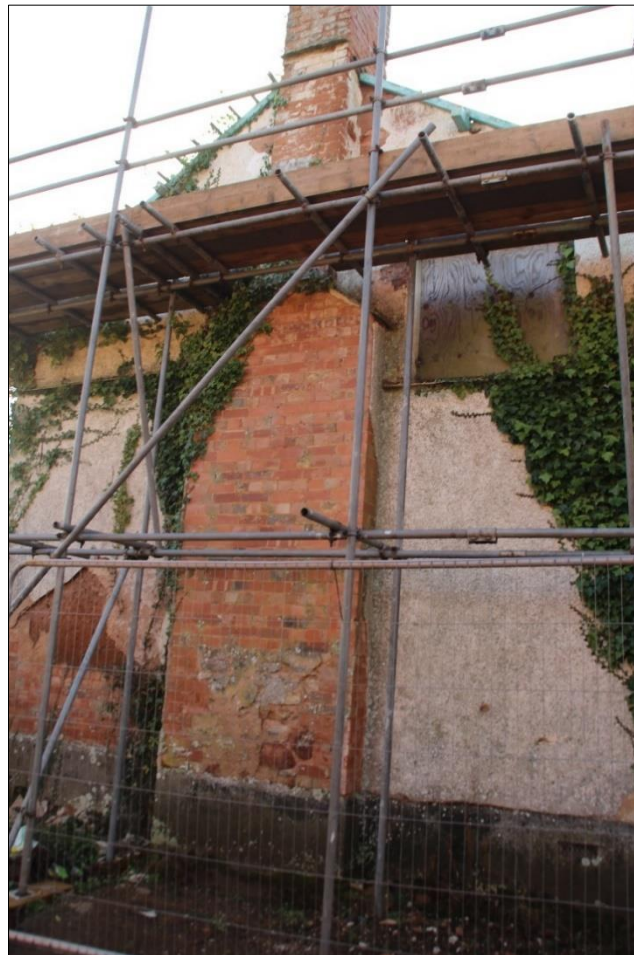
- 4.5. Of interest here is the use of brick refacing to the lower sections, with cob above, as shown in Fig. 9 and 10. As this is conjectured to be the older part of the Building, it is likely that this gable wall was repaired, stabilised with machine made brick or partially rebuilt along with the chimney stack, possibly during the 1900 phase of works to the property. As Morriss identifies, the lower portion of the chimney stack is constructed from machine cut pale red brick, whilst the upper section has an older patina.

**Fig.9 The north elevation and gable end**

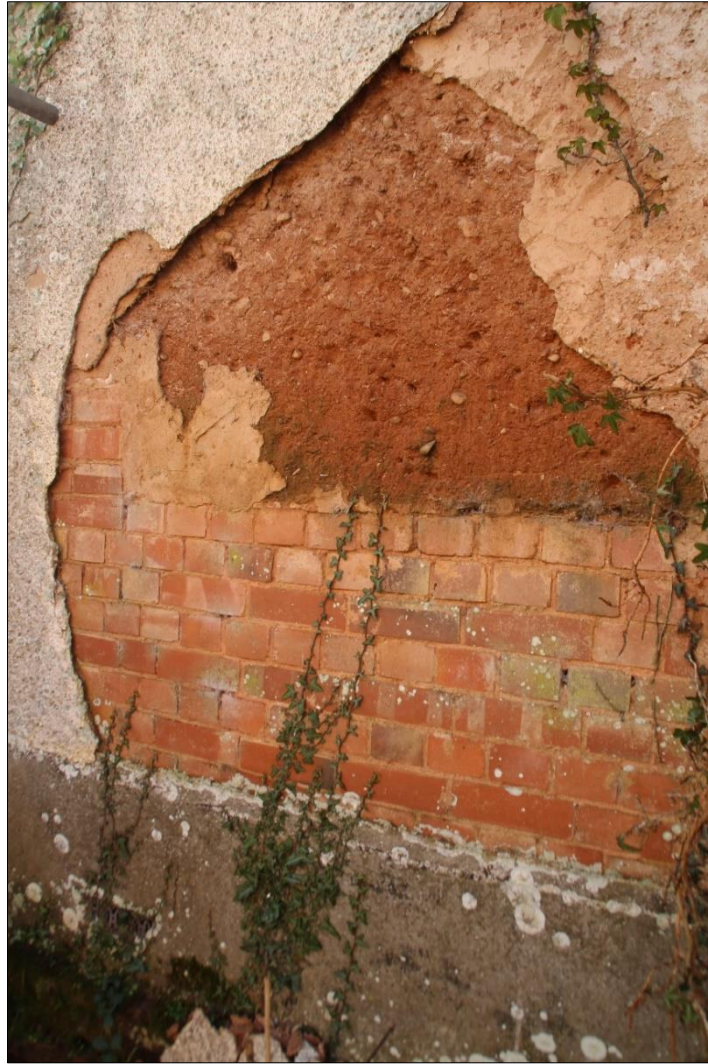
**Fig.10 detail of north gable wall showing brick and cob with render layers**

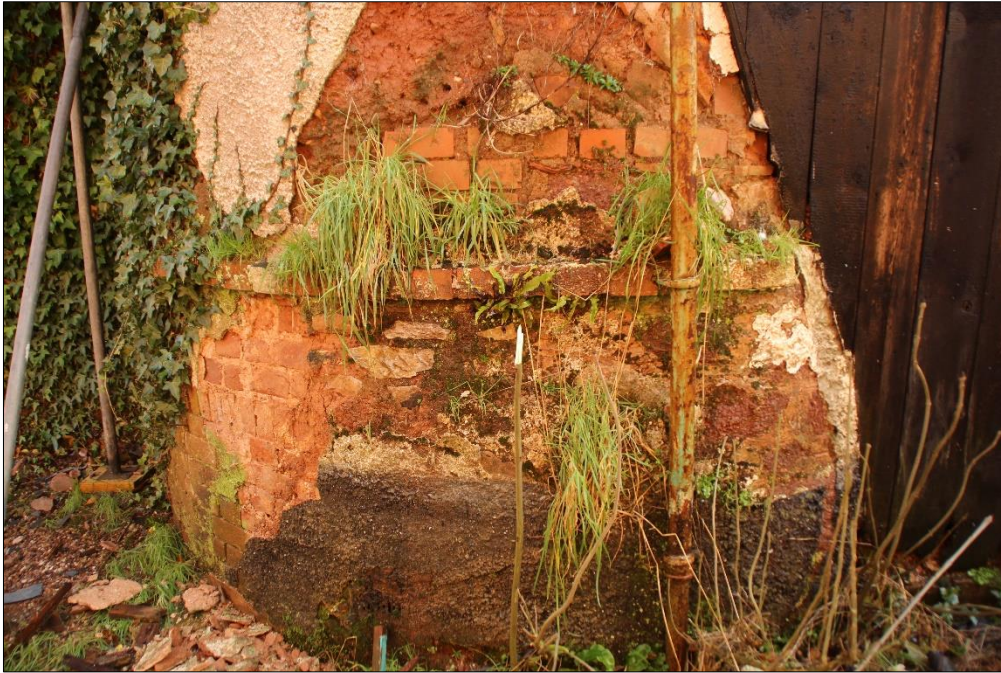
- 4.6. The west elevation is the most complex, as it has both the circular turret and the kitchen and lean-to extensions. The turret (Fig.11) had lost some of its render at this site visit, and it was observed that the structure has been heavily repaired over the years, a hotchpotch mix of cob, brick and local stone, thought to be Heavitree, was observed within the walling. A low brick string course was observed, presumably inserted for structural reasons. The small window top lighting the modern lavatory now within the interior of the turret, with its thick splayed reveals, was observed, and the slate lean-to roof was at this point still in-situ.

**Fig.11 View of the turret on the west elevation showing mixed materials**

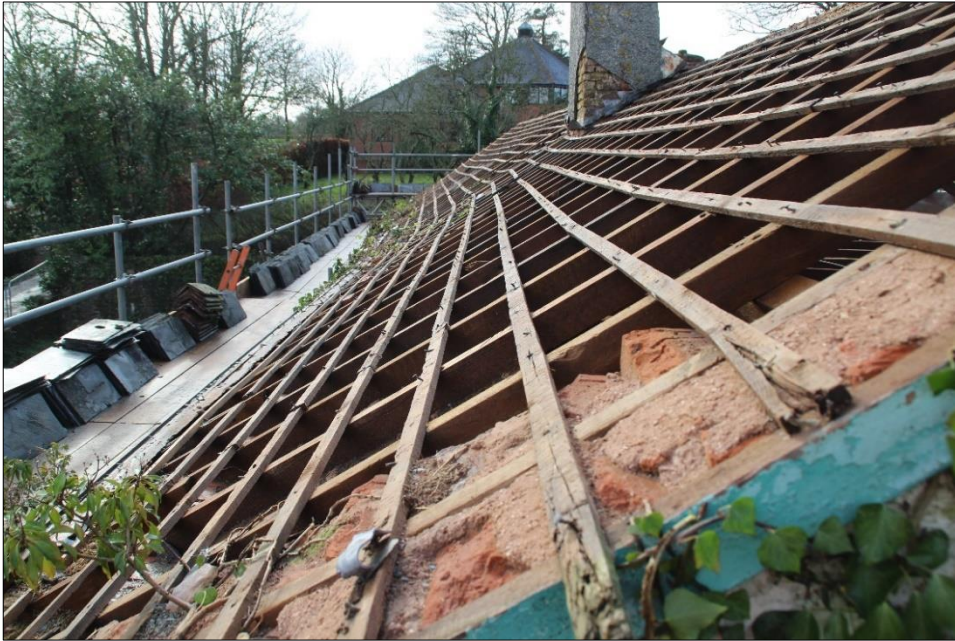
**Fig.16 View of the eastern roofscape, looking south**

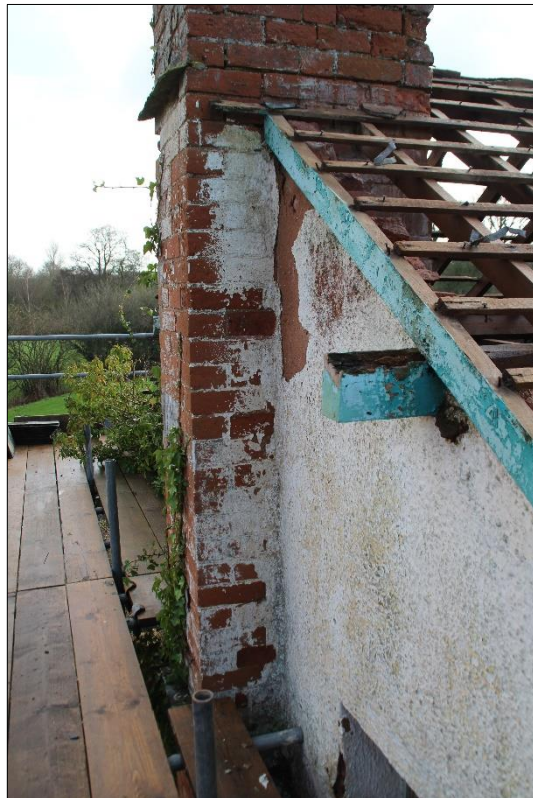
- 
- 4.11. Fig.18 shows the upper northern gable end of the Building, featuring the repaired brick chimney, note the neat machine cut brick to the lower portion, with the upper section, above the slate string course, having a cruder brick appearance, though this may be due to weathering. A purlin is seen piercing the gable end. It is likely that the Building had generous overhanging eaves, as this was a feature of cob buildings in order to assist in water run-off.

**Fig.18 Apex of northern elevation, gable end**

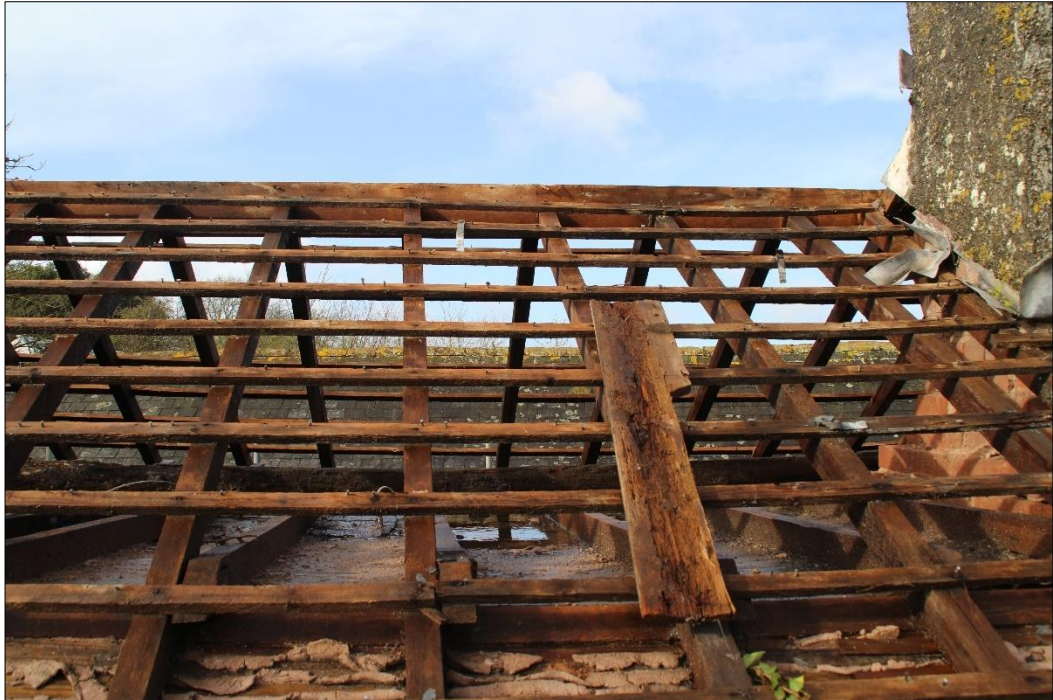
- 4.14. Moving further south on the east elevation, a similar coupled rafter roof structure was observed in the southern portion of the Building, though the ridge piece is in good condition and machine cut, indicating it is a newer piece (Fig.23). Of note here is that there are more substantial and less regular collar tie beams in this part of the Building. They are machined and rest on substantial purlins against up to which there is lathes and torching forming the eaves in the rooms below. This difference between the north and south portions further corroborates the theory that they are of different construction dates.

**Fig.23 Eastern roof slope on the southern part of the building**

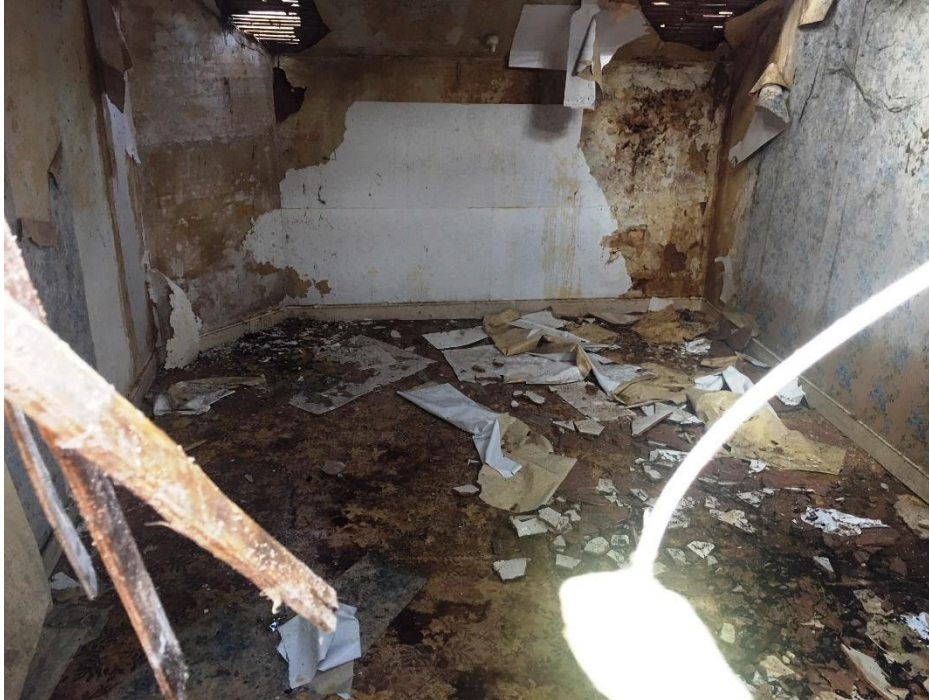
- 
- 4.21. From above on the roof scaffolding it was possible to photograph the interior of the south bedroom, with a corner infill which was very likely a fireplace served by the older chimney at this end of the Building (Fig.31).

**Fig.31 South bedroom viewed from scaffolding platform showing corner chimney breast**

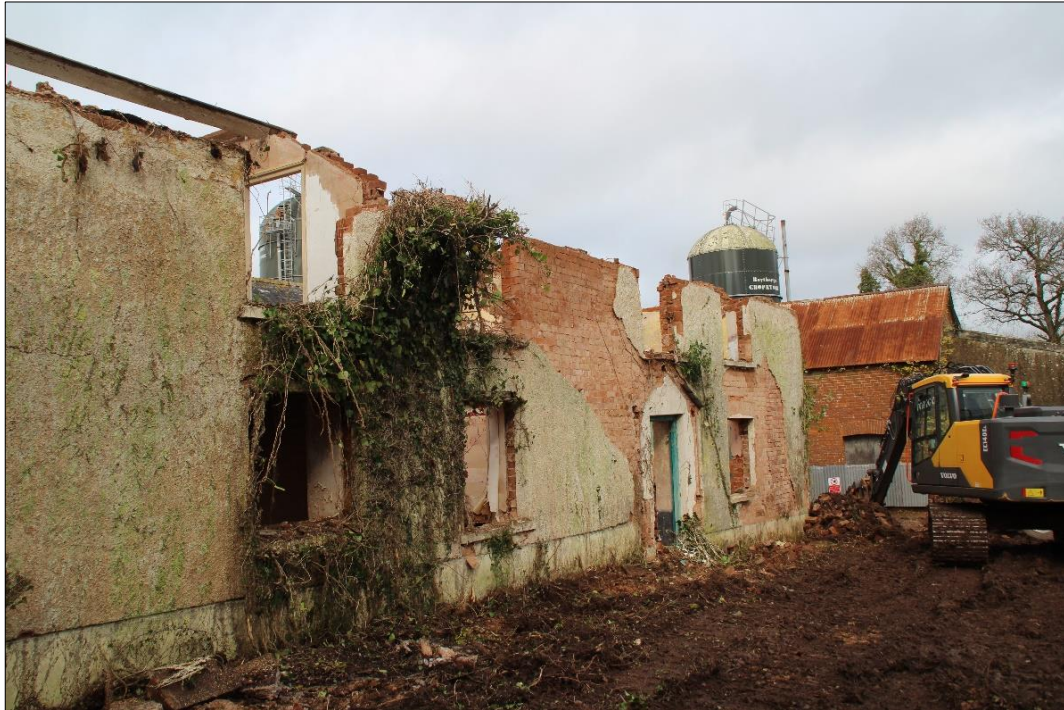
**Fig.38 The eastern elevation of the building looking north**

- 4.27. Fig.38 above shows the east elevation of the Building as seen at this site visit. Interestingly this elevation appears to be entirely brick built which is somewhat at odds with the amount of cob found on the west elevation. There is also a join between what appears to be handmade bricks and machine cut bricks (Fig.39) which suggests that part of the elevation was repaired or rebuilt. The use of brick on this elevation is something of an anomaly which may be explained by the presence of the large older chimney on this side of the house; it would make sense to add to this side with brick to match the chimney rather than construct cob around it. A brick wall can be erected relatively quickly but cob requires time in making and constructing. Also;:

- 
- the elevation could have been rebuilt or repaired when the house was extended pre-1839. The original cob house of ground and upper floor room with stair turret could have been comprehensively remodelled with brick being the most expedient material to use.

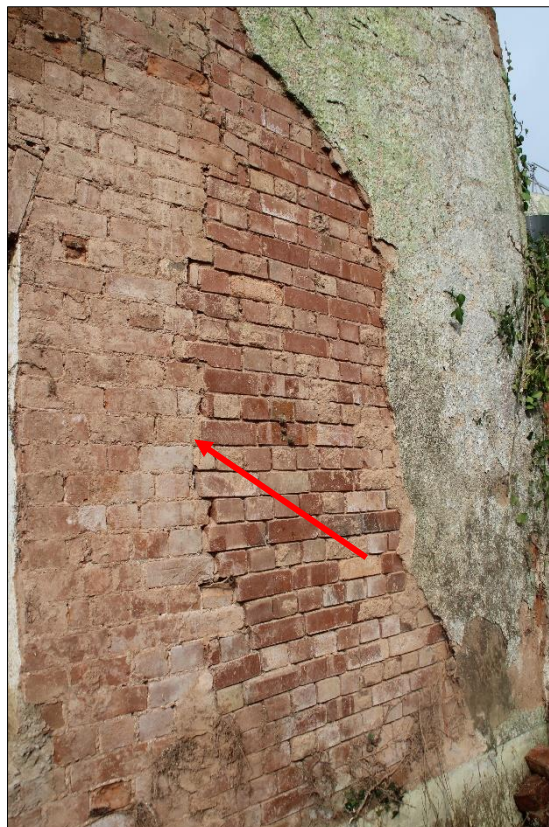
4.29. The machine bricks appear to be poorer quality (cracking and vitrification issues) than would be normal for a principle elevation, so it is very possible that the latter theory above is closest and that the elevation was purposely repaired or patched up with poor quality bricks, 'seconds' if you like, and then intentionally rendered.

**Fig.39 Detail showing modern brick (left hand side) and handmade bricks (shown with arrow)**

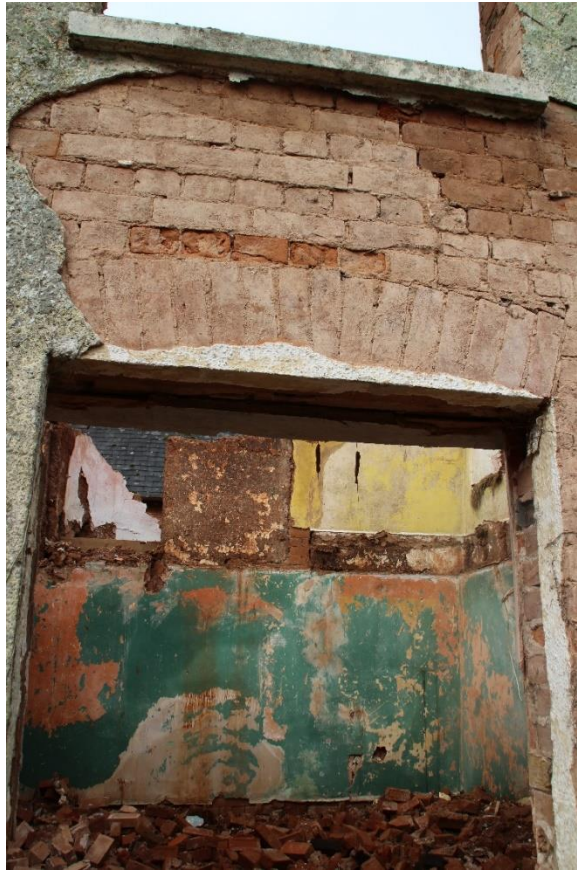
4.30. Shallow segmental brick arches are seen over door and window openings (Fig.40).

**Fig.40 Detail of shallow segmental arches over doors and windows on eastern elevation**

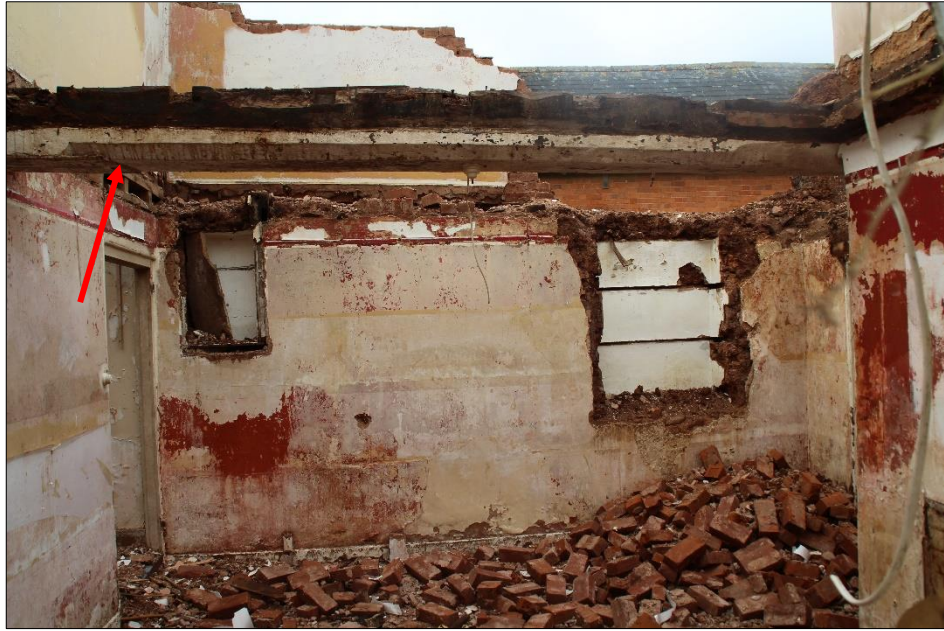
- 4.33. The living room is shown in Fig.44 showing part cob and part brick walling, with both cupboard alcoves described by Morriss recessed into the cob. The large lateral beam shown in Fig.45 is seen in more detail here. It looks to be a substantial hand cut oak member with a chamfer detail. Areas of blackening may point towards some smoke damage which may help corroborate the theory that the Building suffered a fire near the large central chimney at some point in its history.

**Fig.44 View of the living room looking west with beam**

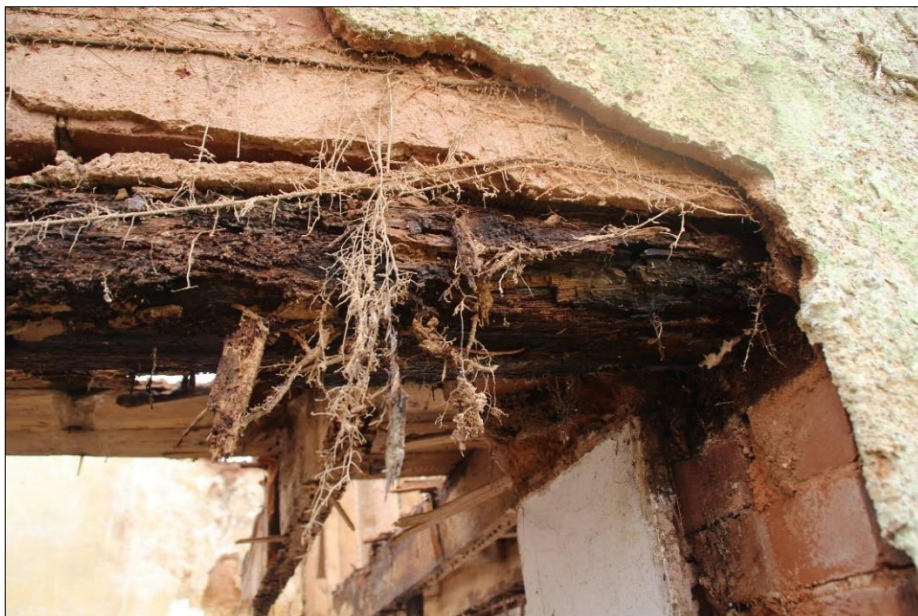
- 4.36. The lintel in the eastern dairy window was obviously wooden, now rotted from water ingress (Fig.47). This part of the elevation appears to be covered in a clay or red sand based smooth render covered in a rough cast render.

**Fig.47 View of timber lintel over window to dairy**

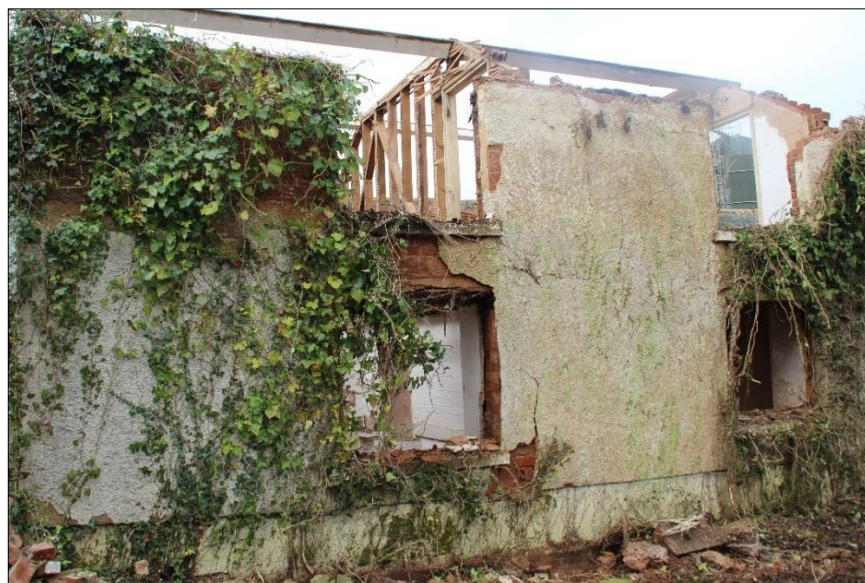
- 4.38. Of interest in the southern section of the dwelling was part of the skeleton of studwork and spine wall at the first-floor level as seen in Fig.49. A single purlin spans two rooms (dairy and rear hall) with the studwork of the wall dividing west and south bedrooms visible, as is the brick spine wall of the upper landing. The timbers are all machine cut and look to relatively modern; they could relate to the c.1900 refurbishment.

**Fig.49 View of the southern part of the building, eastern elevation, looking west**

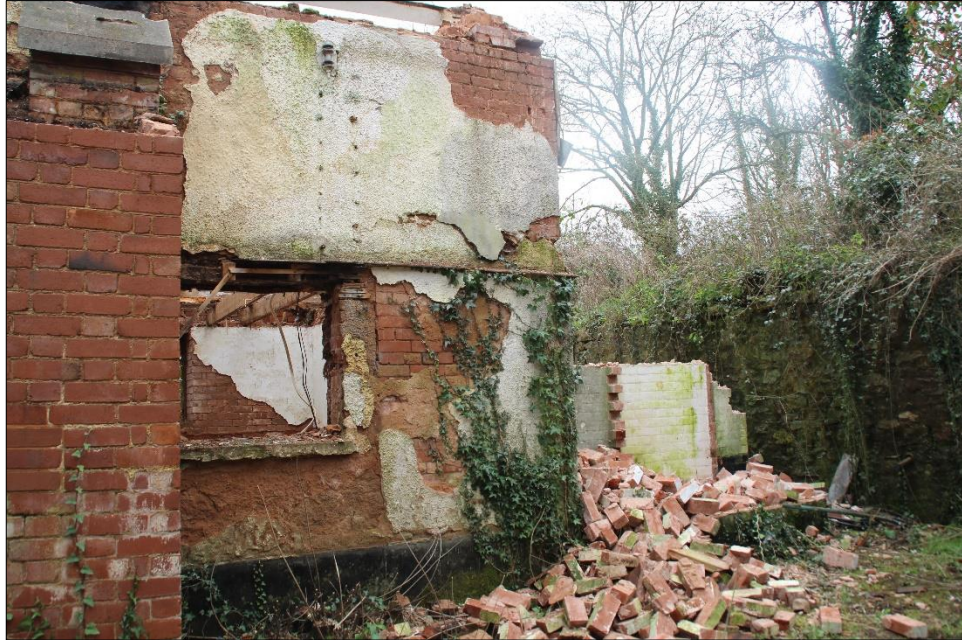
- 
- 4.42. The western wall of the dairy room shown in Fig.55 reveals that some of this section of wall is brick, particularly the southernmost portion, suggesting some repair work may have occurred when the dairy extension was added.

**Fig.55 Southern most end of the western elevation**

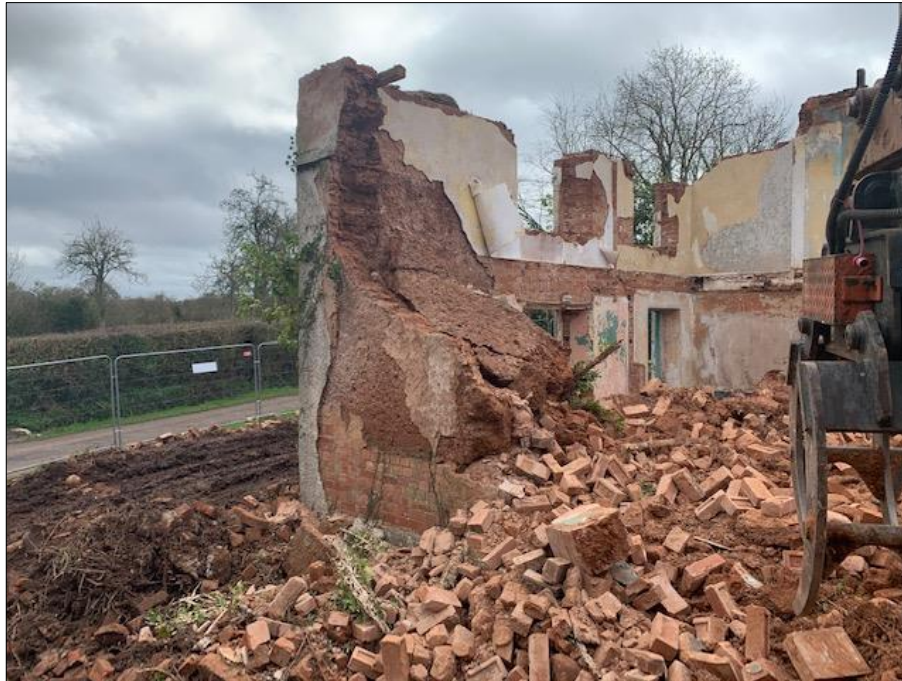
- 
- 4.44. Further demolition of the northern gable elevation revealed that a good proportion of this elevation was formed cob, as seen in Fig.57. A section of wall at low level was also found to be local stone blocks, possibly Heavitree stone (Fig.58)

**Fig.57 View of the northern elevation as its collapses showing cob**

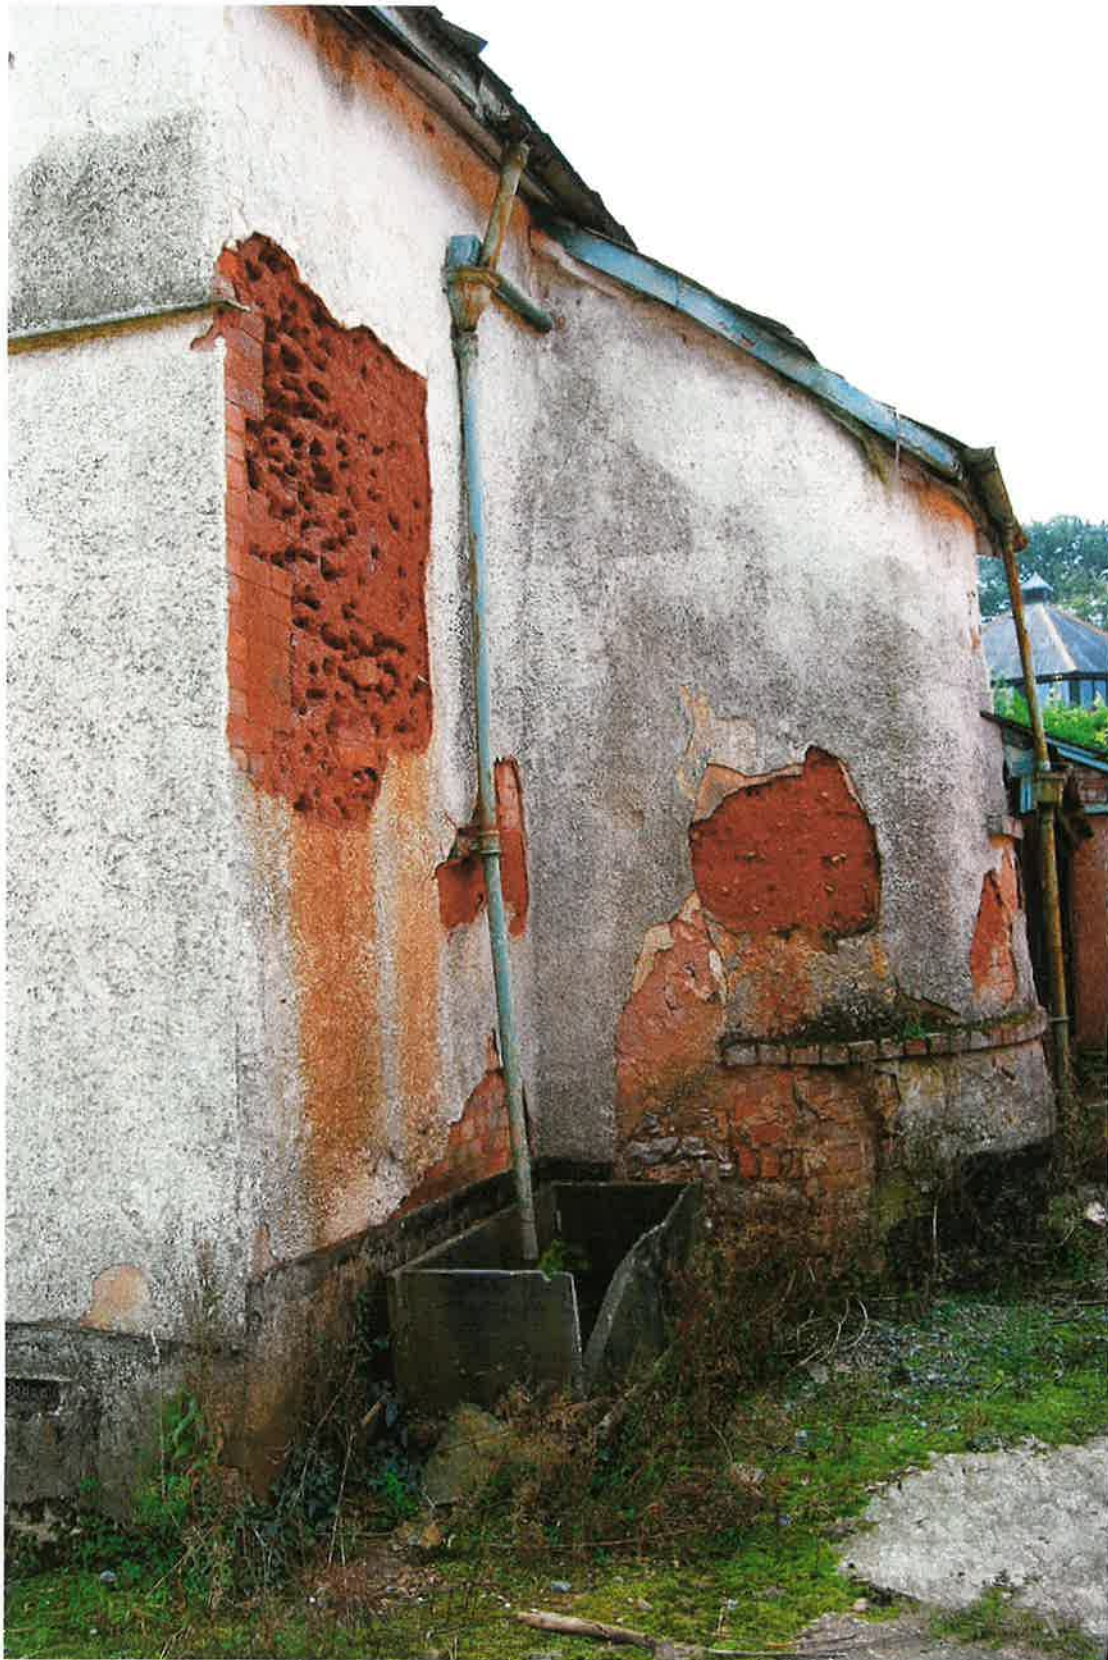
Pl.5: The rear, or west, elevation of the northern portion of the farmhouse, showing the semi-circular projection and the condition of the cob.
