# The Maltings, Tetbury Lane Nailsworth

*Historic Building Recording (Level 2)*

CA Project: CR0178

December 2019

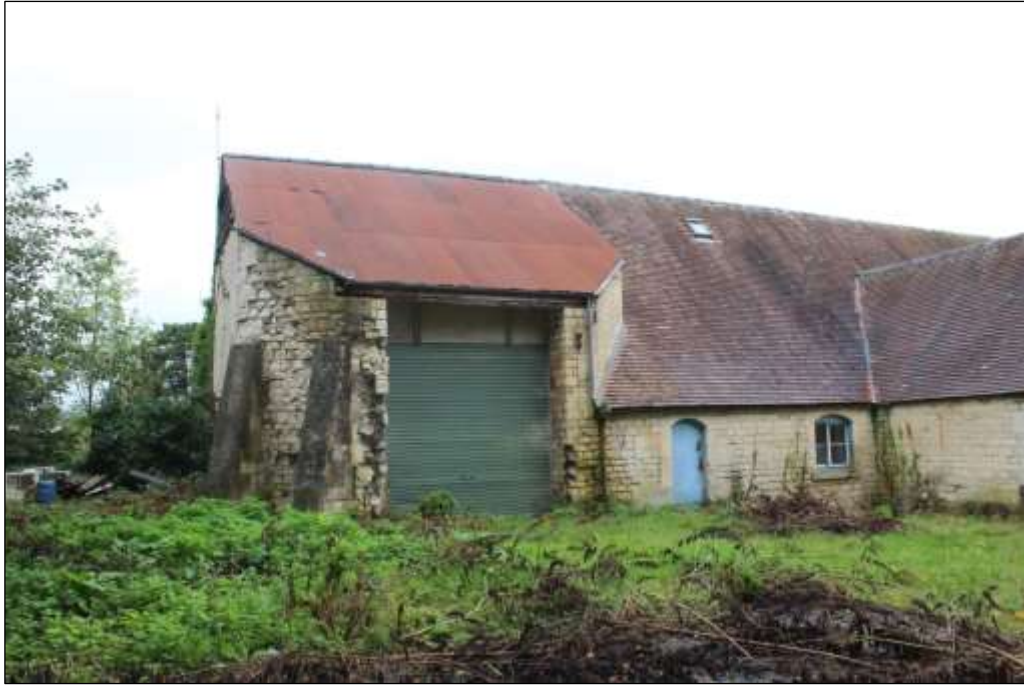
**Fig.11 View towards the north of the kiln of Maltings 1**

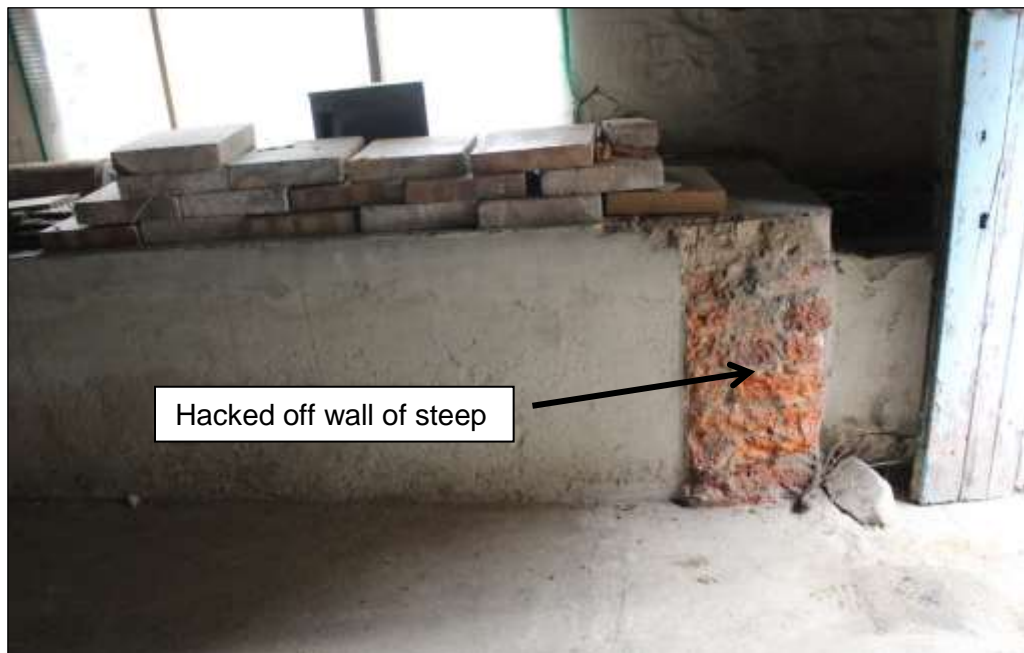
Fig.26 Hacked end of the steep which would have formed a rectangular 'bath'

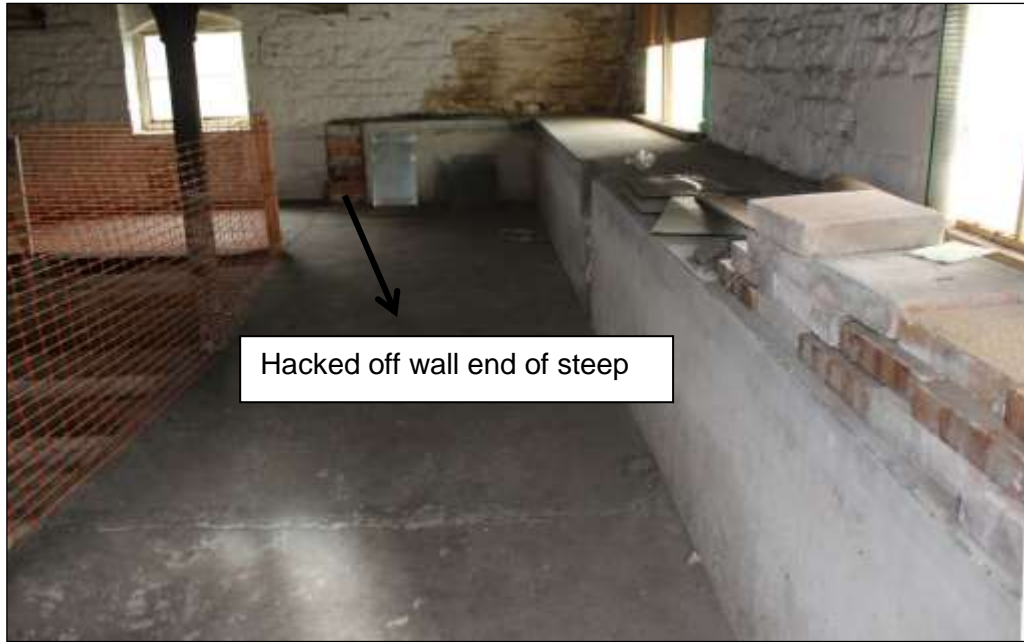
Hacked off wall end of steep

**Fig. 27 View of steep floor with hacked corner detailed**

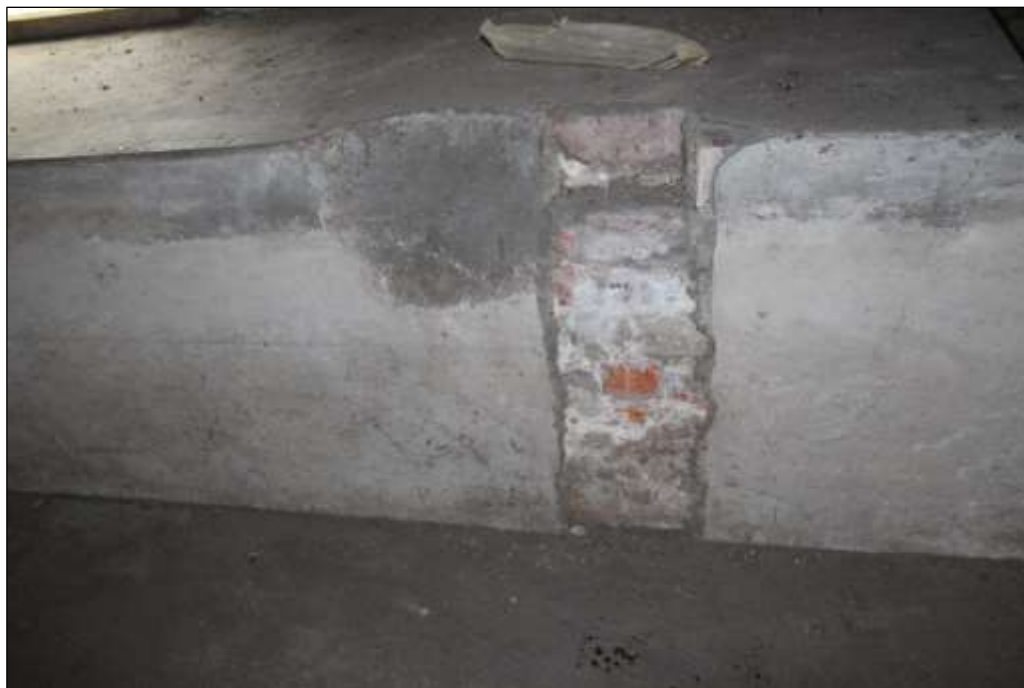
**Fig.28 View of middle hacked wall of steep (the steep divider), showing concrete lining**

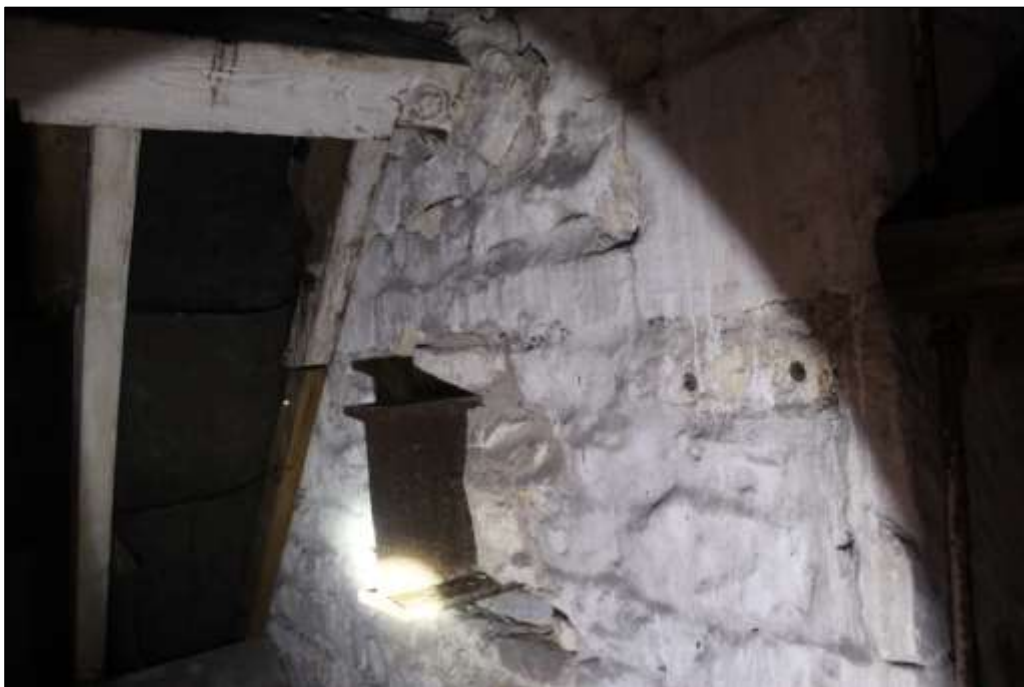
**Fig.41 View of kiln end wall, showing various insertions and additions**

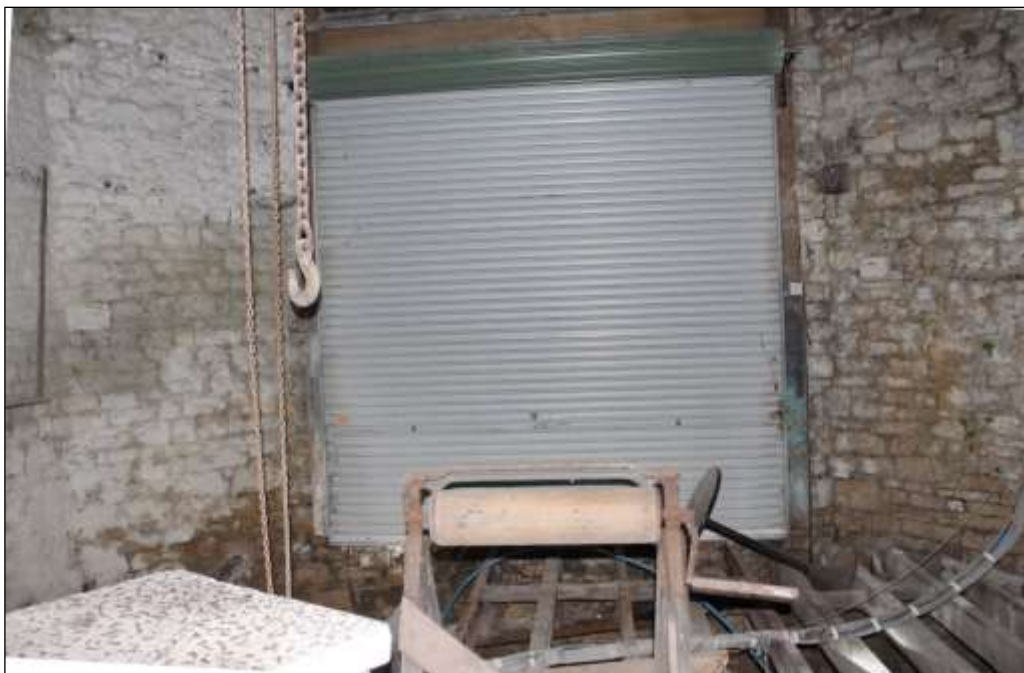
**Fig.47 Kiln chamber, showing modern inserted garage doors, half the floor surface is missing**

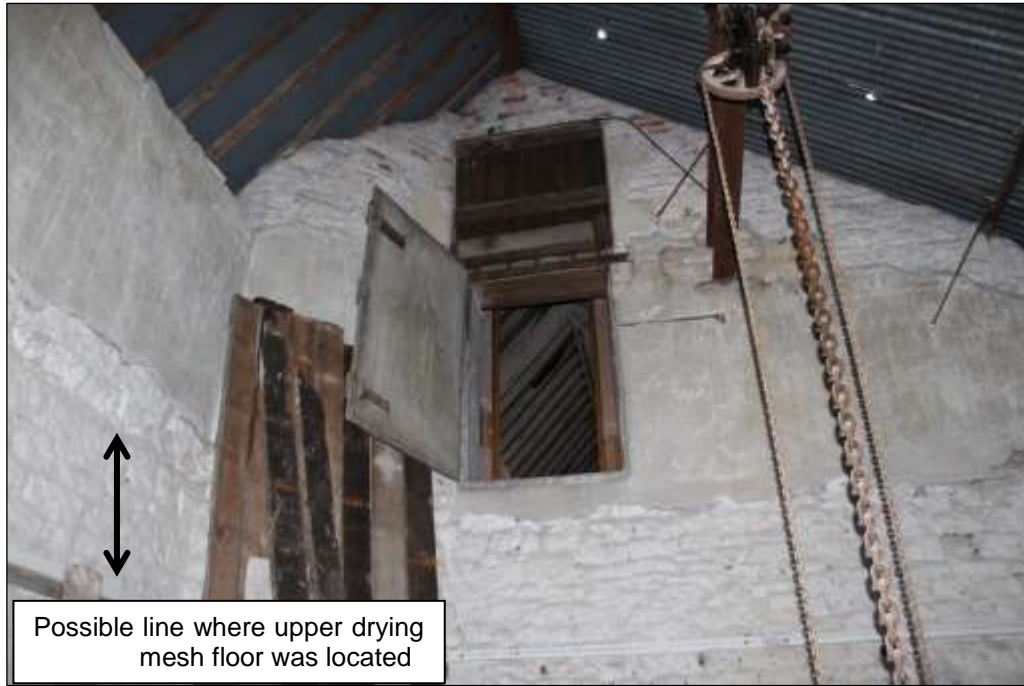
**Fig.48** View up to kiln roof area showing altered areas of walling, and doorway into upper drying floor (attic space)

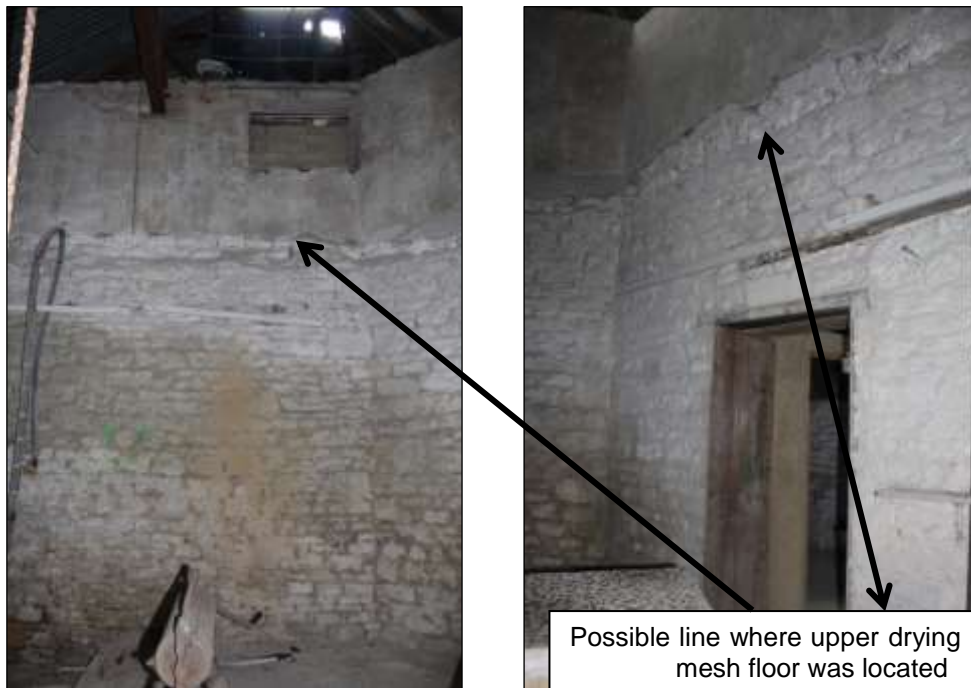
**Fig.49** Two views of scar lines showing where the drying floor in the kiln was located

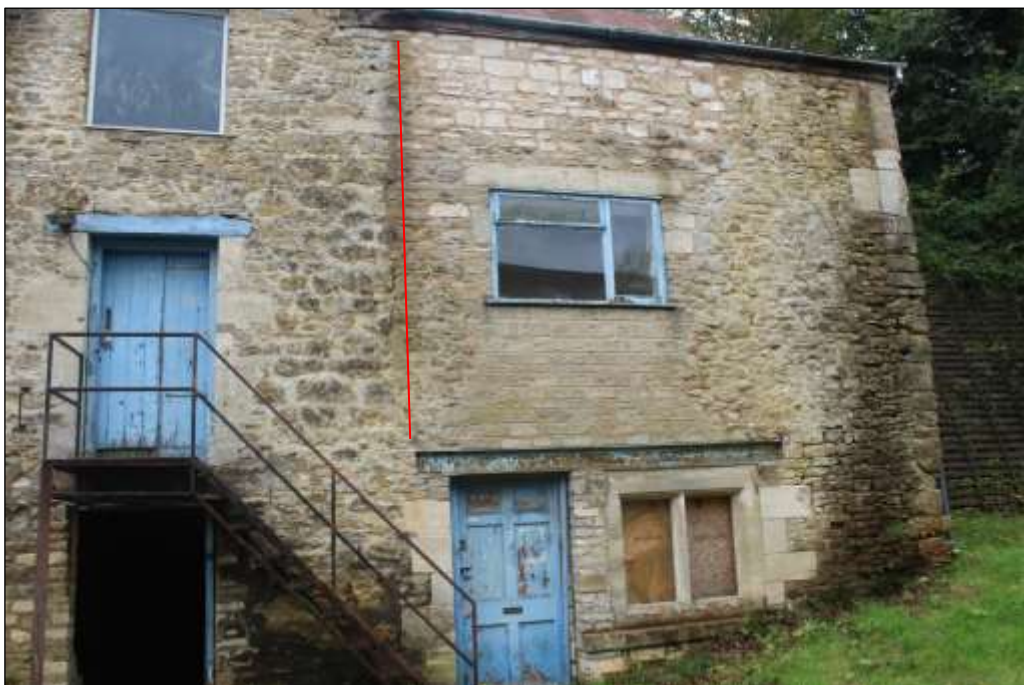
- 3.44. The north facing elevation of the kiln building (Fig. 63) features a doorway and stone window, both with steel lintel above. Both are likely to be original openings (light and access being needed) but the stone work of the mullion window (not seen anywhere else on the Site) suggests it is a newer insertion, possibly during one of the abortive attempts to convert the building. The date stone 1988 may date this work. The building is clearly added on as a joint between the original building and the kiln is clearly visible (Fig. 63). The roof features a corrugated iron roof, which replaces a conical kiln roof that would once have been present.

**Fig.63** View of western north-facing elevation of Maltings 2, the kiln, showing building join in red

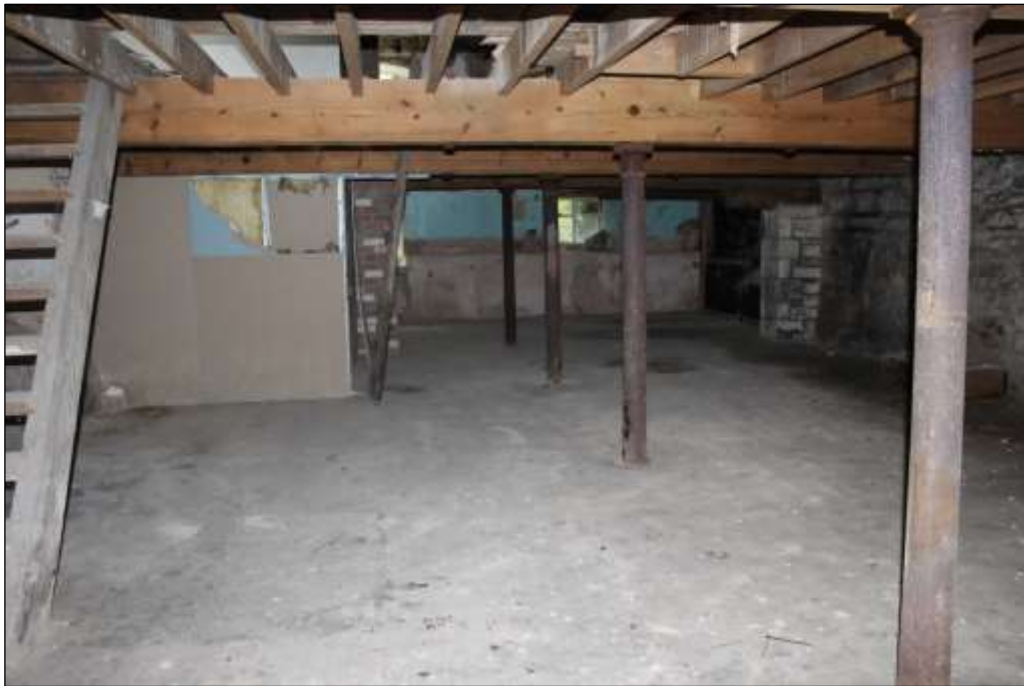
**Fig.68** The lower growing floor of Maltings 2, view to the east, showing modern insertion of dividing walls

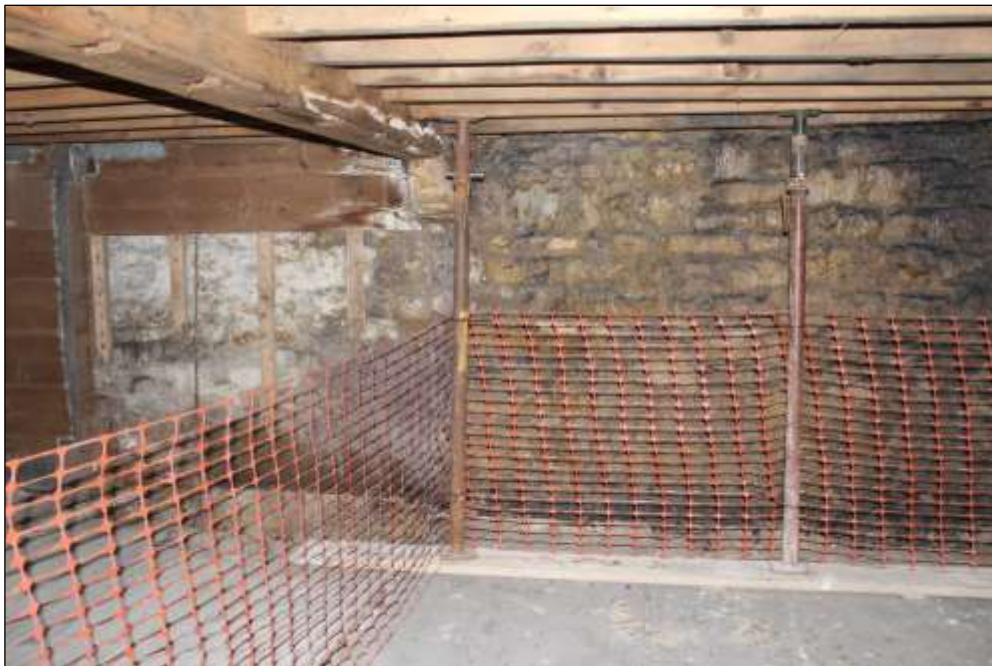
- 3.55. The asphalt to this floor has been removed and the slim timber floor battens are evident. The removal of the asphalt has revealed that the timber battens were covered in a grey rubble material followed by the asphalt, the layers are evident near the back wall; it is clear the asphalt also covered the lower part of the wall as a sort of skirting and that lead flashing has been applied in places, probably to help with water-tightness as the back wall is clearly wet, being built against a bank (Fig. 74). Some of the back (southern) wall of the building has been boarded in timber, though the ingress of damp has resulted in some deterioration and removal of this surface (Fig. 73).

**Fig.73 View of upper growing floor, south wall with some timber boarding removed**

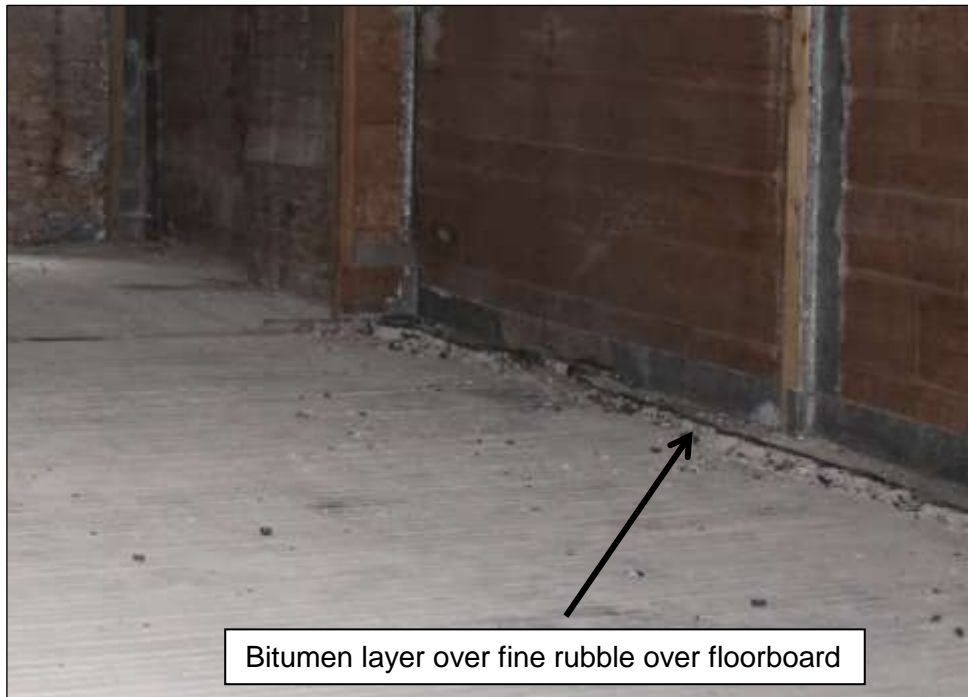
**Fig.74 View showing bitumen layer over rubble over floorboards, now removed**

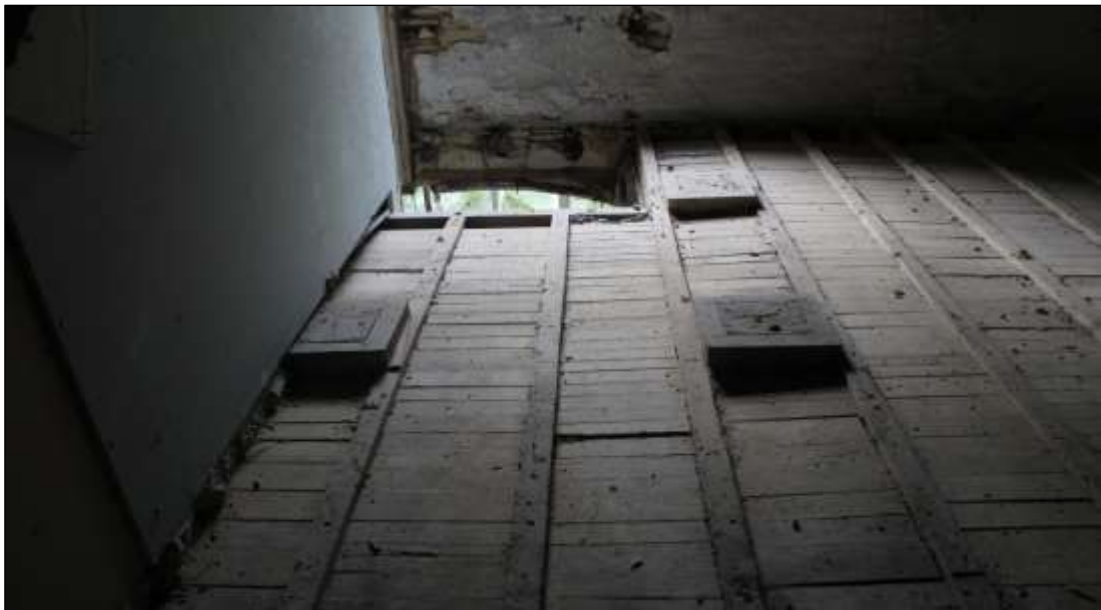
**Fig.77 Detail of hatches revealed where asphalt has been removed**

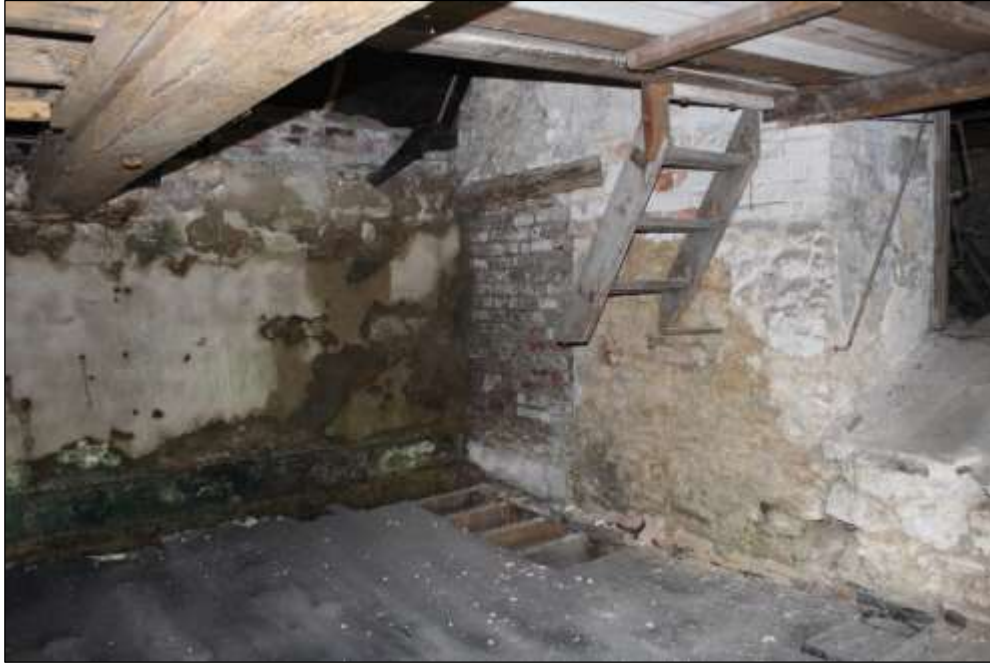
**Fig.78 Truncated stairway to upper floor and filled in doorway, possibly predating the kiln**
