Hinds Head Hotel Aldermaston West Berkshire

Historic Building Recording

CA Project: AN0206

CA Report: AN0206_1

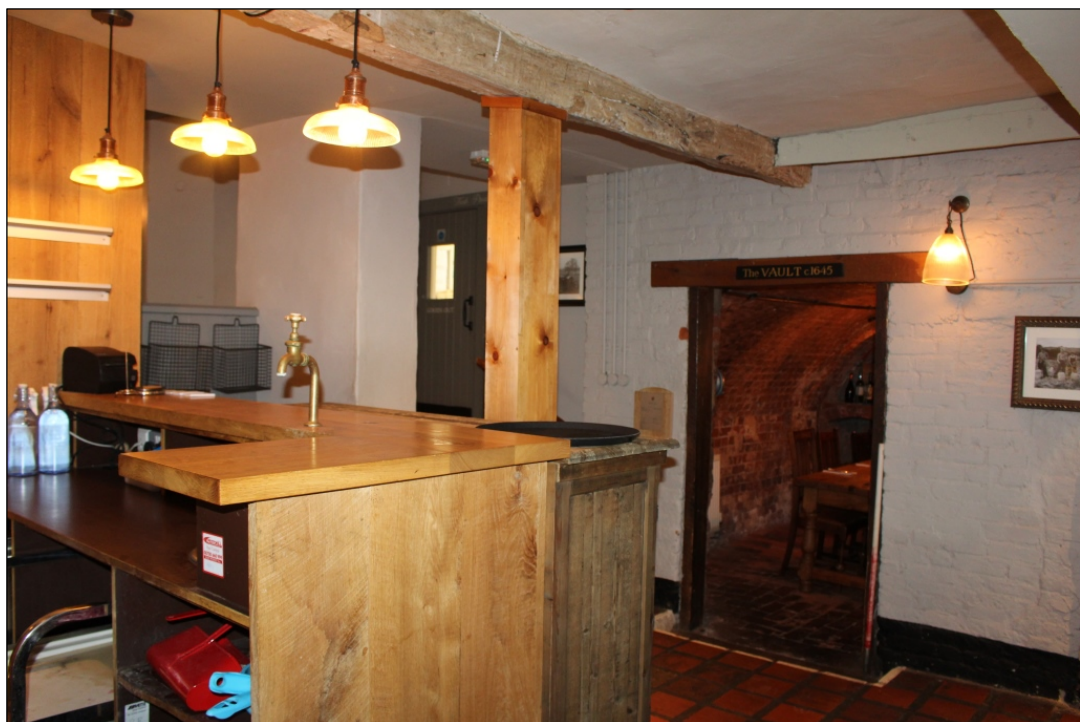
Photo 9: The western extent of the cellar bar from the south-east.

- 4.2. The structural survey describes the floor within the laundry room as being comprised of varying sizes of joists and those on the left (west side) of the beam appear to be original, measuring 52mm by 93mm deep and with 400mm spacings. Those to the east of the beam were thought to be newer and measure 40 by 150mm deep and with 400mm spacings (BG Consulting, 2019). Part of the first-floor ceiling boards are exposed within an area to the north-east of the beam. The beam is defective and has been temporarily supported with the insertion of an Acrow prop encased and clad in MDF which has been positioned against the north-eastern extent of the bar counter within the south-western corner of the cellar bar (Photos 9 to 11).

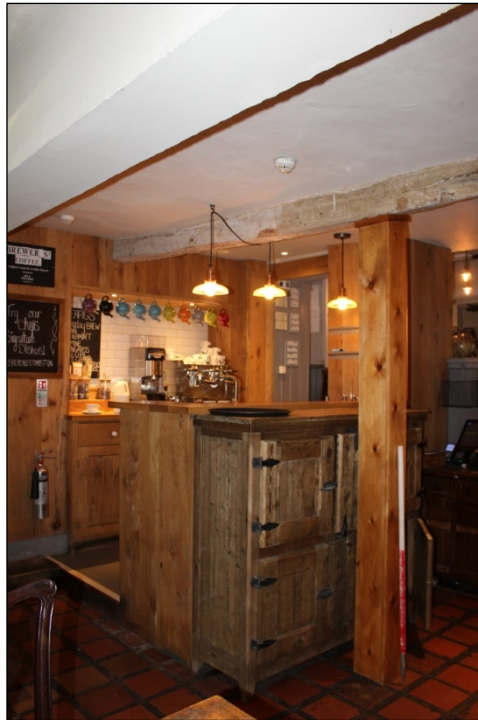
Photo 10: The cellar bar from the north-east.

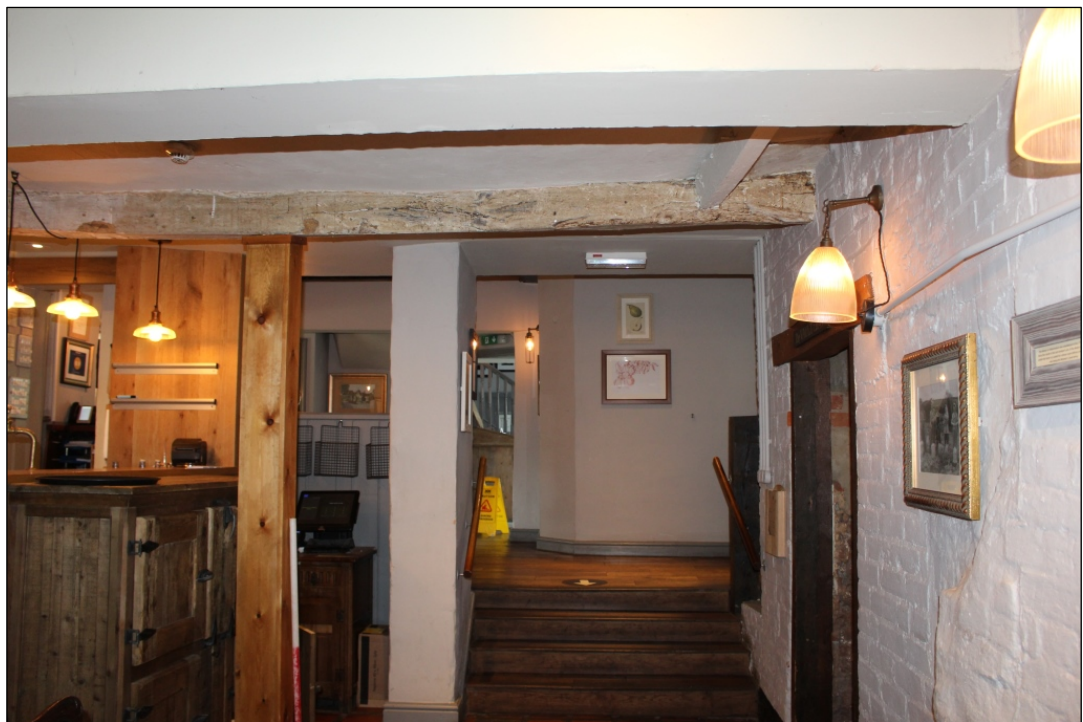
Photo 11: The cellar bar from the east.

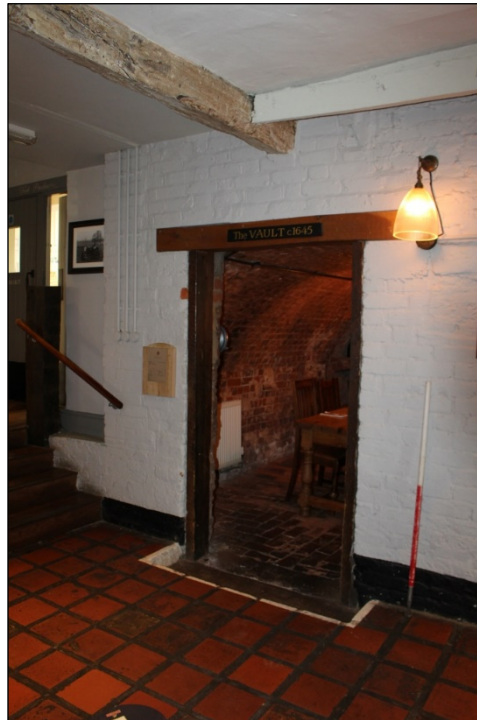
Photo 12: The timber beam extends above the door opening into a vaulted cellar dating to the late 17th century.

- 4.4. The northern extent of the beam is set within a brick-built wall of a cellar vault which reputedly dates to the late 17th century (Photos 12 and 13). The southern extent is situated within a brick-built wall which separates the cellar vault from the main room situated against the southern elevation of the 17th-century building core (Photos 12 and 21). The position of the beam indicates that it likely falls within the earliest part of the building, within the 17th-century core and that this area was opened up to the east to create a larger room following the 18th century extension to the east.

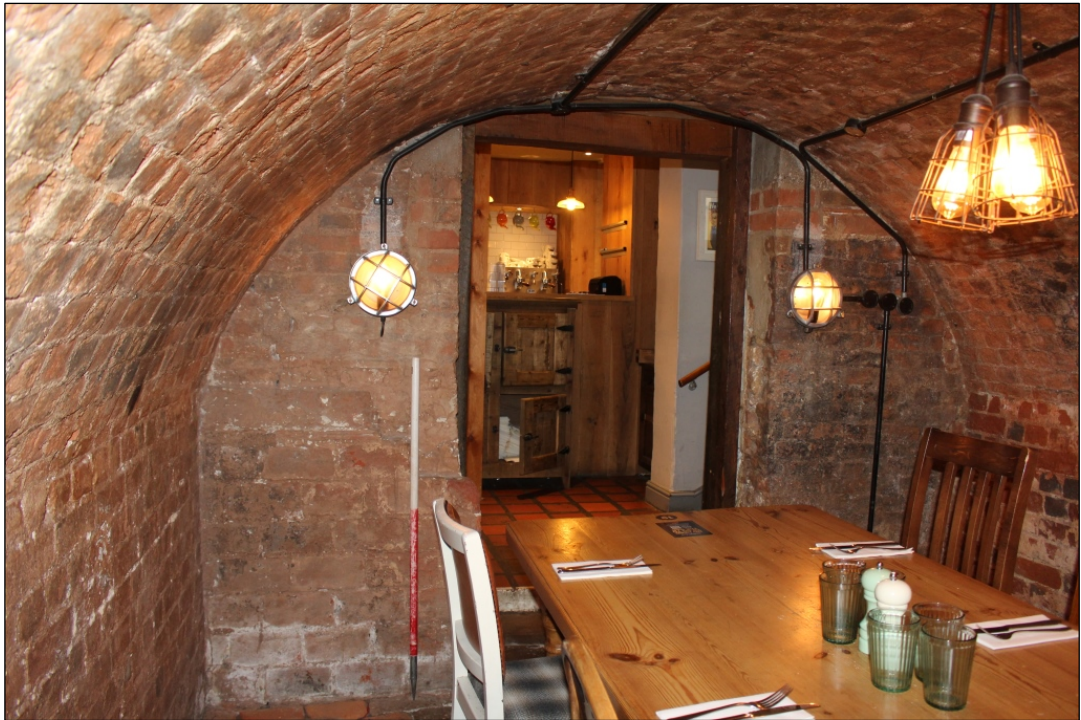
Photo 13: The view south towards the beam from within the cellar vault.

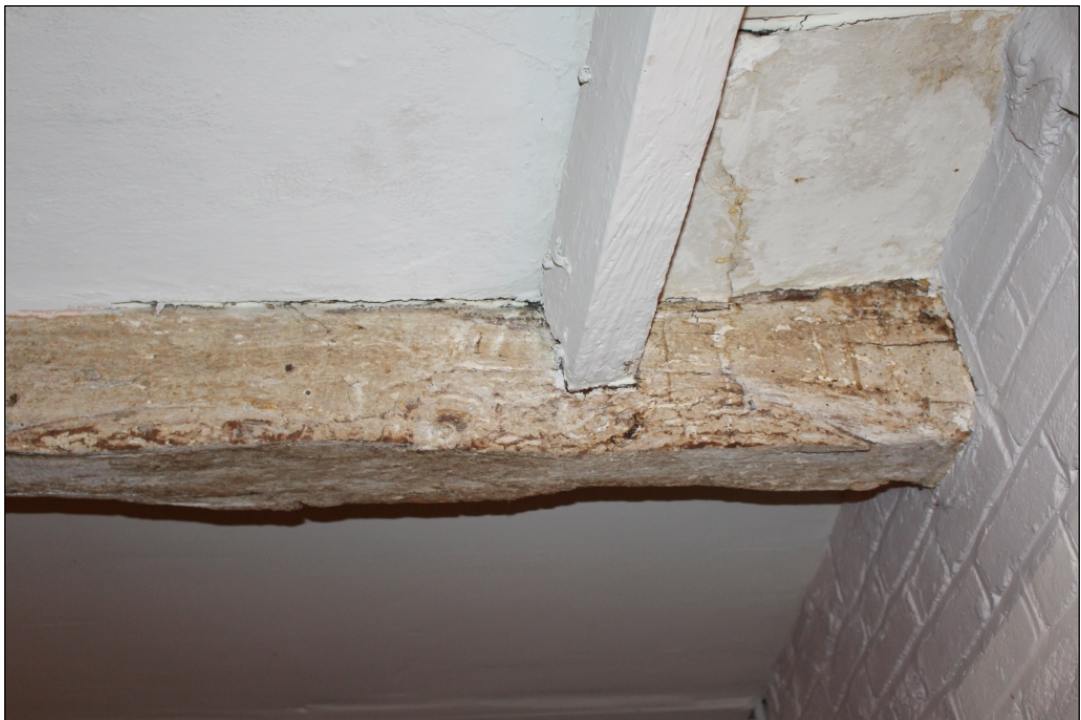
- 4.5. The beam is of crude form and does not display any evidence of chamfering, decoration or carpenters' marks. There are no visible kerf marks to indicate that the beam was sawn and the ridged surface of the timber suggests it has been hand hewn (Photos 14 to 21).

Photo 14: The northern extent of the beam from the east.

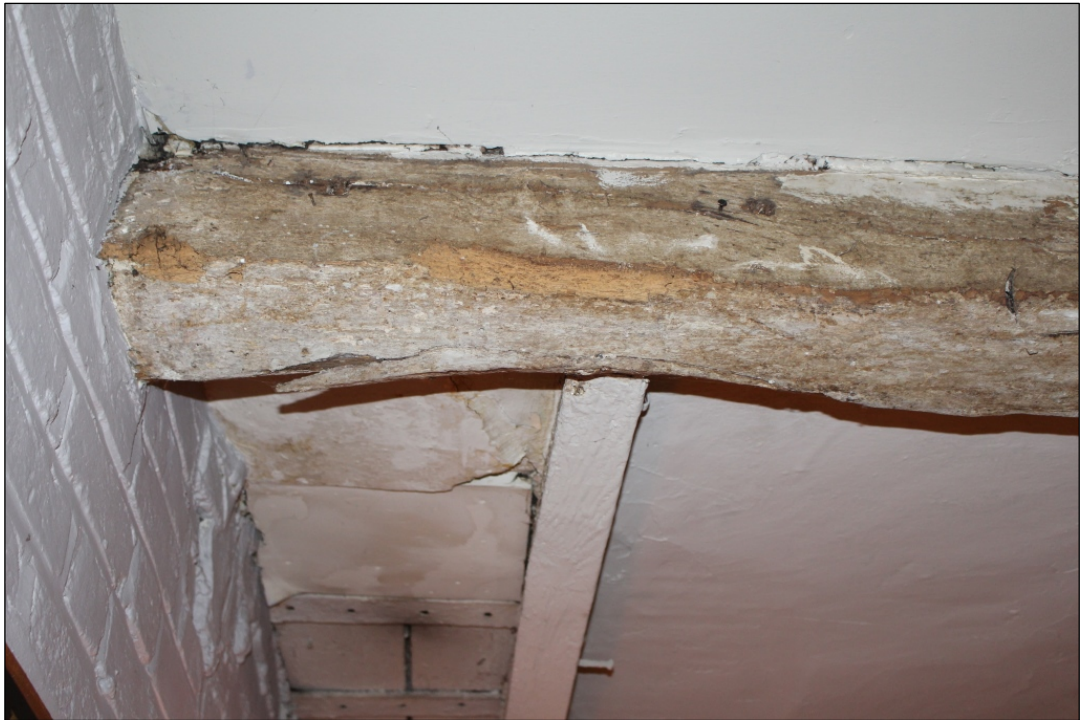
Photo 15: The northern extent of the timber beam.

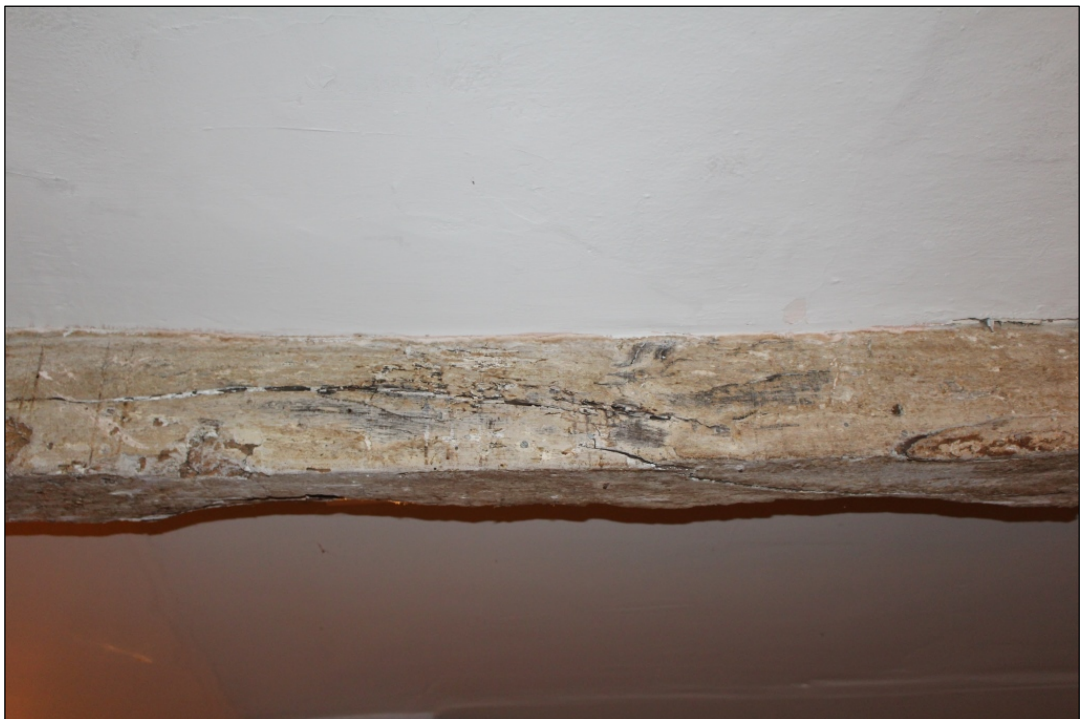
Photo 16: The eastern extent of a central part of the timber beam.

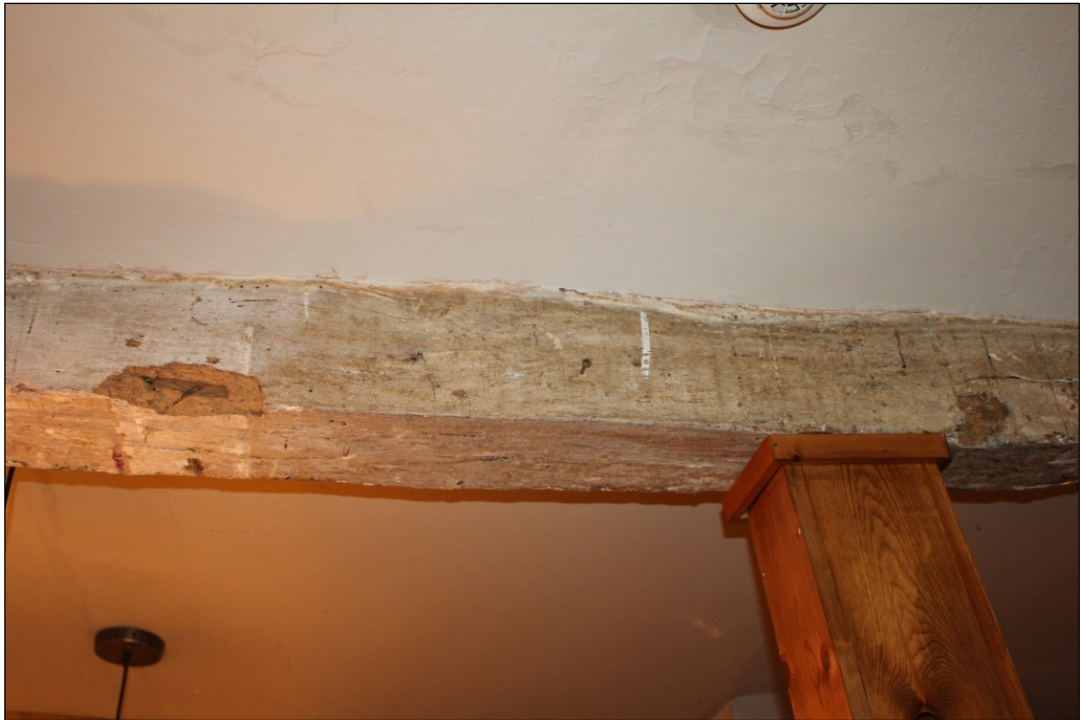
Photo 17: The eastern extent of the centre of the timber beam which is currently propped.

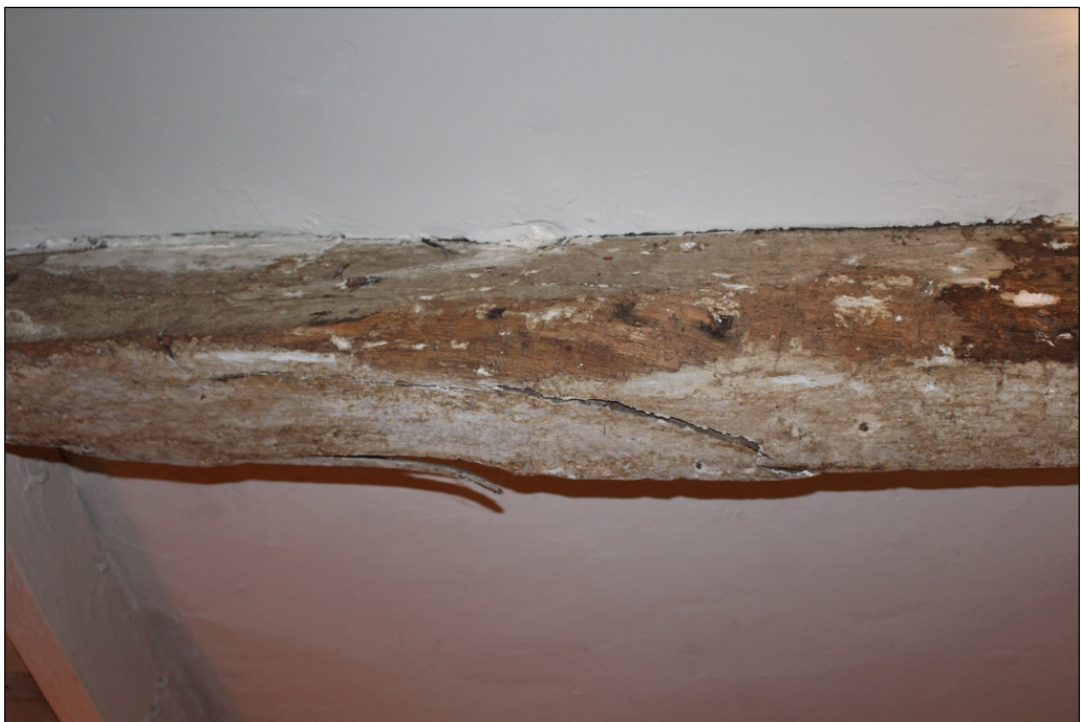
Photo 18: Detail of the timber beam from the west.

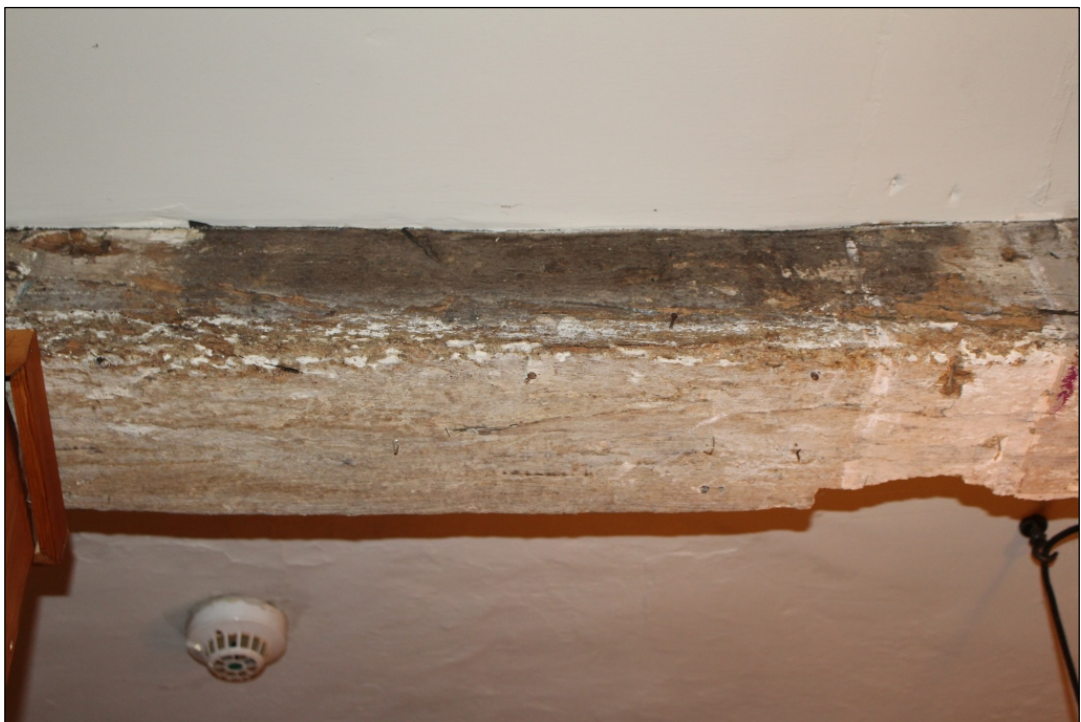
4.6. The southern extent of the beam has been painted (Photo 21). The crude, hewn appearance of the beam appears to conform with the beams used within the main bar against the southern elevation of the 17th-century structure (Photo 5). The shared appearance of the beam with those used within the core of the 17th-century structure, and the proximity of the beam to the 17th century core, suggests that the beam may form a structural component of the earliest part of the Hinds Head. Towards the northern extent of the southern half of the beam and within proximity of the extant Acrow prop is a slight indent within the beam marked either side by two lines in paint and suggesting that there may have been an earlier post abutting the beam in this location (Photo 19).

Photo 19: The southern half of the timber beam from the west.

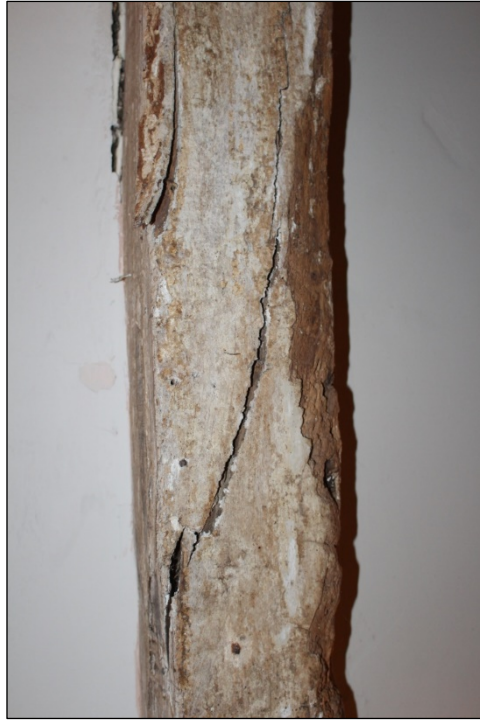
Photo 20: The underside of the northern half of the beam.

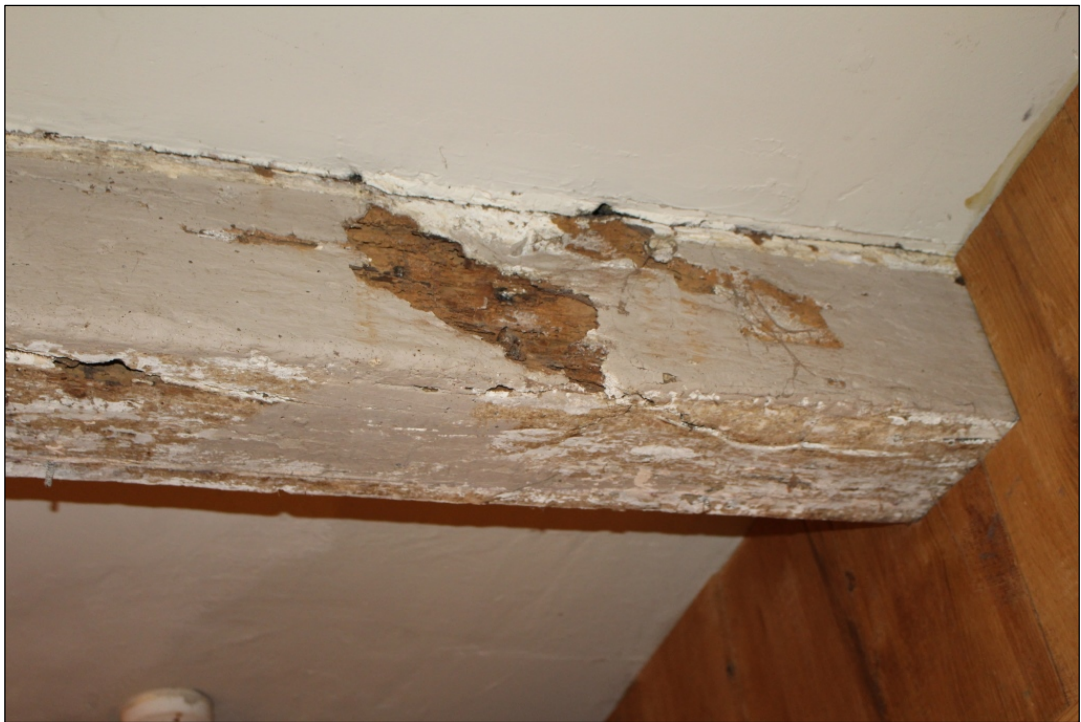
Photo 21: The southern extent of the timber beam from the north-west.

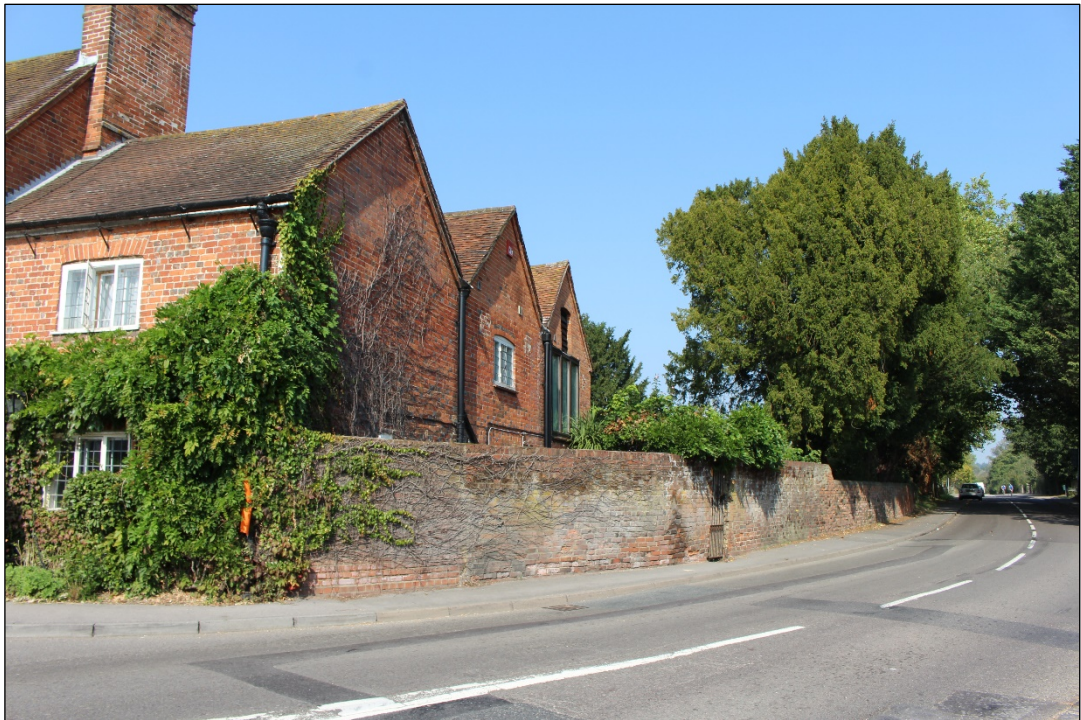
Photo 22: The eastern elevation of the boundary wall from the south-east.

- 4.8. The eastern elevation of the wall is bound by a pavement running along the western extent of Basingstoke Road (Photos 22 to 25). To the eastern elevation, approximately 16.5m of the southern extent of the wall is at a height of 1.6m. Section

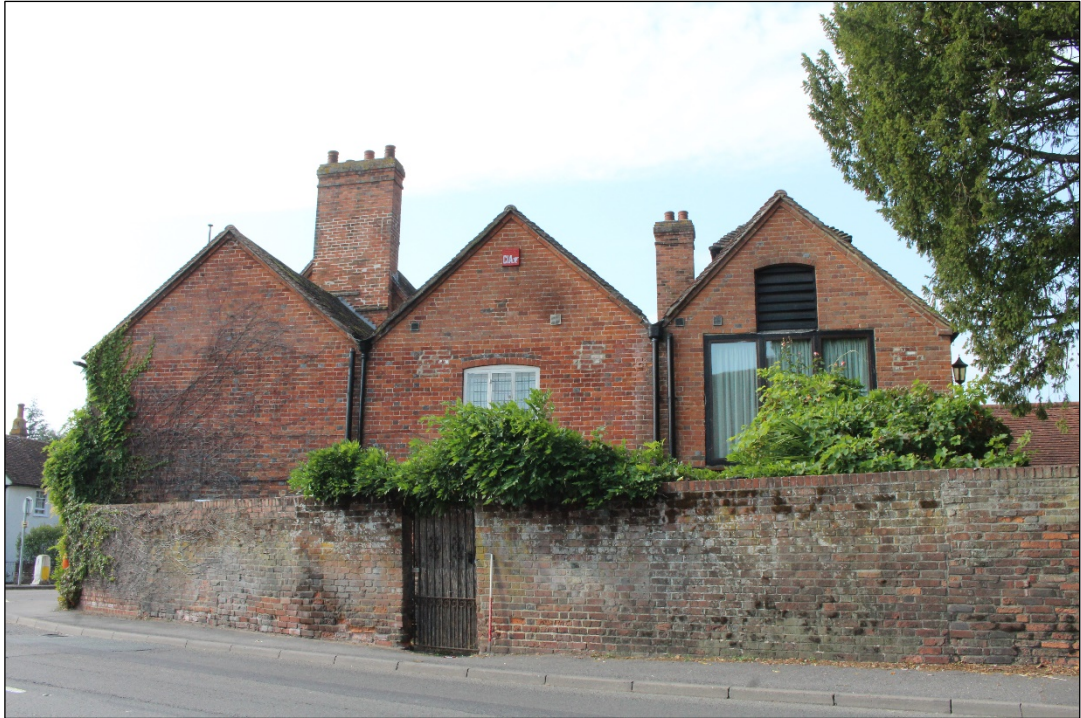
Photo 23: The eastern elevation from the east.

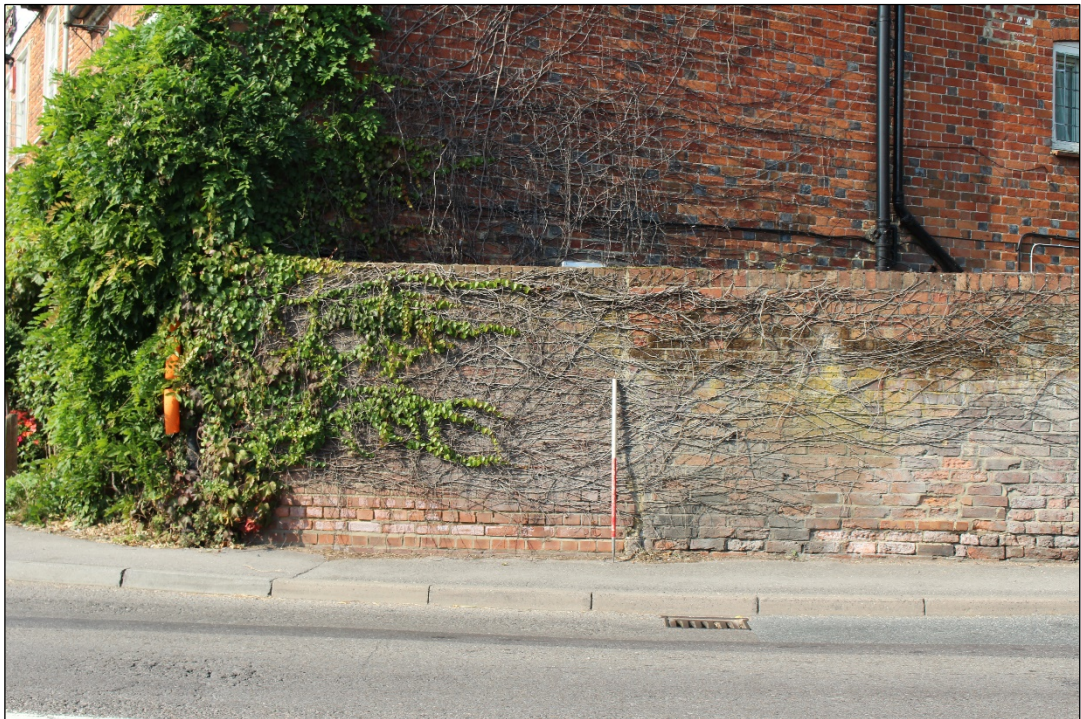
1 of the wall comprises the southern-most extent of the wall and runs for a course of c.2.3m. This section is constructed of light coloured red brick laid in English Bond with alternating courses of headers and stretchers (Photos 22 and 25). The eastern elevation of this section is partially obscured by vegetation whilst the western elevation is fully visible (Photo 26). The section is capped with bricks stood on their header end. Typically, English Bond is one of the oldest brickwork bonds and was utilised as a popular bond until the late 17th century. This section appears to have been rebuilt and the bricks conform with standard metric brick sizes of 215mm by 100mm by 65mm. An example of a brick used within this section of the boundary wall measured approximately 215mm by 100mm by 70mm.

Photo 25: Detail of the re-built section (Section 1) at the southern extent of the eastern elevation.

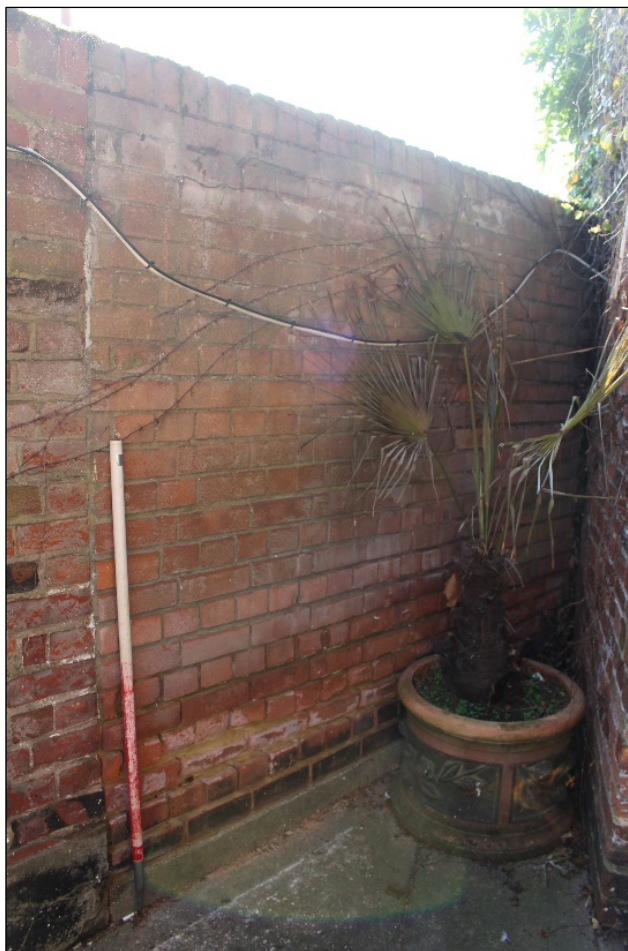
Photo 26: Section 1 of the western elevation from the north-west.

- 4.9. Section 2 is most noticeable to the western elevation of the wall and comprises a section of wall approximately 3.9m wide (Photos 22 and 23). The southern extent of this section simply abuts Section 1 (Photo 26) whilst the northern extent is demarcated by a brick pilaster/buttress (Photos 27 and 28). The section is spalling and heavily eroded as a result of the cementitious strap pointing utilised and the extent of decay and repointing in cement results in the obscuring of the original brick bond.

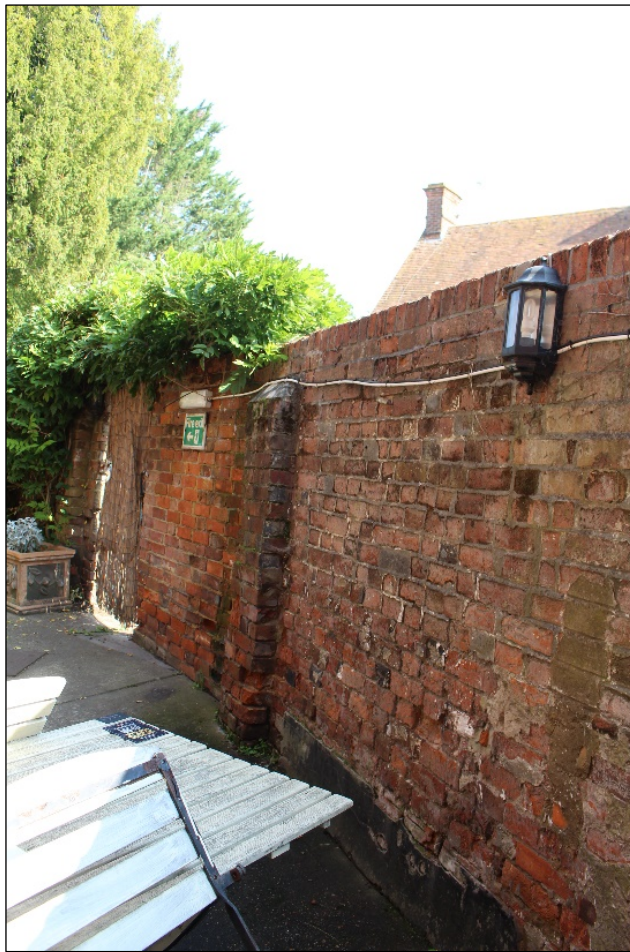
- 4.10. The visible bond is best appreciated within the southern extent of the section which appears to have been constructed in stretcher bond whilst the northern part is potentially of header bond construction in part. The size of an average brick utilised within this section broadly corresponds with imperial brick measurements of the late 19th century (typically 225mm by 110mm by 65mm) with a measured example measuring approximately 220mm by 120mm by 70mm). This section continues the capping on Section 1 with bricks stood on their header end.

Photo 27: Sections 2 and 3 of the western elevation from the south-west.

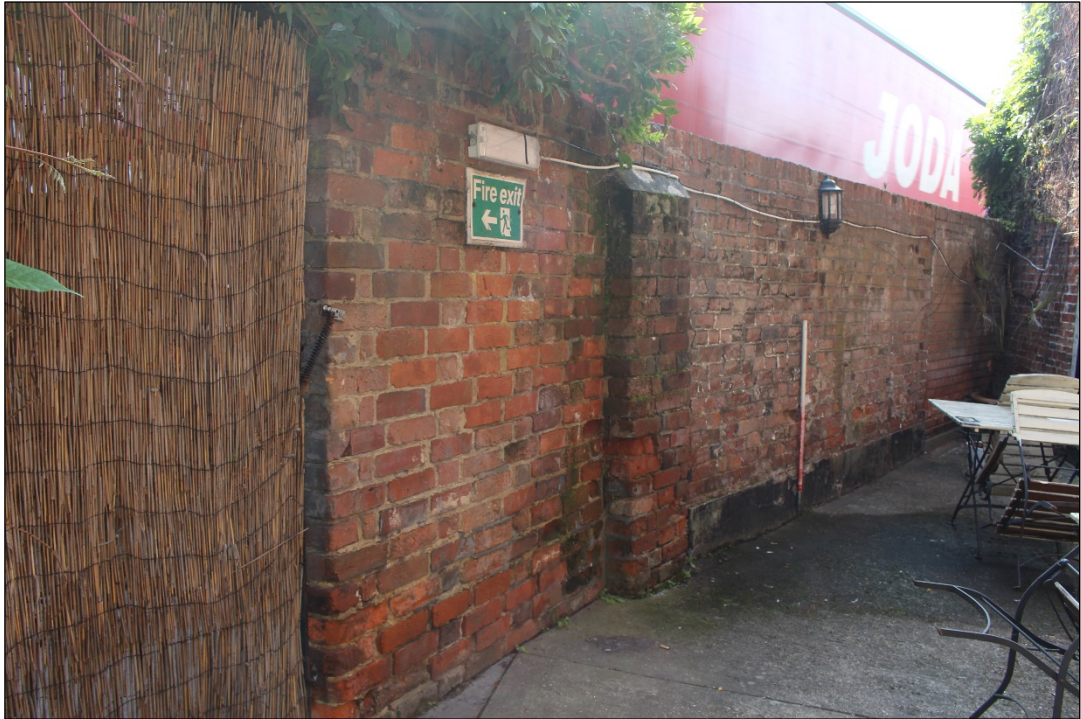
- 4.12. The brickwork is in better condition with less spalling visible within the western elevation compared to Section 2, suggesting that this area has been pointed with a softer material. There are queen closer bricks present to the south of the opening within this section which likely indicate the section was intentionally constructed to contain an opening, providing access from the yard to the east of the 18th-century range onto the course of Basingstoke Road.

Photo 28: Sections 3, 2 and 1 of the western elevation from the north-west.

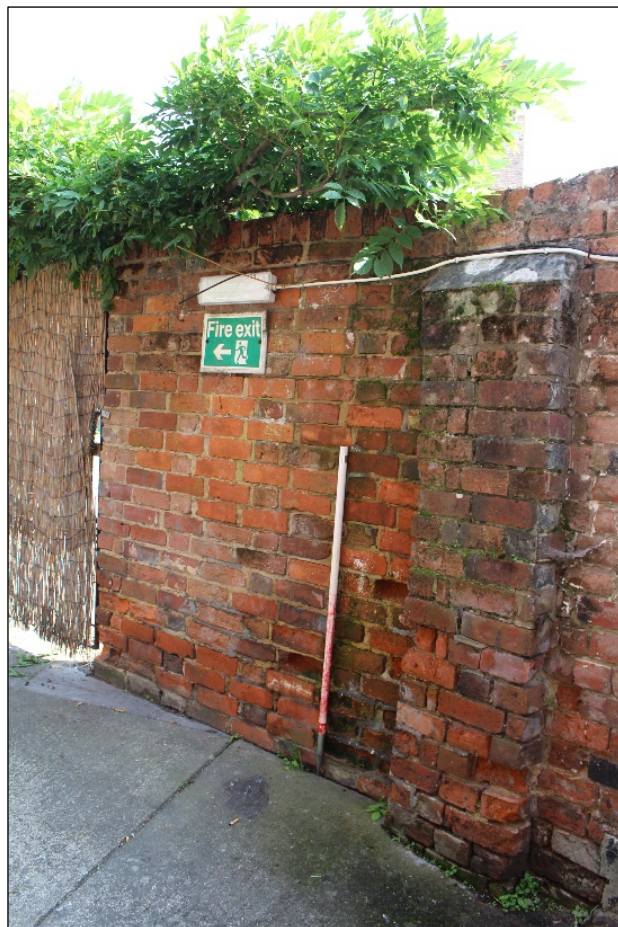
Photo 29: Section 3 of the western elevation from the south-west.

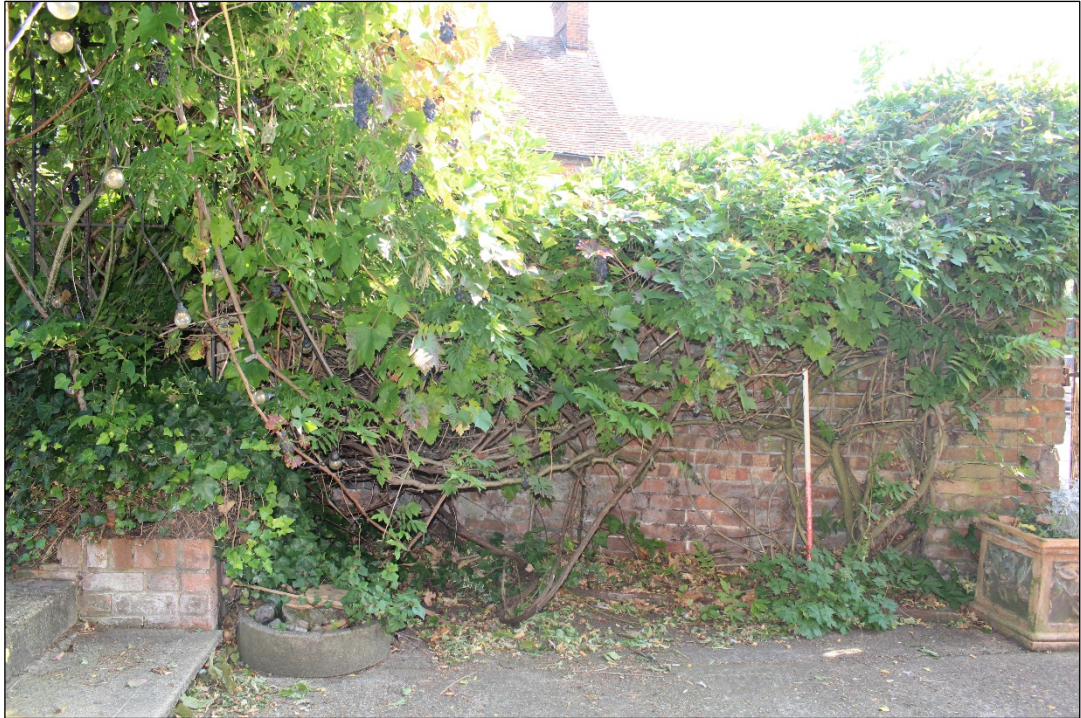
- 4.13. Section 4 comprises a section which continues north from the buttress to the north of Section 3 (Photos 31 and 32). The northern extent of the western elevation of this section is partially obscured by vegetation. The section measures approximately 2.4m in length. It is of redbrick construction in stretcher bond. An example brick used within the western elevation of this section broadly follows Georgian imperial brick measurements (typically 225mm by 95mm by 60mm) with the example brick measuring 230mm by 80mm by 70mm.

Photo 31: Section 4 of the western elevation from the west.

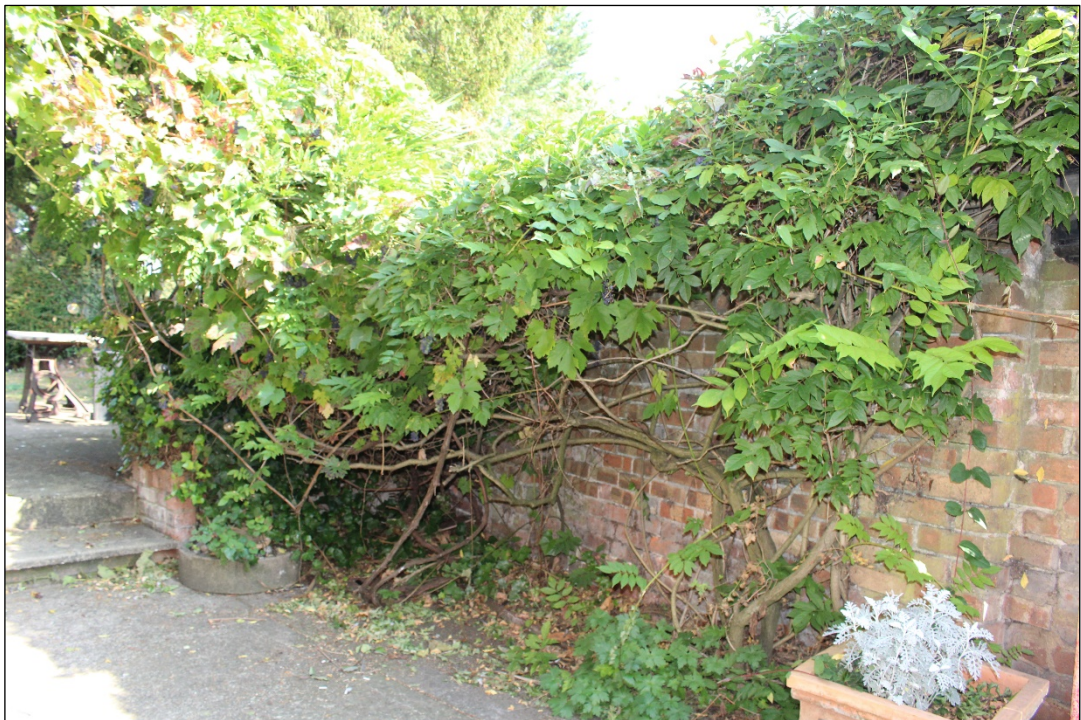
Photo 32: Section 4 from the south-west.
