Nesscliffe Training Camp Wilcott, Shropshire

Historic Building Recording

CA Report: CR0683_1

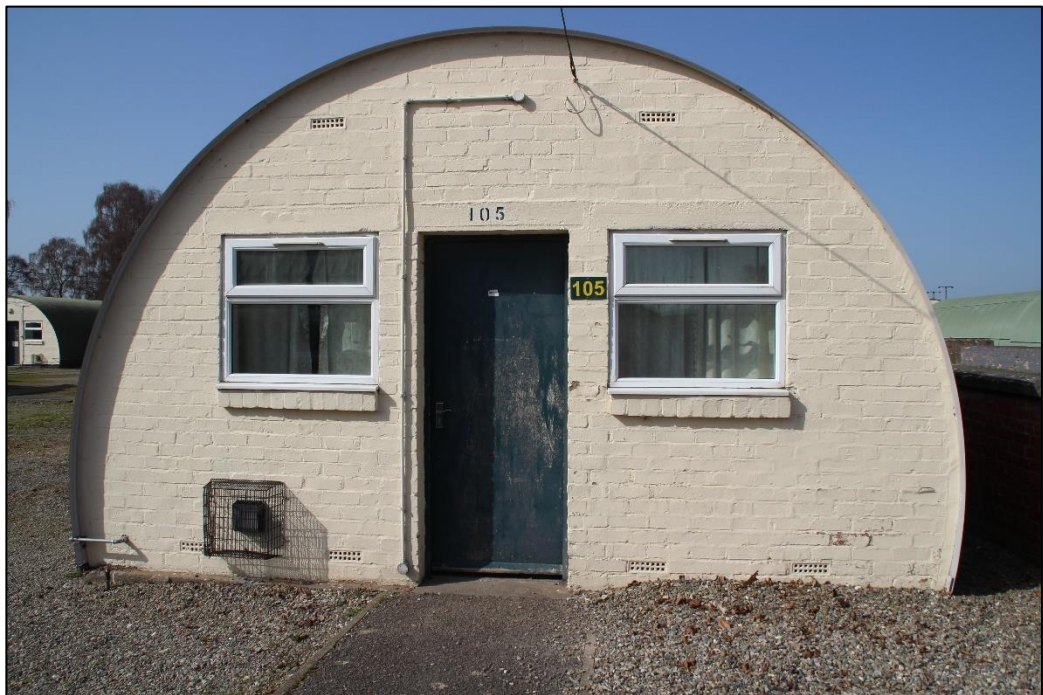
- 4.3. Buildings 85 to 105 comprise residential accommodation buildings. They are built of brick to each end with a central brick spine wall and measure 10.1m long, 5.1m wide and 3.1m tall. The front and rear elevations comprise a brick façade with a central doorway flanked by a pair of top opening uPVC windows with brick sills. The windows are clearly replacements of earlier metal versions, part of the ongoing modernisation of the structures over time. The lintels to both door and windows are concrete, as seen in Photo 8 below. The doors are flat without panels and with modern door furniture and are again no doubt replacement for earlier versions, those being likely braced and ledged or plainly panelled timber doors. The Building is built on a concrete plinth with brick facing. Air bricks are incorporated into the brick façade at floor and apex level. Newer insertions of gas venting and gas heating services are evident; the Buildings would once have been heated by an internal stove.

Photo 8: View of front elevation of Hut 105

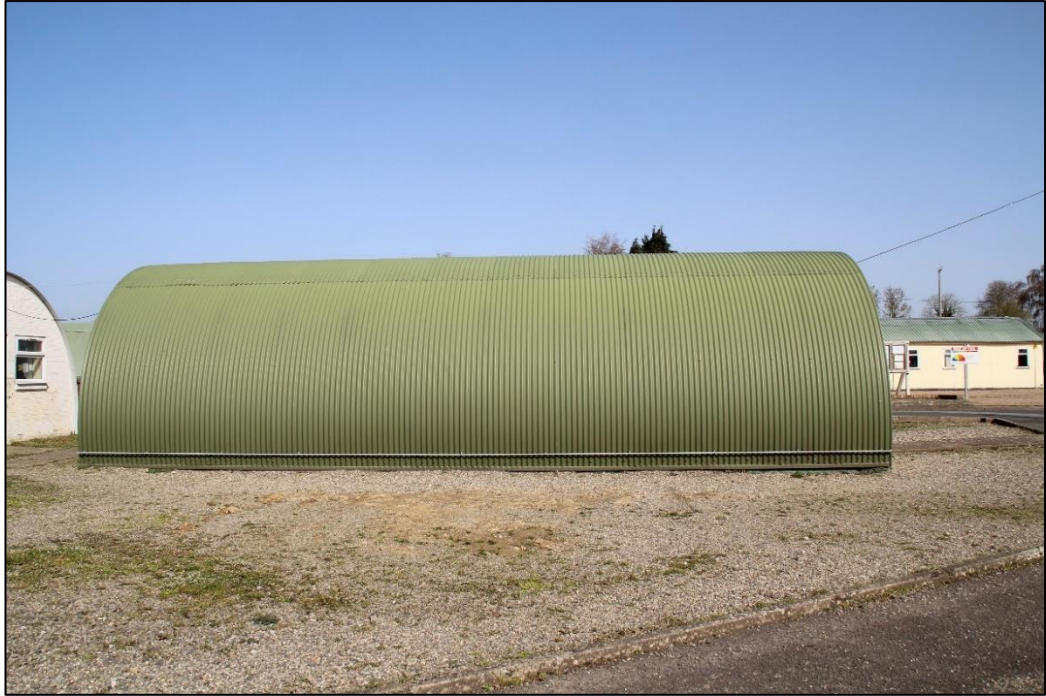
- 4.4. Buildings 85-105 have been re-clad in the recent past in a coated metal corrugated sheeting laid vertically over the structure, this is best seen in Photo 9.

Photo 9: View of Hut 105 from the side angle

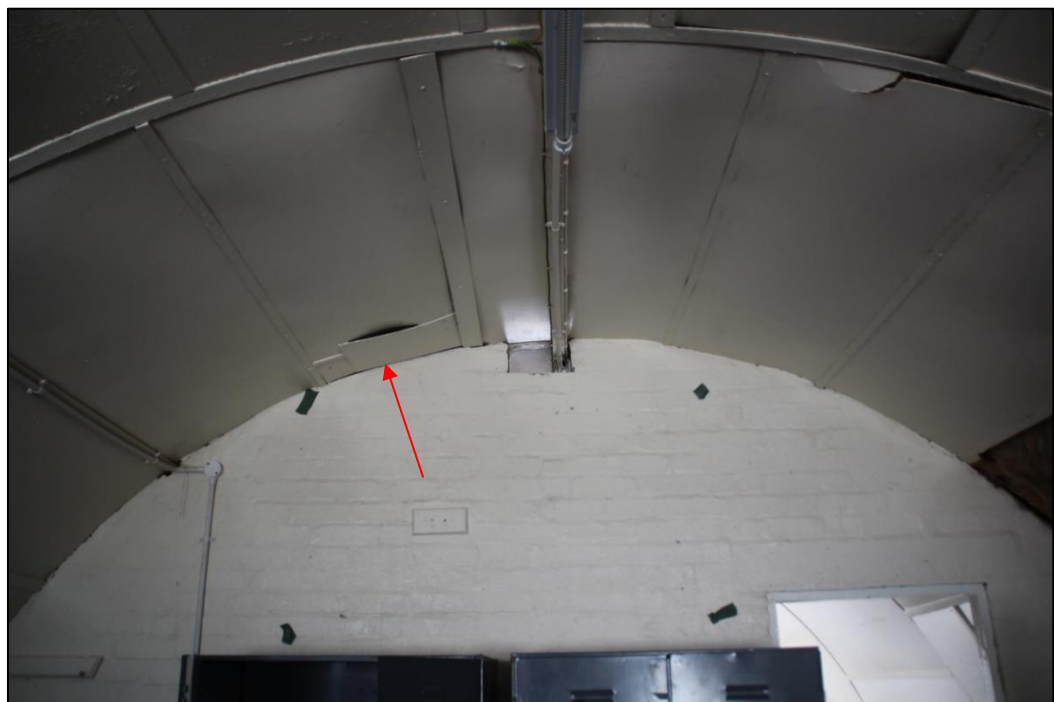
- 4.5. Internally the Building forms two plain and functional sleeping spaces, each holding four beds, the central spine wall is painted brick with a timber framed doorway off centre providing access to the second room. The floor is concrete with a polished patina that no doubt comes from age and historic floor varnish or paint (Photos 10 and 11).
- 4.6. The interior of the Building is cladded in a matchboard material, battened with timber joists in a grid pattern. The metal rib pieces are evident at c.180cm intervals with the battens abutting the ribs, which are bolted together in lengths (Photo 12). Also evident in the interior fabric is patching where the stove flue hole would have been located.

Photo 13: View of the roof apex with flue hole cover arrowed

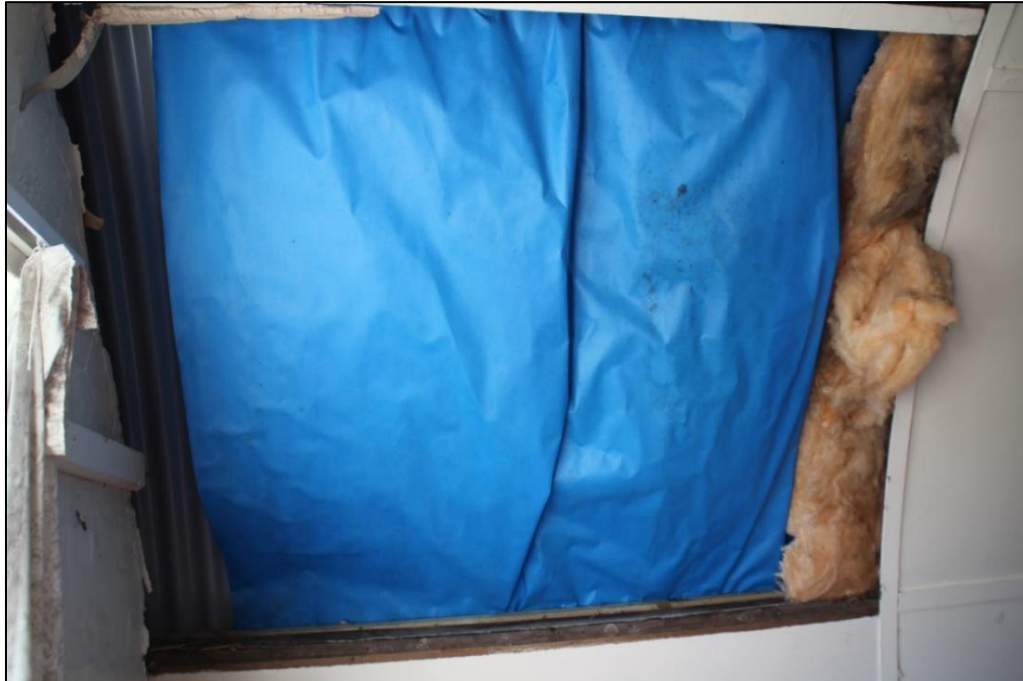
- 4.7. The Buildings' have obviously undergone some alteration to improve their thermal performance, both plastic lining and rock wool were evident in the void between the matching boarding/battening and the external metal cladding as seen in Photos 14 to 15. Also evident was the insertion of a concrete plinth internally running along

Photo 14: View of the plastic lining and rock wool in Hut 103

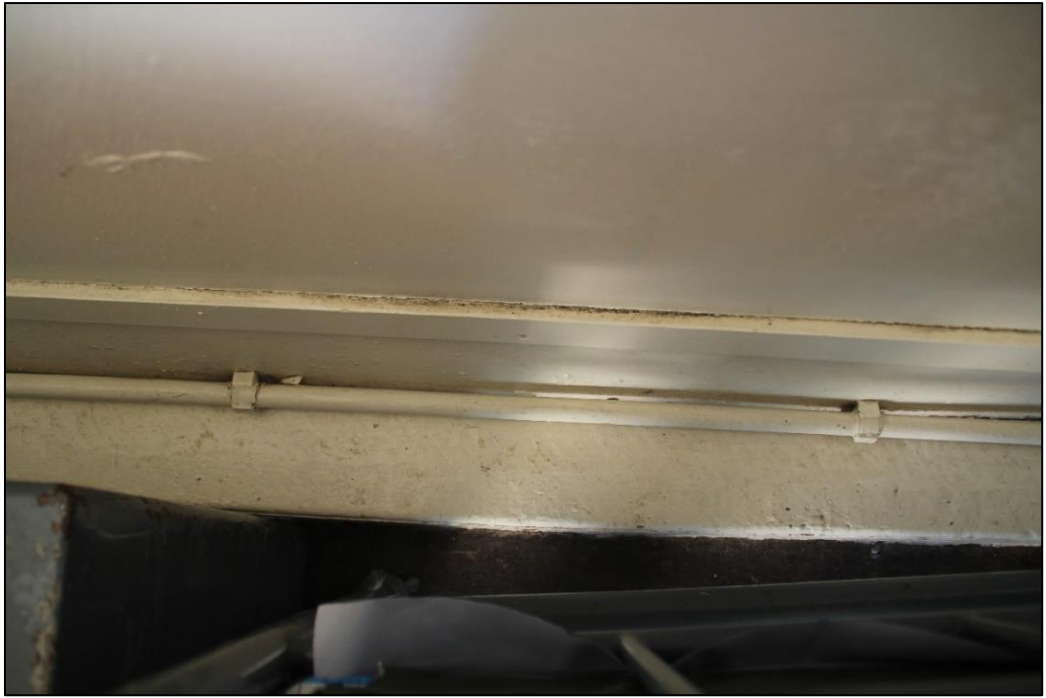
the sides of the hut. This creates a sort of rim to the internal concrete floor which was no doubt installed to make the huts watertight and mitigate draughts. Other huts elsewhere in camp which were inspected for this recording did not have such a plinth and were actually suffering from gapping between the concrete base and the bottom of the corrugated structure where timber plinths had degraded.

Photo 16: Detail of concrete 'rim' to floor

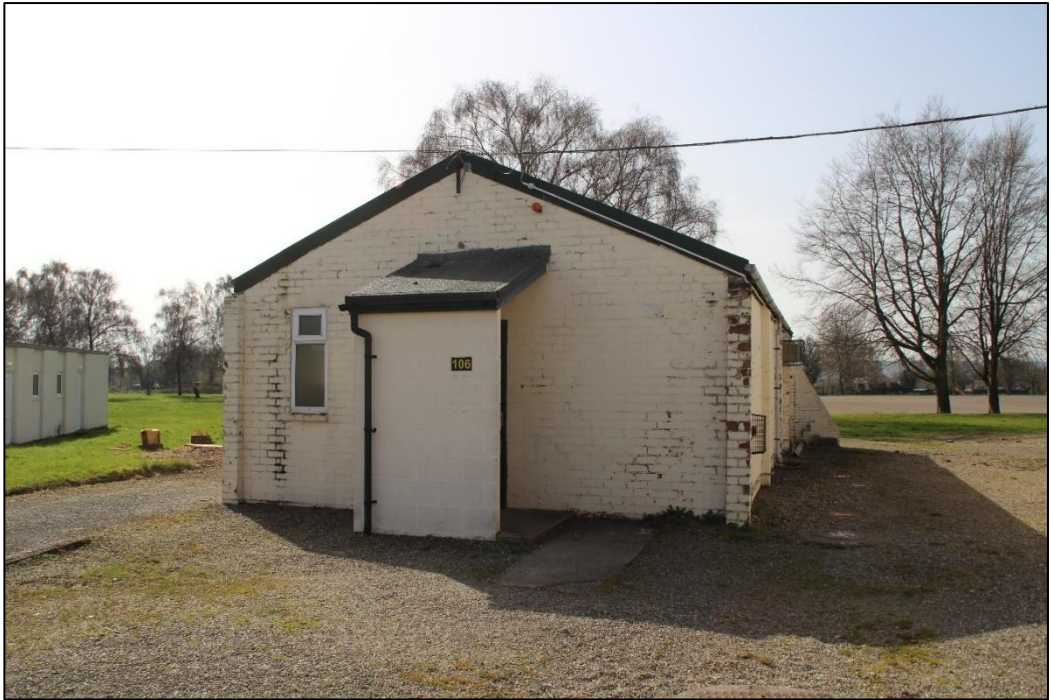
- 4.8. Blocks 106 and 104 are brick-built toilet and wash blocks. It is not clear when they were built, but they are likely to be mid-20th century in date based on the evidence of their materials, fixtures, and construction. They are rectangular in plan with a shallow pitched roof with gable ends. Each roof truss is supported by an additional brick pier visible on the exterior. Lean-to porches have been added to the northern elevations constructed of concrete blockwork with felt roofs. Block 106 has a buttress built on its south-western corner, presumably to correct a structural weakness.

Photo 17: View of toilet and wash block 106, image taken looking south

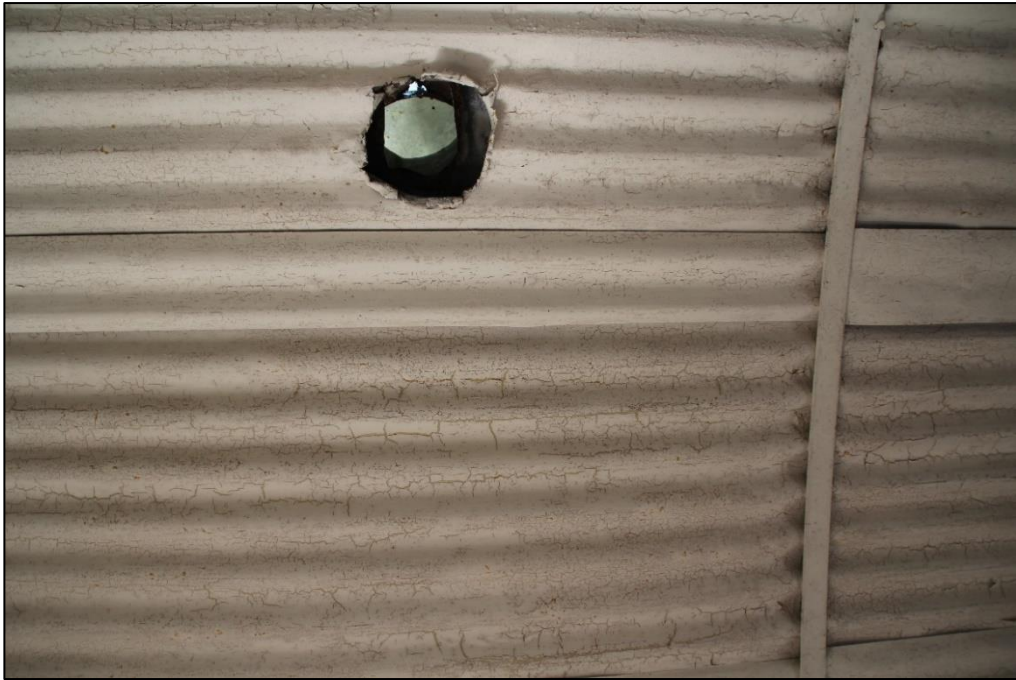
-
- 4.14. The interior metal cladding has been clipped into the metal ribs as seen in Photo 29. A central timber ridgepiece holds electric lighting and forms a longitudinal rib. There was no insulation apparent in areas where the metal had been removed for investigations. The opening for the stove flue was evident in the apex of the ceiling as seen in Photo 31.

Photo 31: View of the former stove flue hole

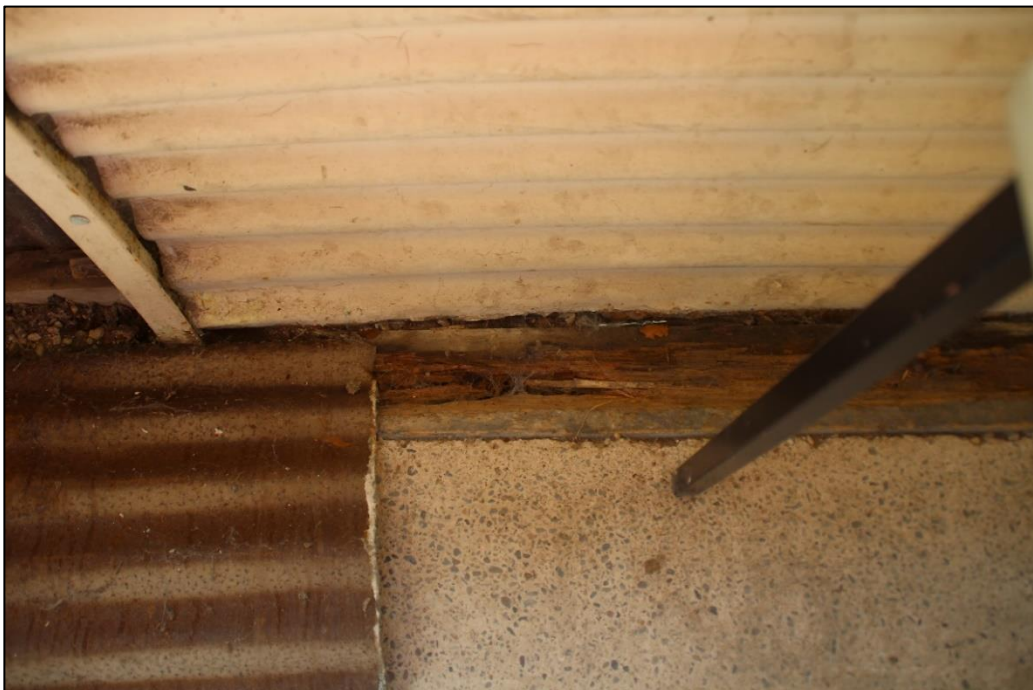
- 4.15. Areas of rotted timber were seen encircling the concrete base, in some areas creating gapping between the exterior cladding and the exterior ground and the concrete floor (Photo 32).

Photo 32: View of timber plinth to concrete floor and gapping to the exterior

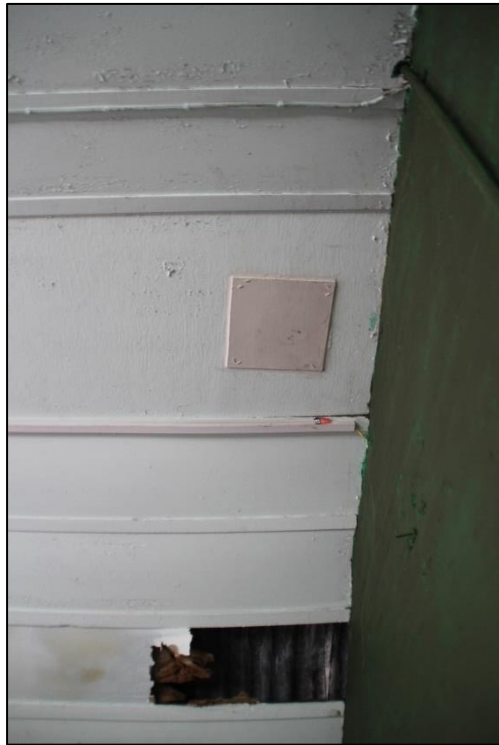
Photo 34: Interior view of the covered flue hole in the office hut (77

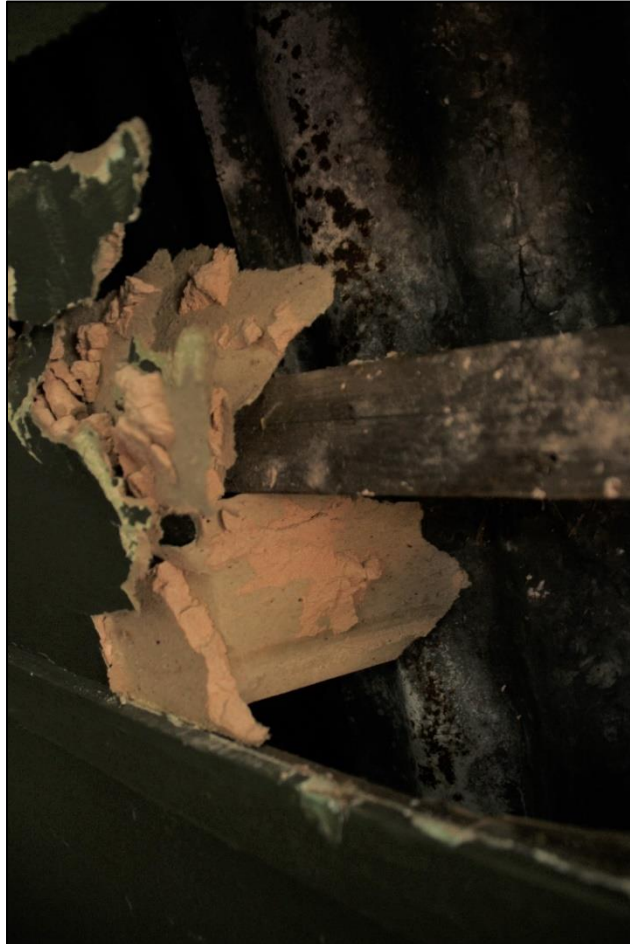
-
- 4.17. An interesting cross section is shown in Photo 36, showing how timber 'purlins' are braced within the frame between the interior and exterior cladding. Clearly this building has been plaster boarded internally between the battens, presumably for insulation.

Photo 36: Internal detail view in office hut 77

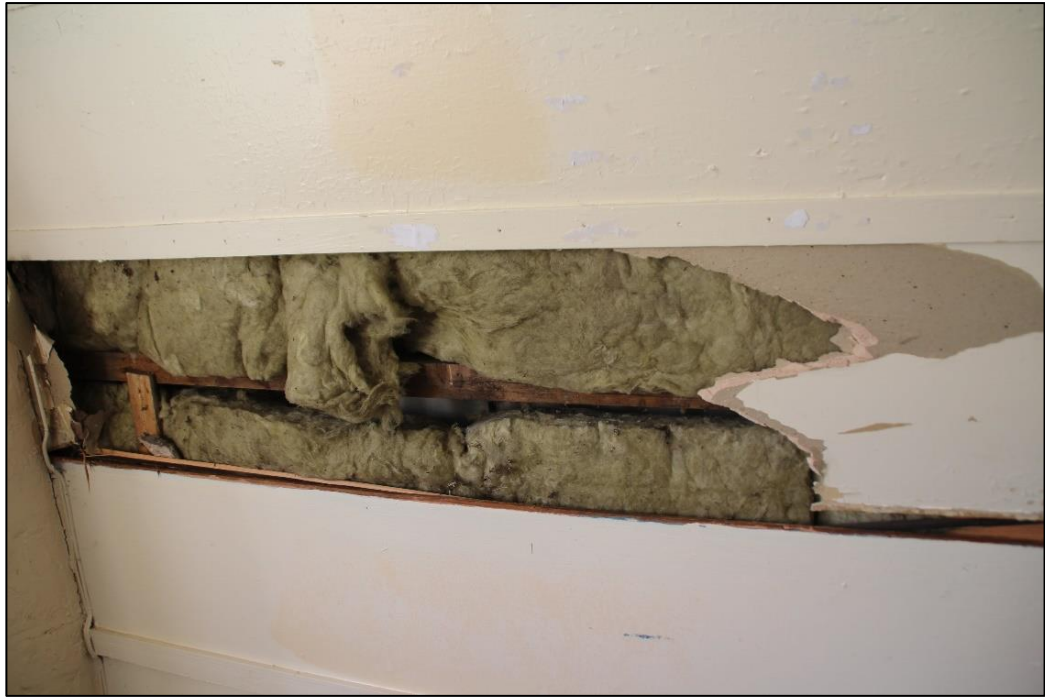
4.21. The interior cladding has clearly been upgraded since its original construction, with plasterboard sections and rock wool inserted in the void between the exterior and interior cladding (Photo 42).

Photo 42: Detail of rock wool insulation and plasterboard cladding – Medical hut

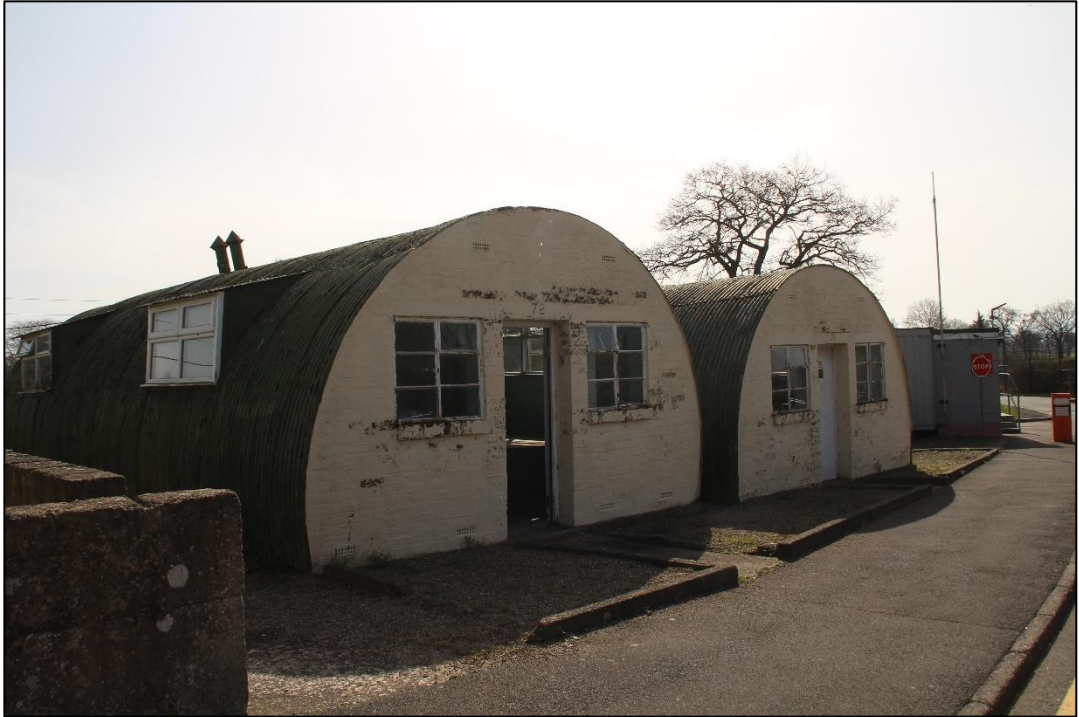
- 4.24. It was not possible to ascertain the function of huts 72 or 71 (Photo 47) however in appearance and construction there are identical to the office and storage huts. They have metal windows to front and rear, and timber to the side dormers. The

front doors are modern timber versions, however the rear doors are the original braced and ledged versions.

Photo 47: Huts 72 and 71 – western elevations

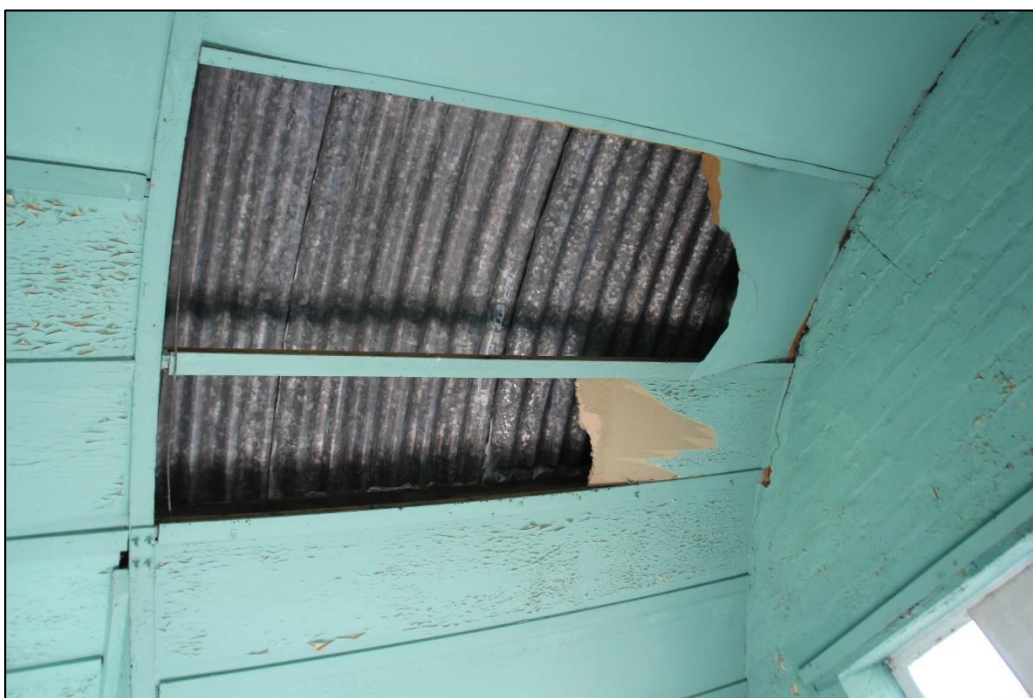
- 4.25. Internally the buildings have the traditional central brick spine wall with off centre door (Photos 48 - 52). The doors are the original four panelled versions. The internal cladding is similar to that in the other huts, with regularly spaced battens pinning plasterboard/thin board cladding in place, punctuated by the metal ribs. The covered stove flue pipe is evident. The floor is concrete and there does not appear to have been any insulation inserted as evidenced in Photo 49.

Photo 49: View of cladding and void, hut 72
