# No.6 Motor Transport Site RAF Quedgeley (now Quedgeley East Business Park)

*Historic Building Recording (Level 2)*

CA Project: CR0694

CA Report: CR0694\_1

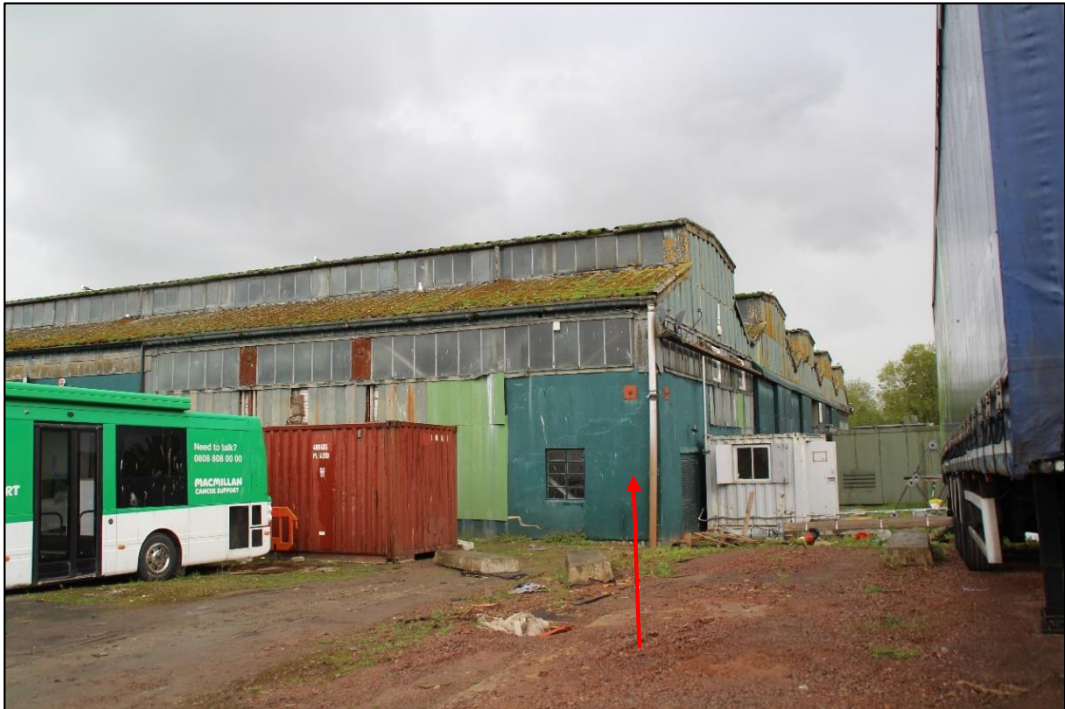
15, this is unusual as it is not seen in the other store block buildings and represents a departure from the normal building typology. There is a metal multi-paned window on the south elevation, and a double timber louvred door on the eastern elevation. Internally it presents as a full height brick room with an unusual feature which will be discussed in the section dealing with the interior. The louvres on the door suggest it may have stored materials that needed ventilation or operated as a furnace room or similar.

**Photo 15** View of the south-west corner of store block 1 (unusual anomaly arrowed)

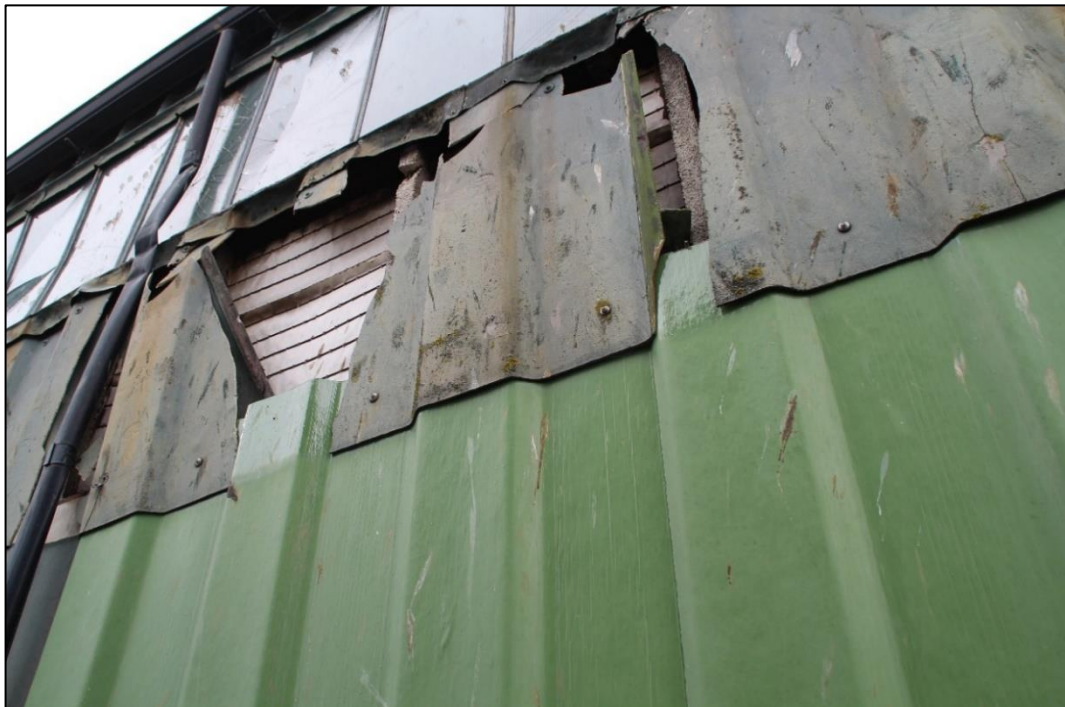
**Photo 19**      **View of broken cladding, internal fabric and under eaves glazing of store block 1**

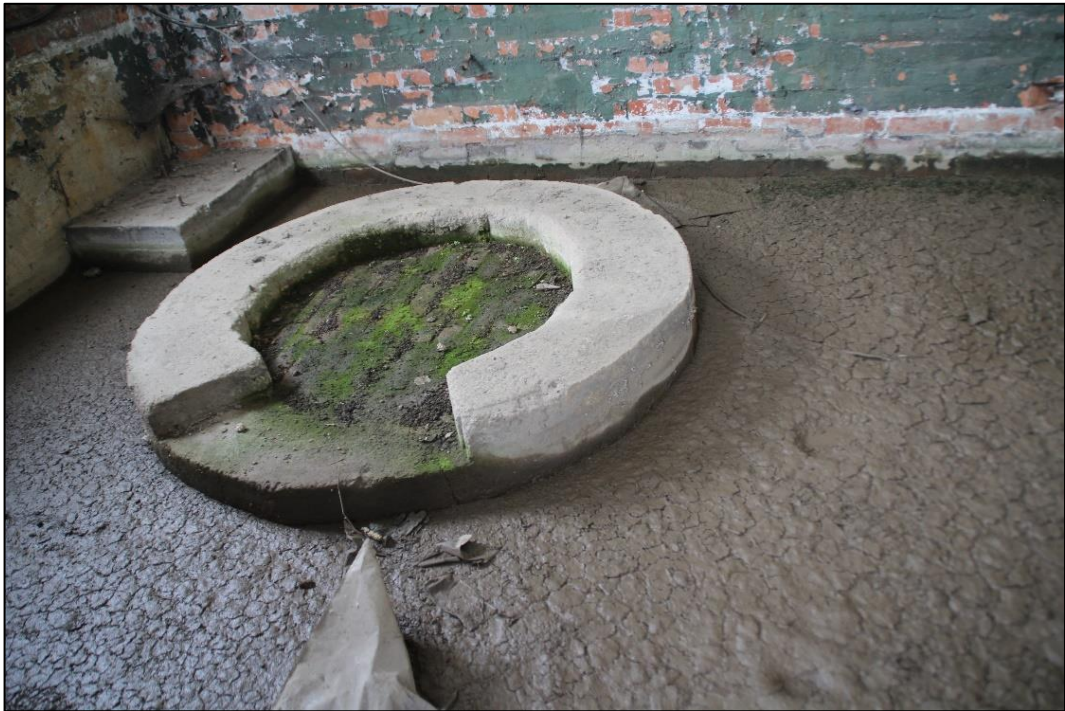
4.23. The full height room accessed from the exterior is difficult to interpret, based on its current appearance. It contains a circular plinth with hole and open section as seen in Photo 30, with structural bracing as seen in Photo 31. It rises to the roof as seen in Photo 32 but any machinery or equipment that was present here is no longer extant. It potentially contained a large tank for petrol or water, or alternatively may have contained a furnace or similar to allow metal repairs to be undertaken.

**Photo 30** View of the circular concrete plinth in the full-height corner room of store block 2

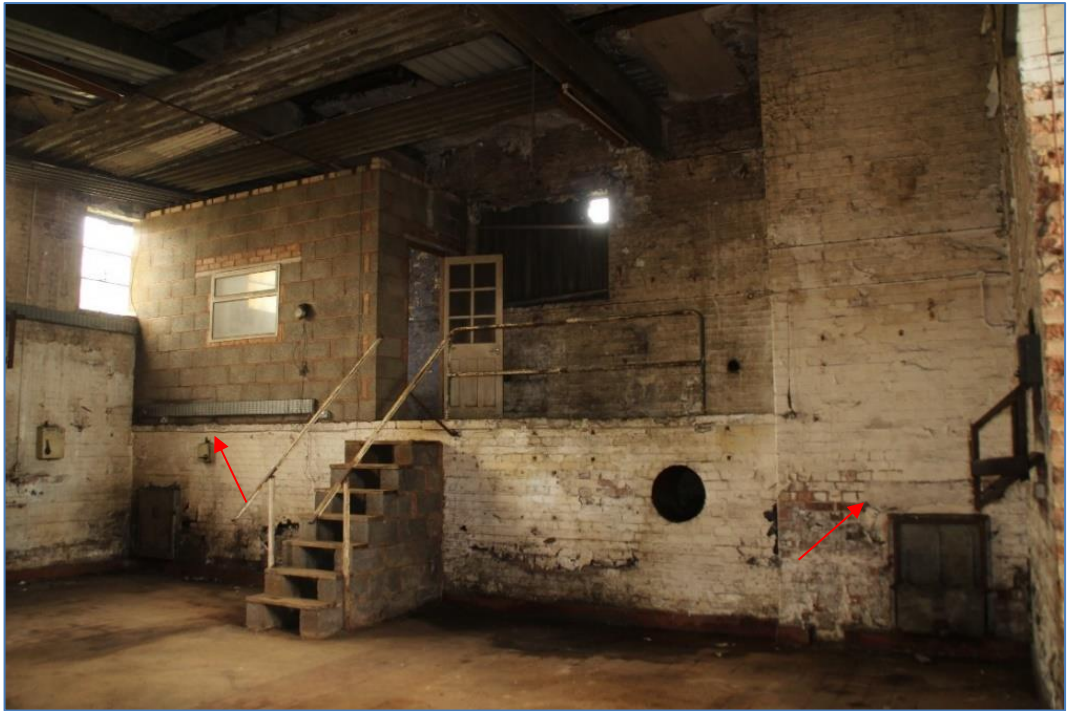
- 4.34. Internally the boiler room is a large open plan room with a brick mezzanine housing a modern cement blockwork ‘cabin’. Two coal chutes are seen to either side of the room (arrowed in Photo 52 and seen in detail in 53). The ceiling is formed of concrete beams and the floor retains remnants of quarry tiles in some areas. Remains of historic equipment is extant on walls as seen in Photo 54. This room would have housed three coal-fired boilers which were converted later in the century to oil-fired boilers utilising fuel tanks housed in the compound (AFRG 2004).

**Photo 52** The interior of the CHS main boiler room with early coal chutes arrowed

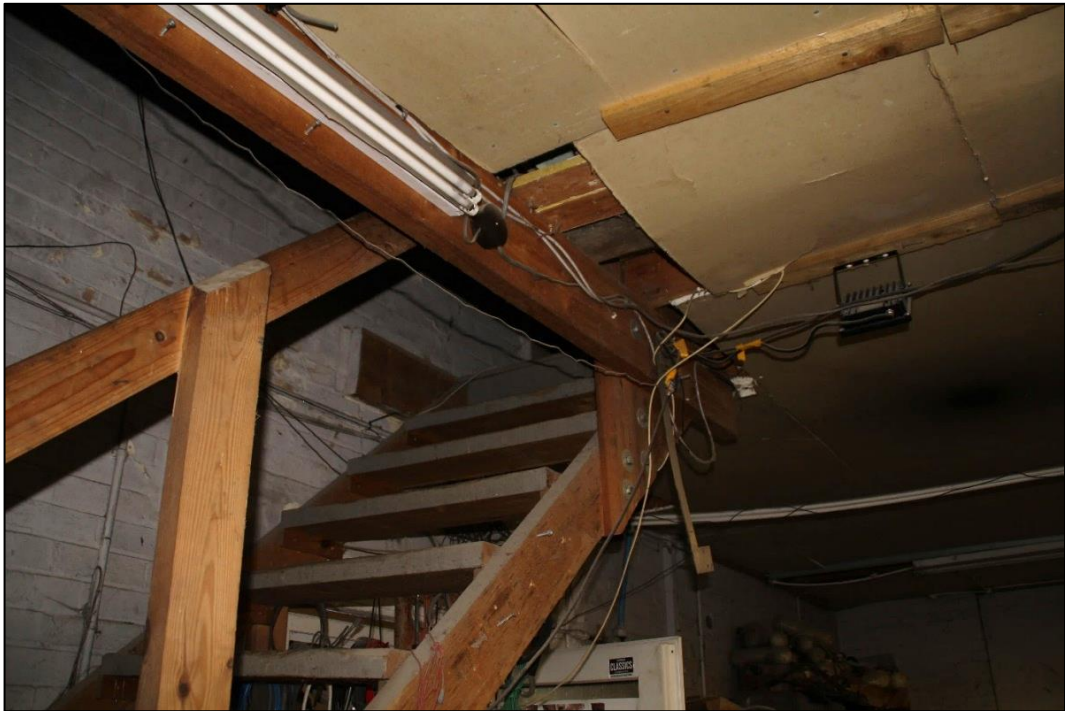
**Photo 60** Timber staircase to the first-floor mezzanine, likely a later addition

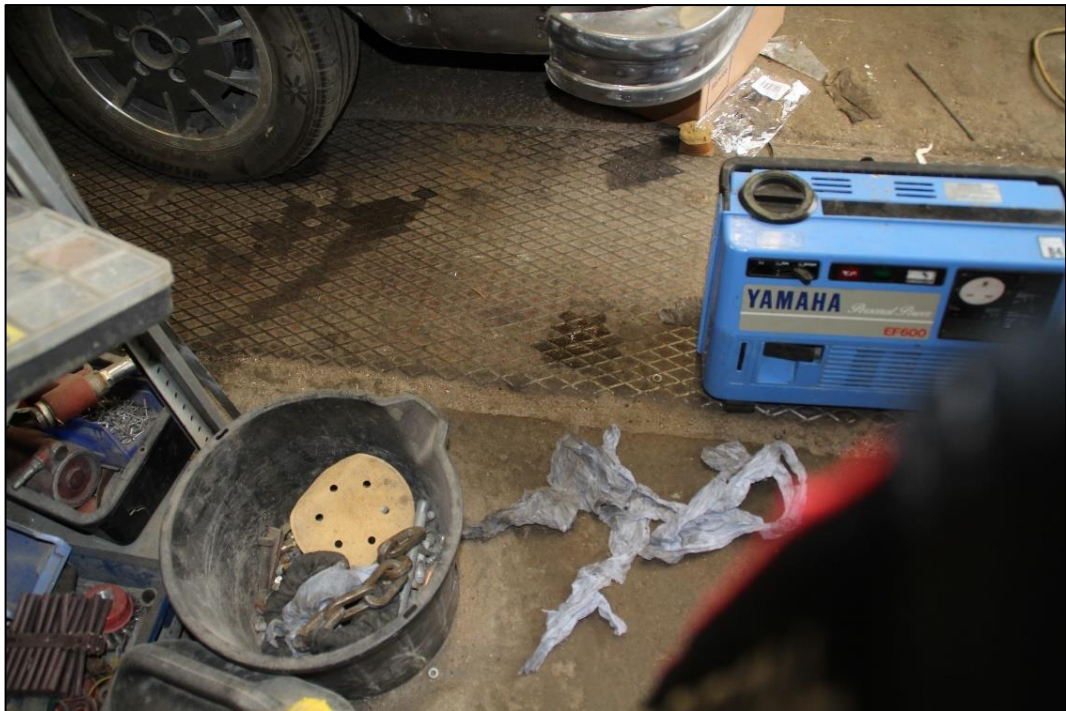
newer timber work leading to the first-floor mezzanine. This structure is supported by concrete blockwork pillars, but they also appear to form support for the original roof truss at full height. Photo 62 gives a view across the building in an east-west orientation showing how full the interior space is which impeded proper internal inspection. An area of metal floor within each bay suggests the presence of repair pits (now unused) as seen in Photo 61.

Photo 61 Metal coverings to probable former repair pits

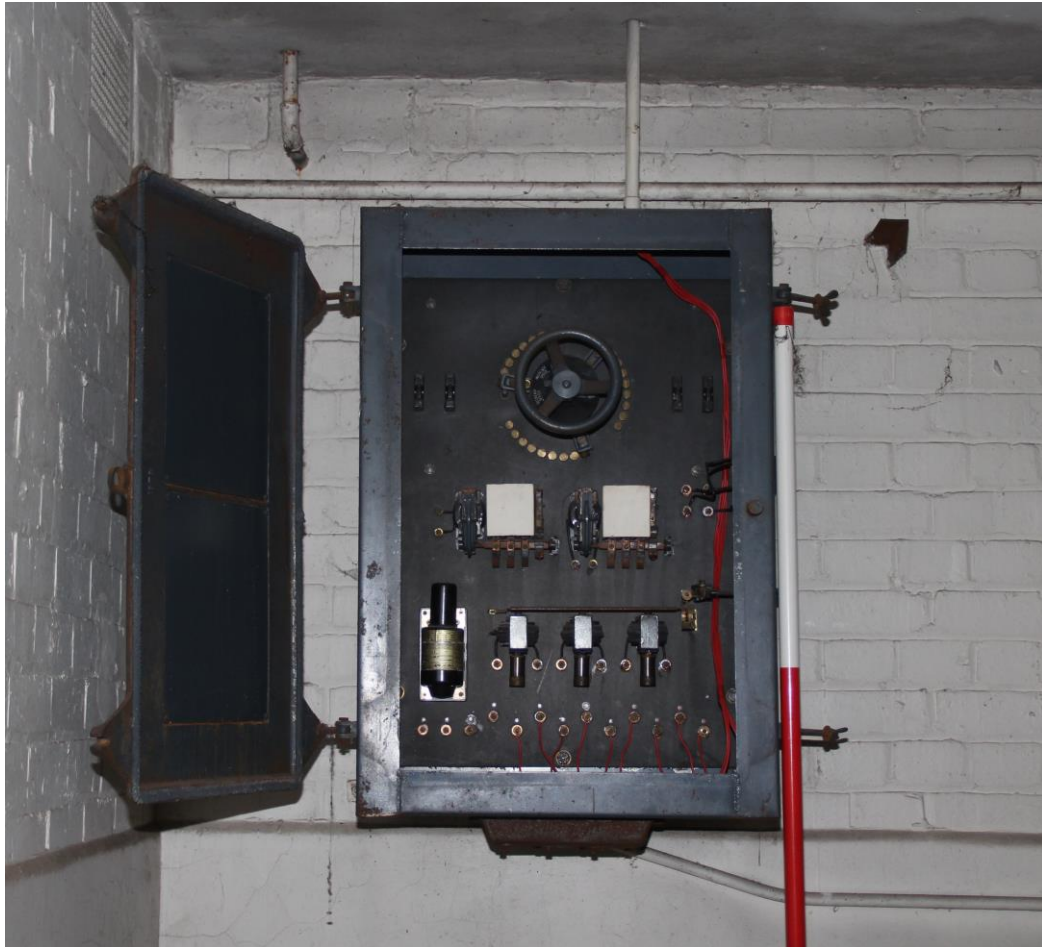
- 
- 4.10. Room G8 clearly had some kind of heavy electrical equipment as a 400v control box is still *in situ* on the west wall (dashed line on Fig. 5 and unopened in Fig. 11) and there is a heavy-duty junction box on the north wall (just visible in Fig. 19). The control box has a potentiometer to control the speed of three electric motors in unison, a mercury switch and other electrical components beyond my technical knowledge to interpret, but which appear to be in triplicate (Fig. 13). As the ventilation ducts seem to begin in this room, it is assumed that that the motors drove ventilation fans. The ducting only seems to have served rooms G6 and G9 (Fig. 5).

**Figure 13** Room G8 in Building 1, the electric motor control box

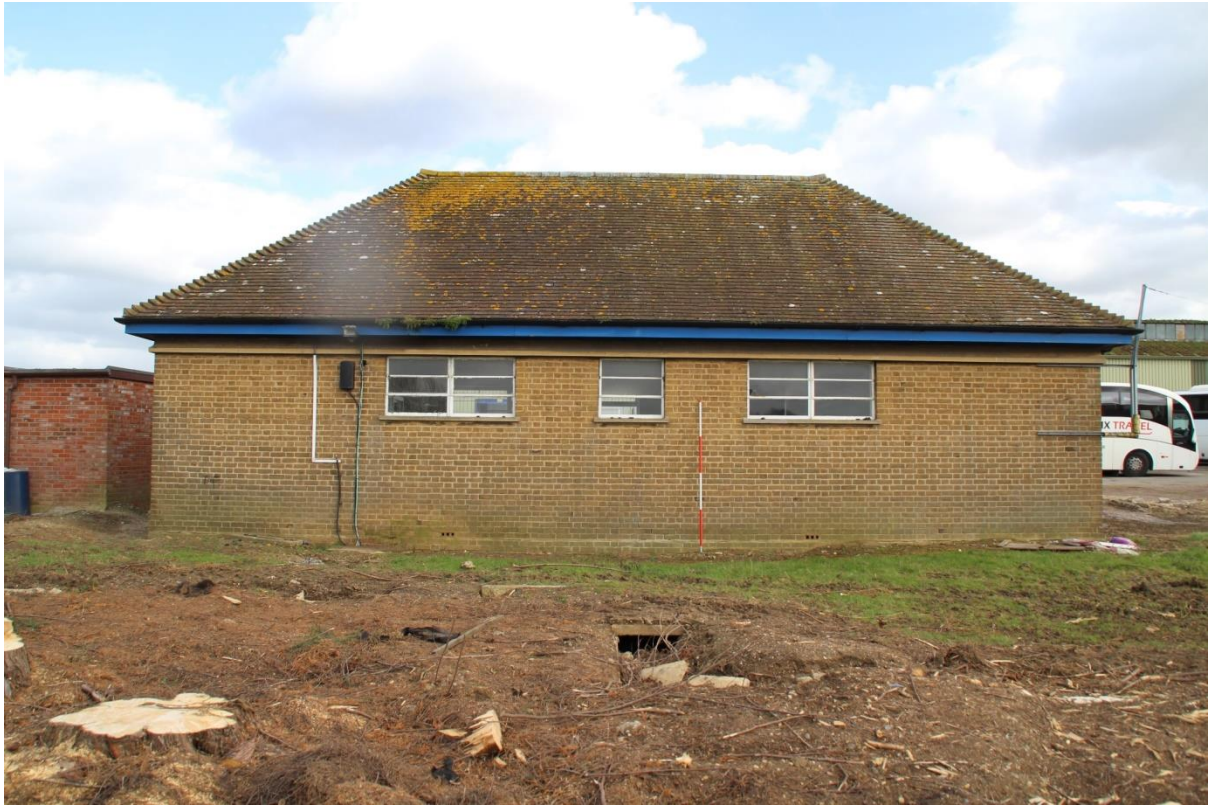
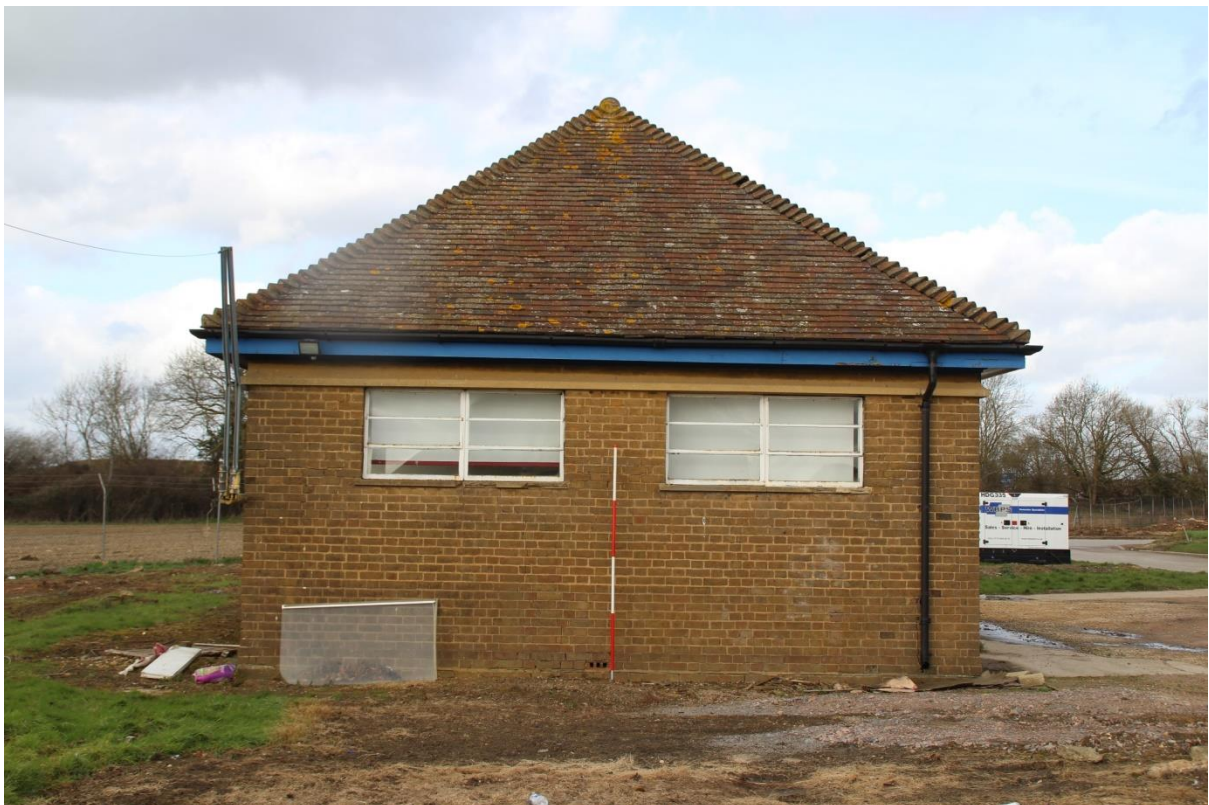
- 4.51. They were built in no expectation of a long life and all show some signs of structural failure, mostly in the brickwork. The concrete is in quite poor condition too.
- 4.52. They are typical of the time and place and of the RAF expansion scheme.

**Figures 35 and 36** *The west and south elevations of Building 3 (scale 2m)*
