Holmbush Mine Engine House Windsor Lane, Kelly Bray Cornwall

*Costed and Prioritised Proposals for Capital Works
to support Conservation and Management of the
Scheduled Monument
(Costs redacted version)*

CA Report: CR1008_2

December 2022

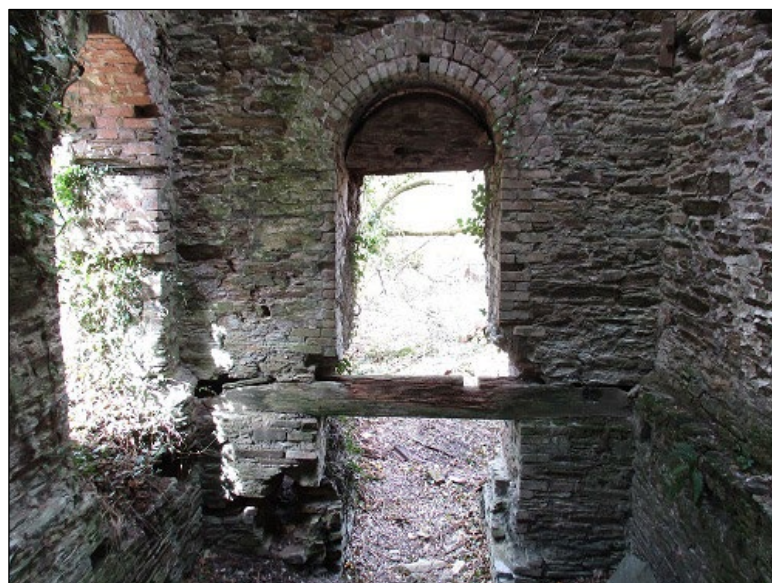
5.20. On the bob wall, the plug door with its three courses of internally visible brick arch headers appeared to be in similar condition to that set out in 1998, but with a partially slipped brick at the crown of the arch, and bricks also missing generally from around the reveal (Photograph 2). In addition, it was noted that the internal wood lintel had rotted out leaving the masonry panel and opening unsupported. The opposing external part of the arch was infilled with masonry. A localised masonry collapse and hole through the wall was also recorded below the plug door, internally on the west side, just above ground level (Photograph 2).

Photograph 2. Plug door looking north from within the interior

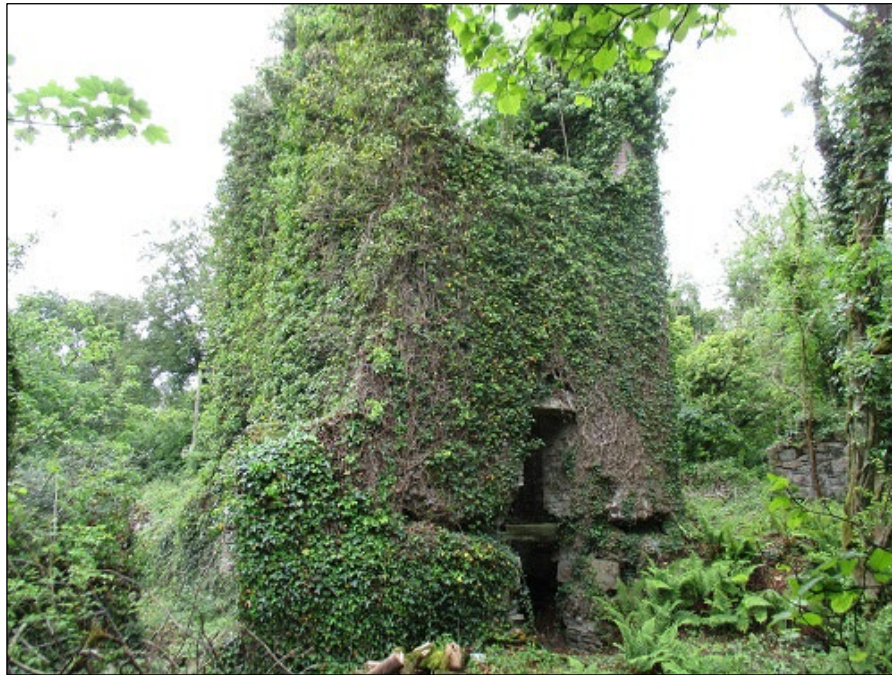
5.21. Externally, a number of original timbers had rotted out at low level, with voids in the stonework local to the central opening. The internal floor level timber bearer was found to be in a deteriorating condition (Photograph 2) and the external bearer entirely missing, creating a significant weakness (Photograph 3). The tie bars were still visible on both the east and west side of the plug door. The bob wall was densely covered by ivy, with small trees growing from wall heads. Without intervention, it is considered that elements of the bob wall could further collapse and fail.

Photograph 3. Bob wall looking south

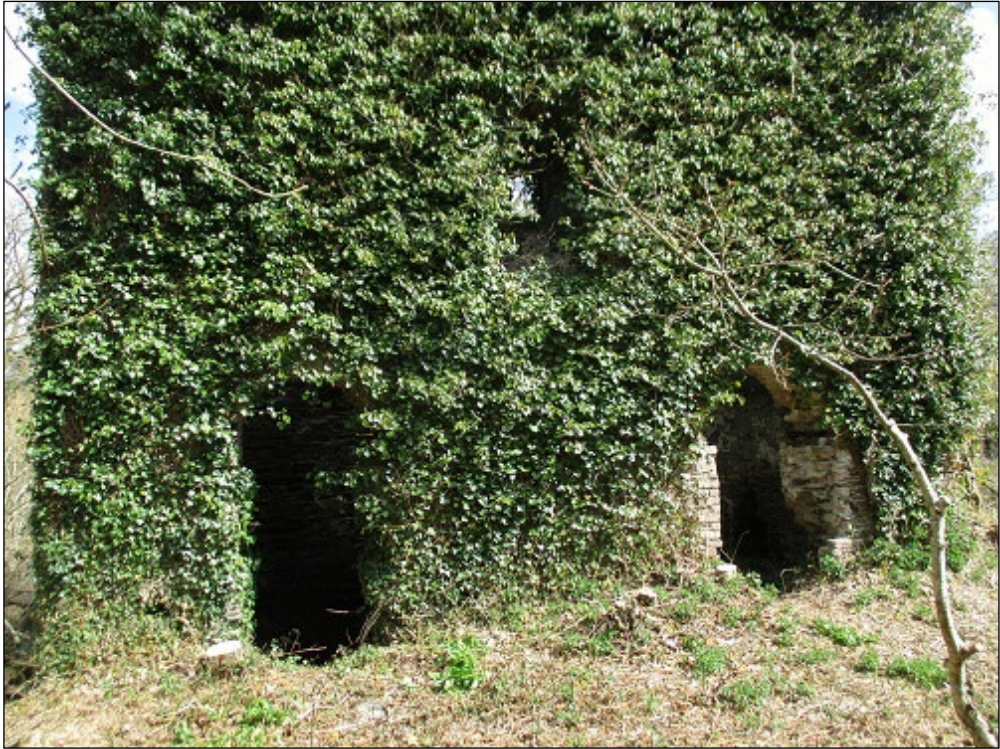
5.22. On the west wing wall, externally, both ground level openings were partly visible (Photograph 4), although all features above their brick arched headers were concealed beneath dense ivy. There were loose or missing bricks in the internal reveals to most openings (Photograph 5). However, the crack identified in 1998, running from the brick arch to the first floor window to the cill of the second floor window above could not be seen due to ivy. Indeed, a relatively thick covering of ivy on the internal side of the west wing wall, above the level of the first floor window arch, precluded a meaningful assessment of condition, or identification of other features recoded in 1998. Rotted timber lintels were also noted to the northern door opening, and to the blocked opening located just above and to the south of the first floor opening. Externally, the masonry appeared to be relatively stable, but several original roof timbers were noted hanging down from the top of the wall, which are potentially unsafe, and there were also loose slates.

Photograph 4. West wing wall looking east from platform

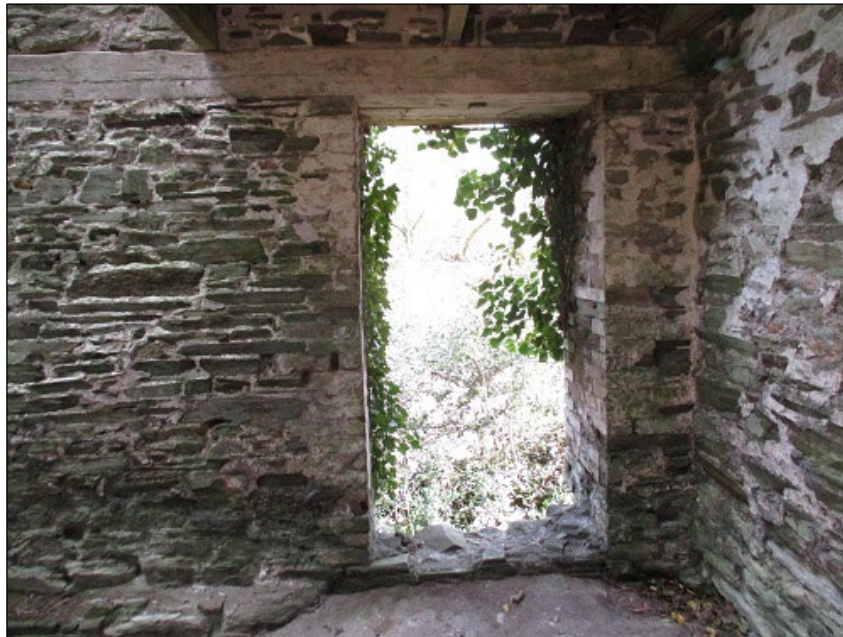
5.23. On the east wing wall, from the exterior, the openings described in 1998 were only partly visible due to the dense colonisation of ivy, but of complicated arrangement. Internally, the bedstone level door opening (Photograph 6), first floor window opening, and opening just above and to the south were visible (Photograph 7) and their condition more readily assessed. These features all appeared to be in similar condition to that described 1998, with no obvious structural failures.

Photograph 6. Door in east wing wall to Boiler House

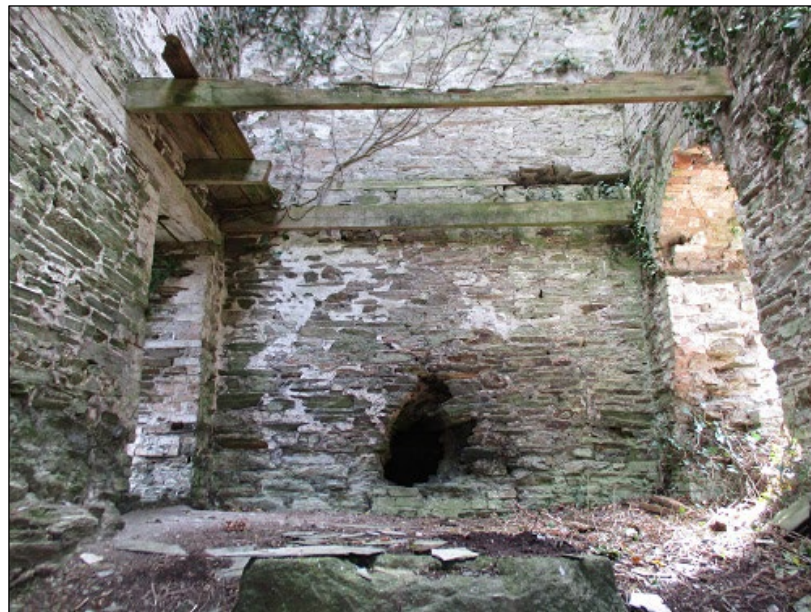
5.24. Externally, the rear gable wall was completely concealed by ivy. Internally, the condition was similar to that described in 1998. The triangular opening to the chimney flue was obviously visible and appeared to be in a stable condition, although with no support to the stonework (Photograph 8). There were no obvious failures to the wall itself, although a partially removed/rotted timber wall plate was visible on the west side, just above the surviving first floor joists, leaving stonework unsupported. On the next level above, there are four recessed voids with their timber lintels thought to be in fair condition, although assessment was difficult due to ivy growth. Generally, masonry to this internal elevation appeared to be in good condition.

Photograph 8. Gable end wall opening to chimney flue

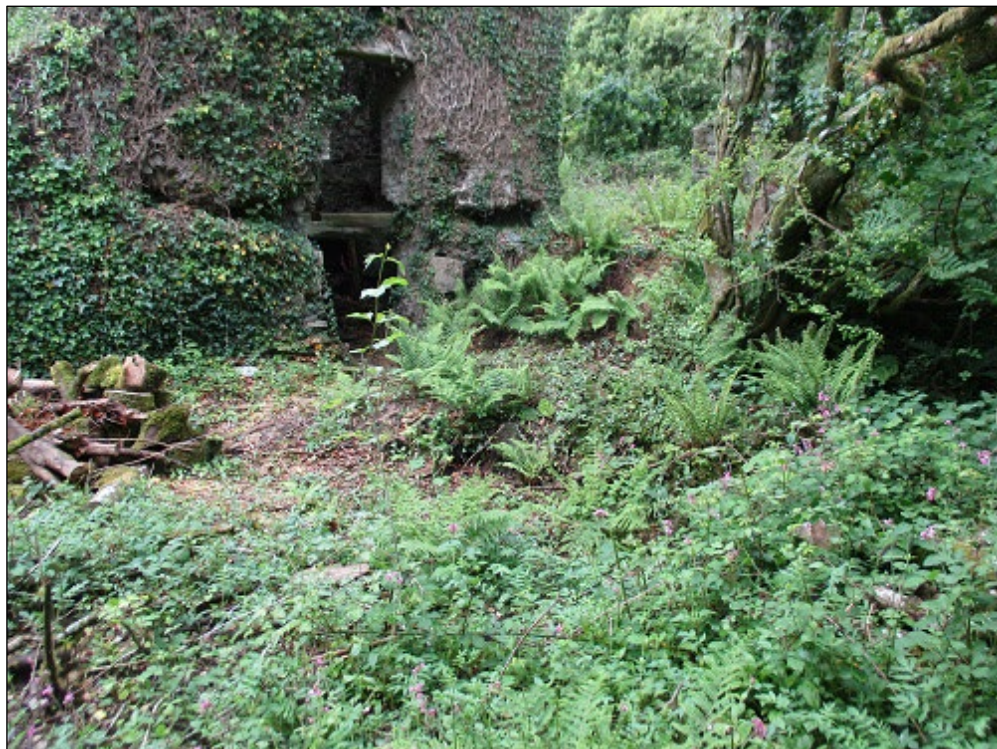
5.28. The loadings were set externally against the bob wall, projecting to the north to encompass an area of approximately 7m by 7m. As recorded in 1998, these survive in very fragmentary condition, having been extensively robbed of material and reduced in height, so that only a low masonry footprint remains, set within a depression (Photograph 11). The iron mounting bolts protruding from the crankshaft and winding drum loadings are still visible, and overall, the condition of the loadings appears unchanged from the 1998 survey. Indeed, the overlying remnants of the corrugated iron shed are still visible on the ground.

Photograph 11. Loadings looking south-west

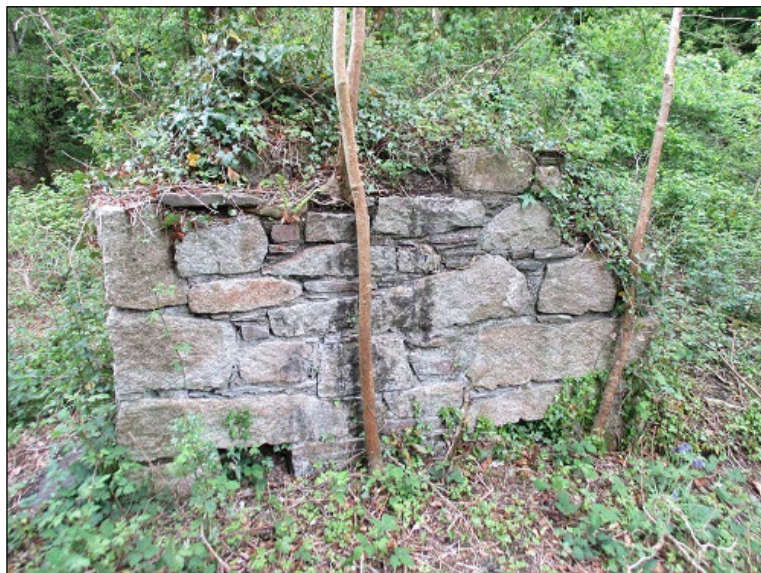
5.31. The granite quoined plinth, located on the platform, measured approximately 2.6m long by 1.6m wide and 1.6m high (Photograph 12). It was mostly constructed of partially coursed granite, built with a lime mortar which included a course gritty sand. The stonework was found to be open jointed in extensive areas. Two openings were partly exposed at ground level on its east side, measuring approximately 0.2m wide and at least 0.3m high, although their lower sections were infilled and below the ground surface level.

Photograph 12. Stone Plinth, east facing elevation

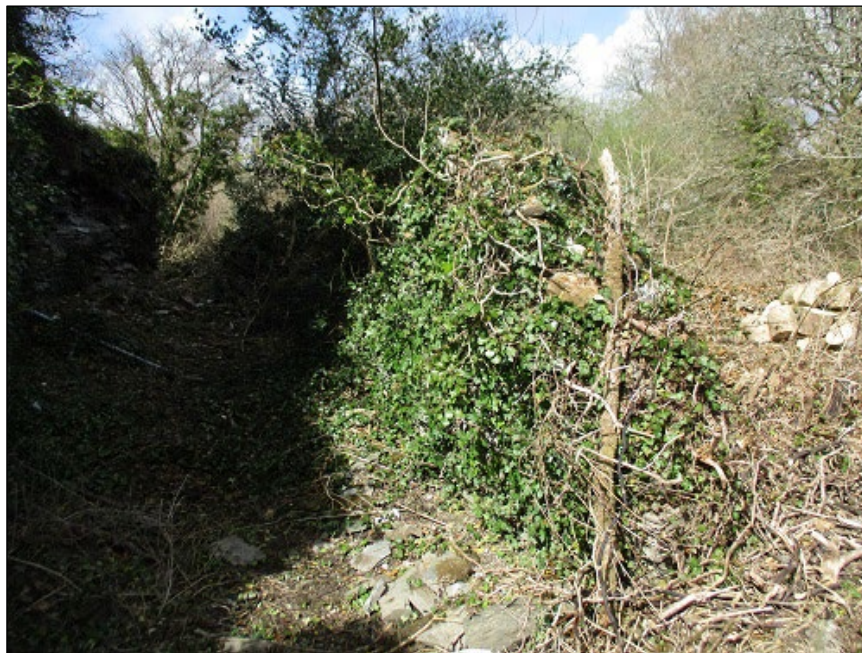
Photograph 14. East wall leaning inward, looking north from beside collapsed opening

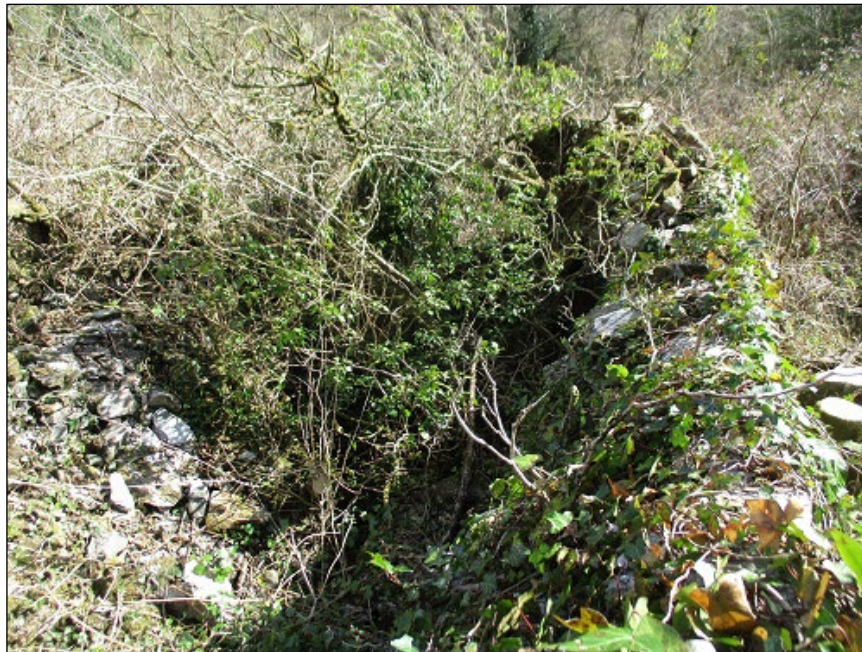
5.39. The south gable end wall was densely covered in vegetation and appeared to have been significantly reduced in height from the 4.0m, recorded in 1998. The dense vegetation and fallen masonry on and around this gable end wall made close inspection impossible (Photograph 15). The opening identified in 1998 was not visible, and the maximum surviving height appeared to be little more than 2m at the corners, with a more substantial central collapse. Masonry and vegetation also obscured the top of the wall when viewed externally from the platform (Photograph 16), alongside the Boiler Houses west wall.

Photograph 15. Looking along the top of the Boiler House west wall at the south gable end wall obscured by vegetation and fallen masonry

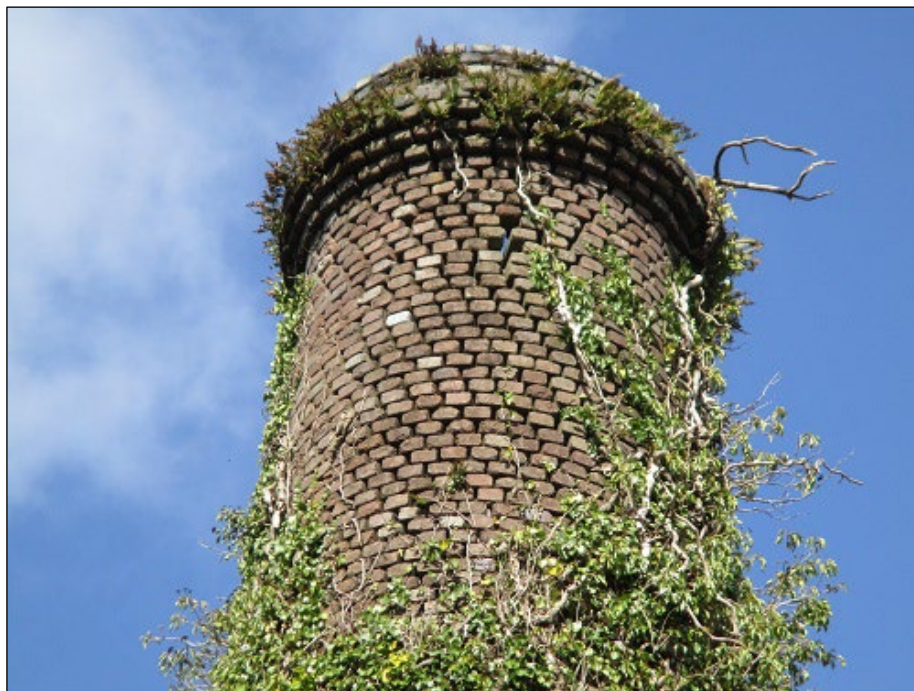
- 5.48. On balance, the Boiler House Chimney was assessed to be in **medium condition**.

Photograph 20. Open jointed brickwork on the Boiler House Chimney brick capping course

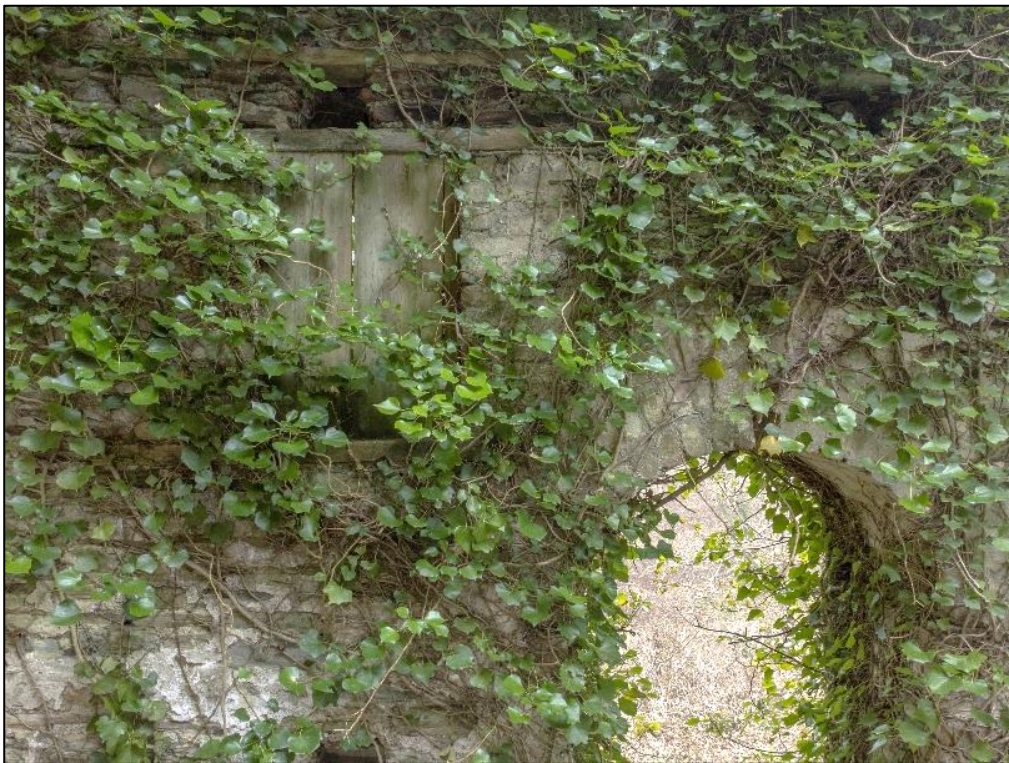
As viewed internally, it is evident that there is a further opening in this elevation with an additional small opening above, as shown in figure 23.03. These openings are above and to the south of the central high-level arched opening, though the larger of the two openings has been blocked with timber panels. The lintel to the larger, blocked opening appears to have rotted out on the south bearing, but the level of ivy growth makes assessment of the smaller opening difficult. There are loose or missing bricks in the internal reveals to most openings in this elevation, with more missing from the two lower openings; as an example see 23.04.

Figure 23.03 – Boarded opening in west elevation

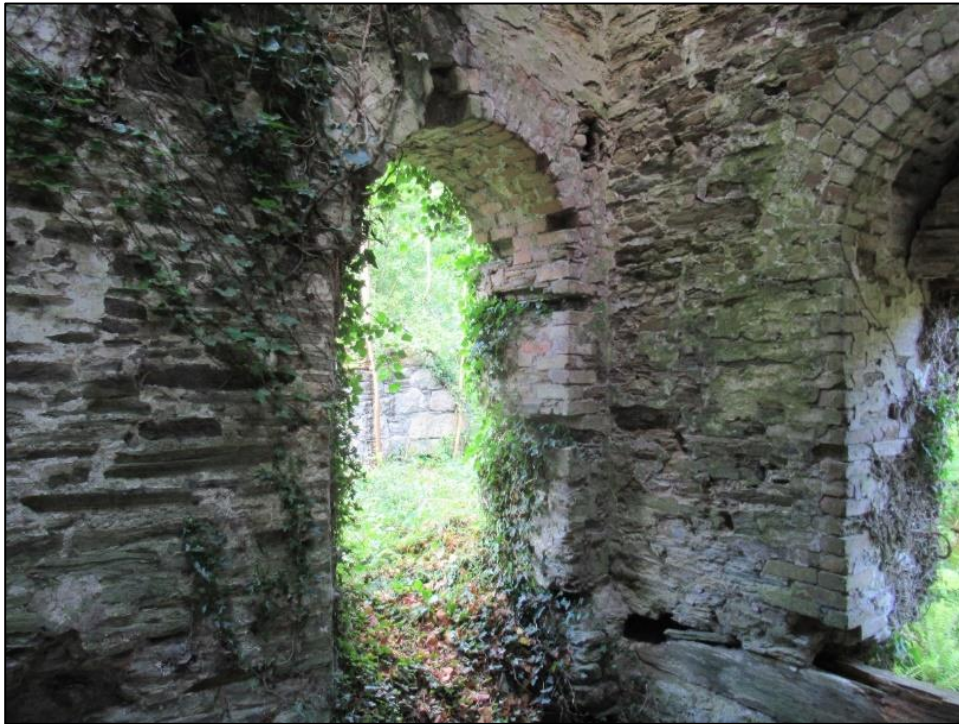
Figure 23.04 – Loose and missing bricks in reveals.

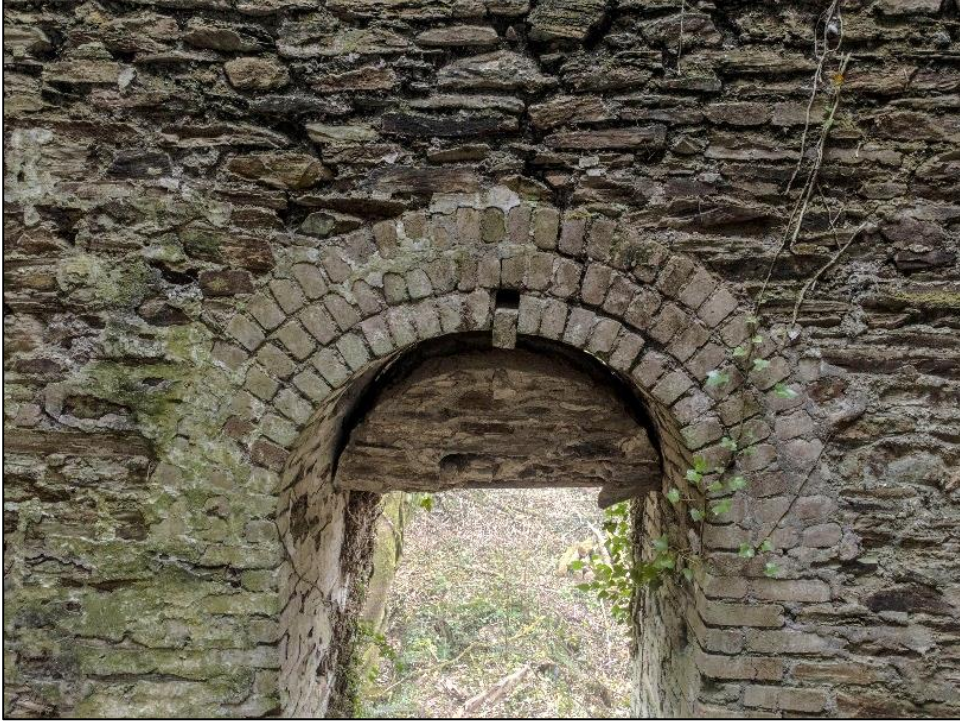
Figure 23.05 – Loose masonry local to arch crown

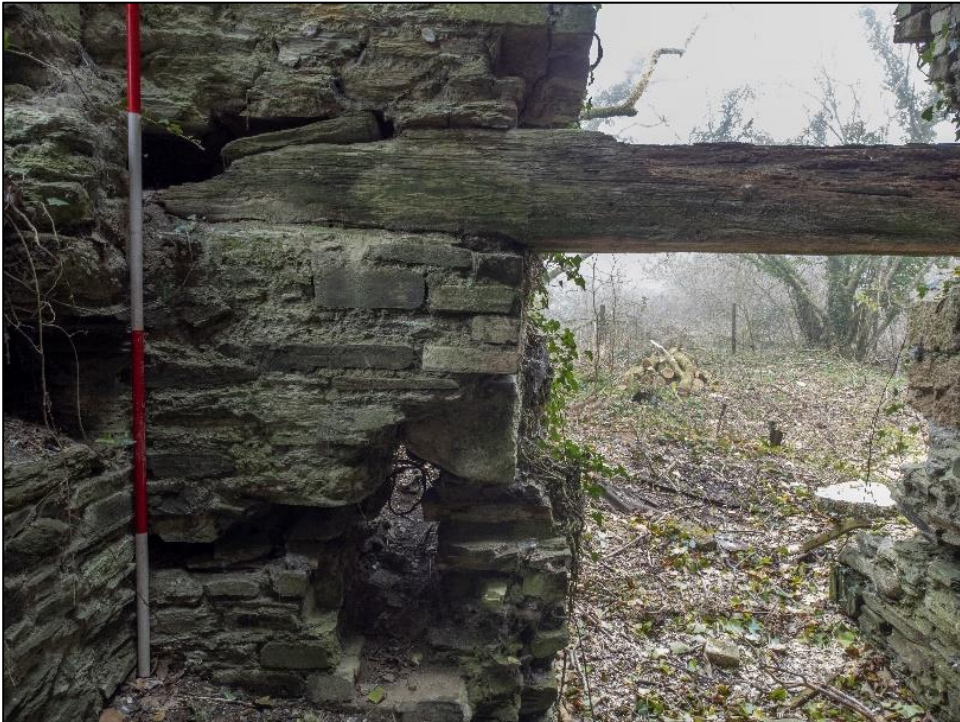
Figure 23.06 – Rotting internal lintel and hole through wall.

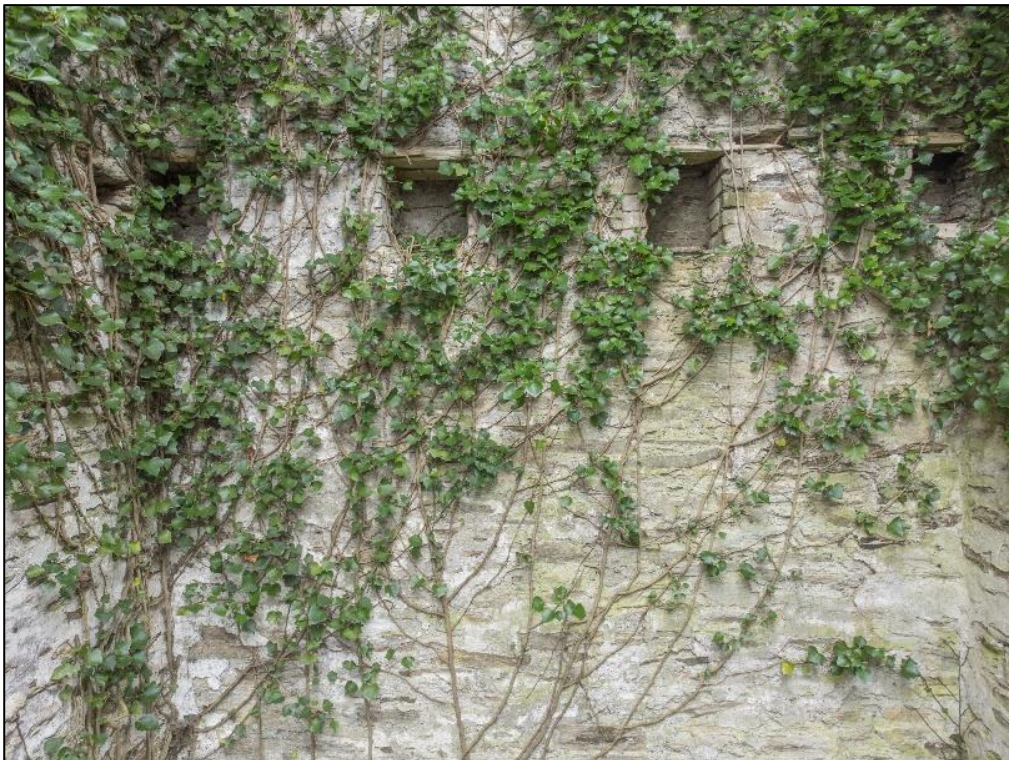
At the next level, there are four recessed voids with timber lintels shown in figure 23.11. The lintels to these voids appear to be in a fair condition, though assessment is difficult due to ivy growth. Generally, the masonry to the internal face of this elevation seems to be in a reasonable condition.

Figure 23.11 – Four high-level recessed voids.

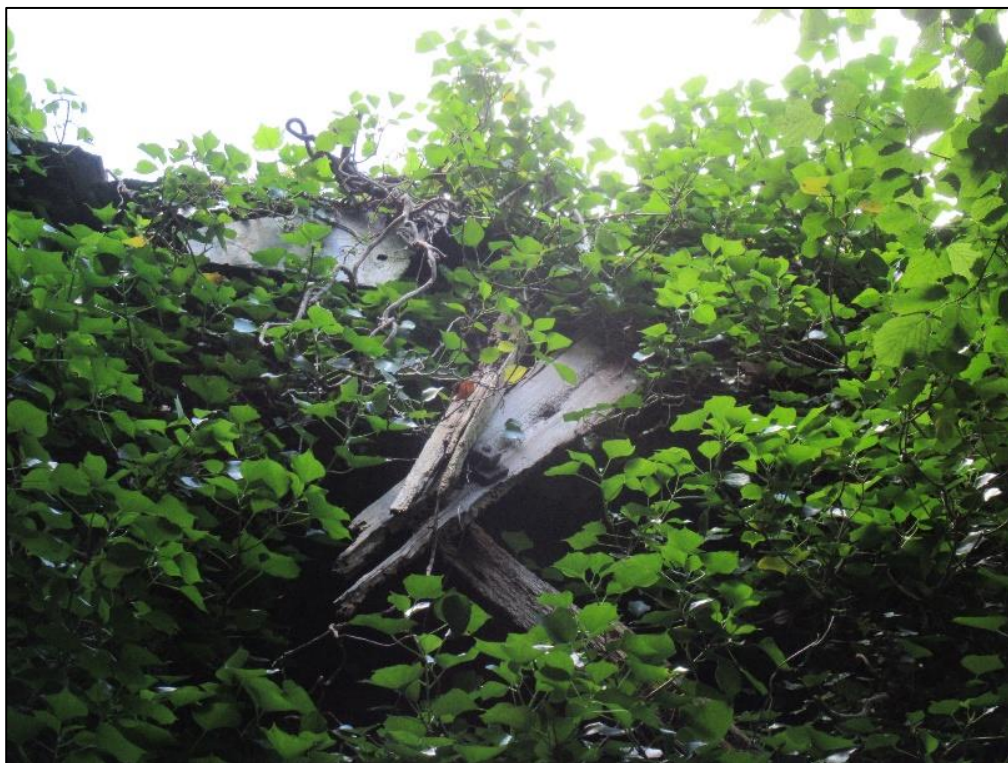
23.13 Timbers and slates hanging from walls

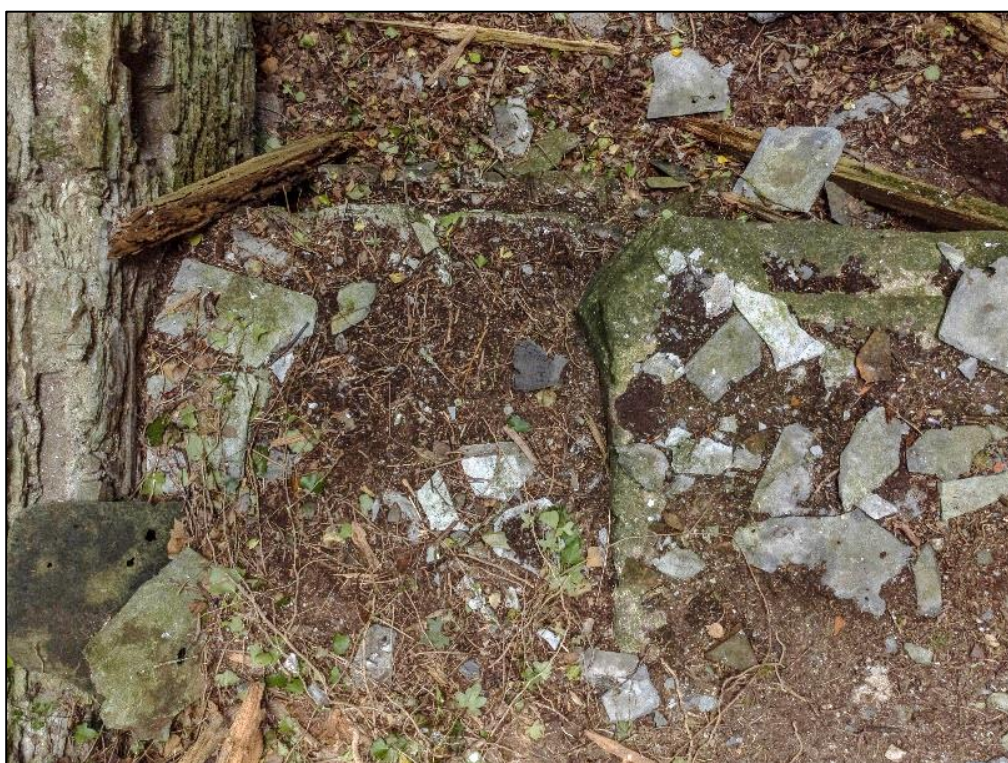
Figure 23.14 – Fallen roof slates on the floor of the Engine House

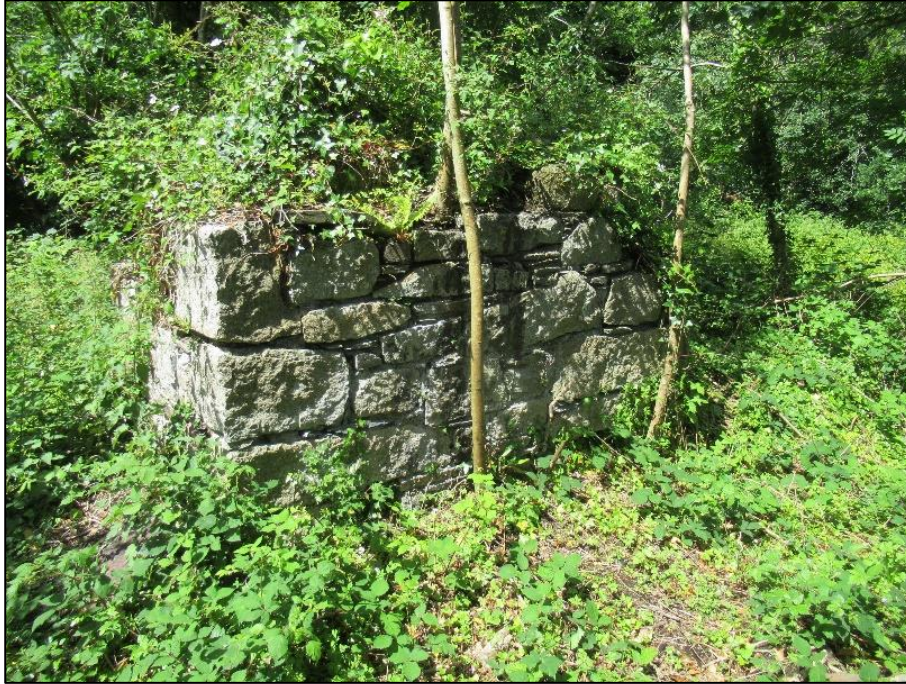
Site 23b**Plinth****Condition: 2, Significance: 1**

**Figure 23.13 – Plinth with vegetation**

- Cut down trees and clear vegetation from around the structure
- Clear ivy and vegetation from the stonework
- Locally rebed loose stones and consolidate stonework where required
- Repoint open jointed stonework
- Monitor condition and control vegetation

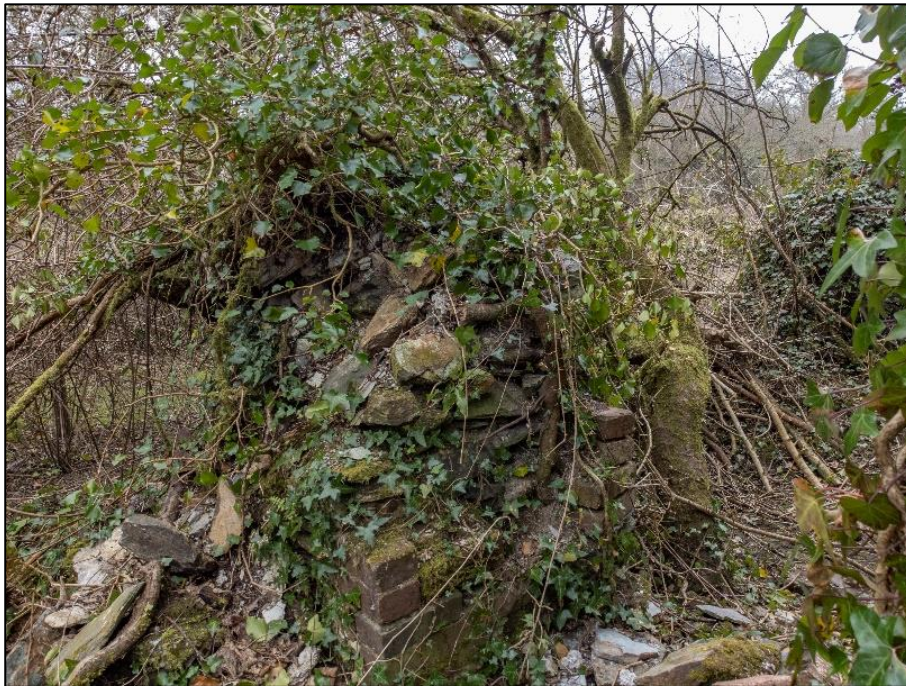
Site 24 **Boiler House**
Condition: 4, Significance: 2

Figure 24.02 – Collapsed brick quoining and stonework with trees growing from wall head.

- Clear site as necessary to provide safe access and to erect low level scaffold
- Carefully clear ivy and vegetation and control
- Following clearance of vegetation, condition of stonework to be further assessed
- Allow to infill voids and locally rebuild partially collapsed sections of wall. Extent to be reviewed to ensure walls are stable
- Consolidate and locally rebuild wall heads where required, ensuring they are fully 'weathered' and repointed as a 'ruin'
- Replace rotten lintels and timber grounds and make-good affected stonework
- Repoint open jointed stonework and those areas affected by ingrowing ivy and vegetation
- Monitor condition and control vegetation.

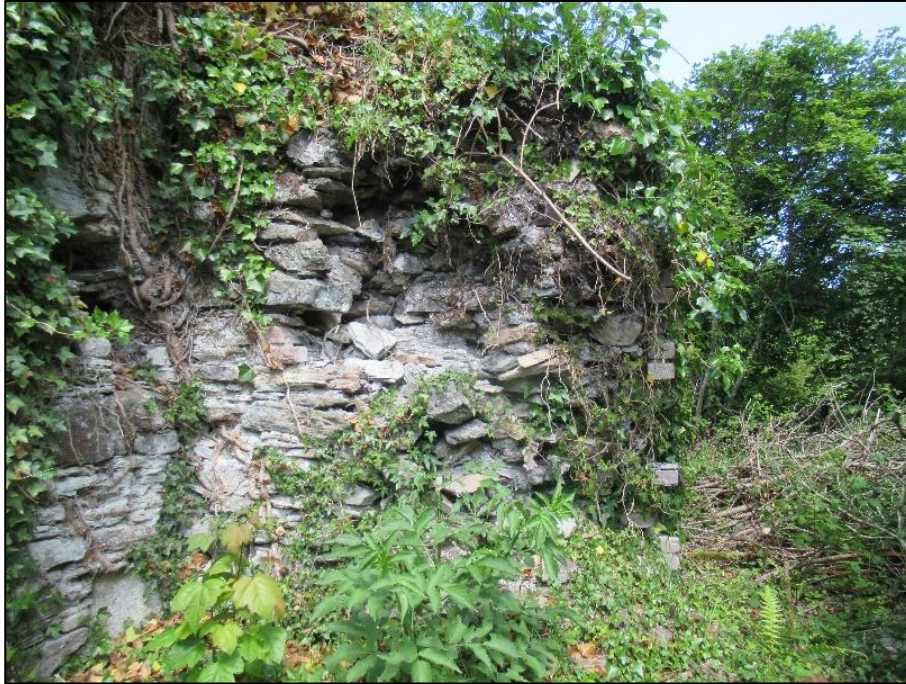
Figure 24.03 – Failed veneer at north end.

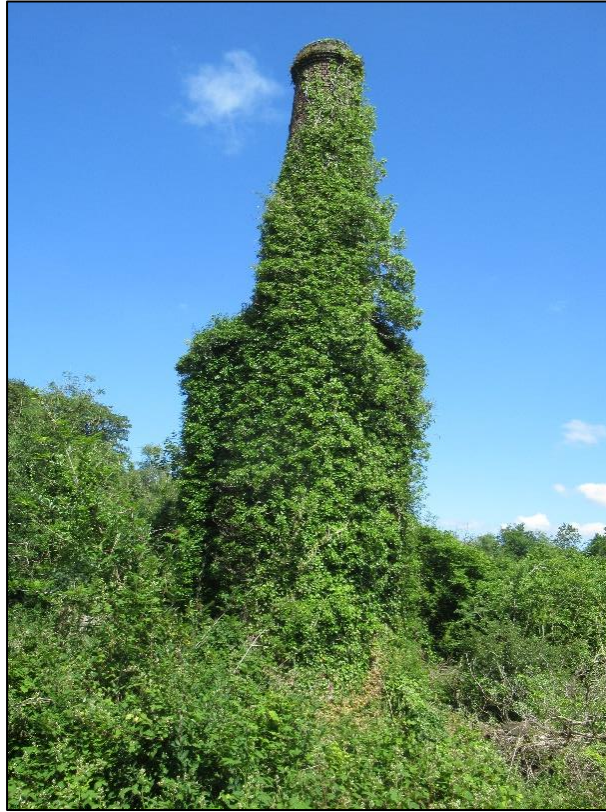
Site 25 **Engine House Chimney**
Condition: 2, Significance: 4

Figure 25.01 – Full length of chimney with heavy vegetation covering.

- Clear site as necessary to provide safe access to erect full scaffold around the chimney
- Carefully clear ivy and vegetation and control
- Following clearance of vegetation, condition of stonework and brickwork to be further assessed
- Allow to infill voids and locally rebuild and repoint affected areas of stonework. Extent to be reviewed
- Repoint upper courses of brickwork, allowing to rebuild potential 12 courses of brickwork using reclaimed bricks
- Ensure wall head is well 'weathered'
- Stabilise further areas of loose brickwork/stonework and repoint as required
- Monitor condition and control vegetation

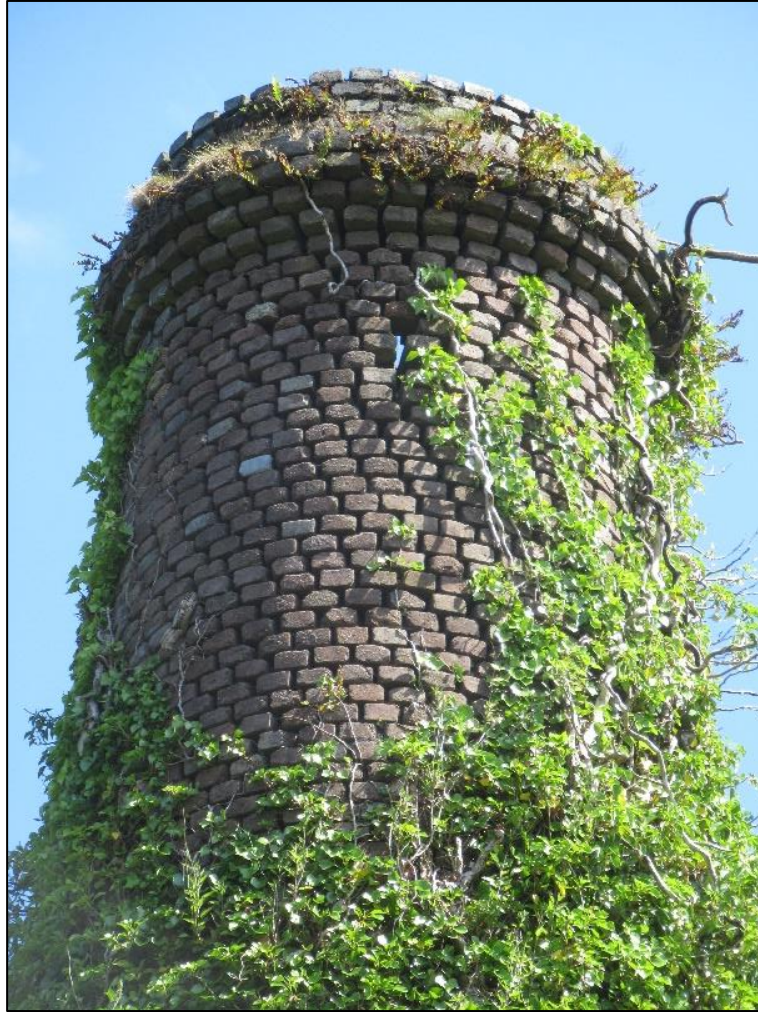
Figure 25.02 – Open jointed brickwork at upper levels of chimney

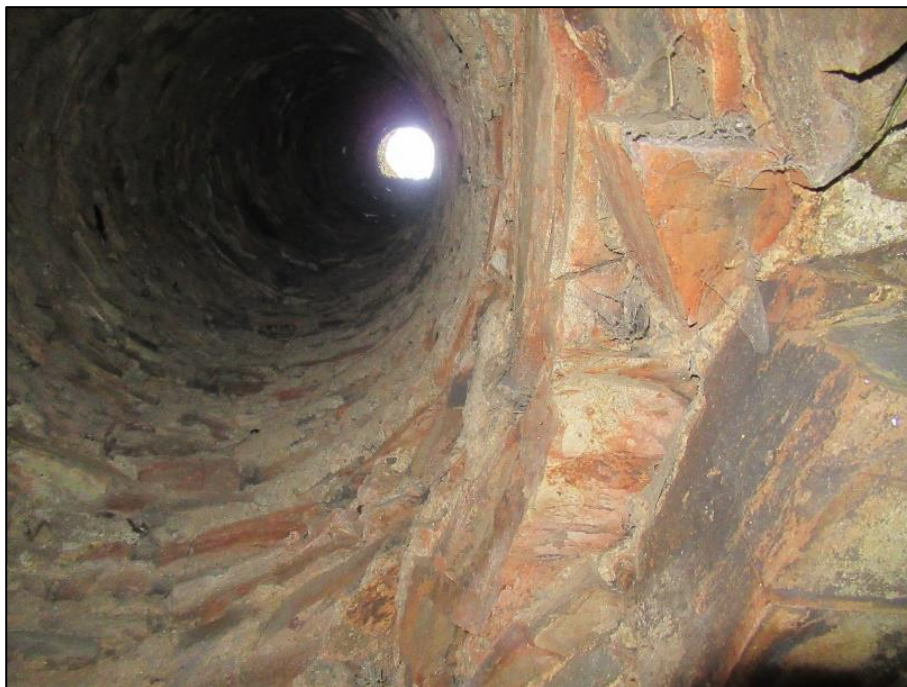
Figure 25.03 – Chimney internal showing condition and high-level vegetation

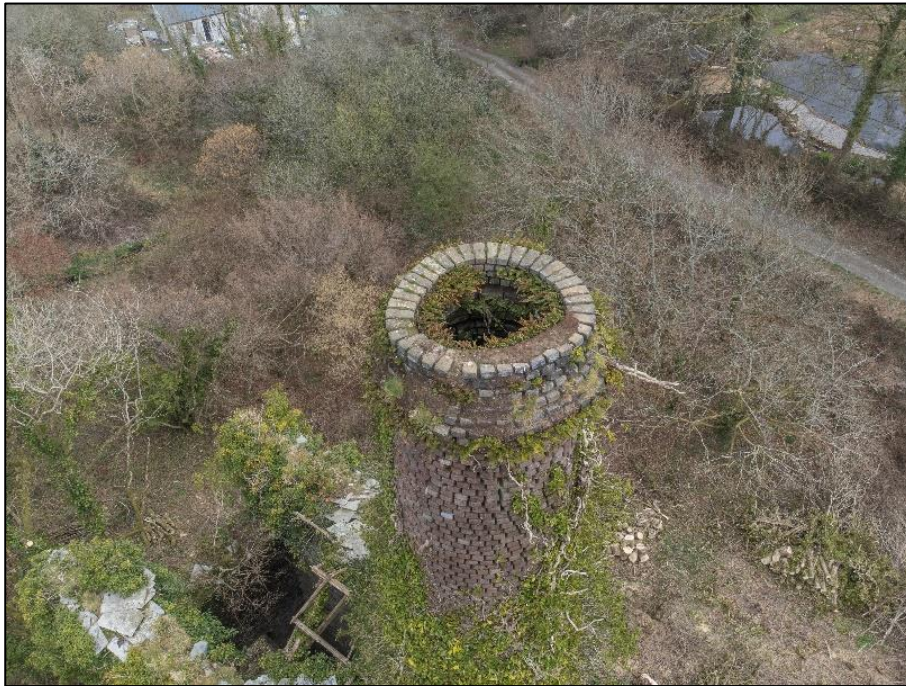
Figure 25.04 – Chimney head and open jointed brickwork.
