**Hamilton Lodge
Parsons Hill
Great Bromley
Essex**

Level 2 Historic Building Recording

CA Project: SU0444

CA Report: SU0444_1

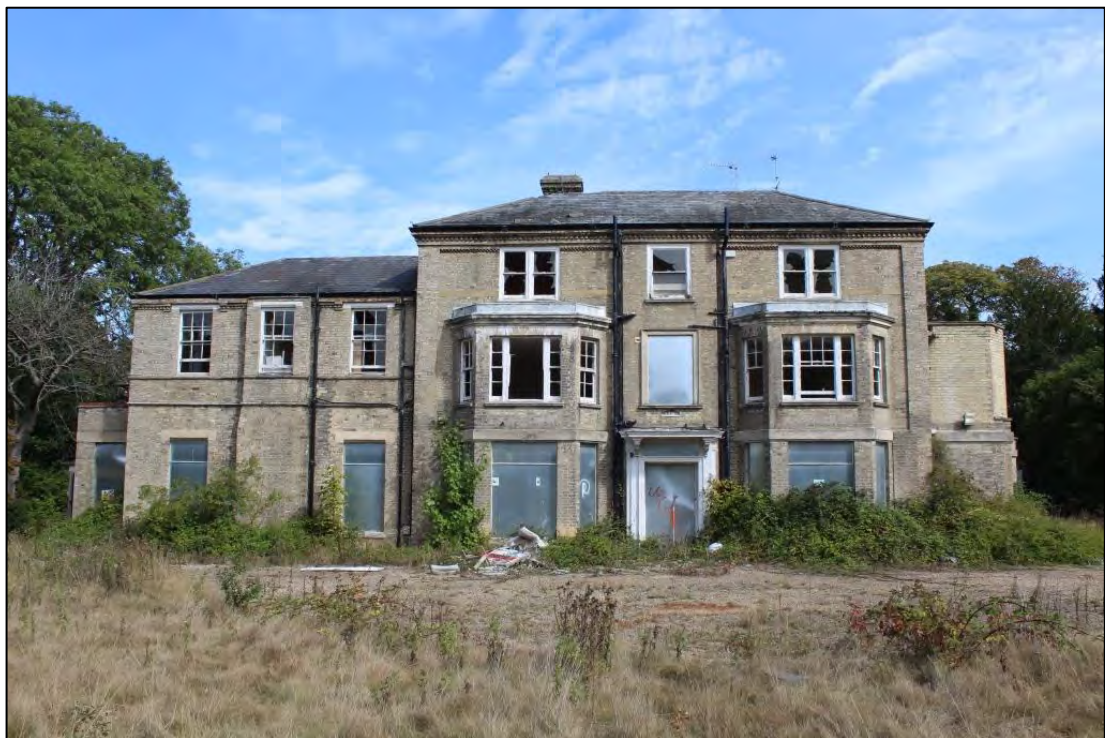
Photo 1: South-western elevation of the house

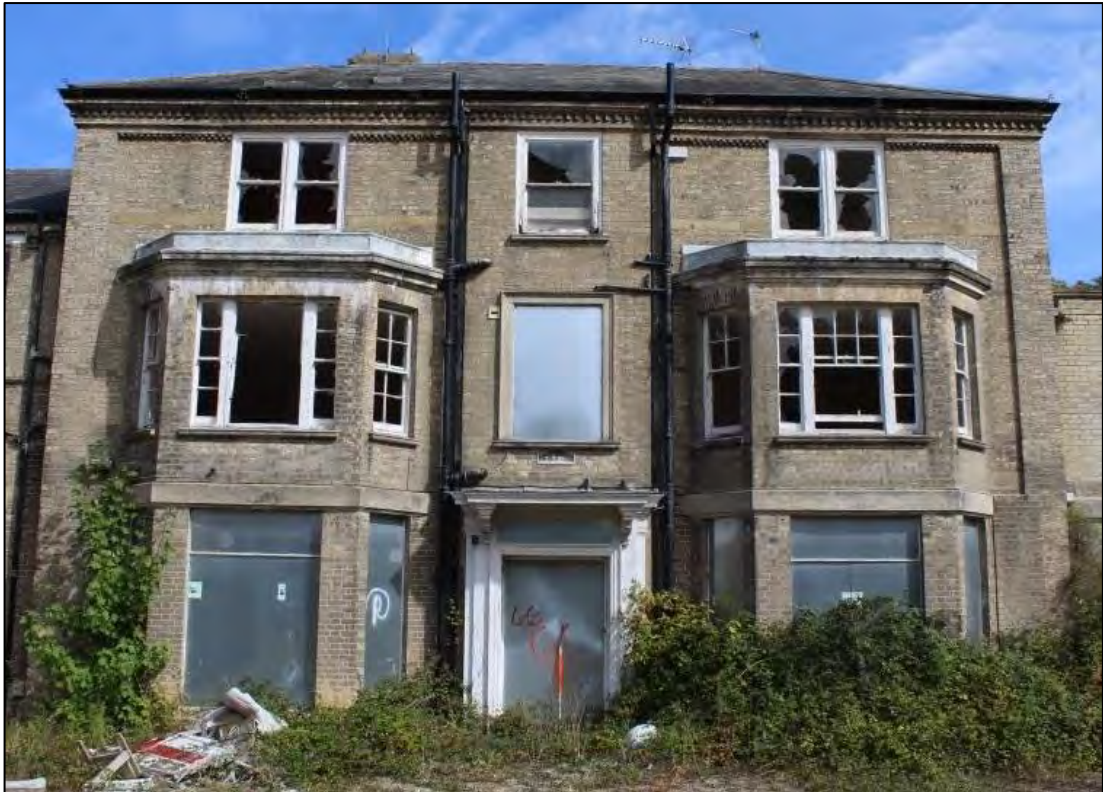
Photo 2: South-western façade of principal building element

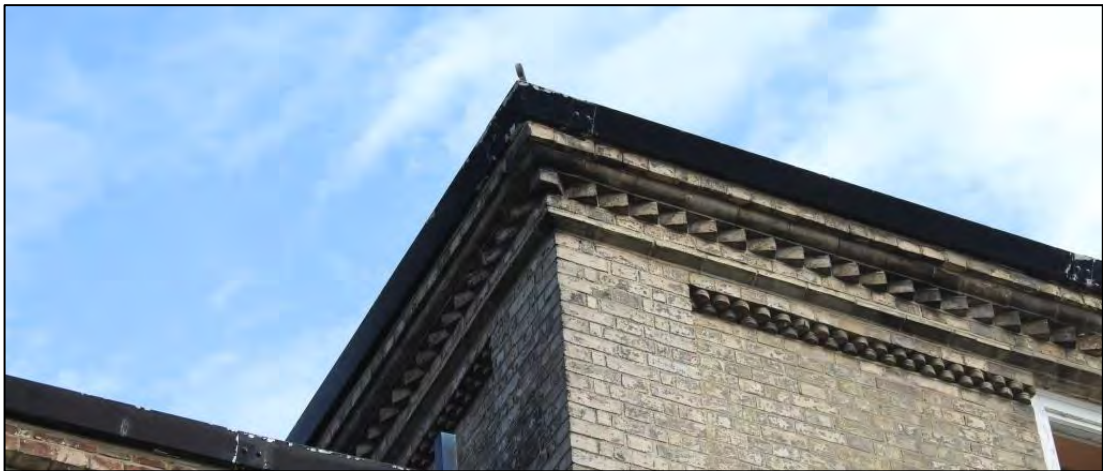
- 4.10. The left and right bays of this part of the façade are slightly recessed, allowing the central bay to project, echoing the more dramatic arrangement of the late 19th-century gothic profile (Fig. 7). The canted bay windows are aesthetically plain, reflecting a more restrained approach in comparison to the decorative square bay windows of the former gothic façade. The elevation incorporates dog-toothed brickwork beneath the eaves of the roof which is supplemented by overlapping rounded dentils at the top of each sunken panel (Photo 3).

Photo 3: Detail of dog-tooth and curved dentil decoration

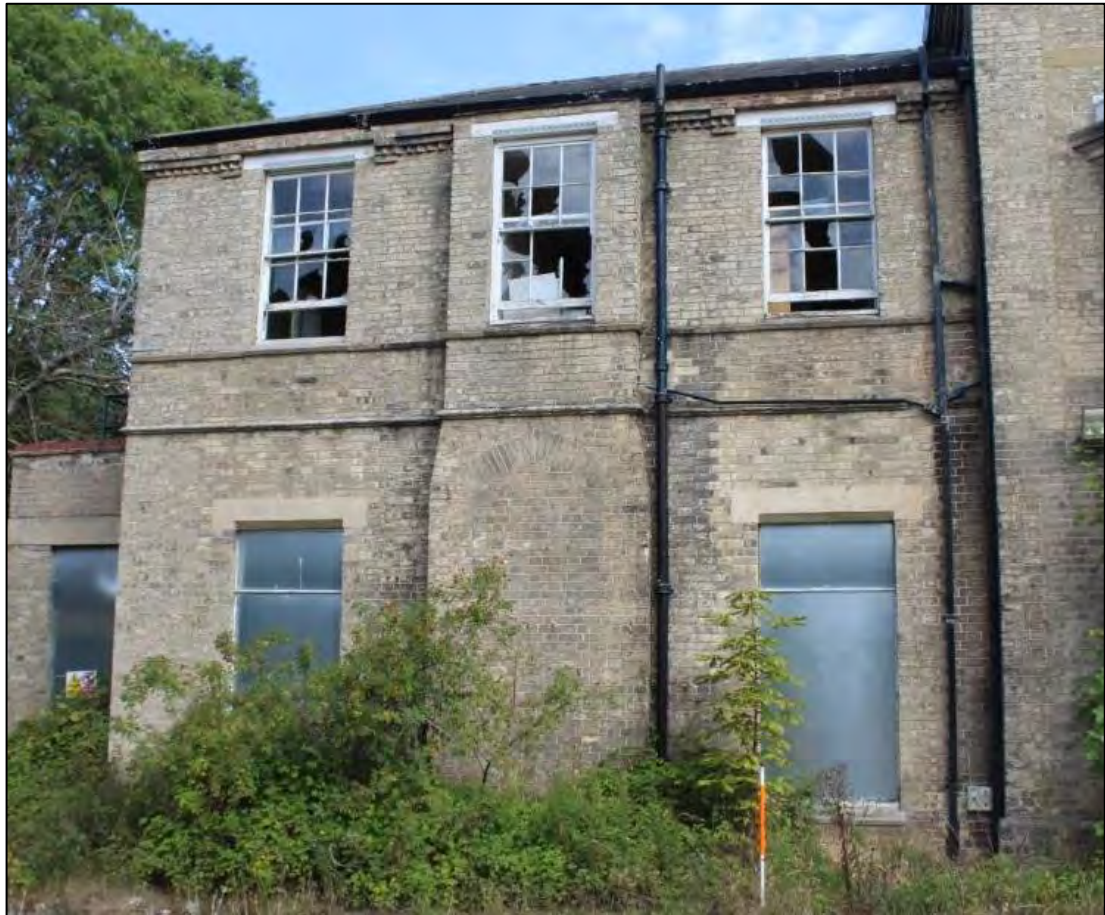
- 4.11. The northern extent of the south-western elevation is lower in height and forms an adjunct to the three-storey element (Photos 1 and 4). The historic map of 1845 (Fig. 6) suggests that this element was possibly added later than the original construction of the building, where it first appears in 1874-75 (Fig. 8). Nevertheless, this element formed part of the gothic aesthetic of the building (Fig. 7) and incorporated a pair of dormer windows, either side of a substantial chimney stack, which survived the refacing of the elevation but no longer exist now, replaced by a window at first floor

level (Photo 4). Beneath this central window is a relieving arch. It is evident from the configuration and areas of repair that this part of the elevation has undergone considerable alteration over time. It is evident from the photograph of 1938 (Fig. 11) that this part of the elevation remained as it was, after the reconfiguration of the principal, three-storey portion of the elevation; however, it was subsequently altered to remove the chimney and dormers at an unknown date during the mid 20th century.

Photo 4: Northern extent of south-western elevation

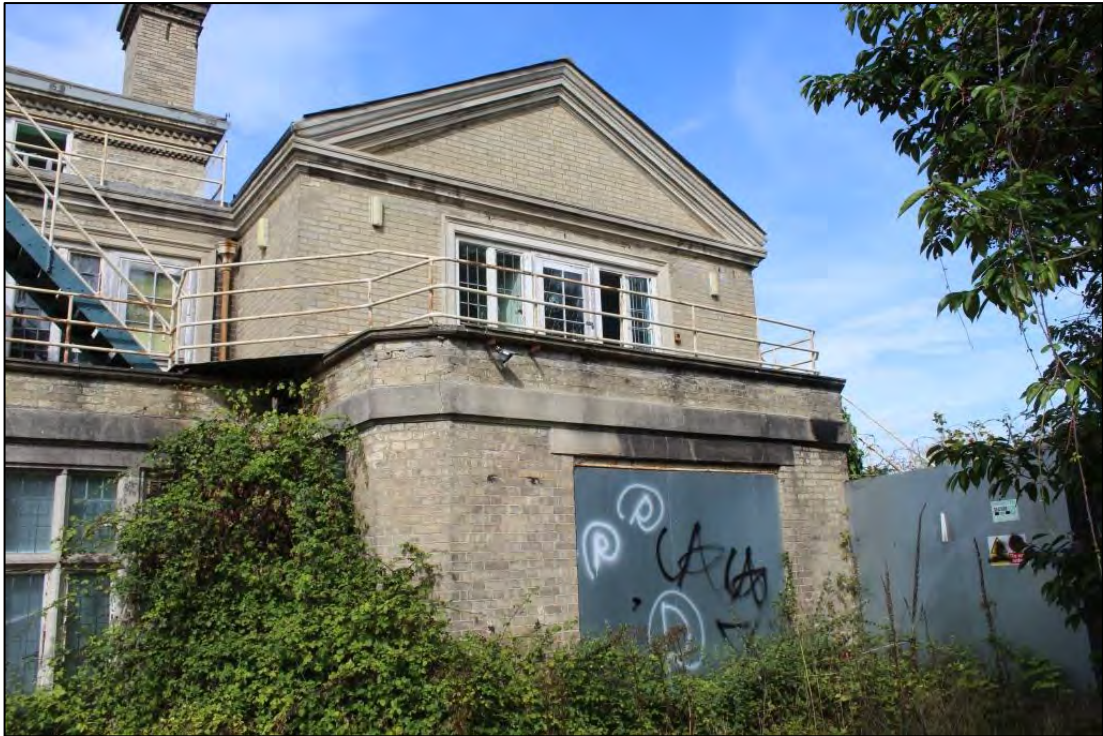
- 4.13. At the eastern extent of the south-eastern elevation is a further two-storey projection that incorporates a gable end with pediment and plain tympanum (Photo 6). This element is clearly visible on the 1938 photograph (Fig. 11); however, the use of stretcher bond brickwork suggests that it had not long been completed by this time, possibly during the 1920s or 1930s.

Photo 6: Eastern extent of south-eastern elevation

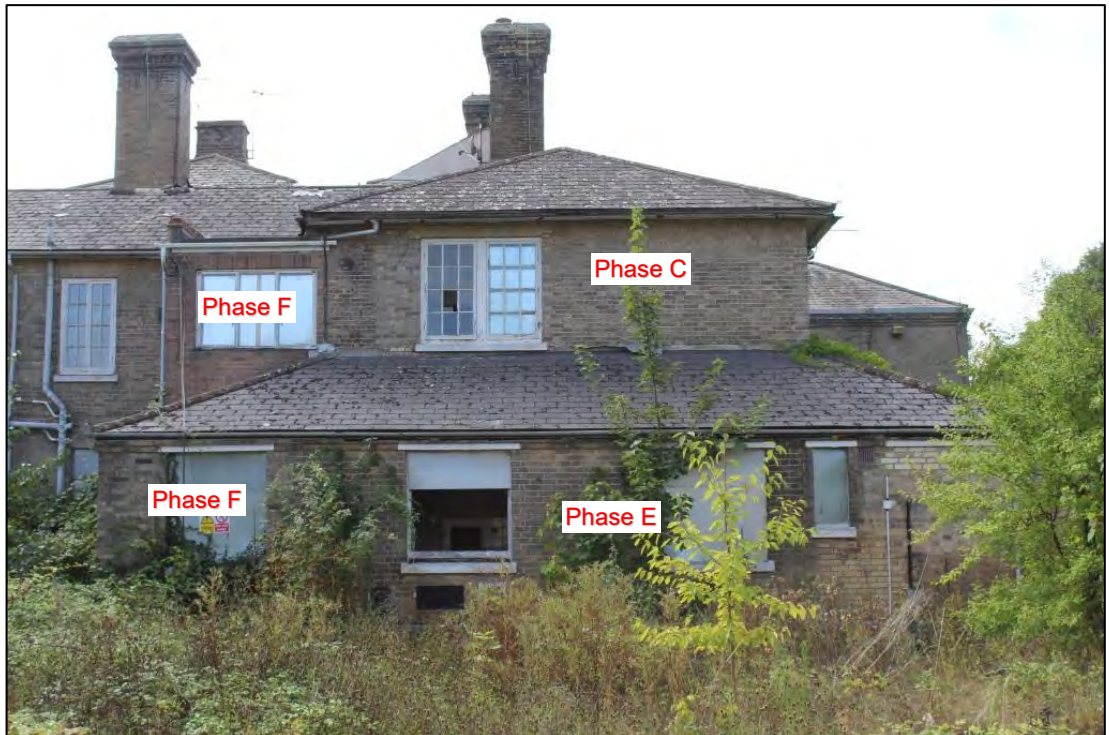
- 4.15. The northern extent of the elevation (Photo 8) comprises a combination of phased elements that evidence changes in brickwork tone and appearance, indicating an iterative approach to development. Broadly, the visible ground floor elements are likely to be contemporary with Phases E and F whilst the recessed first floor evidences an earlier projection that incorporates gault bricks and shaped voussoirs, indicative of its construction as part of Phase C. A modern extension, likely dating to Phase F, has been appended to the southern end of this projection.

Photo 8: Northern extent of north-eastern elevation

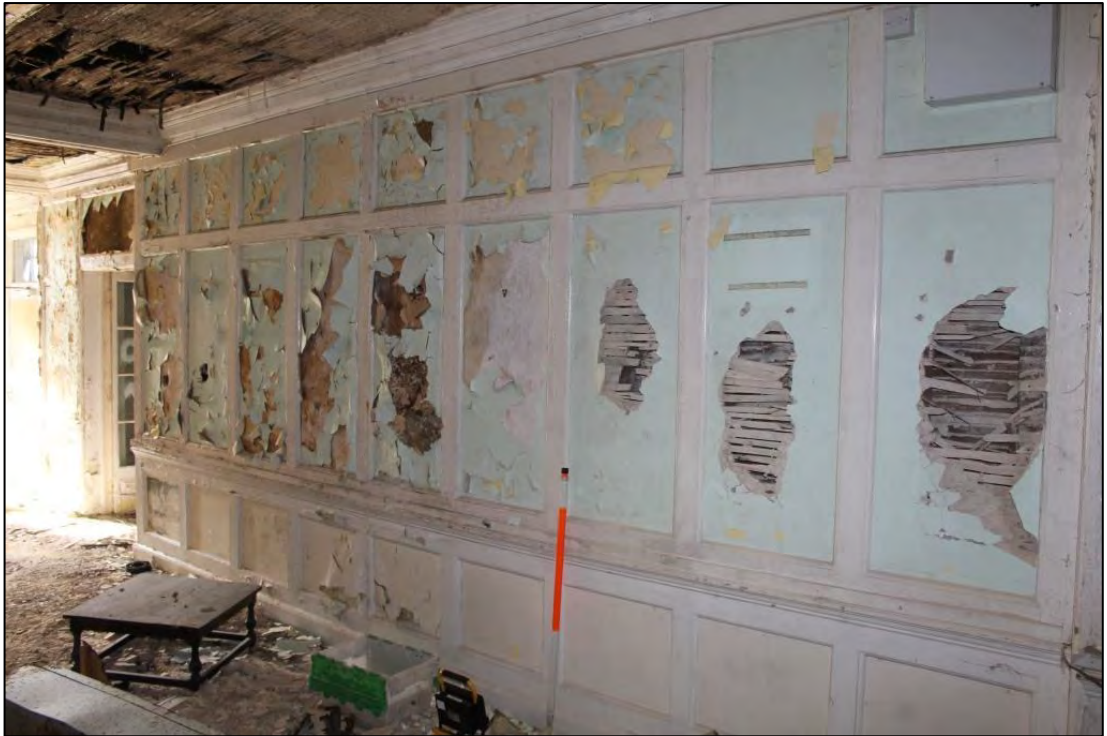
- 4.19. The panelling extends the entire length of the room and was probably installed as part of Phase D or E. Damage to portions of the panelling evidence the use of lime plaster applied to laths beneath the panels (Photo 12). Within the north-eastern wall are two separate doorways integrated within the panelling that lead to a cupboard and Room 24 respectively (Photo 13). This was seemingly to preserve the panelled aesthetic of the room and minimise the visual interruption of doorways.

Photo 12: Detail of panels within Room 1, showing damaged portions

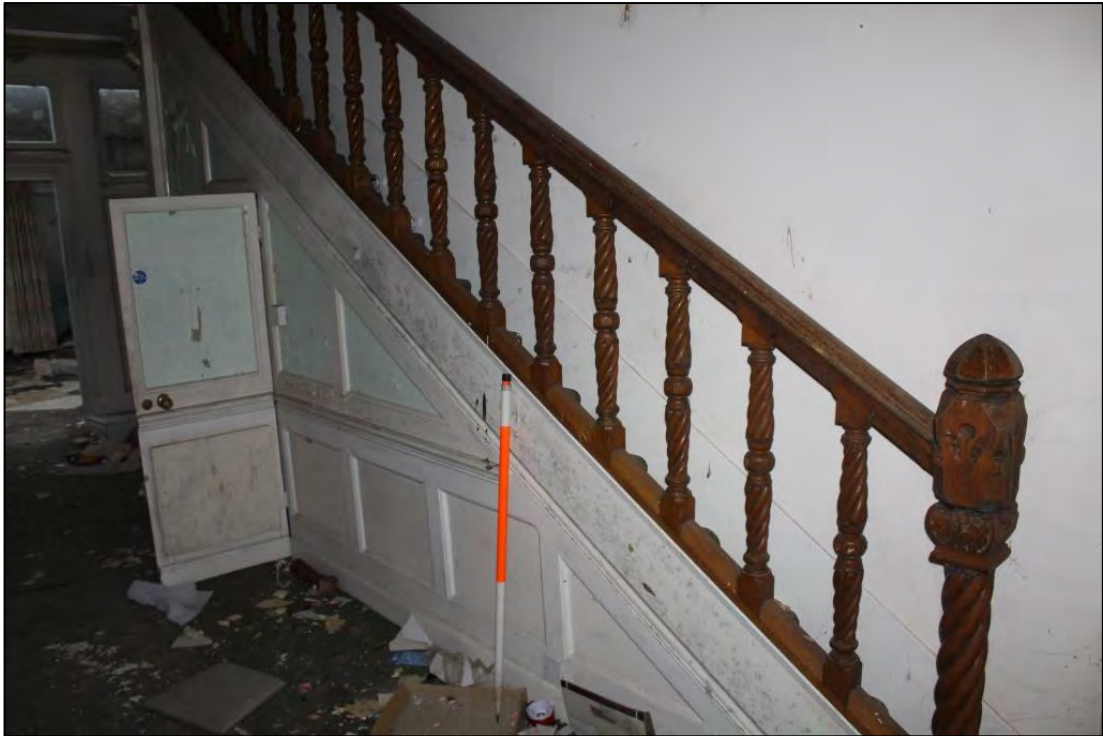
- 4.20. Room 1 incorporates the principal staircase of the house, positioned to the north-western extent of the room (Photo 14). The staircase comprises a closed string with pine balusters and banister. The balusters are widely spaced and incorporate a heavy, twisted form. The newel post also incorporates a twisted post that is topped with a complex carved cap. The style is atypical for the late Georgian or Victorian periods and was likely installed in the early 20th century. The staircase has been fully enclosed using plasterboard, likely as a safety measure.

Photo 14: Detail of staircase elements

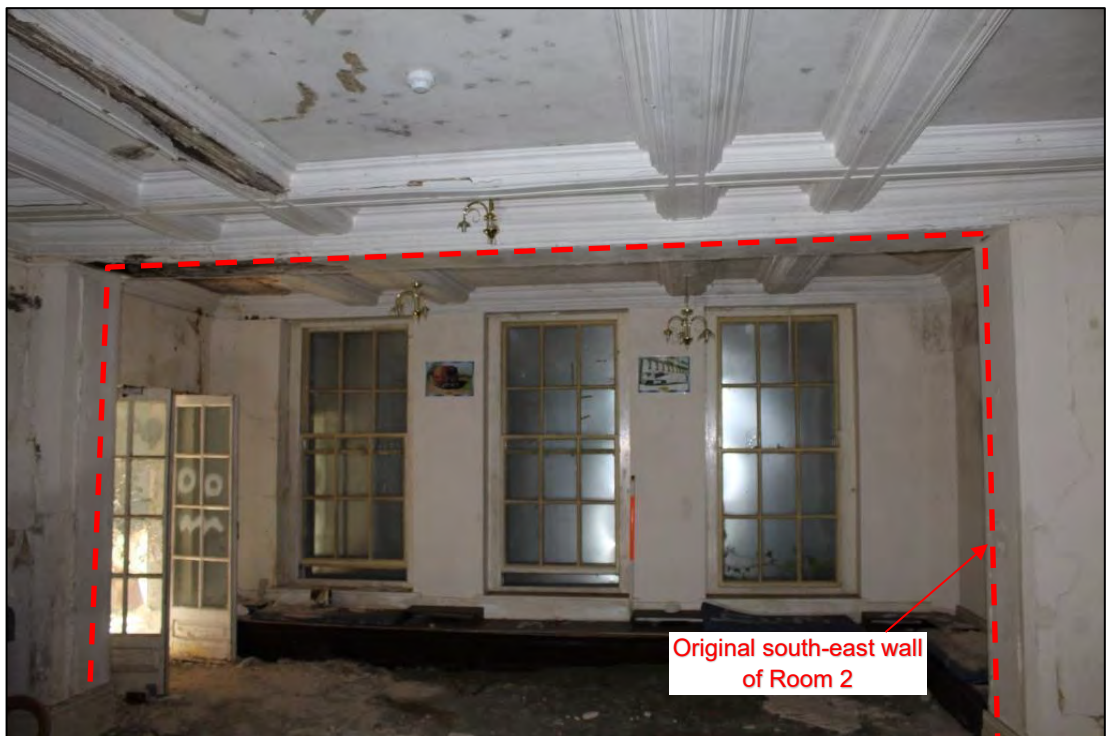
- 4.21. Room 2 (Photo 15) is located at the southern extent of the ground floor and represents the southernmost of the principal reception rooms along the south-western range of the house. The room incorporates one of the canted bay windows and a coffered ceiling, illustrating the room's high status. A blocked-up chimney breast is positioned to the north-eastern side of the room, centrally within a likely previous configuration of the room. When the glazed structure to the south-east was replaced by the present extension during Phase E, it is likely that Room 2 was extended to the south-east to accommodate this new space (Photo 16).

Photo 16: Overview of south-eastern extension of Room 2

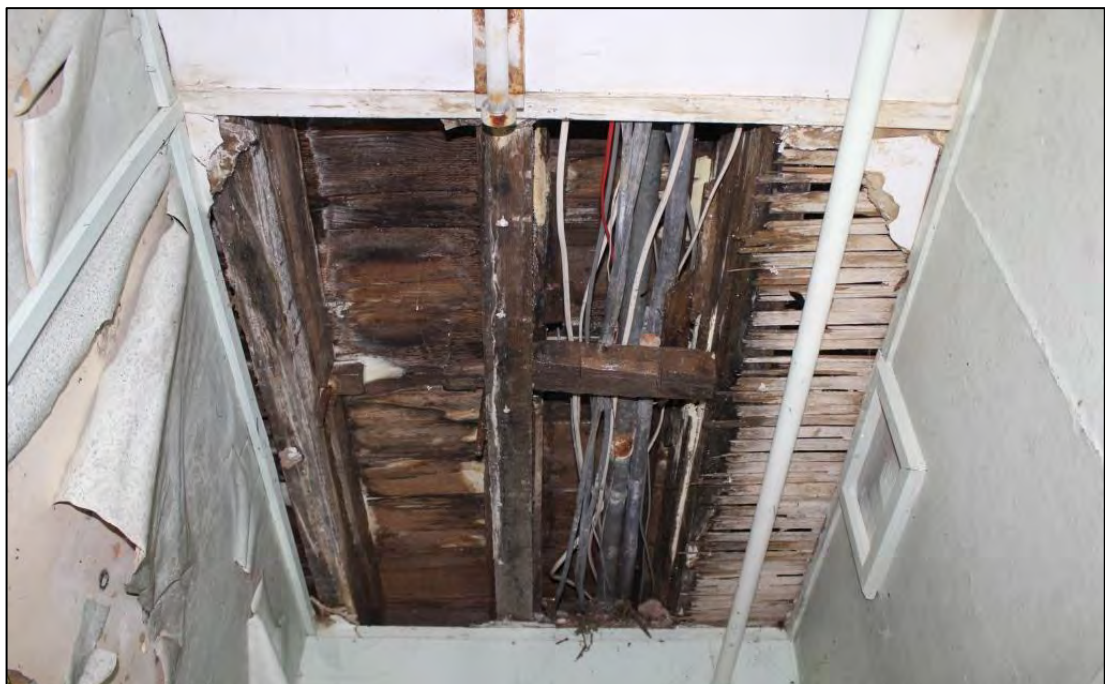
- 4.31. The area that formerly comprised a single kitchen space, according to the 1845 plan (Fig. 19) is presently sub-divided into Rooms 21 to 24, which predominantly function as a group of WC cubicles (Photo 27). Although the rooms are located within the notional footprint of Phase B, the present rooms contain no historical fixtures or fittings. A clue to the origins of the rooms is, however, presently visible due to a damaged ceiling in Room 21 where the timber joists and remains of lath and plaster can be observed (Photo 28).

Photo 28: Detail of ceiling construction, Room 21

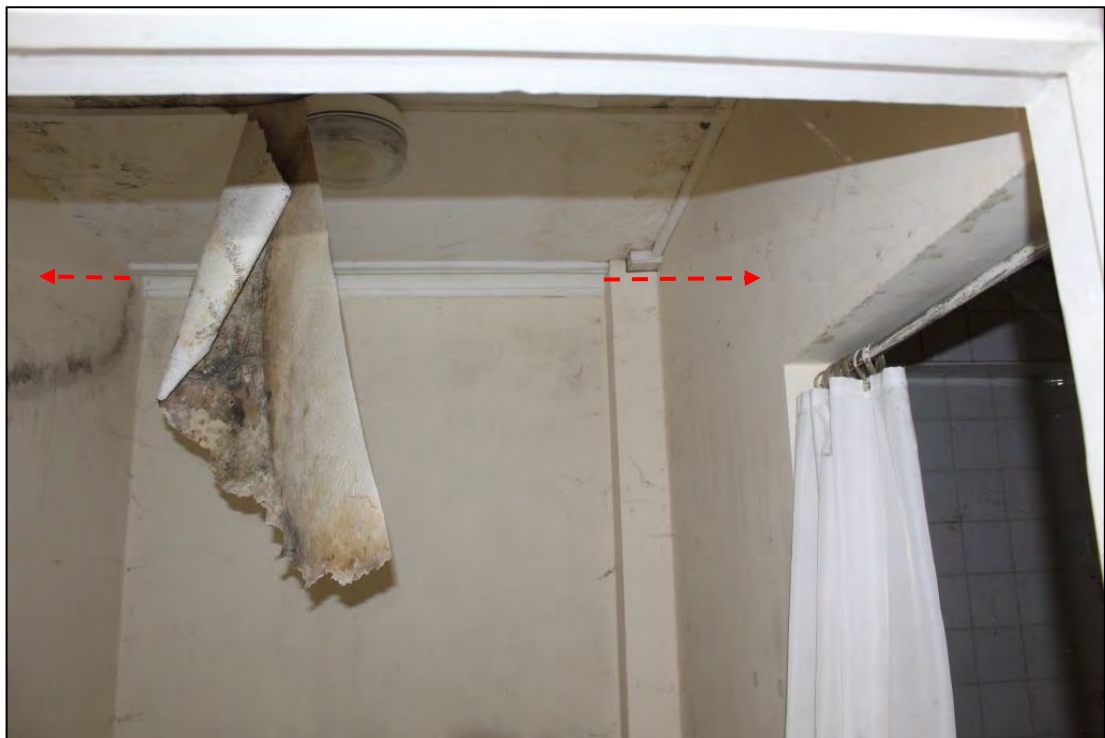
Photo 37: Detail of cornice remains within the WC of Room 42, looking north-west

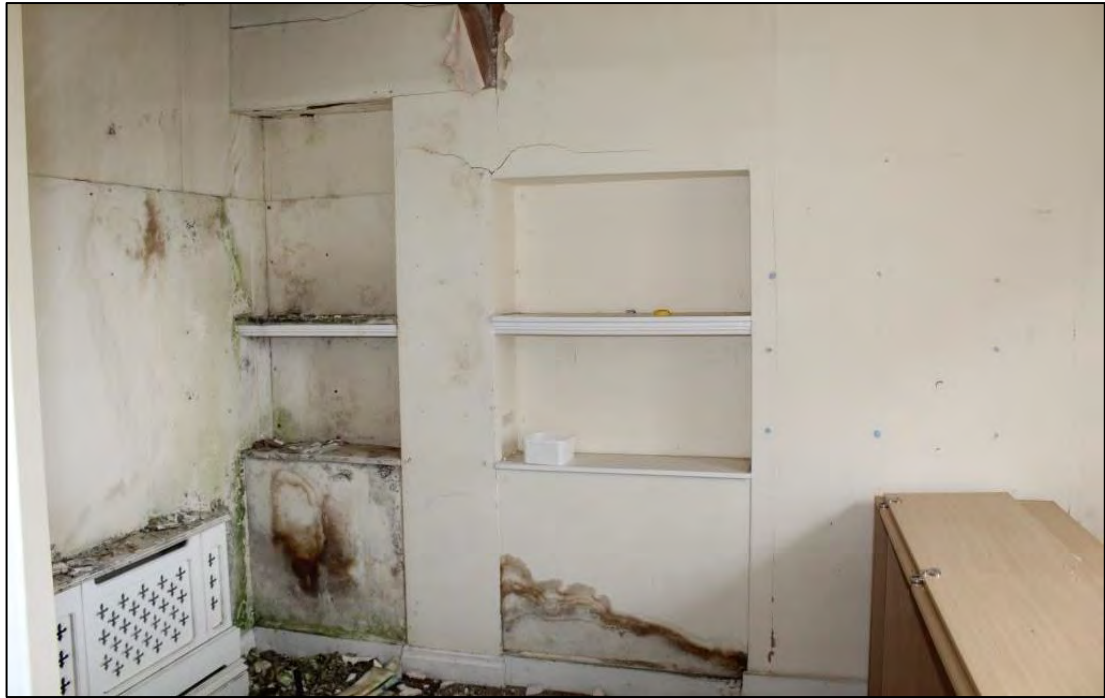
4.39. Room 43 represents a further corridor extending north-eastwards from Room 37, which provides access to Rooms 44 to 51. Rooms 44, 45 and 46 comprise a group of three rooms that function as a corridor, bedroom and bathroom. The space has likely been sub-divided and may have originated as a single large room. The rooms are all accessed by modern doors and contain no features of historical interest. Despite this, the external fabric and historical map evidence suggests that these rooms are located within the footprint of Phase B. A pair of recesses within Room 45 (Photo 38) suggest the former presence of a window and/or door aperture, illustrating a possible former access to the room.

Photo 38: Recessed areas within Room 45, looking north-west

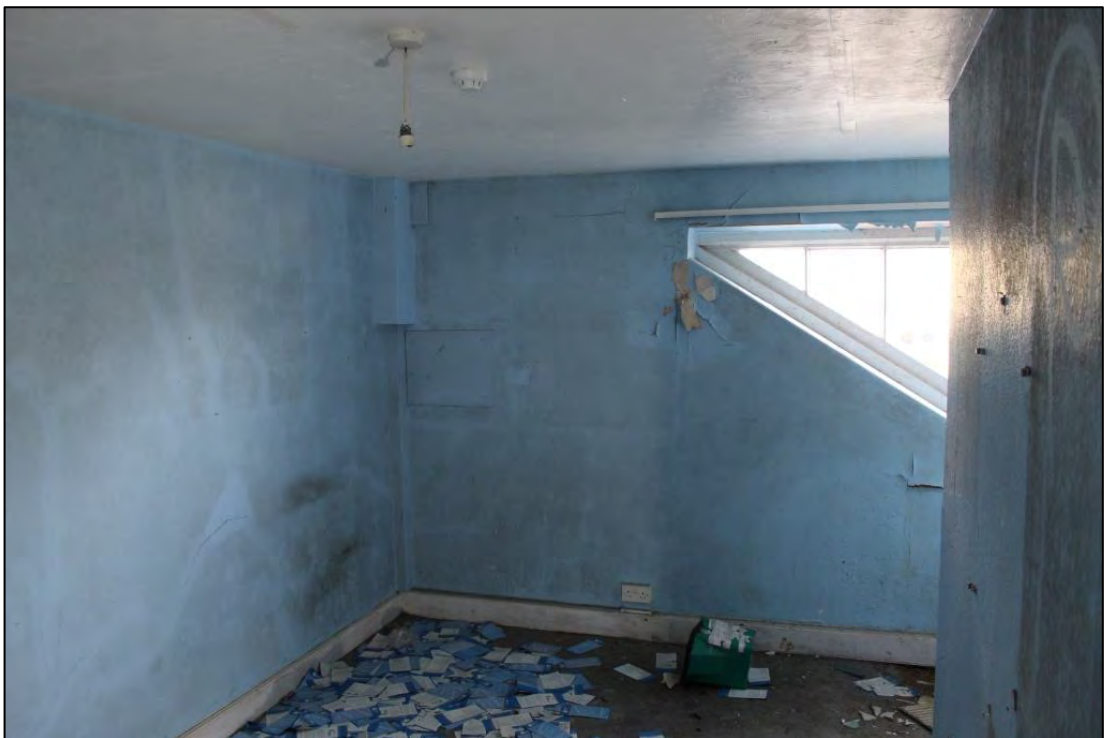
4.44. Room 54 (Photo 43) comprises a small bedroom that incorporates a blocked-up chimney breast and triangular window, and is positioned within the footprint of Phase B. The shape of the window is defined by the slope of the adjacent roof of the two-storey Phase C element, further evidencing the phased approach to the building's evolution, where such a window would not have originally been conceived in this position or shape had the building been constructed as a single phase. Room 55 (Photo 44) functions as the central corridor through the second floor, providing access to all principal rooms. The configuration of doors along the corridor is likely to have changed since Phase C of the building, owing to the reconfiguration and sub-division of bedrooms.

Photo 43: Overview of Room 54, looking north-west

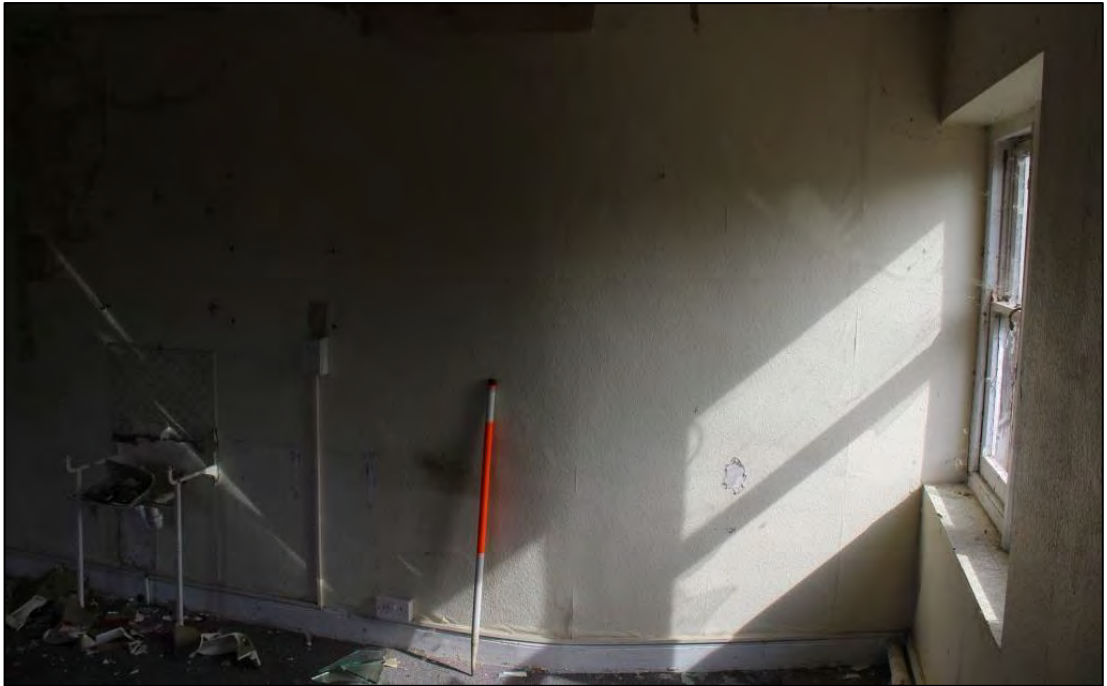
- 4.46. Rooms 58 (Photo 45) and 59 comprise a pair of rooms that may have once formed a single, larger rooms. This is evidenced by the likely presence of a fireplace at the north-eastern side of Room 59 and the awkward positioning and angle of the intervening partition wall which intersects the left hand reveal of the south-eastern window (Photo 45). Even so, the former configuration would have represented a very large room and may have been sub-divided in a different configuration that is no longer in evidence.

Photo 45: Partition between Rooms 58 and 59, viewed north-east from within Room 58

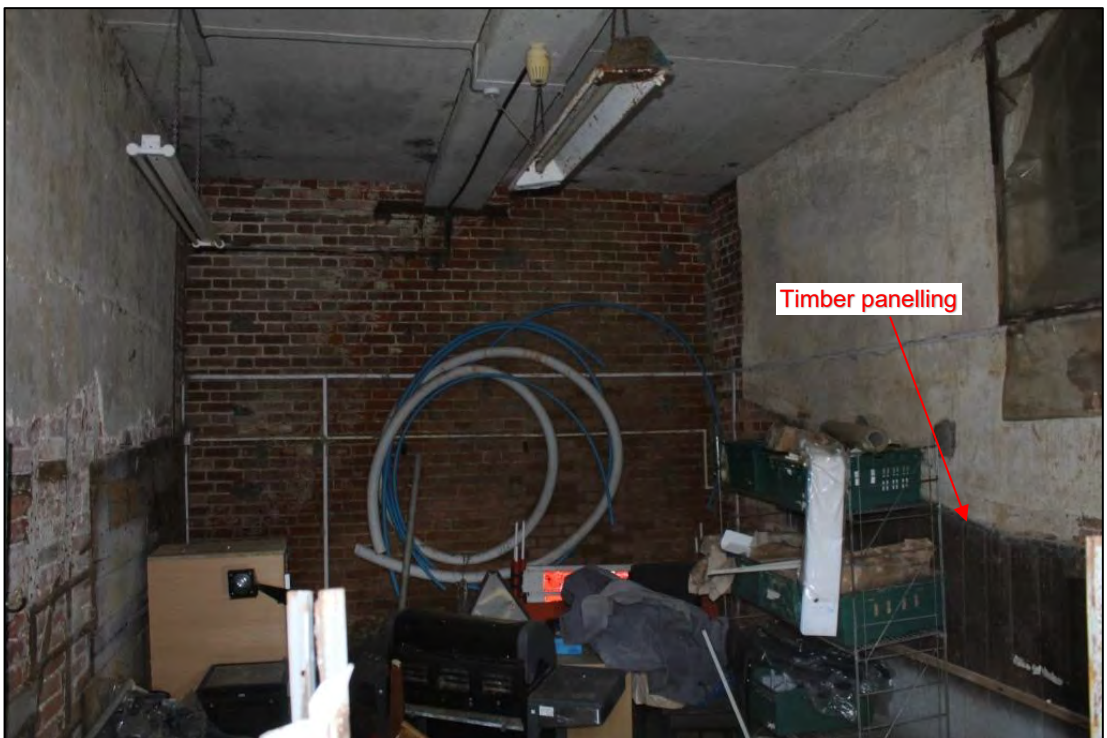
4.55. Rooms C6 and C7 were inaccessible during the survey; however, Room C7 was visible through an open window (Photo 55). The room is presently used for storage and evidences no survival of historical fittings. There are, however, visible remains of further timber panelling on the south-eastern wall of the room, positioned in a 'raked' arrangement, suggesting the possible remains of a stall or loose box. The back wall of the room incorporates no windows, which would accord with the room's use as a stable.

Photo 55: Overview of Room C7, looking north-east

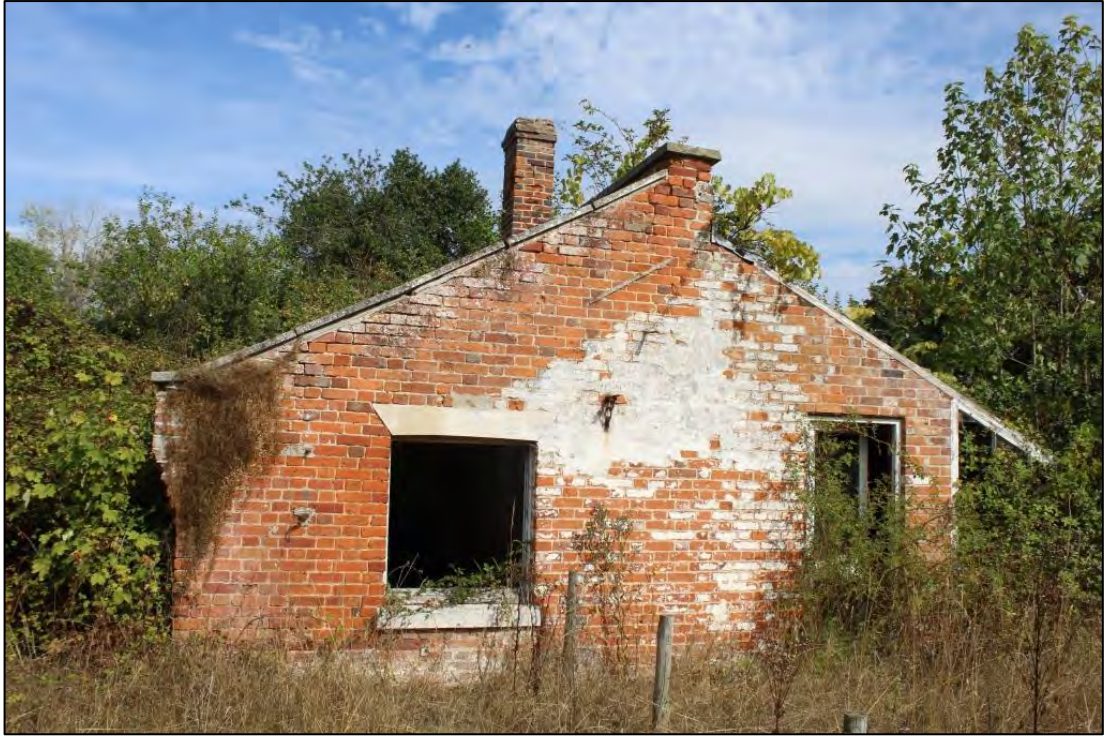
- 4.60. At the south-eastern extent of the garden is a derelict structure (Photo 63) that is indicated on late 20th-century photographs as the 'Vine House' (Fig. 22). The structure incorporated a large, glazed roof, orientated to the south-east, likely for the growing of grape vines or similar. The structure is in a ruinous state and is substantially obscured by vegetation, including unmaintained vines within the structure (Photo 64).

Photo 63: The 'Vine House', looking north-east

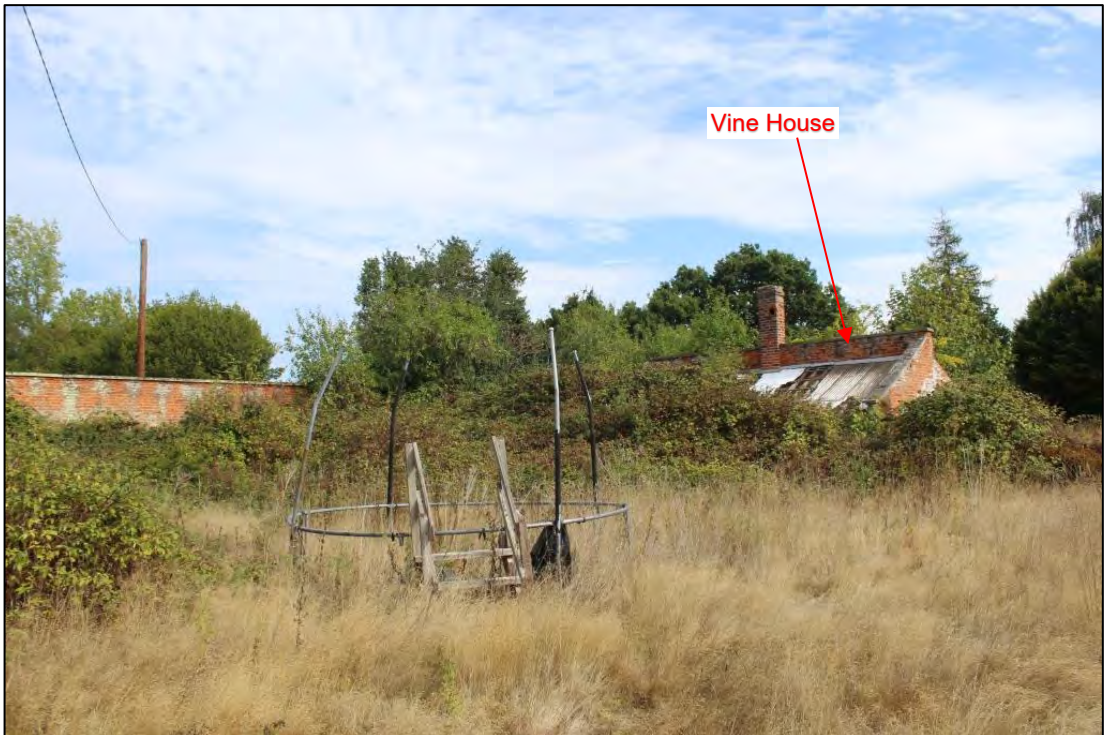
Photo 64: View of north-eastern wall alignment and the 'Vine House', looking south-east from inside the walled garden
