**THE GRAND SPA PUMP ROOM
AVON GORGE HOTEL
CLIFTON
BRISTOL**

HISTORIC BUILDING RECORDING

CA PROJECT: 3123
CA REPORT: 10099

JUNE 2010

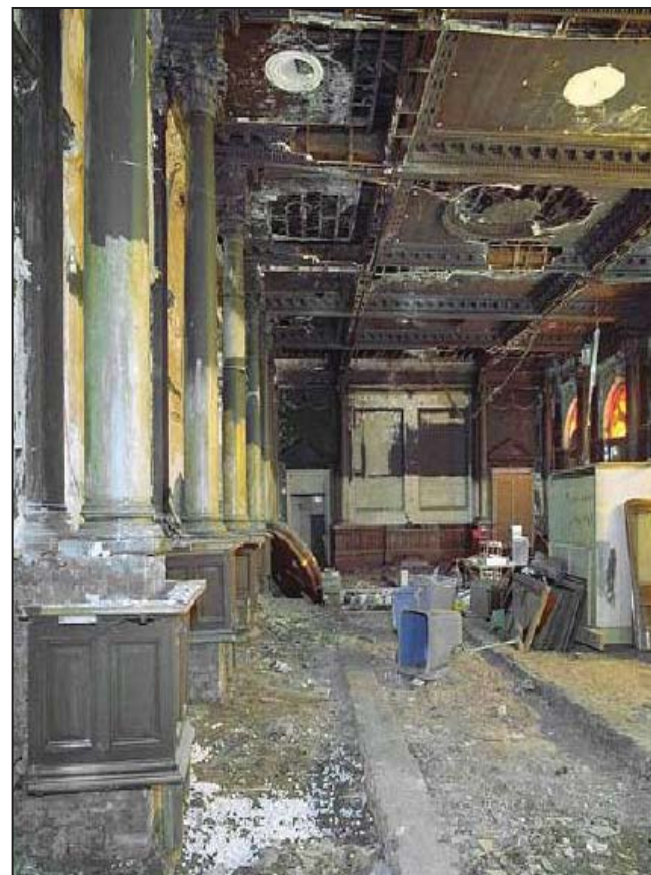
- 1.7 The building continued in use until recently but is now empty and in poor condition (Fig. 5). Some of the decorative ceiling features are missing and others damaged. The wooden floor was removed before the re-Listing in 2000

5 The interior just before the erection of the internal scaffolding in early 2010, looking south

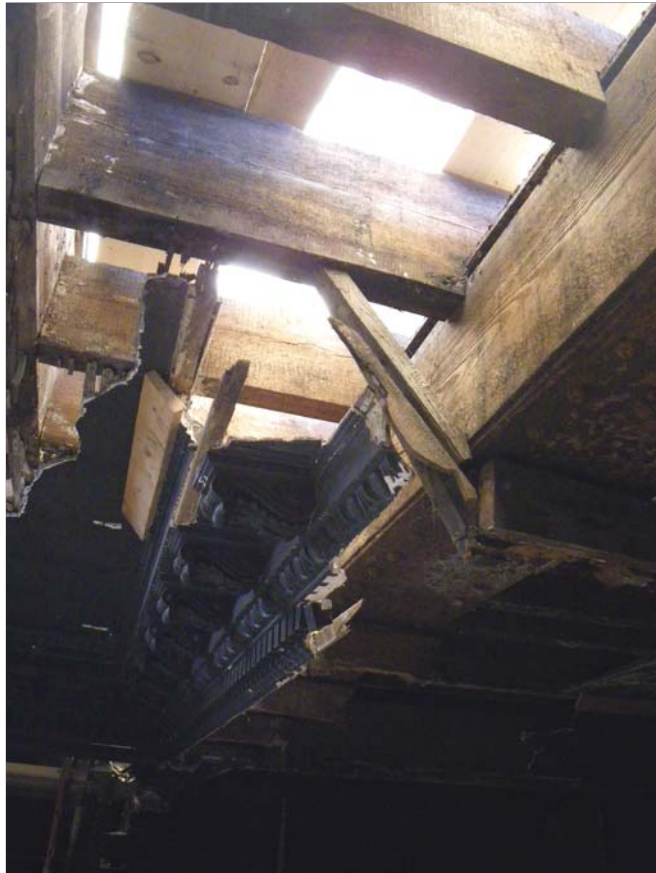
- D2 The decorative elements of the raised central section are completely gone, the corning to the main beams is largely intact except for the central section of the south cornice and the west end of the south cornice. No ceiling plaster survives. A section of one side of the soffit moulding survives on the east beam.

9 Main roof beam on south side of Cell D2 showing timbers of raised central section on left and attachment of plasterwork, looking east

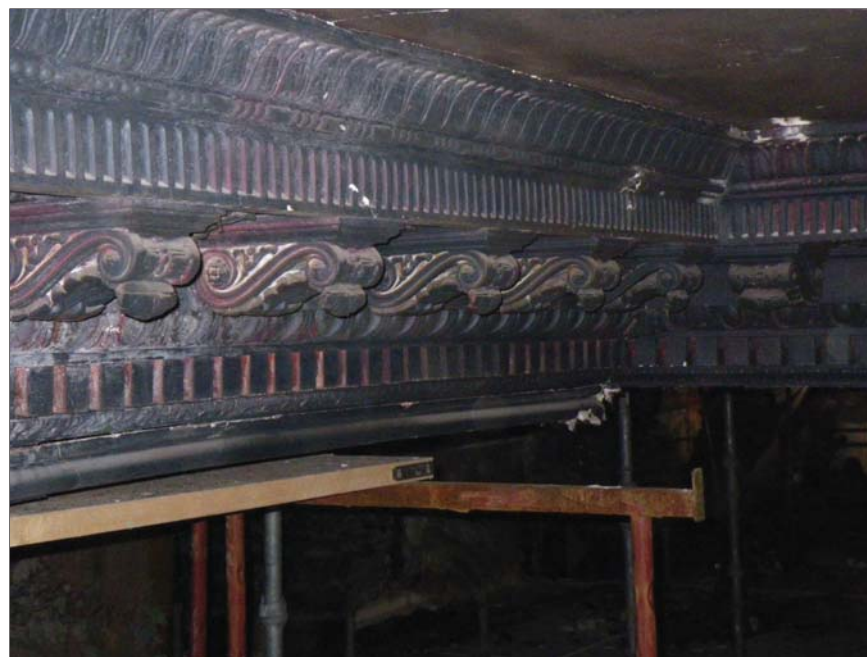
11 Typical length of plasterwork on ceiling beams. Note red paint shadowing. Cell D2, looking south-west

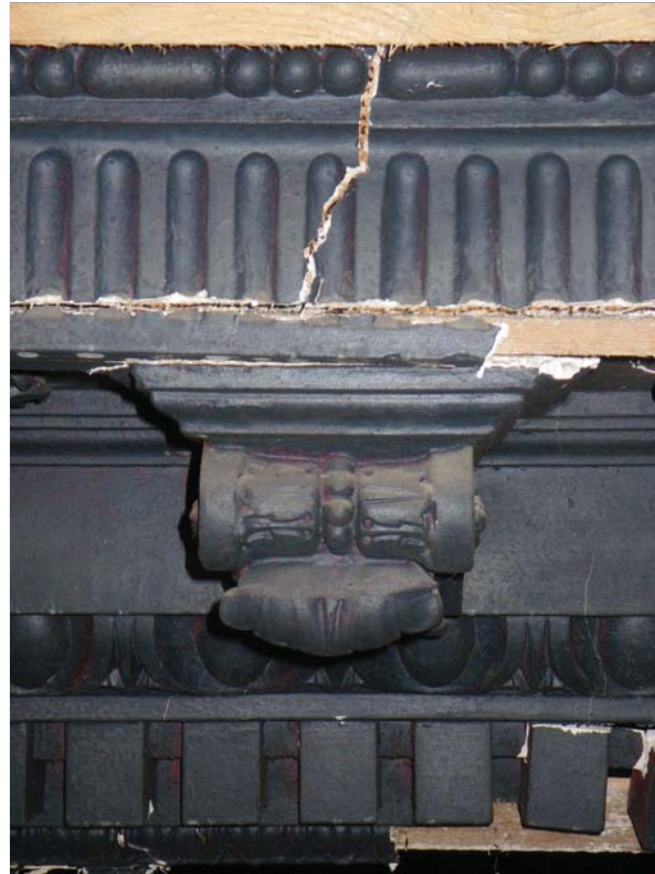
13 Detail of end of console bracket on ceiling beam (note prefabricated elements parting at joints)

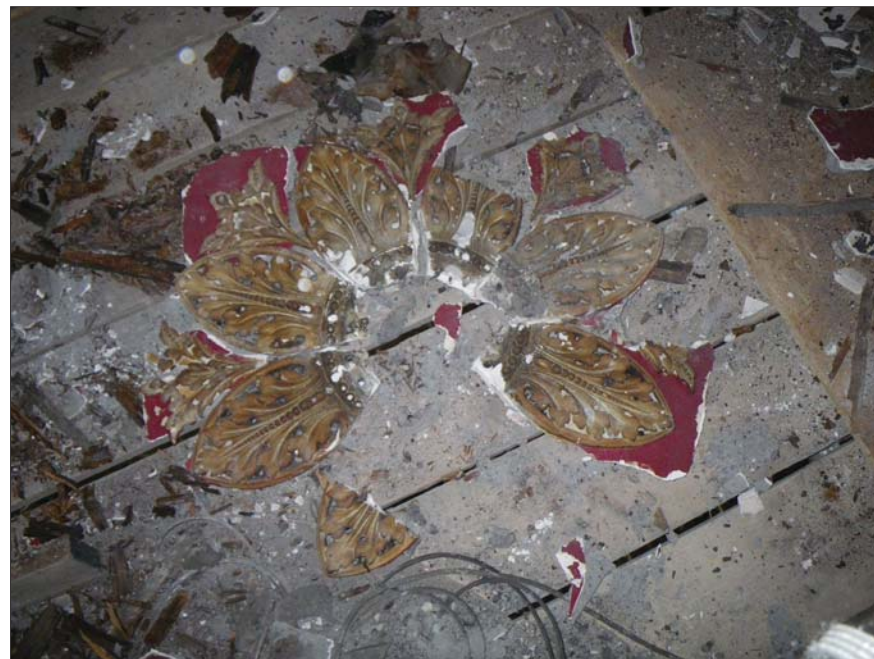
- 2.6 The cast plaster work is pre-fabricated in fibrous plaster/plaster of Paris and attached in sections to the girders and beams via a fairly *ad hoc* system of planks, battens and studs (Fig. 9). Internal strengthening webs can be seen every 15 inches (38.1cm) in the cornice sections (Fig. 7), but it appears that the mouldings were made full length for the final position. It seems probable that the pre-fabricated mouldings themselves are made up of standard elements, as for example, the dentils which are clearly set in place separately (and in some instances were separating from their matrix) and the console brackets, whose relationship to the main cornice mouldings is sometimes misaligned; cracks indicate joins. The corner junctions of the section of moulding are also often misaligned. Further evidence of sectional construction comes from the central elements of the ceiling rose in F2, which fell into its constituent parts when it recently fell to the crash decking (Fig.

18). Ceiling plaster was standard lime plaster over laths, and the prefabricated roses attached to it or, in the case of the recessed roses, the beams above.

18 The centre of the section of the rose in cell F2 reassembled from falled fragments. The total diameter is c.0.76m

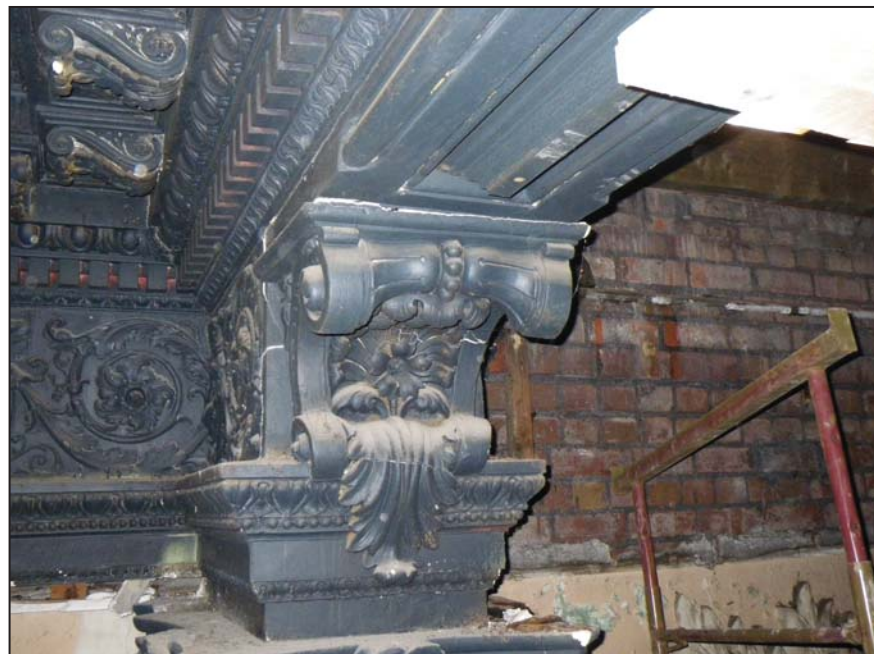
- F1 Ceiling gone on east, no rose, some damage to cornice at east.
- F2 Largely intact, the central decorative elements of the boss (only ones seen or surviving) were found *ex situ* on the scaffolding decking. Soffit to beam survives on south beam, ceiling damaged/missing in north-east quadrant.

20 A preserved column-top console and its surviving beam soffit moulding in cell F2/G2. Contrast plasterwork on left and right

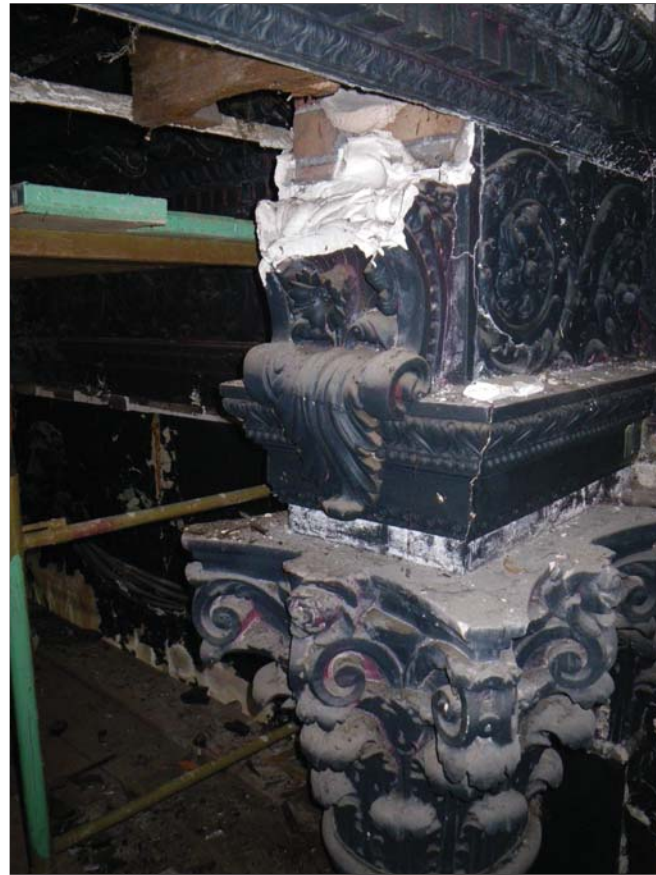
22 Typical damage to column-top consoles caused by insertion of crash decking

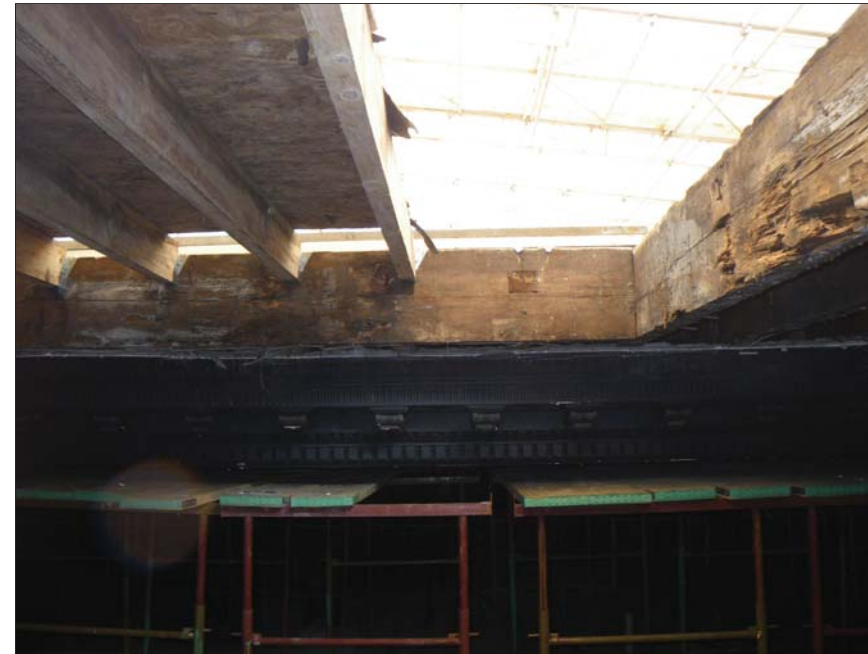
23 The raised ceiling section were the rose was. New joists to left, frame to raised section, rear and right

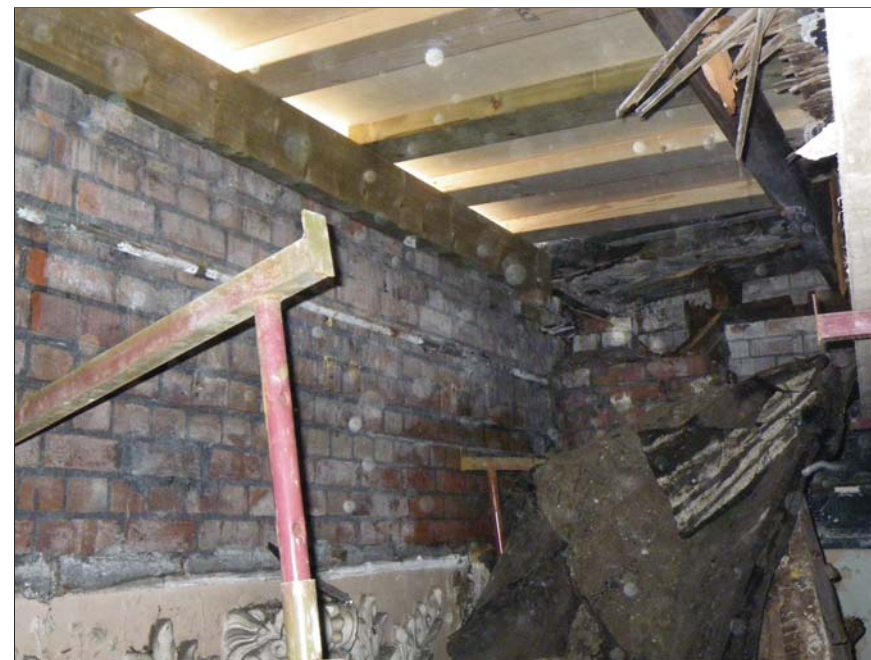
- G1 Very badly damaged; cornice and entire entablature on walls gone to brick and woodwork, ceiling collapsing, rose gone. The decorative plasterwork below the entablature is at risk due to poor protection.
- G2 As G1
- G3 As G1 and G2, but column console bracket survives in north-west corner.
- 3.4 The plasterwork was all painted a dark grey blue when visited, with evidence of a blueish-red shadowing in the recesses. The plasterwork in the centre of the recessed roses was painted a similar red and gold. Early photographs show a light, perhaps white, paint finish, with the columns and pilasters in a contrasting painted marble effect. It seems the beams were earlier finished in a darker tone, later painted to match the walls.

24 The southern end of the building where the plasterwork is most damaged or, indeed, missing. Cell G1, looking south-east
