**MANOR FARM
QUEDGELEY
GLOUCESTERSHIRE**

HISTORIC BUILDING RECORDING

CA PROJECT: 3073
CA REPORT: 10048

APRIL 2010

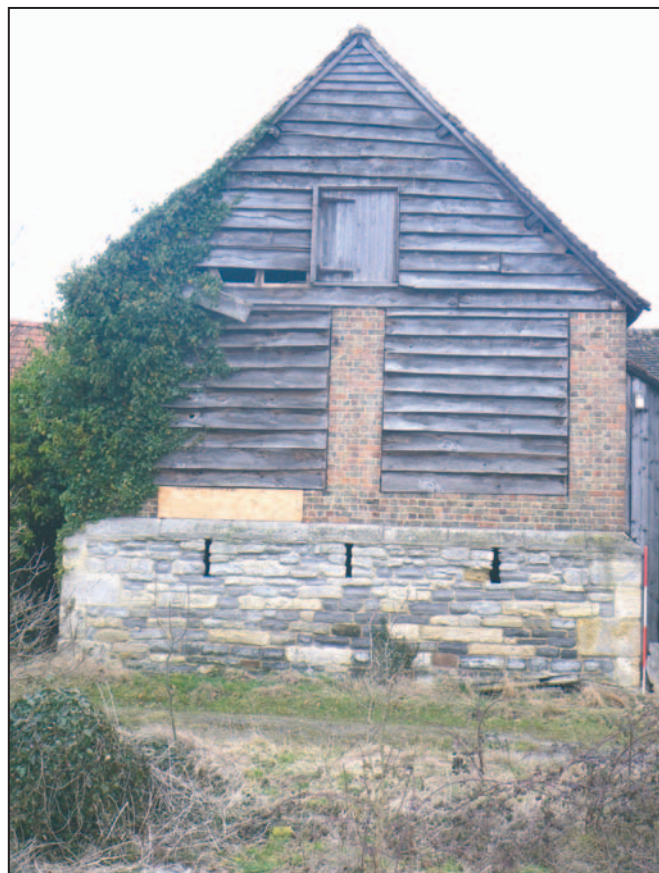
roughly finished lias and oolite limestone (Fig. 6). The upper parts of the stone walls contain very little oolite and are more consistently of lias limestone (Figs 6, 10 and 11). The quoins are built of large oolite ashlar blocks from 0.30m to 0.50m thick. The walls are topped at about 2m (slightly less to the north as the ground rises) by oolite ashlar chamfered plinth blocks c.0.25m thick, and vary from 0.60m thick (1' 11½") to 0.46m (1' 6") on the south-western side north-west of the porch. The centre of each long side is broken by an entrance marked by large oolite quoins. On the north side these are contained within the width of the wall (Fig 7), but at the south they project raggedly as if a porch flanking wall has been removed (Fig 8). Under the ends of the brick porch on the south (described below), in line with these projections, is on each side a squared block of oolite currently serving as the base for the end of the brick porch wall (Fig. 9). Internal stone responds the full height of the plinth divide the remainder of the side walls into two equal parts at the south end and three at the north (Figs 3 and 10). On the north-west gable end are three ventilation slots, clearly original to the stone plinth, but there are none on the north (Fig. 6). A wing wall, integral with south-eastern gable end continues its line to the south-west. This steps up 0.36m and end in massive quoins. It has no return to the north-west (Figs 3, 5 and 11).

6 West elevation of Building 1, looking north. Scale 2m.

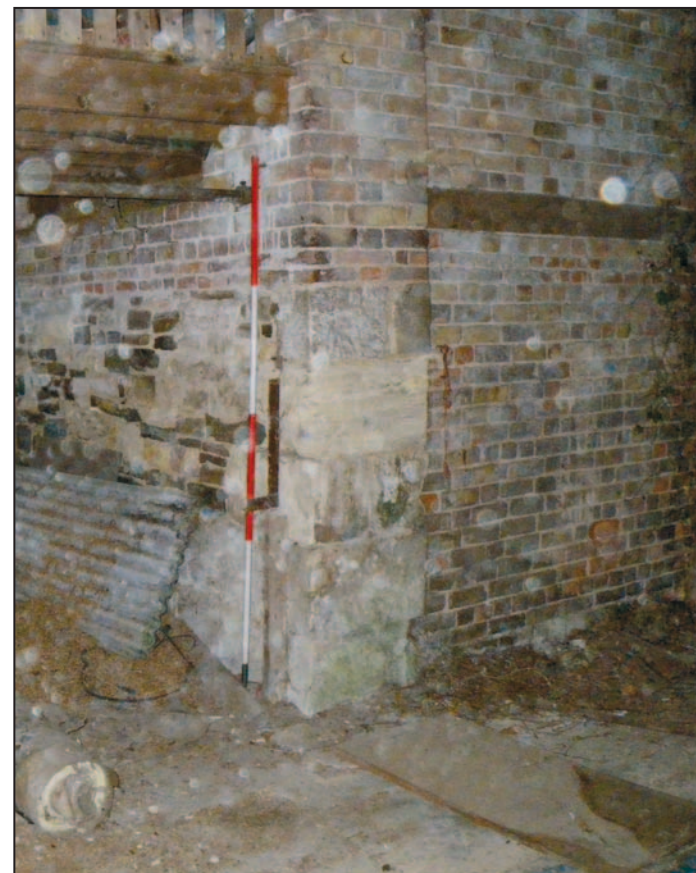
- 3.3 The stone plinth shows clearly that there were two opposed entrances, marked with stone quoins. On the north the quoins show no evidence of side walls for a porch, indeed it is quite clear there were none (Fig. 7). This does not mean that there may not have been a timber porch. On the south the quoins showed that the plinth had originally incorporated masonry side walls, and that these had been partly demolished for the construction of the present brick ones (Fig. 8). At the base of the southern ends of the present side walls, the two large oolite blocks forming the foundations seem to be the remains of the ends of the original stone porch walls (Fig. 9). As with the rest of the building of this period, the upper porch walls would have been of timber.

7 Quoins to the north entrance in Building 1, looking north-west. Scale 2m.

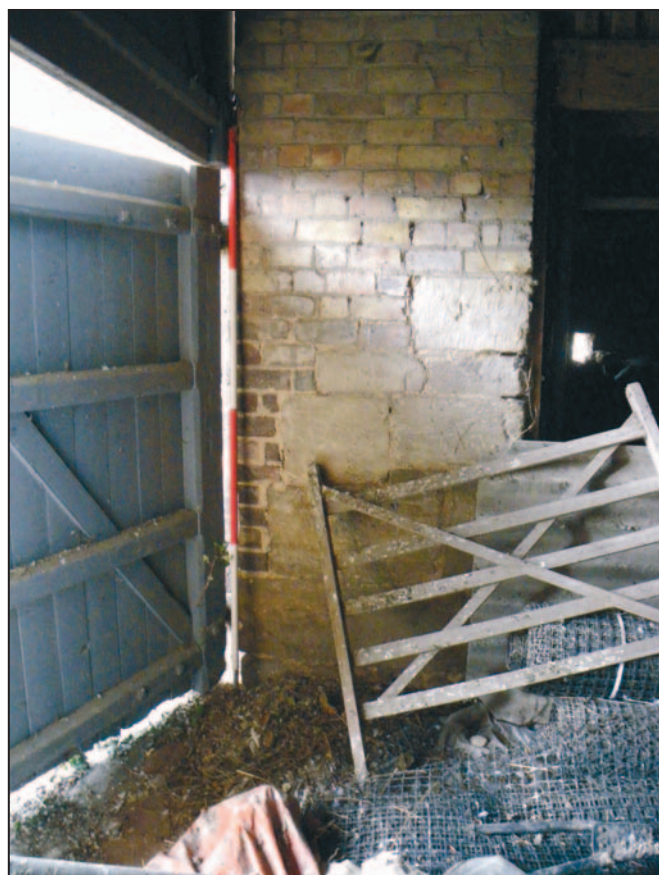
- 2.3 The brick structure is effectively a set of piers on the plinth, framing large openings that go right up to the eaves. The openings are currently closed with clap boarding as are the gables (Figs 5, 6, 11). The porch on the south side is of the same build using the stone blocks and jambs of the plinth in its base (Fig. 8). It has timber wall

8 Quoins to the south entrance in Building 1, looking west. Scale 2m.

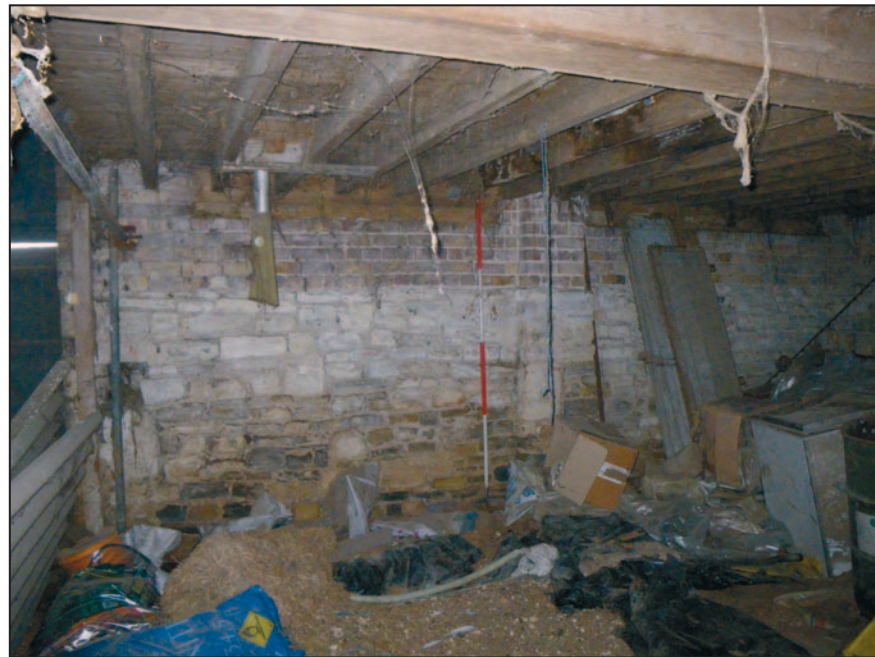
10 Interior of south wall of Building 1, looking south-west. Scale 2m.

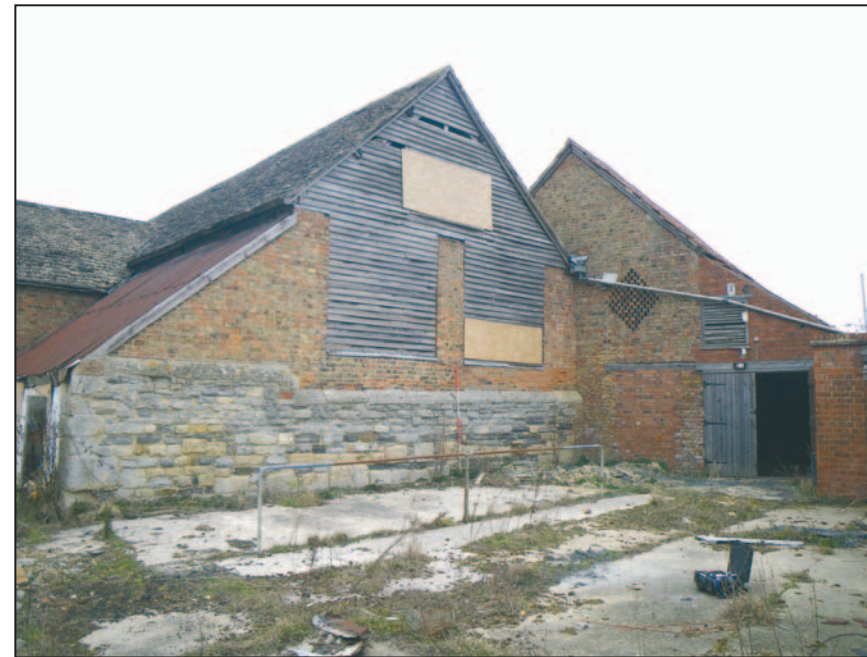
- 2.2 Above the plinth the barn is constructed in stock bricks ranging from yellow to orangey-red (Figs 6 and 11). The bricks are typically 9¼" by 2¾" by 4¼" (there is some variation from 9" to 8½") set in a hard pale ochre lime mortar with cinder and lime specks. In the south-east gable end are some thin, evenly-fired, soft, red bricks which have clearly been reused from another structure (Fig. 12). They are 9" by 2" by 4½". These are interspersed with the stock brick just above the plinth and below the windows, but immediately above the plinth at the south end are three courses dwindling to one. They are the same size as the other thin bricks but are set in a hard pinky-grey mortar as if they are the survivors of an earlier brick phase *in situ*. Similar bricks are seen in two levelling courses under the timber in the south-eastern wall of the south porch. These older bricks and, oddly, the area of wall reusing them below the windows are in Flemish bond. The rest of the brick structure is in English bond.

- 2.19 It was clearly built as a store barn as it has four surviving diamond-shaped ventilation grills, and a huge loading door, now blocked in (Figs 11, 17 and 27). The upper loading door in the west elevation is an oddity as there is no sign of there ever having been an upper floor in the barn. It appears to be an insertion and there may have been a temporary floor that has left no trace. The ground floor was not visible due to a thick layer of hay. The main door has been partly blocked in two phases leaving a tall door on the north. The south wall (Figs 11 and 28) butted the western corner of Building 1 and a door into it (which it has been suggested above was on the site of an earlier door) constructed. Another door to the outside through this wall was also part of the original design of Building 2 (Fig. 28). The roof is of exactly similar design to the other roofs described (Figs 20, 28 and 29).

11 South-east elevation of Building 1 and south elevation of Building 2, looking north-west. Scale 2m.

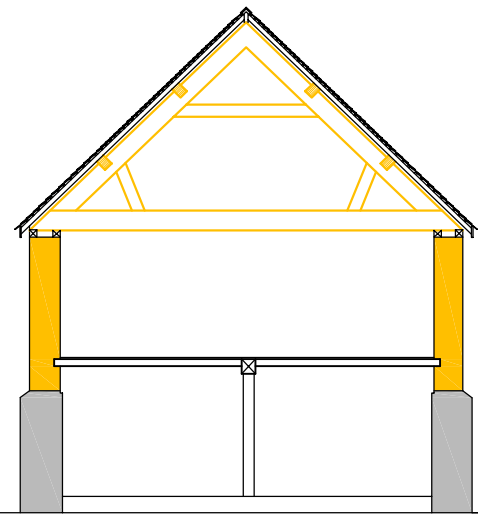
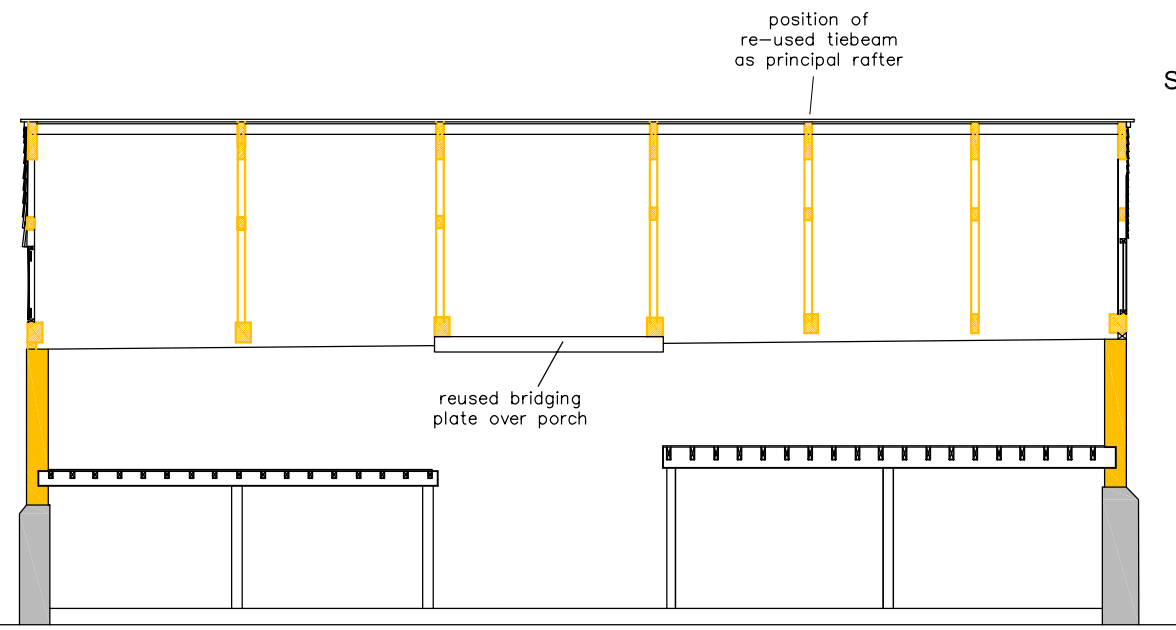
FIGURE TITLE
Cross sections of building 1

- 2.5 The internal first floor was completely modern, having been inserted in the second half of the 20th century (Fig. 13). It was inaccessible for safety reasons but was anyway much obscured by four large feed vats, which also made inspection of the upper walls impossible. It was at a level above the cills of the large openings, which had been partly filled with timber structures to support the beam ends (Fig. 10). No sign of an earlier first floor was visible, as far as could be seen.

- 2.6 The roof of the barn was of the same style and design as the other barns, a simple collar and tie beam principal truss design with small queen struts (Fig. 13). The purlins were shallowly trenched and overlapped. The joints were all mortised and pegged. The tie beams had plain run out chamfers on the undersides (as did the beams in Building 3, see below). Despite this detail much of the timber was wany. The trusses were carried on double wall plates at the wall top. These were rather small but were carried over the doorways by large timbers (Fig. 13). These were re-used and showed irregular, large chamfered mortises as if for wall muntins. This detail was also evident in timber reused as cills in the large wall openings. The rafters supported a roof of Stonesfield "slates".

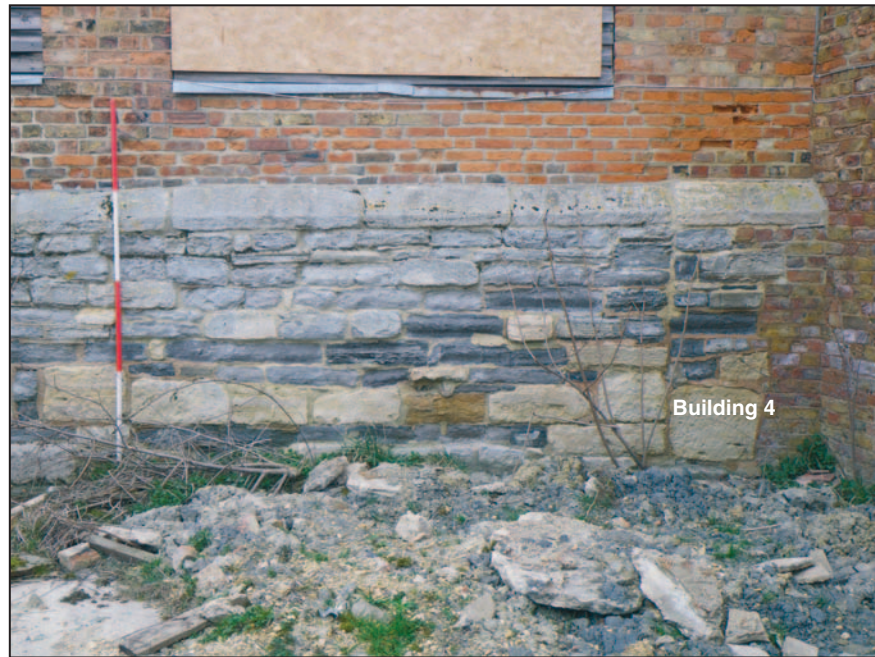
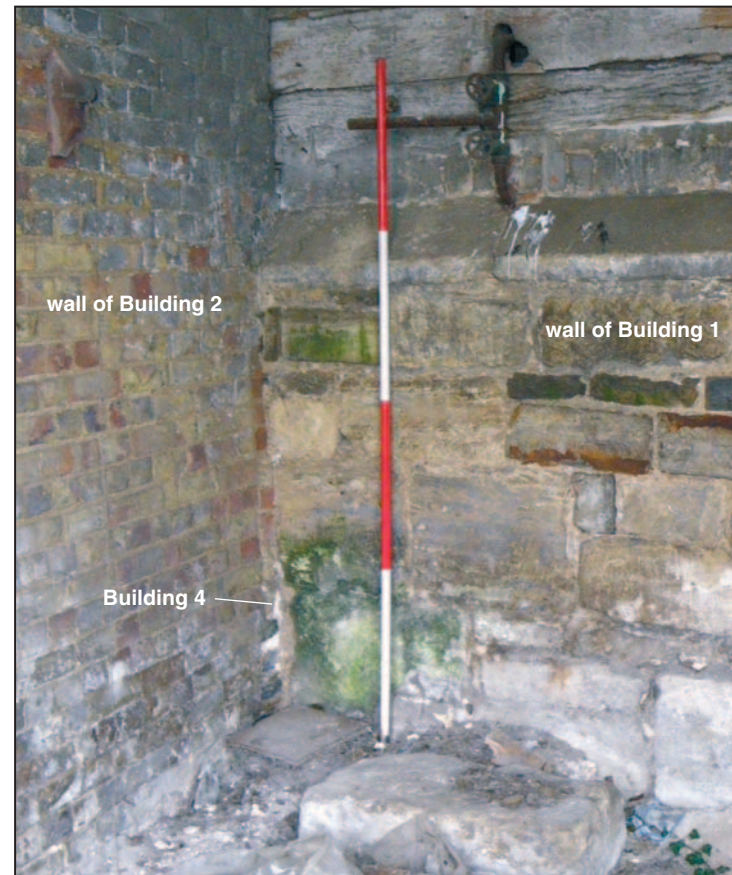
- 3.6 The stub of Building 4 suggests a relatively narrow building added to the north side of the barn (Figs 14 and 15). It perhaps was an animal byre. Both buildings are set at a different alignment from the other barns/byres, but are more or less aligned with the main house. The exact line of the moat on the east side is unclear but it appears that the barns are to its east and line up with its southern arm, and probably extended along the eastern side of the eastern arm. The lack of any subsidence in the barn makes it unlikely that it was built over an in-filled arm. Presumably the farm buildings were beyond the polite enclosure of the moat but still, as an expression of wealth, given a certain formal expression by the geometrical relationship to the house and moat.

14 Fragment of Building 4 between Buildings 1 and 2, looking north-west. Scale 2m.

15 North wall fragment of Building 4, looking south-east. Scale 2m.

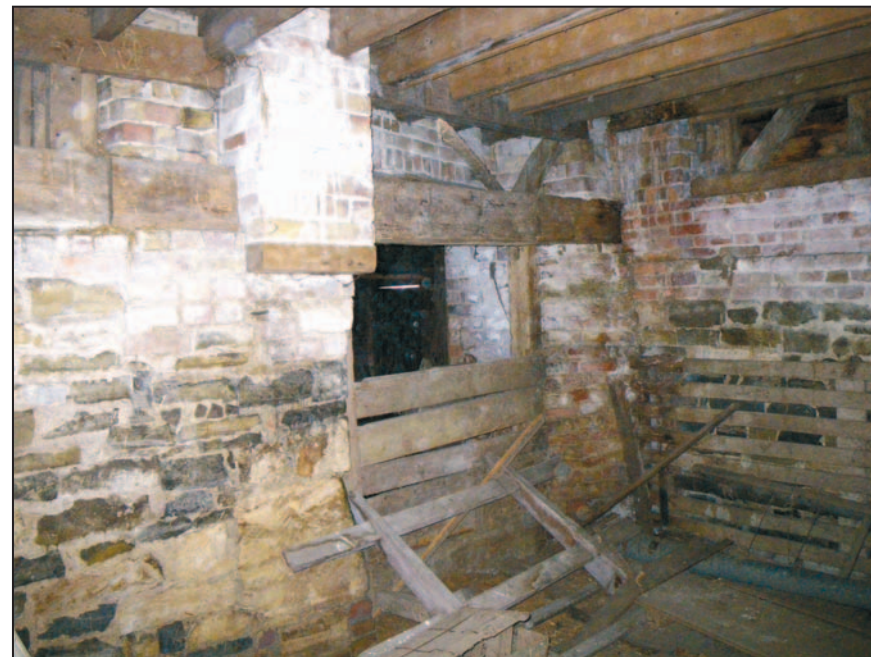
2.9 Access to this part of the interior of Building 1 was very limited, but it seems that the doorway from here into Building 2 may have been in existence when Building 4 still stood, although it was heavily modified when Building 2 was built. This is based on the existence of possible jamb stones in the north side of the opening in Building 1 fabric. However, these also form the north-eastern internal respond of the stone plinth (Fig. 16).

16 Doorway from the east corner of Building 1 into Building 2. (no scale area inaccessible)

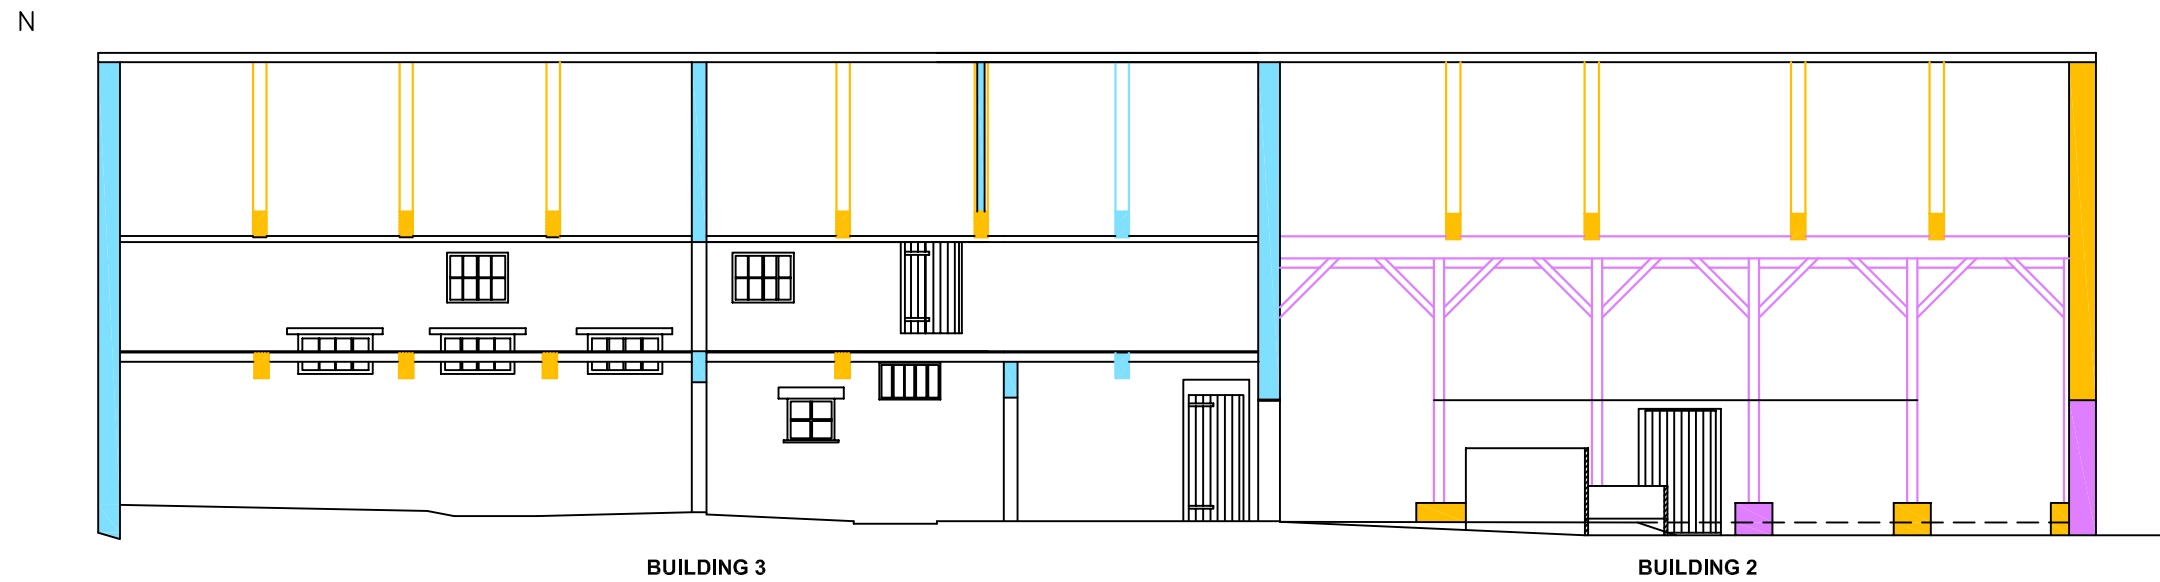
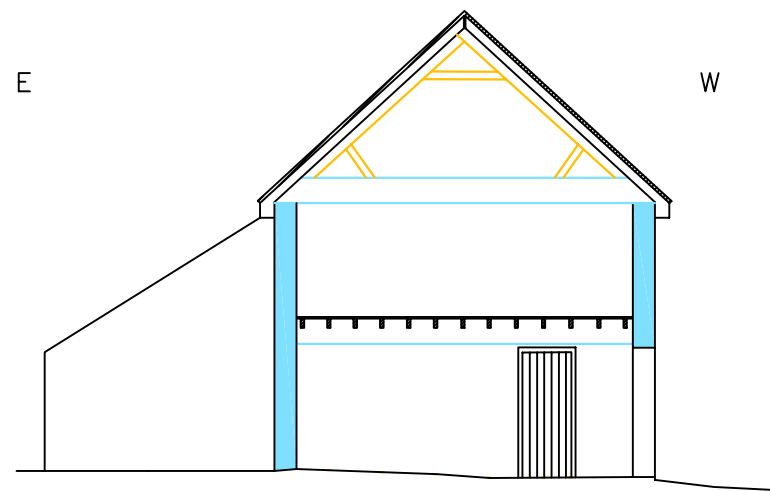
FIGURE TITLE
**Cross-sections of Buildings 2 and
 3**

- 2.12 Four long and shallow openings in the east wall of Room 1 are cut across by the floor and would also have been by the original floor (Fig. 20). However, they are insertions into the original east wall to do with servicing the lean-to shelters (now loose boxes) along the eastern flank (see below and Fig. 26). They would have allowed the overhead delivery of feed from the hay loft into these flanking rooms, and cut-outs in the floor would have provided the space for the chute. There is no evidence of a cut-out in the present floor which must post-date the closing of these openings. In the central room (2) a similar, single opening is below the level of the floor. The doorframes in the openings between these rooms have run-out chamfers on the jambs. These are badly worn but seem to run out top and bottom. The actual doors seem to be mostly late 19th or 20th century in style.

those downstairs. The roof is a standard tie beam and collar truss design with small queen struts (Figs 20 and 22). The purlins are deeply trenched and overlapped and all joints are neatly mortised and pegged. Timbers are machine sawn but many. Many of the common rafters still have bark on. The timber is probably oak. The trusses rest on short baulks of timber on the wall tops nailed back to the thinner wall plates which take only the common rafters.

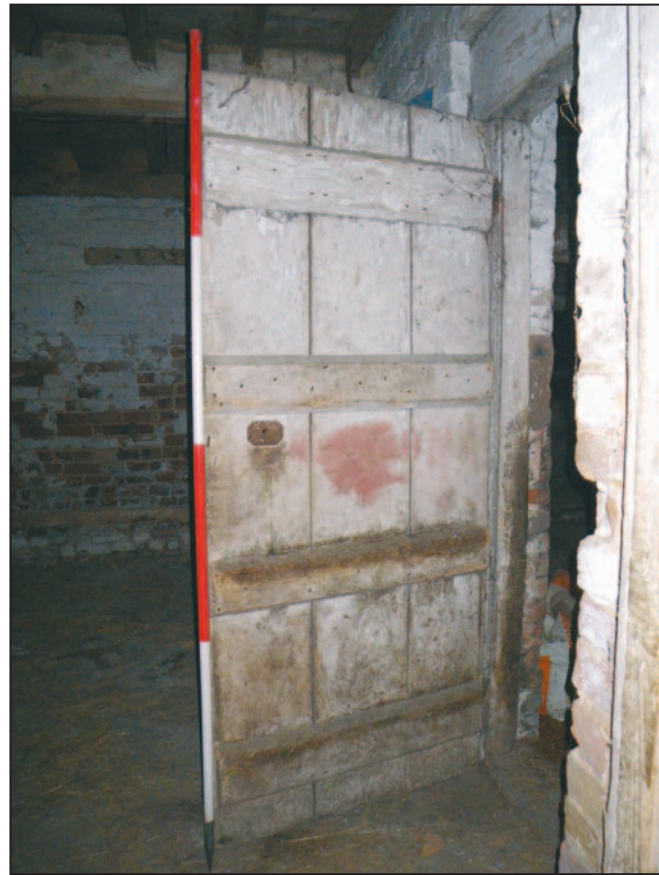
- 2.13 The present floor is probably contemporary with the insertion of metal Crittall-type window frames in the ground floor openings, and drains to the south. The windows are largely in original form otherwise, with large wooden lintels internally and external brick segmental arched heads. The second window from the north on the west face, however, has been converted from a door which was originally similar to the other two in this wall (Figs 17 and 19). Two doors here probably imply that the first use of Room 1 was as a stable, perhaps for two working horses. That Room 2 was also a stable is perhaps indicated by its size, separate door and separate hayloft over it. Room 3 at the south end seems only to have been reached via this second stable in its first form, as the two doors in its south and east walls are secondary insertions. If the other rooms were indeed stables, Room 3 would be a tack room. Although an insertion, the doorway to the east is closed with a ledger door with very wide boards, and a hand-smithed lock plate. This is an early door, reset, very probably of 18th-century (or earlier) date (Fig. 21).

21 The early ledger door in Room 3. Scale 2m.

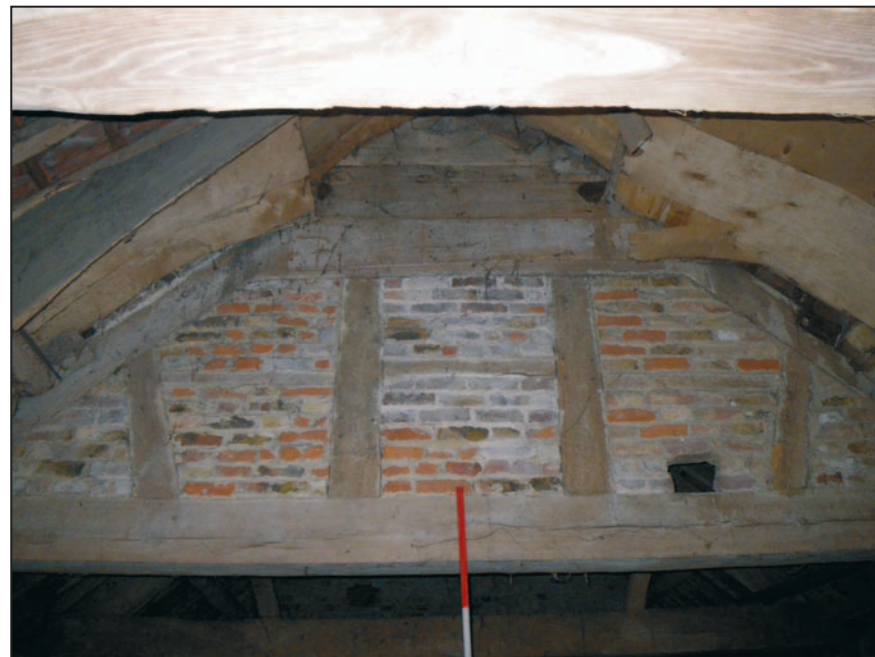
- 2.15 The middle truss in Room 8 is unusual, in that it is a queen post truss (the queen posts are reused wall posts with mortises for a mid rail) and the panels are infilled in brick. Above the collar, the panel is filled with wide lapped planks. There is no sign of a wall below the tie beam either in timber or brick on beam or wall. The other trusses are equally bare of any indications of infill. The truss is close to but not over the cross wall between Rooms 1 and 2 downstairs. The bricks are similar overall to the rest of the building and set in lime mortar (Fig. 23).

23 The in-filled Truss in Room 8, Building 3, looking north. Scale bar 0.5m.

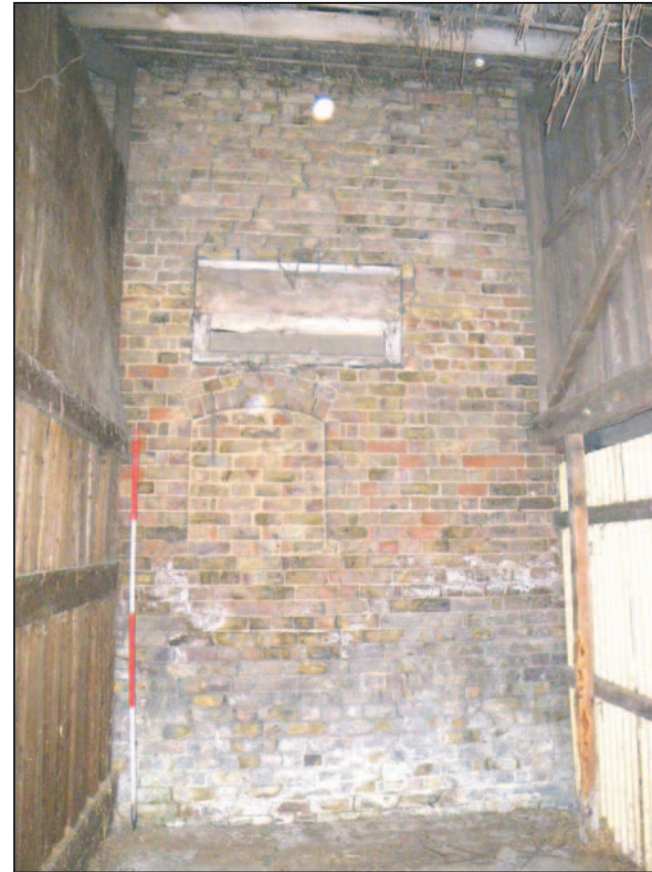
- 2.17 Along the north and east sides of Building 3 is a range of lean-to timber stalls with a corrugated metal roof. These are of relatively recent construction and seem to have functioned as loose boxes (Fig. 26). However, they incorporate some fragments of an earlier building of similar plan. This is indicated by a set of stone post-bases. These have an iron spigot to locate a wooden post. Five of these (at least) survive along the east side and two on the north (Fig. 24). Some of the wooden posts also survive, incorporated in the more recent rebuild. This original range appears to have its south wall still standing in timber (Fig. 25), meaning that the inserted door in Room 3 (with the old ledger re-used in it) would have opened alongside this range, not into it. It now opens into Room 5. The roof was probably the same shape and size as the current one, as there is no sign of a roof line internally. This range was only partly accessible, and the northern end not at all. A photo was taken of the east wall of Building 3 as seen in the northernmost of these boxes, showing that the loading slots are insertions and the blocking of earlier windows similar to those in the west elevation (Fig. 26)

26 The east wall of Building 2 at the north end, inside one of the loose boxes. Scale 2m.

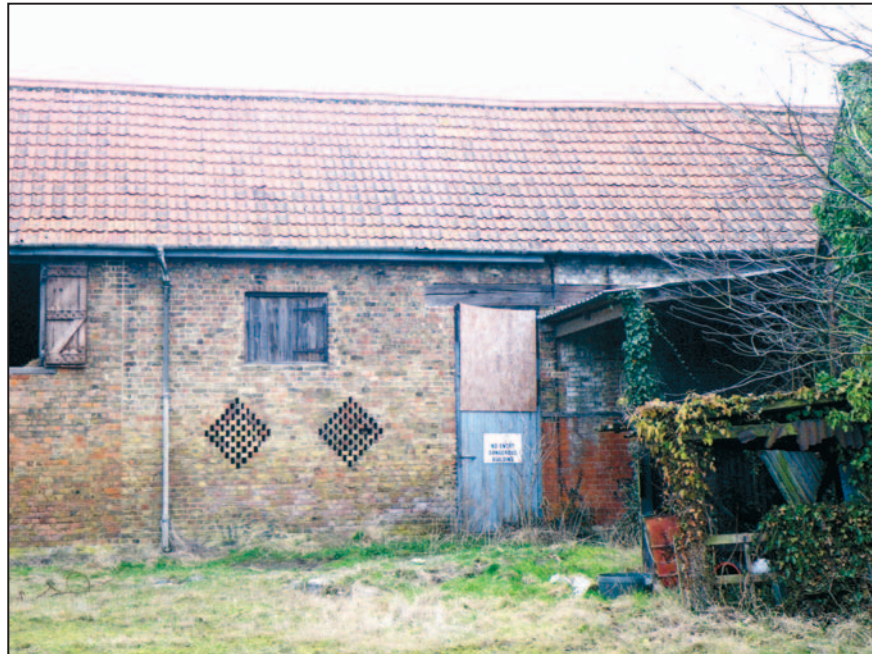
- 2.18 Building 2 is a barn built against the south end of Building 3 and the western corner of Building 1 (Room number 4). It is a rectangle 13.85m by 6.29m (45' 5" x 20' 7½" – Fig. 3). The eastern wall has been taken out, and arcade of posts set in to hold up the roof (Fig. 20), and a lean-to added (Building 2a or Room 4a – Fig. 3). This barn is the same height and style as Building 3, but its bricks are generally more consistently yellow stock brick. They are the same size but are laid in thicker joints so the courses do not run in line (Fig. 27).

27 The west elevation of Building 2 and its junction with Building 3.

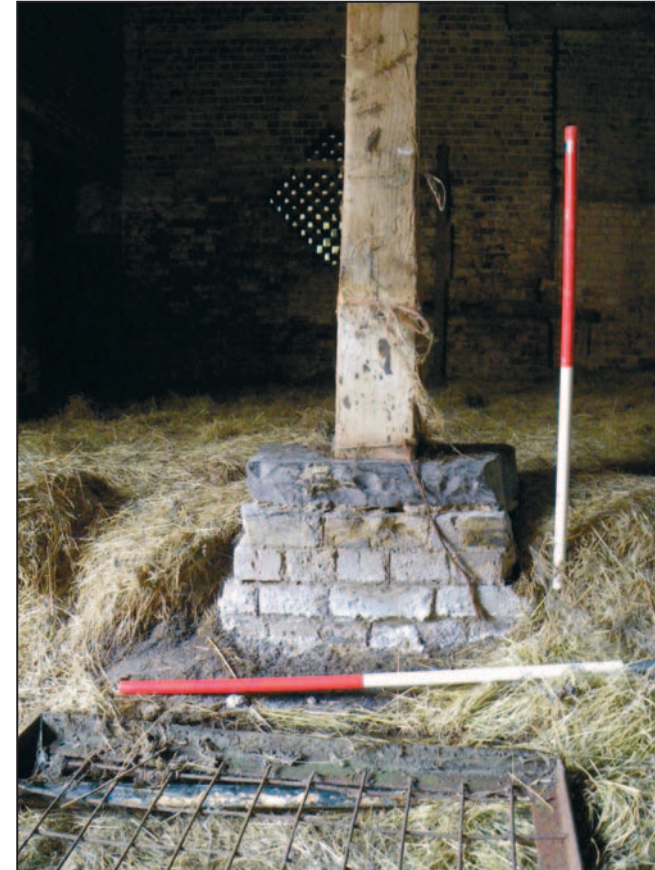
30 Fragment of east wall of Building 2 used as base of one of the southern arcade posts of Building 2/2a, looking west. Scales 1m.

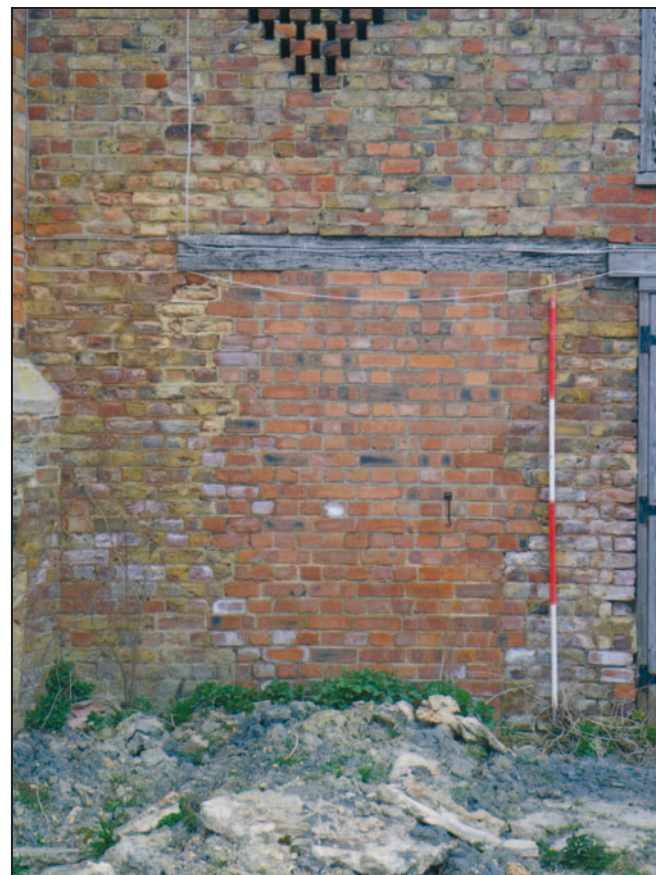
31 The blocked-in doorway in the south gable end of Building 2, looking north. Scale 2m.
