**THE WOOLPACK INN
RISBOROUGH ROAD
STOKE MANDEVILLE
BUCKINGHAMSHIRE**

**HISTORIC BUILDING RECORDING &
ARCHAEOLOGICAL WATCHING BRIEF**

CA PROJECT: 2870
CA REPORT: 09108

JANUARY 2010

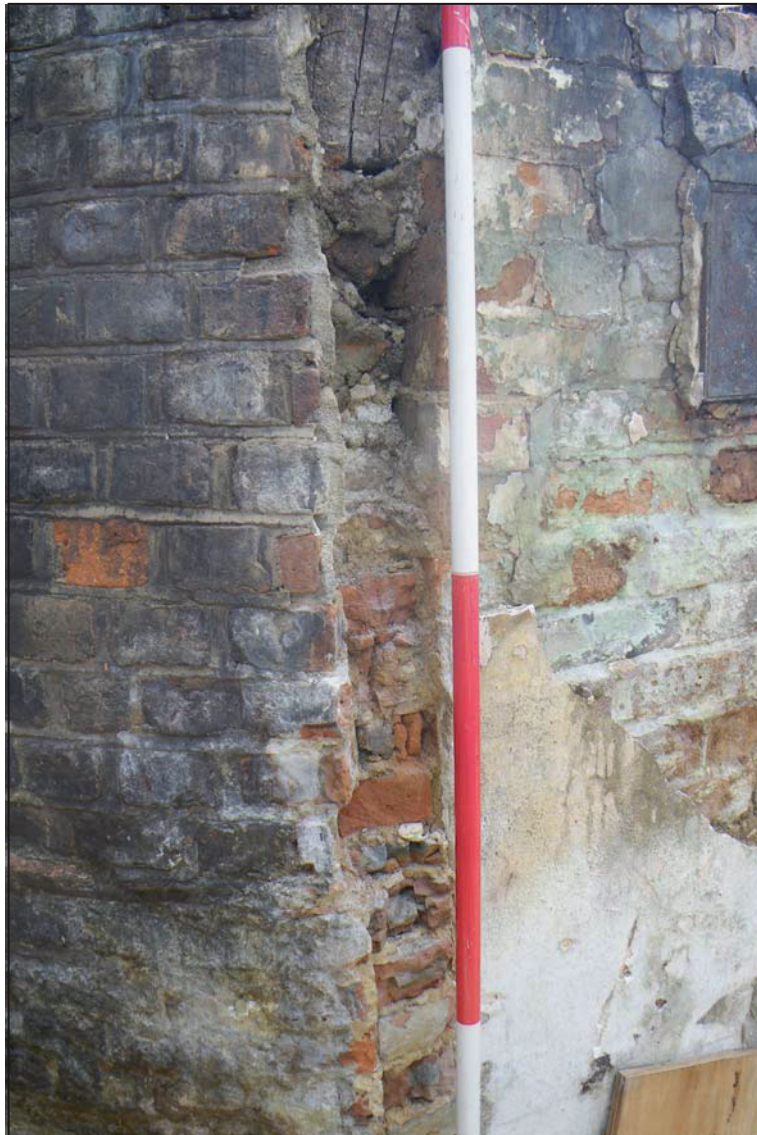
21 The single-skin brick wall of the north side of the south range sandwiched between the south range cross wall and the curving wall added to the north range stack, looking east. Scale divisions 0.5m

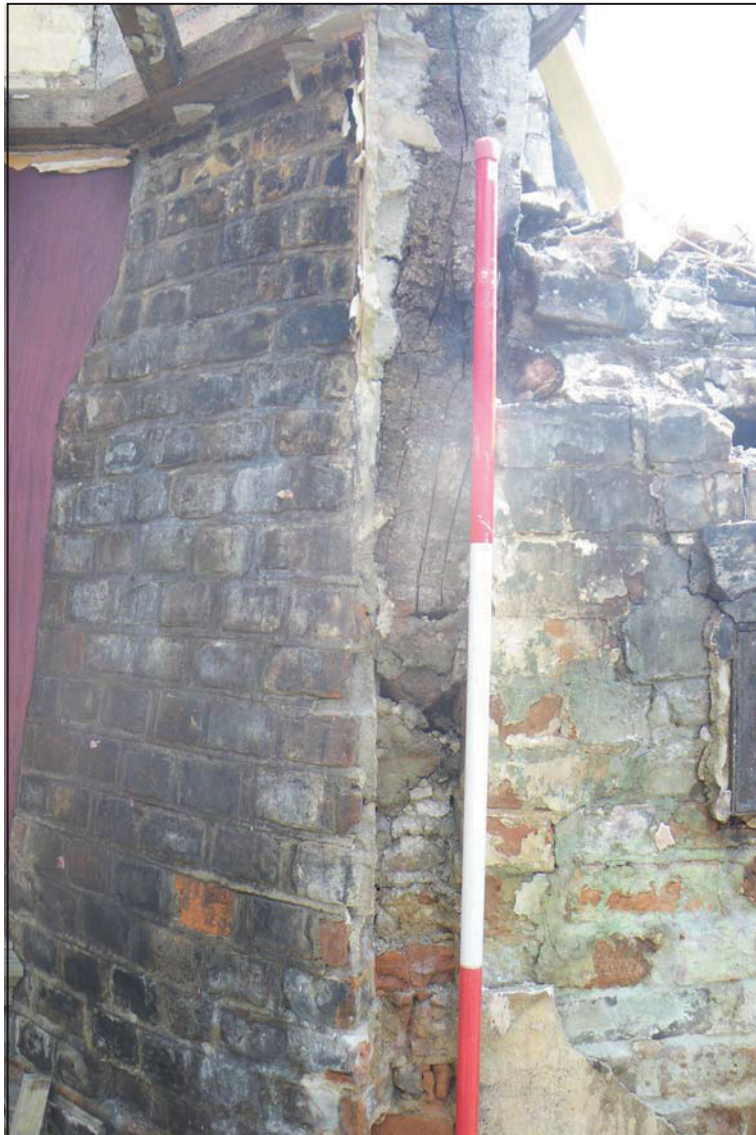
- 2.19 The bricks were smaller and the foundation was less deep than the western and southern brick walls of the south range, and was earlier than they. The junction of the later wall with the older is apparent externally in the north face of the wall (Fig. 24). The wall continued eastwards and was butted by the inserted chimney/kitchen cross wall on the south and by the curved brick wall in the south-east corner of the lean-to on the north (Fig. 21). The wall had clearly under-built or partly incorporated the top part of the northern wall post of Truss A (see below), which had been sawn off at 1.75m above the present floor level. It may originally have been sawn off 0.35m lower as the area of wall between these two levels looked as if it had been repaired later after more timber had rotted (Fig. 22).

22 The sawn-off wall post of Truss A and the early brick under-building, looking east. Scale divisions 0.5m

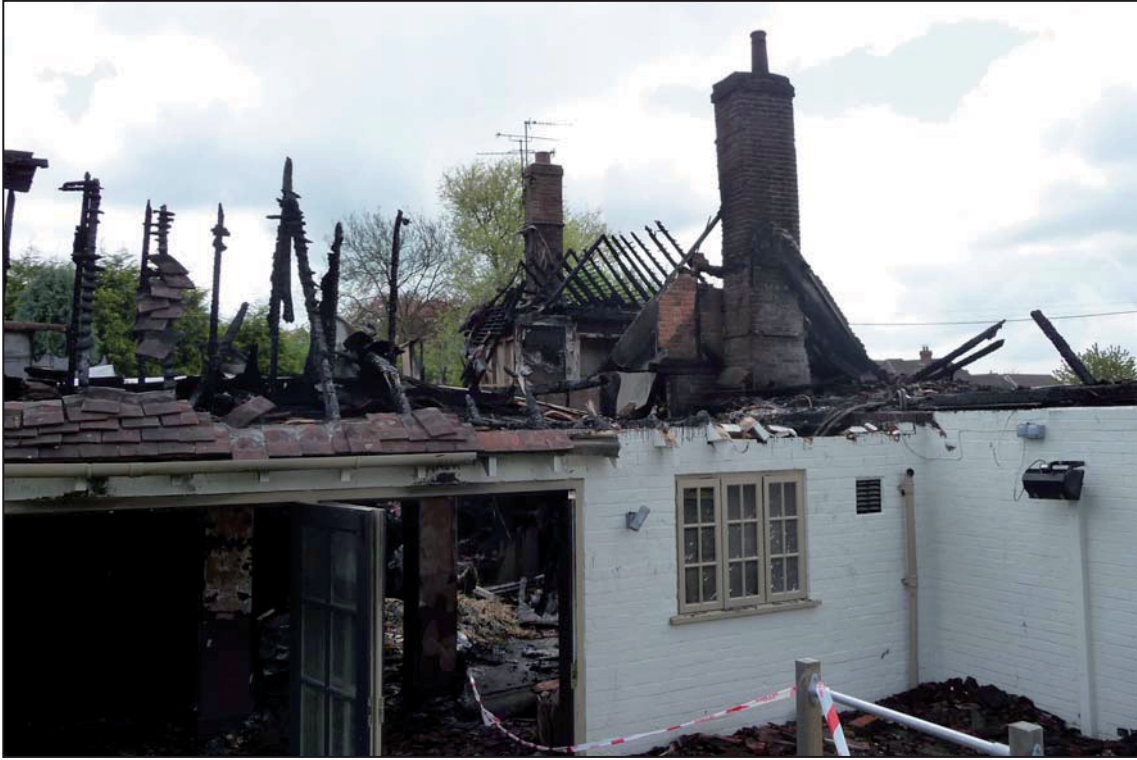
30 North gable before safety demolition, looking southwest

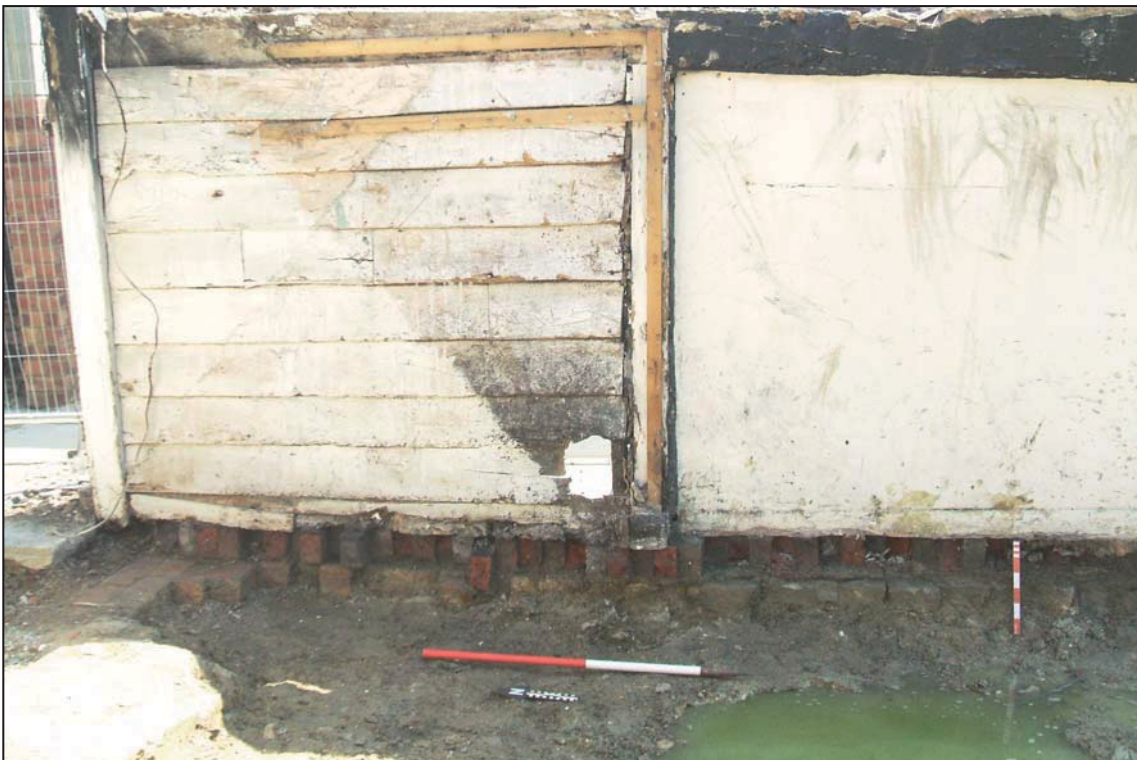
31

- 4.6 A carefully laid sandstone and red brick floor 210 was seen under the east wall of this room, the line of Truss B of the south range (Fig. 31). It only survived under this wall except for one small area at the north where a brick floor extended three bricks from the wall face. The bricks were confined to the north end of the wall, suggesting a local repair in brick of the otherwise stone floor. The floor seemed to be bedded on 203, a layer seen all over this trench and making it seem likely that the stone floor extended over the whole room at least. The floor supported a line of red bricks laid on edge 209 which functioned as the footing for the inserted timber cross wall in Truss B. These bricks are in fact the survivors of the floor seen complete before the floor was lifted and which formed the brick floor in use in the narrow space occupied by the successive stairs and associated small passage (Fig. 32). It must pre-date the insertion of both sections of the wooden wall here.

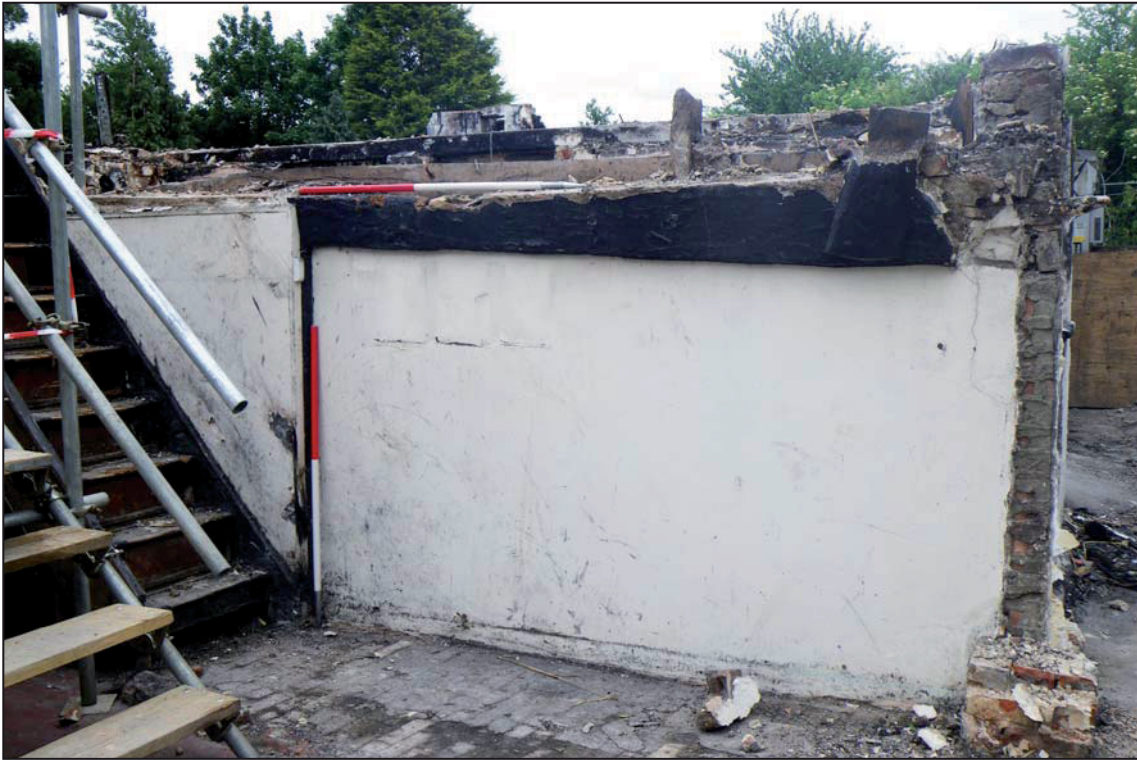
32 The brick paving 209 still in situ, looking east-north-east. Scales 1m
