**MILLEND MILL
EASTINGTON
GLOUCESTERSHIRE**

**ARCHAEOLOGICAL BUILDING
RECORDING AND WATCHING BRIEF**

CA PROJECT: 2779
CA REPORT: 09138

JANUARY 2010

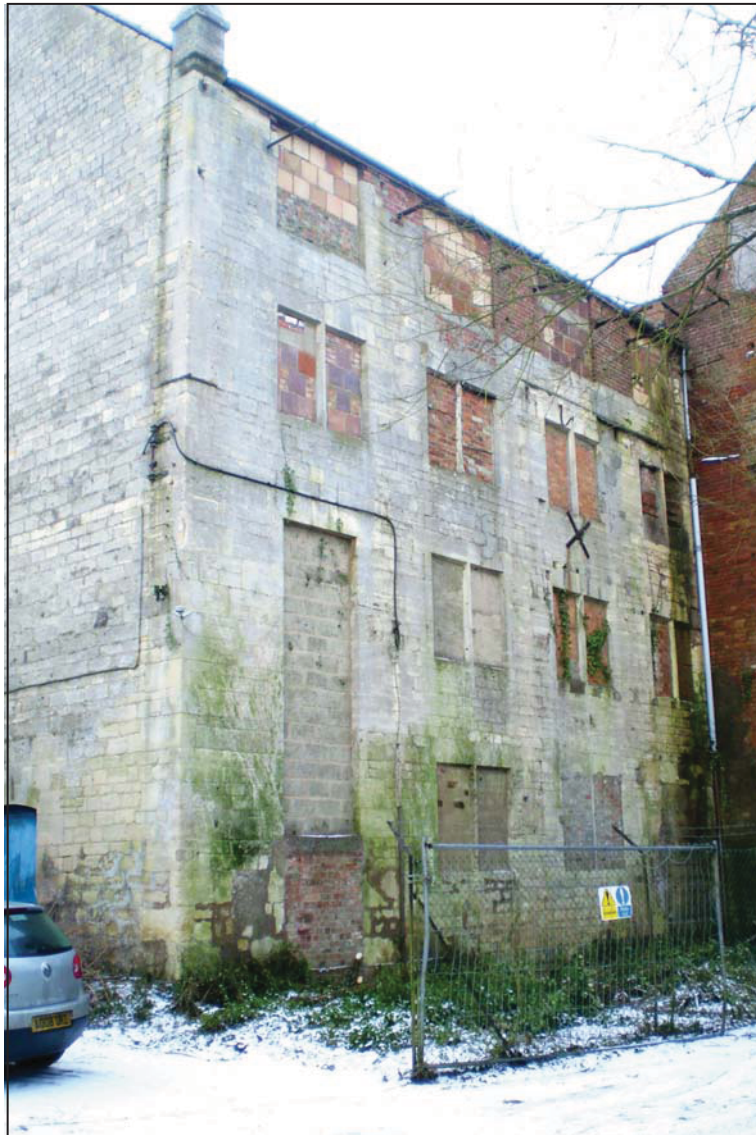
3 Millend Mill Building 1, west face, looking south-east

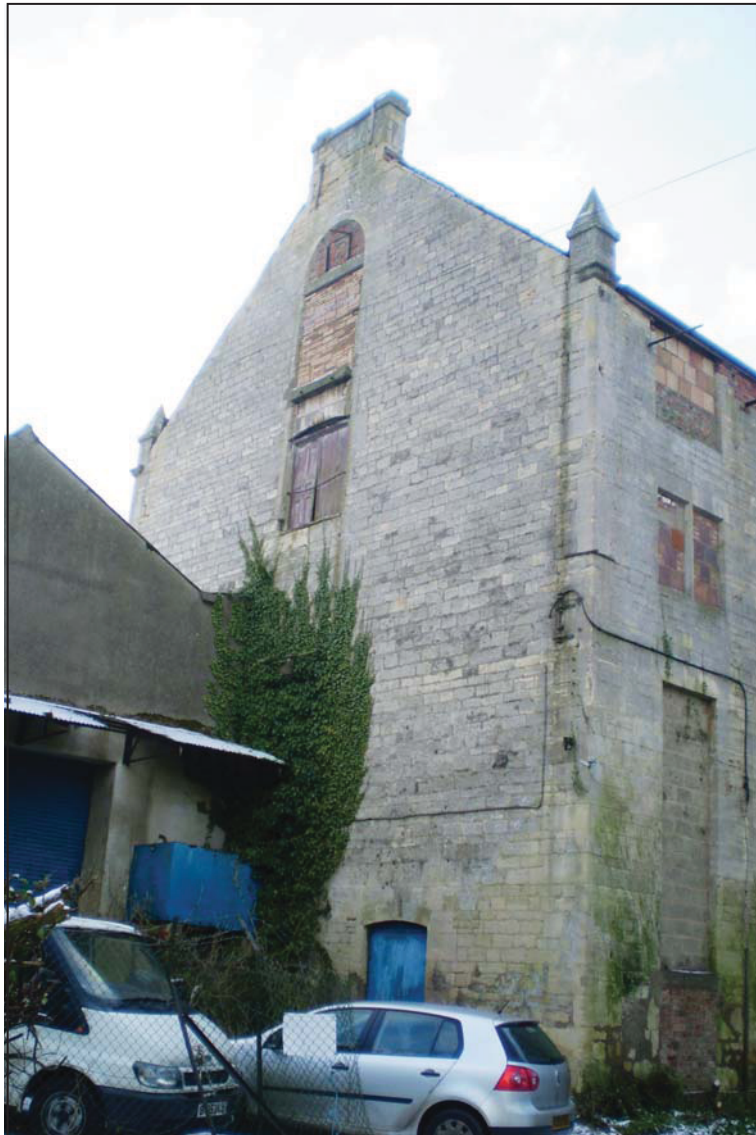
(Fig. 21). Morriss' suggestion that the attached ground floor piers supporting the floor joists are not primary was supported by the observations made for this report (Fig. 20). Evidence of the gap, later inbuilt, between Building 4 and Building 1 suggested by Morriss is indeed ambiguous, but such a gap is clearly shown on the 1873 map (*ibid*, fig 1) as is a building on the east end of Building 1 possibly reflecting the blocked joist pockets on this face just above the wheel arch (*ibid*, 15) and which must have been demolished for the addition of the present link building. The arched door head of the access to this link building from Building 1 is only paralleled by that of the top-floor hoist door in the east gable of Building 1, thought to be a later alteration (Fig. 4).

4 Millend Mill Building 1, north face, looking south-east

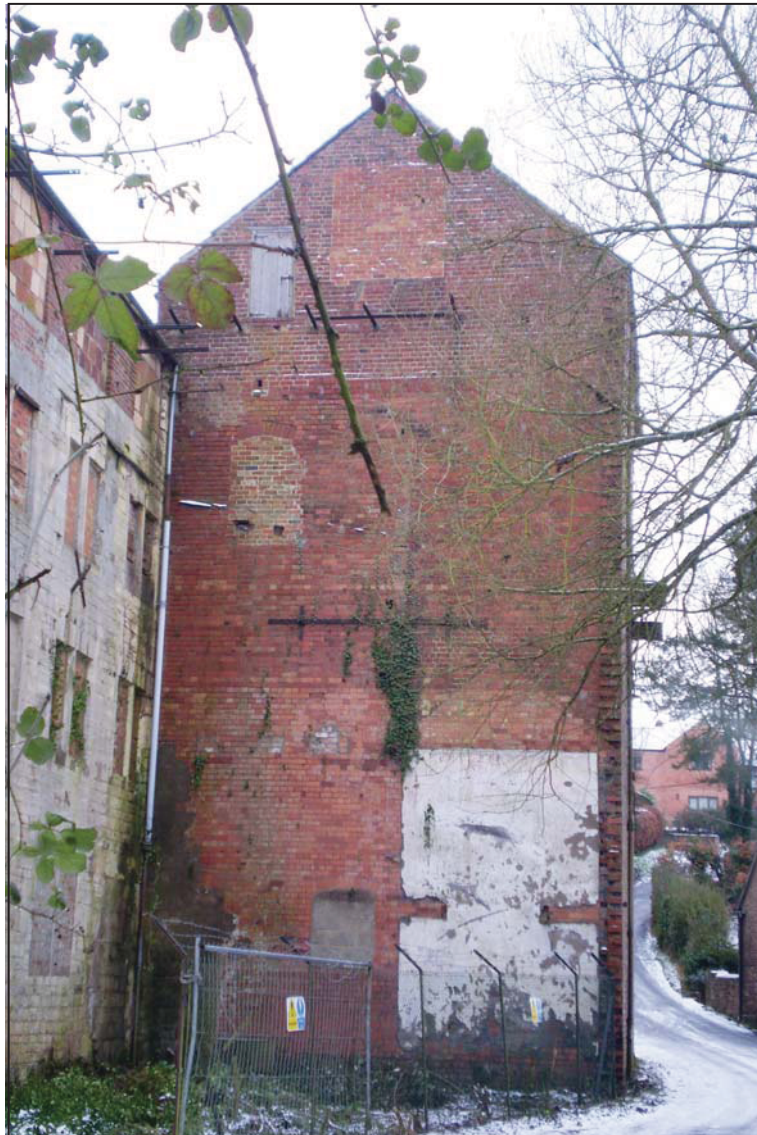
- 2.3 It is clear that Building 2 (Figs 5 and 6) was added to the main mill. Morriss dated this event as probably just prior to 1914 on the grounds that the malting company seems to have set up in that year or just before (Morriss 1998, 8). The building does not appear on the OS map of 1884 but is there on the 1923 edition, supporting this deduction. The use of black mortar, the kind of bricks used, the steelwork and the general style all indicate a late 19th- to early 20th-century date. The malthouse seems to have replaced a building of similar but slightly smaller extent, shown on 19th-century maps back to the Tithe Apportionment Map of 1839 (see also Morriss 1998, Figs 1 and 5). Both Morriss (1998, 20) and the present author noted the marks of the malting kiln flues on the interior walls of Building 2 (Fig. 17). Morriss correctly predicted the existence of the central malt kiln which was uncovered in the watching brief phase in Area 2 (below; Figs 24 to 26).

5 Millend Mill Building 2, north face, looking south

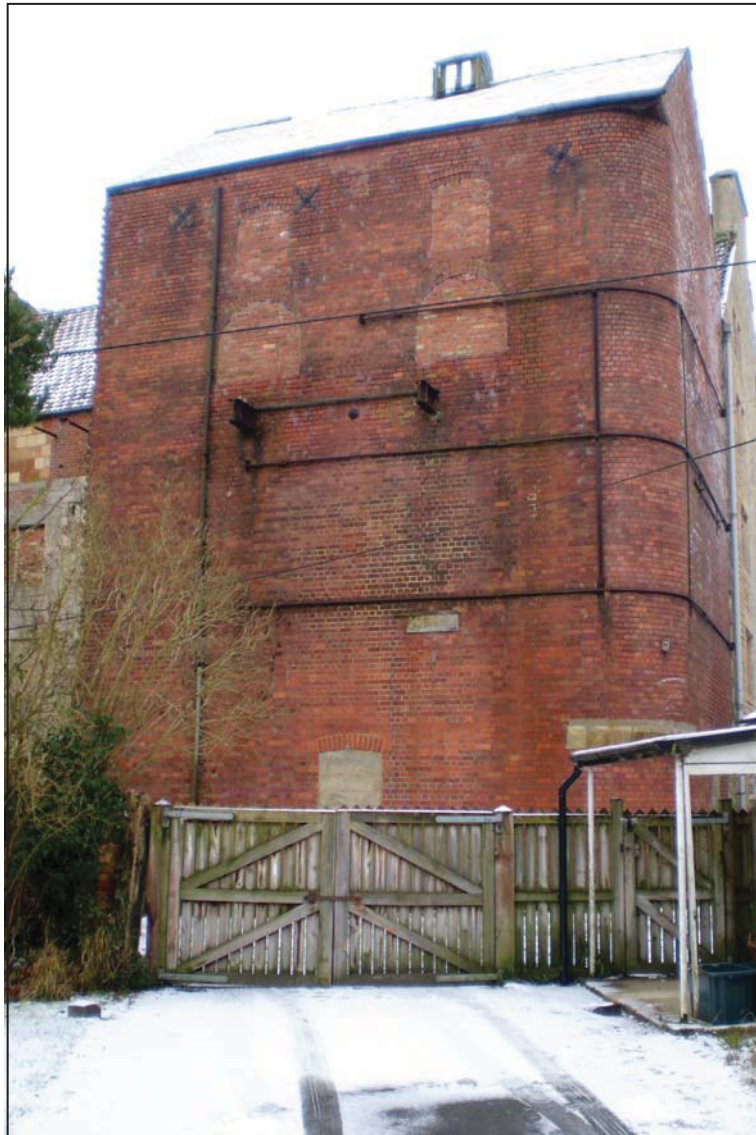
6 Millend Mill Building 2, west face, looking east

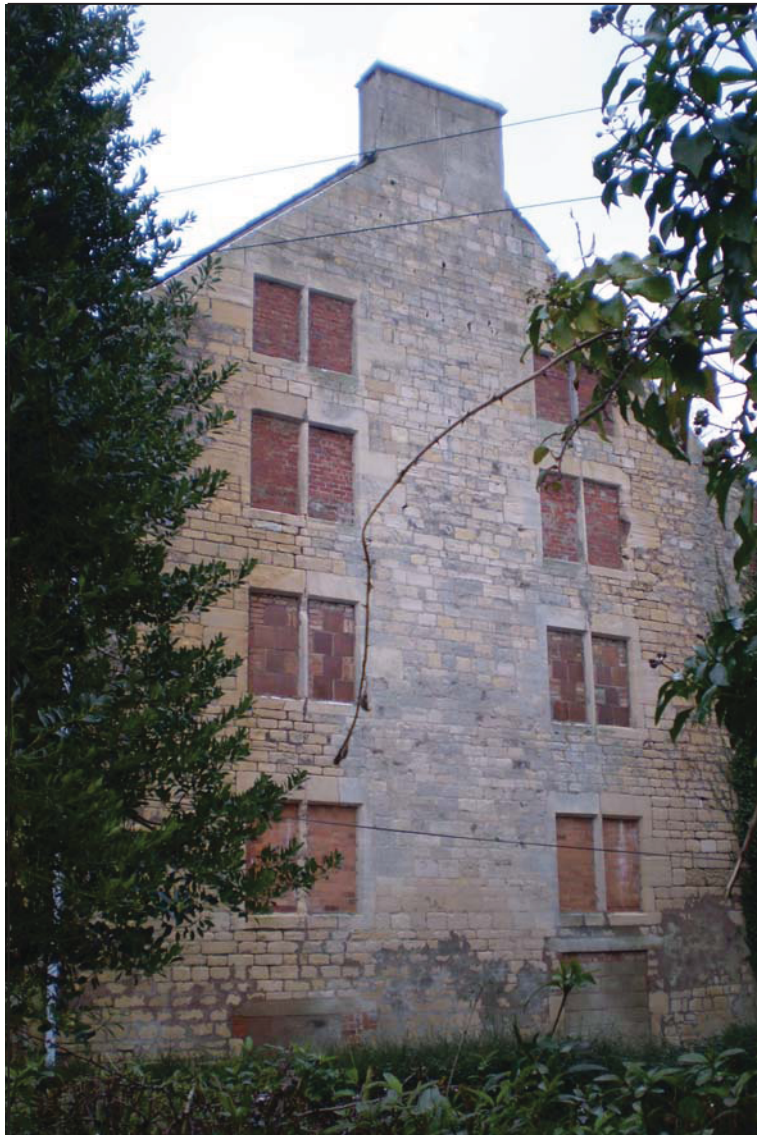
7 Mill Building 1, south face, looking north-north-east

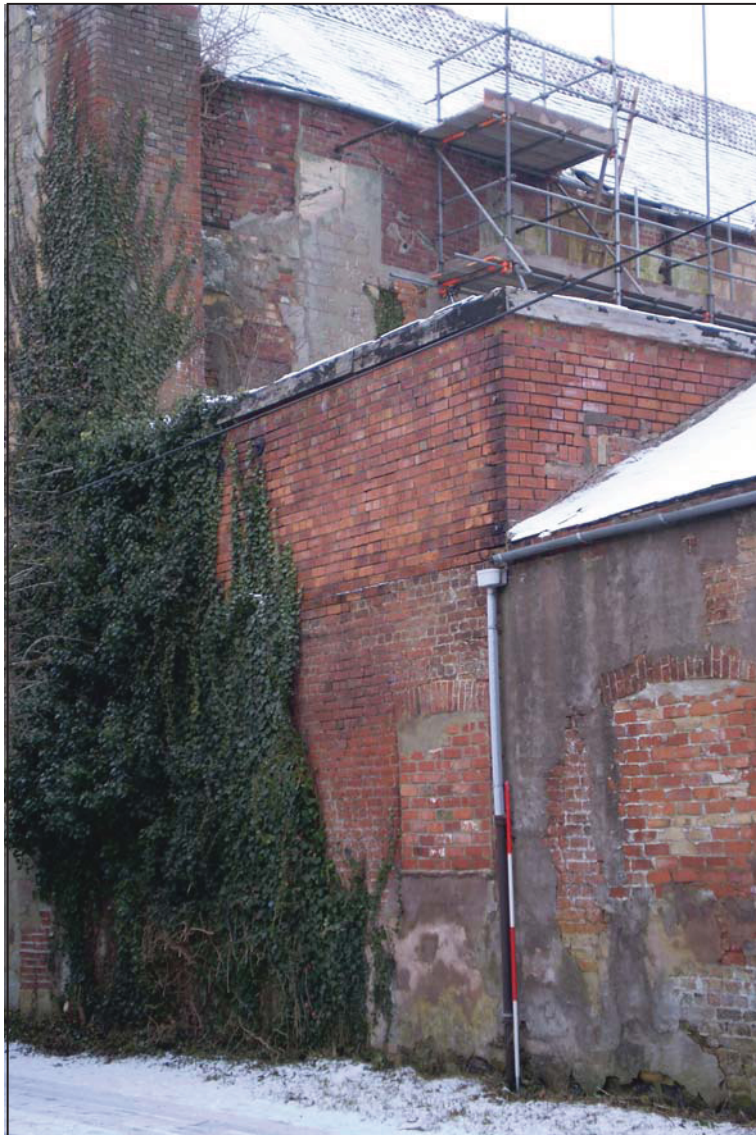
8 Millend Mill Building 3 and east face of Building 1 above, looking north-west. Scale 2m

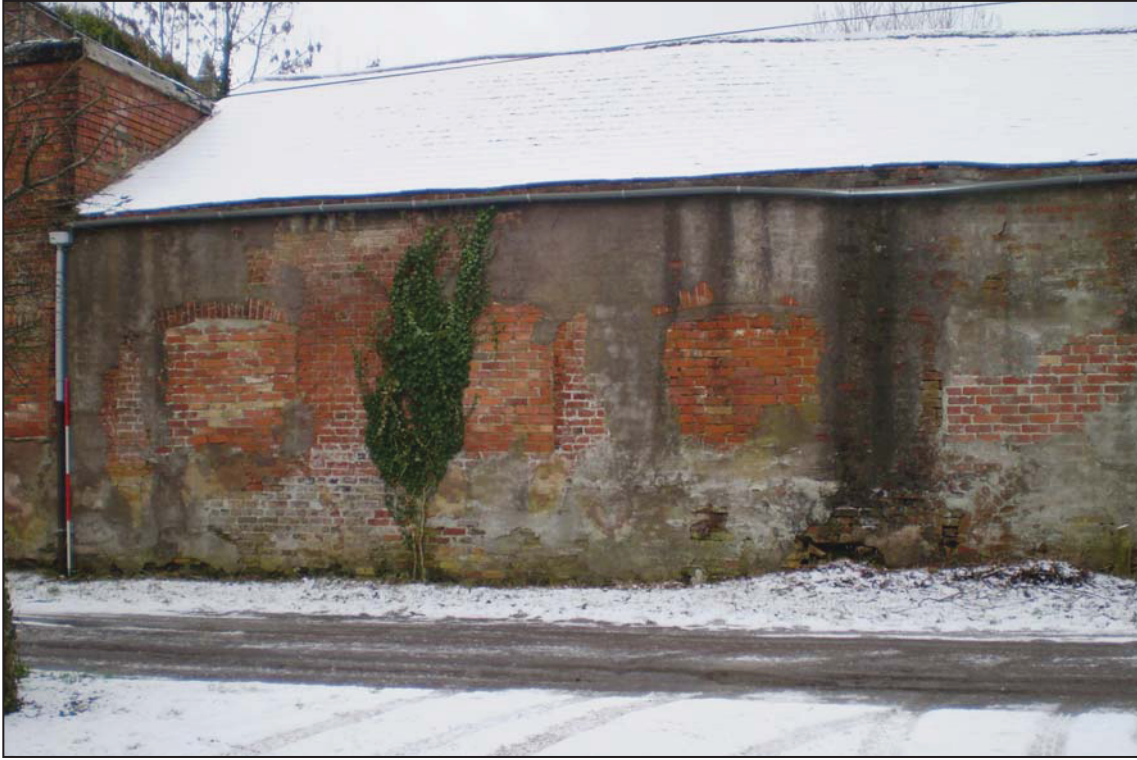
9

<p>9 Millend Mill Building 3, south face, west end, looking north. Scale 2m</p> <p>10 Millend Mill Building 3, north face, looking east-south-east. Scale 2m</p>

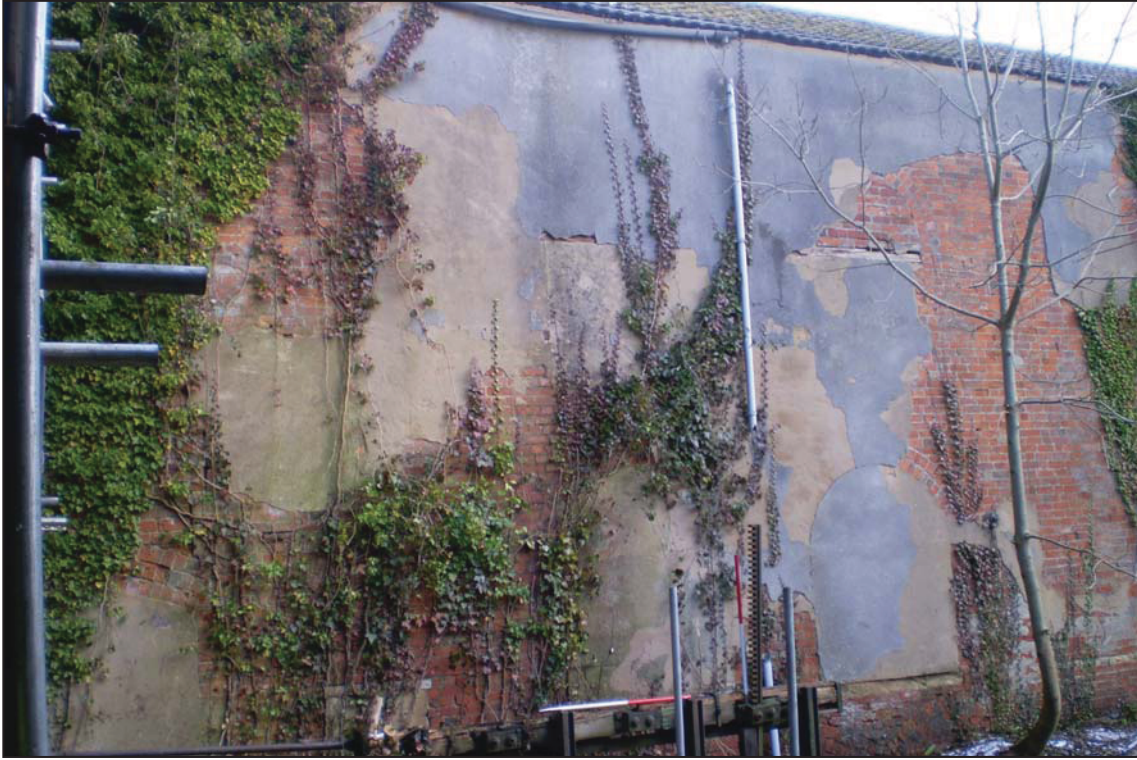
11 Millend Mill Building 4, south face, looking north-north-east. Scale 1m

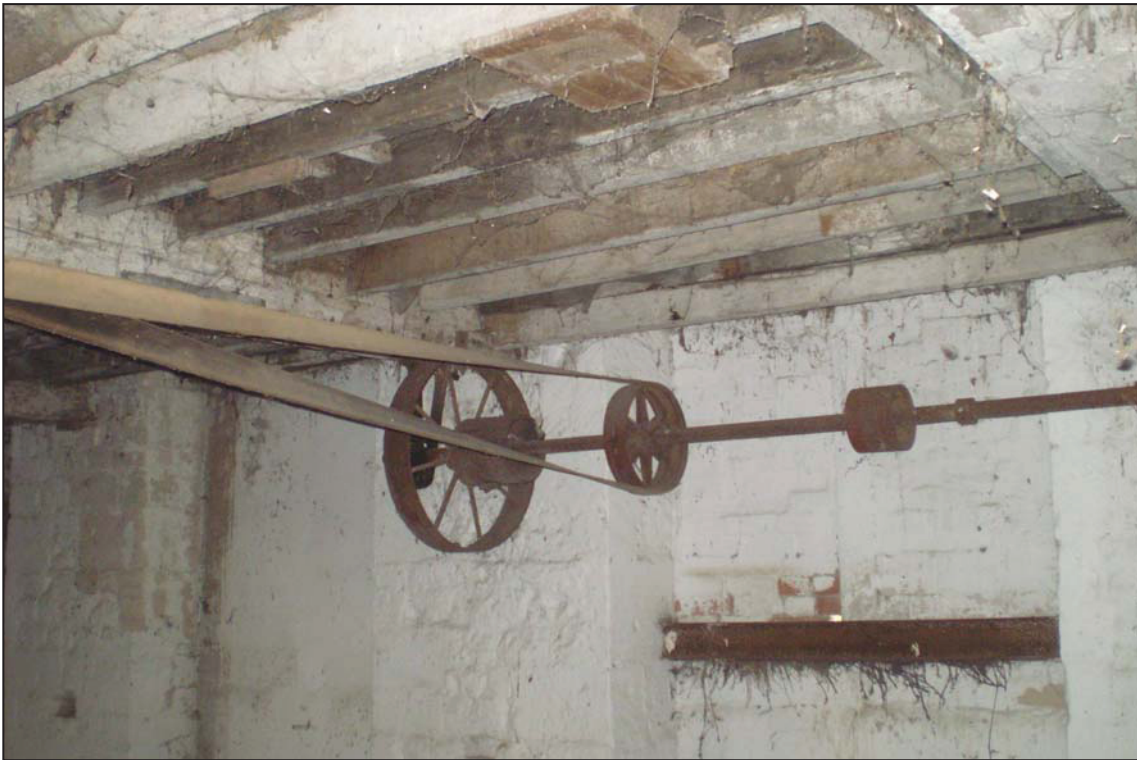
12 Millend Mill Building 1 interior, first floor, looking south-west from stair: belt drive mechanism

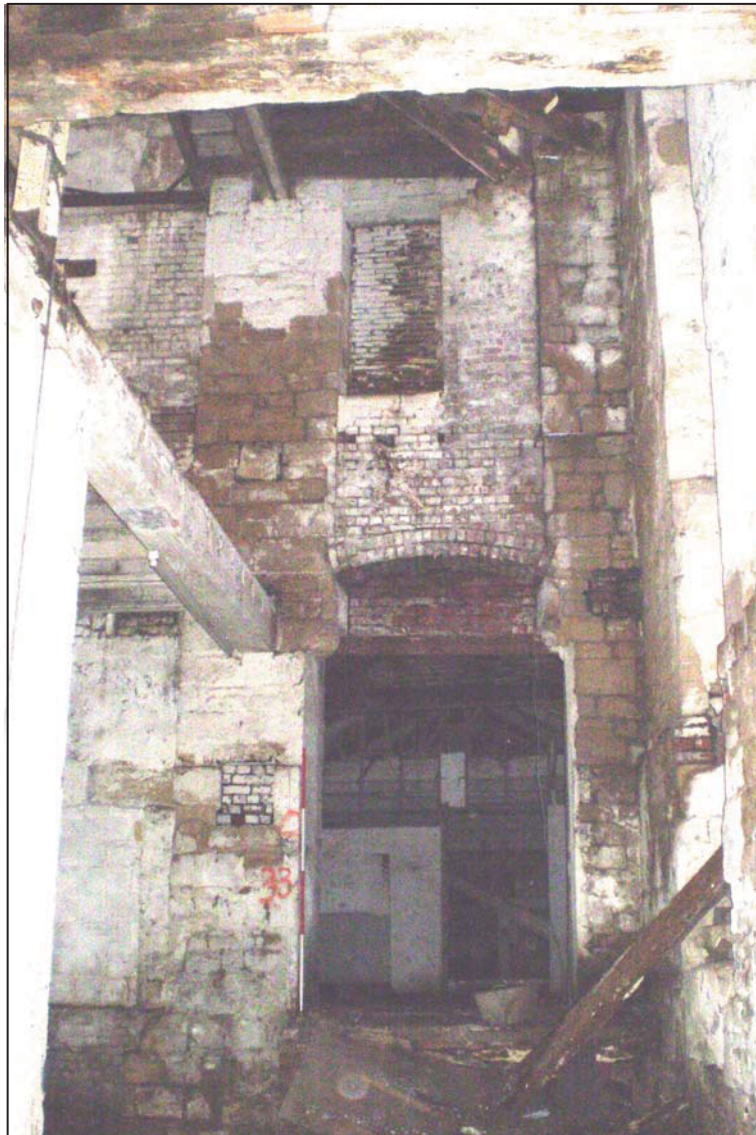
13 Millend Mill Building 1 interior, south end of east elevation, modified for access to Building 3. Scale 2m

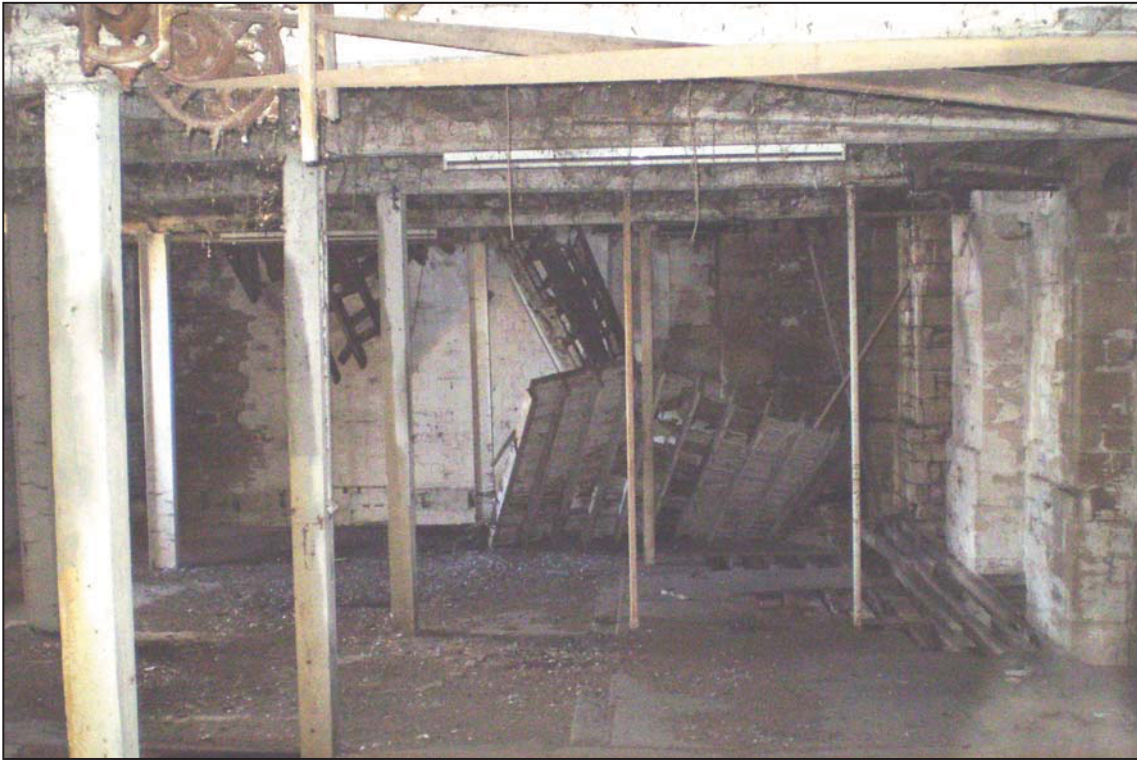
14 Millend Mill Building 1 interior, first floor, looking south from stair

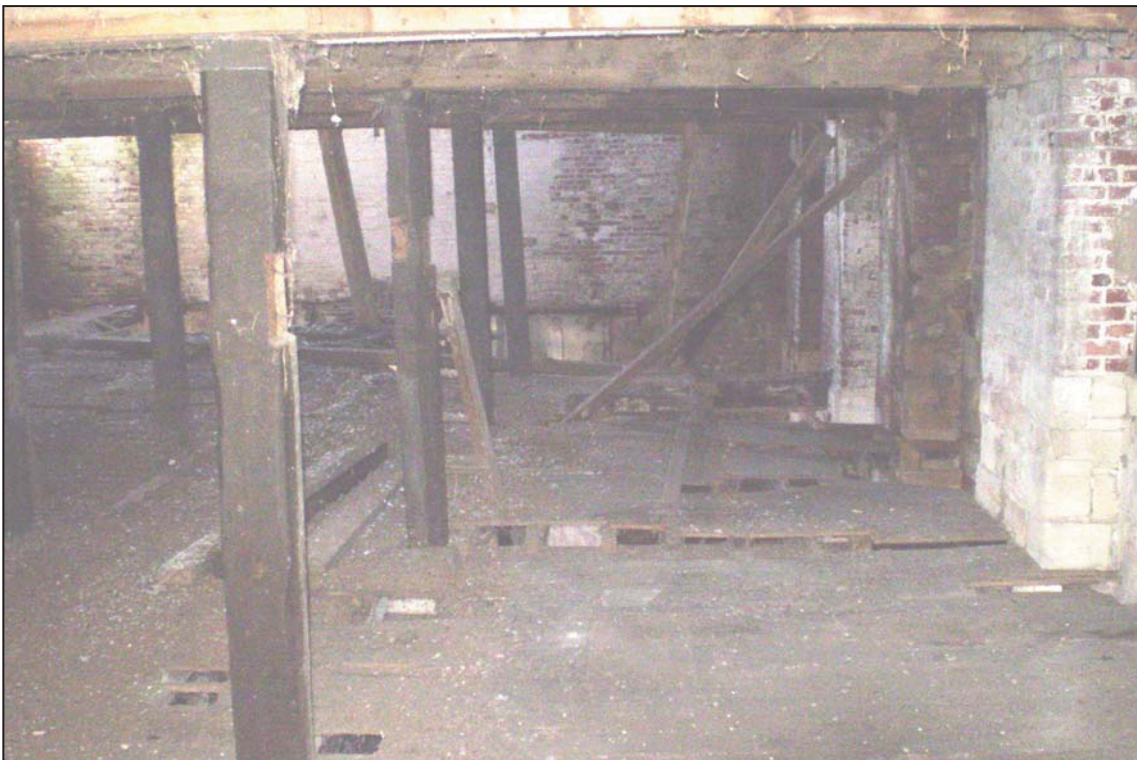
15 Millend Mill Building 1 interior, second floor, looking south from stair

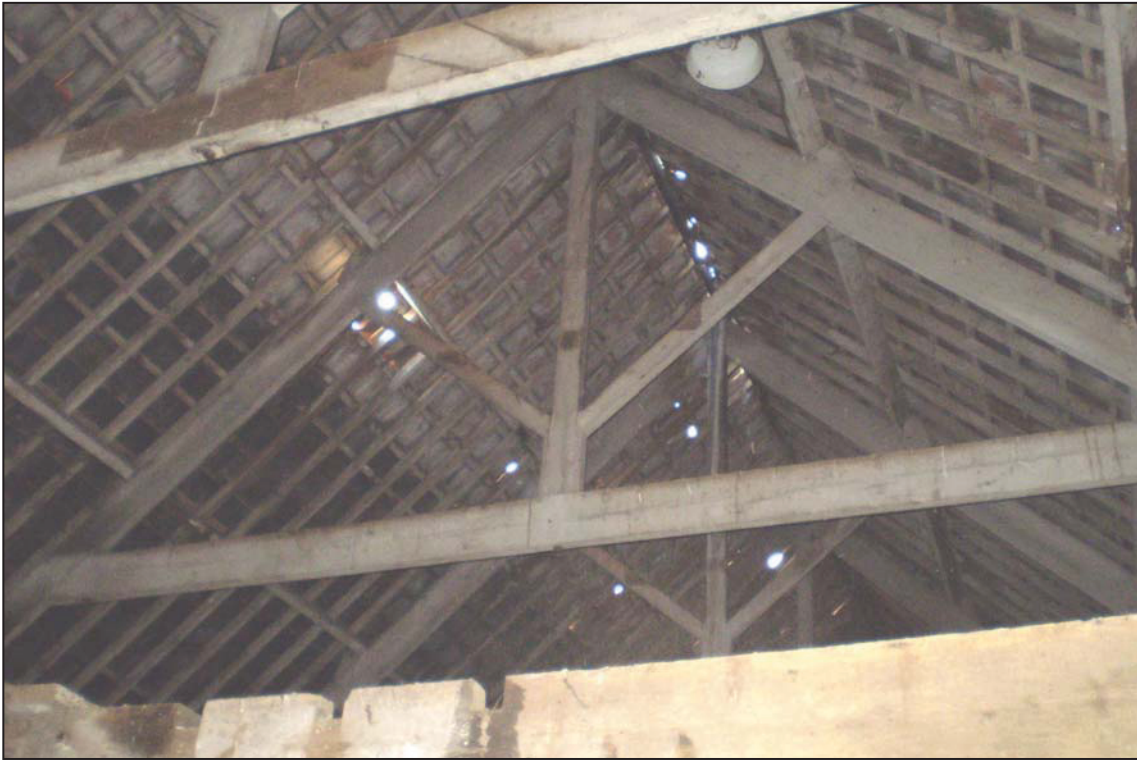
16 Millend Mill Building 1, interior roof timbers, looking up and south-east from stair

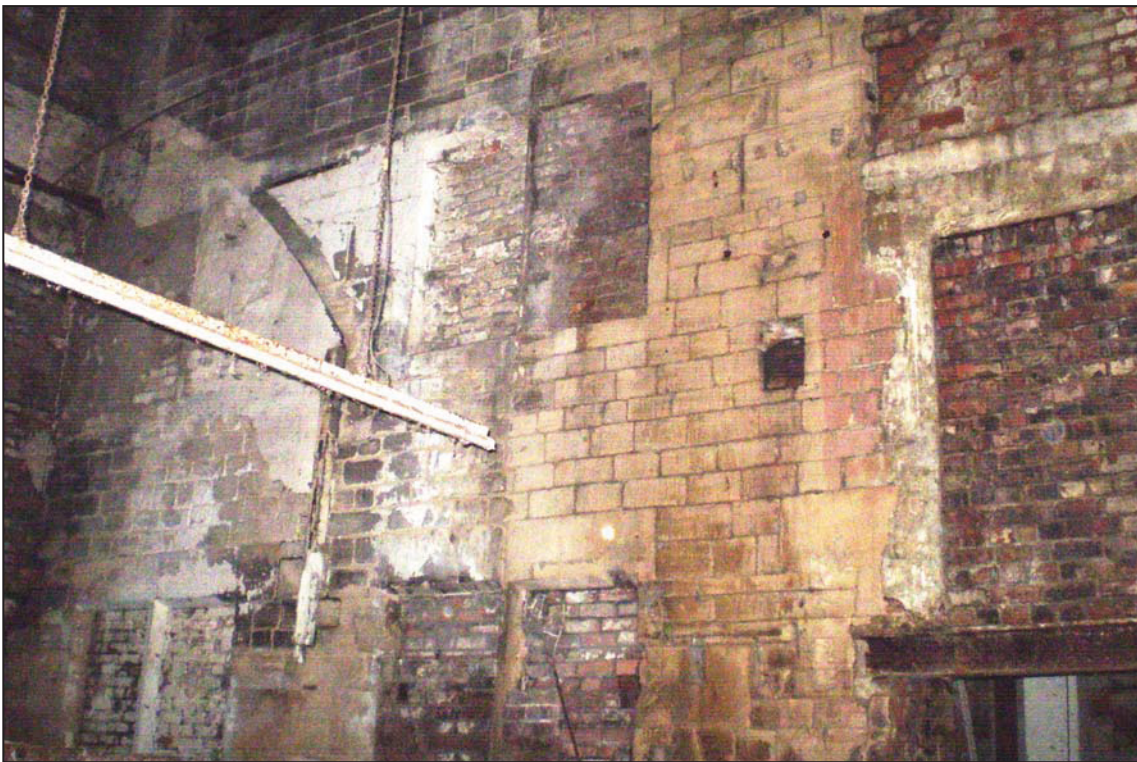
17 Millend Mill Building 1, west wall, forming interior of Building 2. Malting floor and flue scar visible

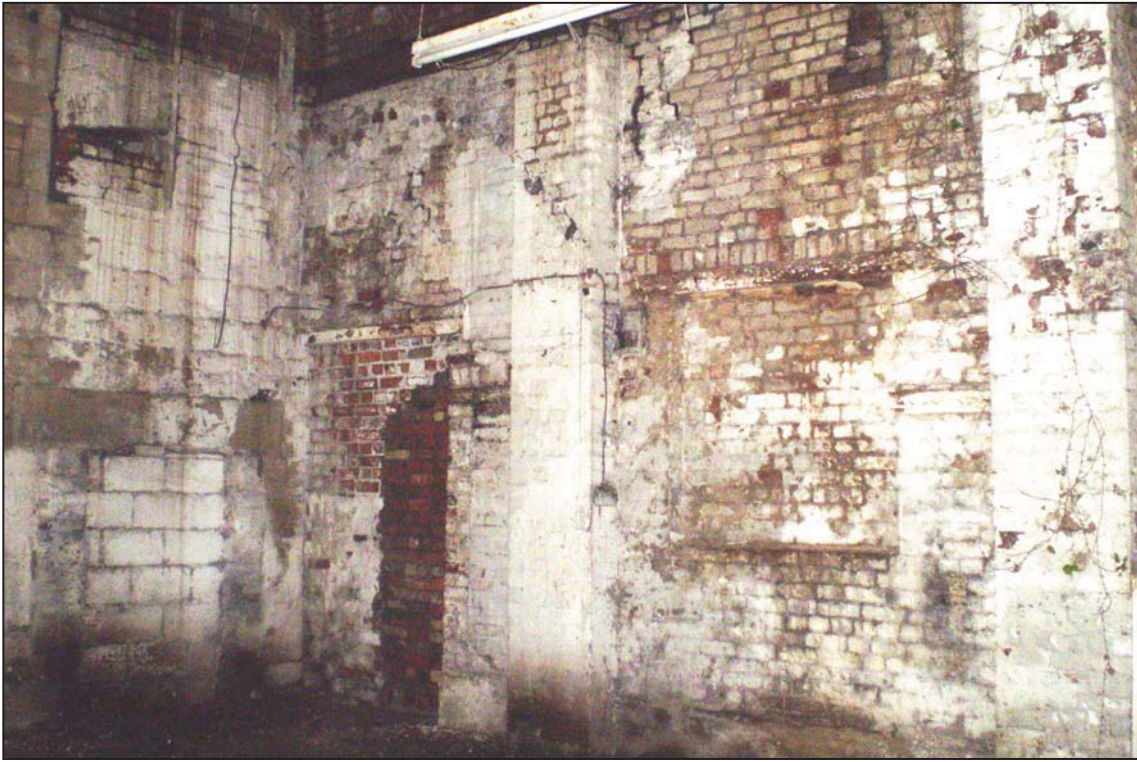
18

<p>18 Millend Mill Building 3 interior, ground floor, north wall looking north-west</p> <p>19 Millend Mill Building 3 interior, general view looking east</p>

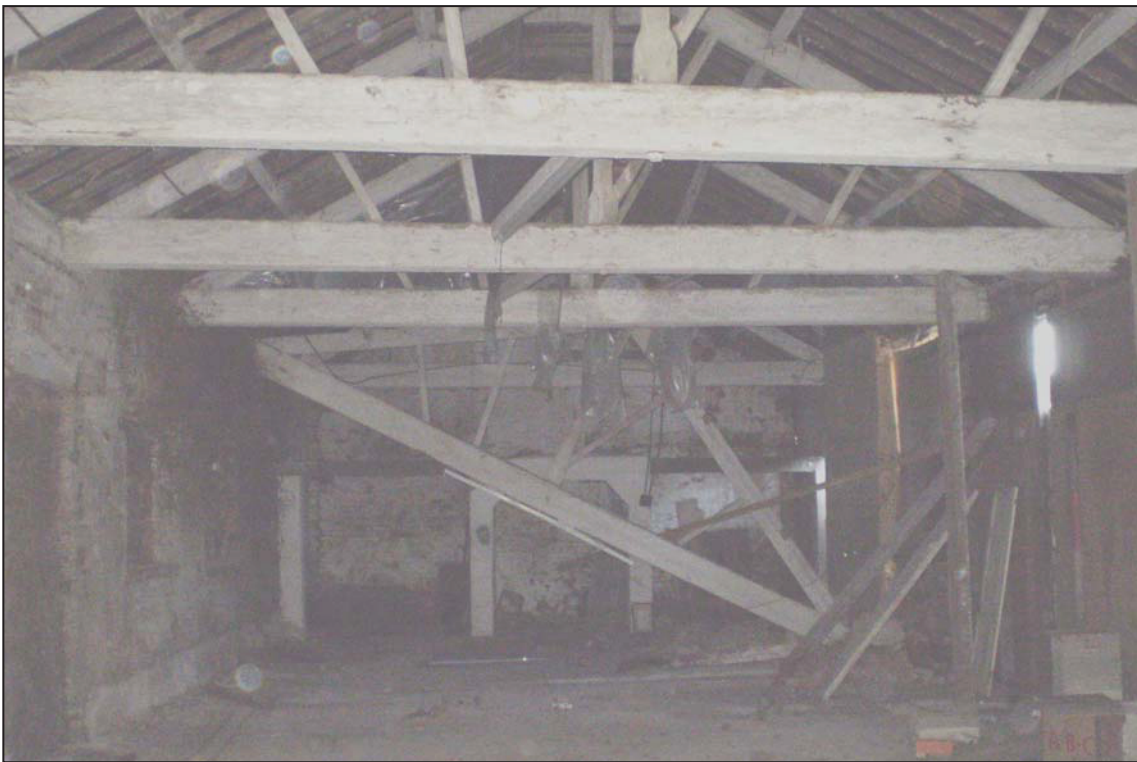
19

- 3.2 The brick tank and culvert at the south end of Building 3 are aligned on that building, but their neat relationship to the south gable, which Morriss points out is the result of a late truncation (between 1884 and 1923 on map evidence), might suggest that they are part of the above-ground brick and concrete structures, possibly for holding some kind of tank, which, until the recent works, occupied this end of the building (Fig. 19).

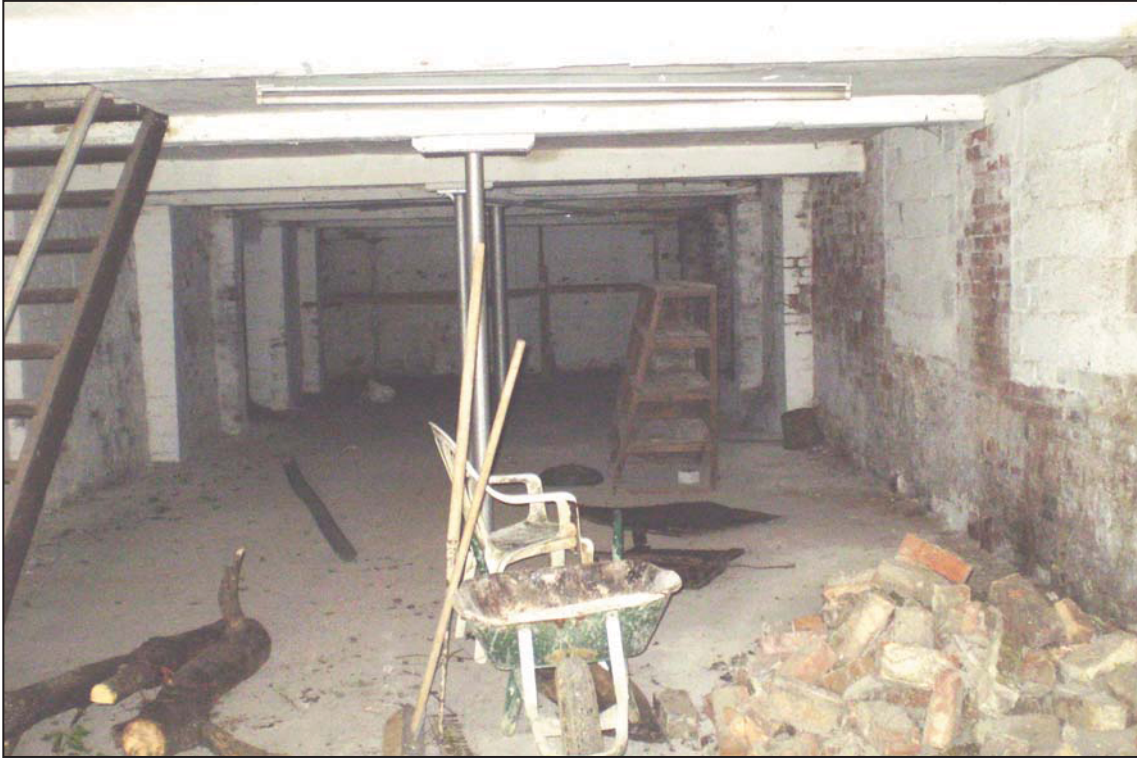
20 Millend Mill Building 4 interior, ground floor, general view looking east

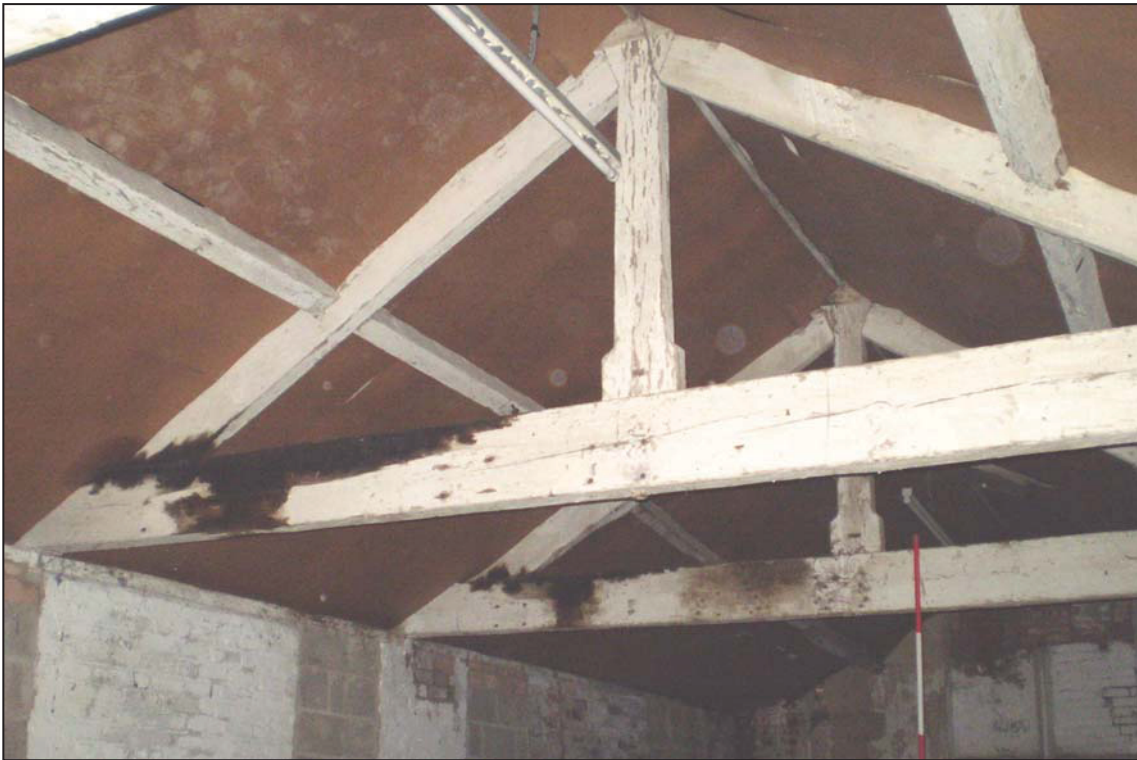
- 2.7 Building 4 is a three-storey building and on these grounds identified by Morriss as the “three-storey air house” of the 1872 sales (Morriss 1998, 25). The relationship of the elevation openings (all blocked) and the floors suggests there has been a re-ordering and possibly addition of floors, but there is no reason to suppose that this post-dated 1872. The roof appears of a typical later 18th to mid 19th-century design

21 Millend Mill Building 4 interior, roof trusses and west end second floor, looking south-south-west. Scale 1m

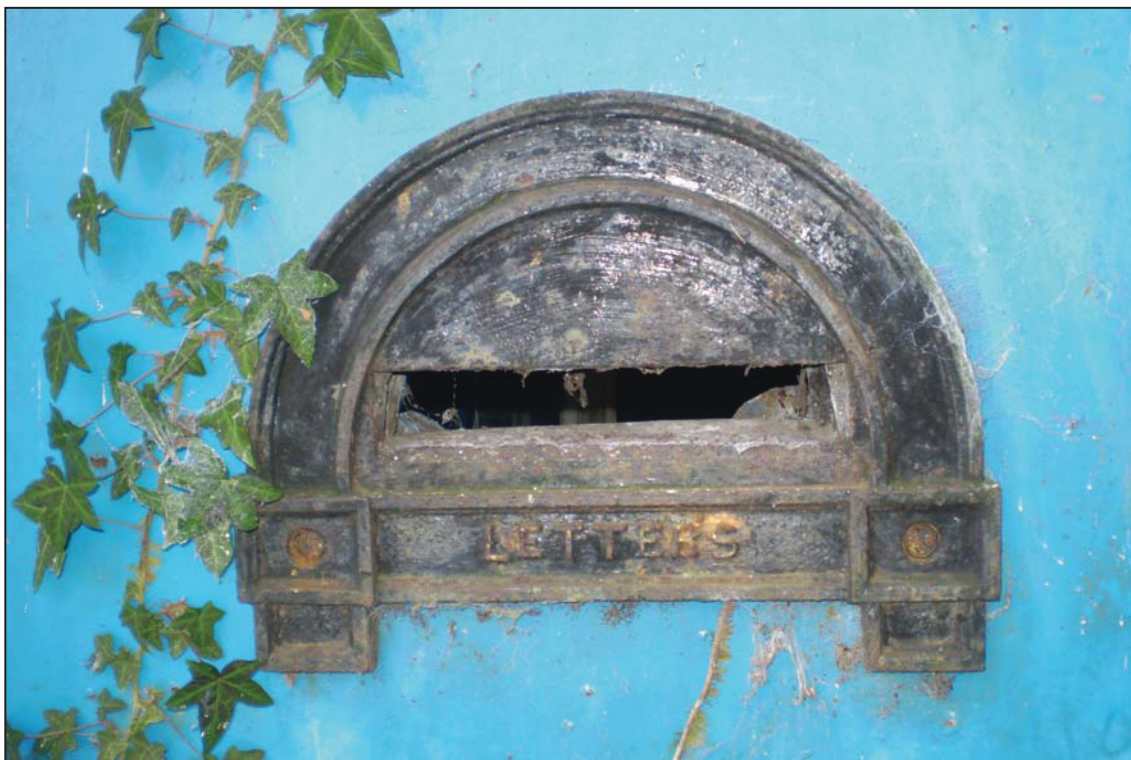
- 2.8 Few or no smaller items from the early phases of the mill survive. One that that was observed during the January visit was a cast-iron letter box which stylistically was of early 19th-century date, and which had been set in the modern door of Building 5 (Fig. 22).

22 Millend Mill Building 5, probable 1818 letterbox in 20th century door

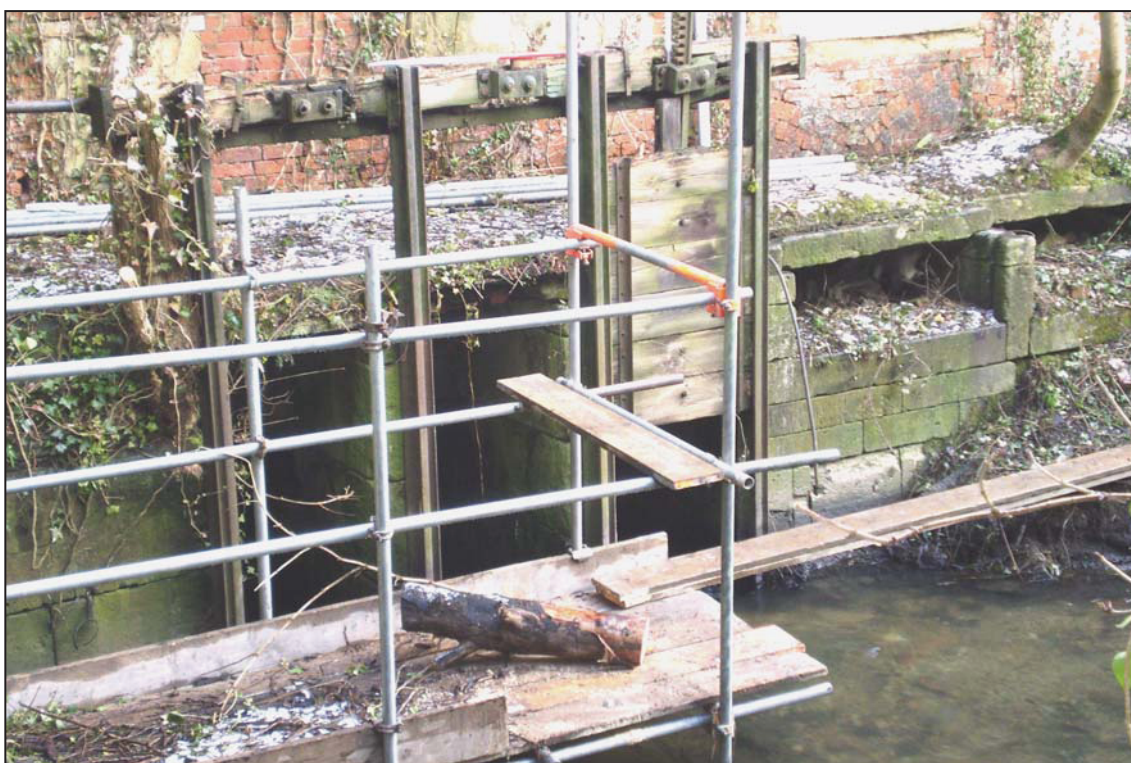
23 Millend Mill sluice and overflow channels under south side of Building 4, looking north-east

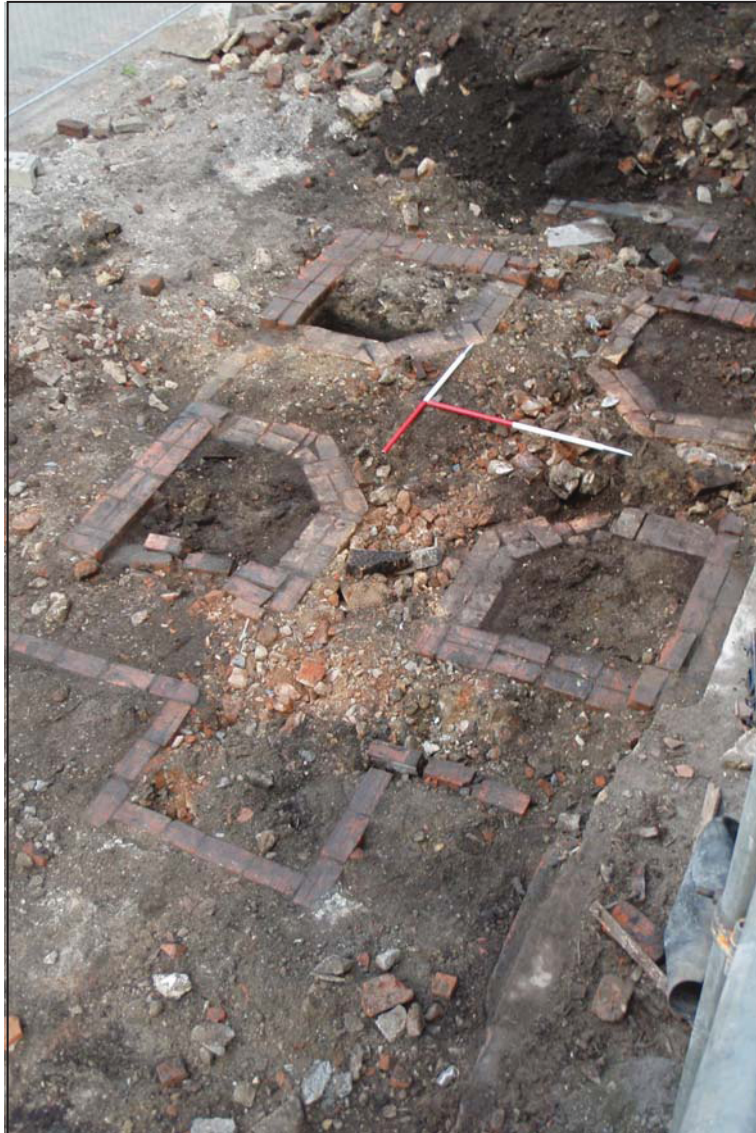
- 2.12 The foundations of a brick-built malting kiln base, 1025, were revealed at a depth of 0.3m BPGL on the site of Building 2 (Figs 24 and 25). It measured 5.6m in length and 3.5m in width and survived to a height of at least 0.6m, although it was not revealed in its entirety during the groundworks. The structure was broadly symmetrical and was set in the centre of Building 2. It consisted of a single brick-thickness square outer wall with quadrant corners surviving on the north-west and south-east. The east and west sides each had a central rectangular alcove projecting to the exterior. The south side was obscured by the concrete floor that was not removed here. Within the outer wall, separated from it by a narrow passage or duct, was a double brick thickness wall with two cross passages or ducts. These met at the centre and the corners were chamfered to form an octagonal space. In the corners of the square, between the ducts, were four hollow pier or flue bases (Fig. 25 and 26). These were constructed of a yellow 'fire' brick. The walls were all bonded with black ash mortar. The two types of malting kiln floor bricks used as blocking in the stair tower in Building 1 (Fig. 27) are more than likely from this kiln. A black ash deposit 1026, containing kiln brick and cereal grain, was revealed filling the four alcove structures. Partially burnt grain present in 1026 was identified as barley, likely to represent waste from the malting process. This was covered by a rubble layer 1024, 0.1m thick, which was overlain by a flagstone floor 1023, 0.2m thick. This was covered by a concrete slab 1022, 0.2m thick.

25 The malting kiln foundations seen from the scaffolding on the north side of Building 1, after the demolition of Building 2, looking north-east. Scales 1m

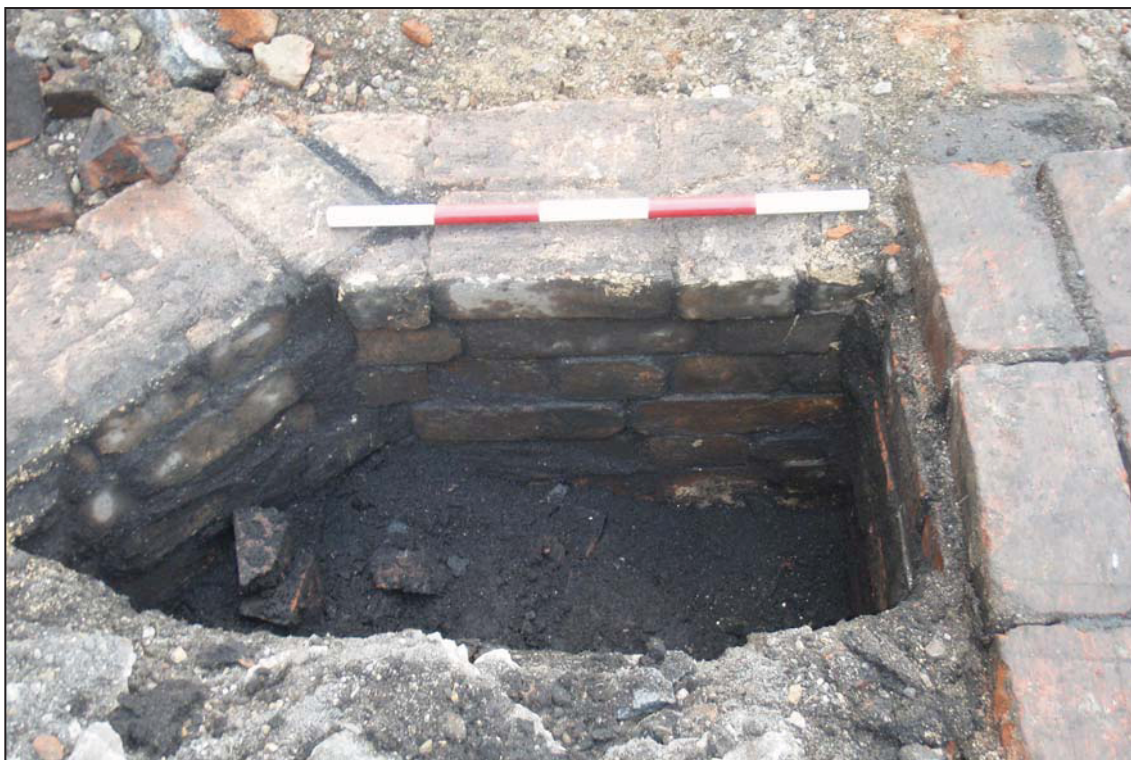
26 Detail of the interior of one of the corner structures of the malting kiln base, looking west, scale 0.5m

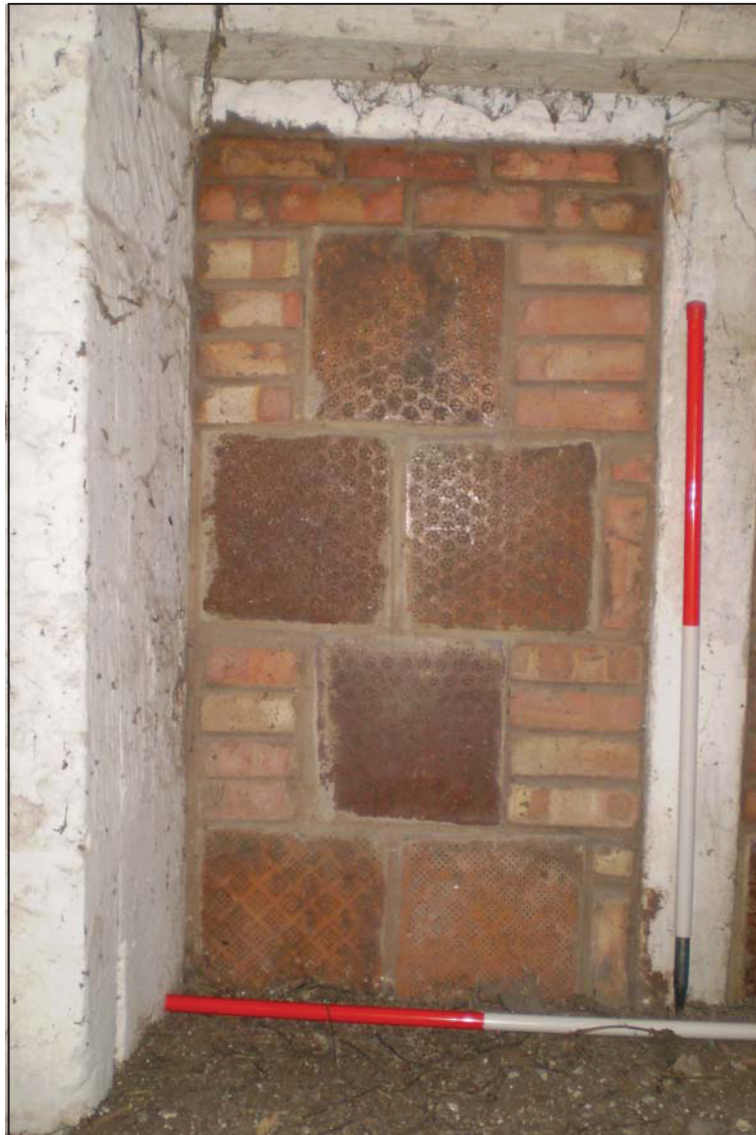
- 2.10 The windows in Building 1 are mostly blocked up with bricks. The majority of these are the perforated bricks from the malting floor of Building 2, which originally sat on the steel grill floor frame still *in situ* at the time of the recording visits (others are fire bricks and others still are modern fletton commons, suggesting that all this blocking occurred after the demolition of the interior of the maltings). These were of two kinds, both about 0.30m square. One kind was perforated with patterns of eight holes arranged in a rosette pattern, and the rosettes set in staggered rows of ten. These bricks were glazed with a thin dark red-brown glaze. The second type was unglazed and the perforations were arranged in squares of 16 holes, the squares arranged in a diaper pattern (Fig. 27).

27 Two types of malting kiln floor bricks used to block windows in the stair tower in Building 1. Scales 1m
