The Templar Lodge Hotel,  
Gullane,  
East Lothian.

**April-May 2011**

**Carried out on behalf of Lorn MacNeal Architects**

connolly • heritage • consultancy

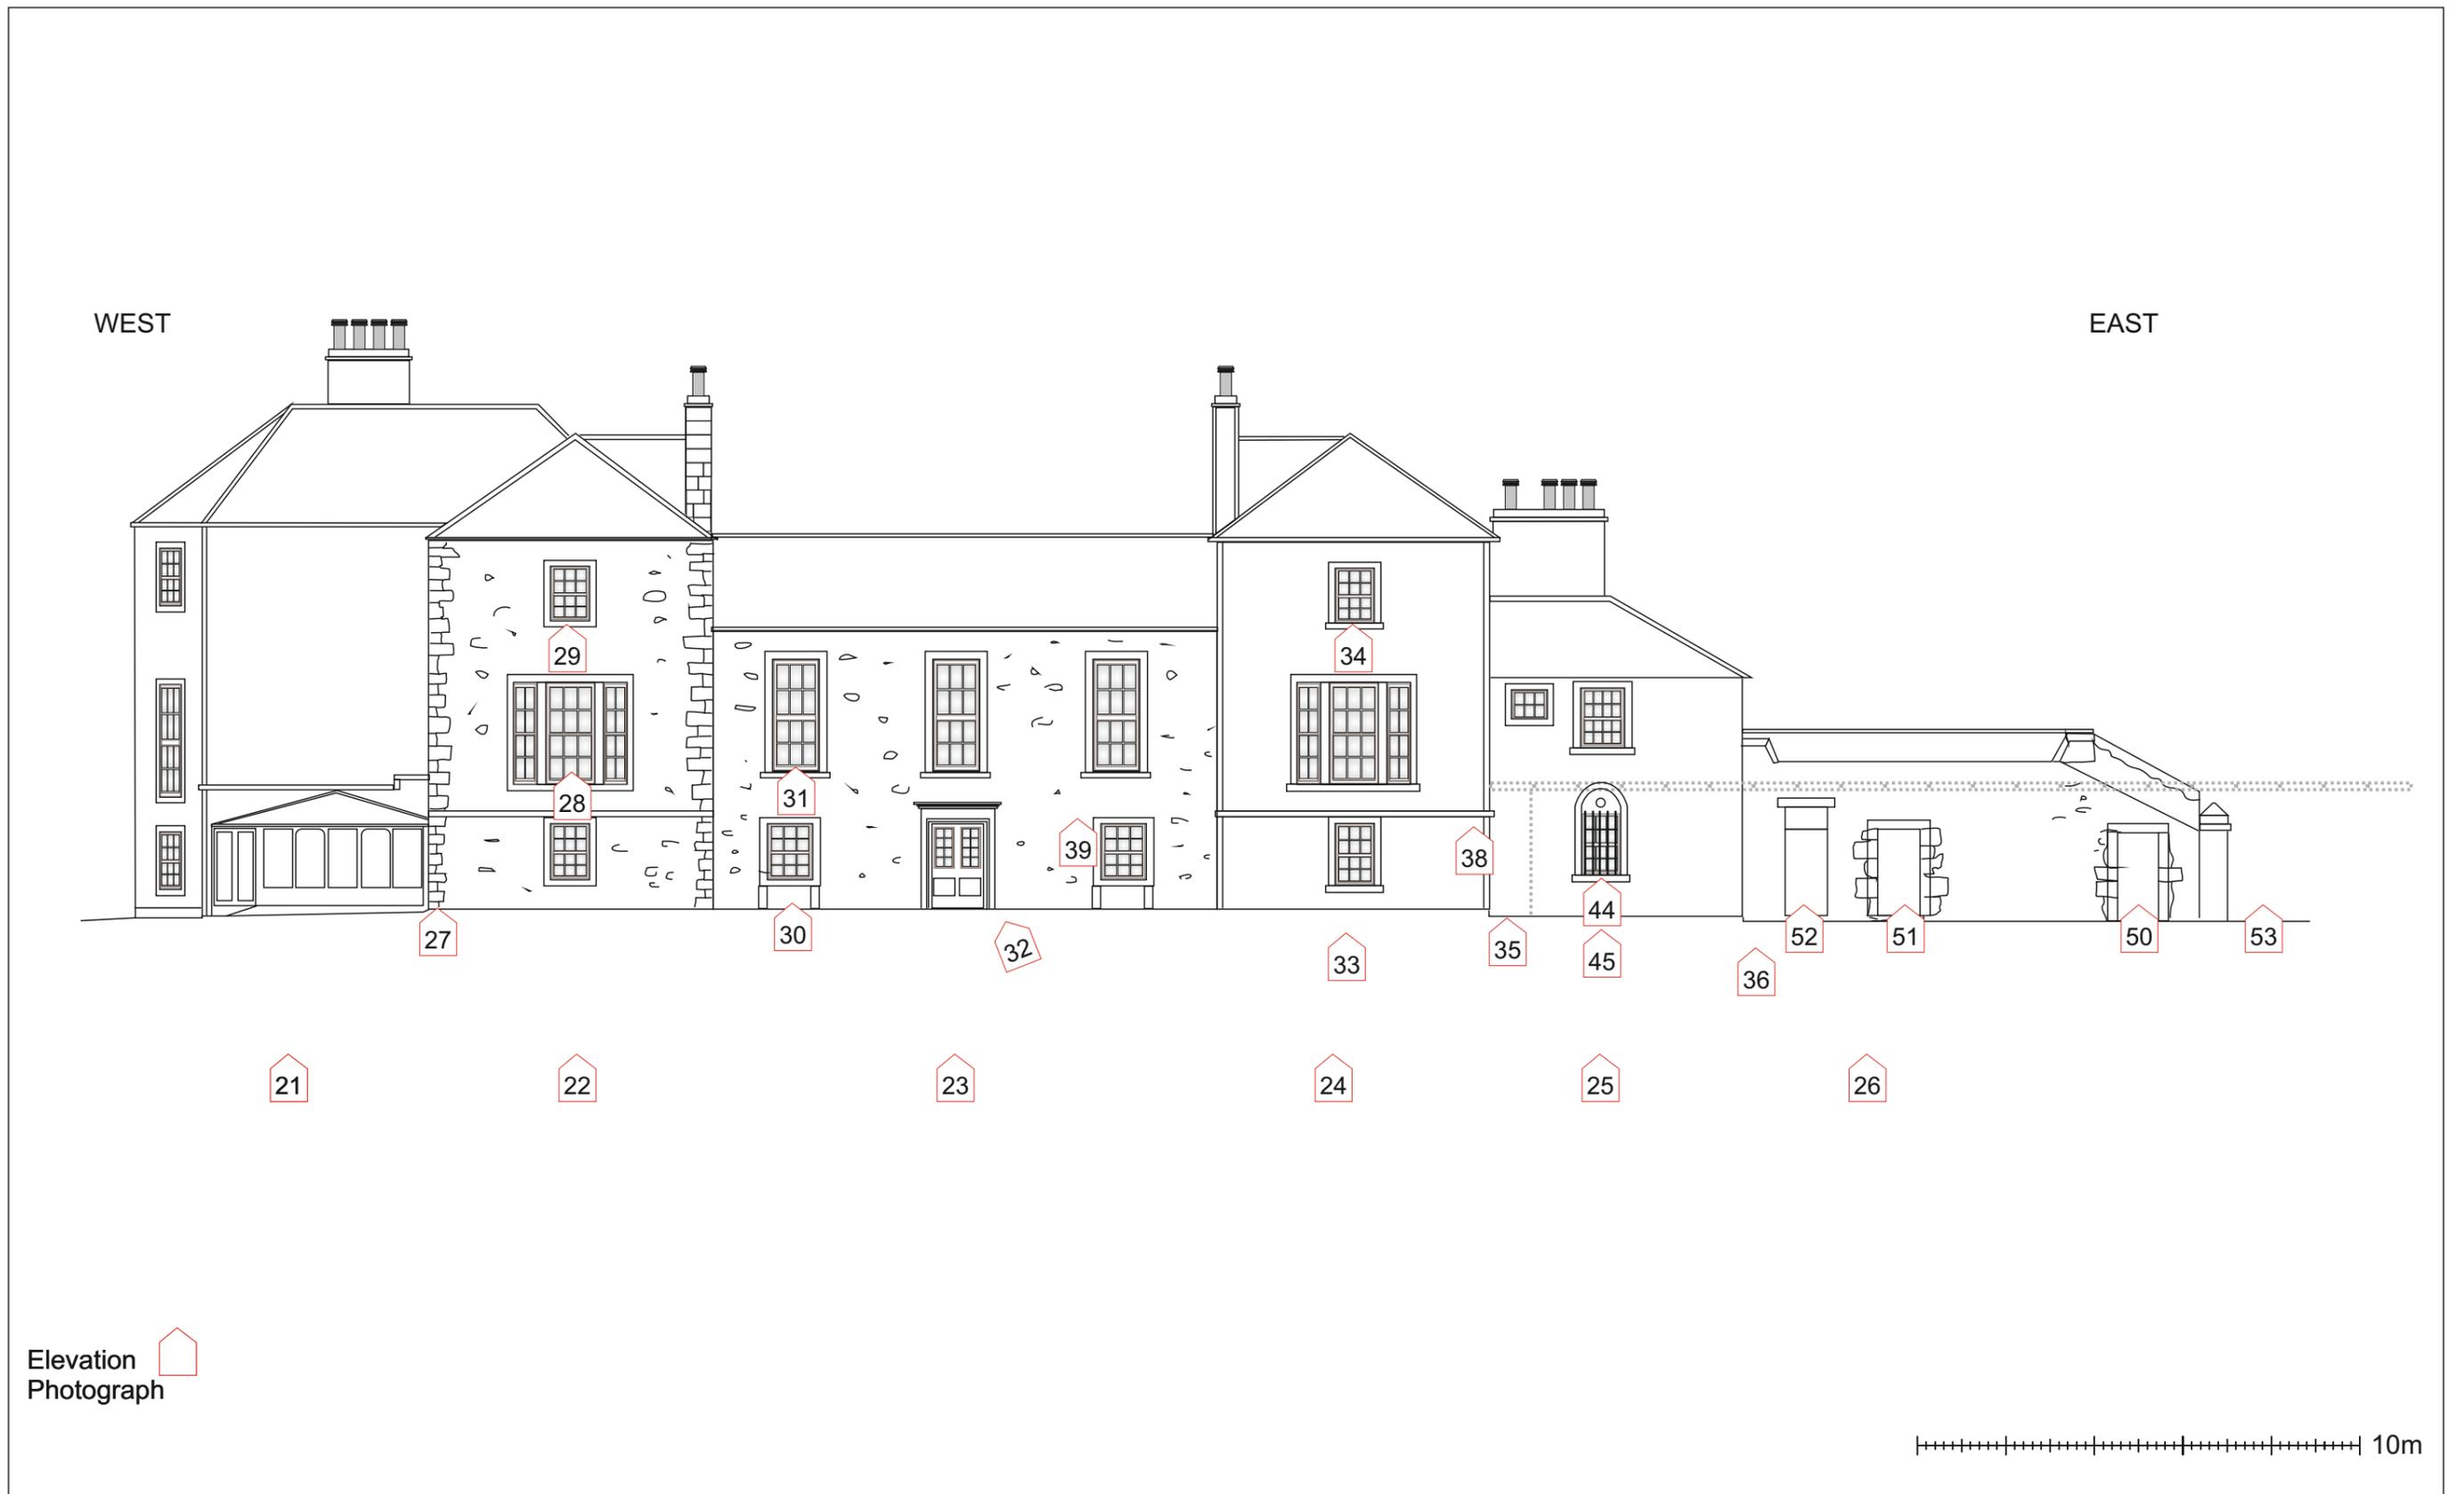
Figure 3: South facing elevation

5.2.1 The exterior does not provide much to explain the complex evolution of the structure, the whitewash and harl obscuring most constructional details. It is clear however, that the left pavilion with it's in-out quoins is the original structure built on the site in the mid 18<sup>th</sup> century. The rear and right pavilion follow and it is then that refenestration is conducted across the building.

5.2.2 The right pavilion has a simple raised margin however it has continued with a first floor string course that is also present on the earlier structure. Remaining windows do point to the original structure having a series of 2 bays on the west elevation and the door being in the east elevation with the doorway now incorporated in the centre of the principal elevation.

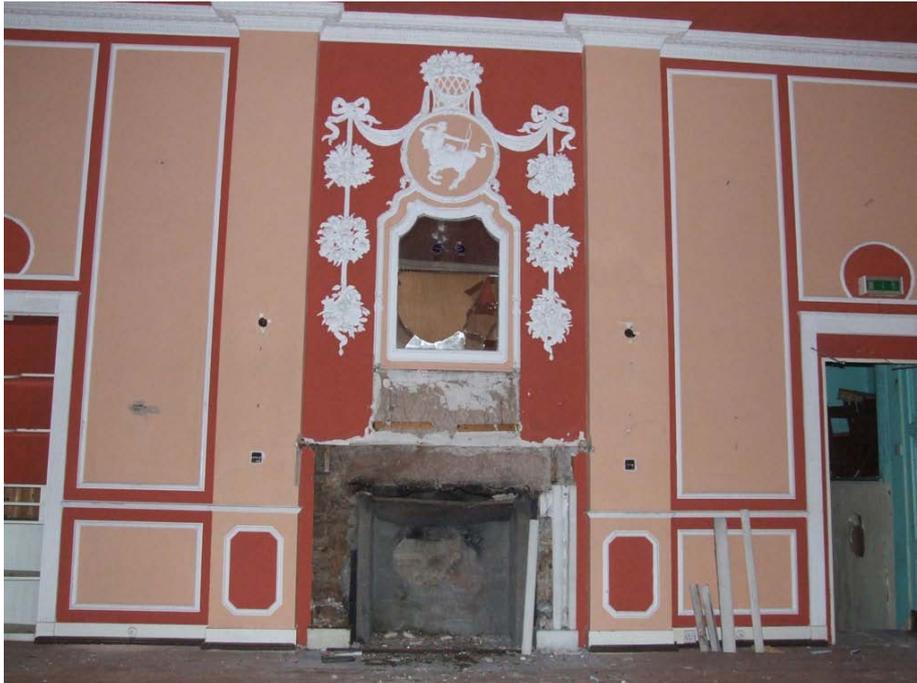
### 5.2.21 **Structure 5 Room 13 / West Hall (see image below)**

Elegantly proportioned Georgian extension with later plasterwork and white marble fireplace (removed). Canted bay to west with 3 x 6/6 sash and case windows to full height. Doorway to the north elevation leads downstairs into the later 60s extension. However, this was originally an alcove. Entrance was by a single doorway in the southeast corner. Entrance by a single doorway in the southeast corner.

- 6.7 Sympathetic retention of this main structure will enhance the area again – the interior has nothing left to retain except the mid 19<sup>th</sup> century or later plasterwork in the canted bay structure.

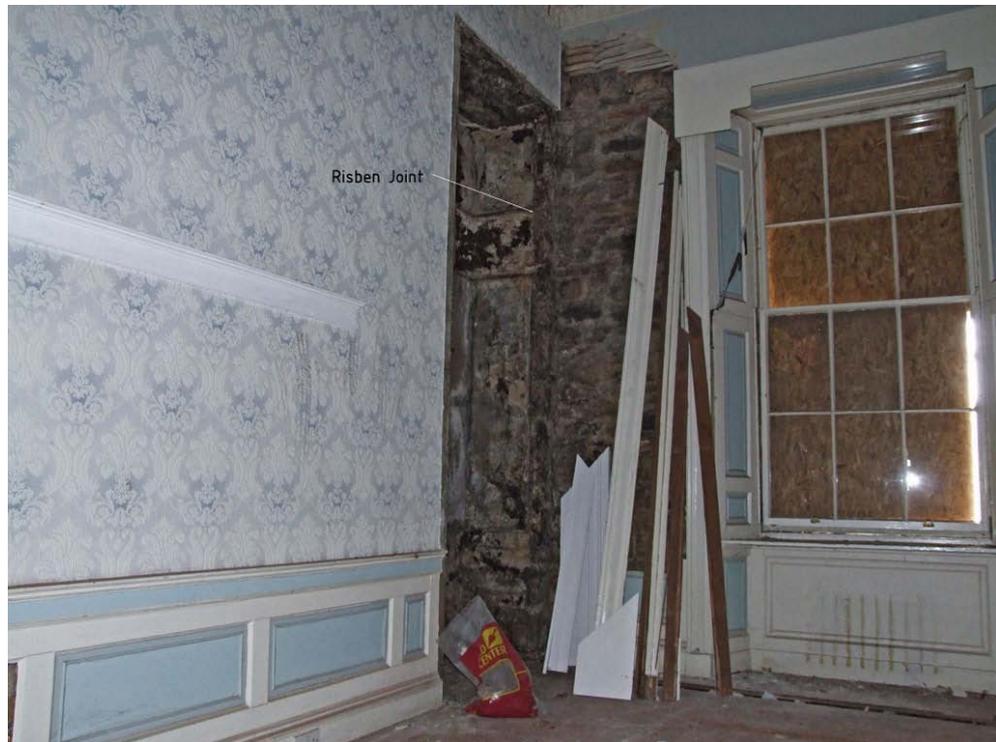
### 5.2.25 **Structure 7 / Room 16 / Mid Hall (see image below)**

60mm floorboards. Fireplace in west elevation and blocked fireplace in east elevation. Tall cupboards and press in the southeast corner. Shows risben joint between north south wall and east west façade. (See photo 99). Two doors in north elevation with large Georgian surrounds. South elevation contains three window bays with large 6/6 sash and case. Acanthus leaf cornice.

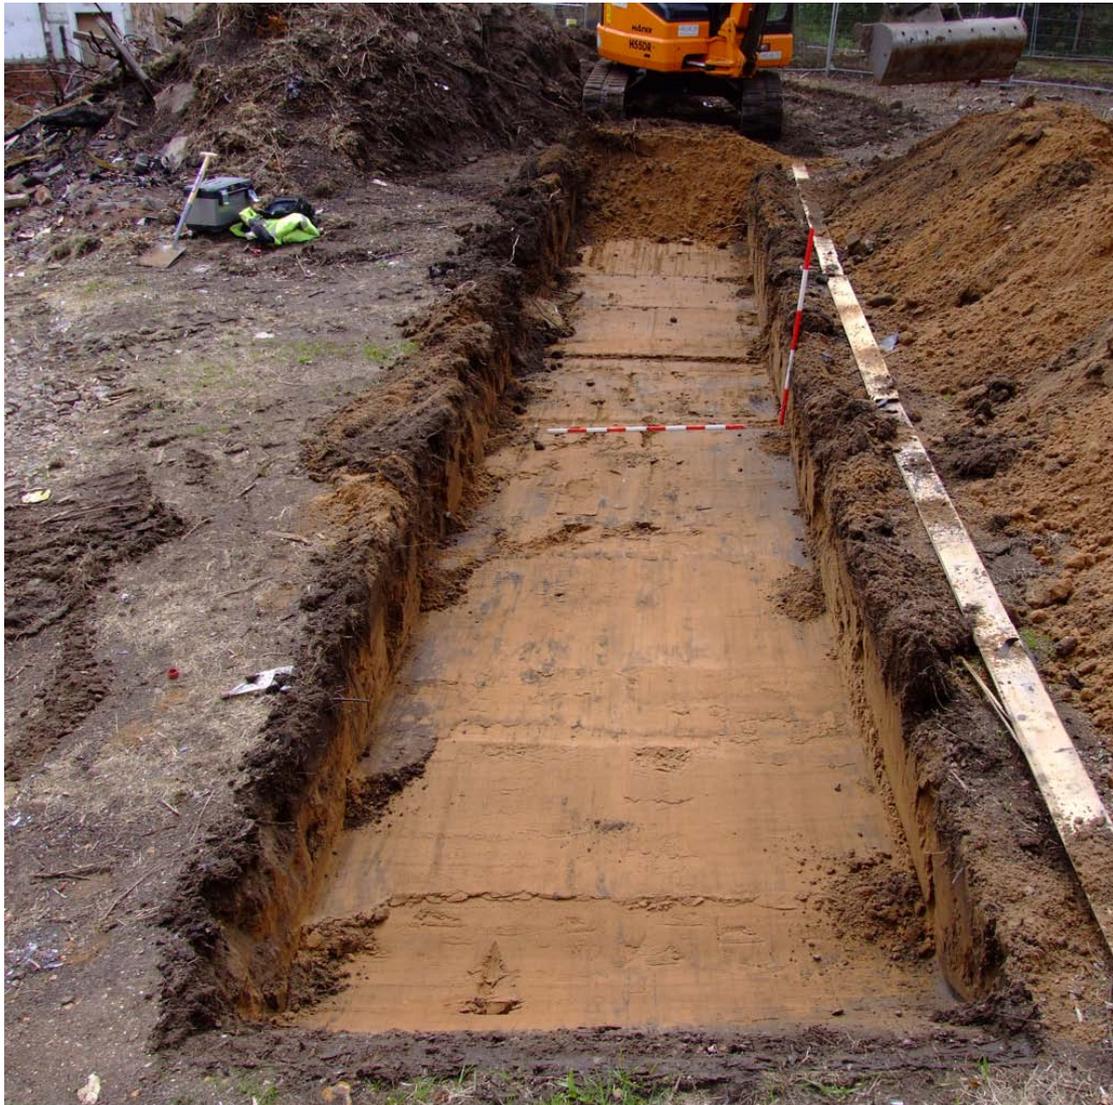
5.3.1.1. A dirty mixed dark brown silty sand topsoil [1001], circa 200mm deep was removed onto a clean yellow sand [1002].

5.3.1.2. A sondage through the sand confirmed the sand was natural.

PLATE 1: TRENCH 1 TO SOUTHWEST SHOWING CLEAN SAND LAYER [1002]

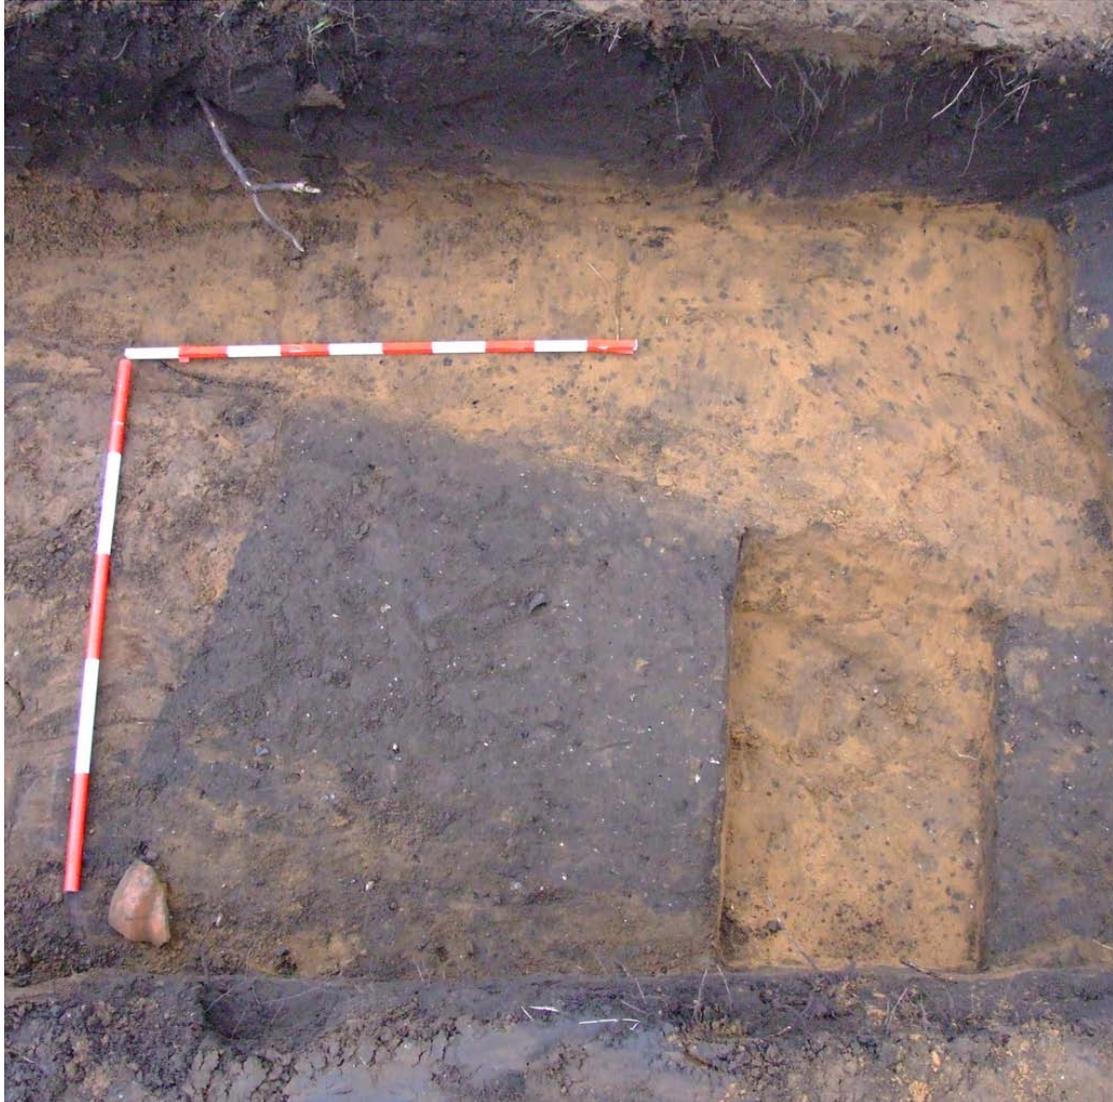
- 5.3.3.1. A mixed dark brown silty sand topsoil [3001], circa 400mm deep was removed onto a clean yellow sand [3004].
- 5.3.3.2. A series of intercutting linear features [3002 & 3003] were recorded (see plate 2) which seemed to represent disused service trenches.

PLATE 2: LINEAR FEATURE [3002] WITH SECTION REMOVED TO EXPOSE SHALLOW FLAT BASED CUT WITH FEATURE [3003] TO LEFT.

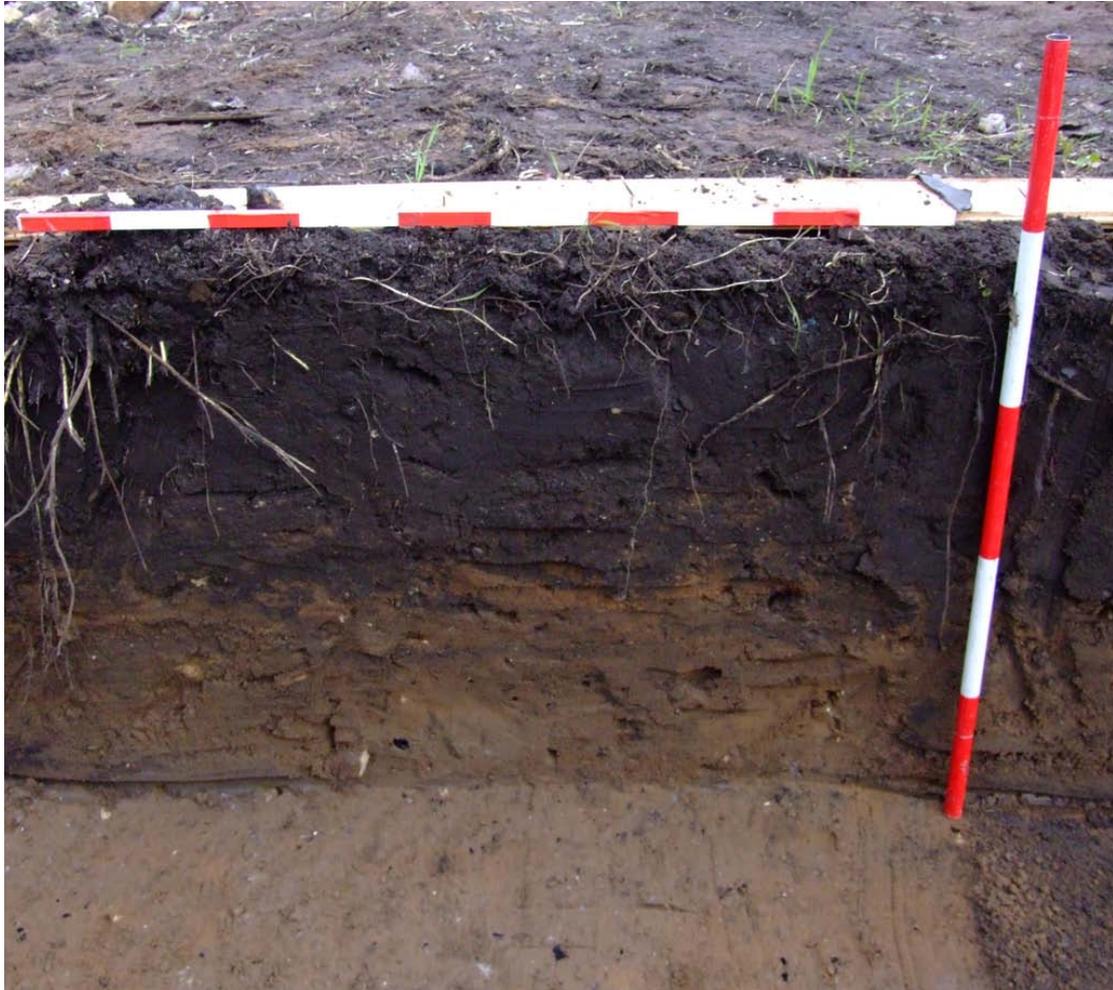
- 5.3.4.1. A dark brown silty sand topsoil [4001], circa 350mm deep was removed onto a dirty sand with frequent inclusions of mortar, coal and stone chips [4003].

PLATE 3: DEEP LAYER OF GARDEN SOIL (350MM) OVER THE DIRTY SAND WITH INCLUSIONS OF CONSTRUCTIONAL DEBRIS. [4003]. THE LAYER AT BASE OF SECTION SHOWS LAYER [4004]

- 5.3.4.2. Within the layer [4003] were remnants of more substantial sandstone fragments and mortar [4002] – initially suspected to be a wall before resolving into a random spread of dump. The stone fragments were up to 250mm in size of angular buff sandstone. In addition to the mortar it is likely this represents a phase of construction prior to levelling with imported topsoil.
- 5.3.4.3. After the removal of a further 300mm of [4003] a layer of sand was encountered that was markedly different in colour and texture (see Plate 3) It was greyer in colour and had frequent patches of grey claylike lenses [4004] . There were frequent inclusions of coal, mortar and sandstone chips, and clearly suggests constructional activity. A sondage was taken through this for a further 300mm but no change was located.

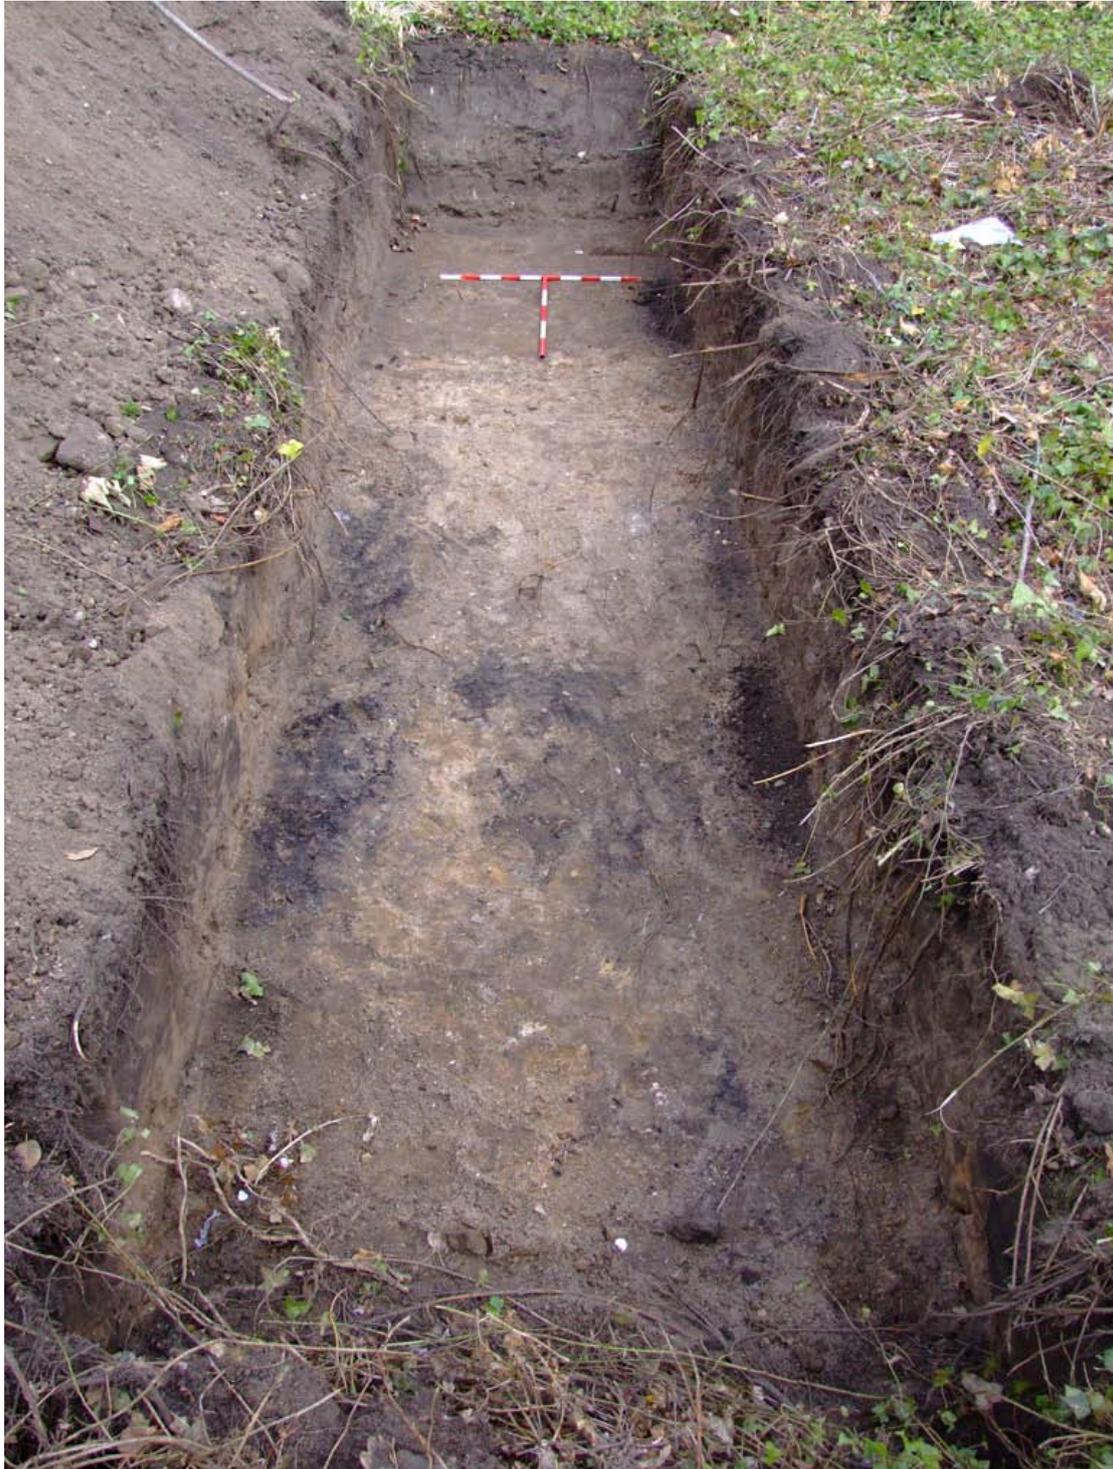
- 5.3.5.1. A dark brown clay silt topsoil [5001], circa 200mm deep was removed to expose a layer of light brown silty clay [5002] that contained frequent mortar fragments and building debris. This was removed to expose a rubble [5003] that lay in a conical pile, consisting of medium sized sandstone rubble and mortar lumps. , over 500mm high. This lay on a surface ( see Plate 4)

PLATE 4: THE FINAL SURFACE OF TRENCH 5 – [5004] WITH BURNT MATERIAL AND MORTAR TRAMPLE [5007]

- 5.3.5.2. The exposed surface consisted of a clay 'floor [5004] on which lay a mixture of burnt material and mortar[5007]. A distinct line of change was seen to the west (see plate 4) where the mortar and burnt material stopped abruptly as if constrained by a flat object. It was noted in the 'floor surface a two parallel 'grooves, [5005-5006]that may represent some structural element of wood, that was later removed.
- 5.3.5.3. Finds recovered from the layer [5007] point to a late 18<sup>th</sup> century/early 19<sup>th</sup> century activity and in conjunction with building debris would point to construction of a major building in the area. This can only perhaps be related to the enlargement of the building.
