Cheviot House Mill

Haddington, East Lothian.

January 2013

- 1.1 An archaeological buildings appraisal was required due to an archaeological condition placed on the development at The Cheviot House Mill, Haddington, East Lothian. The site is located, within an historic mill complex, and forms part of the largely demolished West Mills. (NMRS - NT57SW 82) (see Figure 1).

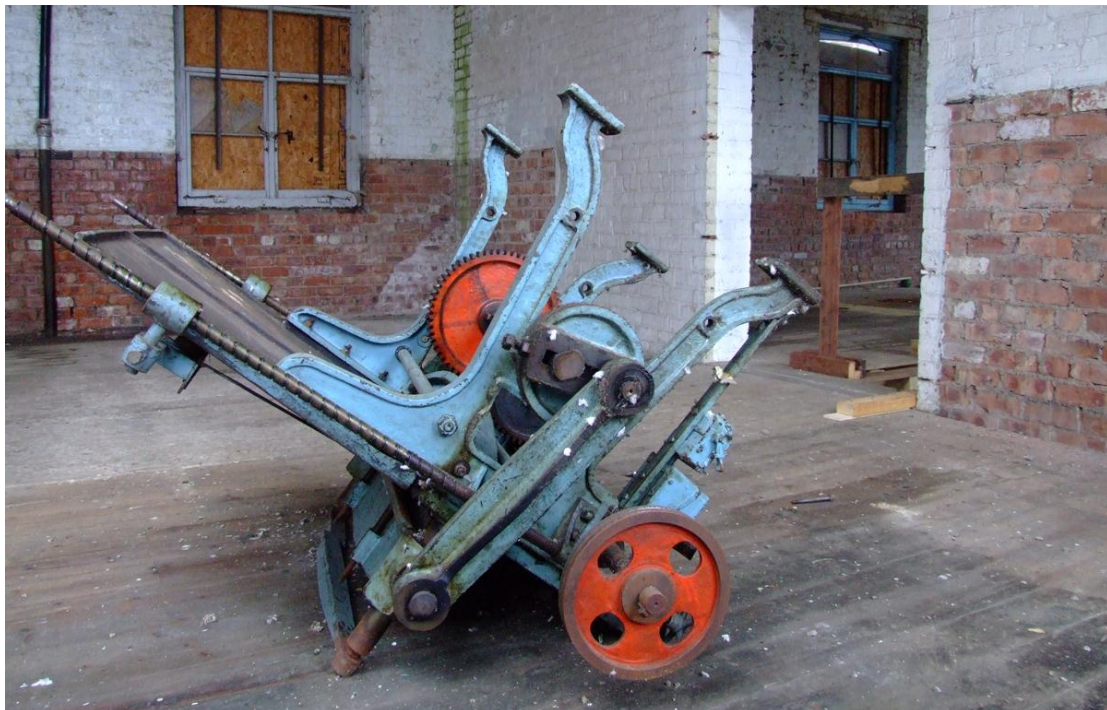
PLATE 2: ALL THAT REMAINS OF THE MACHINERY FROM THE TWEED MILL.

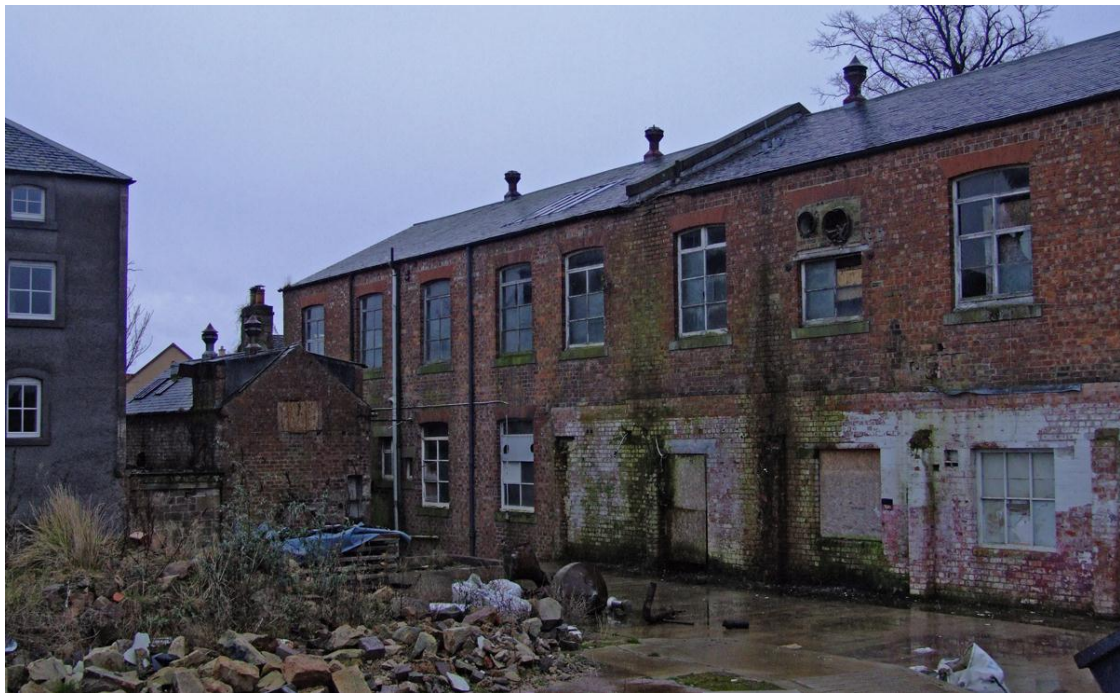
PLATE 3: REAR ELEVATION OF CHEVIOT HOUSE MILL, WITH THE WEST MILL TO THE LEFT AND BETWEEN THE TWO STRUCTURE THE PATERSON MILL ENGINE SHED. THE MILL LADE RUNS THROUGH THE SITE, BENEATH THE COURTYARD.

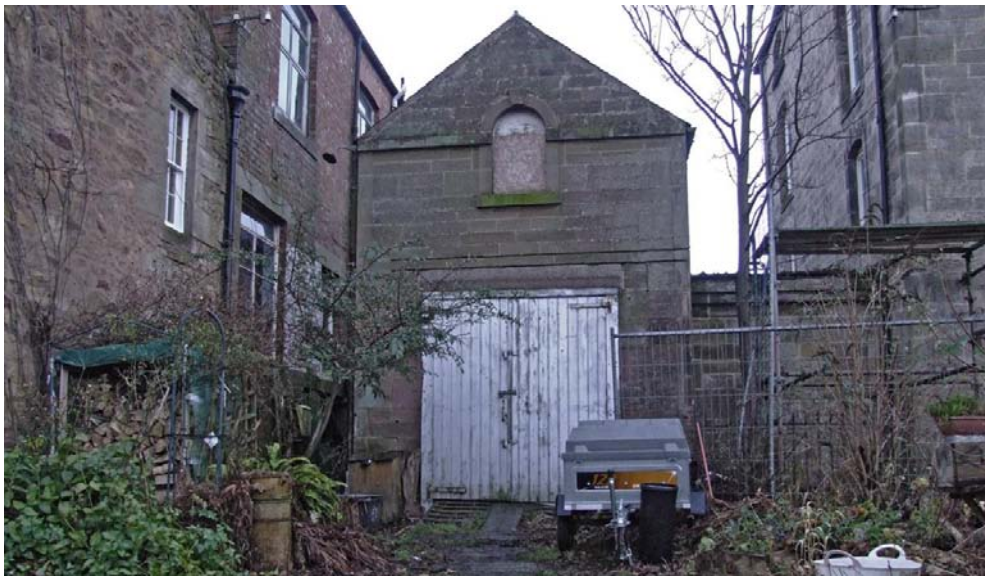
- 5.1.1 The first building examined was the Paterson Mill Engine House. (Plate 4) The Principal elevation (east) is a pedimented gable elevation constructed of dressed ashlar with a central double door on the ground floor and an arched window on the upper floor. With raised margin and keystone.
- 5.1.2 The interior is plastered on the hard and featureless; the concrete floor shows the evidence in the form of metal fixings for the location of machinery. The rear wall, which is to be breached, is also featureless internally. With a small upper window opening and a vertical slot opening to the south.

PLATE 4: THE EAST FACING PRINCIPAL ELEVATION OF THE PATERSON ENGINE HOUSE.

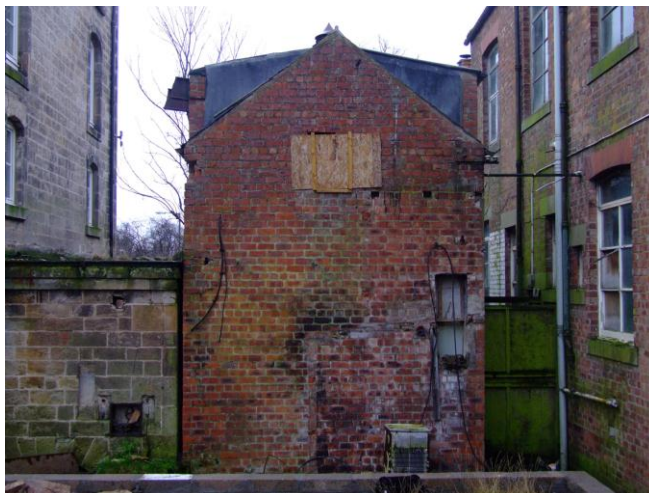
PLATE 5: THE REAR ELEVATION OF THE ENGINE HOUSE

The other three walls of the engine house are constructed of 19th century brick. The rear elevation lies over the mill lade that appears on the earlier plans (Figure 2). A slot opening to the south was for an exhaust vent for the engine within, when it is converted to diesel power in the 20th century. The traces of a wooden lean-to are visible on the wall surface.

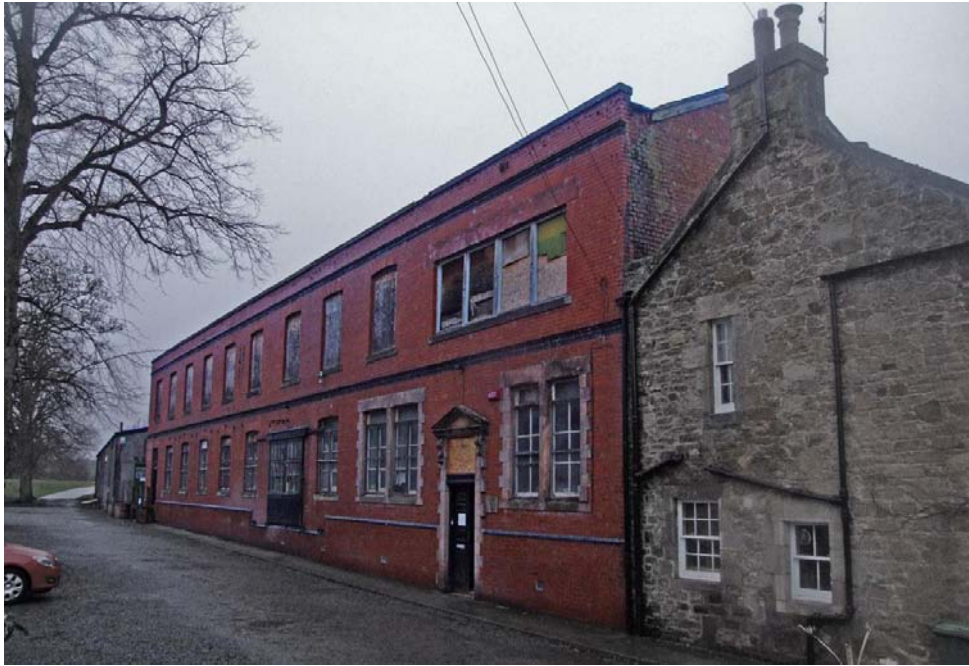
PLATE 6: PRINCIPAL ELEVATION OF CHEVIOT HOUSE MILL, WITH LATE 18TH CENTURY HOUSE TO RIGHT.

- 5.1.3 The Cheviot House Mill has a principal elevation to the south and consists of a two storey 11 bay structure with a glazed red brick façade (Plate 6/photo 62). The first floor originally consisted of 11 flat cambered brick arched windows, the eastern most 2 having been altered in the 20th century (photo 64) into a single long plate glass window with 4 equal divisions. The ground floor is divided into an east and west by a large central goods door that splits and slides parallel to the wall – with gas lamp fitting above - (Plate 7/photo 67) and is raised circa 0.80 metres above the ground surface. Consistent with the First floor, the windows to the west are all of similar style with a flat cambered arch.

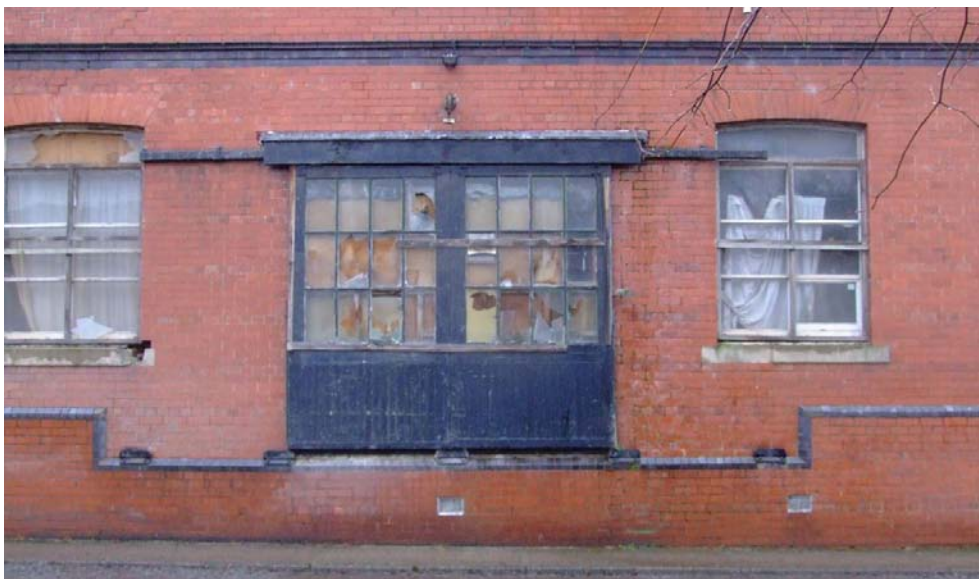
PLATE 7: CENTRAL GOODS DOOR, TYPICAL WINDOW AND PLINTH - SOUTH ELEVATION

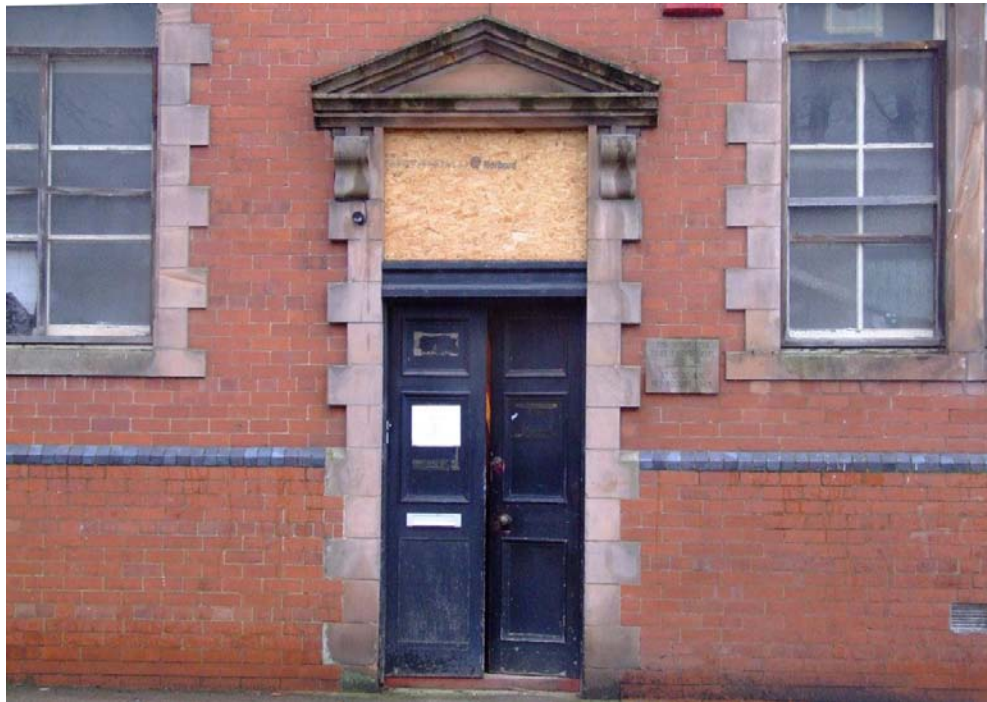
- 5.1.4 To the east there is a pedimented sandstone surround public entrance with window light above (Plate 8/photo 63), flanked by 2 sandstone surround windows. The door pediment is supported by a scrolled corbel and both the door and windows have Gibsion surrounds. To the right of the doorway there is a sandstone marker 1.95 metres above the ground level that marks the limits of the flood waters that was reached on the 13th August 1948 (Plate 8/photo 66). Vents are located above the ground level along the east half of the elevation to provide circulation within the raised floor level within (photo 69).

PLATE 8: PUBLIC ENTRANCE ON WSOUTH FASCADE, WITH FLOOD MARKER TO RIGHT OF DOOR

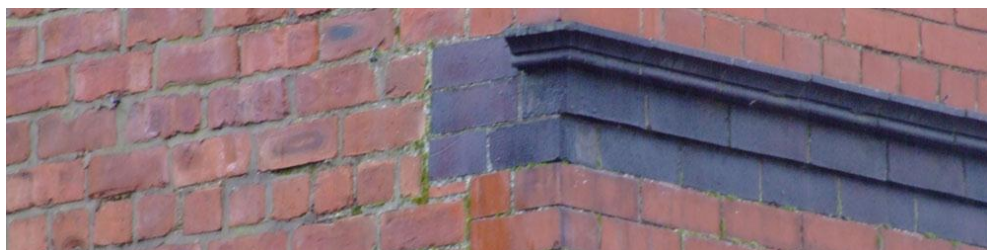
- 5.1.5 Ties to the west just below the First floor level relate to a cast iron plate within the interior of the structure used to support later Eye-beams. Black bricks are used for highlighting decorative features. A chamfered black brick decorates the top of the plinth (photo 74) that extends 50 mm from the main plane of the wall. A further string course of black bricks (Plate 9/photo 75) highlights the division between the first and ground floor, while a final course picks out the raised wallhead parapet (photo 76). The entire elevation is designed to act as a unified façade that also delineates the interior space function, where it is clear that the ground floor to the west is office space and public, as opposed to factory space which is restricted.

PLATE 9:BLACK GLAZED BRICK CORNICE DETAIL ON SOUTH FASCADE

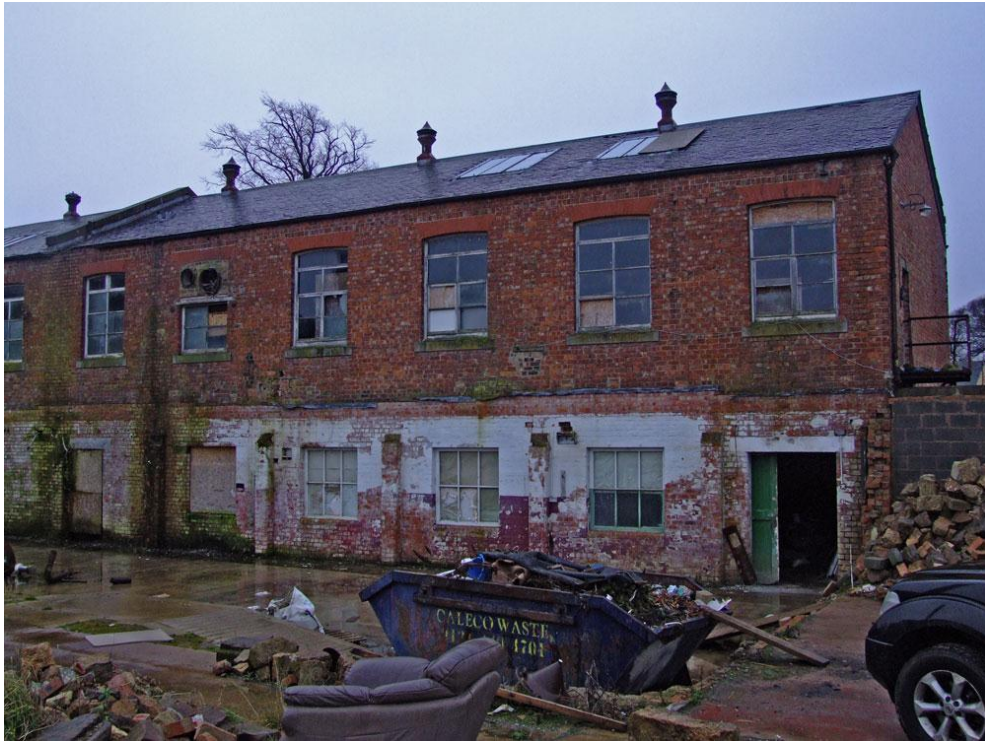
- 5.1.6 The north external elevation is built of common brick (Plate 10/photo 49 & 50) and the First floor has 11 equally spaced flat cambered arched windows (Plate 10/photo 51) with a central wall divide marking 5 to the east and 6 to the west, which is visible by the gable wallhead on the roof line.

PLATE 10: NORTH ELEVATION (WEST END) NOTE PILLASTERS AND LOCATION OF LOWER NORTHERN EXTENSION

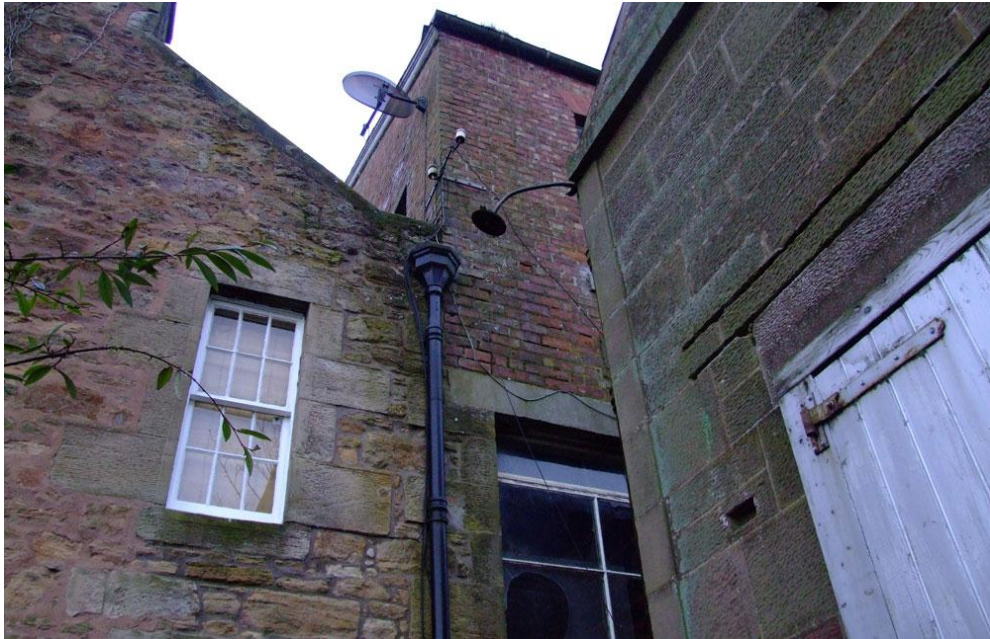
PLATE 11: CHEVIOT HOUSE MILL BUILT INTO AND OVER COTTAGE. NOTE PATERSON ENGINE HOUSE TO RIGHT

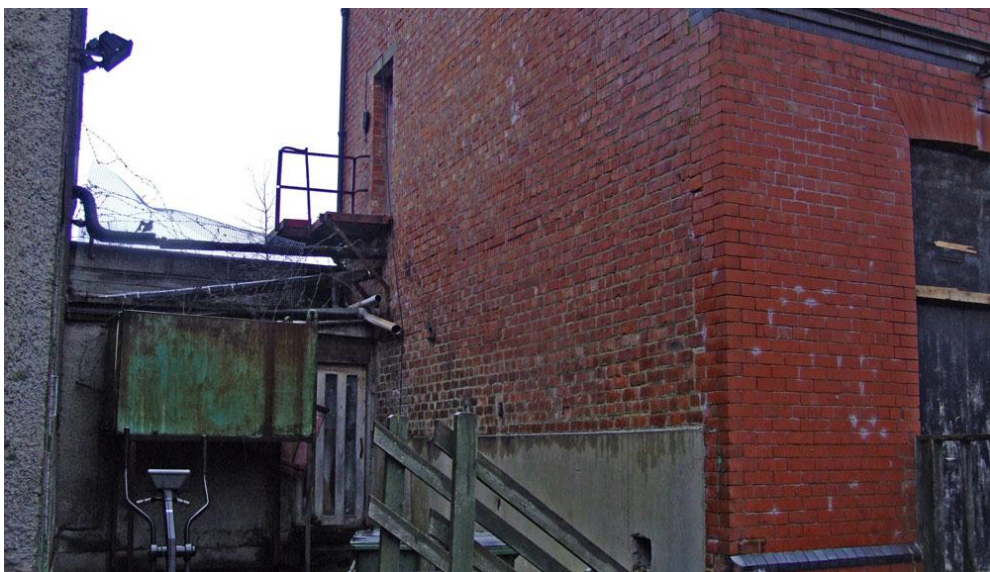
PLATE 12: WEST GABLE, WITH STAIRWAY SCAR AND 1ST FLOOR FIRE EXIT.

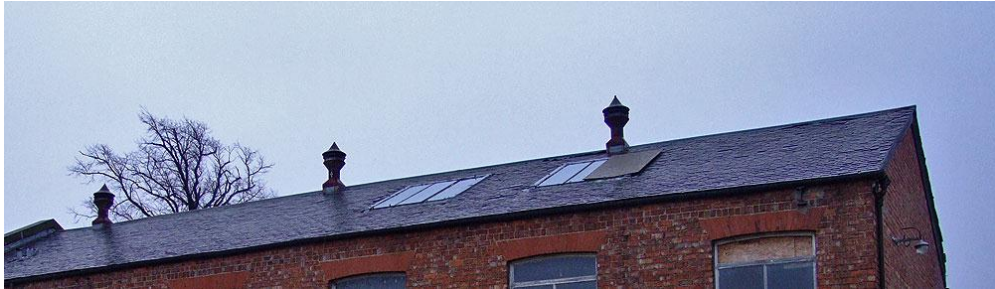
- 5.1.10 The east elevation almost entirely consists of the rear elevation of the sandstone later 18th century cottage (photo 3 & 62). The first floor common brick of Cheviot House Mill extends beyond the wallhead and is penetrated by a later insertion of a small window to the north east.
- 5.1.11 The pitched roof is slated and has 5 equally spaced metal ventilation cowls (Plate 13/photo 80) along the ridge. There are also glazed window panels to the north.

PLATE 13: SLATE ROOF. ROOF LIGHTS AND VENTILATION COWELS

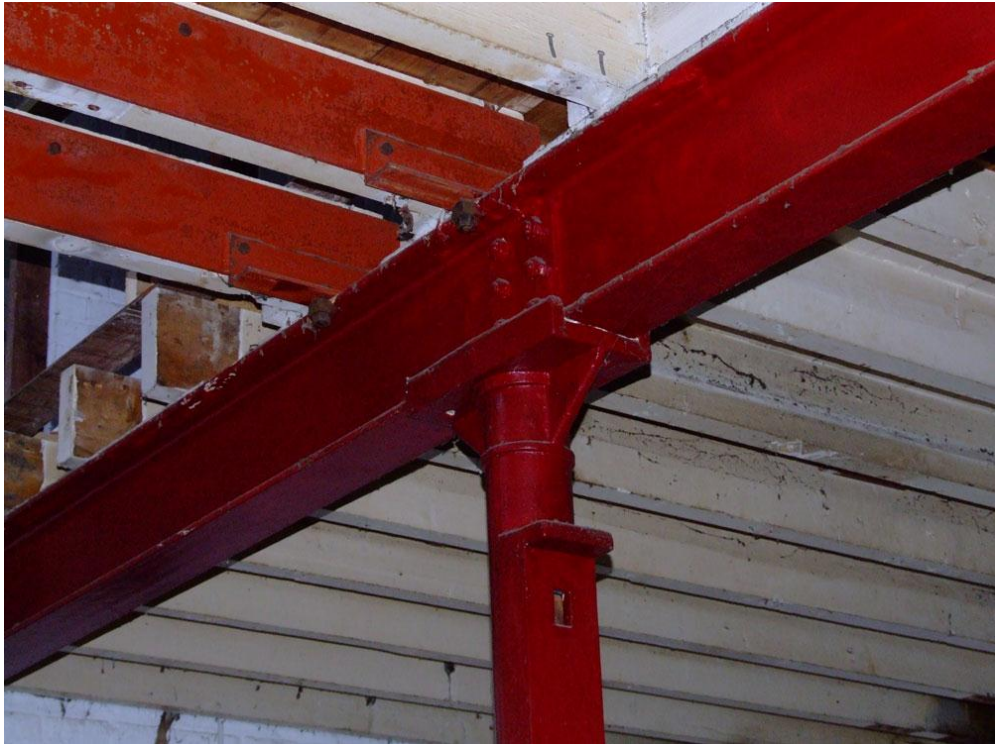
PLATE 14: DETAIL OF PILLAR CAPITAL, WITH FITTING AND ADDITIONAL FLANGES. NOTE UPPER ADDITIONAL TRUSS SUPPORTS TO LEFT.

- 5.1.15 The 2 easternmost cast iron pillars within Room 3 have additional flanges towards the top of the column (Plate 14/photo 31), though it is difficult to see how these would have been of any use as they do not face each other to allow the fixing of heavy machinery and may only represent the company buying the pillars that were available as opposed to the ones that were needed. There are doors in the north elevation to the east and west (photo 27) which would have led into the exterior structure to the north. There is a further door in the northwest corner of the west gable and a larger goods door to the west of the south gable (photo 28), this leads to a set of stairs down to the road beyond.

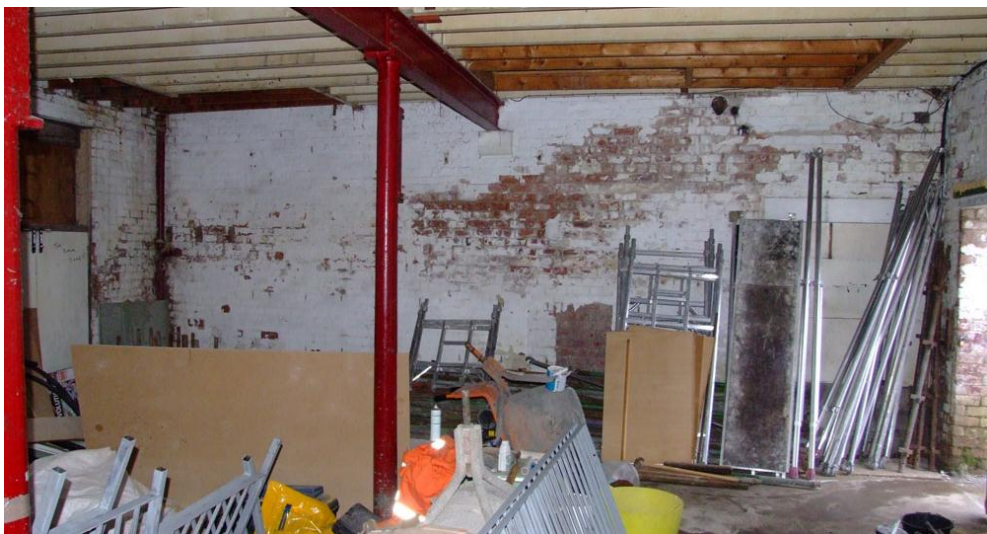
PLATE 15: ROOM 3 SHOWING SANDSTONE CORBEL FOR I-BEAM SUPPORT AND CONCRETE FLOOR - WEST

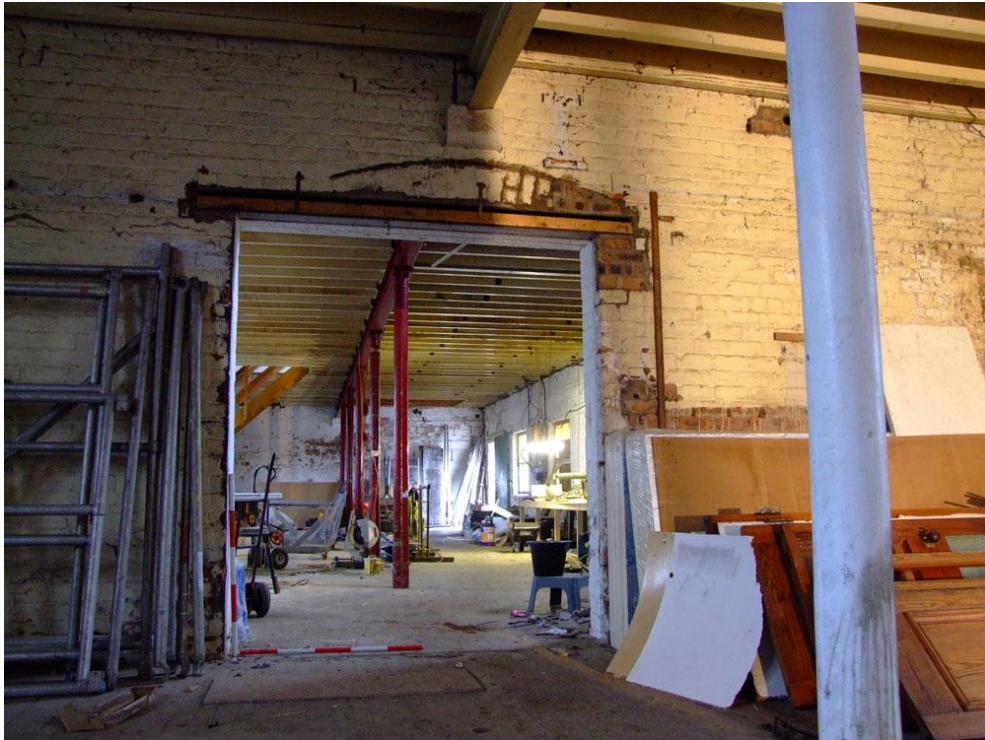
- 5.1.14 The central dividing wall to the east has an enlarged opening with steel girder lintel (photo 34); however, the original opening size can be inferred as the flat corbelled arch is still visible above. The south wall has a cast iron L-plate bolted to the interior and further steel beams have been inserted from the north exterior to support every second wooden truss in this area (photo 28). The floor is of concrete which itself envelopes the base of each of the cast iron pillars (photo 32), however, an inspection trench clearly shows that the original surface was on solid footings unlike the floor to the east.

PLATE 16: ROOM 3 BEYOND THE CENTRAL DIVIDING WALL - NOTE TRANSITION TO WOODEN FLOOR AND THE ENLARGED OPENING WITH ORIGINAL ARCH VISIBLE ABOVE.

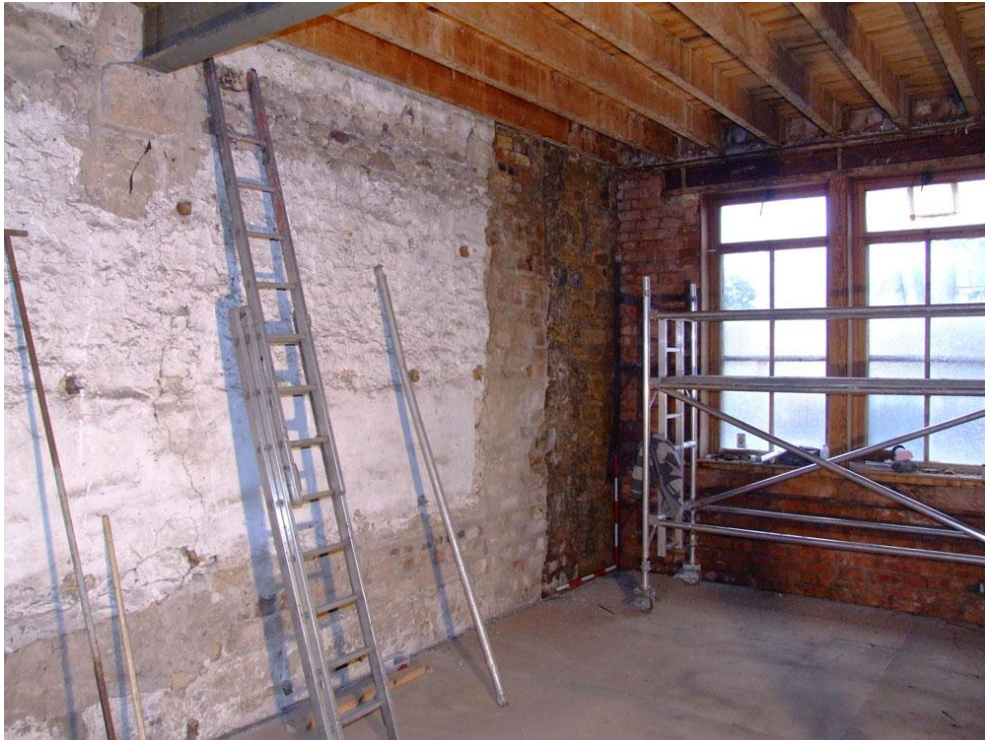
PLATE 17: INTERIOR - SHOWING READR WALL OF COTTAGE AND REPAIRED FLUE IN BRICK.

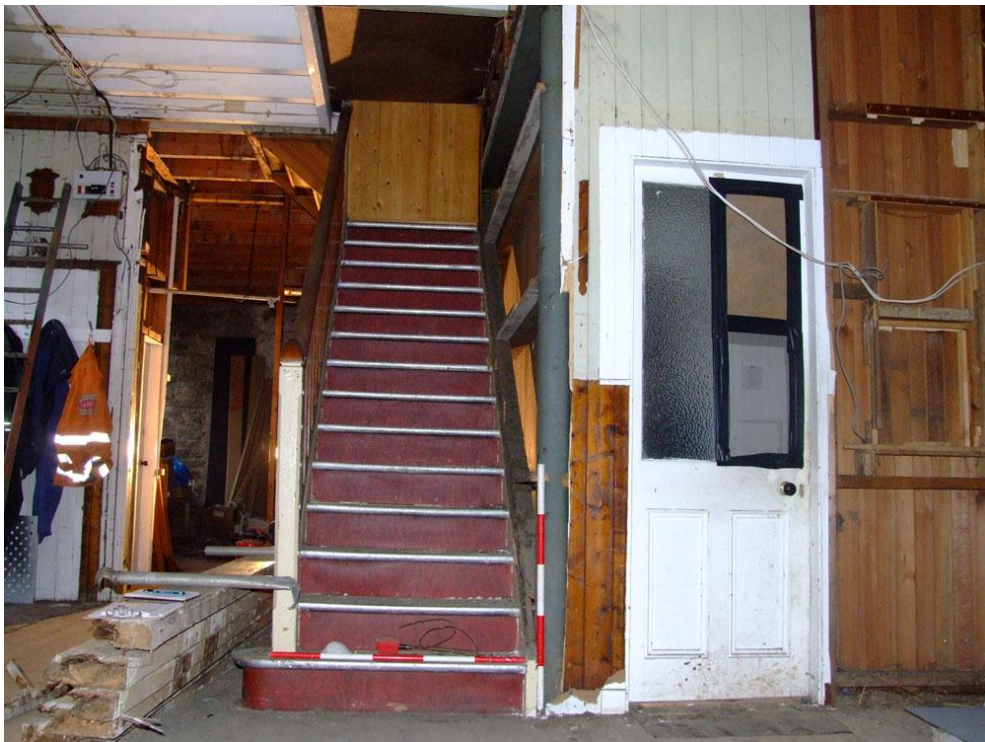
again rest on sandstone corbels (Plate 16/photo 42 & 45). Here however, the wooden panelled rooms and stairway to the First floor (Plate 18/photo 43) shows how the pillars have been wrapped within the later panelling.

PLATE 18: STAIRS TO UPPER FLOOR AND ROOM 2, ALSO SHWING PANELLING AND OFFICE SPACE TO RIGHT

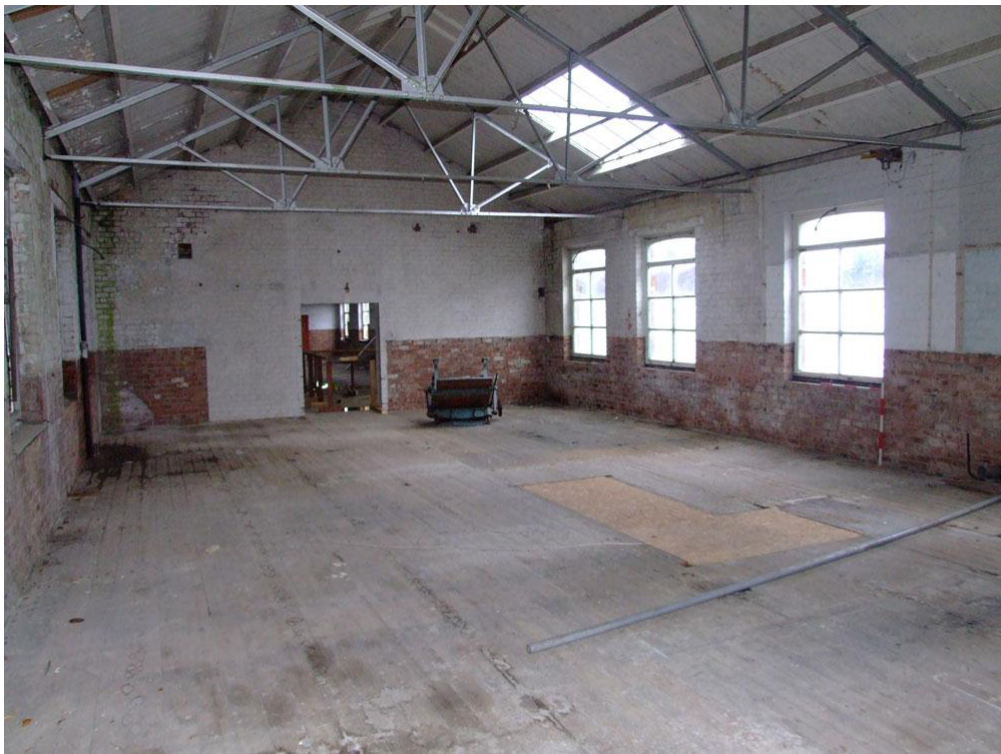
- 5.1.18 The upper floor consists of 2 main spaces which although devoid of internal divisions now, it is possible to make out the panelled rooms from the floor and wall scars (Plate 19/photo 20 & 22). For ease of description they are referred to only as the 2 rooms that currently exist. There is nothing remarkable about any of these spaces and they are devoid of any architectural detailing except panelling to dado level. The door in the west elevation of Room 1 leads to the external fire escape. Both rooms are accessed by separate staircases from the ground floor and the central dividing wall has the original flat cambered arch centrally located. Windows in both the west and east elevation provide extensive natural light along with the roof lights. There are floor hatches in both Rooms 1 & 2 through the wooden floor. The Room 1 floor has been re-enforced by additional girder supports to the wooden trusses, which suggests that this space contained heavier machinery than what is suspected to be the office space to the east.

PLATE 19: ROOM 2 WITH ROOM 1 BEYOND. NOTE FLOOR SCARS OF INTERNAL DIVISIONS AND LOCATION OF STAIRS TO GROUND FLOOR (COVERED IN NEW BOARD) ABOVE IS THE CAST IRON CANTILEVER TRUSS ROOF SUPPORT
