SANDY LOAN, GULLANE: EAST LoTHIAN

JULY 2015

CARRIED OUT ON BEHALF OF REYWOOD CONSTRUCTION

| TYPE(S) OF PROJECT: | Monitored strip |

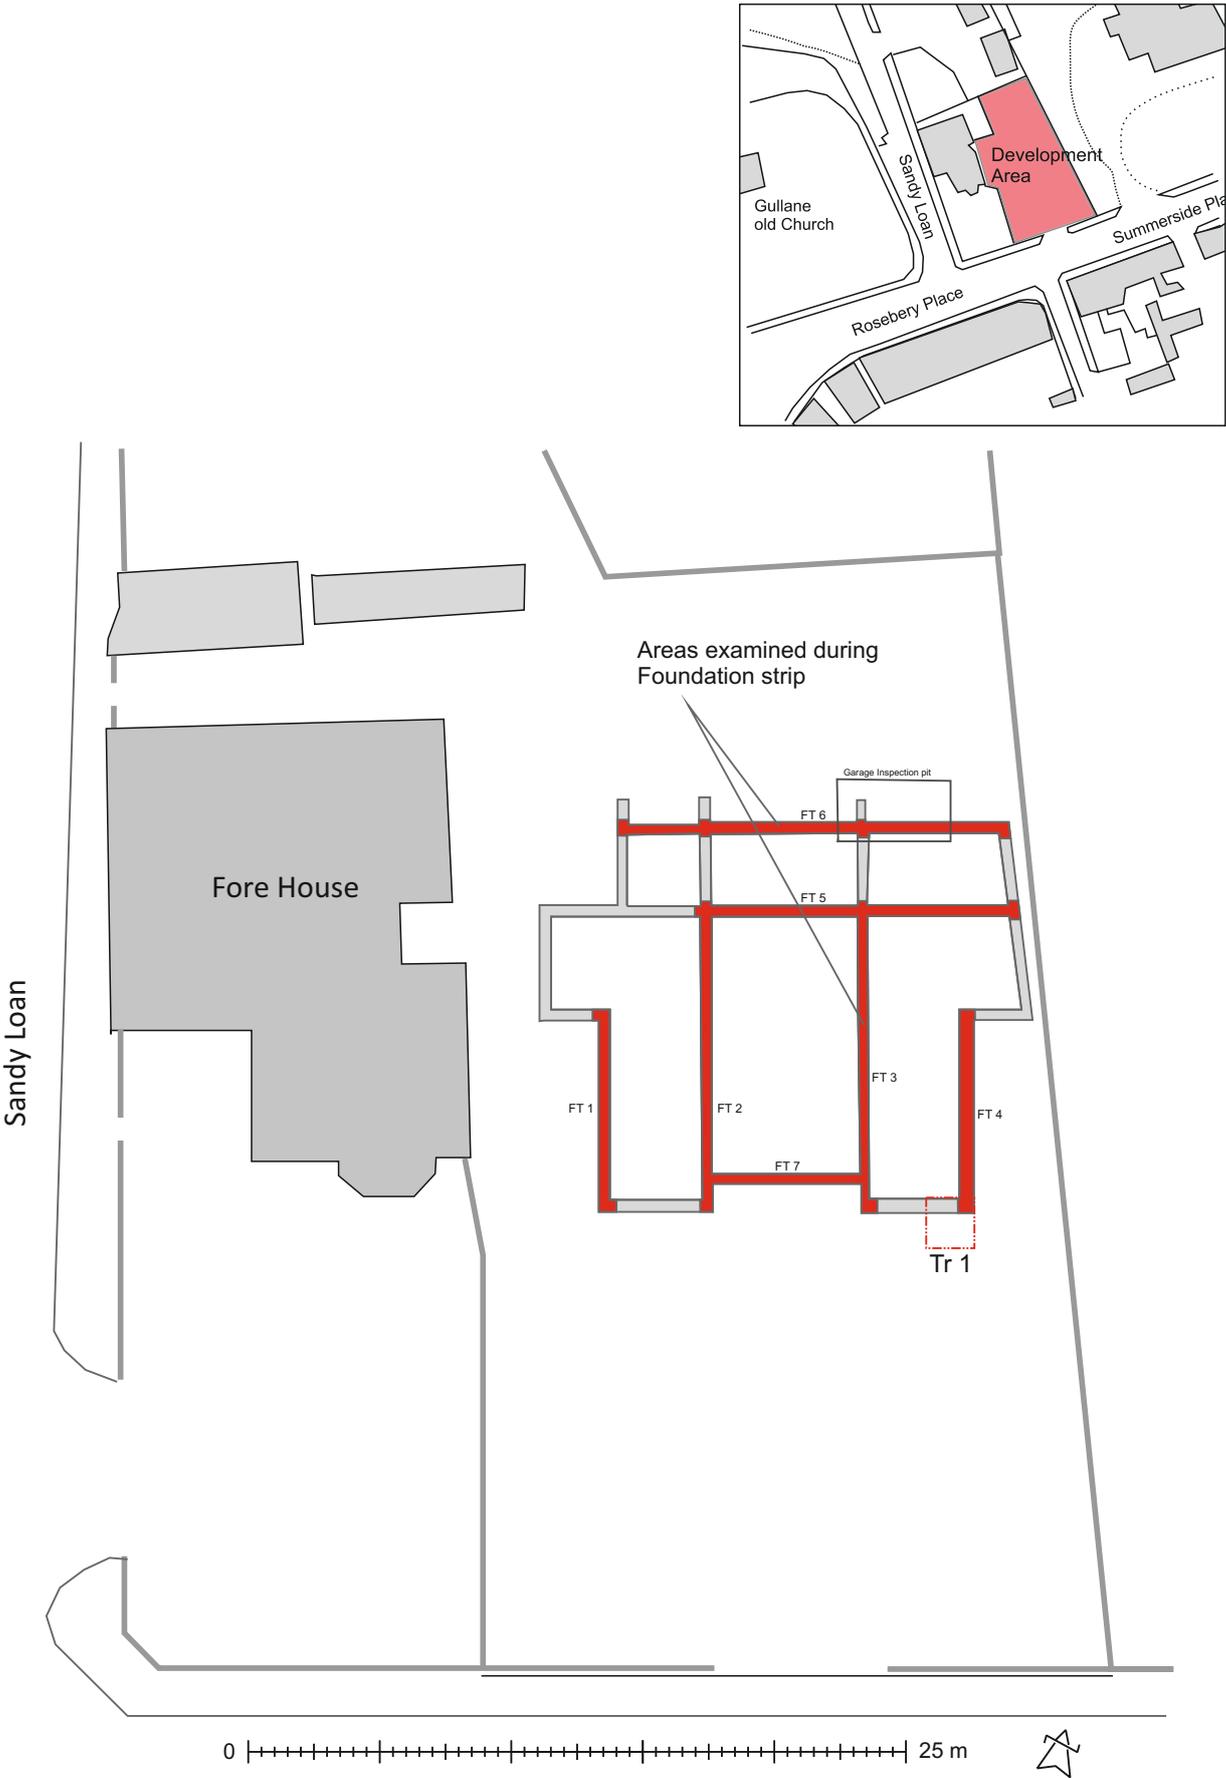
Figure 2: Site Plan showing area of excavation and monitored strip

- 1.2 The work consisted of visual inspection of the strip foundations to a depth of up to 1.5 metres (Figure 2) and the subsequent 2m x 2m trench to evaluate and characterise a wall uncovered during the previous phase of works. The work was undertaken on the 9th July 2015 and 23rd July 2015 in bright but overcast conditions.

- 5.1.2 The initial monitored foundation trenching (Figure 2) revealed the depth of overlying subsoils and recent dumping relating to the garage across the site. The foundation trenches that were full examined were numbered T1 – T8.

- 5.1.3 The depth of windblown sands was variable across the site, ranging from 0.25m – 1.20m below current ground surface (c. 25maOD) and it was clear from sections cut through the sands, to depths of up to 1.50m, that they represented various events of sand inundation and then soil stabilisations, with repeated layers of sands and soils. There is of course potential that beneath these levels there are further archaeological deposits, but as the foundations of the current structure will rarely exceed 1.00m, these deposits, if they exist will not be affected.

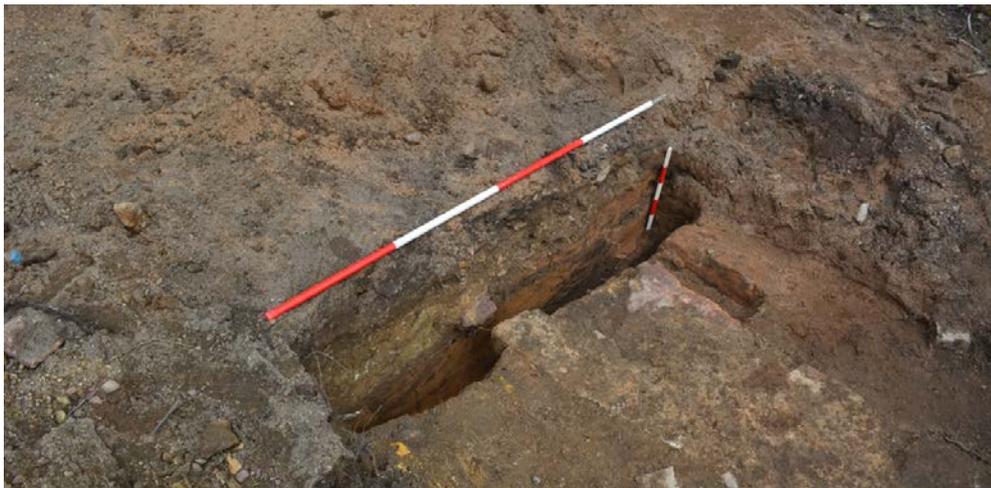
Plate 1: Excavated wall with sondage trench and section

- 5.1.4 In the southeast corner of the site, a linear stone feature bonded with mortar was located, covered in a dump of recent ceramic and building material. This was considered to be of enough importance to investigate and characterise the feature as well as ensure that there were no further features on the same line, such as might be found on backlot divisions. (ditches, walls, fences etc)

- 5.1.11 During the watching brief, a linear stone structure was recovered. Further removal of the surface layer revealed this structure to be a wall at foundation level as well as uncovering an external corner. This indicates a stone building of no more than one storey in height based on the shallow depth of foundation. To the west of the wall there was a deposit of yellow sandy-clay laid down as floor preparation. Digging through this revealed the same orange sand (naturally deposited) with lenses of dark silty sand. A sondage against the section proved there were no further archaeological features beneath this sequence, other than the constant inundation of windblown sand.

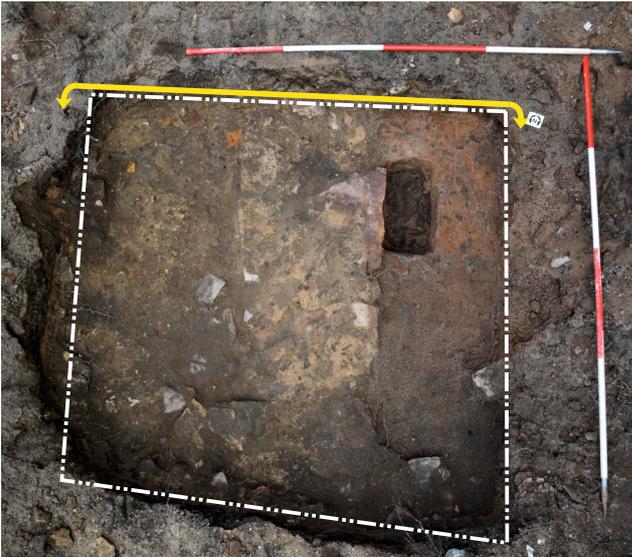
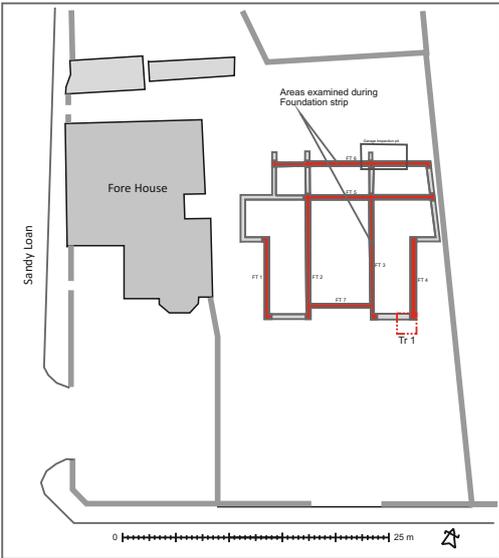
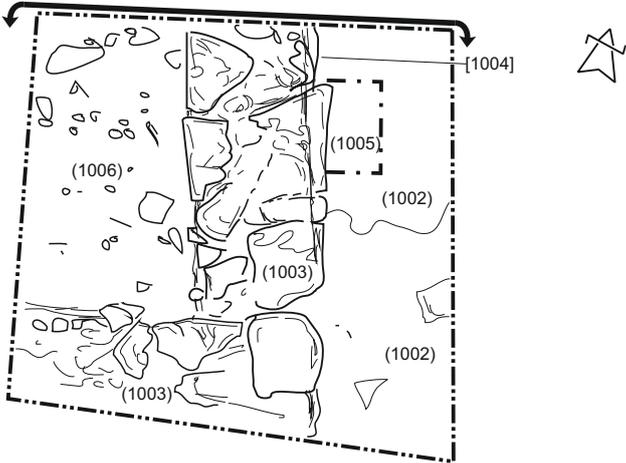
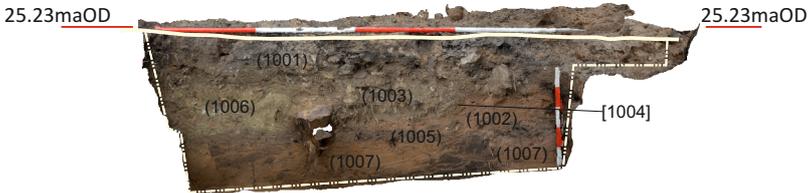
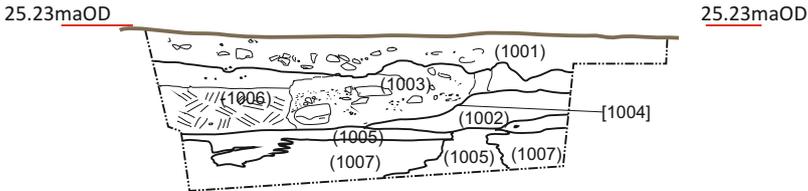
Figure 3: Trench Plan and section

- 5.1.6 Context (1001) overlay all deposits, as a mix dump layer of masonry, brick and early 20th century ceramics. It is clear the material represents a levelling deposit, over the truncated features below.

- 5.1.7 The loose orange brown sandy material to the east of the trench contained charcoal, and would have been exposed during the construction of the wall structure. Cut [1004] was a shallow 0.40m deep foundation cut, extending to the west where it would have formed a wide trench the width and length of the building. This was not a foundation trench, but rather a foundation area strip. The wall was constructed of flat sandstone slabs mortared together with a deep cream sandy mortar. The wall footings would have been built around the foundation trench edges, and then infilled with the green yellow clay (1006) to form a solid platform for constructing what must have been low single story buildings.

- 5.1.8 The clay platform would have been the footings for a slab floor (now removed) Beneath these deposits and cuts there are the layered sands and soil deposits (1005) and (1007) which will continue down to a depth of at least 1.50m.

- 5.1.9 A slot trench was taken down to a depth of 0.70m but no sign of further features on the same alignment were noted.
- 5.1.10 Examination of the OS maps (Figure 4) confirmend the origin and possible function of this stretch of walling. Dating to the early 19th century, there is a linear range of structures to the east of the grounds of the current house. That they represent stables or couch houses must be seen as a possibility. By the 2nd edition map of 1892, the south end of the range has been truncated, and this ties well with the possible return noted in the trench, where a smaller wall is seen heading west, though slightly overlying the Wall [1003]. When plotted onto the map, it is clear the excavation represents this corner of the building.

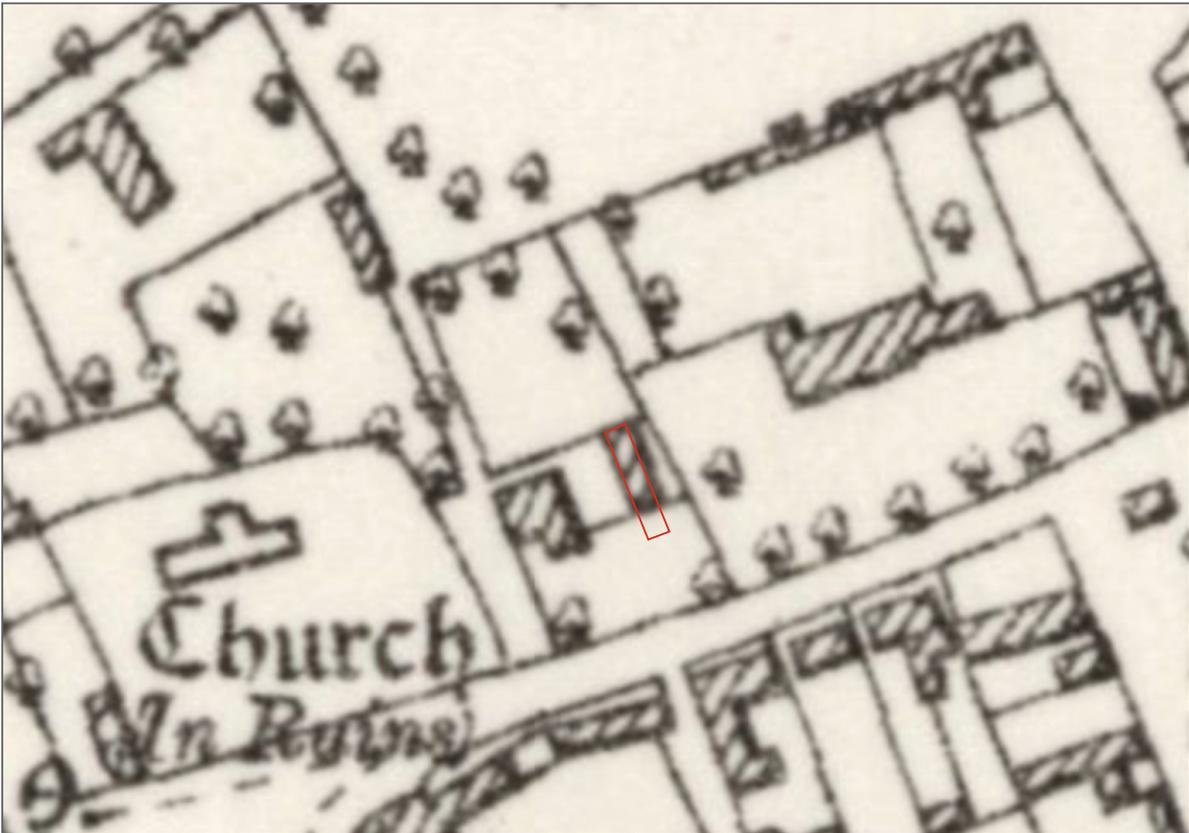
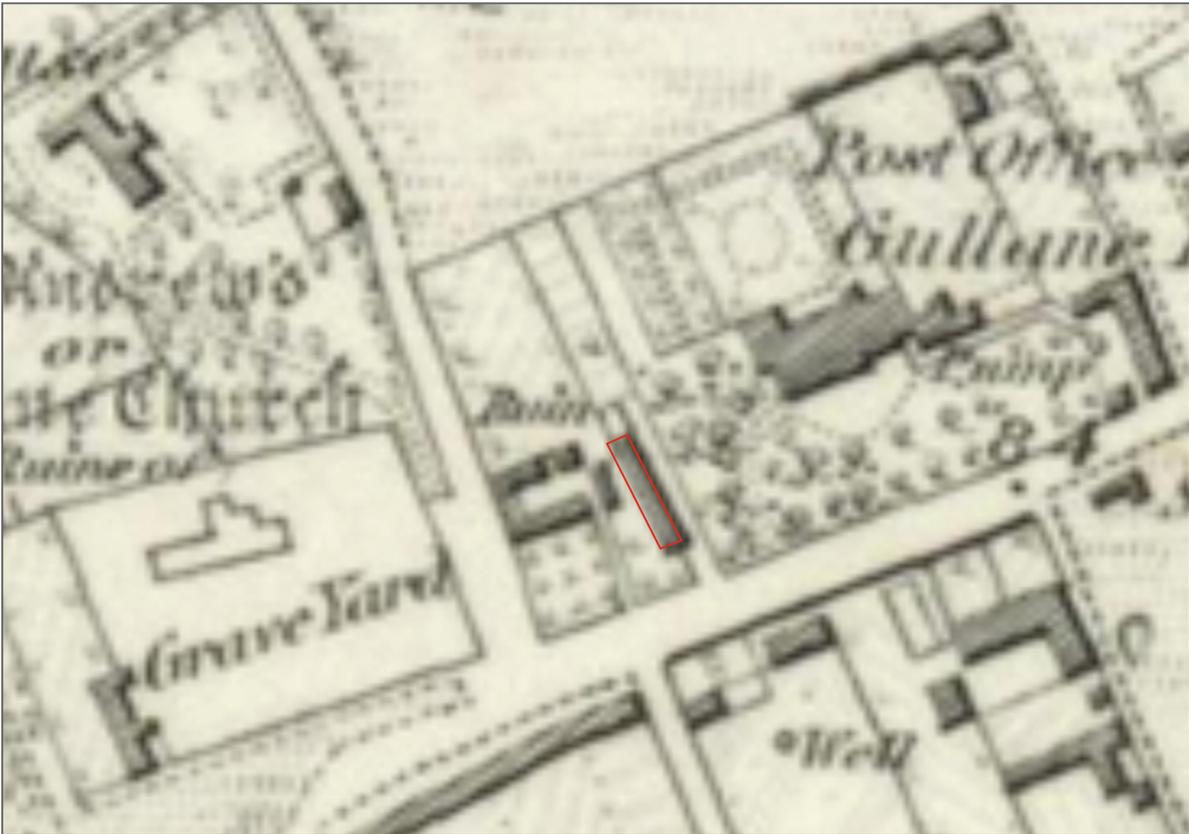
Figure 4: 1842 and 1888 OS plan of site showing long cottage row.

- 1.3 The wall is matched with a 19th century OS map of the area showing a range of structures along the eastern boundary of the plot, and may represent stables and carriage-house.
