MEIKLE RIG STEADING, STENTON, EAST LoTHIAN

BUILDING APPRAISAL

MARCH 2016

CARRIED OUT ON BEHALF OF MR J. KINNAIRD

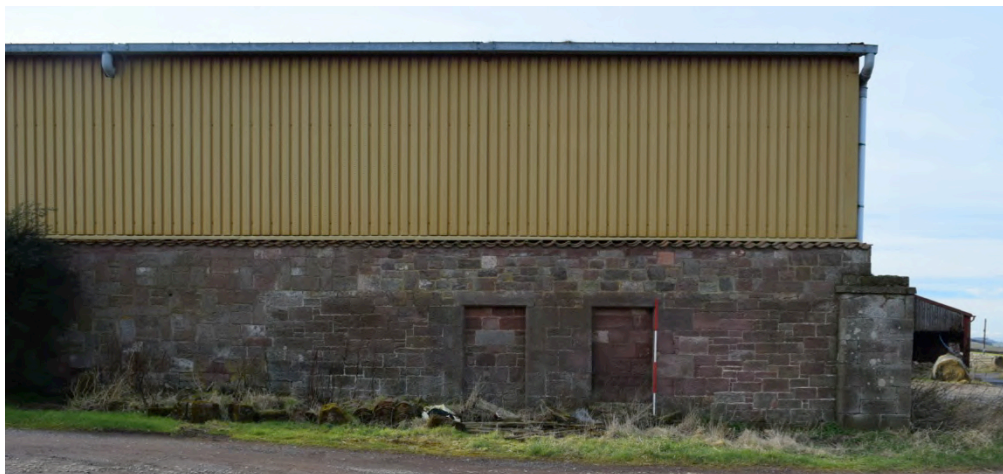
- 5.1.2 The east exterior wall of Yard 2, which abuts the workshop structure, is made of roughly squared coursed sandstone up to half way along its length, where it gives way to clearly more recent (twentieth century) masonry section. This consists of squared coursed masonry of various stone types. The wall head of both, the modern and the nineteenth century wall sections is coped with pantiles over which a corrugated metal barn superstructure has been erected. The nineteenth century masonry survives in the north end of the upstanding east elevation and includes two blocked entries/doors (**Plate 1**).

Plate 1: View of the east exterior elevation of Yard 2 – with two blocked entries; pier; pantile coped wall and the corrugated barn structure. Note also the differential masonry sections.

- 5.1.3 At the very north end of the east wall is a masonry pier (**Plate 1**) made of well-dressed rectangular blocks of sandstone. The pier projects from the main wall line towards east and north and the wall appears to have been erected subsequently to the pier's construction. Although it was initially interpreted as part of the yard gate, its more detailed examination disapproved this and there appears no readily apparent purpose for the pier's original function. Its make-up/finish and character is different from the rest of the wall and it is not clear when or for what purpose it has

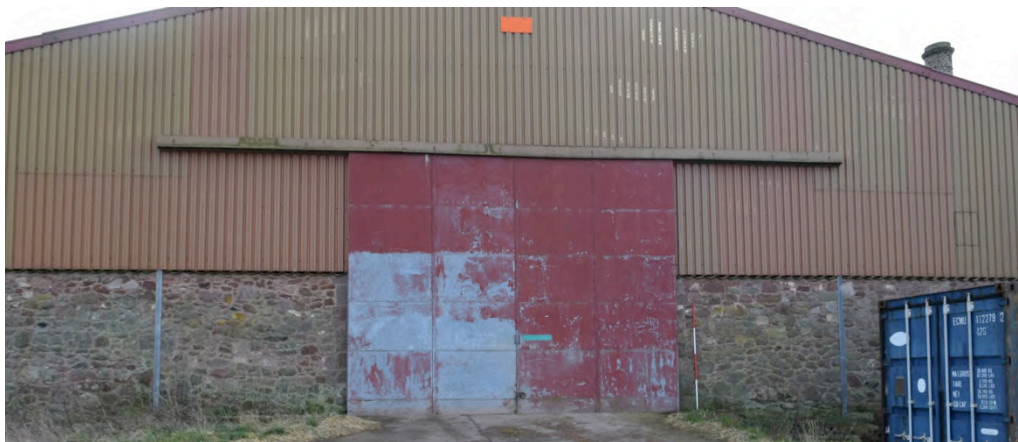
- 5.1.4 The north range (Yard 2) has a single wide entrance set into a coursed rubble wall, which differs in character from the other remains within the same compound (**Plate 2**). The more recent northern entry replaced one which originally allowed access into the cattle courts of YARD 2 from the east the blocked opening is still visible in the east exterior wall as a modern infill blocking (**Figure 4**). The wall head is coped with pantiles, but the main surviving pitched roof superstructure is composed of metal sheeting. The floor of the interior is a concrete surface. Most of the nineteenth century structures of the north range have been removed— apart from at the very western limit.

Plate 2: Yard 2— view of portion of the north exterior elevation, with wide entry and coursed rubble wall.

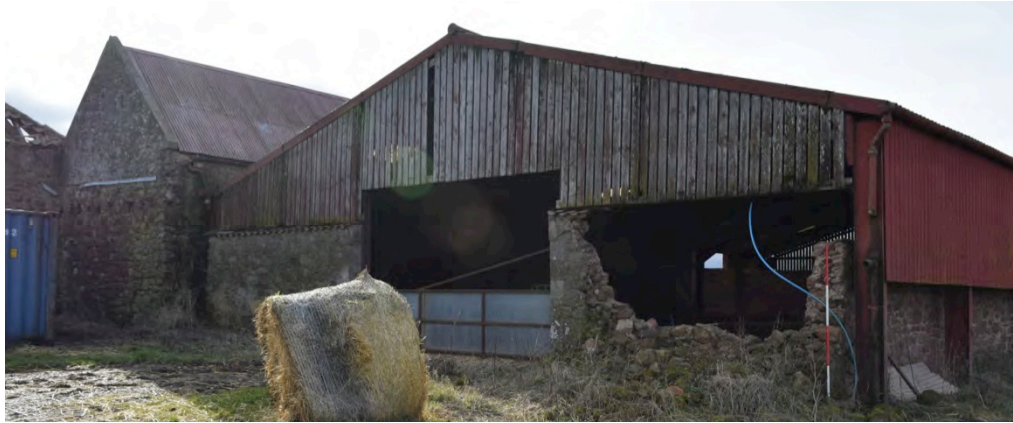
- 5.1.5 The junction between Yard 2 (nineteenth century) and Yard 1 (possibly eighteenth century), located approximately midway along the current northern range, is obvious from the remains of flashing and joist holes visible on the façade of gable wall of the original south range of Yard 1 (**Plate 3**). This, along with the but joint of YARD 2 to this structure provides the evidence that the YARD 1 range of buildings predates the YARD 2 structures. The north-east corner of the original YARD 1 includes a wall stump running north, which represents almost the sole evidence for the north range of the earlier steading (eighteenth century). It is now almost completely rebuilt as a cattle court, complete with reconstructed stone wall and girder and sheet metal barn superstructure above (**Figure 4**).

Plate 3: View of the east and partial north elevation of Yard 1– with flashing and joist holes in gable end of south range, wall stump and metal girder superstructure over the cattle court.

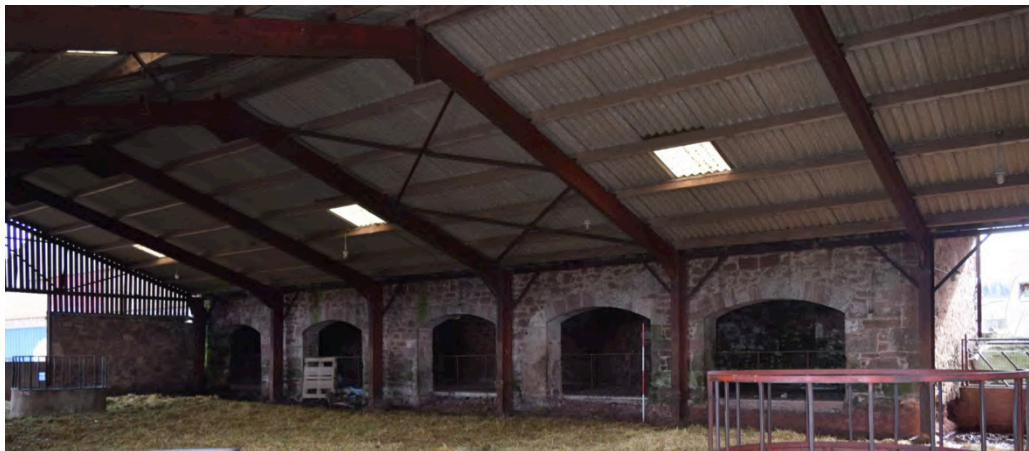
- 5.1.6 The Yard 1 consists of surrounding east, north and west walls, most likely a modern twentieth or possibly nineteenth century rebuilds– probably utilising material from the earlier walls. Surviving remnants of the original Yard 1 are represented by the south range– consisting of five shallow arched cart openings (**Plate 4**). These are constructed of red sandstone, corresponding to the rest of the surviving nineteenth and eighteenth century structures. The ground level and the bedrock beneath the courtyard area has been significantly levelled/reduced in recent history, by approximately 0.40-0.50 m.

Plate 4: Yard 1– detail of five arched cart openings set into the south range. Note also the modern metal girder superstructure.

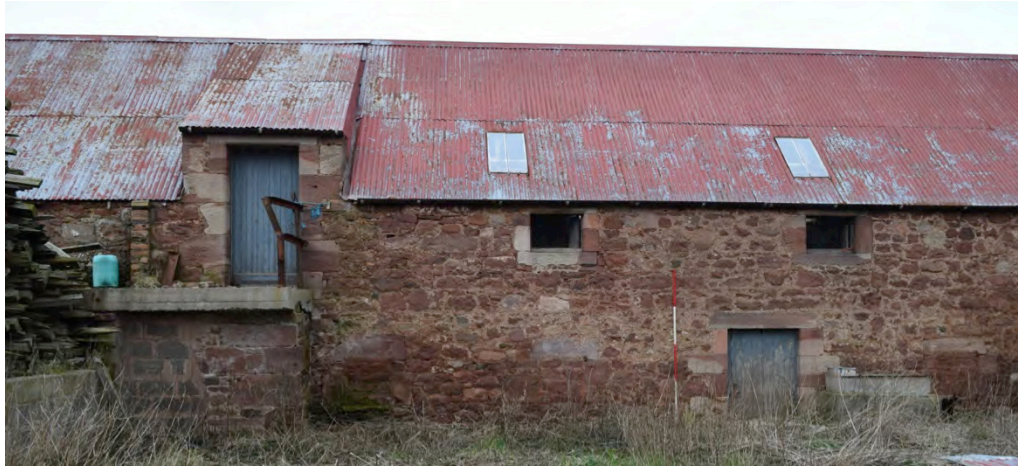
- 5.1.7 The west gable end of the south range of Yard 1 bears traces of a previous structure, in form of wall scars, and the ghost of a pitch roof as a render remains on the existing façade.
- 5.1.8 The south range of original steading – YARD 1 which would have been the Cartshed with granary over (**Plate 5**), is built of coursed red sandstone, and shows clear signs of rebuilding with the three upper storey windows having surrounds of different character to the lower four blocked windows. Their setting within the façade also disagrees with the fenestration of the lower level. The ground floor blocked

openings still retain the latch and hinge pins for shutters. A dormer door with cat-slide dormer, located centrally within the upper floor level, has a concrete platform/porch in front (originally of stonework which is still visible beneath, ascended by a set of concrete steps). The platform/porch has been built against the existing elevation and as such, it clearly represents later addition to the elevation – perhaps related to the same phase of works as the upper storey windows. Correspondingly, the lower ground level entrance is also a later insertion, providing access from the newly formed courtyard of the Yard 2. Its surrounds are similar in character to the upper level windows.

Plate 5: Yard 1; South range– detail of south exterior elevation with blocked ground floor windows, ground floor entrance, upper floor windows and cat-slide dormer door.

- 5.1.9 Although the masonry part of south range of Yard 1 survives to a reasonable original degree, its entire roof is a recent (twentieth century) construct, made of corrugated iron and including roof lights (**Plate 5**). The roof skeleton is also recent—being constructed of machine sawn square timbers, as are the floor-boards of the upper floor level.
- 5.1.10 The west range of Yard 2 is built of red sandstone with fine droved quoins. The north portion (**Plate 6**) of the west range is topped by pitched partially collapsed red pantile roof and has one wide entry in its south end, adjoining a chimney stack base. It also includes single tall window, situated north of the entry (see also interior notes). The interior of this range section is badly overgrown and covered by debris but includes in the east wall what appears to be an original entry with door still in place (**Plate 7**).

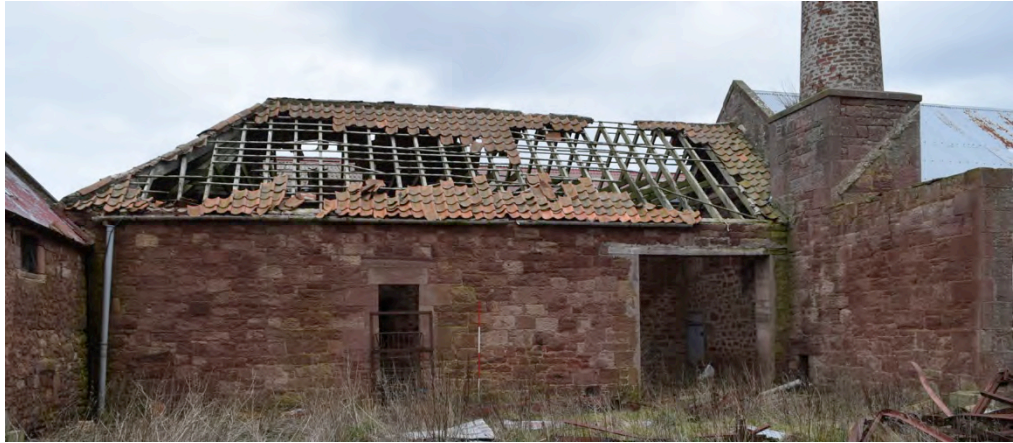
Plate 6: Yard 2; west exterior range– with partially collapsed pantile roof; wide entry and a tall window.

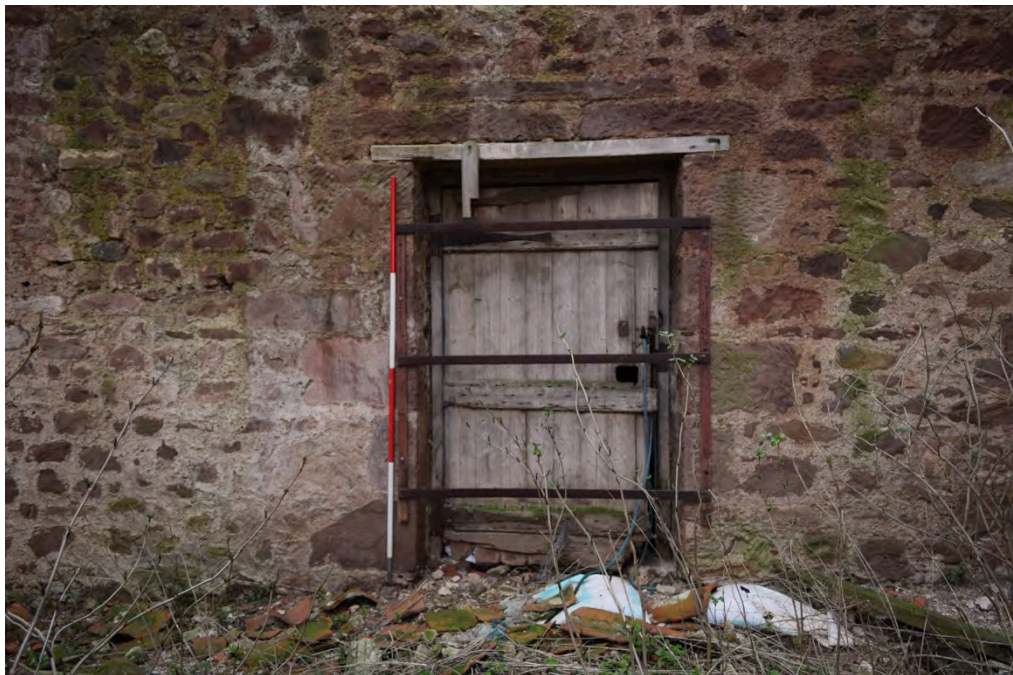
Plate 7: Detail of original door within the north portion of west range of Yard 2.

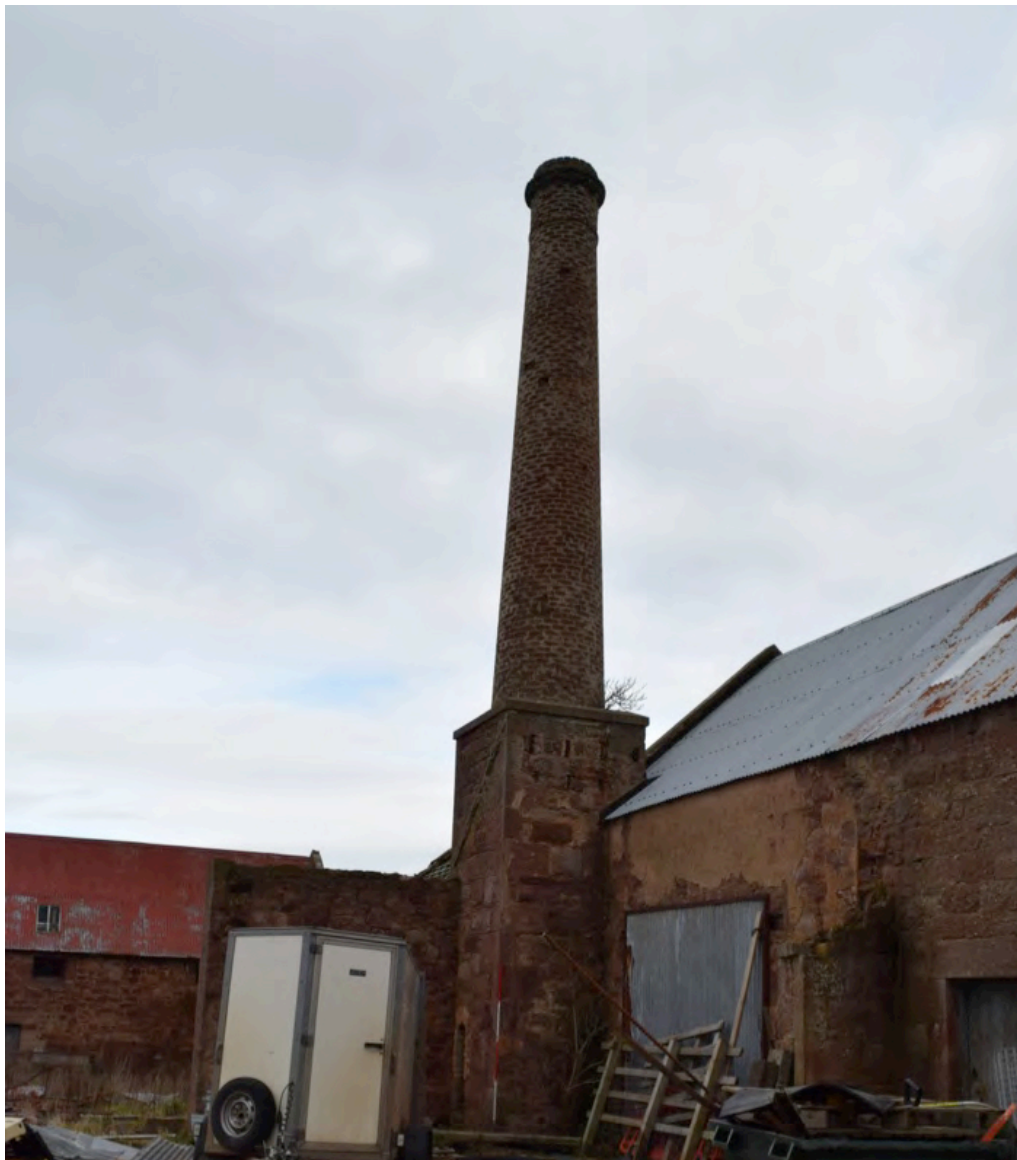
Plate 8: View of chimney stack, with raggle line scar on its west face and joist holes on its south face.

- 5.1.13 Approximately in the middle of the existing west range of Yard 2 is now much reduced footprint of a former engine house (extending to the west), complete with a tall sandstone chimney stack base and brick chimney. The roof of the engine house is evidenced as a raggle line scar on the west face of the chimney base and as joist

holes on the south elevation of the chimney base (**Plate 8**). The larger opening in the dividing wall between the north and south rooms (portions) of the west range would have held chutes to transport the grain into carts. The chimney base includes two openings– the first set within the north face represents an ash hole topped with large flat red sandstone lintel; while the second, with partially bricked arch, sits within the west face and represents former fire hole (**Plate 9**).

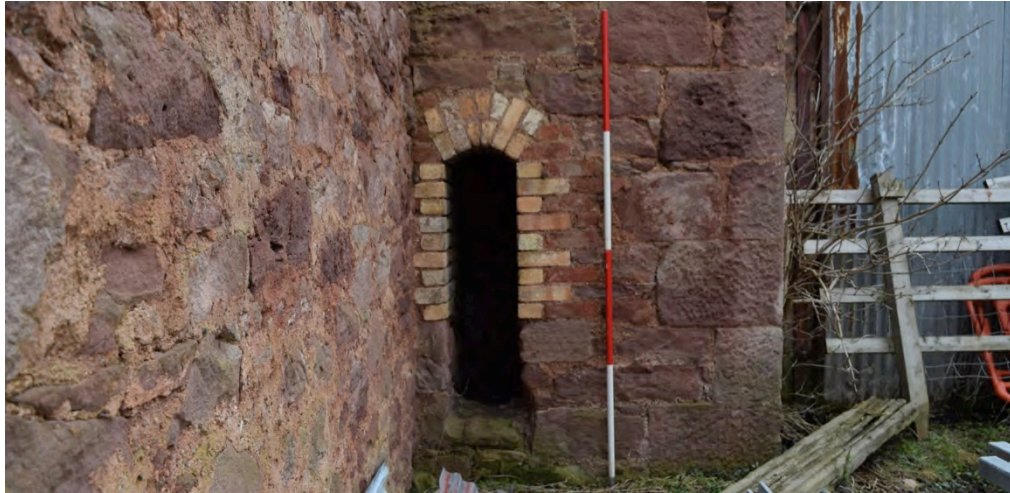
Plate 8: Yard 2; west range– detail of fire hole within the base of the chimney stack.

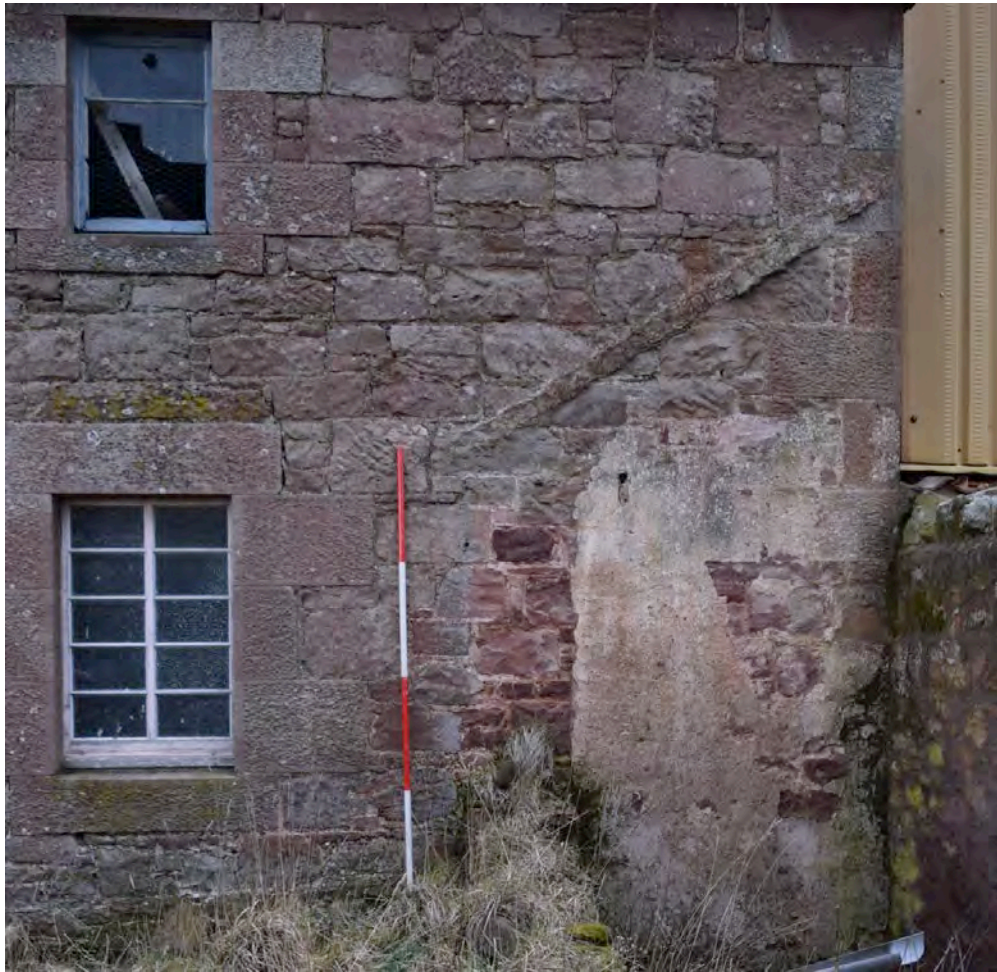
- 5.1.14 The extant south exterior wall of the west range of Yard 2 has two centrally located windows. A raggle line scar of a former pitched roof is visible on the same façade– on its east terminal and corresponds to the location of a wall stump extending from the façade towards south (**Plate 10**). The same wall is also manifested as a scar line on the façade. This now largely demolished structure does not appear to have been part of the original design for the Yard 2, as it covered the fine worked quoins on the east edge of the southern external façade of the west range. The quoins were clearly built as a corner prior to the erection of the now demolished structure confirming it was added after the initial construction of the Yard 2 has been completed. As it appears on the earliest OS maps of the 1840s, this again points to Yard 2 being a pre 1840s build and as this addition was not planned as part of the original Yard 2 construction then it must be early 19th century/late 18th century, given that the steam engine house was integral with the Yard construction. .

Plate 9: Yard 2; south range—detail of raggle line scar of a former pitched roof and wall scar visible on the same façade; note also turf covered wall stump extending from the façade towards south.
