Newhailes House Estate, Flower Garden Wall recording.

March 2007

Carried out on behalf of the National Trust for Scotland

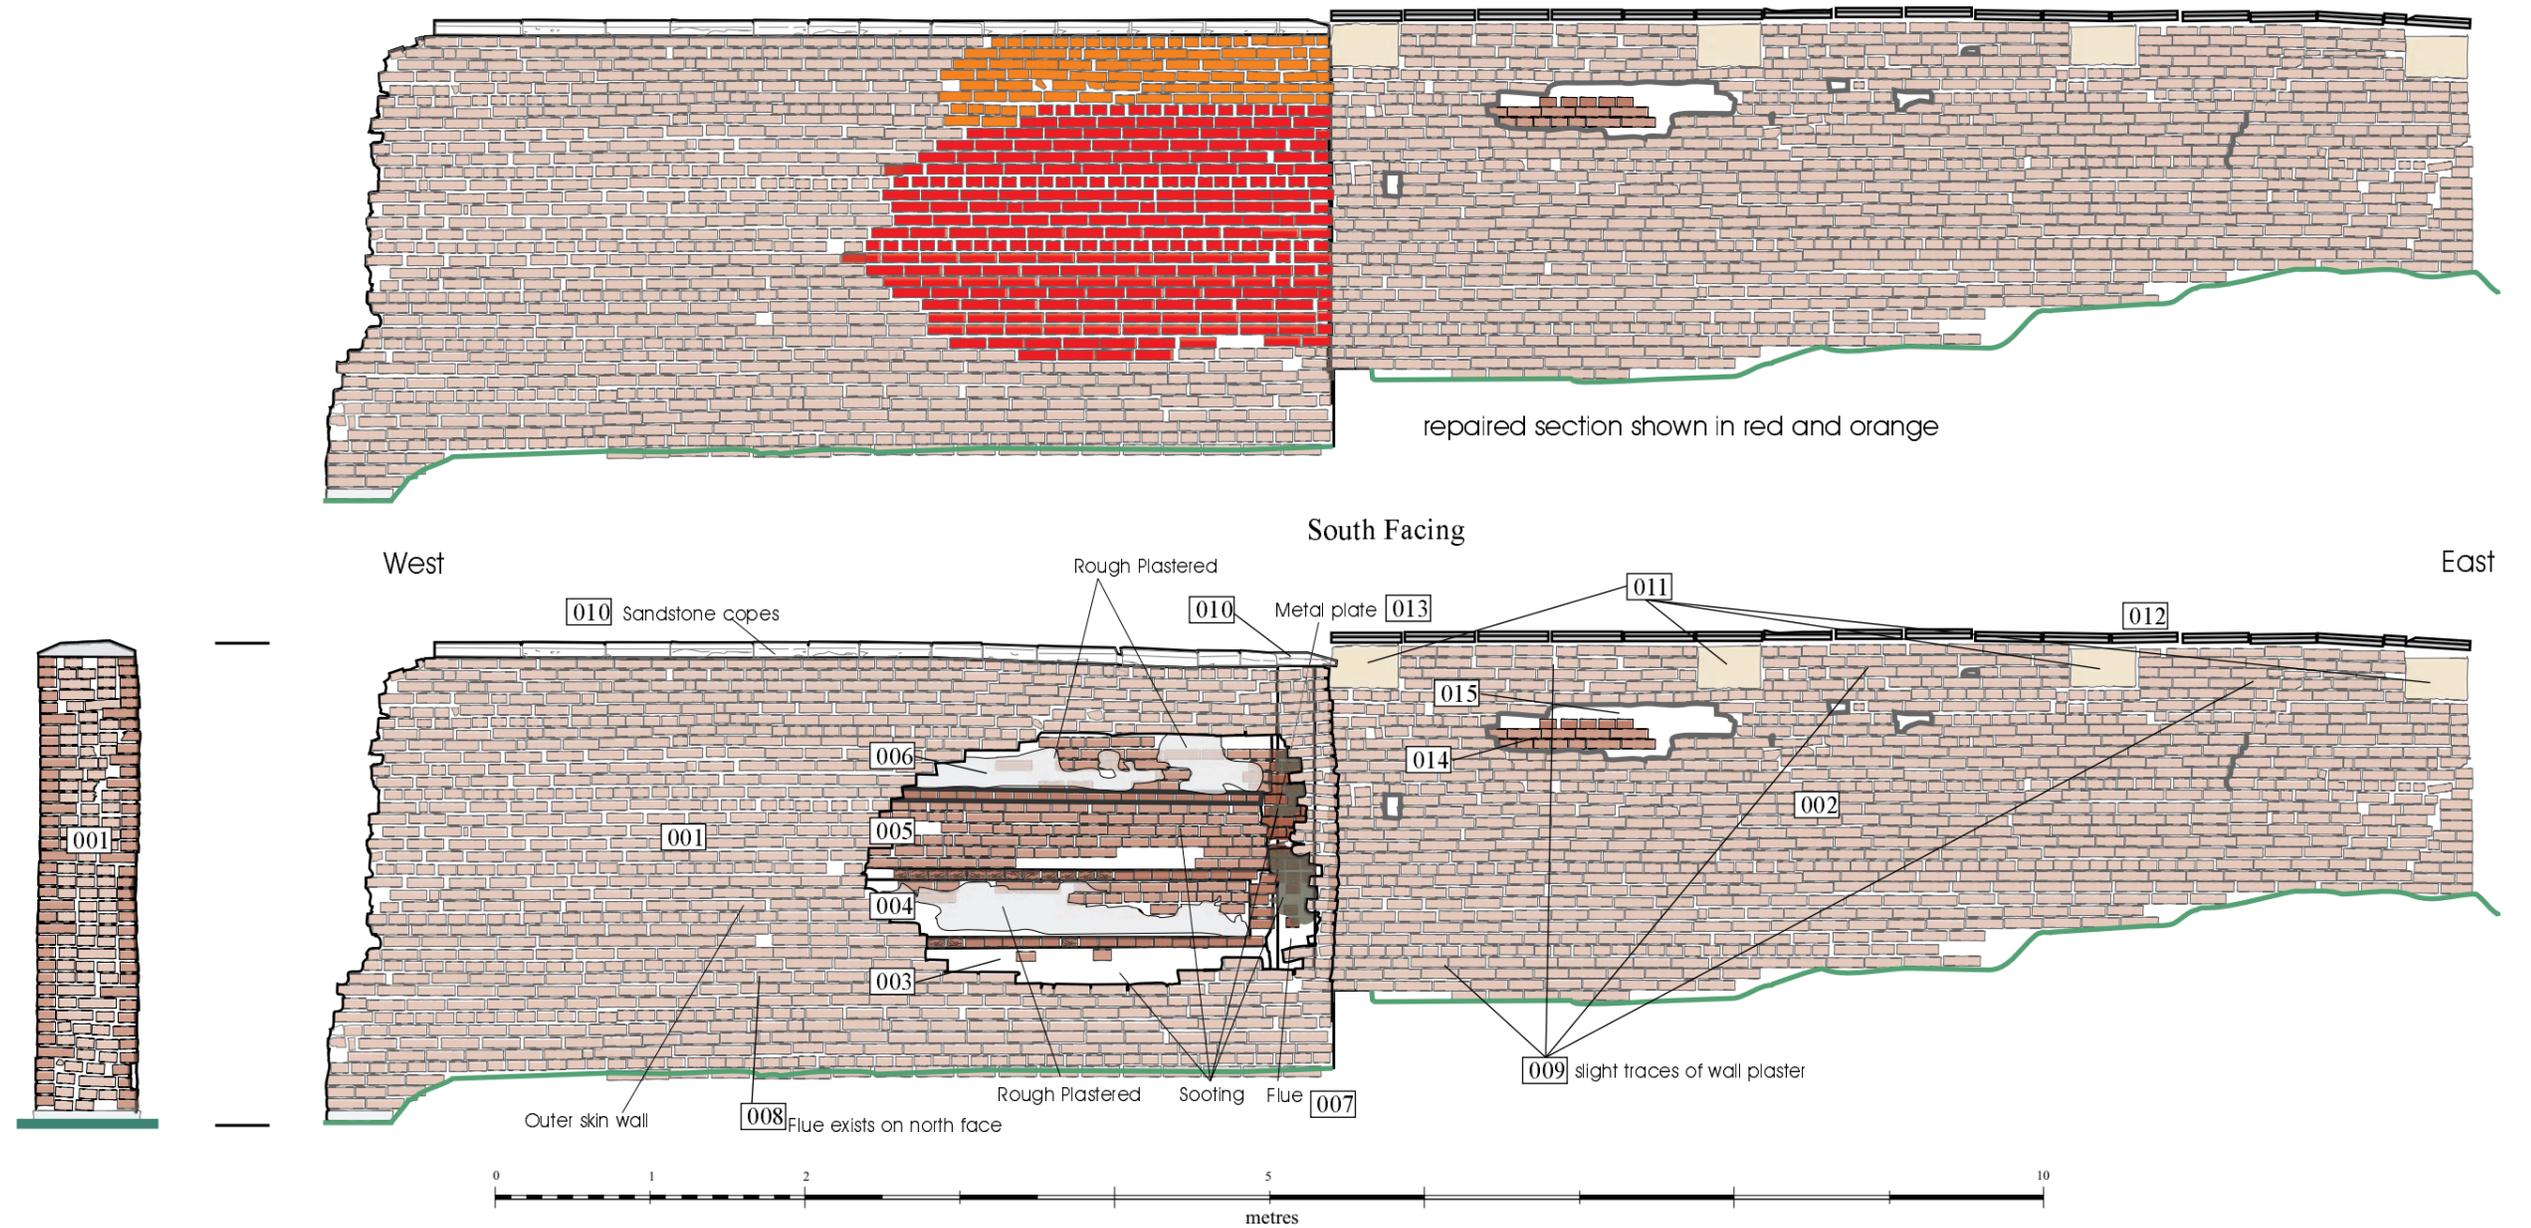
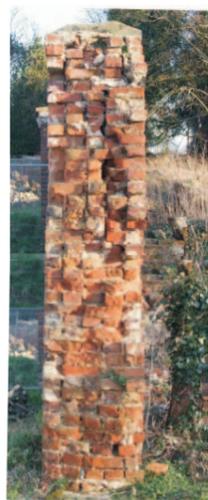
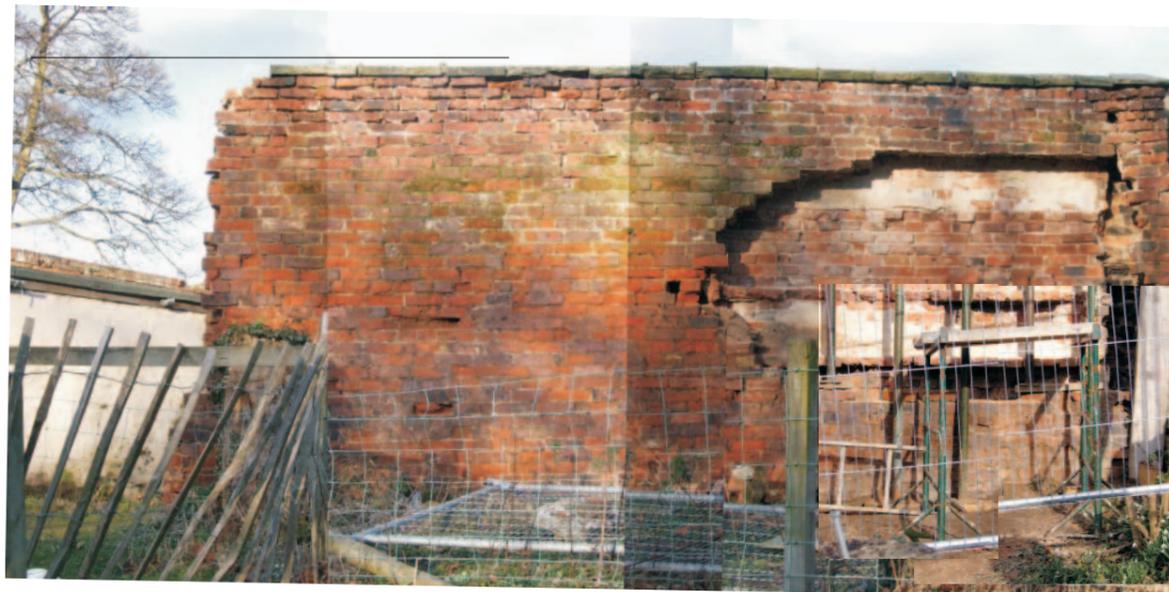
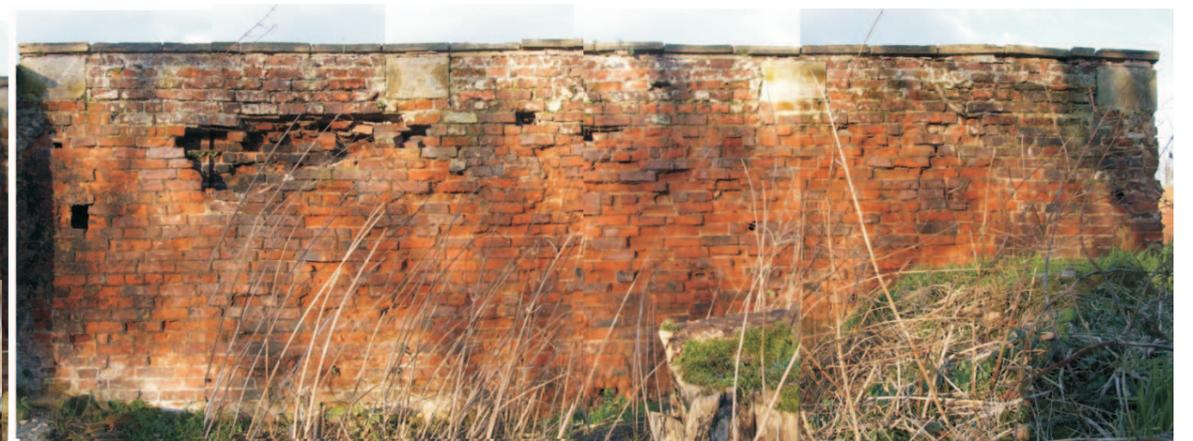
Wall [001] measures 6.50m (21'4") in length before a return to the north, followed by the continuation of wall [002] for a further 7.42m (24' 4"). The height of the wall from the base of the extreme west end, which forms a terminus, is to the top of the copes is 3.07m (10').

The brick style used is English Garden Wall bond, which is specific to strong walling techniques and would have been a commonly employed method in the 18th century, matching the date of the bricks. The bricks measure 235 mm x 64mm x 83mm (9 ¼ " x 2 ½ " x 3 ¼ ") and are hand-made, most probably locally. The thickness of the wall (640 mm or 2'1") allows space for the internal horizontal flues, four in total [003-6], a vertical flue [007] leading to a chimney hole in the stone wall cope [010], and a further flue [008] that exits from the north face of wall [001]. There is a flaw in this design however: the internal stretcher courses of bricks that create the horizontal divide between the flues are not tied into the southern skin wall of brick (see Fig. 7).

A metal plate [013] has been inserted into the wall from the north side (Fig. 5), and this could have been slid into or out of the vertical flue to control draught which was integral to the original system.

Figure 3: Top: Wall showing area to be repaired and position of bricks
 Middle: Wall recorded as seen
 Bottom: Photomontage of wall.

This programme of works has recorded the walls as specified. An elevation of repair has been produced (Fig. 5) and the construction and operation of the flue has been interpreted (Fig. 6).

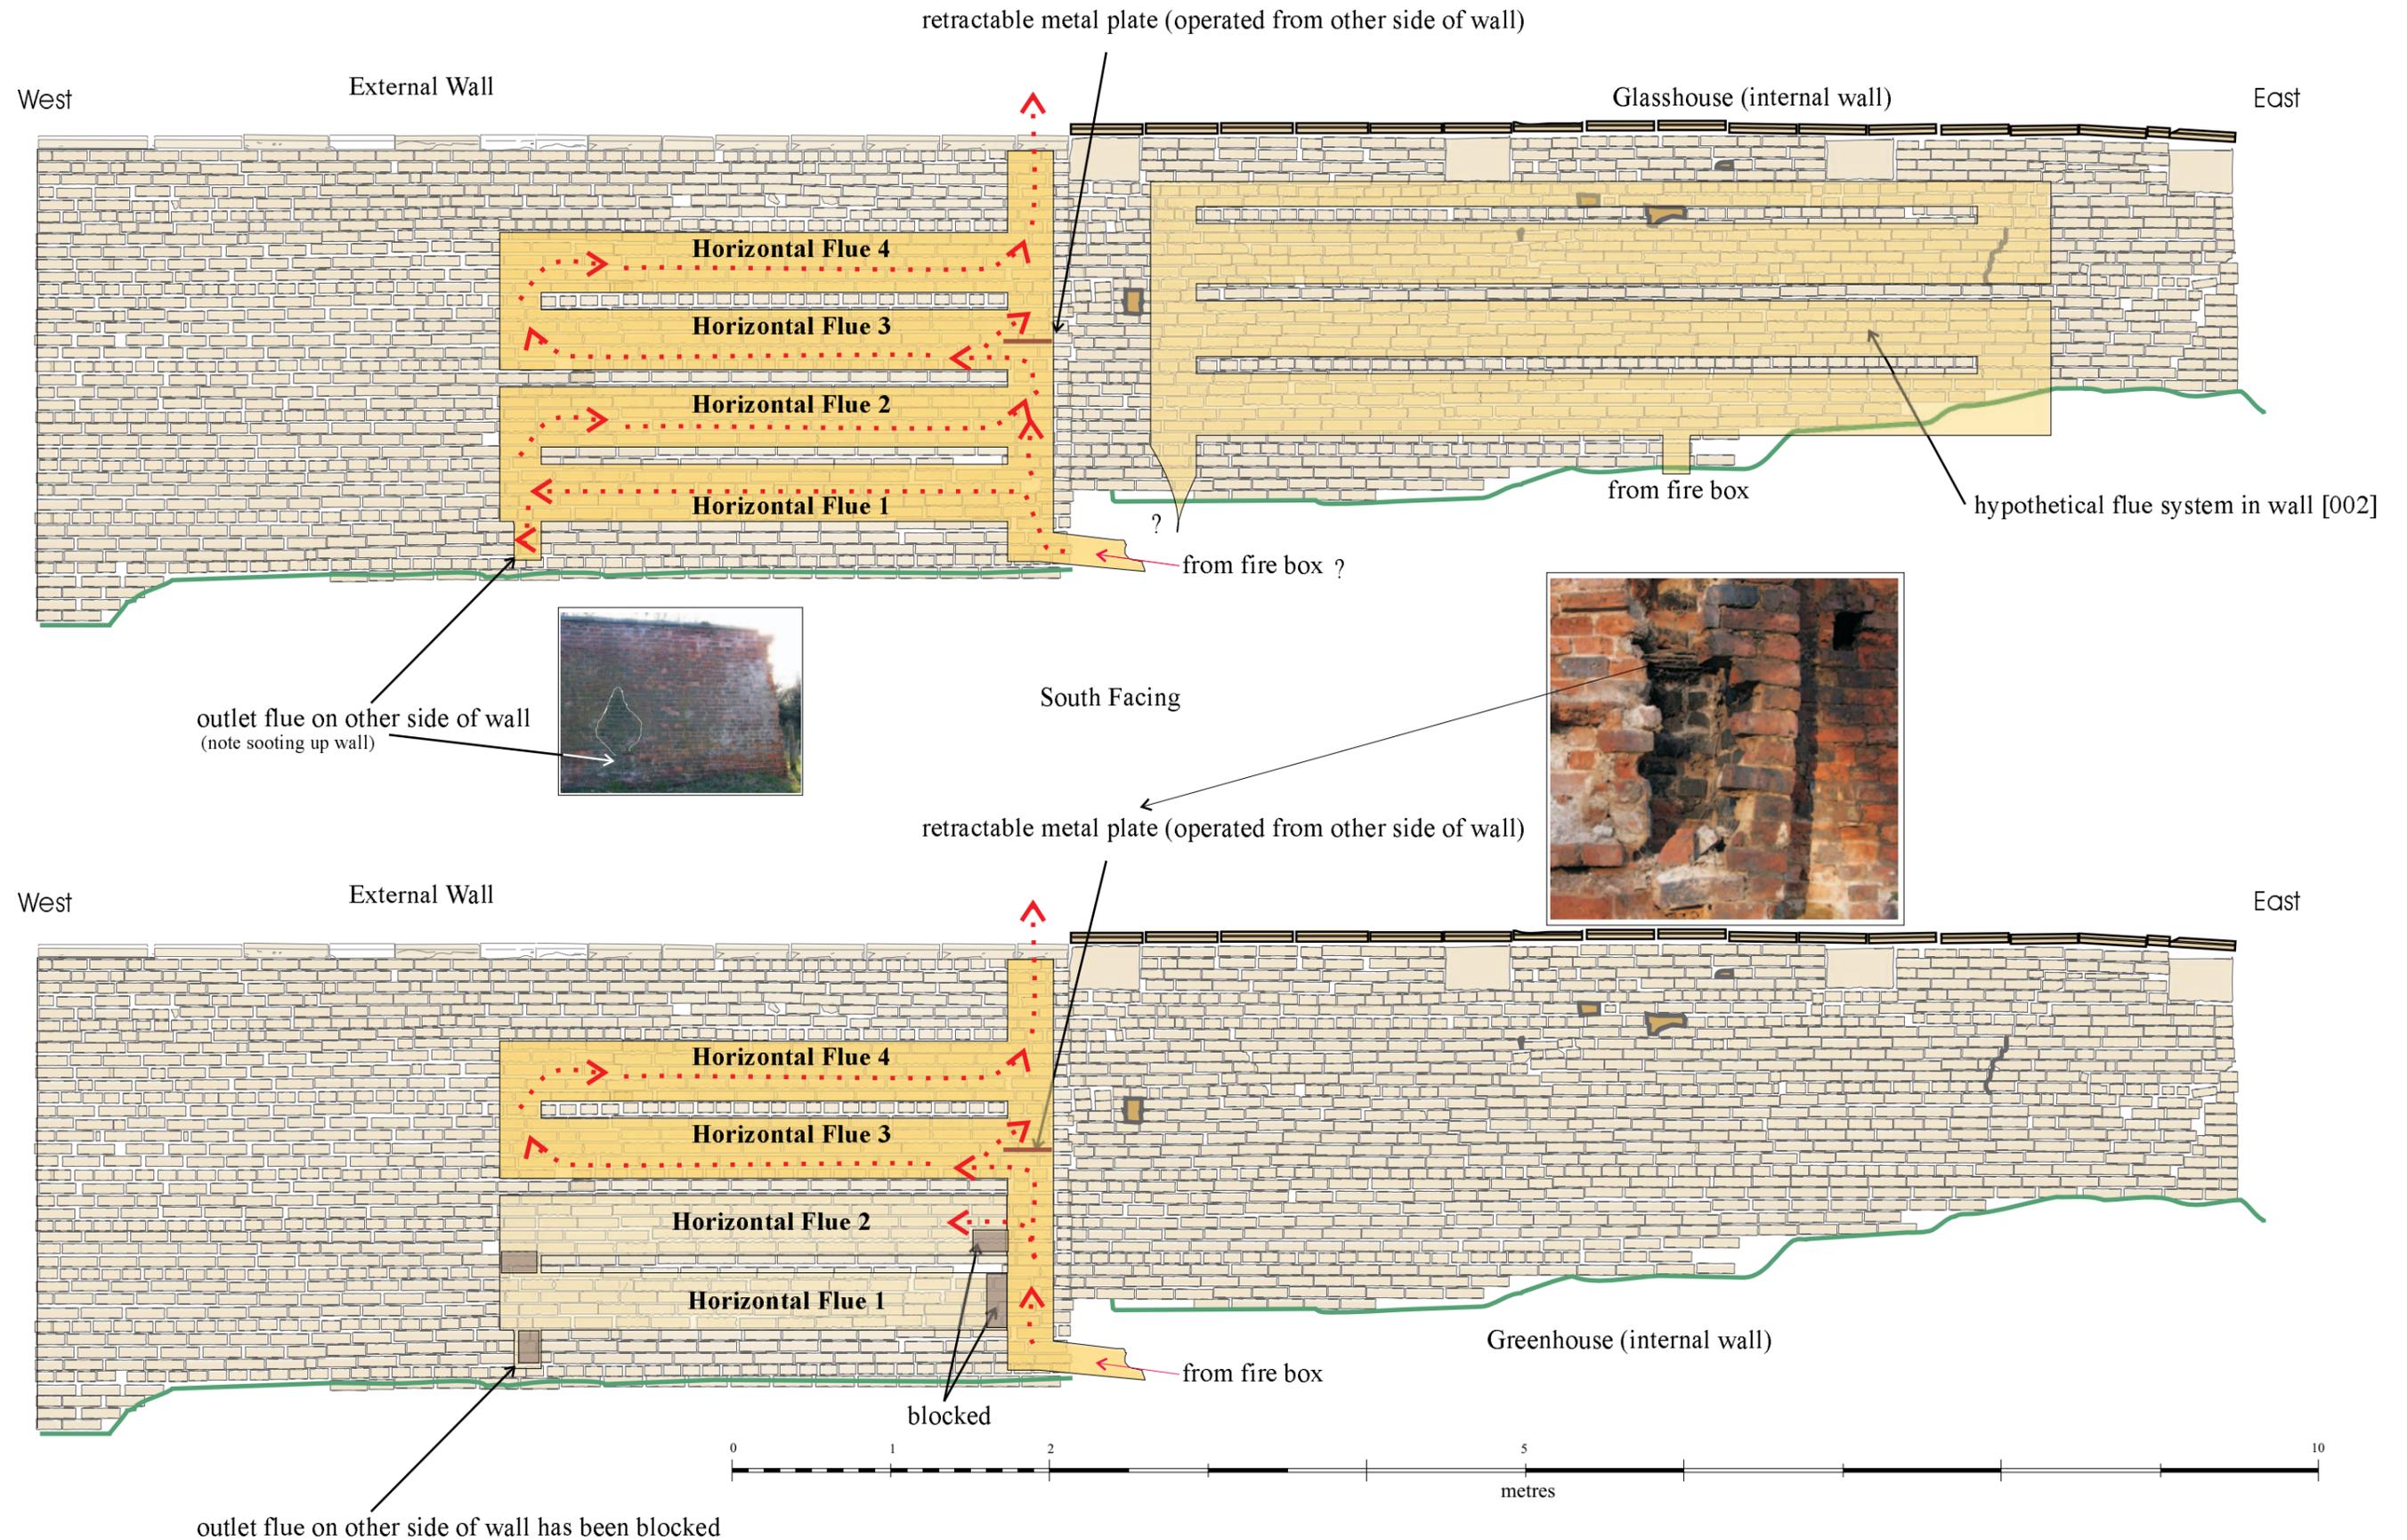
It is clear that two phases of use had taken place within wall [001]. As much as can be understood, the original phase had four horizontal flues [003-6] that drew heat from the main firebox to the rear of wall [002]. The heat would be drawn up both the vertical chimney flue [007] and along flue 1 [003] (the draw for flue 1 is created by a small aperture [008] in the north face of wall [001][not clear what this means]). This would draw hot air into flue 1 [003] and then up into flue 2 [004]. If the iron plate [013] was also set in place (as it is positioned half way down flue 3) the draw would continue along flue 3 [005] and return by flue 4 [006] back to the vertical chimney flue [007]

It is clear that the metal plate was essential for regulating and controlling the system. The deep blackened sooting on the lowest flue [003], and the blocking of this flue at the east and west ends, leads to the conclusion that a fire damaged the system. It is not clear how these systems could have been cleaned to help prevent chimney fires - a more difficult task with complicated horizontal flues that double back on themselves.

The blocking of flue 1 [003] and the partial blocking of flue 2 [004] would have meant that only the top two flues [005 and 6] would continue to work. This would make the use of the metal flue plate essential to ensure that a draw was created through the upper flues rather than directly up the vertical flue and chimney.

Figure 6: Top: Wall as built, with 4 flues operational. Bottom: Wall after blocking of lower flue.

Further remedial work will be required on the east wall, to both repair the collapses and also to ensure that the flue and heating system is repaired fully, as the entire system must be rebuilt and cleaned before any of it will function. A glasshouse could be reconstructed on the foundations present, in which case further recording work would be required on the remainder of the wall, and plans made of the foundations. Research on similar structures would be useful.

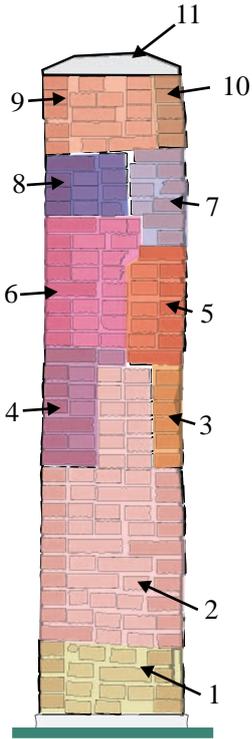
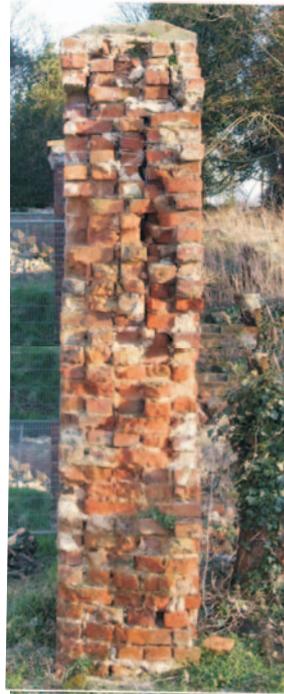
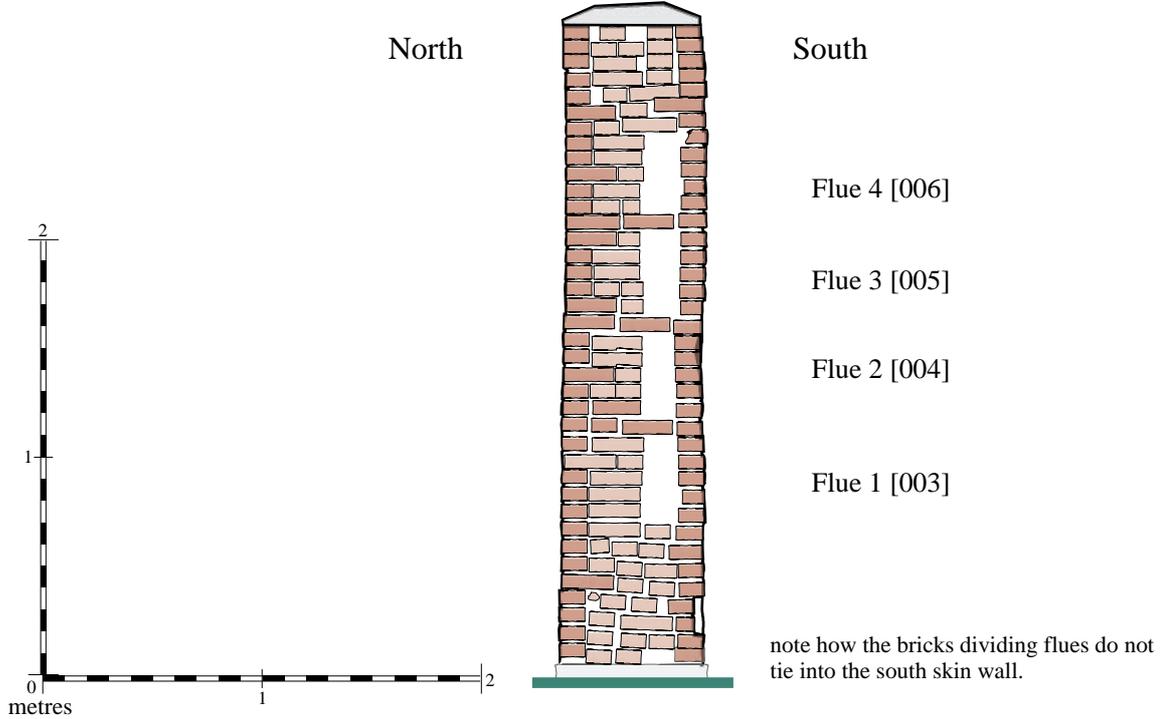
phases of construction for building wall [001]

The workings of this system can be viewed on Figure 6, while a cross-section on Figure 7 shows the lack of tying in of the bricks dividing the flues with the south skin wall.

Figure 7: Cross section of Wall [001] showing flues and possible phased construction of wall.

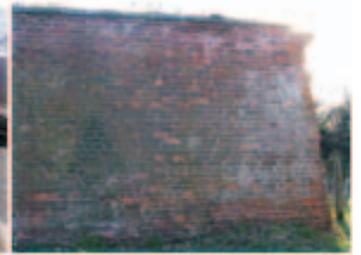
NH_1_067.JPG

64	NH_1_064	View of horizontal course in Flue [004] - note bricks do not tie to wall.	-	“
65	NH_1_065	View along Flue [004]	-	“
66	NH_1_066	View along Flue [003] – note solid brick terminus	-	“
67	NH_1_067	Details shot of blocked flue exit in wall [001] on north facing elevation, including soot marks up wall.	NE	“
68	NH_1_068	Detail of Flues [003] & [004] and vertical flue [007] – metal plate to top of image.	SW	“
