# Blenheim House Hotel, North Berwick, East Lothian

Data Structure Report

May 2017

## Data Structure Report

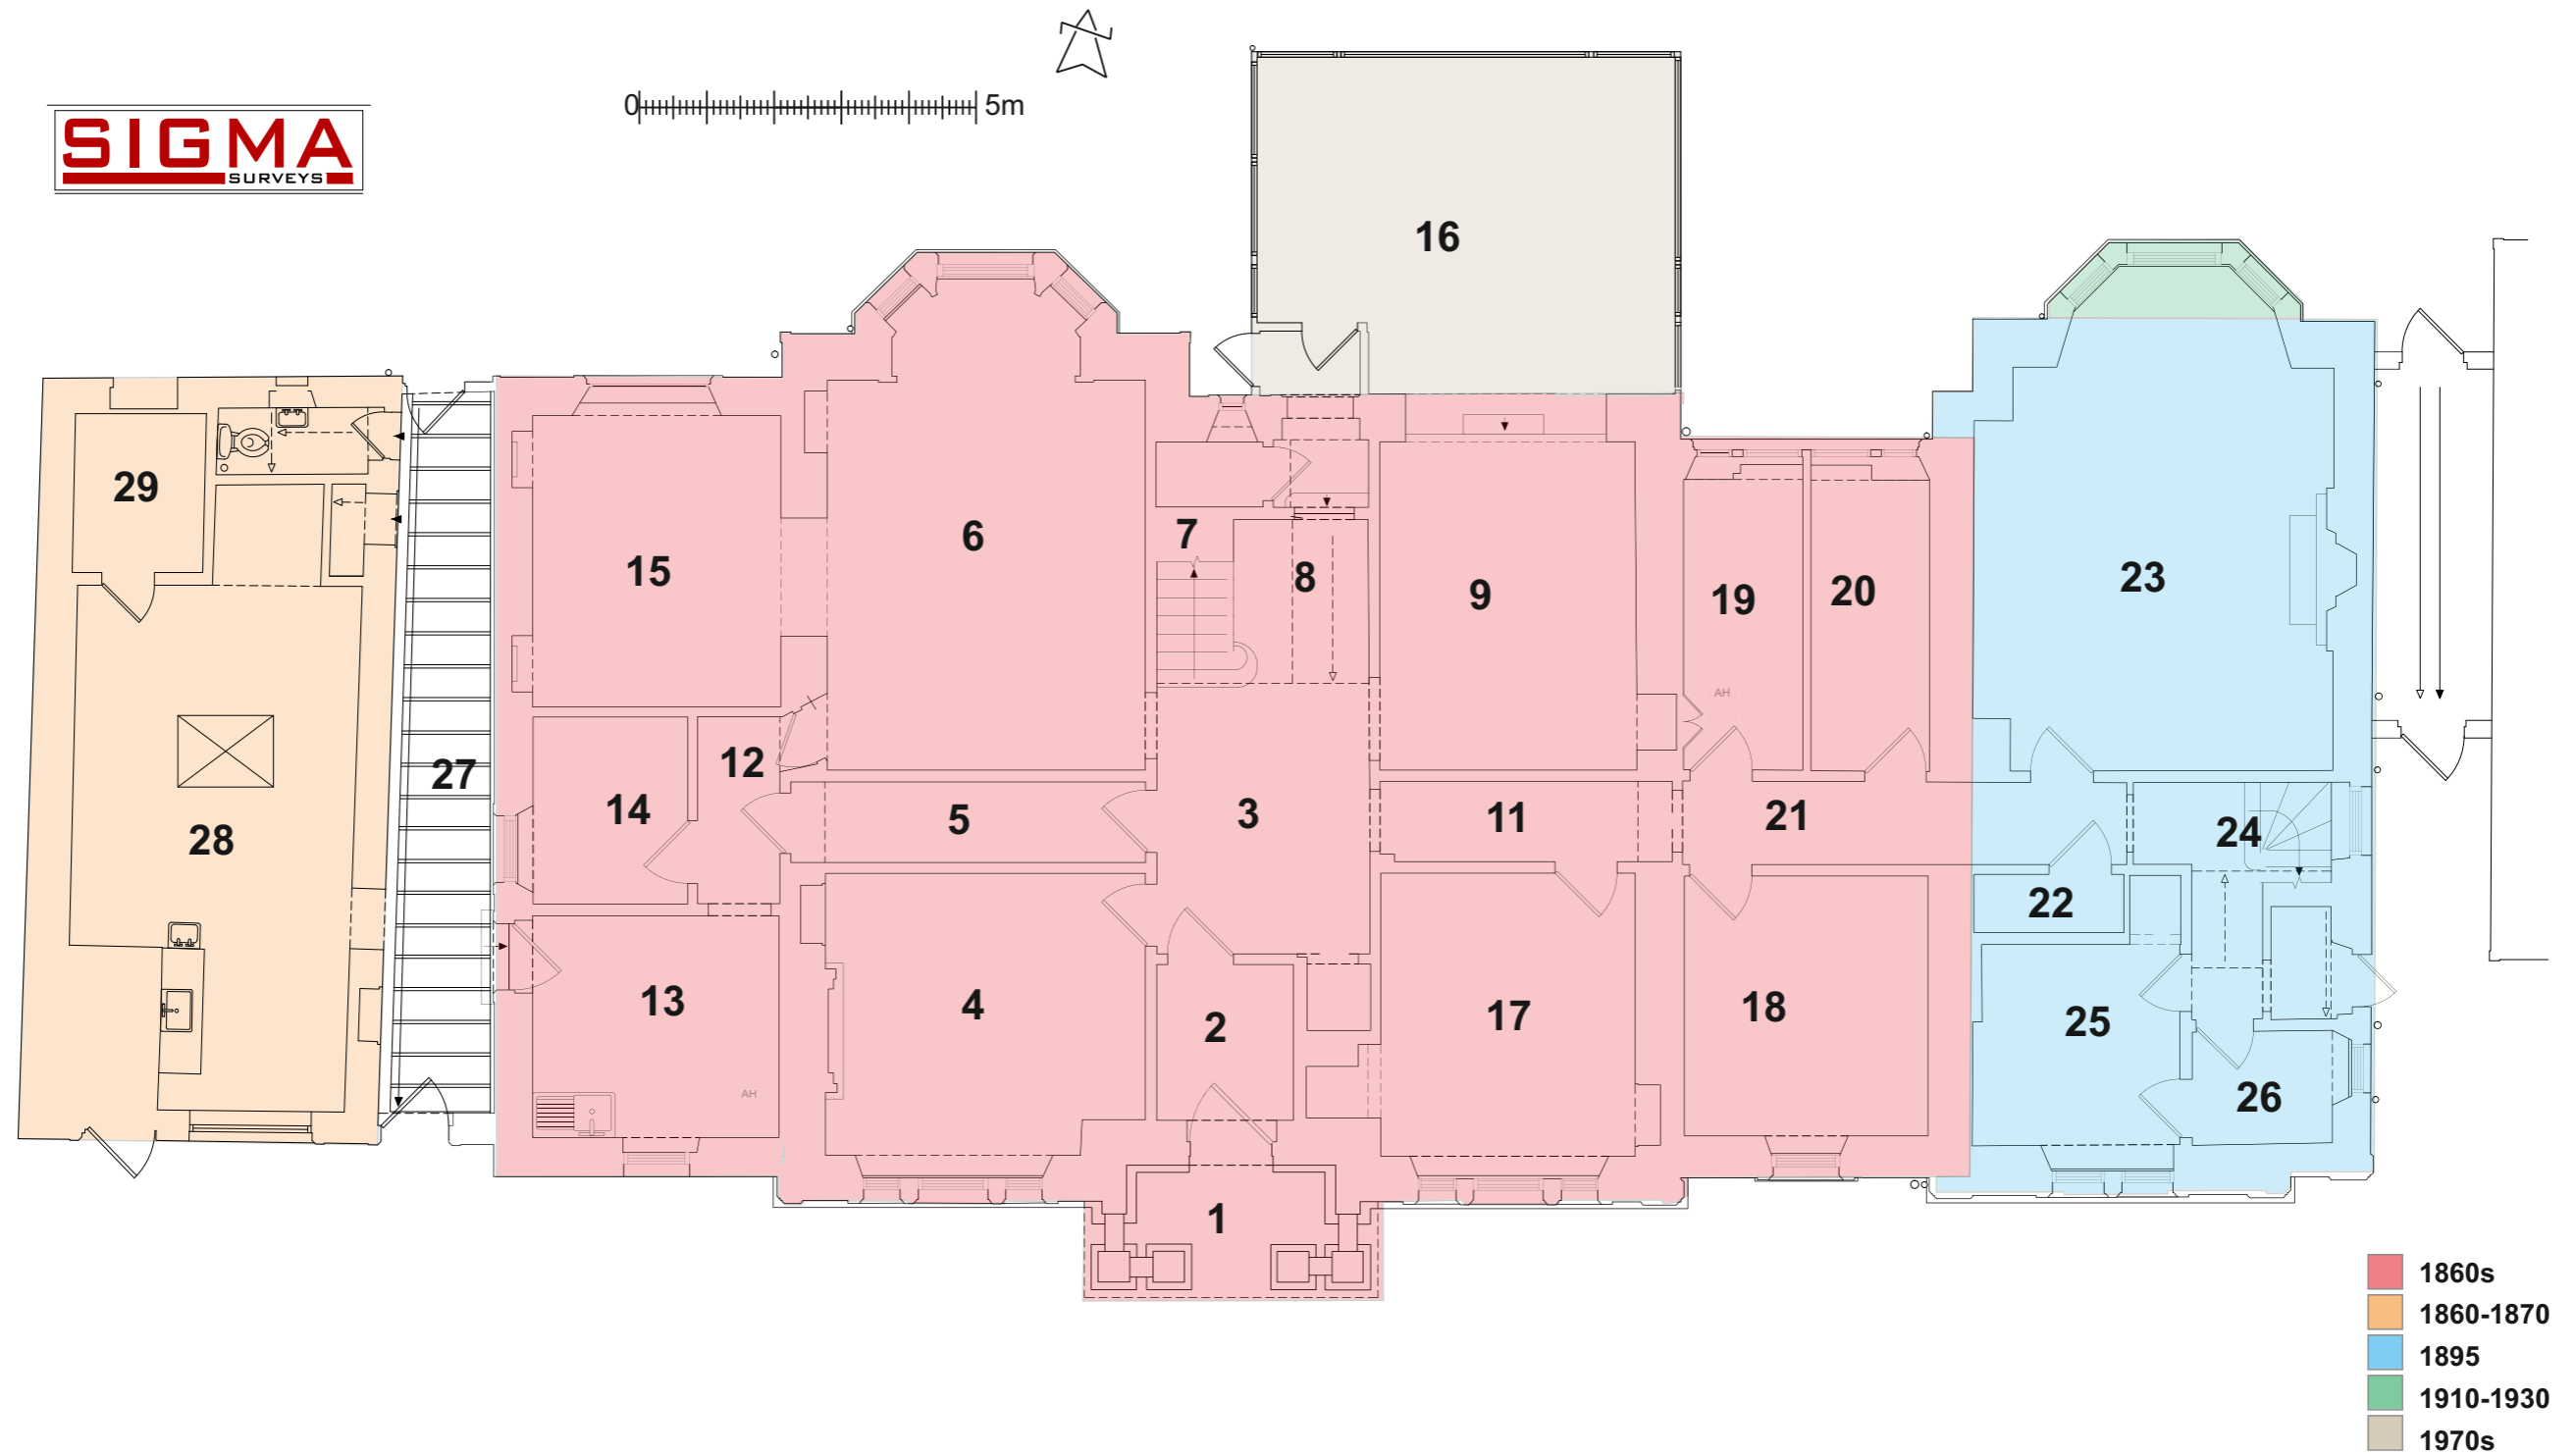
Figure 3: Ground floor plan  
Plan based on survey carried out by Sigma Surveys

Ground floor (**Figure 3**) consists of a total of 29 rooms, including the kitchen (Room 28), two large and handsomely decorated (former) reception rooms, with canted bay windows (Room 6 and 23) and the roofed front porch (Room 1). Rooms 1 to 21 (excluding 16) correspond to the original build (1860s); Rooms 27 to 29 to the western flanking wing and Rooms 22 to 26 represent the later extension (1895).

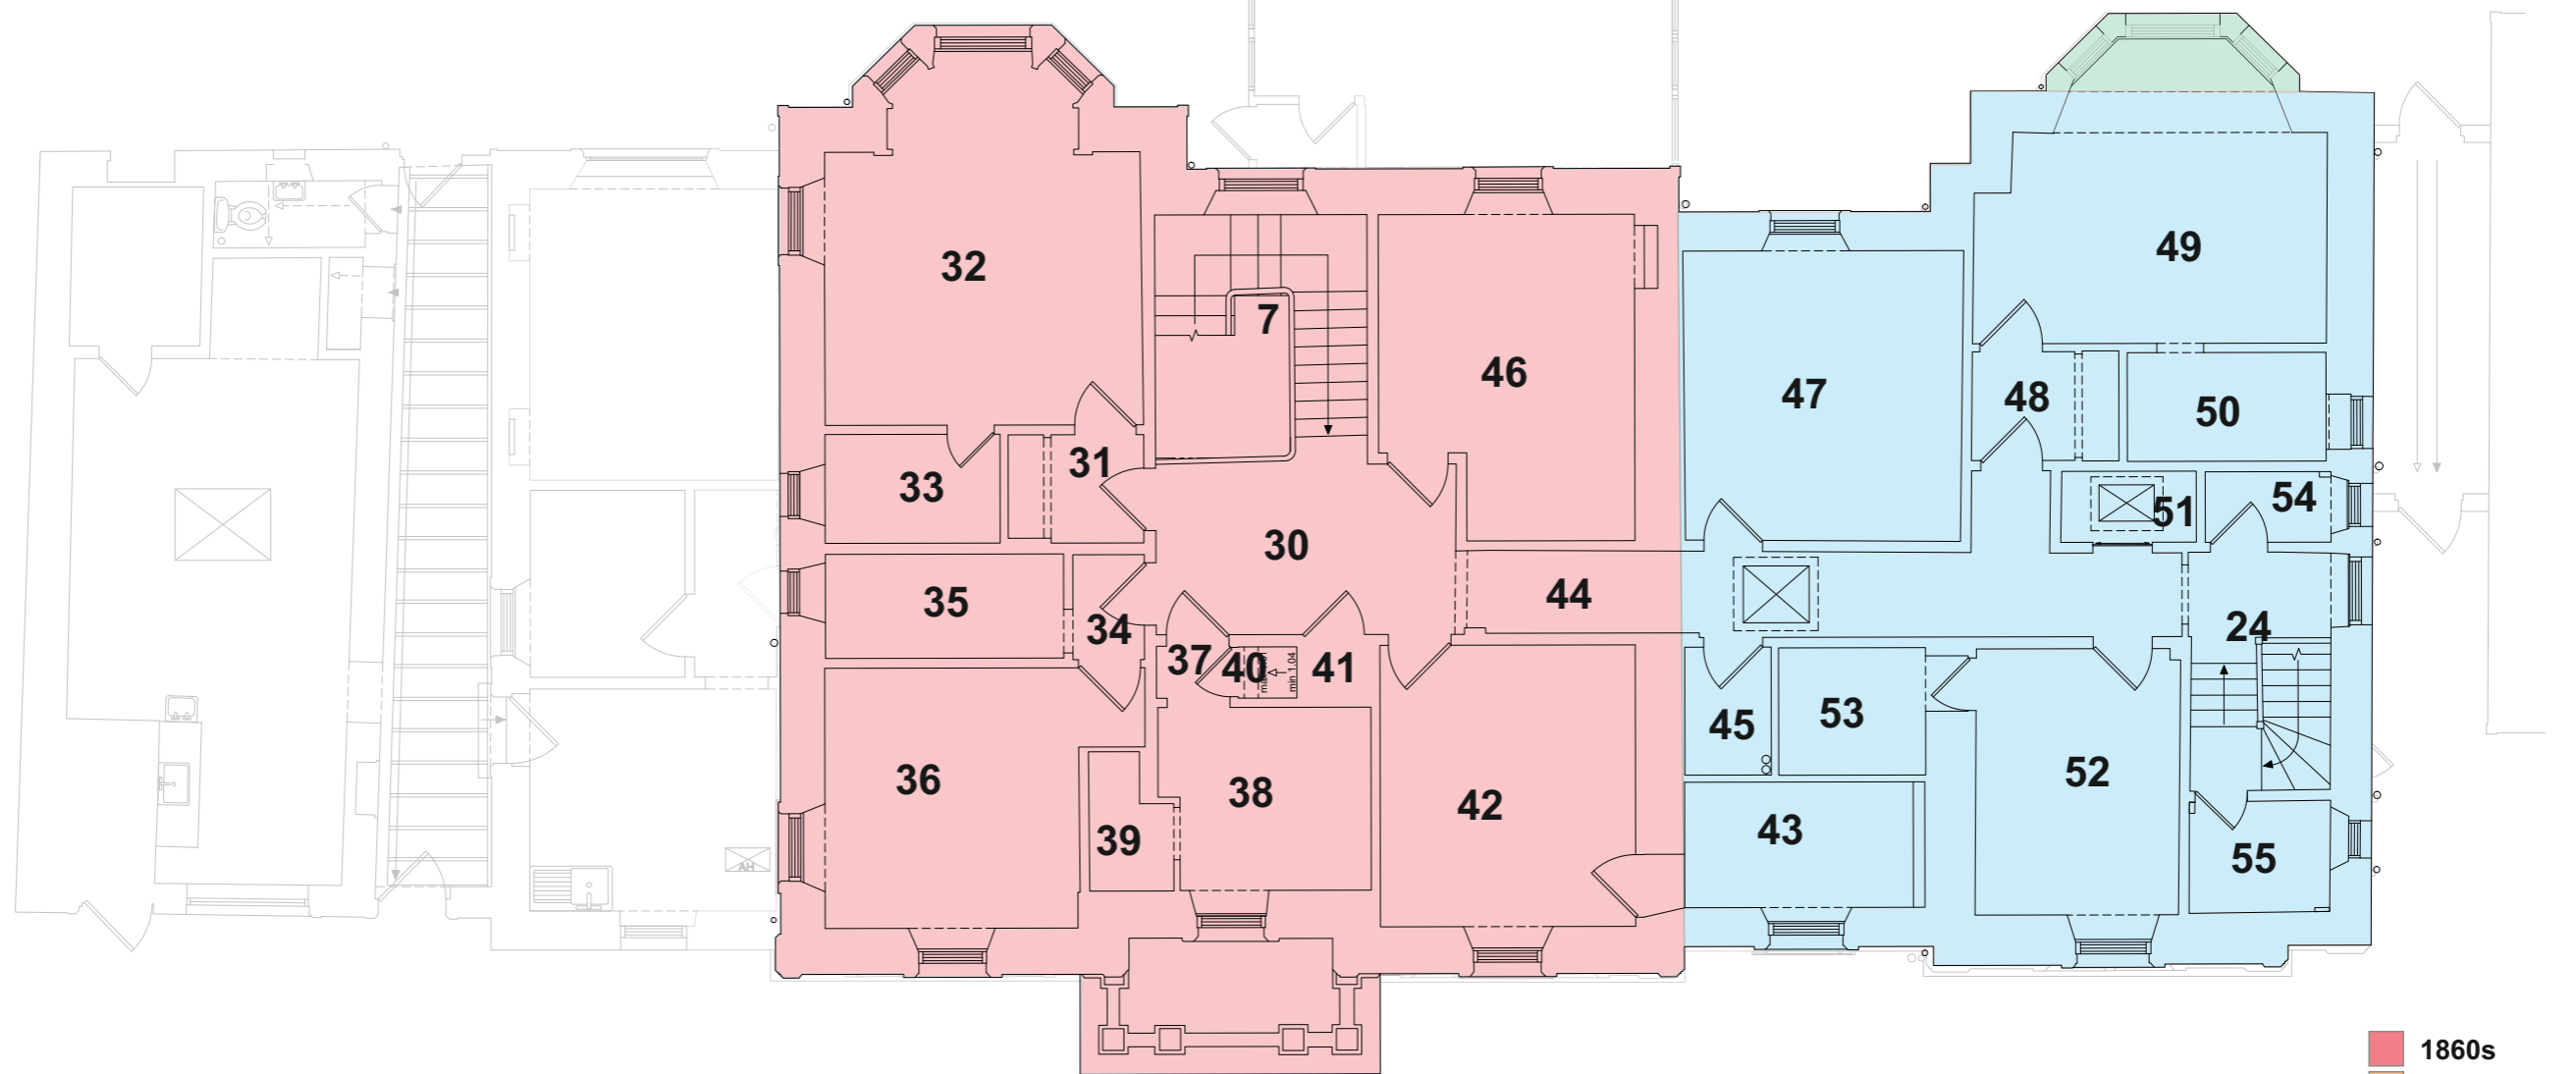
Figure 4: First floor plan  
Plan based on survey carried out by Sigma Surveys

The first floor consists of sweet of 26 rooms– mostly bedrooms and ablution chambers (**Figure 4**). The first room worth highlighting is a small Room 51 (corresponding to the 1890s extension phase), formerly probably a linen cupboard. The room retains beautifully preserved two-leafed sliding doors (**Plate 10**), complete with original covered key-hole, situated on the left hand-side of a door-frame, as part of a locking mechanism. The sliding door runs on cast-iron pulley wheels, forged in the Carron Valley Ironworks. The room is lit by original (1895) roof light (cupula) high on the ceiling.

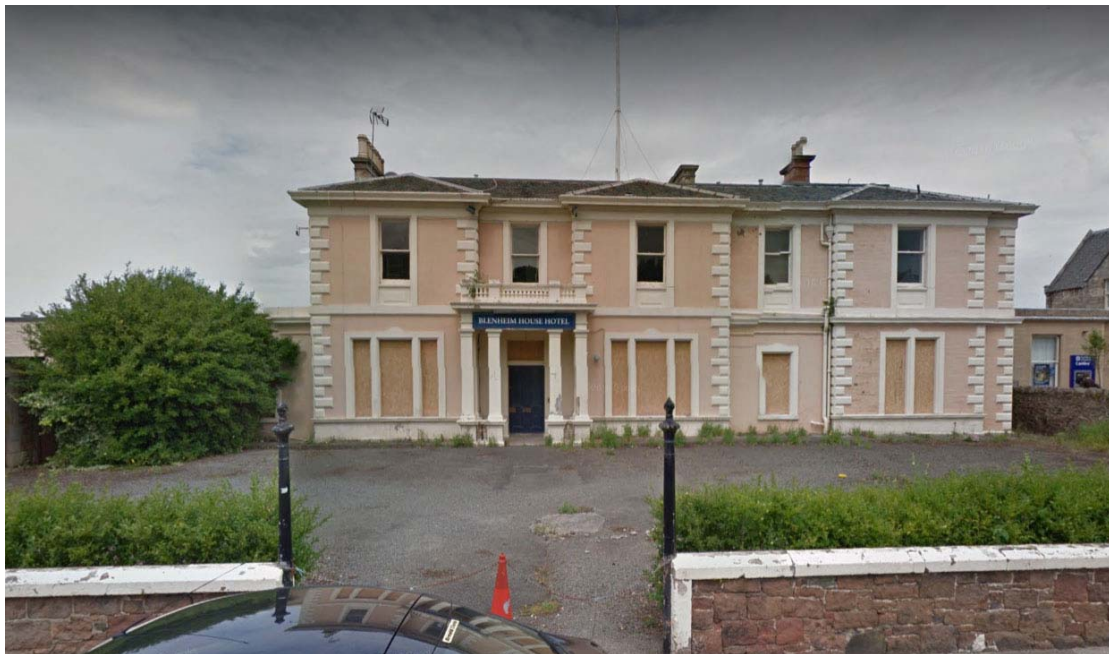
*Plate 2: The south principal elevation, with 1895 extension to right.*

The main fabric of the south exterior façade, corresponding to the original build (i.e. 1860s), consists of a fine ashlar sandstone, painted light pink, with rusticated quoins, raised margins and eaves courses painted white (**Plate 2**). A single story tripartite porch extends from the central bay, with pedestaled piers and squared balustrade. The two flanking bays are advanced with tripartite windows at ground floor and single sash-and-case plate glass windows above—these with raised panels below. The original house had a low pitched-roof, single story wings to east and west—both constructed of similar well-dressed sandstone ashlar and with single centrally placed framed sash-and-case windows.

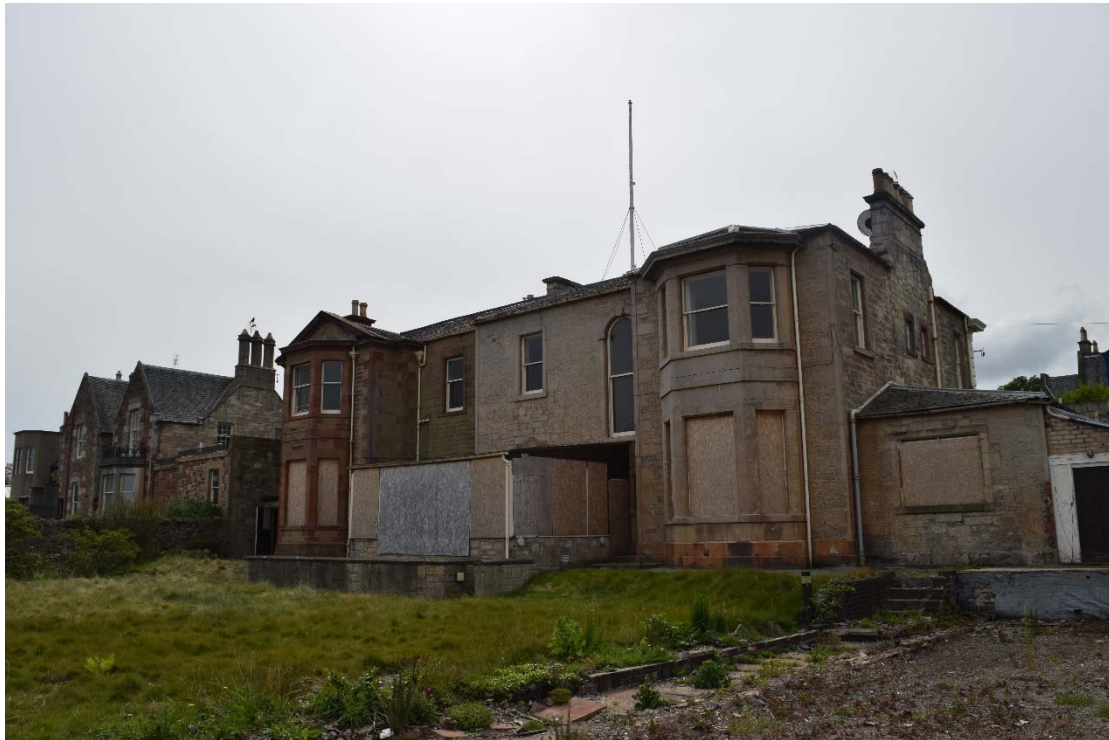
*Plate 3: The rear North elevation with later 1895 extension (note pedimented façade) and later canted bay in red sandstone to left; original build centrally and single-story west wing to right.*

The N (rear) exterior elevation of the original build is composed of squared rough coursed sandstone and ashlar quoins on a red sandstone plinth (**Plate 3**). Windows are of finely dressed sandstone with raised margins. A full height canted bay to the west with low pitched roof contains wide sash-and-case windows. There is a tall round arched stair window at the centre of the original elevation, with raised keystone and springer voussoirs. There is a single window at first floor level to the east. The later 1970s extension obscures much of the ground floor fenestration to the east of the canted bay but the location of one is just visible directly beneath the first floor window, and it can be assumed a further window would have been located beneath the long stair window.. The original lower window on the east wing has been widened to accommodate interior alteration, while the west wing retains its original square form, with raised margins.

The western flank extension is again plain coursed with squared rubble (**Plate 3**). It is attached to the west wing of the main house with a later brick wall and door, opening into the bisecting corridor; there is a single small barred window in the elevation. A demolished modern structure has been removed from directly north of this location, evidenced by the traces of brick built foundations.

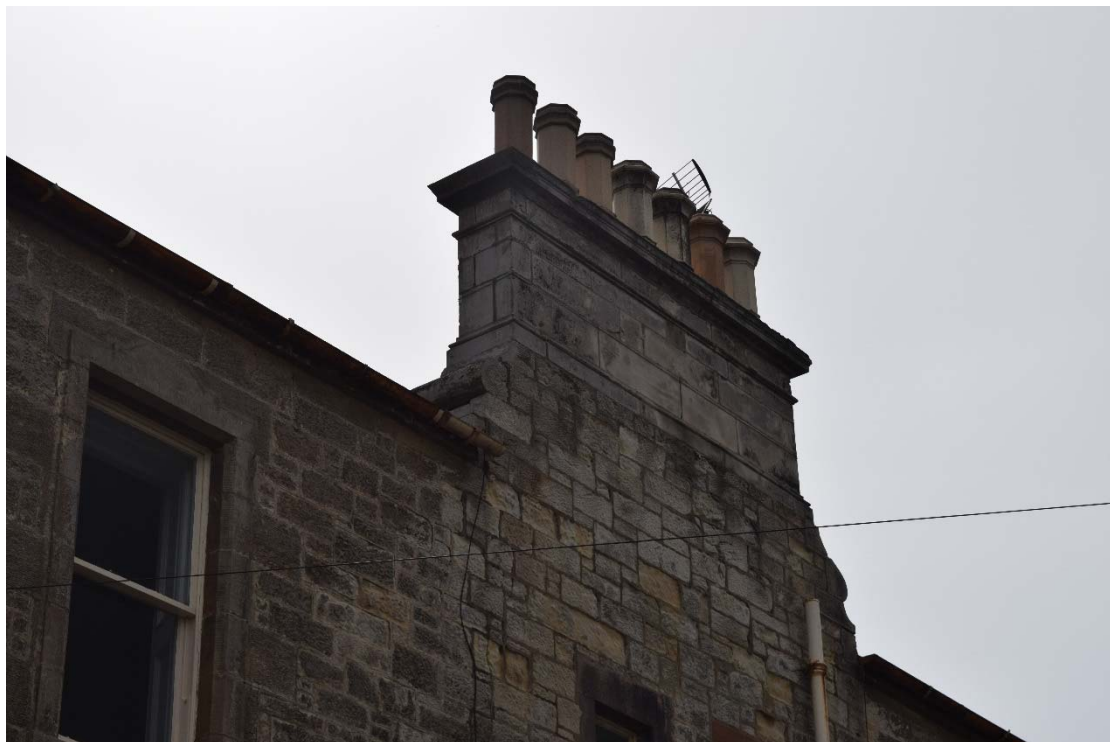
Both elevations have low, pitched slate roofs, with roof stacks of ashlar masonry (**Plate 4**), the central stack representing the original east bounds of the house.

*Plate 4: West elevation detail with gable end chimney stack.*

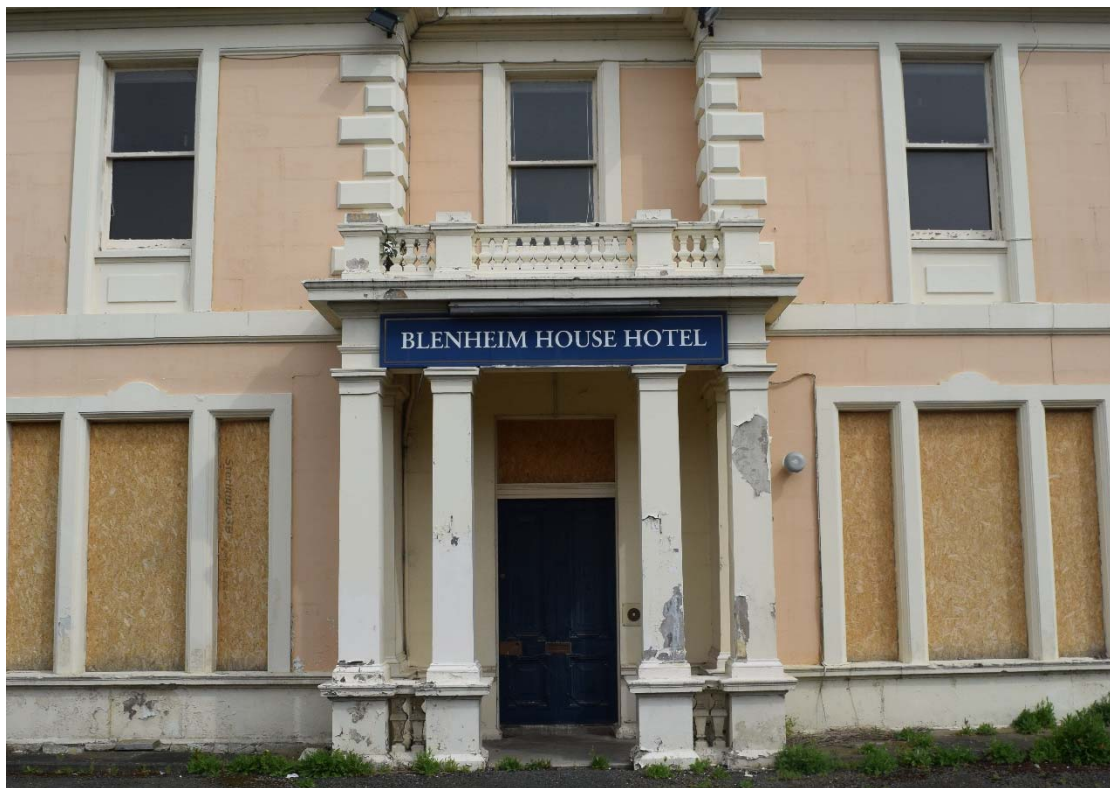
*Plate 5: Detail of the exterior porch (Room 1) on the principal south elevation.*

The roofed porch (Room 1; **Plate 5**) projecting from the principal south exterior façade leads into a small entrance hall/foyer (Room 2), this with well-preserved original tiled floor. The foyer (Room 2), in turn, leads into the ground floor hall (Room 3), where, unlike in Room 2, the tiled floor is significantly damaged due to the inconsiderate use of a carpet glue (**Plate 6**).

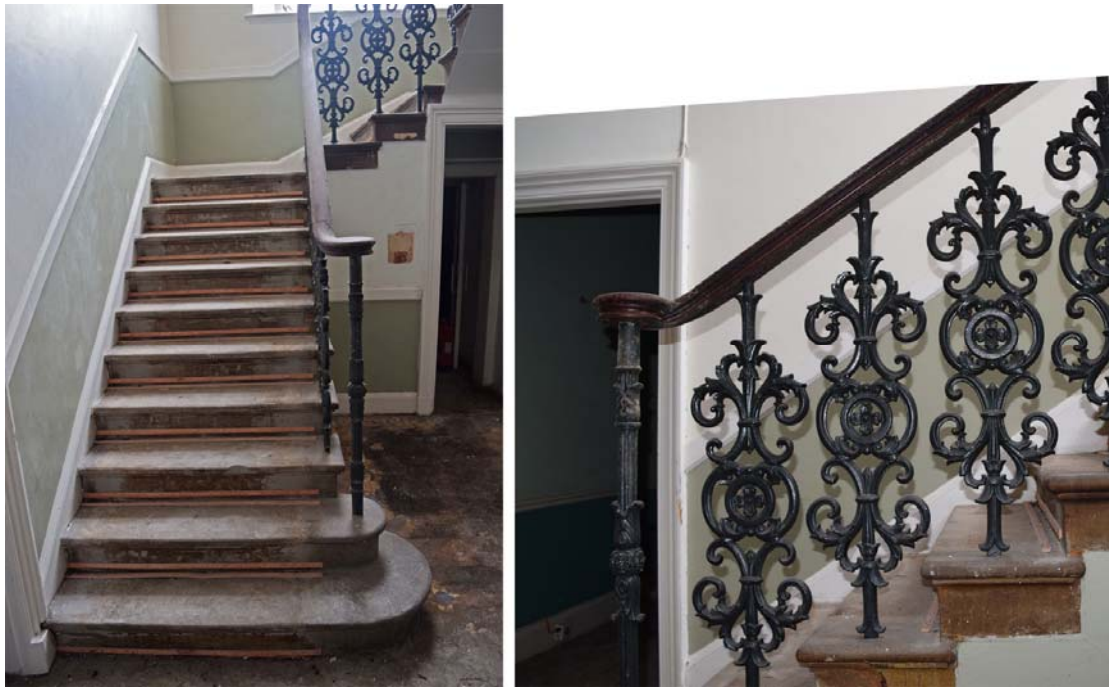
Plate 6: Left, Main stairs (Room 7); right, detail of ornate ironwork on the main staircase.

A well proportioned original dogleg staircase (Room 7; **Plate 6**), consisting of two curtail steps at the bottom, bull-nosed risers and wrought iron work supporting the banisters, leads to the first floor. The main staircase is lit and embellished by a tall round arched stair window.

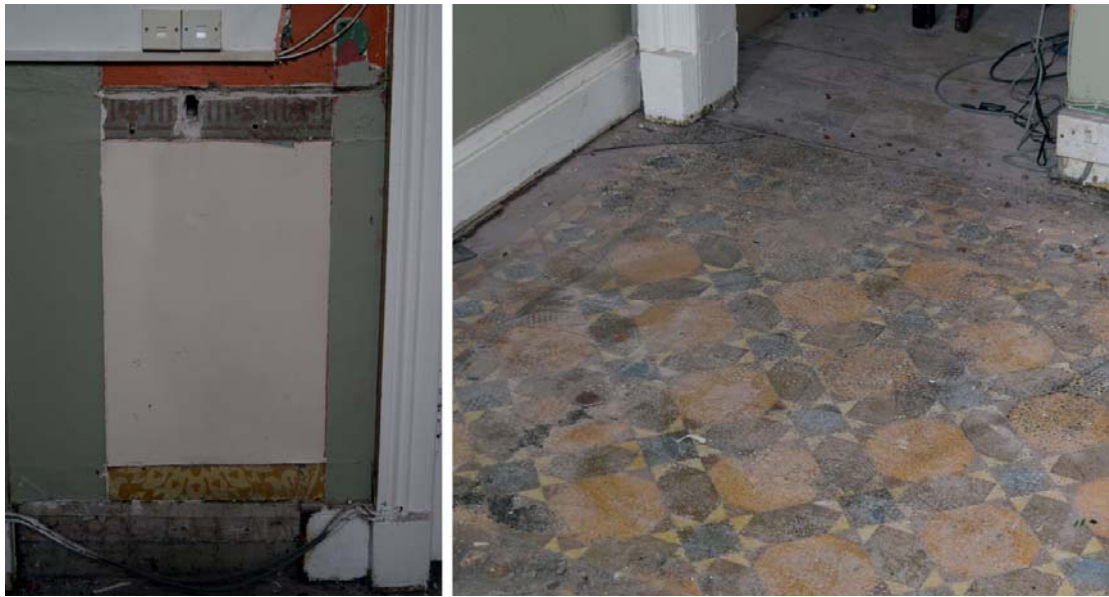
Original decoration scheme survives on the south elevation of Room 3, in the form of small portion of a wall-paper, which was preserved under later panel (**Plate 7**). A number of panelled doors lead off the hallway (Room 3) to a variety of rooms and two long narrow corridors to the east (Room 10) and west (Room 5).

*Plate 7: Room 3– detail of decorative paint scheme (left) and floor tiles (right).*

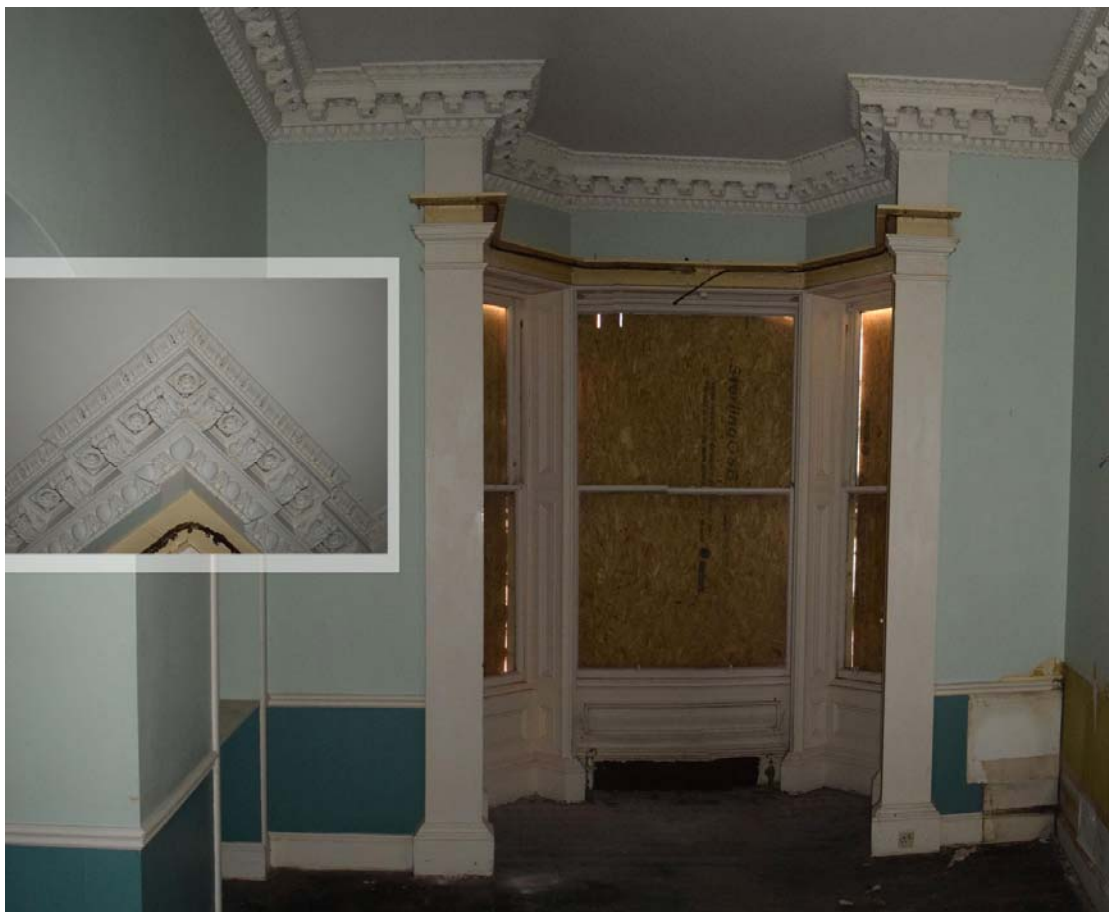
Room 6 is worth highlighting as retaining a beautifully preserved period features– a fine example of an enriched cornice of acanthus brackets and egg-and-dart décor (**Plate 8**). It also retains a high canted bay window (sash-and-case). In contrast to the splendid decorative cornicing in Room 6, Room 4 retains simple cornice but includes a large decorated stone fireplace with wooden mantelpiece on the west elevation (**Plate 9**). It also retains a picture rail on all elevations, suggesting the room was intended for display and to receive guests (i.e. served as a reception room). Corridor (Room 5), west of the main hall (Room 3) leads to the low (single storied) west wing; corridor to the east (Room 10) provides access to the east wing. Small chamber (Room 11) in the south-east corner of Room 3 undeniably functioned as a former telephone room.

*Plate 8: Room 6, detail of the south elevation, with canted bay and decorative surrounds; inset– detail of ornate cornice.*

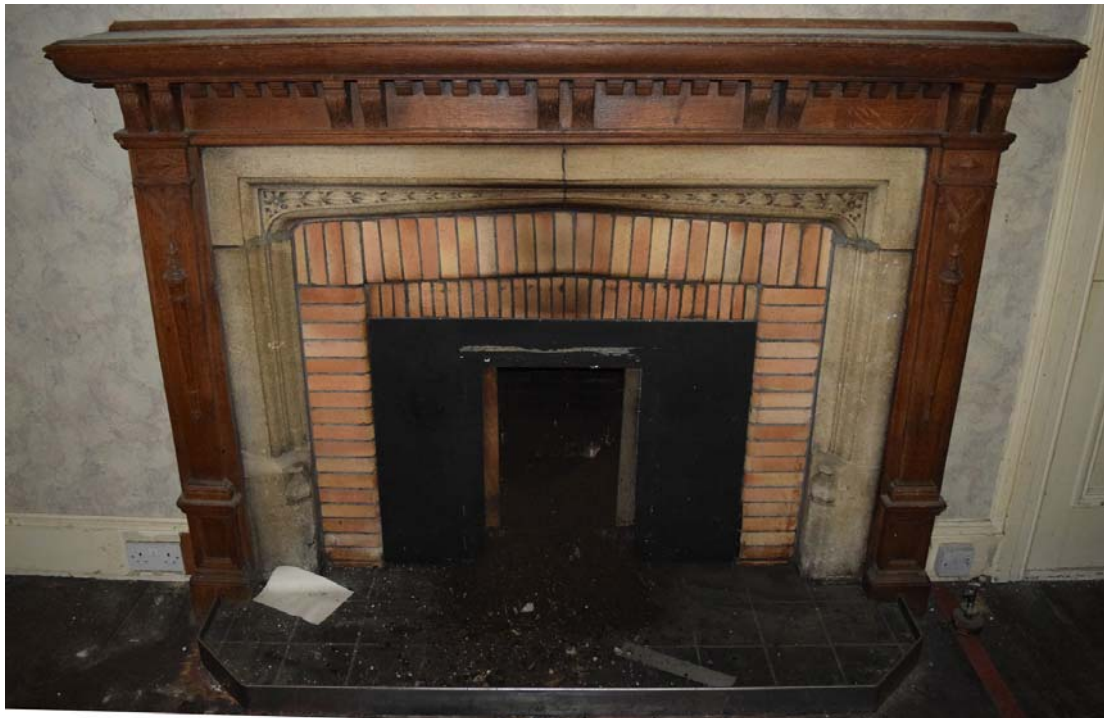
*Plate 9: Room 4, a ground floor reception room (1860s), detail of fireplace on the west elevation.*

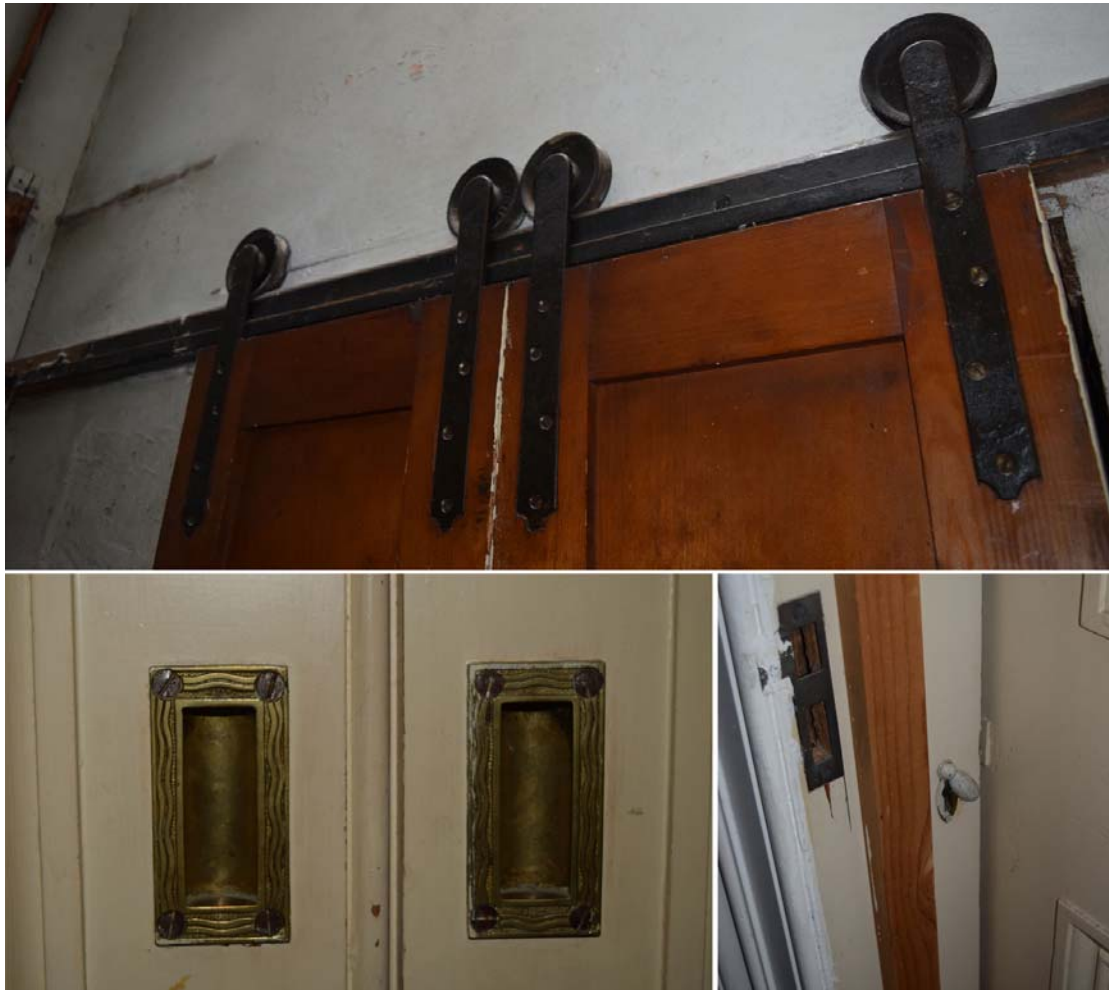
*Plate 10: Room 51, with cast iron hanging rollers, inset brass door fittings and side mounted locking.*

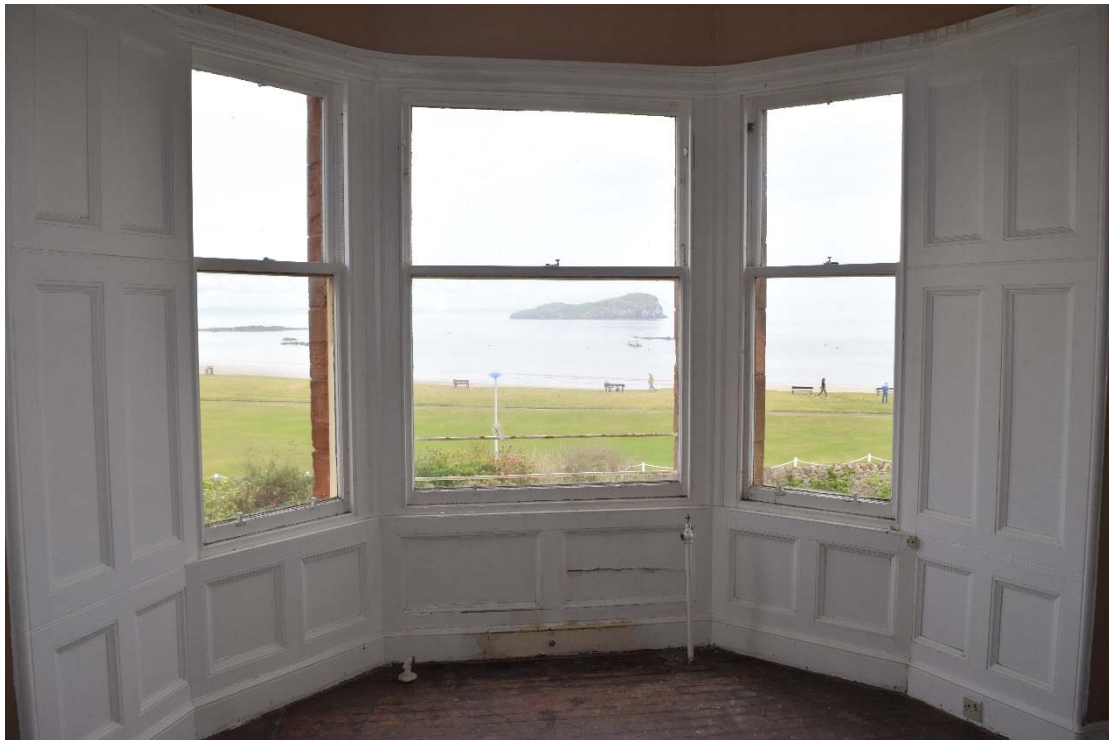
The extension phase is further represented by Room 49. The room contains a tall canted bay window (**Plate 11**), which has been added post-1906, to the original flat pedimented elevation, clearly intended as a near match to the one in the Room 32 (original) at the west end for the purpose of a symmetry. Room 49 and associated Rooms 48, 50, 52 are all accessed from long narrow corridor (Room 44), this lit by a cupula roof light.

*Plate 11: Detail of later canted bay in Room 49, added after 1906.*

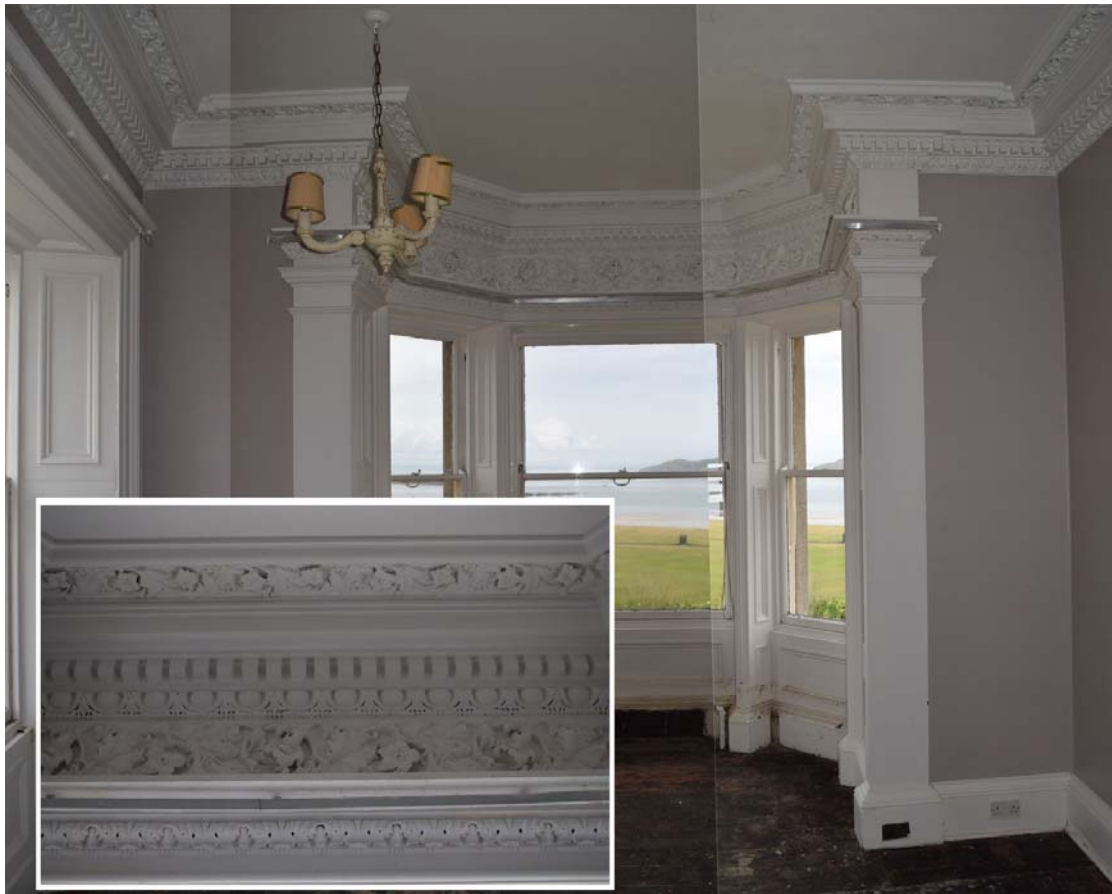
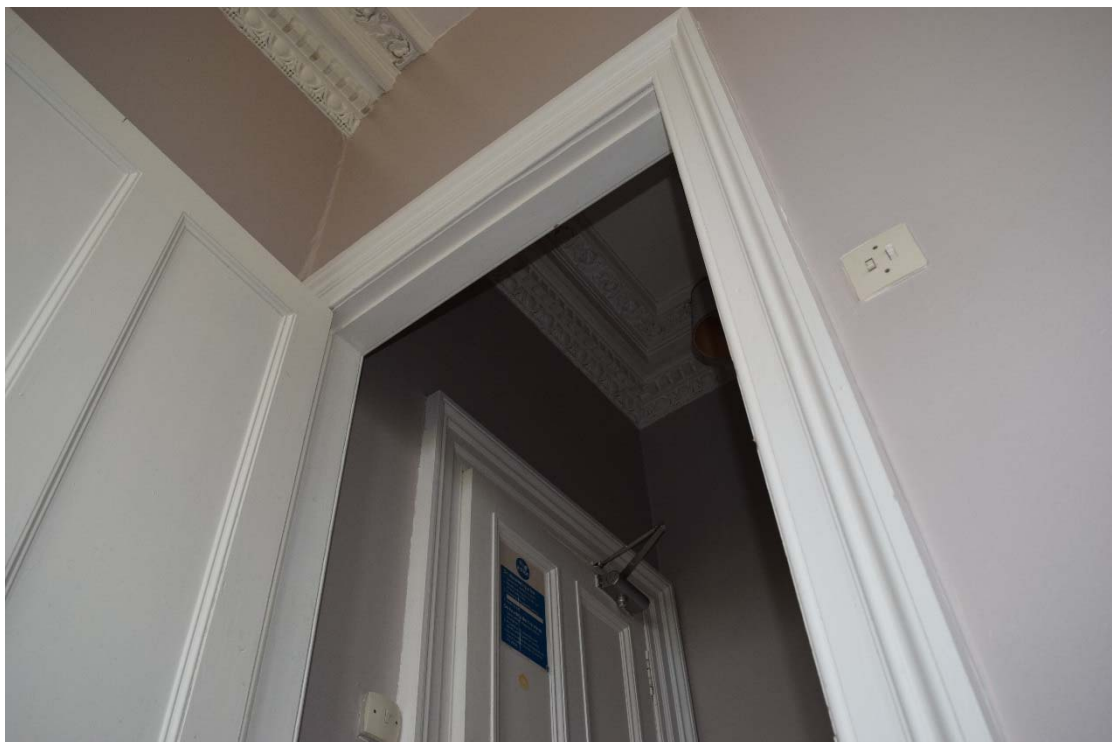
Room 30 leads to the narrow corridor (Room 44) to the east and a sweet of rooms to the west, including a finely appointed Room 32, situated to the north-west of the first floor (**Plate 12**). Room 32 includes the finest example of a decorative cornice—comprising heading, followed by egg-and-dart with denticulation above, and finished with a band of floral decoration on the ceiling. The room is magnificently lit by a large bay window on the N elevation, where the moulded decoration continues below the cornice level with further broad and bold floral frieze. Below this is a band of acanthus leaves springing from the square pilasters, which frame the bay window. The bay window appears to be largely unaltered from the original, with windows surrounded by false shuttering and heavy beading. Room 32 would have originally formed a single chamber with Rooms 31 and 33, as evidenced from the continuation of the highly decorative cornicing. Intriguingly, the door-frame and the skirting on the inserted wall match the original ones to the minute detail, suggesting remarkable consideration for retaining the room's original character.

*Plate 12: Room 32; top—detail of the highly decorated canted bay window and detail of the cornice work; bottom—the truncated cornice continuing south into Rooms 31 and 33.*

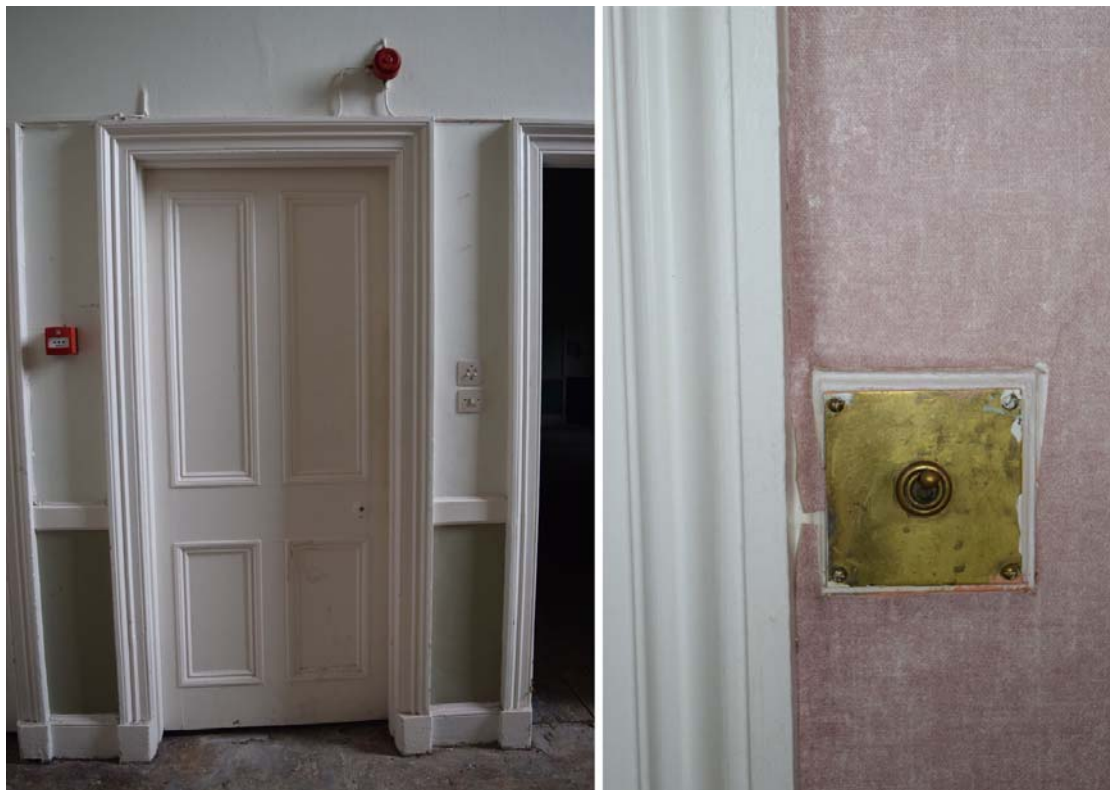
All door surrounds are also identical– consisting of a mock Georgian style, with heavily advanced surrounds (**Plate 13**).

Plate 13: Left—Typical door surround; right—earlier 20th century brass light switch in Room 42.

Original brass electric switches (early 1920s) are retained in some rooms (**Plate 13**).
