Culross Palace Garden Wall, Culross

July 2007

Carried out on behalf of the National Trust for Scotland

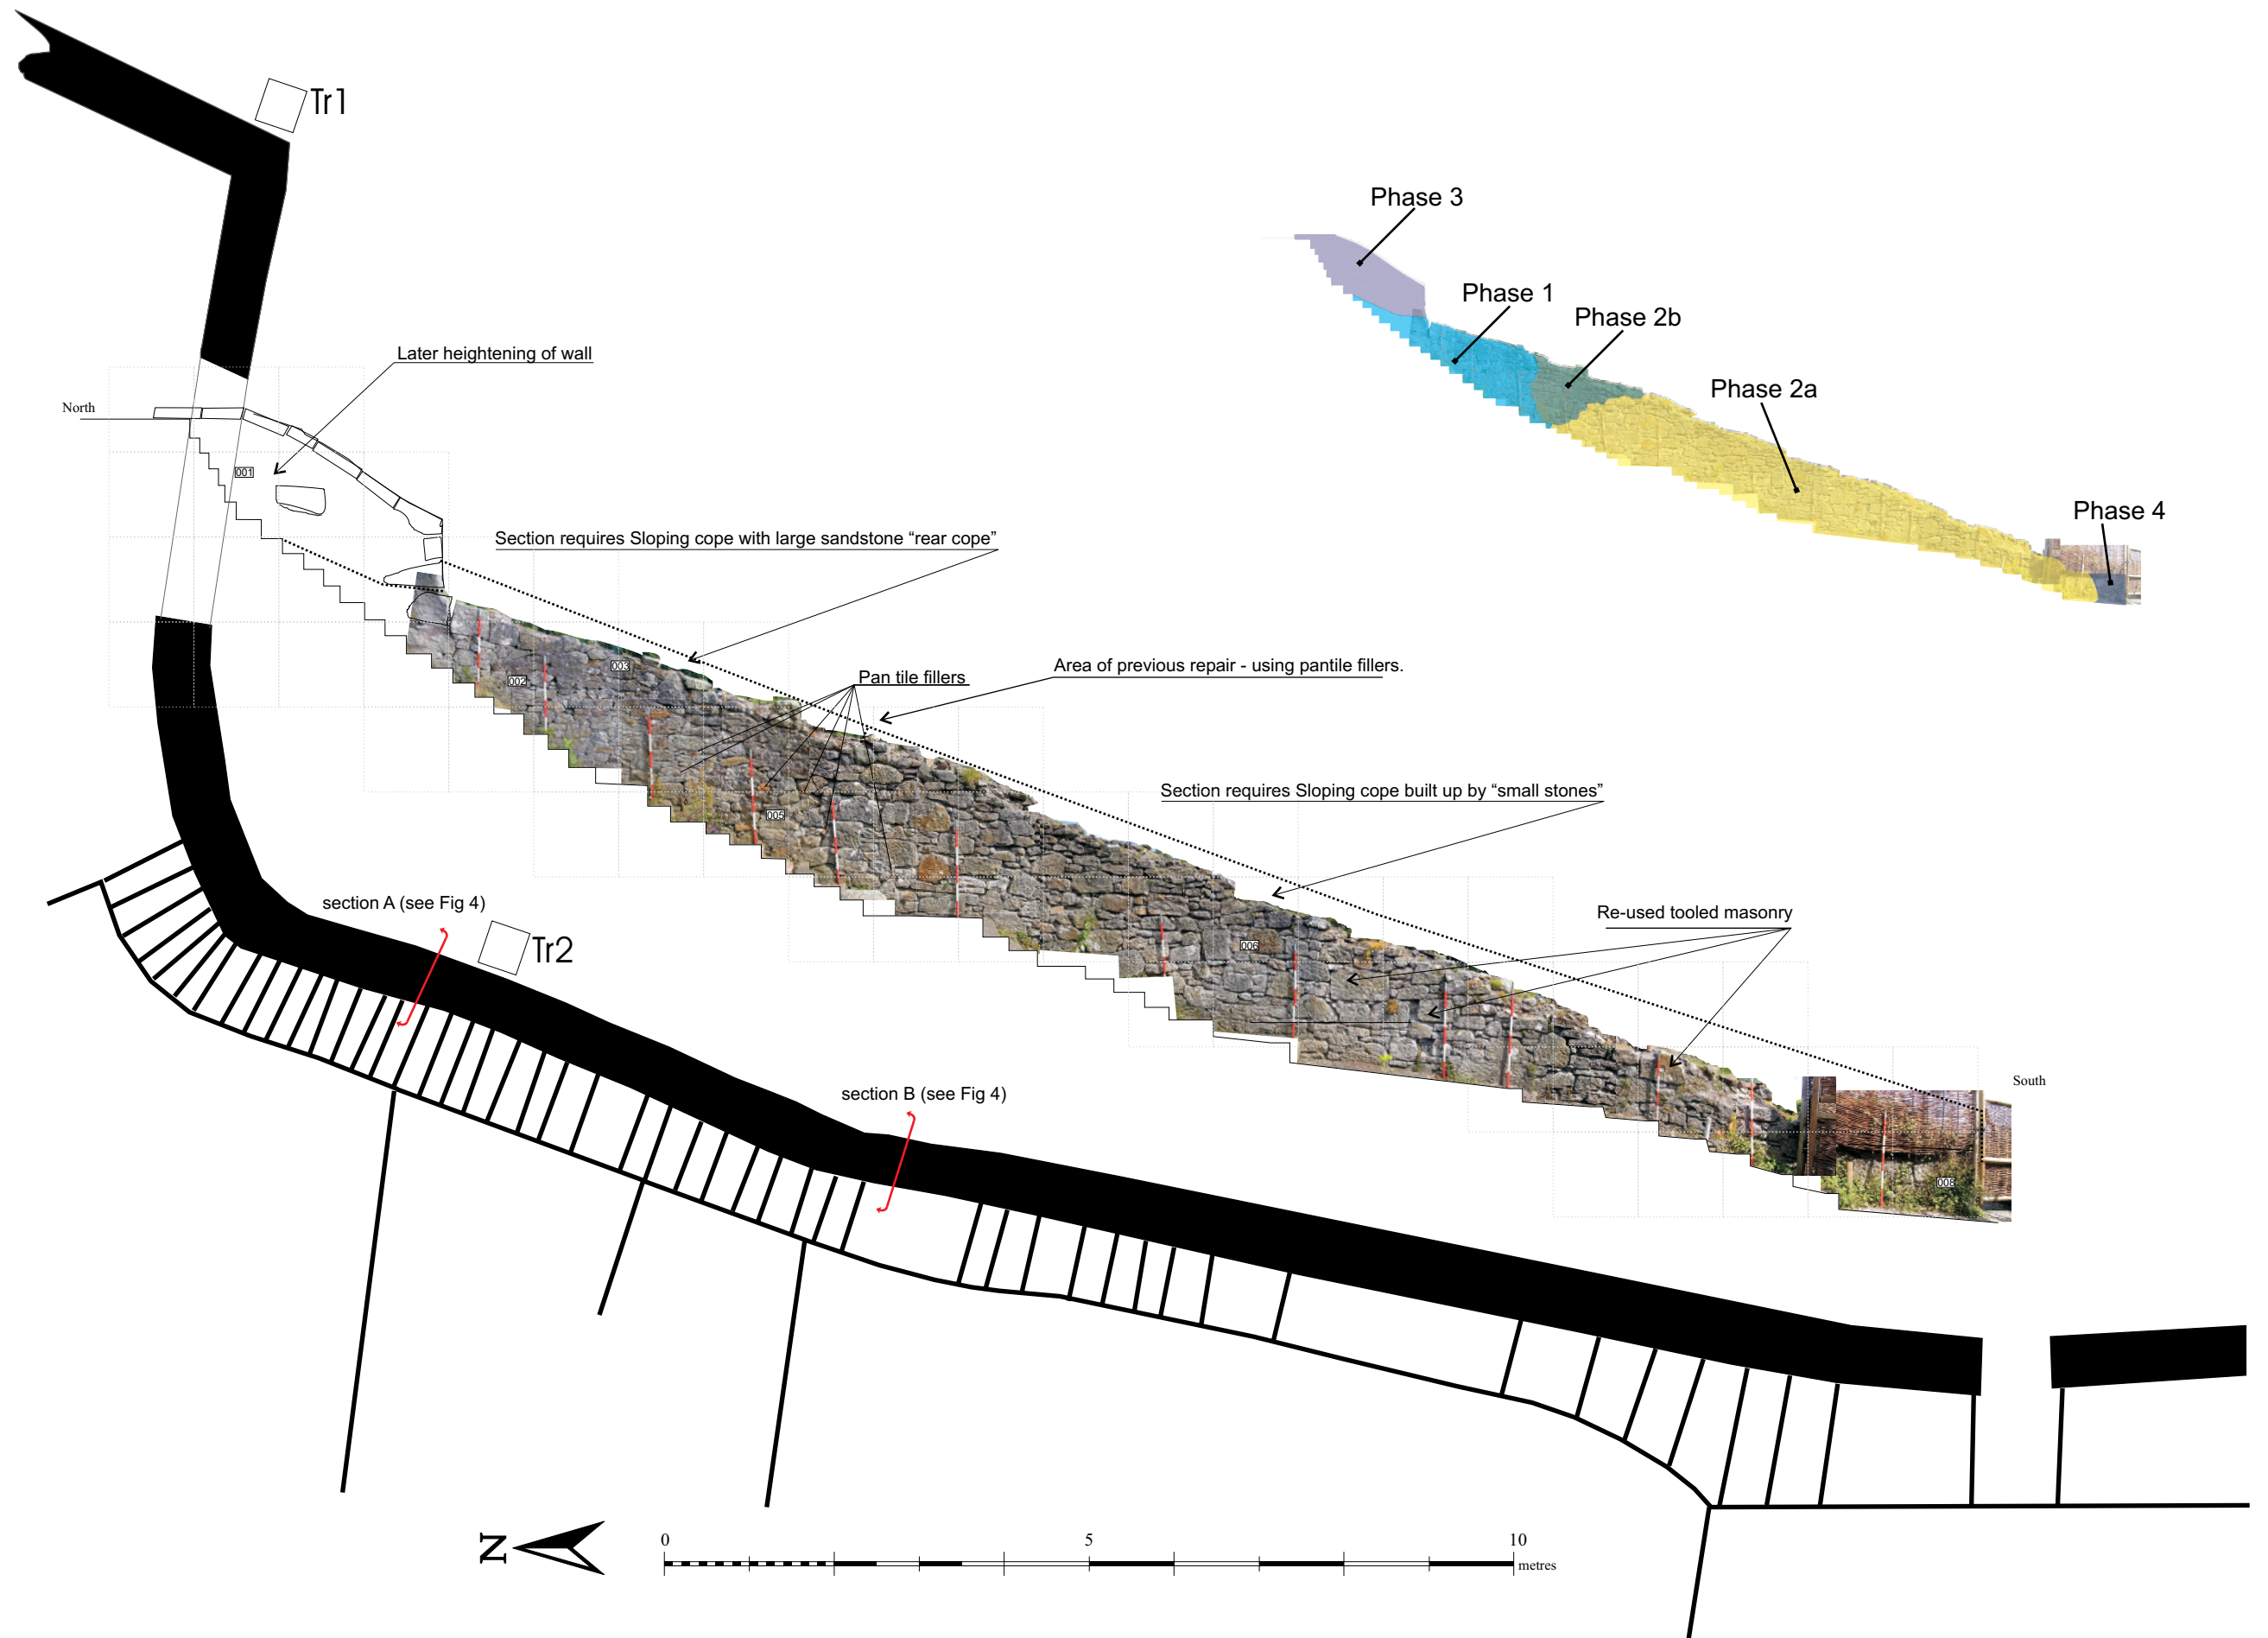
Figure 2: west facing wall, with phased elevation

5.1 Garden Wall (west facing elevation) (Fig. 2)

The original surviving phase 1 wall is visible at the north end of the wall [002], before the wall steps up [001] in phase 3. The construction is of rough yellow sandstone with a cream mortar containing frequent inclusions of shell and grit.

The alignment of the wall curves round, however the phase 2a wall [006] of grey hard sandstone rubble build with several large blocks that show reuse from other buildings (tooling marks and droving for example) lies directly on the original wall alignment, as evidenced on the east facing elevation (though on this elevation the original phase 1 walling [007] cannot be seen).

A levelling course can be seen running parallel to the slope overlying wall [002] and rebuild [005], large blocks are used at intervals to insure stability.

To join the wall rebuild [006] and the original wall [002] a section of walling bears the evidence of repair. The V-shaped loose walling of [005] which although of similar physical makeup to [002] is looser in build quality and contains frequent brick and pantile fragments as fillers. This section of wall (attributed to phase 2b) is of very poor quality, although the mortar is similar to [006] which is bonded by cream mortar with frequent small black grit. The heightened extension to the wall at the north end [001] leads the stairs up to a higher level platform round a dogleg to the east and a large retaining wall.

This phase 3 build overlays the earlier wall, and may be 19th century in date.

The final phase 4 consists of a modern (1980s) opening [008] at the extreme south of the recorded wall, leading from the stairs into the east garden.

Reconstruction should take into account the variation of stone type and the two separate coping details.

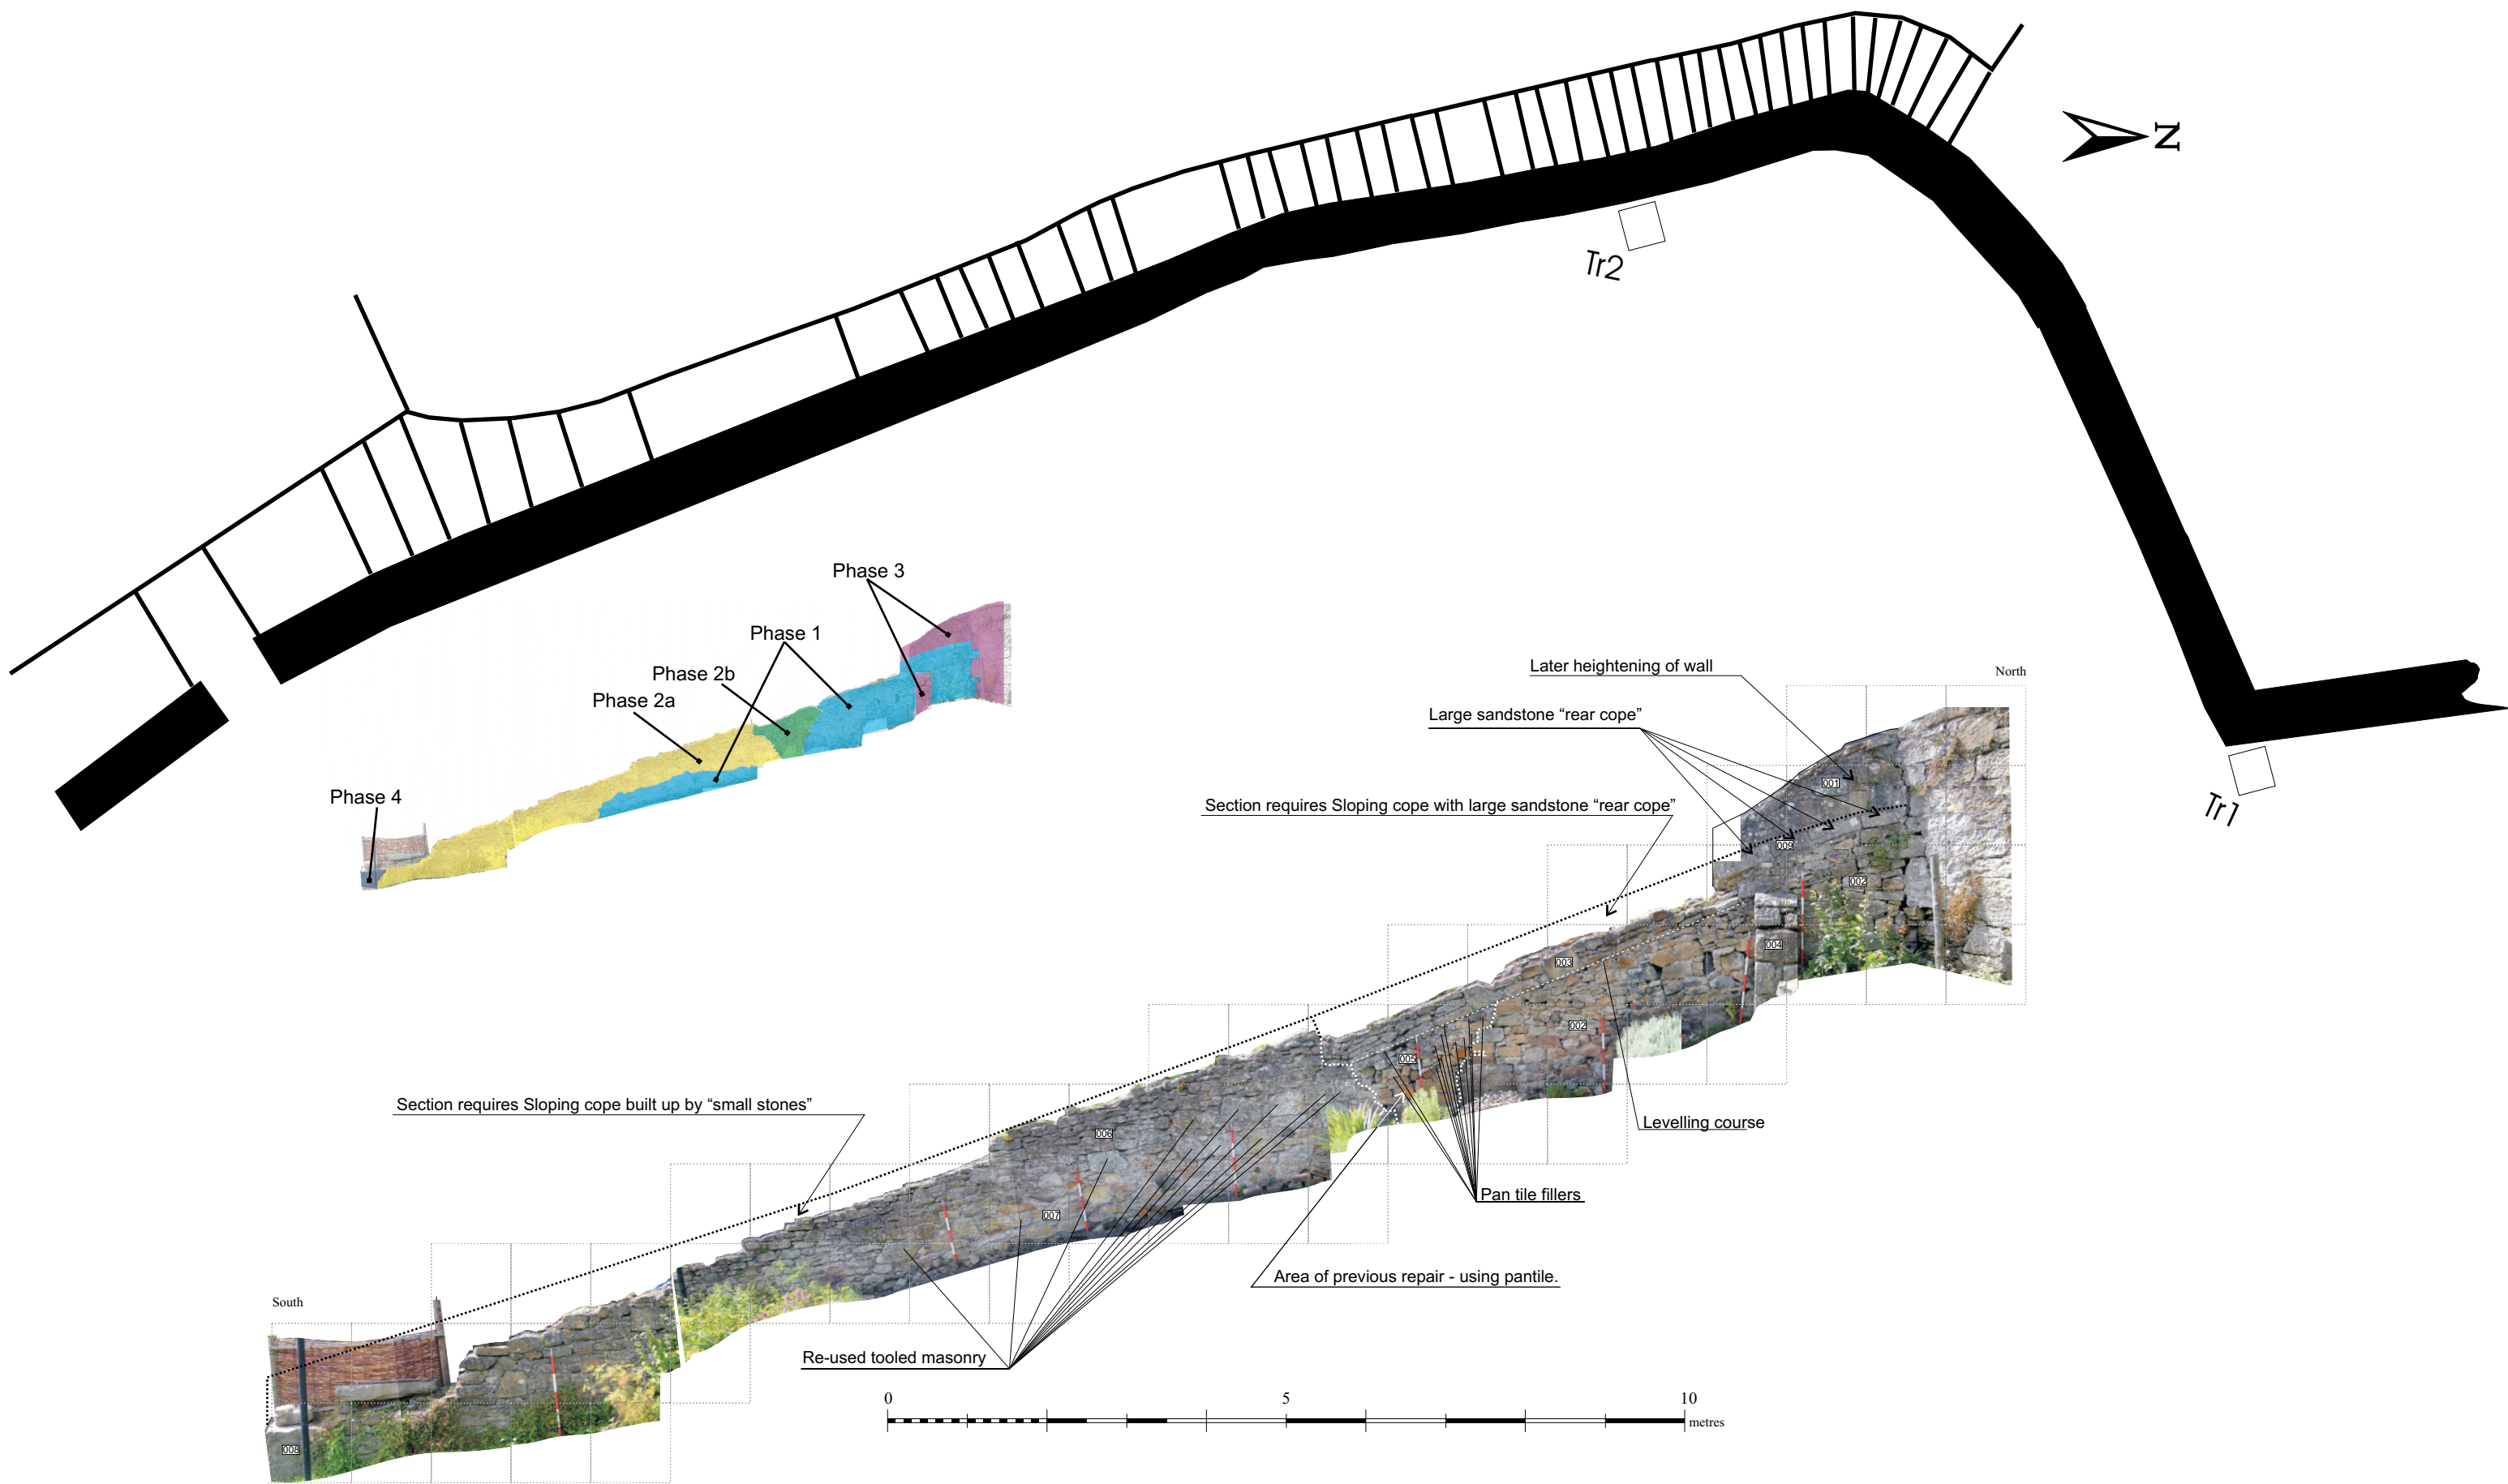
Figure 3: east facing wall, with phased elevation

5.2 Garden Wall (east facing elevation) (Fig. 3)

The east facing elevation shows the same phasing as the west facing elevation, however part of the original wall (consisting of the poor quality yellow sandstone) survives centrally at a lower level [007]. Above this section the wall survives to the full height, though the rear coping is built of the smaller stones, as opposed to the earlier northern coping with large blocks to the rear [009] surviving beneath the later rebuild [001]. The pressure of the addition [001] must have caused structural instability, and a buttress has been added [004] of roughly squared grey sandstone.

(cutting into the base of the original wall – and not fully tied in, as evidenced by a large structural crack at this join) and the raising of the upper section [001] over the original walling. This has then required the installation of a buttress [004] to strengthen the structural integrity. The final alterations – phase 4 – took place in the 1980s, with the forcing of a new gate from the stairway into the eastern garden, which suggests that entry to this terraced garden backlot was from the buildings to the south only.

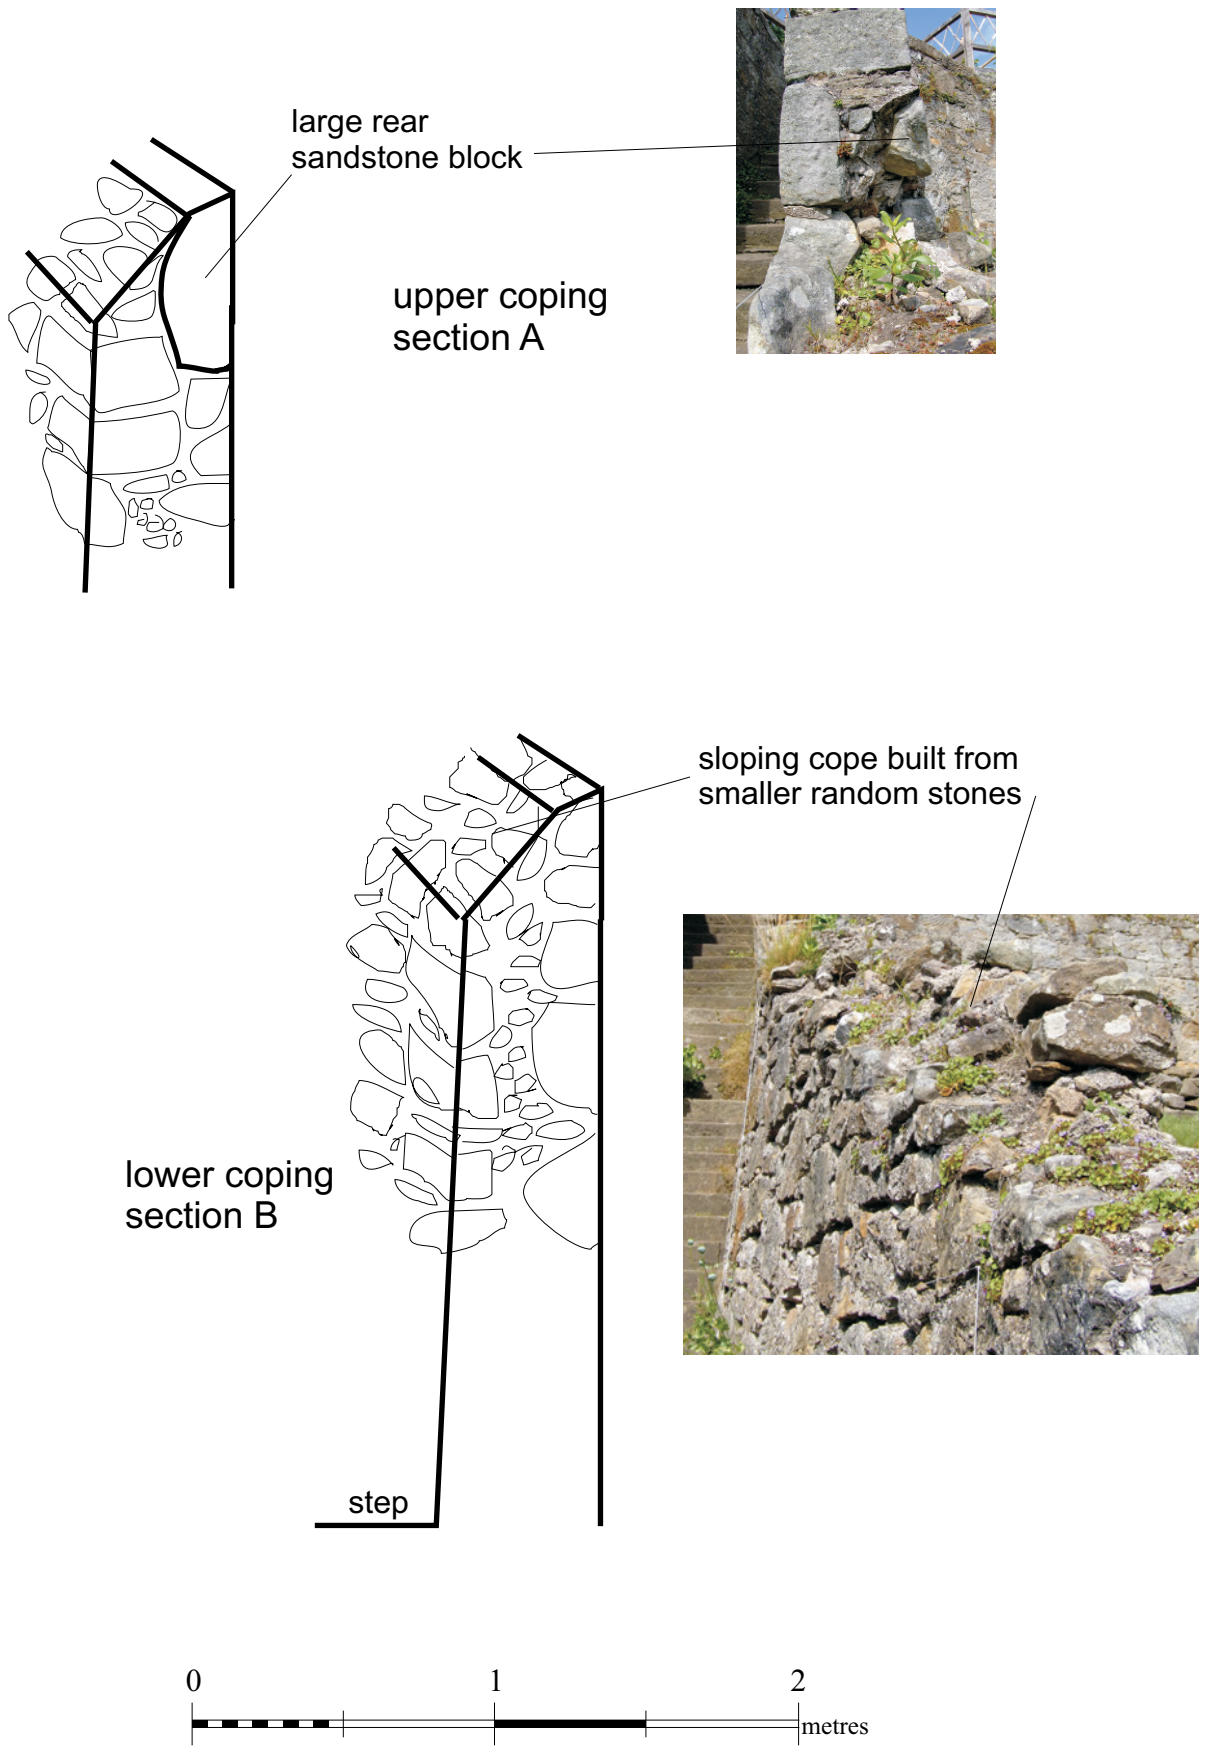
Figure 4: Cross sections A and B showing two forms of coping detail

5.3 Garden Wall (Coping) (Fig. 4)

The local vernacular for coping is of a single slope and this wall contains two distinct variations. The earlier construction consists of a horizontally coursed wall [002], which is then levelled to the line of the slope [003], the rear cope is a large, slab of grey sandstone with smaller stones set in mortar

making up the slope to the west. This can be seen in the photograph in Figure 4. The lower coping (integral to wall [005]), as commented on previously, consists of smaller stones from rear to front face, set in mortar, and flush pointed.

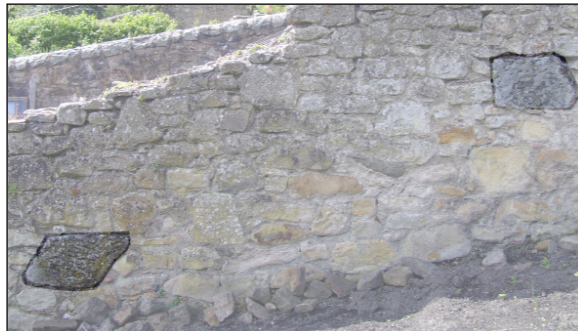
Reused stonework in [005] highlighted

later 18th century/early 19th century, due to the reuse of tooled architectural fragments that are at least mid-18th century in date. The repair [005] must have taken place soon after (if not coeval with) this construction. The next
