Newhailes House Estate, Tea House – Architectural Fragment Recovery Corporate Challenge.

November 2007

A National Trust for Scotland Report

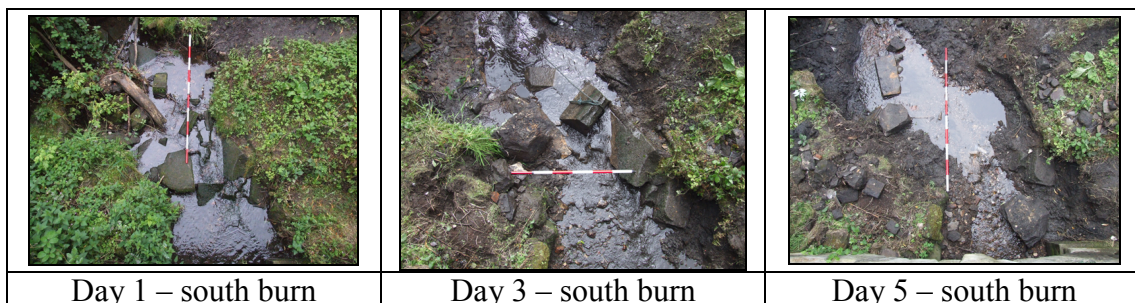
The following images show the gradual clearance progressing to the south of the Tea House.

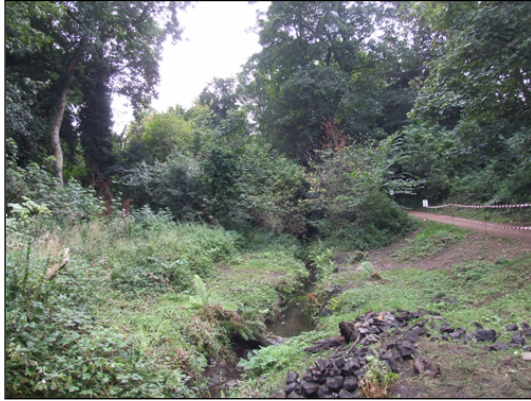
First was the existence of three rectangular pond which lay to the south of the Tea House, which continued the series of rectangular water works and complex hydrology that had been examined to the south. The Roy map of 1755 (Fig. 5) clearly shows three rectangular pools leading from the Shell Grotto down towards the Tea House.

The photograph to the left shows these slope on either side and it is clear that the burn now flows through a nearly completely filled water feature. When this pool was complete and filled with water (which would have required a dam and sluice system to the north of the Tea House to bring the level of water to the required depth) the view of the Tea House would have been enhanced by a mirror image of the elevation reflected in their pool.

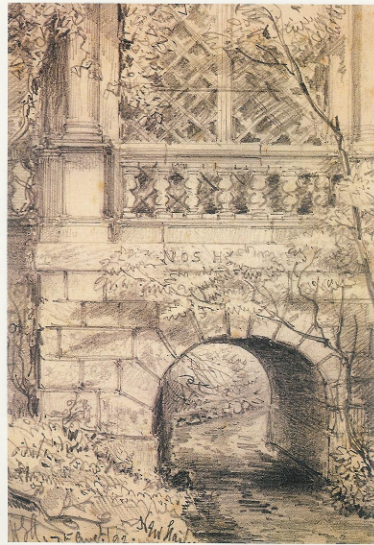
It was mentioned that punting was carried out on this pool, which would have required considerably more depth of water than presently exists, or could exist even with the pool cleared to its original size (*T. Addyman pers. comm.*). As yet, the construction, extent and form of this pool are unclear and further work is required to examine this feature - the 1854 Ordnance Survey 1st edition map (Fig. 5) no longer shows a pool and the single surviving known image of the Tea House dated 1892 shores the banks of the burn reaching down to the arch itself.

This image also shows the burn curving to the right beyond the arch. The view beneath the arch suggests the possibility of being able to observe the course of the burn from a location where one would be at the level of the water itself. If this is the case then it does seem to support the concept that the intention was to give the impression of a river that continued far beyond the Tea House. This would go some distance to explain the offsetting of the arch in the estate wall behind the Tea House, which allows the Brunstane burn to flow out of the policies, as the design seems to attempt to give the illusion that there is greater depth to the landscape than the reality.

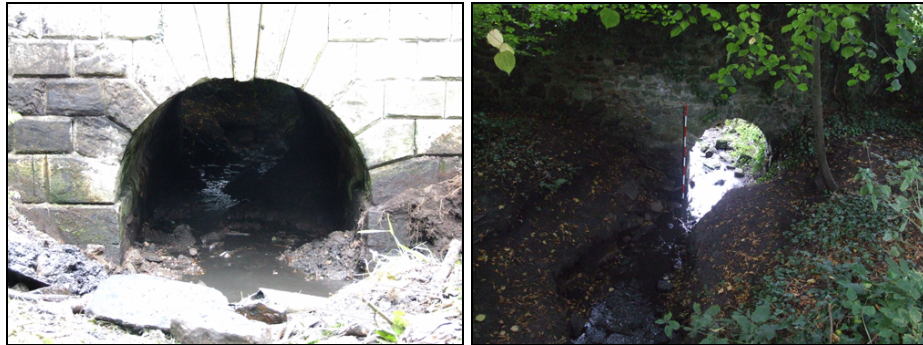
The following photographs show the view under the arch, where it is not possible to see the exit through the boundary wall. Beyond of the Tea House there is only a further 6 m before the Newhailes estate ends; given the plain nature of the rear of the structure it is possible that this side was never meant to be viewed by visitors. It is more than likely that this northern side contained the sluice system that would be required to raise and contain the water level in the pool to the South of the Tea House.

View to north under arch with exit from estate through boundary wall (above) offset to right.
