The Pineapple Walled Gardens, Airth

Report : November 2007

A National Trust for Scotland Report

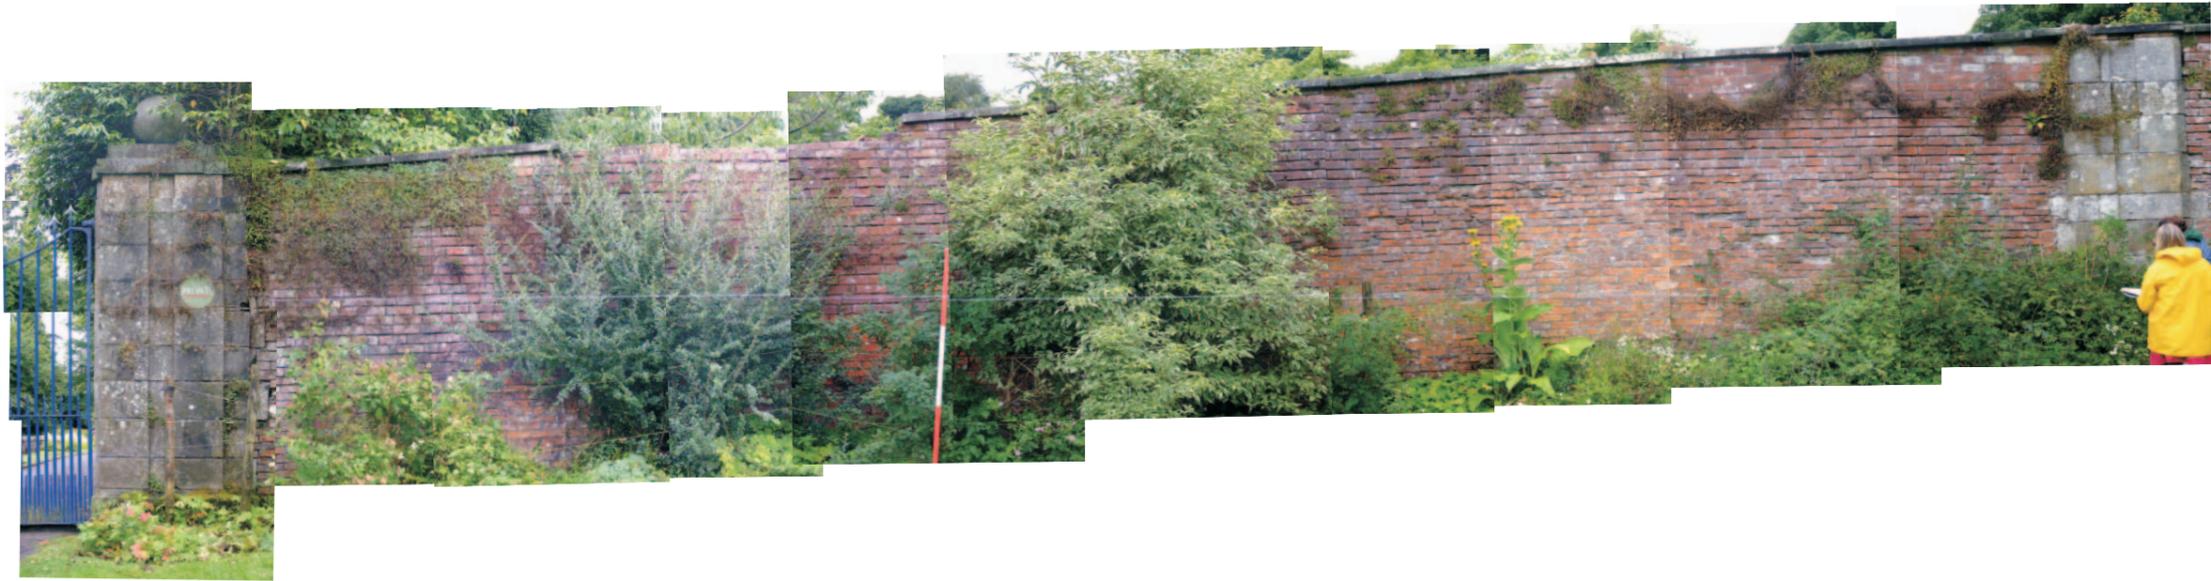
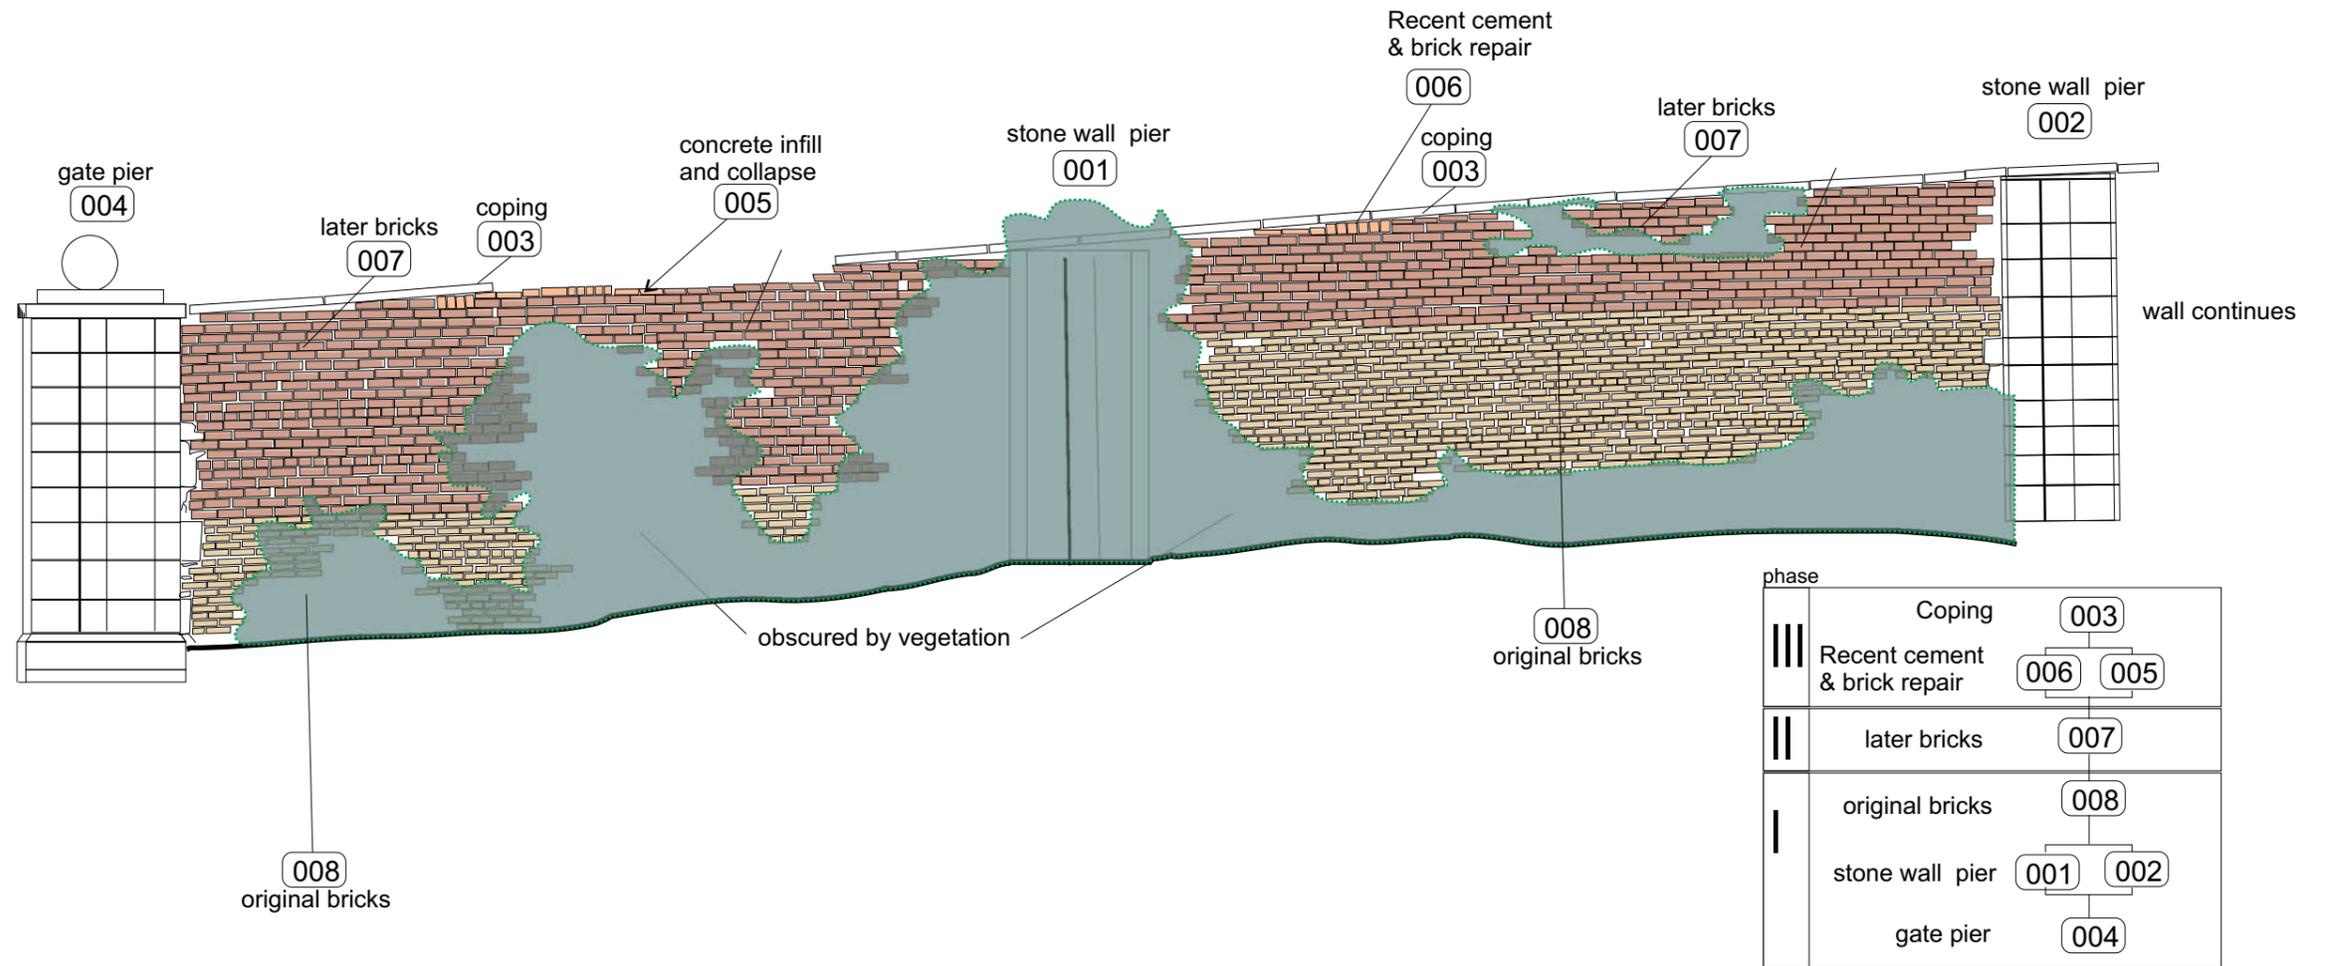
Figure 2: east facing wall, southwest walled garden

5.1 Southwest Walled garden (east facing elevation) (Fig. 2)

The surveyed section covered two bays of walling stretching from the northernmost sandstone built ashlar gate pier [004] to the north (left-hand bay: 7.20m wide and right-hand bay: 7.40m wide). Two further sandstone ashlar built piers [001] and [002] break the wall face, however do not penetrate the width of the wall, and extend only half way through the wall structure. The original brickwork [008] is of standard 18th-century size (approx 205mm x 55mm x 100mm) though it was observed that certain bricks are of an intermediate size (approx 155mm x 55mm x 100mm) and were used on an irregular basis to 'even up' a course. A rough garden bond, was used and bonded with a dark cream mortar with few inclusions. The width of the brick walling is c. 400mm.

At some point in the 19th or early 20th century, an extensive repair took place with machine-made bricks (220mm x 72mm x 100mm) being used to rebuild the upper sections of the wall skin [007], with more extensive repair evident within the first bay.

The wall is coped with sandstone slabs (or what appears to be sandstone) [003] which overlay two areas of obvious late 20th century repair [005] & [006] where modern brick and cement has been used. The main area of wall failure and collapse is in the first wall bay and the recent repair has been exposed, though this is best viewed from the west site.

Although a simple garden wall, the build shows three distinct phases of construction. The southwest walled garden has an inner and outer skin of brickwork with sandstone pillars forming distinct bays along the west wall. The original 18th-century brickwork seems to have been heavily repaired in the 19th or early 20th century (this is evidenced by the brick typology). A further repair in the later 20th century used cement – which is now seen as an inappropriate material, and the collapse of the wallhead shows the repair did not take into account the nature and construction of the wall, and therefore leaves open the potential that the entire walled garden may require remedial works. Cement and rubble seem to have been used to infill the skin walls of brick. A programme of repair, including repointing, structural repairs and reinstating the cope would benefit the wall. The northern gate pier was examined; however access to the external elevation was difficult due to a large evergreen cypress type tree. What was clear though was a twisting in the wall to the north, which has caused a severe structural crack the full height of the wall. A final observation of the earlier brickwork was the discovery of a 2/3rds size brick, which seemed to be used to even up courses of brickwork, this extra size of brick has an affect on the character of the wall, and should be considered during repairs and reconstructions.

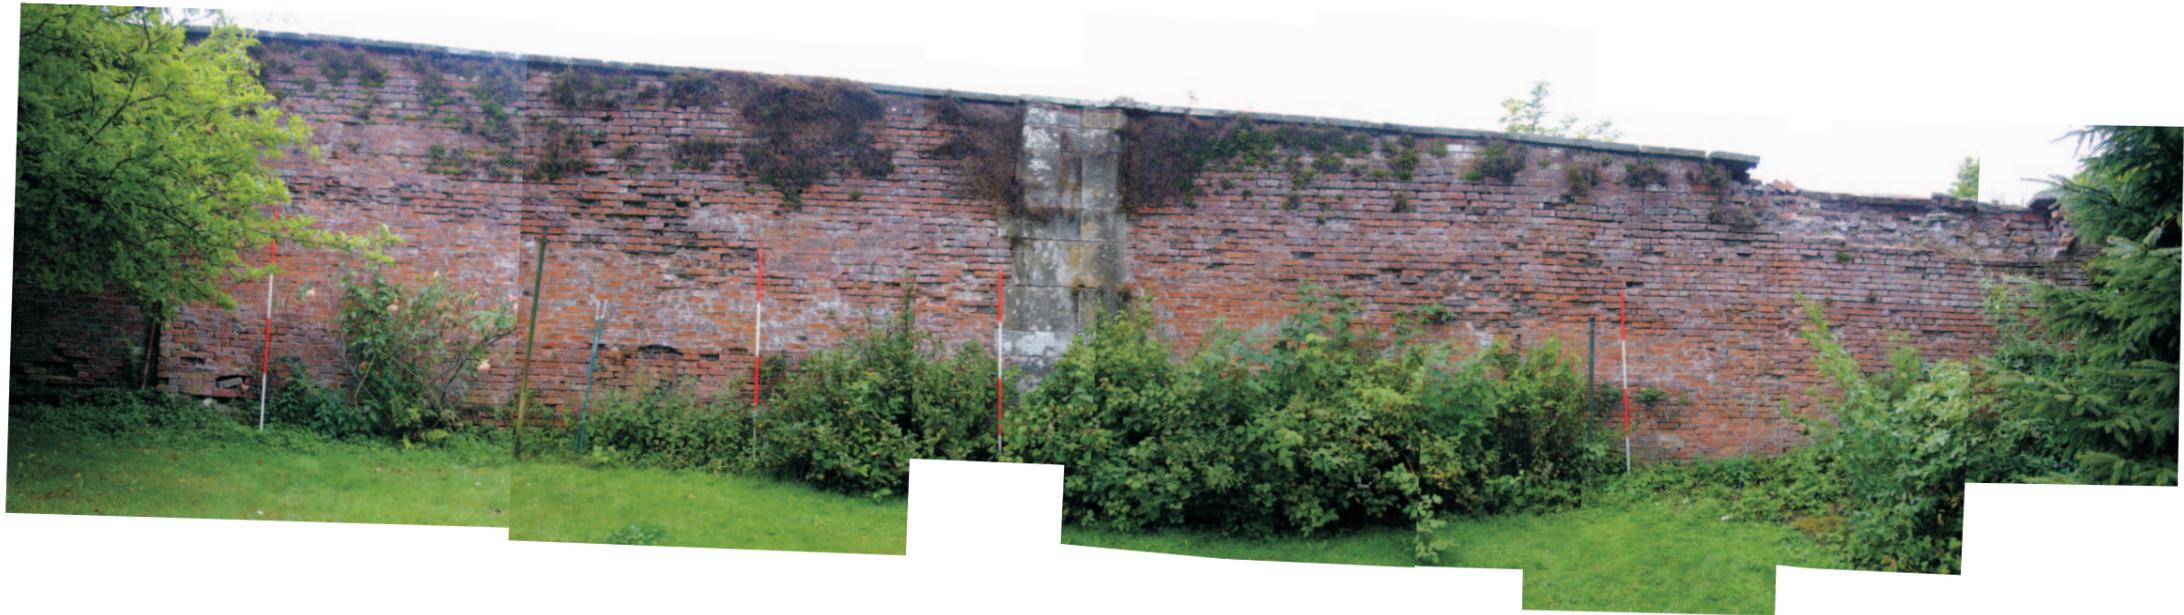
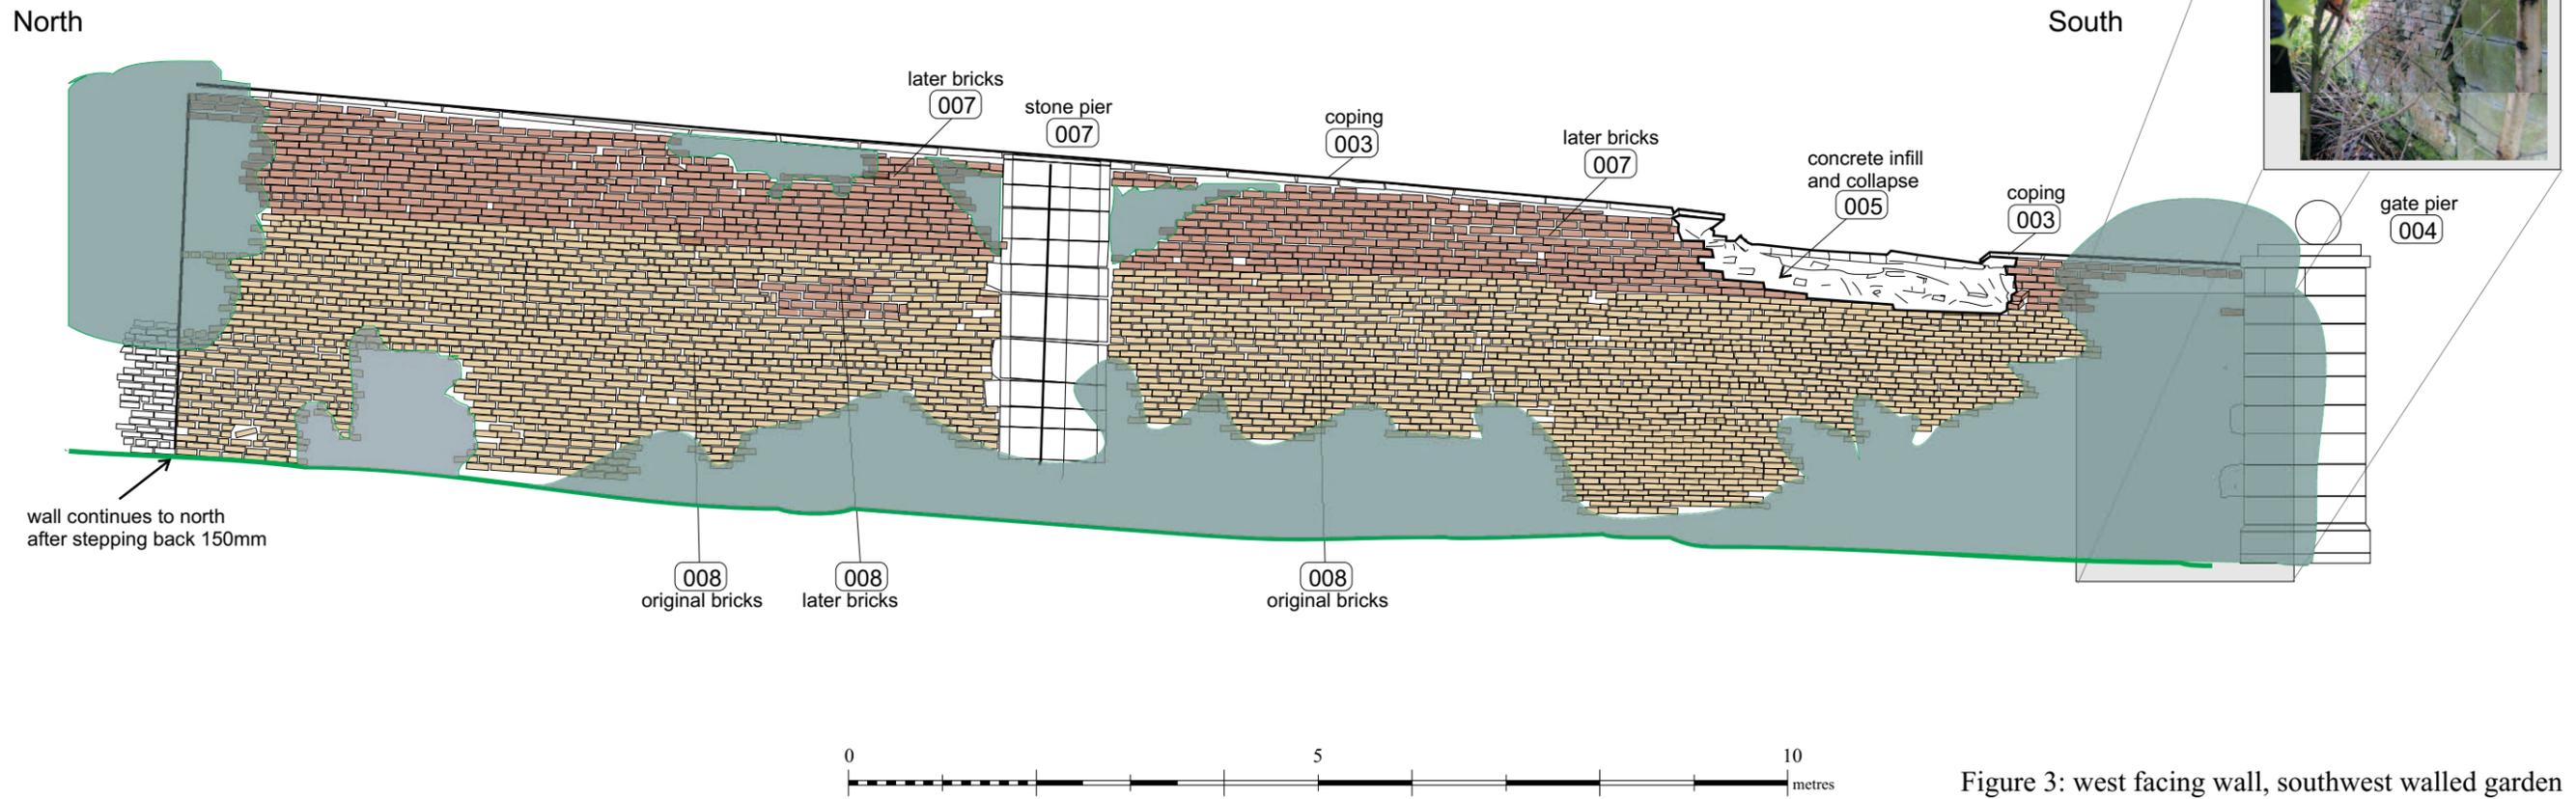
Figure 3: west facing wall, southwest walled garden

5.2 Southwest Walled garden (west facing elevation) (Fig. 3)

The west facing elevation shows the same phasing as the east facing elevation, however part of the original brick wall [008] seems to survive to a greater height. Above this section the wall has been once again rebuilt with 19th/20th century bricks as before [007]. The stone wall piers [001 & 2] do not appear in this elevation, though a sandstone ashlar pier [009] is found on this side approximately half way between the two on the east face. A small amount of earlier repair [010] can be seen within the fabric of [008]. The collapse and failure of the wallhead is clear within the first bay, and exposed cement and recent bricks shows the failure has come in an area of recent repair. Further twisting of the wall away from the gate pier [001] is located behind the tree that obscures the elevation, with a large structural crack and evidence of the footings shifting from the vertical, which have been reported to the structural engineer. The wall steps back a bricks width at the extreme. (left-hand bay to stepback: 8.75m wide and right-hand bay: 12.10m wide)

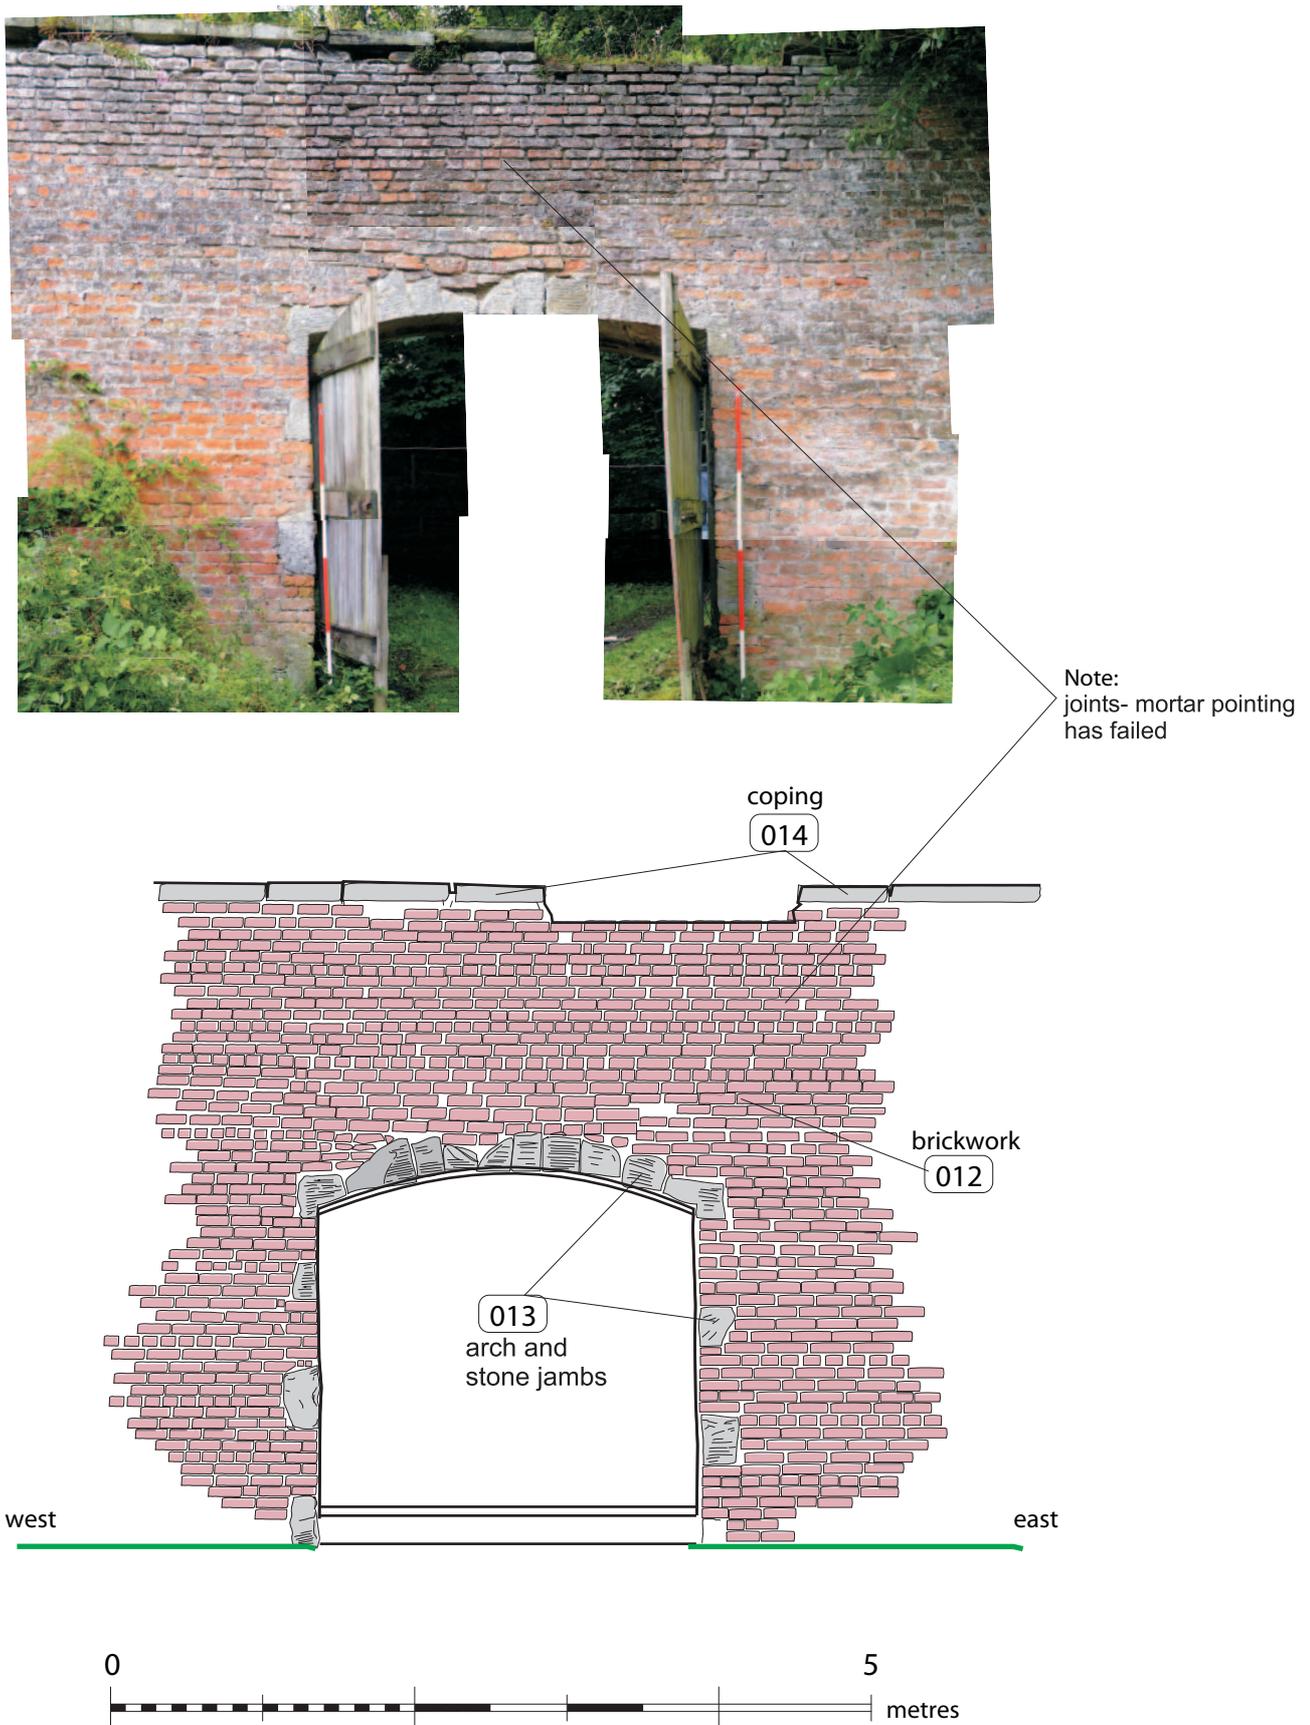
Figure 4: south facing wall, northeast walled garden

5.3 Northeast Walled garden (south facing elevation) (Fig. 4)

A single cart entrance penetrates the northeast walled garden in the north corner. The low arch and quoins [013] on the internal elevation are of a

finegrained sandstone with broad droving and broached margins. The arch is a shallow segmental type. This supports a brick wall skin of 18th century style handmade bricks (230mm x 65mm 100mm) [012], which are flush pointed with a creamy mortar, though this has in the main been lost from the upper half of the skin, leaving the joints unmortared and vulnerable. The style of bond is typical garden bonding. The sandstone slab coping [014] has been damaged by vegetation egress above the arched entrance, rendering the wall open to weather damage and causing shifting of the copes.

Reconstruction should take into account the variation of brick type from each period and the two separate coping details. Re-rendering of the exterior could be considered as an option to ensure the weatherproofing of the stone walling – to allow further water damage to the interior would negate any other repairs to the fabric.

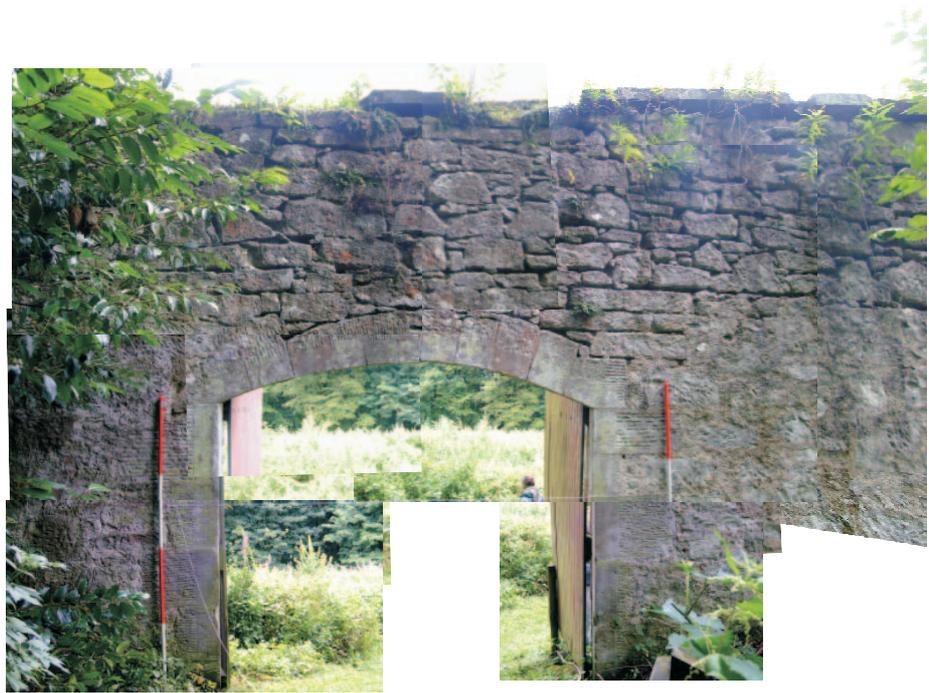
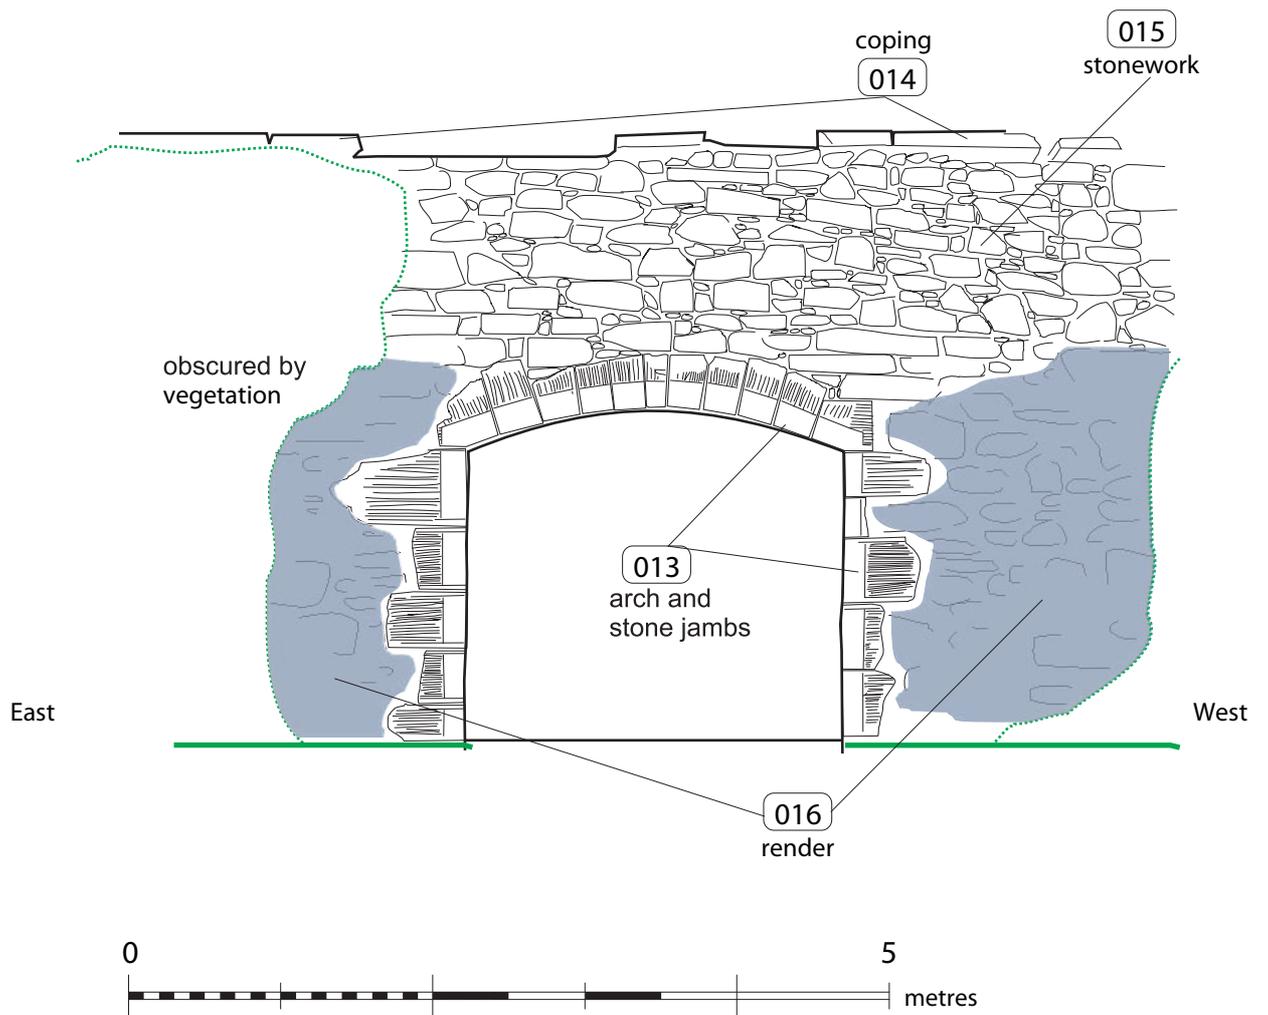
Figure 5: north facing wall, northeast walled garden

5.4 Northeast Walled garden (north facing elevation) (Fig. 5)

The external wall is constructed of coursed sandstone rubble [015] bedded in a creamy gritty mortar around the sandstone arch [013]. The low arch and quoins [013] on the external elevation are of the same finegrained sandstone as the internal elevation however the droving and broached margins are finer and finished with a higher degree of quality. The arch is a shallow segmental type. Movement and loss of the coping [014] has again allowed the joints in the upper section of the wall to be weakened and the pointing and render has been lost. The rough cast render is still in evidence on the lower section of the wall [016].

exit to the north around which this survey has been conducted. It should be noted that the level of finishing of the cart entrance quoins and arch voussoirs is of higher quality than the interior, with finer droving marks, for the obvious reason that this would be the side viewed by visitors to the estate rather than the interior which would only be seen by estate workers. There have been no repairs to this wall, with evidence for only a single phase of construction. The coping slabs have fallen from directly above the cart entrance and are allowing deterioration of the structure.
