The Yards, Duddingston Village , Edinburgh

A National Trust for Scotland Report

April 2008

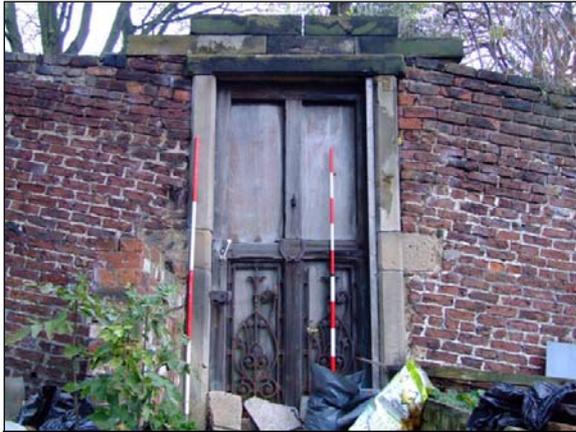
Plate 1 Gateway [8006] connecting Level 1 garden to Hawthorn Brae Property.

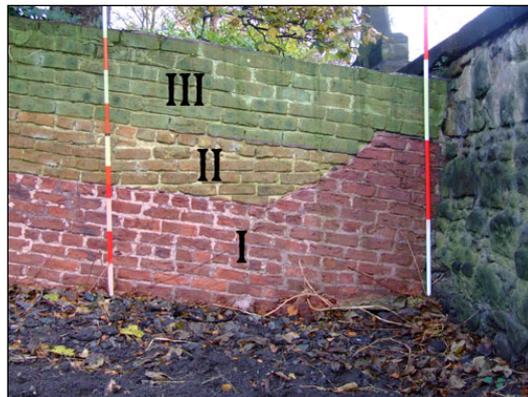
The dividing wall 8 between the site and the Hawthorn Brae property contains within it three important phases that relate to the site. [8001] is the original late 18th-century property division created by James Hamilton the 8th Earl of Abercorn, which contains a very typical for the period swept ogee terminus at its south end. Later heightening of the walls is clearly visible and the insertion of the gateway [8006] in the mid 19th-century provides evidence for the reorganization and ownership of this lower level. The upper section of wall 8 in Level 2 also clearly indicates changes of both ownership and use with the original late 18th-century wall [8008 & 8010] visible behind the 19th-century skin wall and the use of industrial waste [8011] as both decorative and anti intruder properties. Evidence of the function of Level 2 in the later 19th-century as a bowling green and later a tennis court in the 20th-century can be seen in the new brick wall skin of [8009] and the trace surviving elements of a small pavilion [8012].

Plate 2 Three phases of Wall 8 lower, from 18th – late/mid 19th century

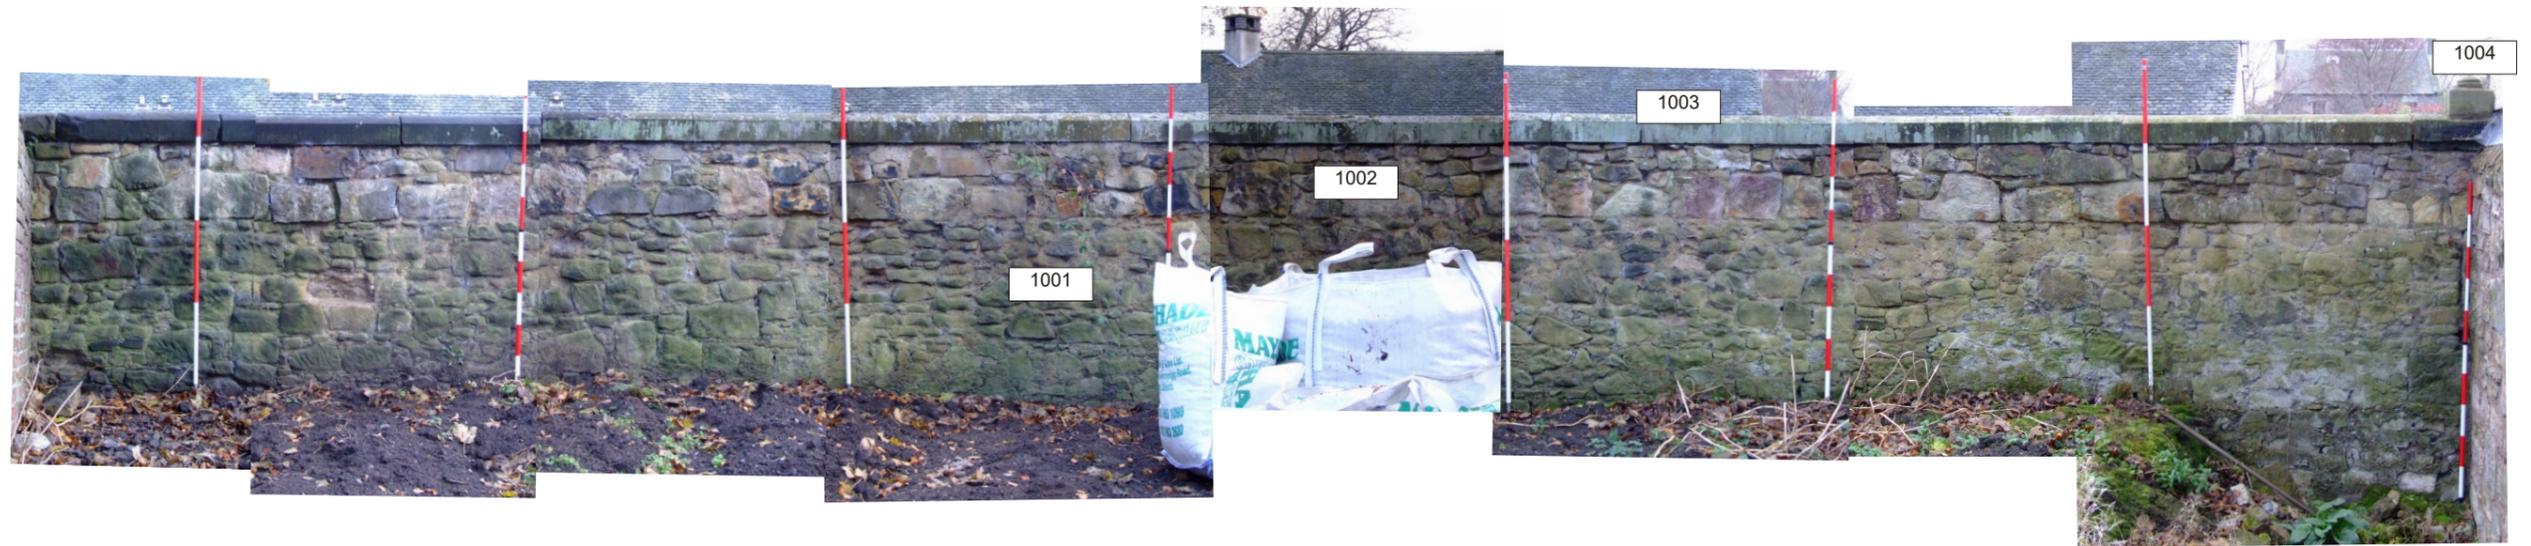
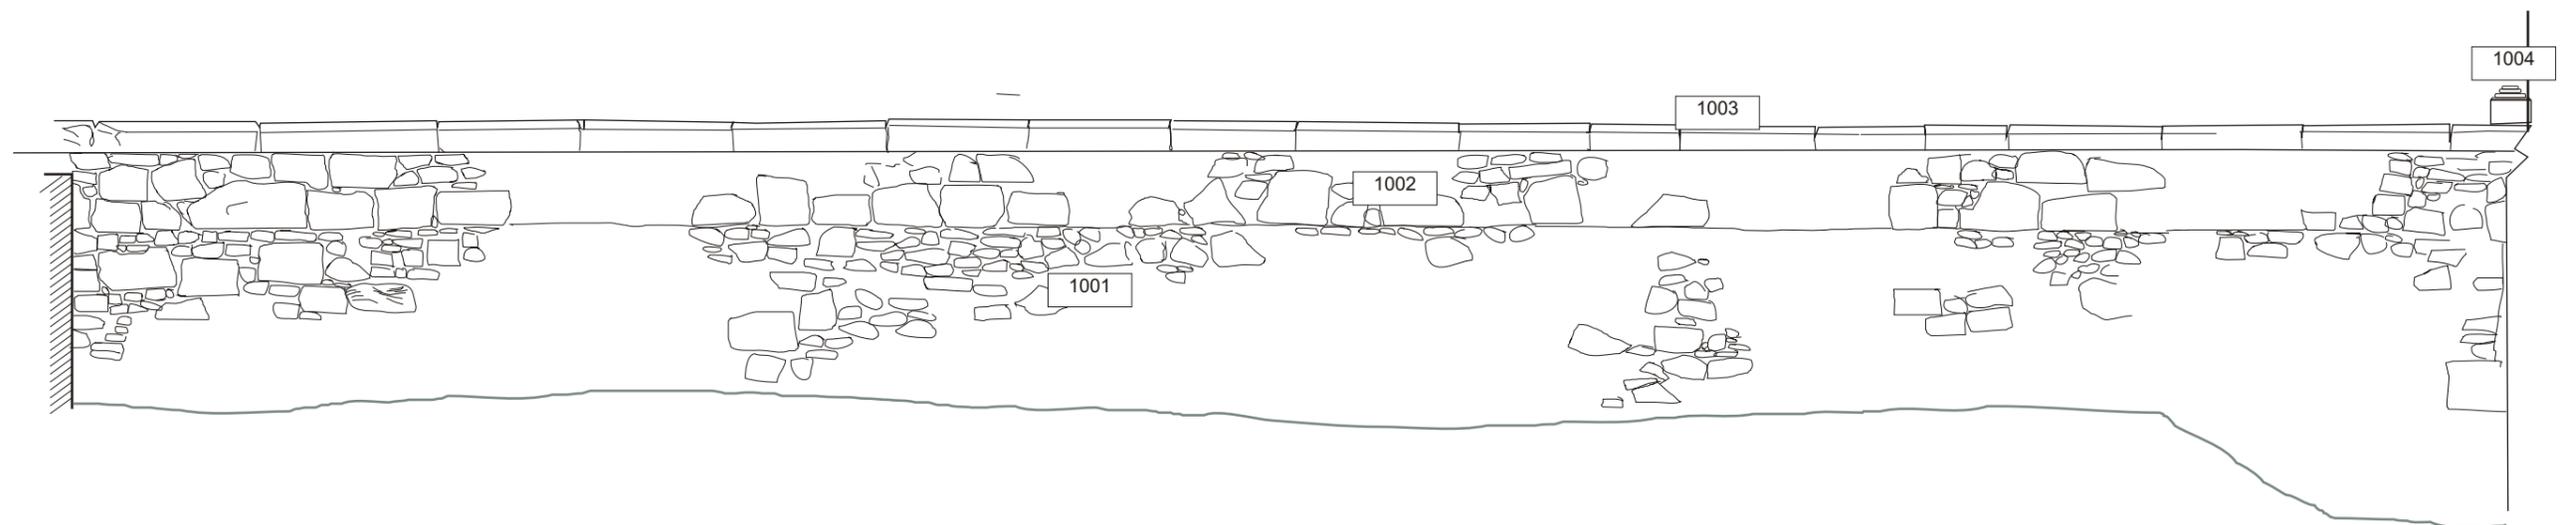
Figure 3: Wall 1, north facing elevation

The surveyed section covers both the external street elevation and the 'internal' elevation (north facing). The south facing elevation forms a unified façade of rectangular soft yellow sandstone blocks of various sizes [1005] forming a skin onto the earlier wall [1001]. The earlier wall is visible on the north facing elevation, and is built of a random rubblework with a creamy yellow course mortar. This section of walling is topped with a further 500mm of sandstone rubblework [1002], with several edge set sandstone blocks to provide the full height for the sandstone wallpaper [1005]. The entire wall is c. 350-400mm thick, and is capped by a flat topped and chamfered cope [1003] of hard quartzite sandstone.

Facing the wall from the street level, the west extremity of the wall has been cut by the insertion of a garage, but the remains of sandstone quoins [1007] point to the position of a gateway associated with the facing wall [1005]. Although clearly now out of position, the coping is topped at this end with the base of what may be either a balustrade base or a base fragment of a gate pier ball decorated capstone [1004]

The pedestrian entrance to Hawthorn Brae House forms the eastern extreme of the survey, and clearly the well dressed sandstone ashlarwork and decorative masonry surround for the gate [1006] is contemporary with both the sandstone facing wallpaper [1005] and the surviving gatepier [1007]

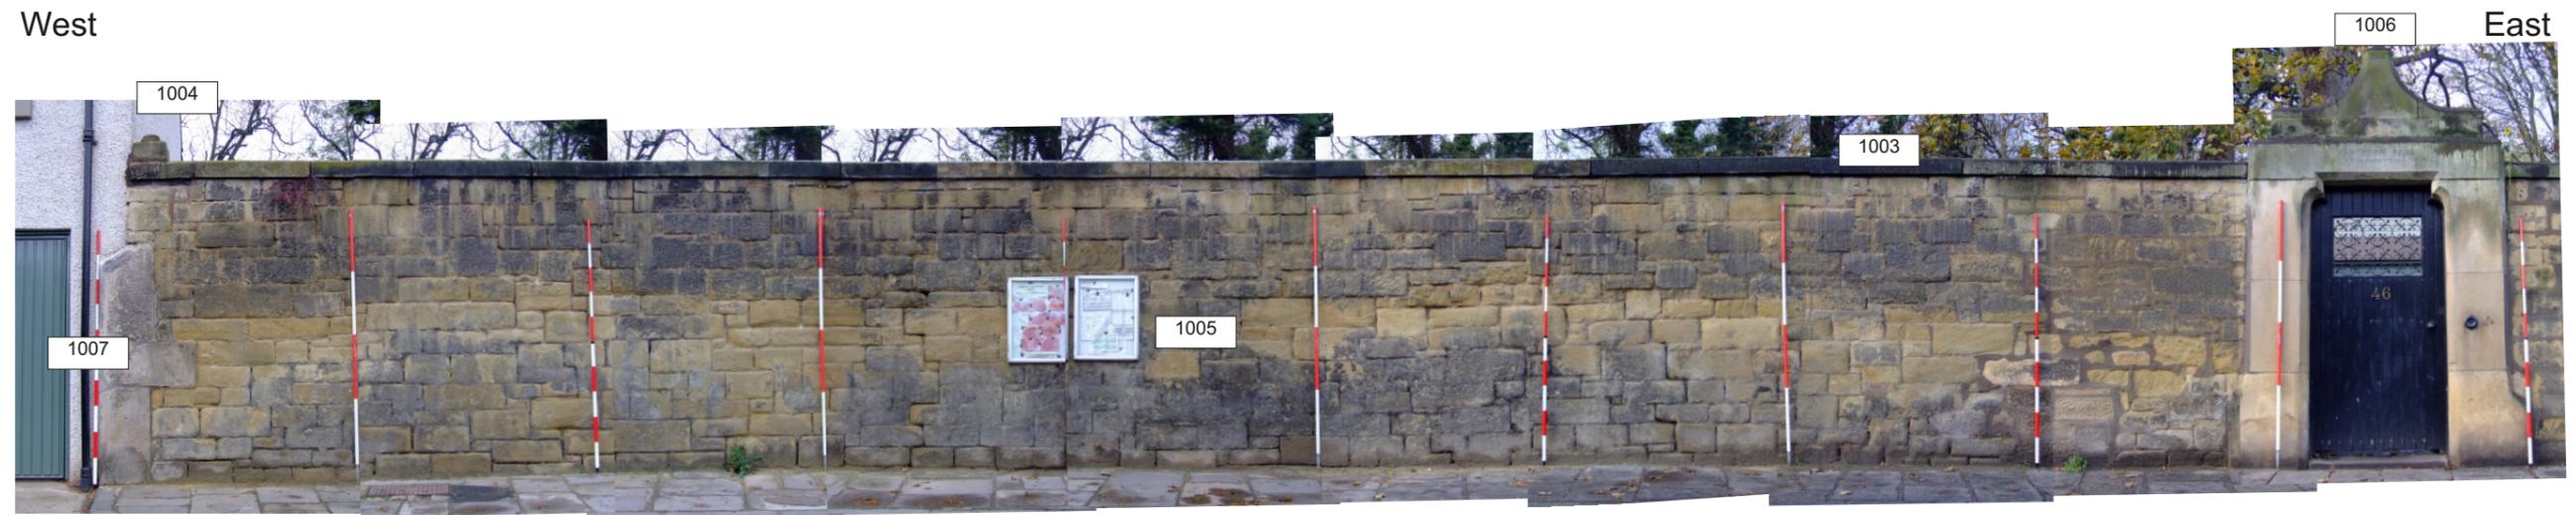
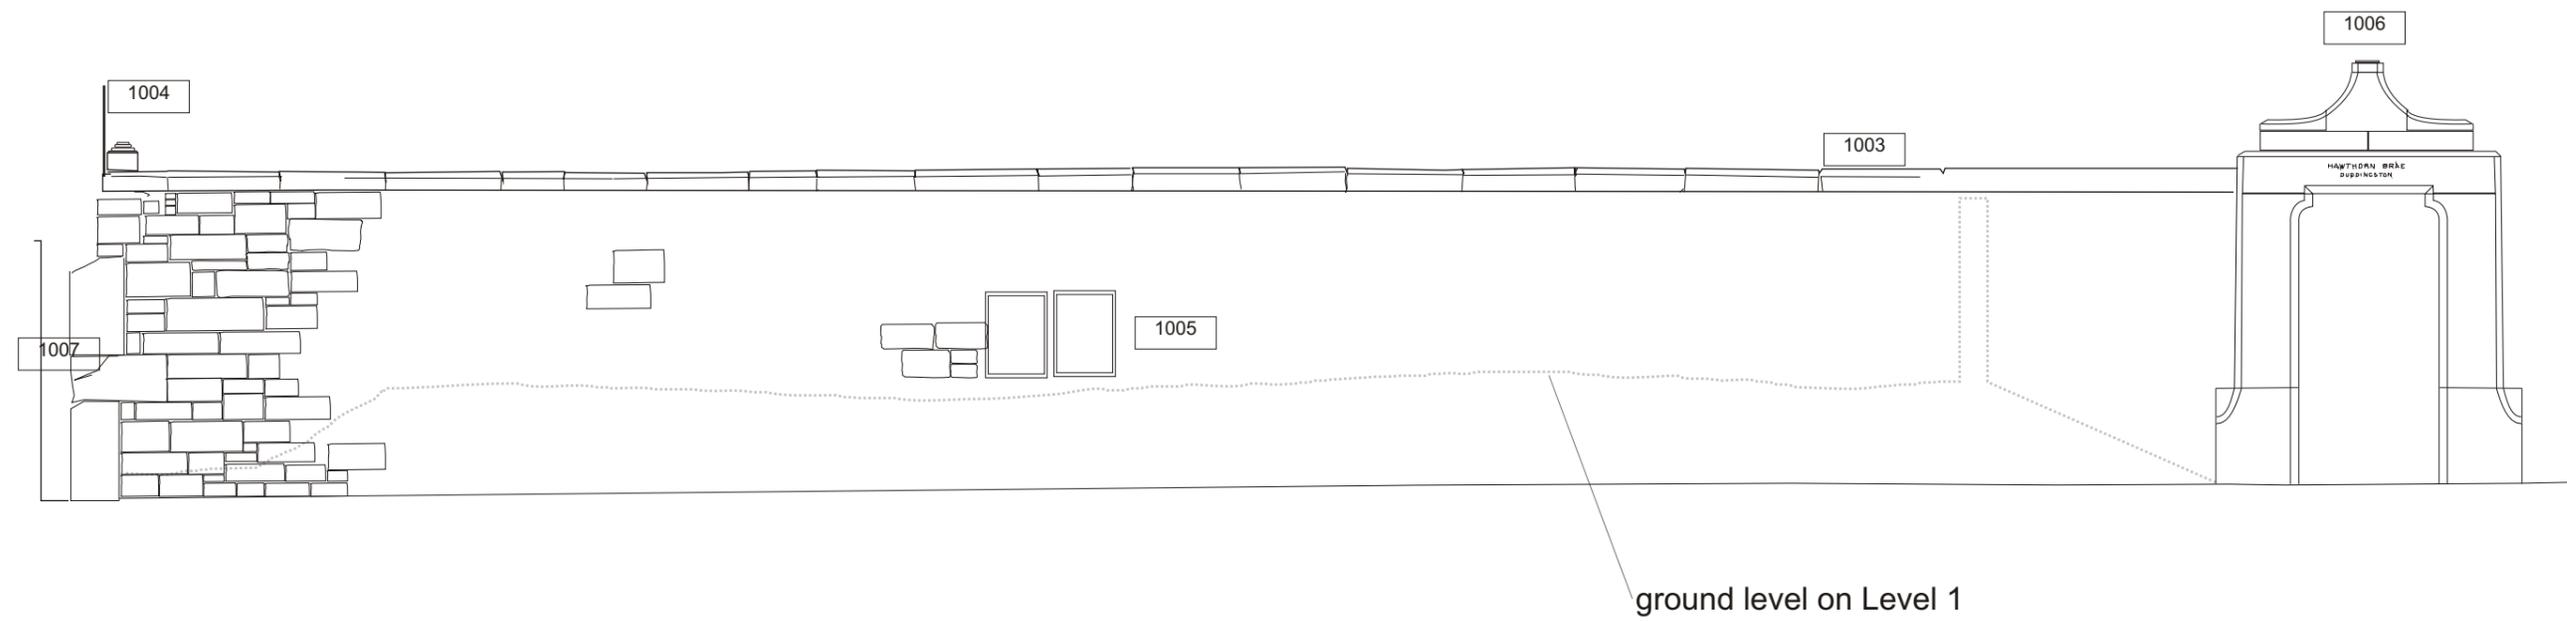
Figure 4: Wall 1, south facing elevation

Wall 1 which fronts the Causeway is of high significance due to its unified façade that defines the property of Hawthorn Brae. The original wall [1001] is completely masked by a yellow sandstone façade [1005] which stretches the entire length of the property. A gateway from this 19th-century façade has been removed by the addition of a modern garage but is still evidenced by a series of quoins [1007].

The most important and highly visible element is that of wall 1 which fronts the Causeway. The original intention of this wall was to create a unified façade stretching the full length of the Hawthorn Brae property. This wall was only breached by two carriage entrances directly in front of the villa

and a single pedestrian entrance [1006] directly to the east of the surveyed site. At the extreme west of the wall [1005] was a further entrance into the rear of the Hawthorn Brae Cottage property. Careful consideration should be given to the insertion of any further entrances, as currently the entire original design is intact. It is recommended that this façade remains intact. However, should it prove necessary to insert a further gateway, this should be done in keeping with the original 1817 design. Wall 8, the property division to the east and the Hawthorn Brae Villa contains a microcosm of the entire site history. Both the form of bricklaying, the mortar used, the heights of the walls and the materials are all important elements that should be considered in any remedial works. There is a danger that any re-building could however unintentionally remove or significantly alter features that add considerable weight to the significance of the property. These range from the swept ogee termination of the wall at the south end, the clear sign of insertion of the gateway [8006] and also the extent and form of the later 19th -century walling on Level 2.

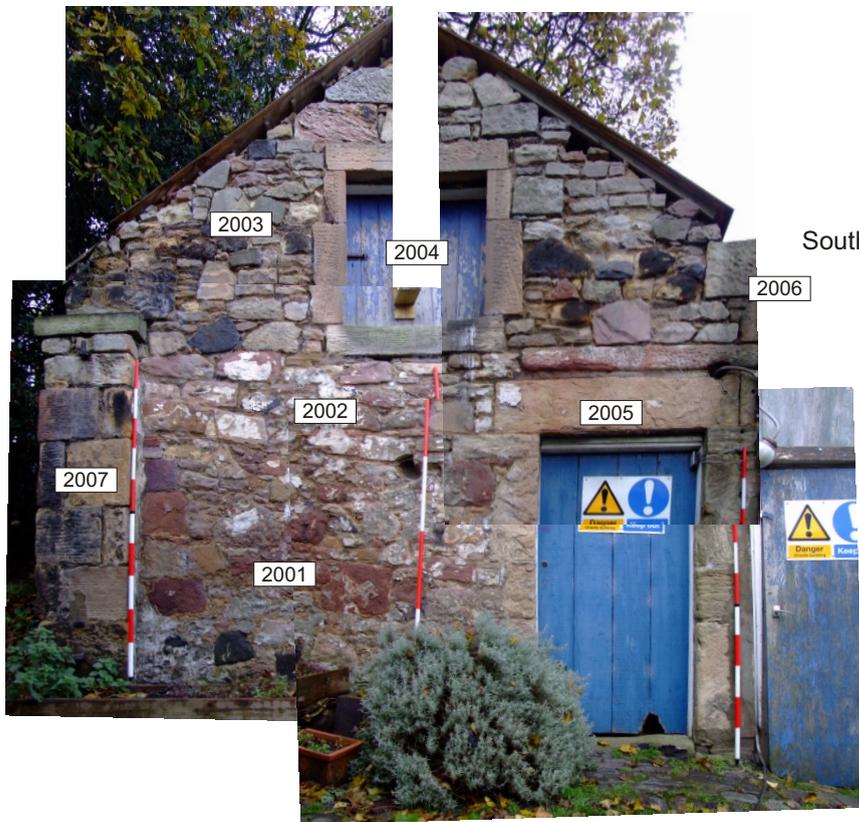
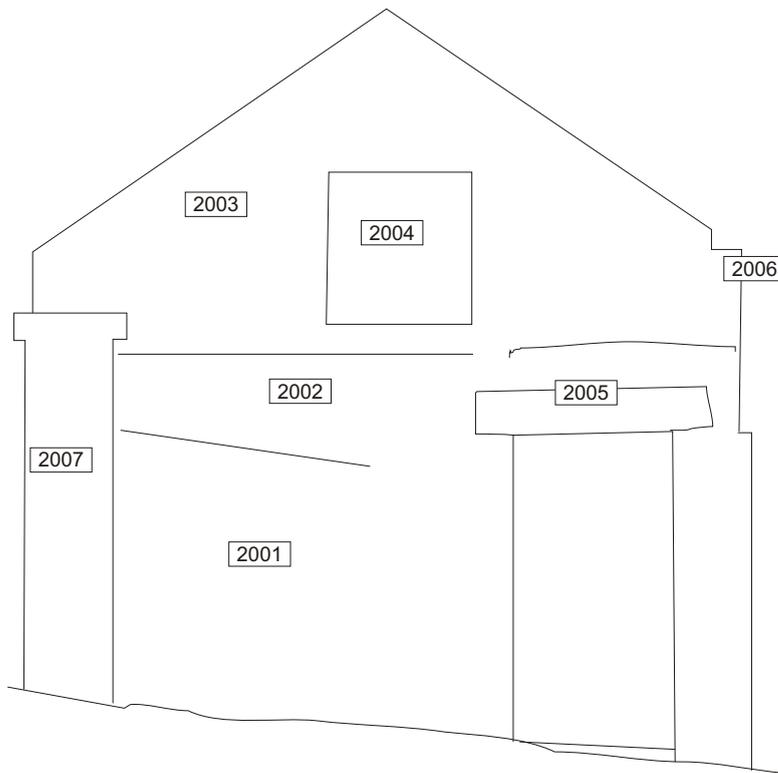
Figure 5: Wall 2, west facing elevation

The earliest wall [2001] of the elevation was the east wall of what is now the close and the angle of the top of this wall can be clearly defined. According to map evidence, this wall extended on to the north. Wall [2002] is also of sandstone rubble build, but creates a level wall head in the elevation, with a single simple doorway [2005] with sandstone surround penetrating the elevation (Room 1/1). The gatepier [2007] is contemporary with this wall raising, and must also relate to the truncation of the wall to the north, and the movement of gatepier from another location. The gatepier is of sandstone block construction with a flat slab cap, which itself is overlaid with the gable extension over [2002]. This gable extension [2003] is of poorly jointed and roughly coursed sandstone penetrated by a single central opening with a poorly constructed sandstone surround (the vertical surround is unstable in construction, being poorly tied into the surrounding stonework.), which leads to a loft space in the interior of the structure. To the south of the gable, there is a sign of further alteration to the south, with a large quoin [2006] and gap above, that may represent further construction to the south, into a structure (Room 1/3) now entered through a large opening to the south, from the close.

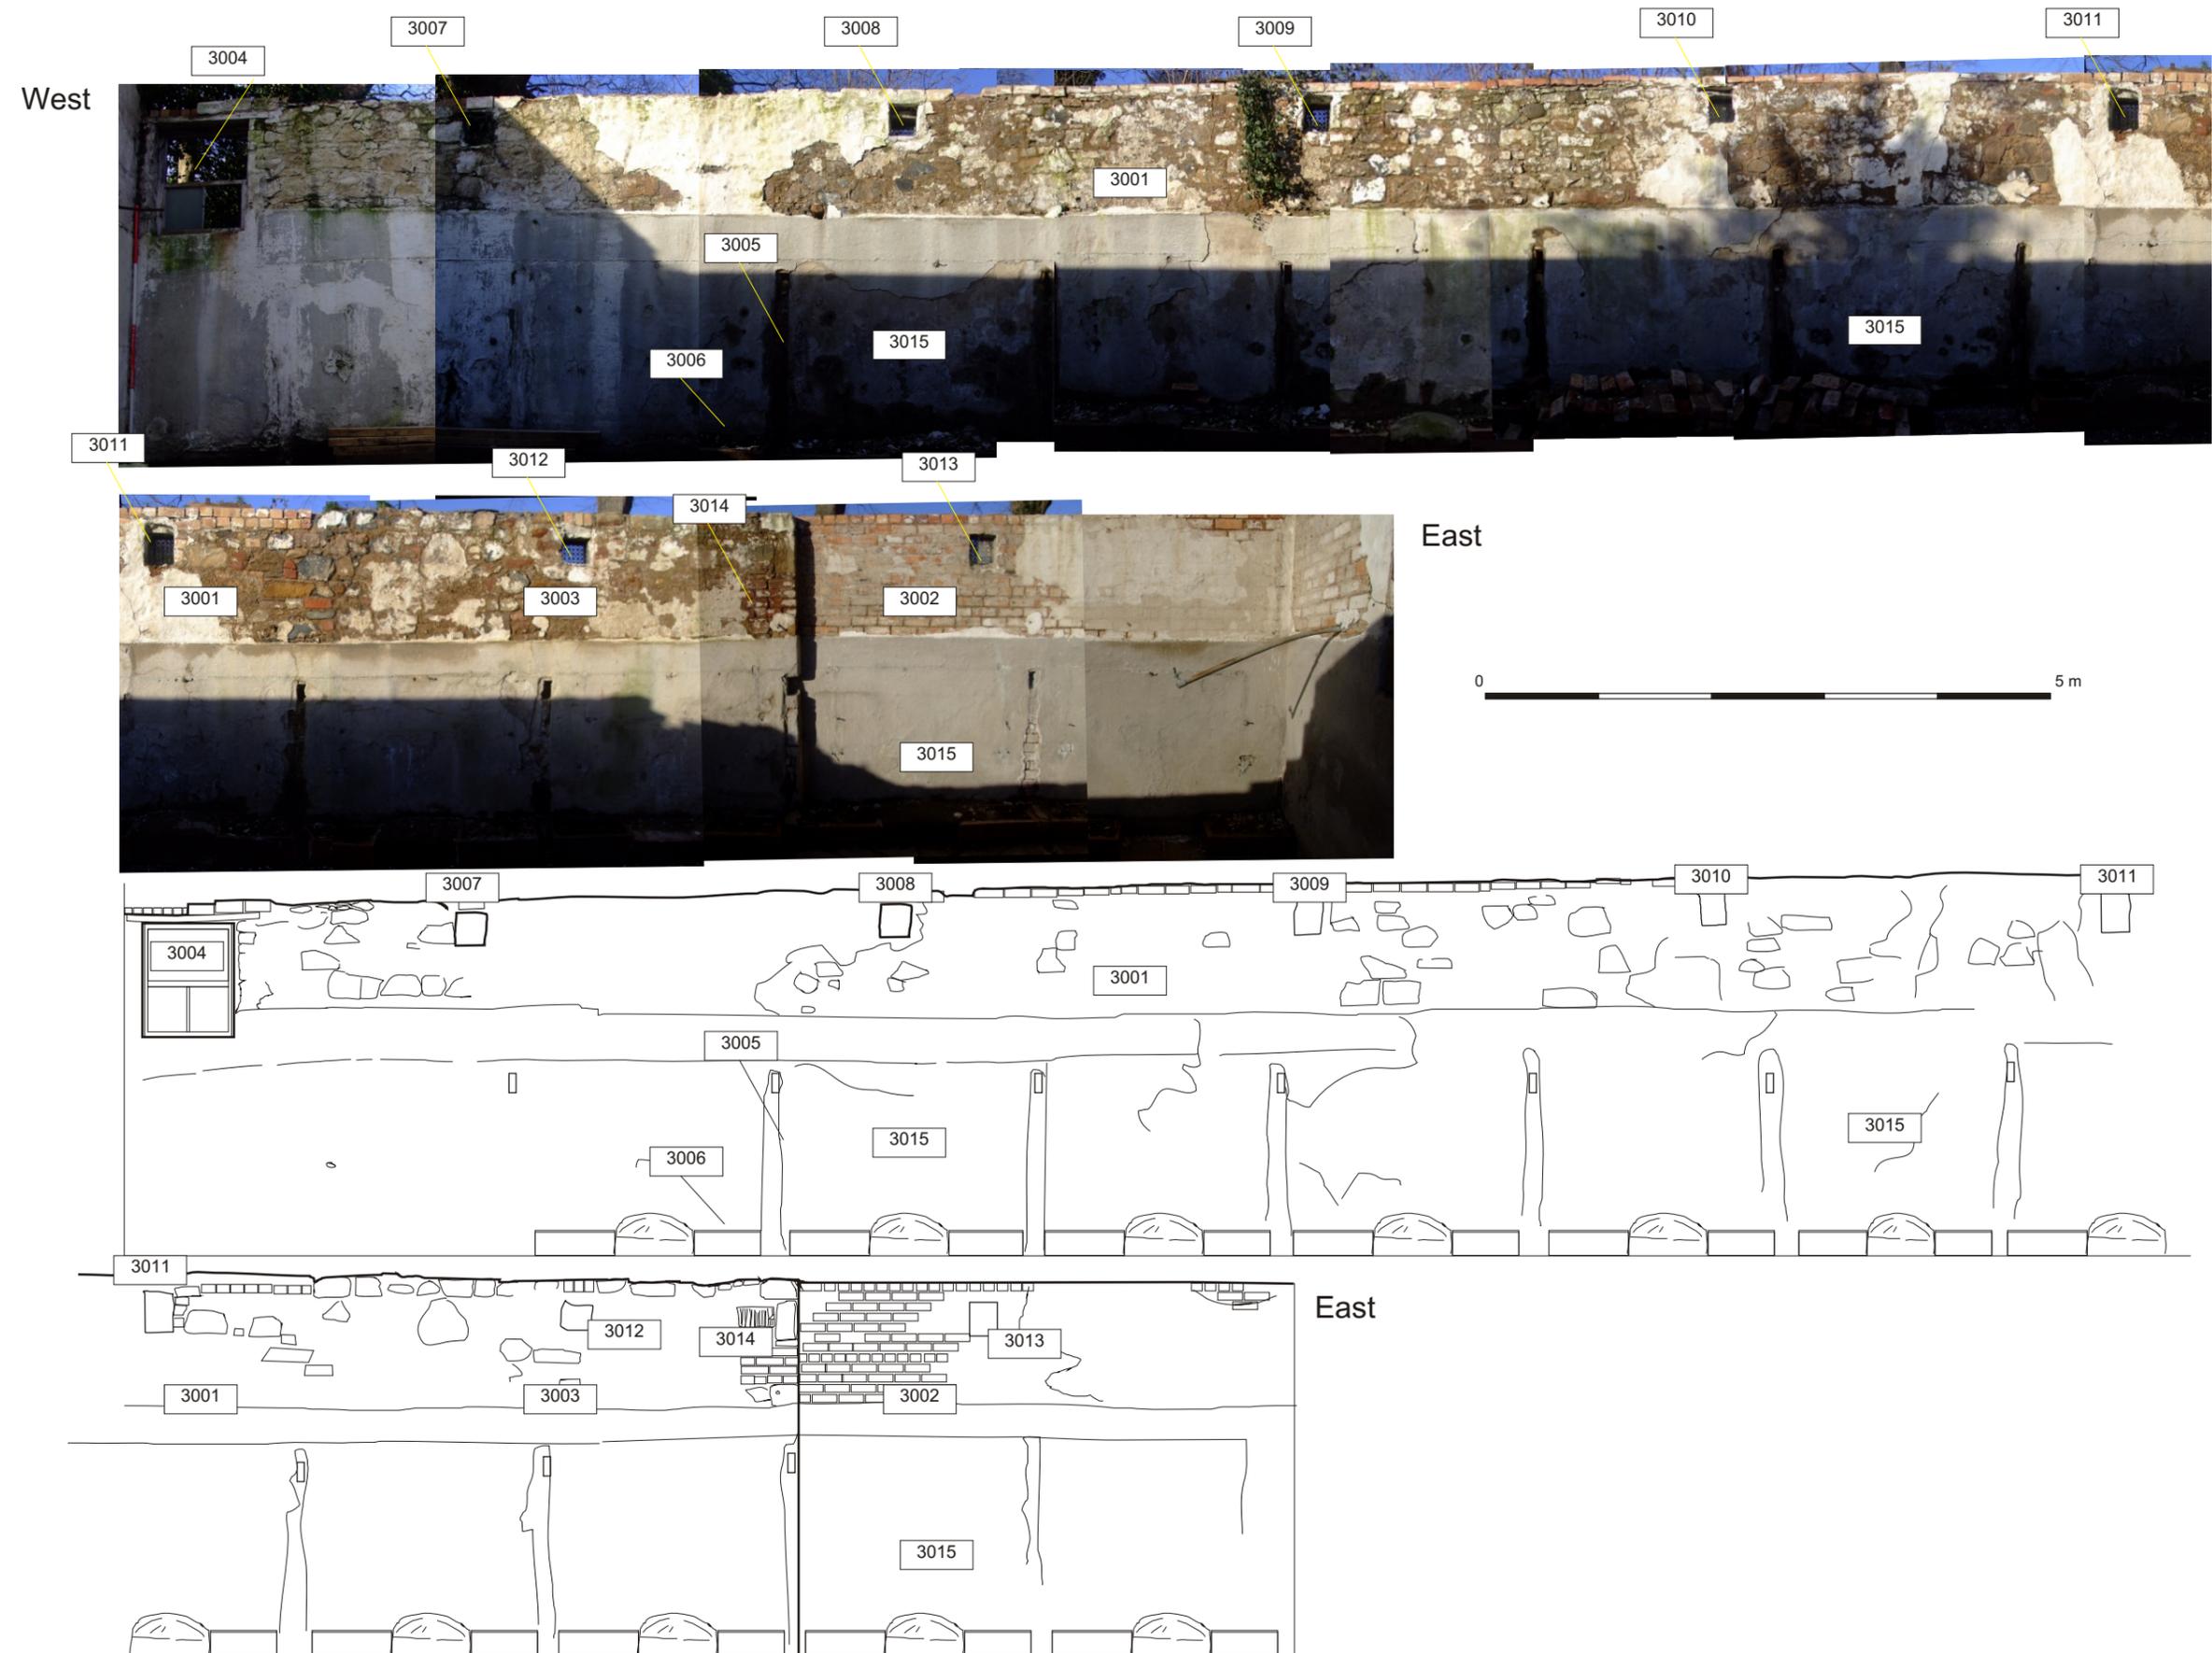
Figure 6: Wall 3, south facing elevation

The main structure of the elevation is a random rubble stone wall [3001] rising c. 3.30 metres from the floor surface to the wallhead, which is capped by a line of bricks along the length. This is acting as a retaining wall for the structure (1) after excavation of material from behind the retaining wall [5001] to the south. This wall is further extended or repaired to the east with another random rubble sandstone wall [3003] which terminates 4.44 metres before the east end of the structure. The quoins have been removed and replaced with bricks [3014]. There is then a step back of c. 0.20m before the wall continues to the east in brick [3002]. Along the whole length of the elevation there is a concrete render [3015] – 2.20m high, relating to the milking stalls represented by the scars for wooden stall dividers [3005] and ceramic feed/water troughs [3006] allowing for 22 animals to be accommodated at any one time. At wallhead level there are a number of small air vents with cast iron grills of various design [3007]-[3014]. However, at the extreme west end there is a window, bearing the remains of a fixed four pane window frame [3004] which predates the 'dairy phase'. The floor in this structure (Room 1/2) is similarly defined by a cobbled surface up to the line of the structure delineated by the end of the stone walling and removed quoins [3014].

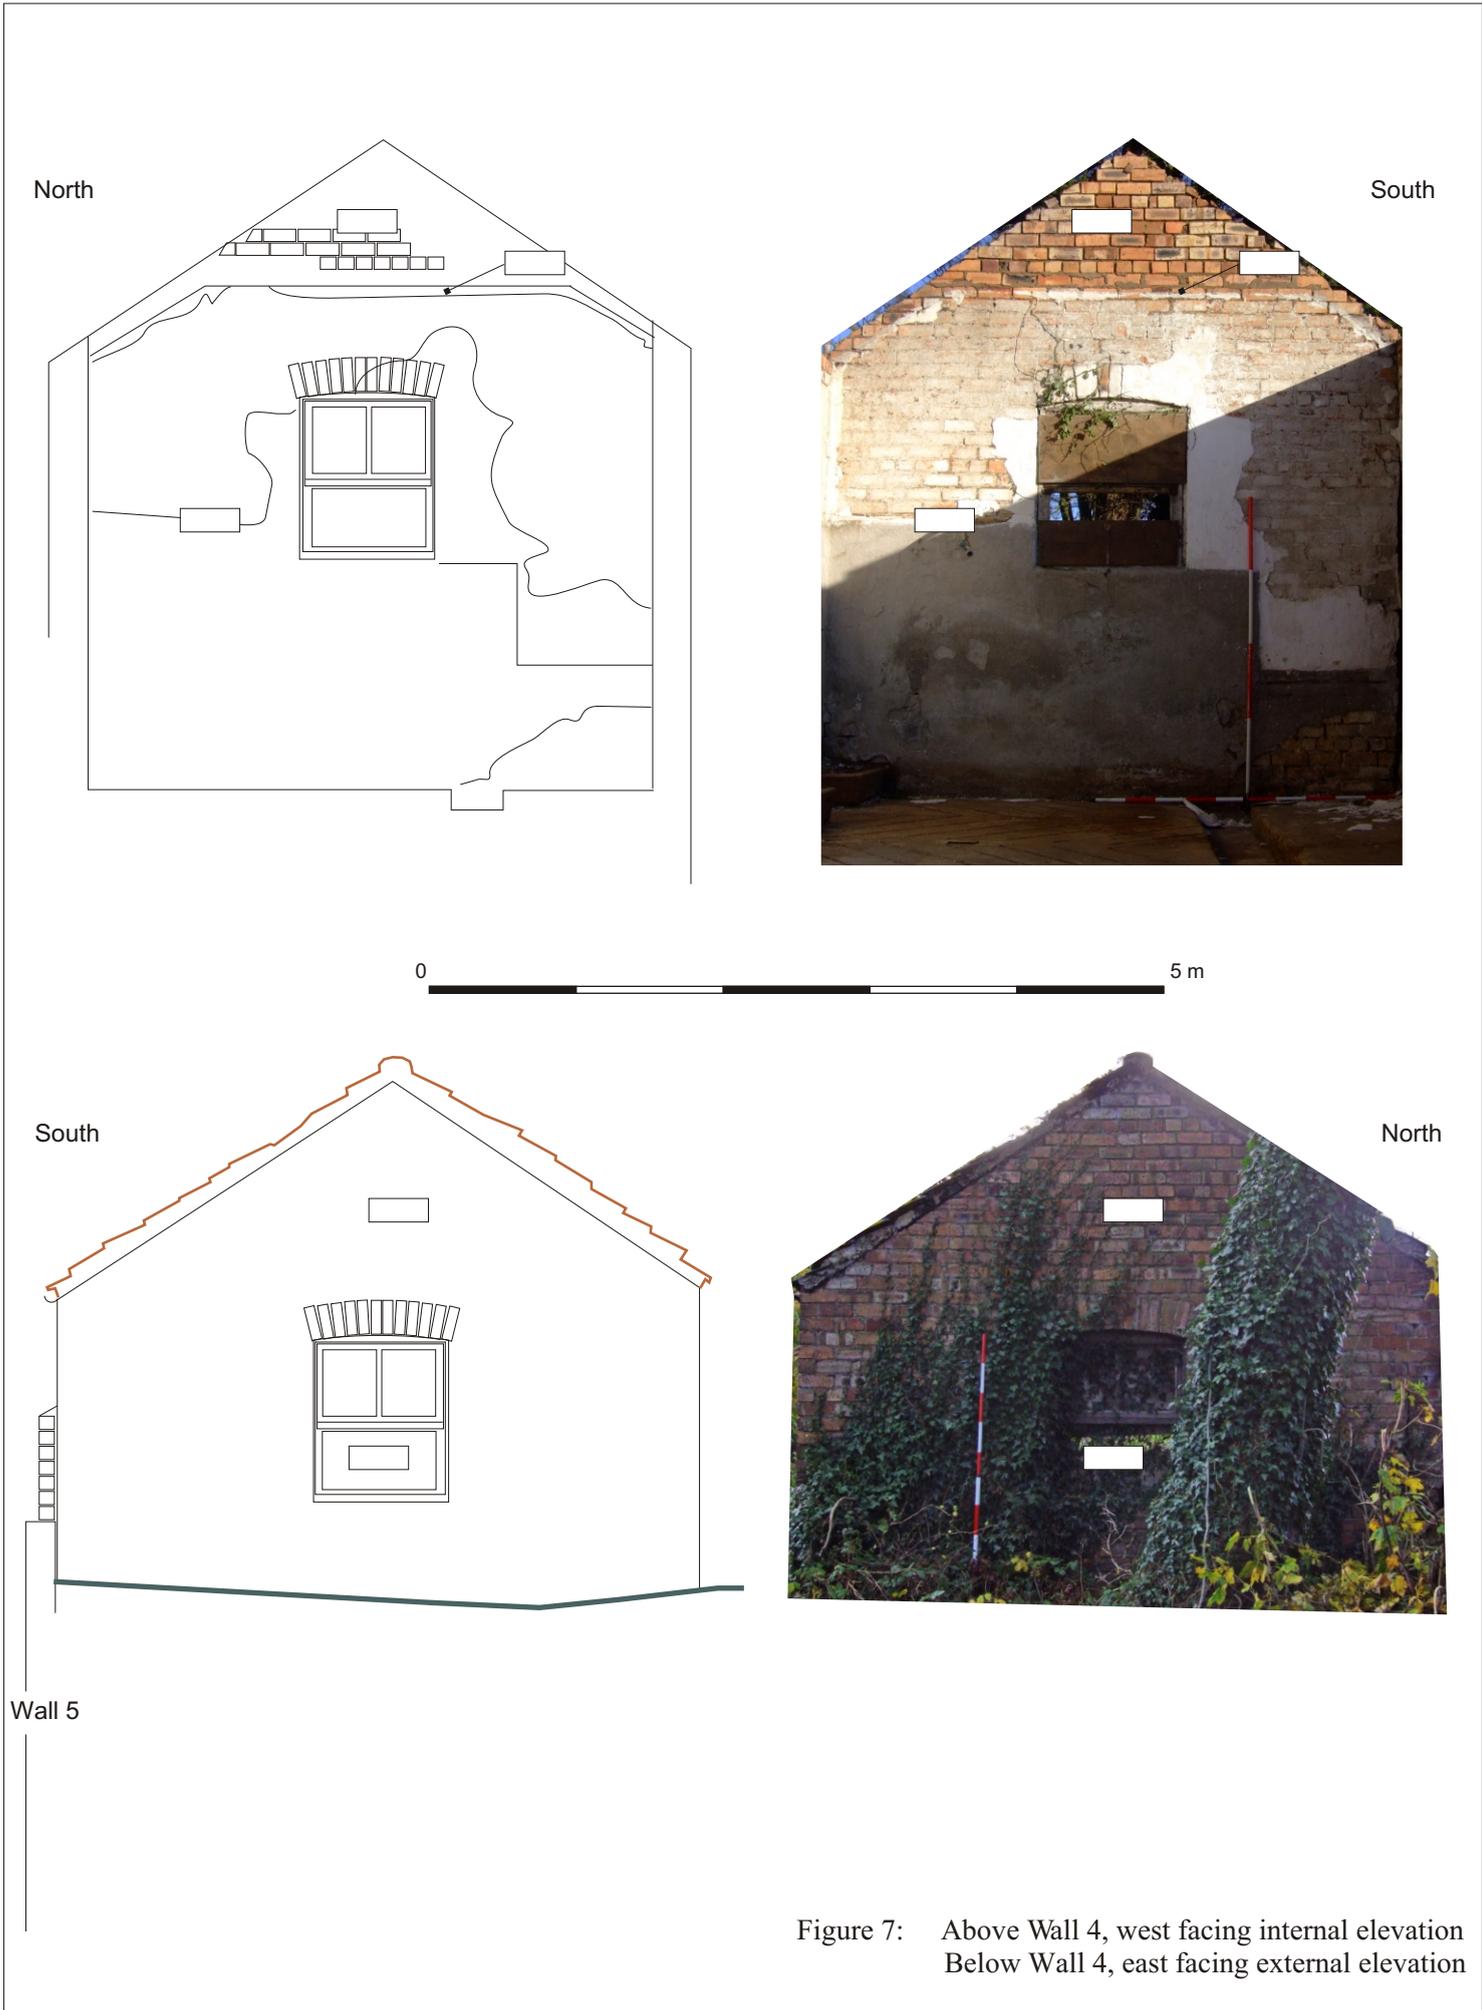
Figure 7: Above Wall 4, west facing internal elevation
Below Wall 4, east facing external elevation

The wall is entirely made of industrial 20th -century brick [4002], and to the west, the wall is partly a retaining wall for Level 2 into which this gable end extends. On the interior west facing elevation there is a cement render that represents the stall divisions [4001]. A single window with segmental arch brick penetrates the gable with a two over one sash window [4003]. The interior elevation shows the scar of a simple machine cut wooden roof truss [4004] that supported a pantile roof. The interior is c. 1.0m deeper the exterior.

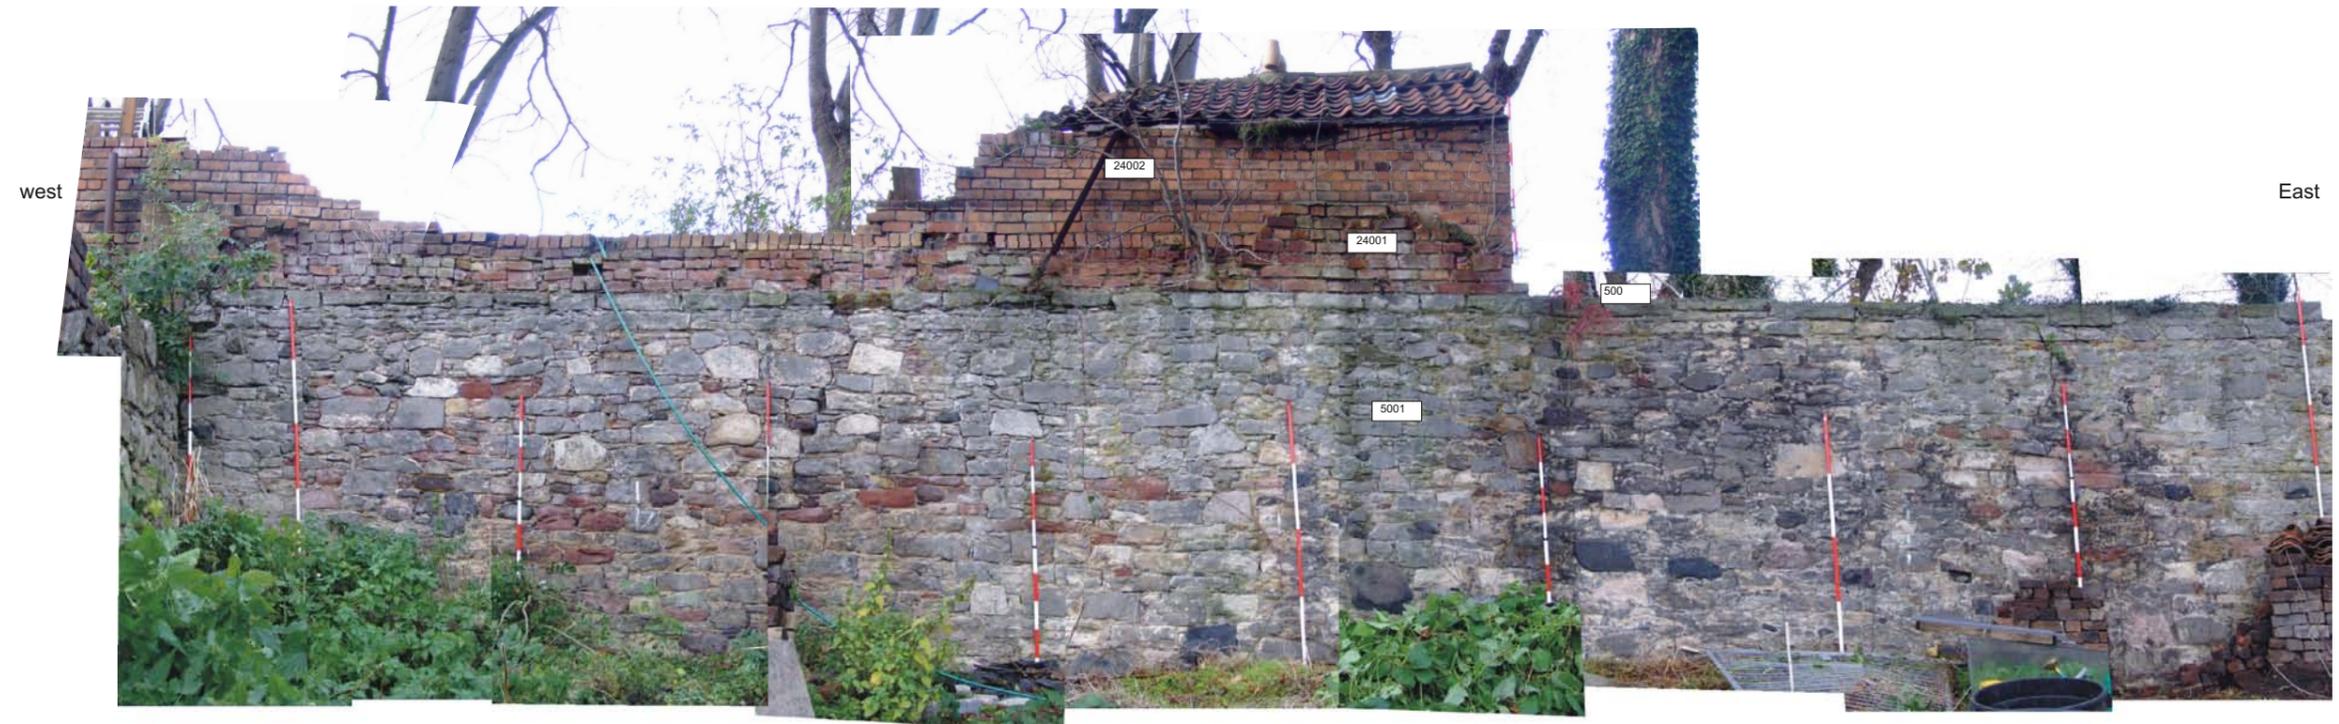
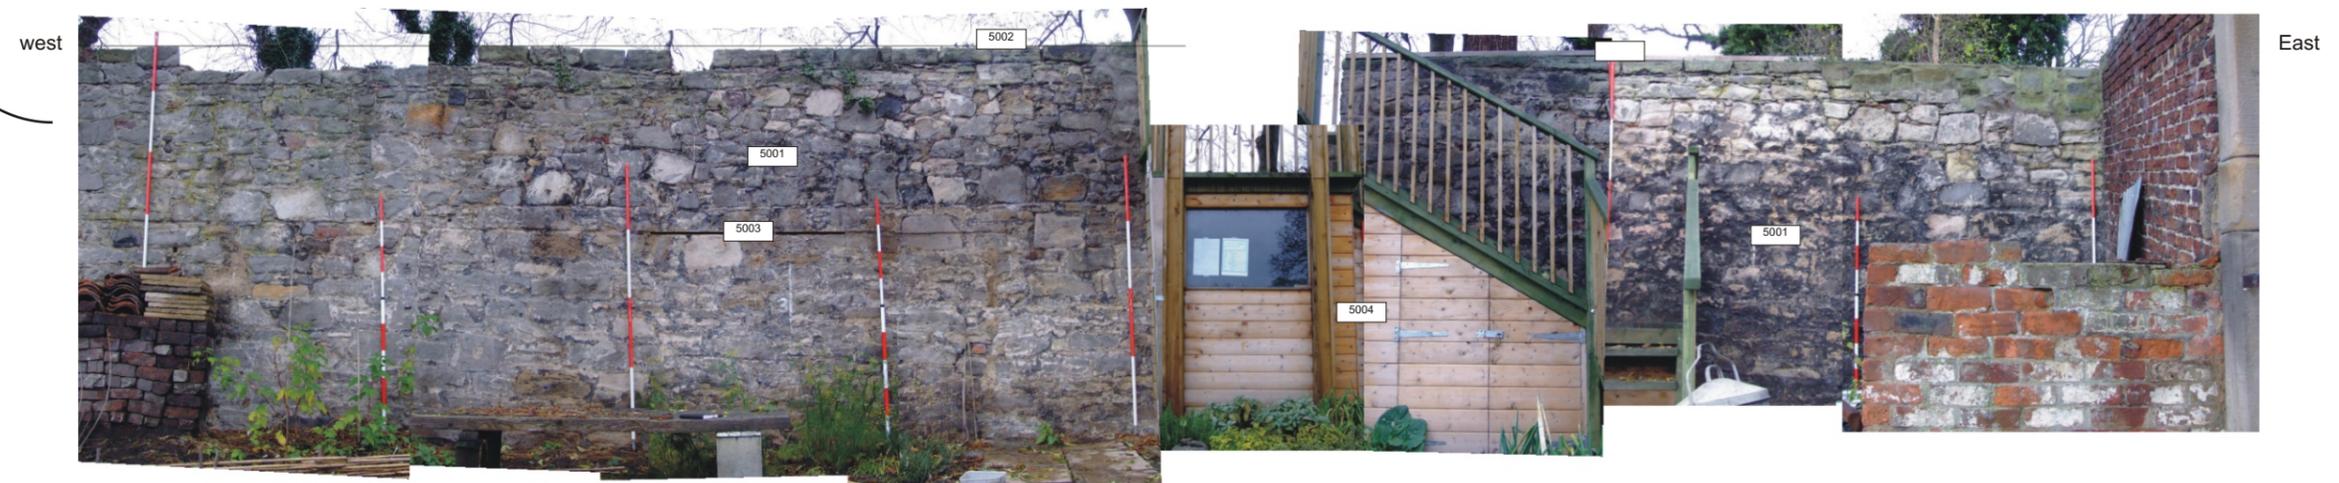
Figure 8: Wall 5, south facing elevation

The retaining wall between Levels 1 and 2 is a single build sandstone rubble wall [5001] capped with a flat sandstone coping that then slopes to the north with random rubble and brick, smoothed with mortar [5002]. Centrally there is a raggle line [5003] cut into the wall, which may be associated with a thin iron wire that runs vertically up the wall to a height of c. 0.60m - which suggests a cold frame structure. [5004] is a recent wooden stair and shed construction which has breached the upper section of the wall and connected Level 1 with Level 2.

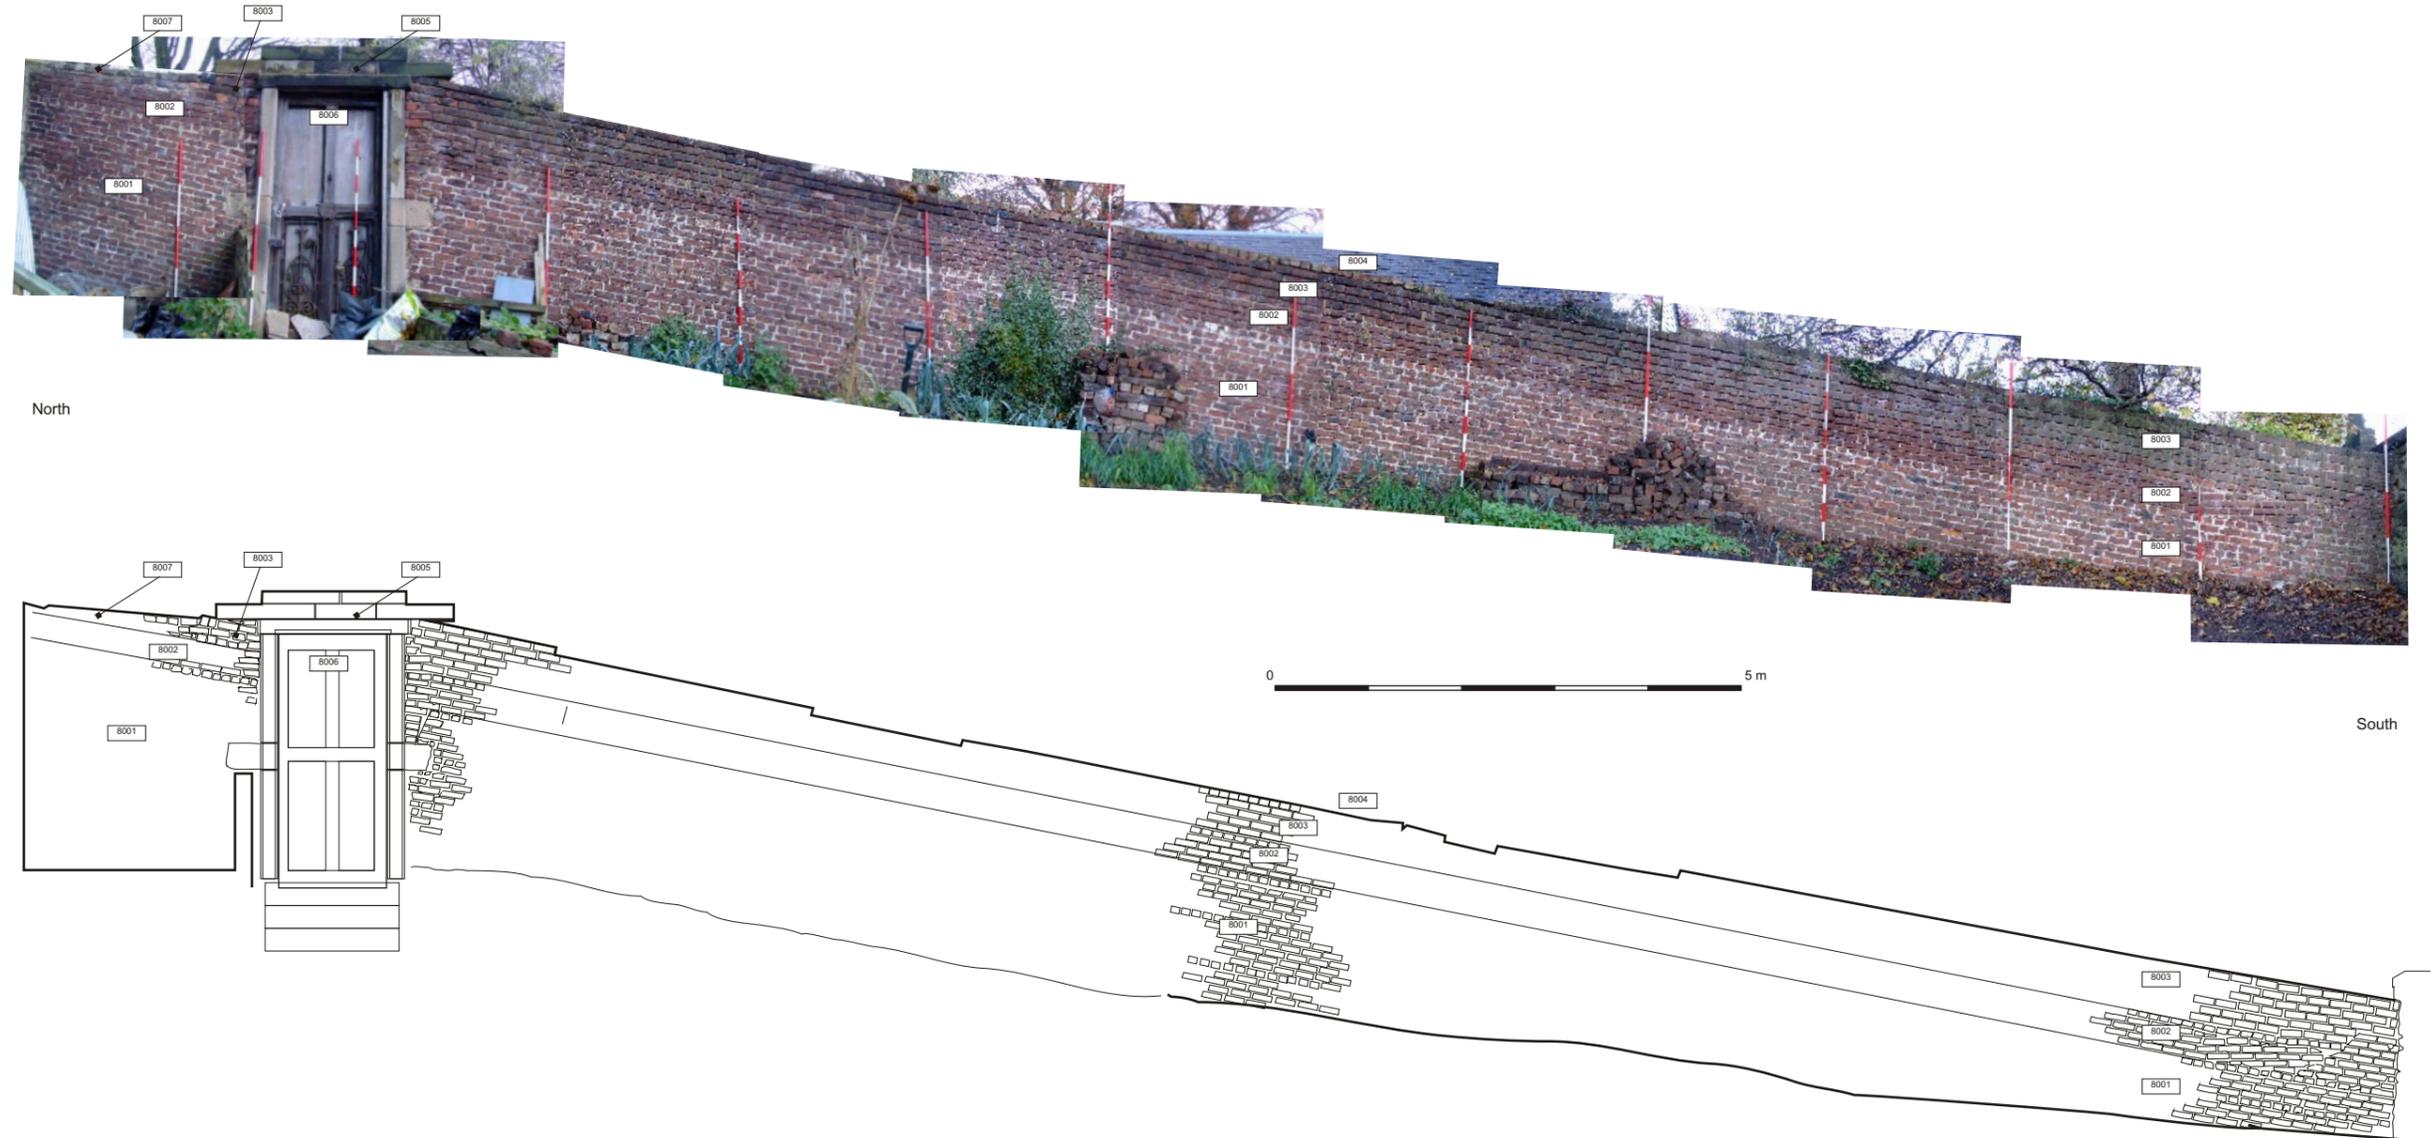
Figure 9: Wall 8 (lower), west facing elevation

The original 18th -century brick wall [8001] is constructed of four stretcher courses between each header course, following the angle of the slope in Level 1. At the extreme south end the brick work curves up in an ogee shape to meet the original height of wall 1. The bricks are set and pointed in a white mortar. The original coping was a stretcher course. [8002] is a further heightening of this wall again in hand made 18th -century bricks which raises the wall to the same height as the ogee end. The wall is then penetrated by a gate way [8005] which is constructed of well dressed sandstone jambs and lintels. The gate is a four frame wooden door with panels made from wrought iron in a floral design. The wall has been further heightened at this period with regular shaped 19th -century bricks [8003] to the height of the lintel. A further later repair in brick has been carried out at the north end of Level 1 [8007]. The final phase of this lower section is represented by a line of 20th -century bricks [8004] which indicate a garage structure to the east in the Hawthorn Brae property.
