The Yards, Duddingston Village , Edinburgh

A National Trust for Scotland Report

April 2008

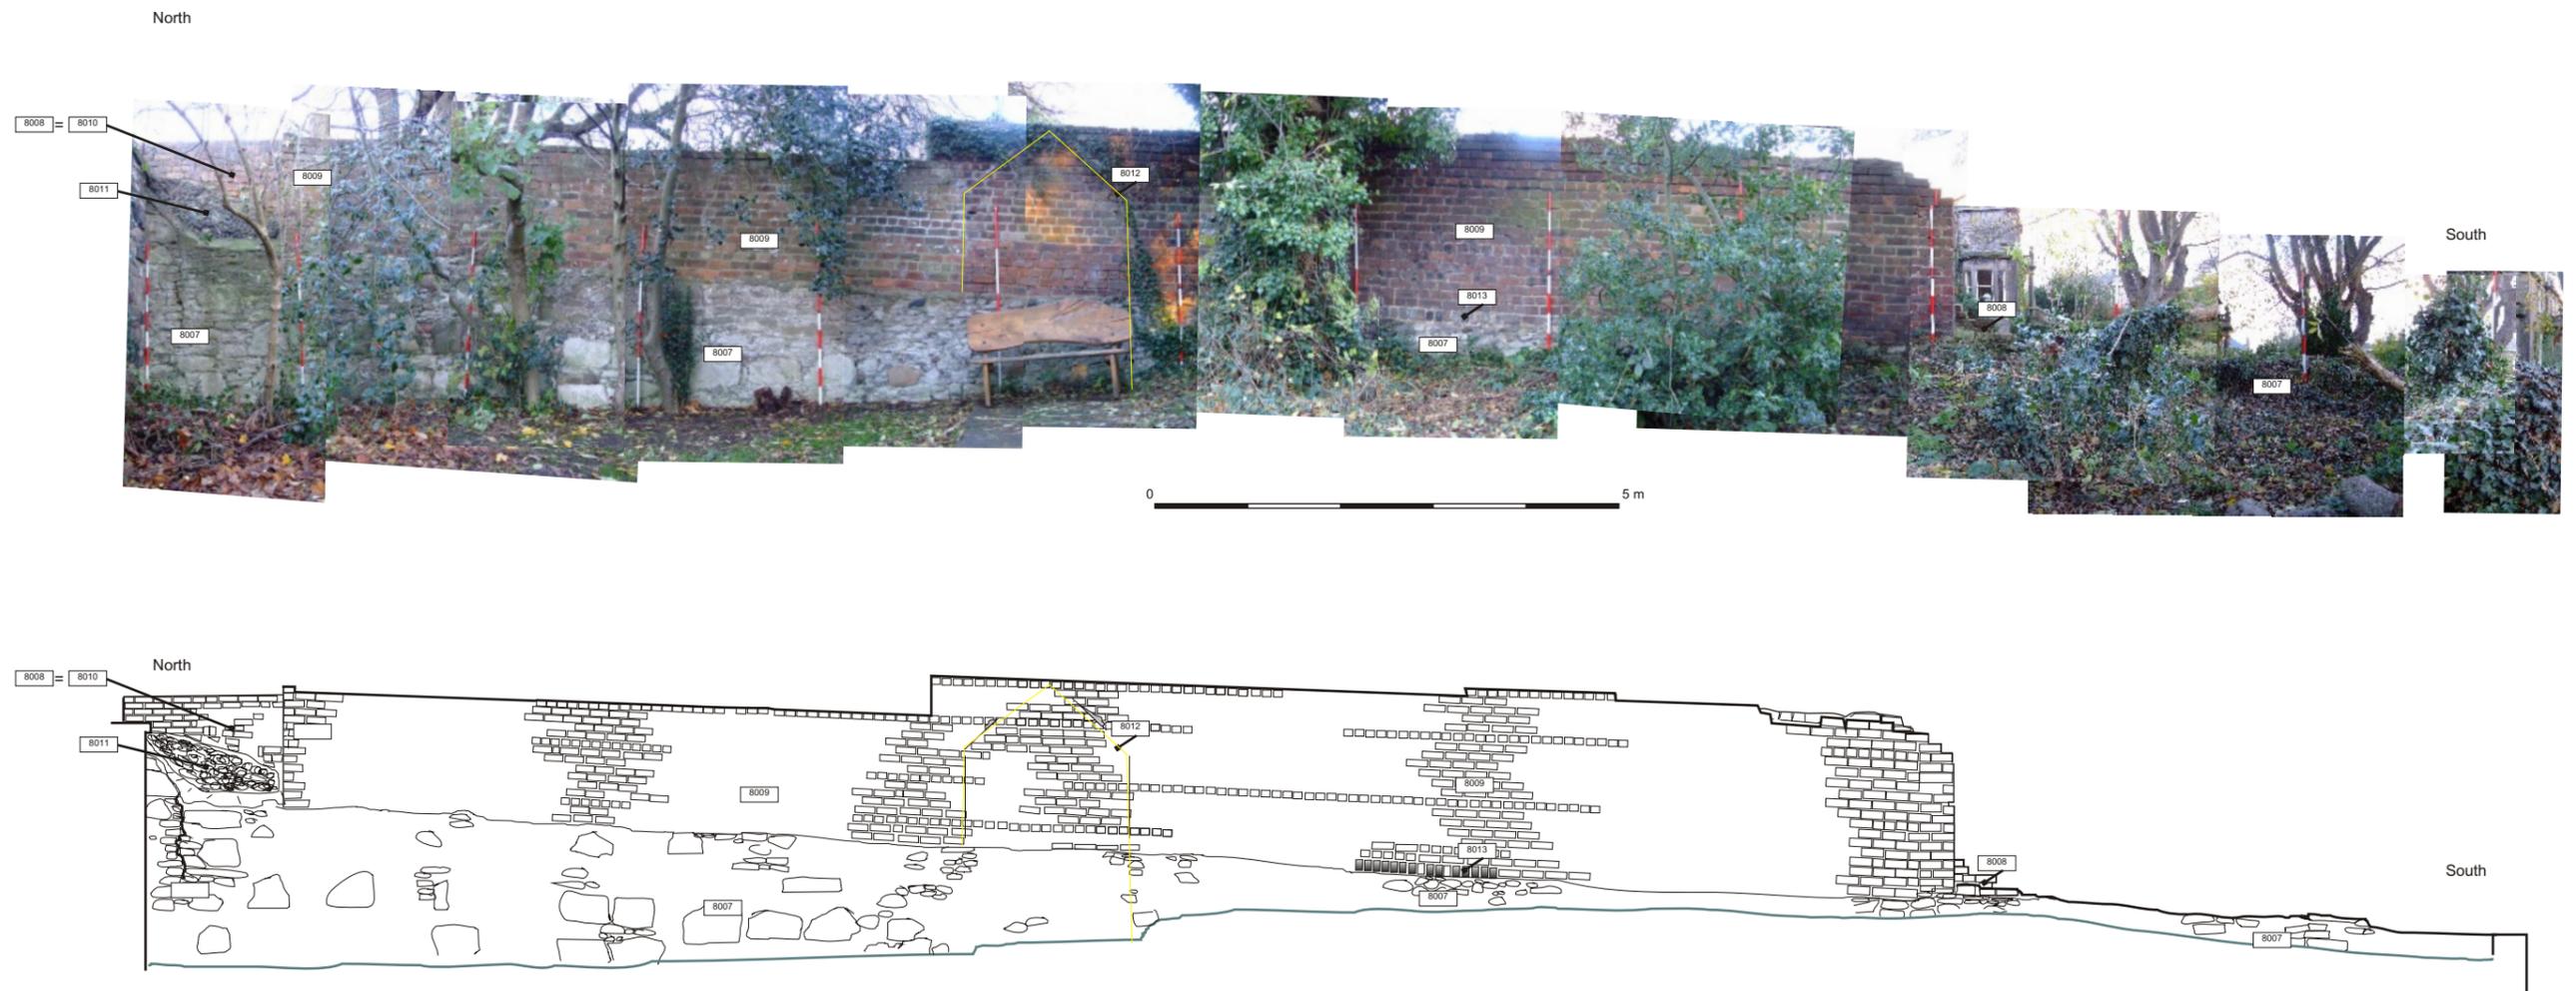
Figure 10: Wall 8 (upper) west facing elevation

The wall line continues into Level 2 where the base is of random rubble construction, both sandstone and whin [refer to figure]. The wall head of which again follows the original slope of the ground. The brick wall above [8009] is of 19th -century date, formed of regular courses consisting of four to five stretcher courses before a header course. Half way along its length the wall steps down five courses before continuing to the north, and this may represent the location of the bowling green pavilion along the higher stretch of wall. The wall ends approximately five metres from the southern drop into Level 1. Behind this brick skin lies an 18th -century brick wall [8008] and this can also be seen to the north as [8010]. Applied to the brick wall [8010] is a mixture of mortar and industrial slag [8011]. On the wall directly behind an existing stone platform in the central area of the elevation, discoloration and elements of cement raggle for a small gable structure is visible [8012]. A final feature which may or may not be significant is a line of bricks [8013] with vitrified or glazed header ends.

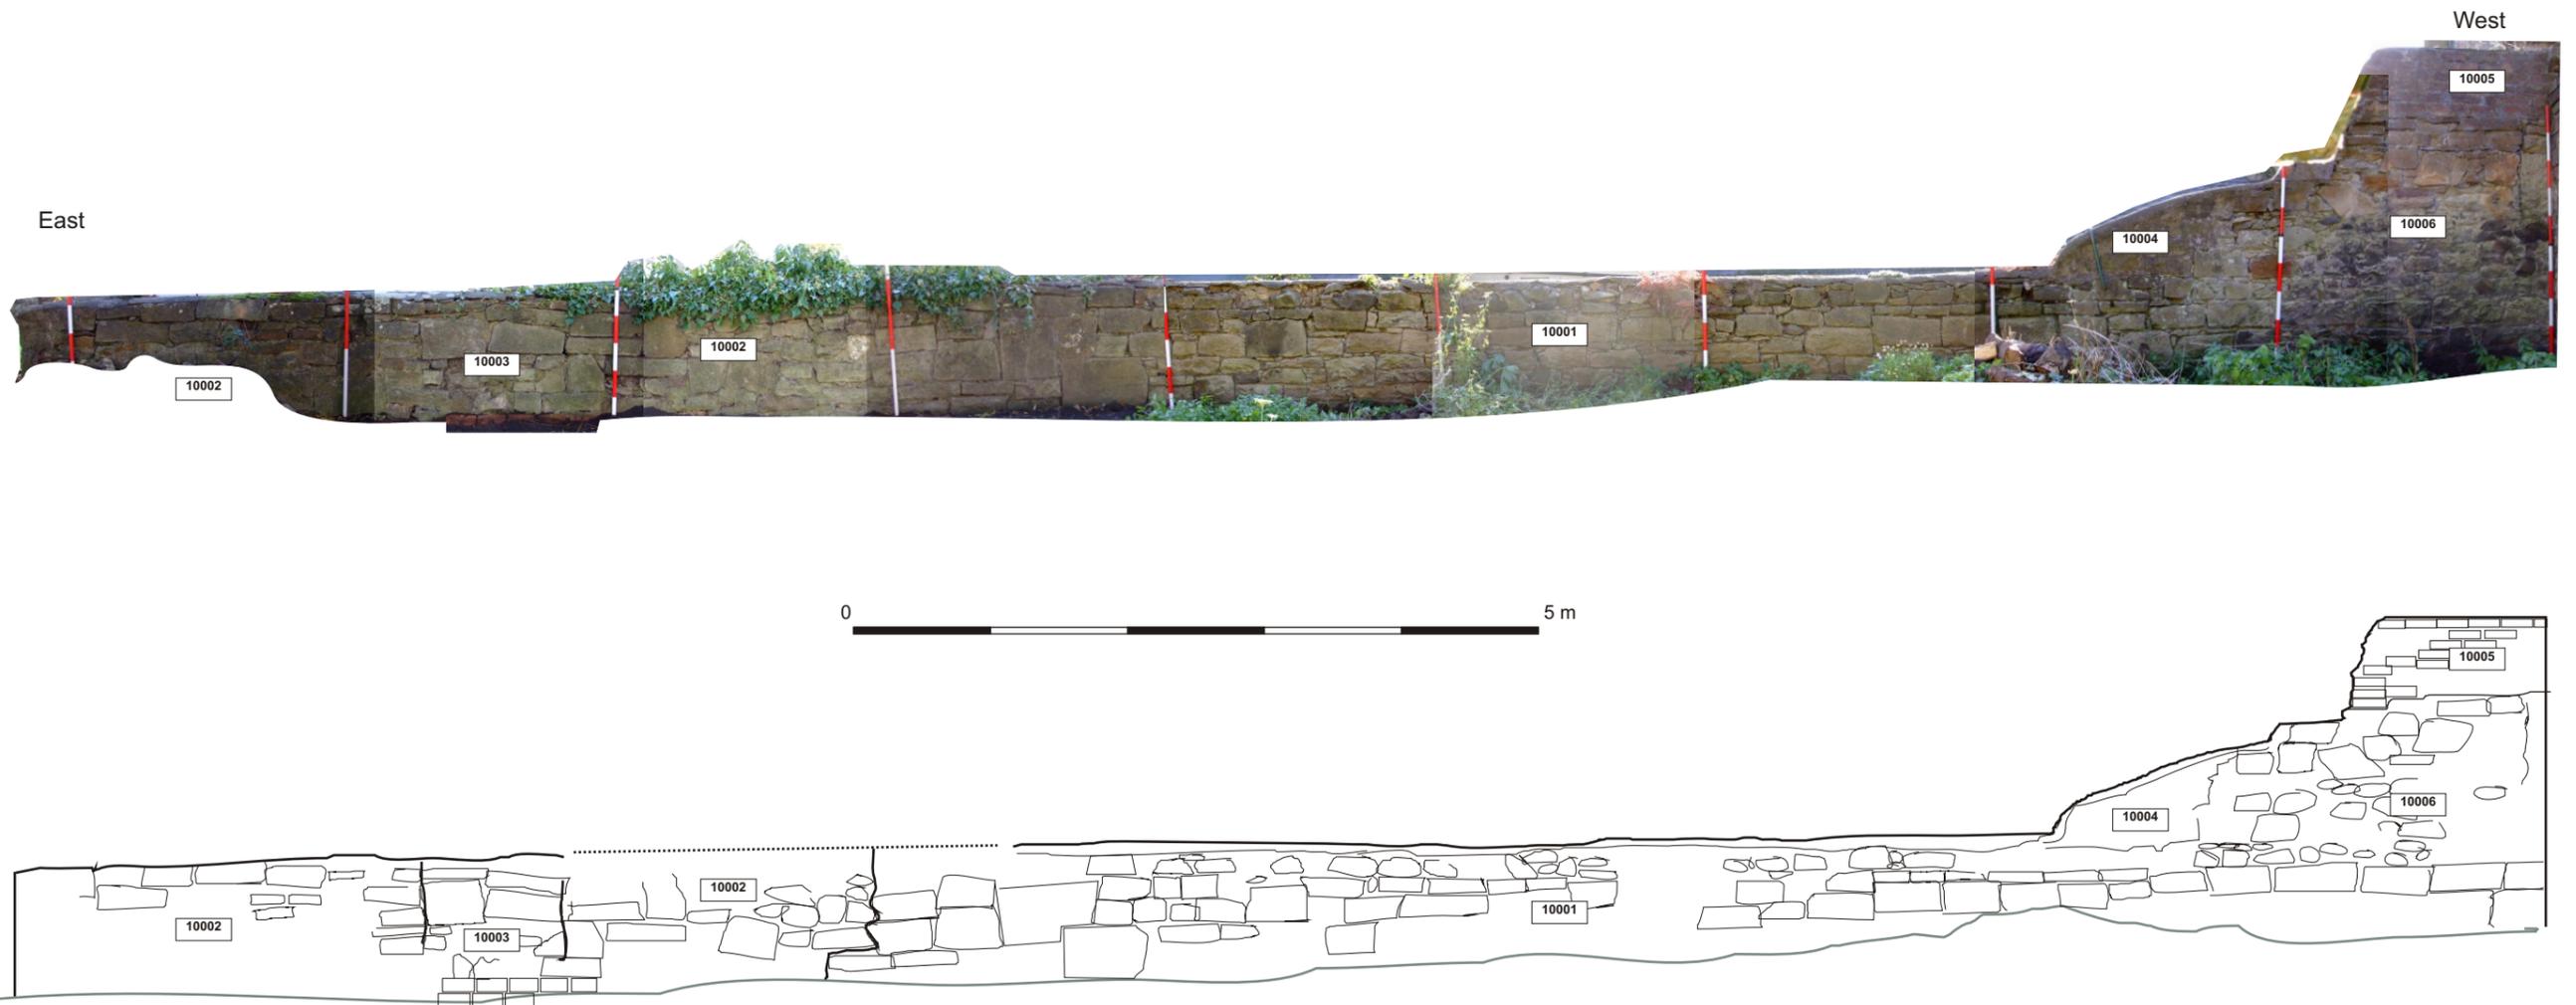
Figure 12: Wall 10 north facing elevation

The main wall construction is of roughly coursed sandstone blocks with a cream mortar [10001]. The eastern half of the wall is of poorly coursed rubble work of sandstone blocks [10002] which had been penetrated down to the property level to the south which had a brick threshold and is now blocked with sandstone. To the west the wall has been raised with random rubble that has been slaister pointed [10006]. A small infilling/raising has taken place adjacent to [10006] and is of random rubble with a cement coping [10004]. The final phase again at the extreme west is a mix of reused bricks [10005], which matches the wall raising on wall 11.

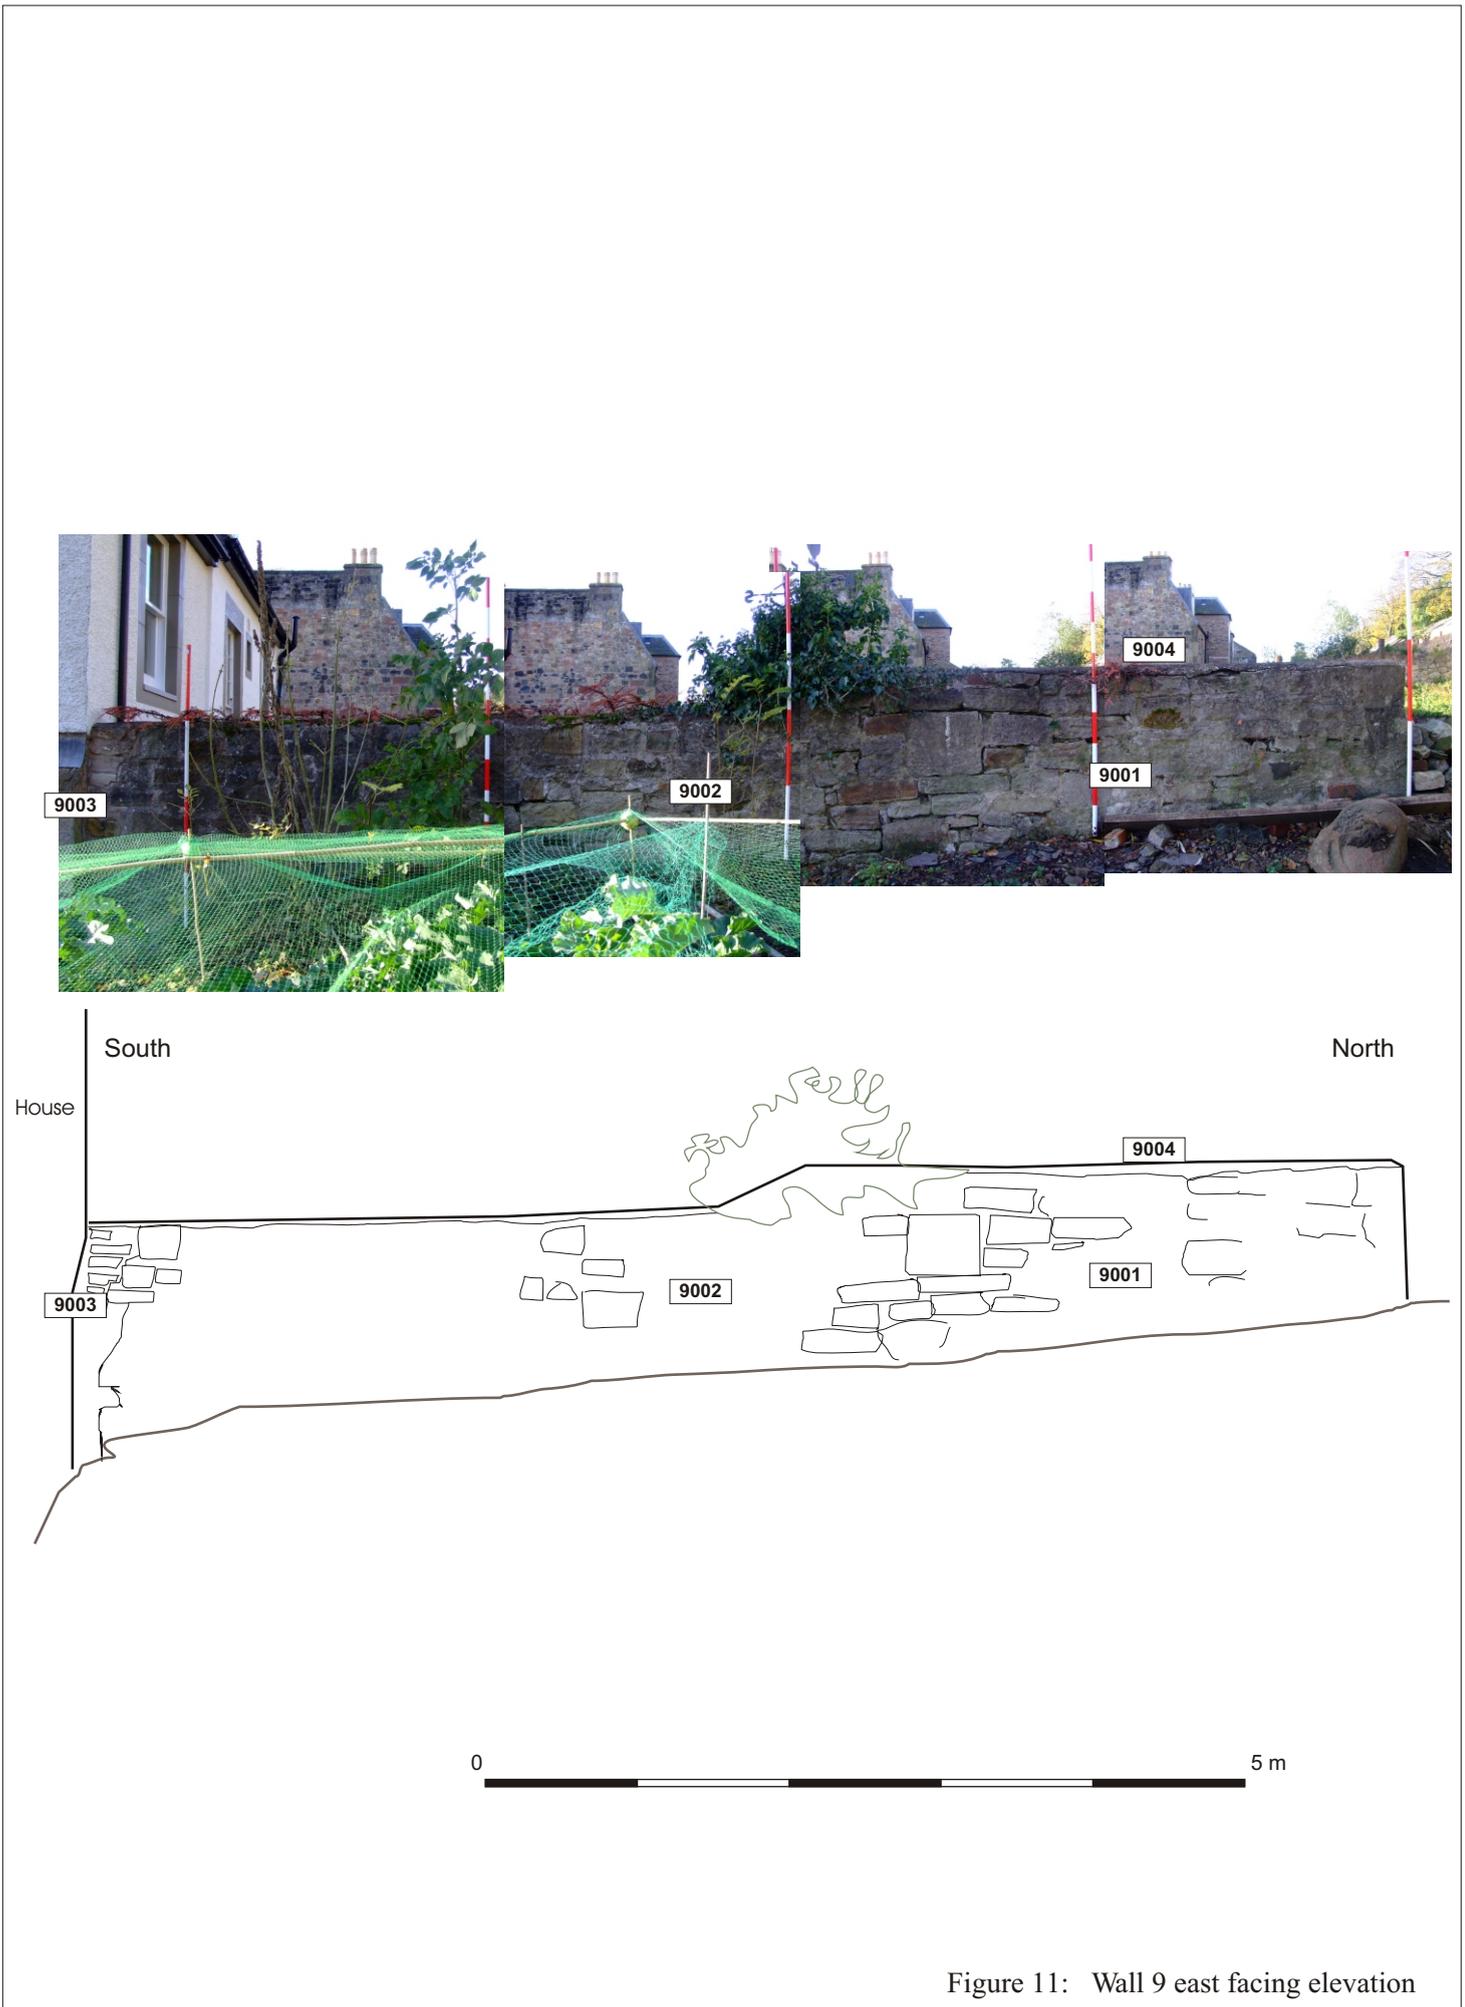
Figure 11: Wall 9 east facing elevation

Random coursed retaining wall [9001] built from sandstone/whin stone and slaister pointed; forms northern part of this remaining land division. This continues to the south with a further coursed sandstone wall with cement pointing [9002]. A small area of infill is visible at the southern end [9003] where the wall has been cut through by the modern garage extension. The entire length has a cement coping [9004] and the wall head steps down from north to south at approximately the line where [9001] changes to [9002].

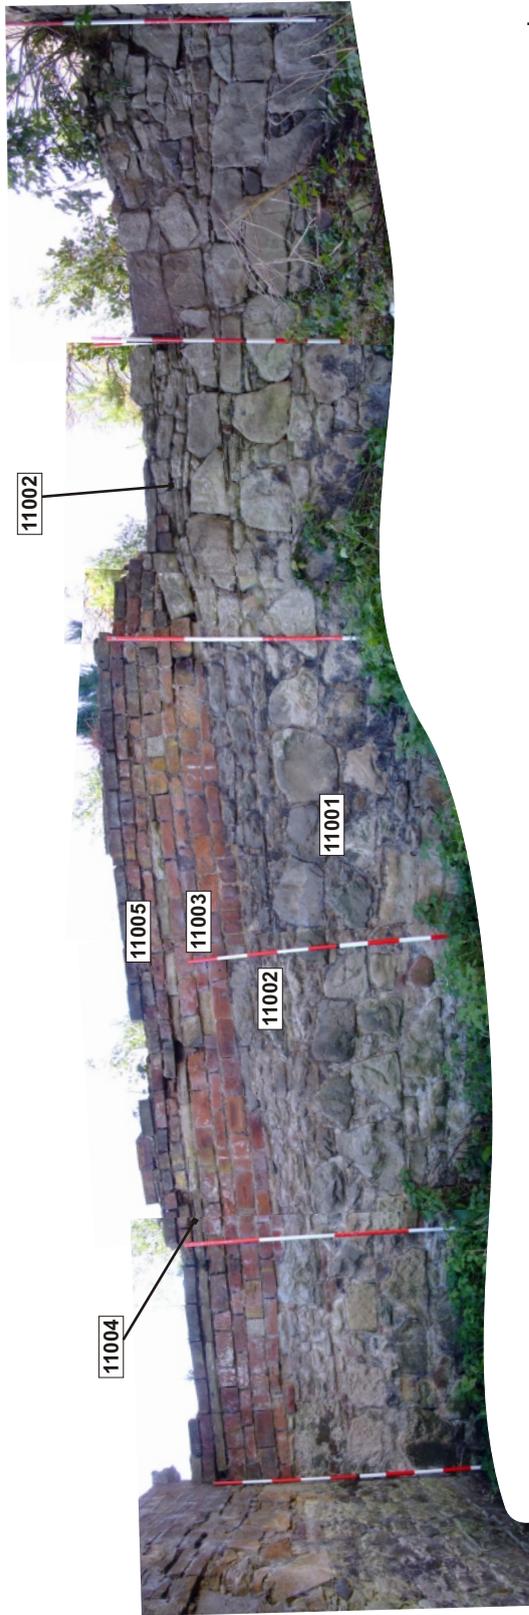
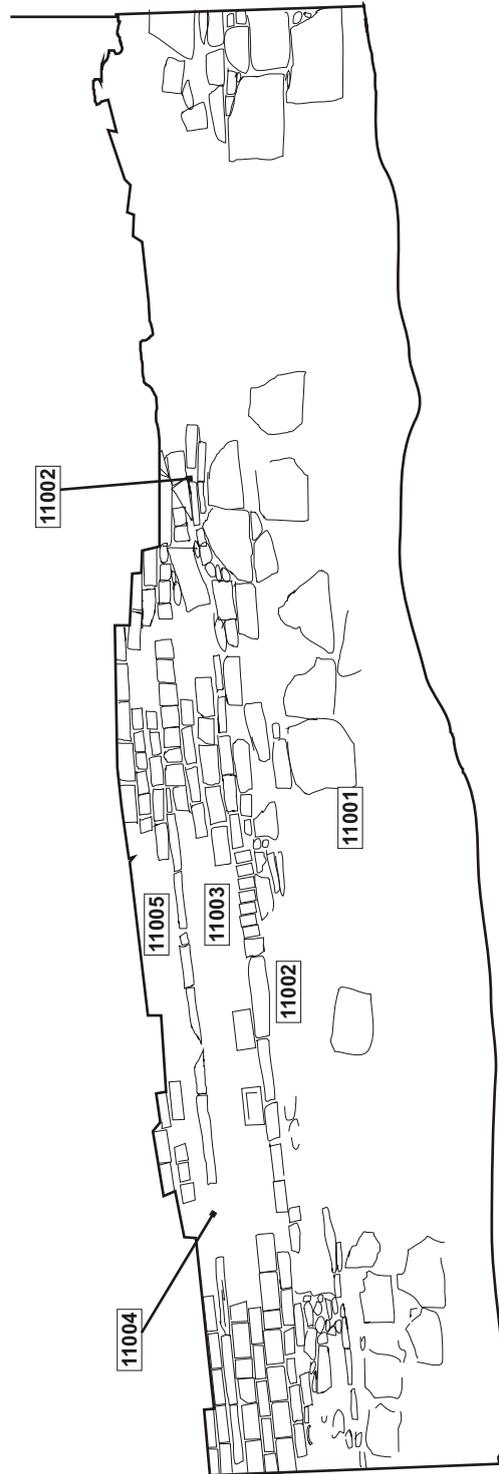
Figure 13: Wall 11 east facing elevation

The base of the wall is constructed of large sandstone angular blocks with smaller snecks between [11001] which is butted against the retaining wall [5001]. A further heightening of the wall is evidenced by around 30cm of smaller flat sandstone set in a pink cream mortar, above this are large end on bricks [11003] of late 18th -century industrial form, though it is clear that they are re-used. This level had flat sandstone coping along part of its length [11004] and matched the height of wall 10 when raised with [10006]. The final raising of the wall which must be contemporary with [10005] is of late 19th -century industrial bricks. The brick sections do not extend the full length of the wall and may represent a structure to the west.

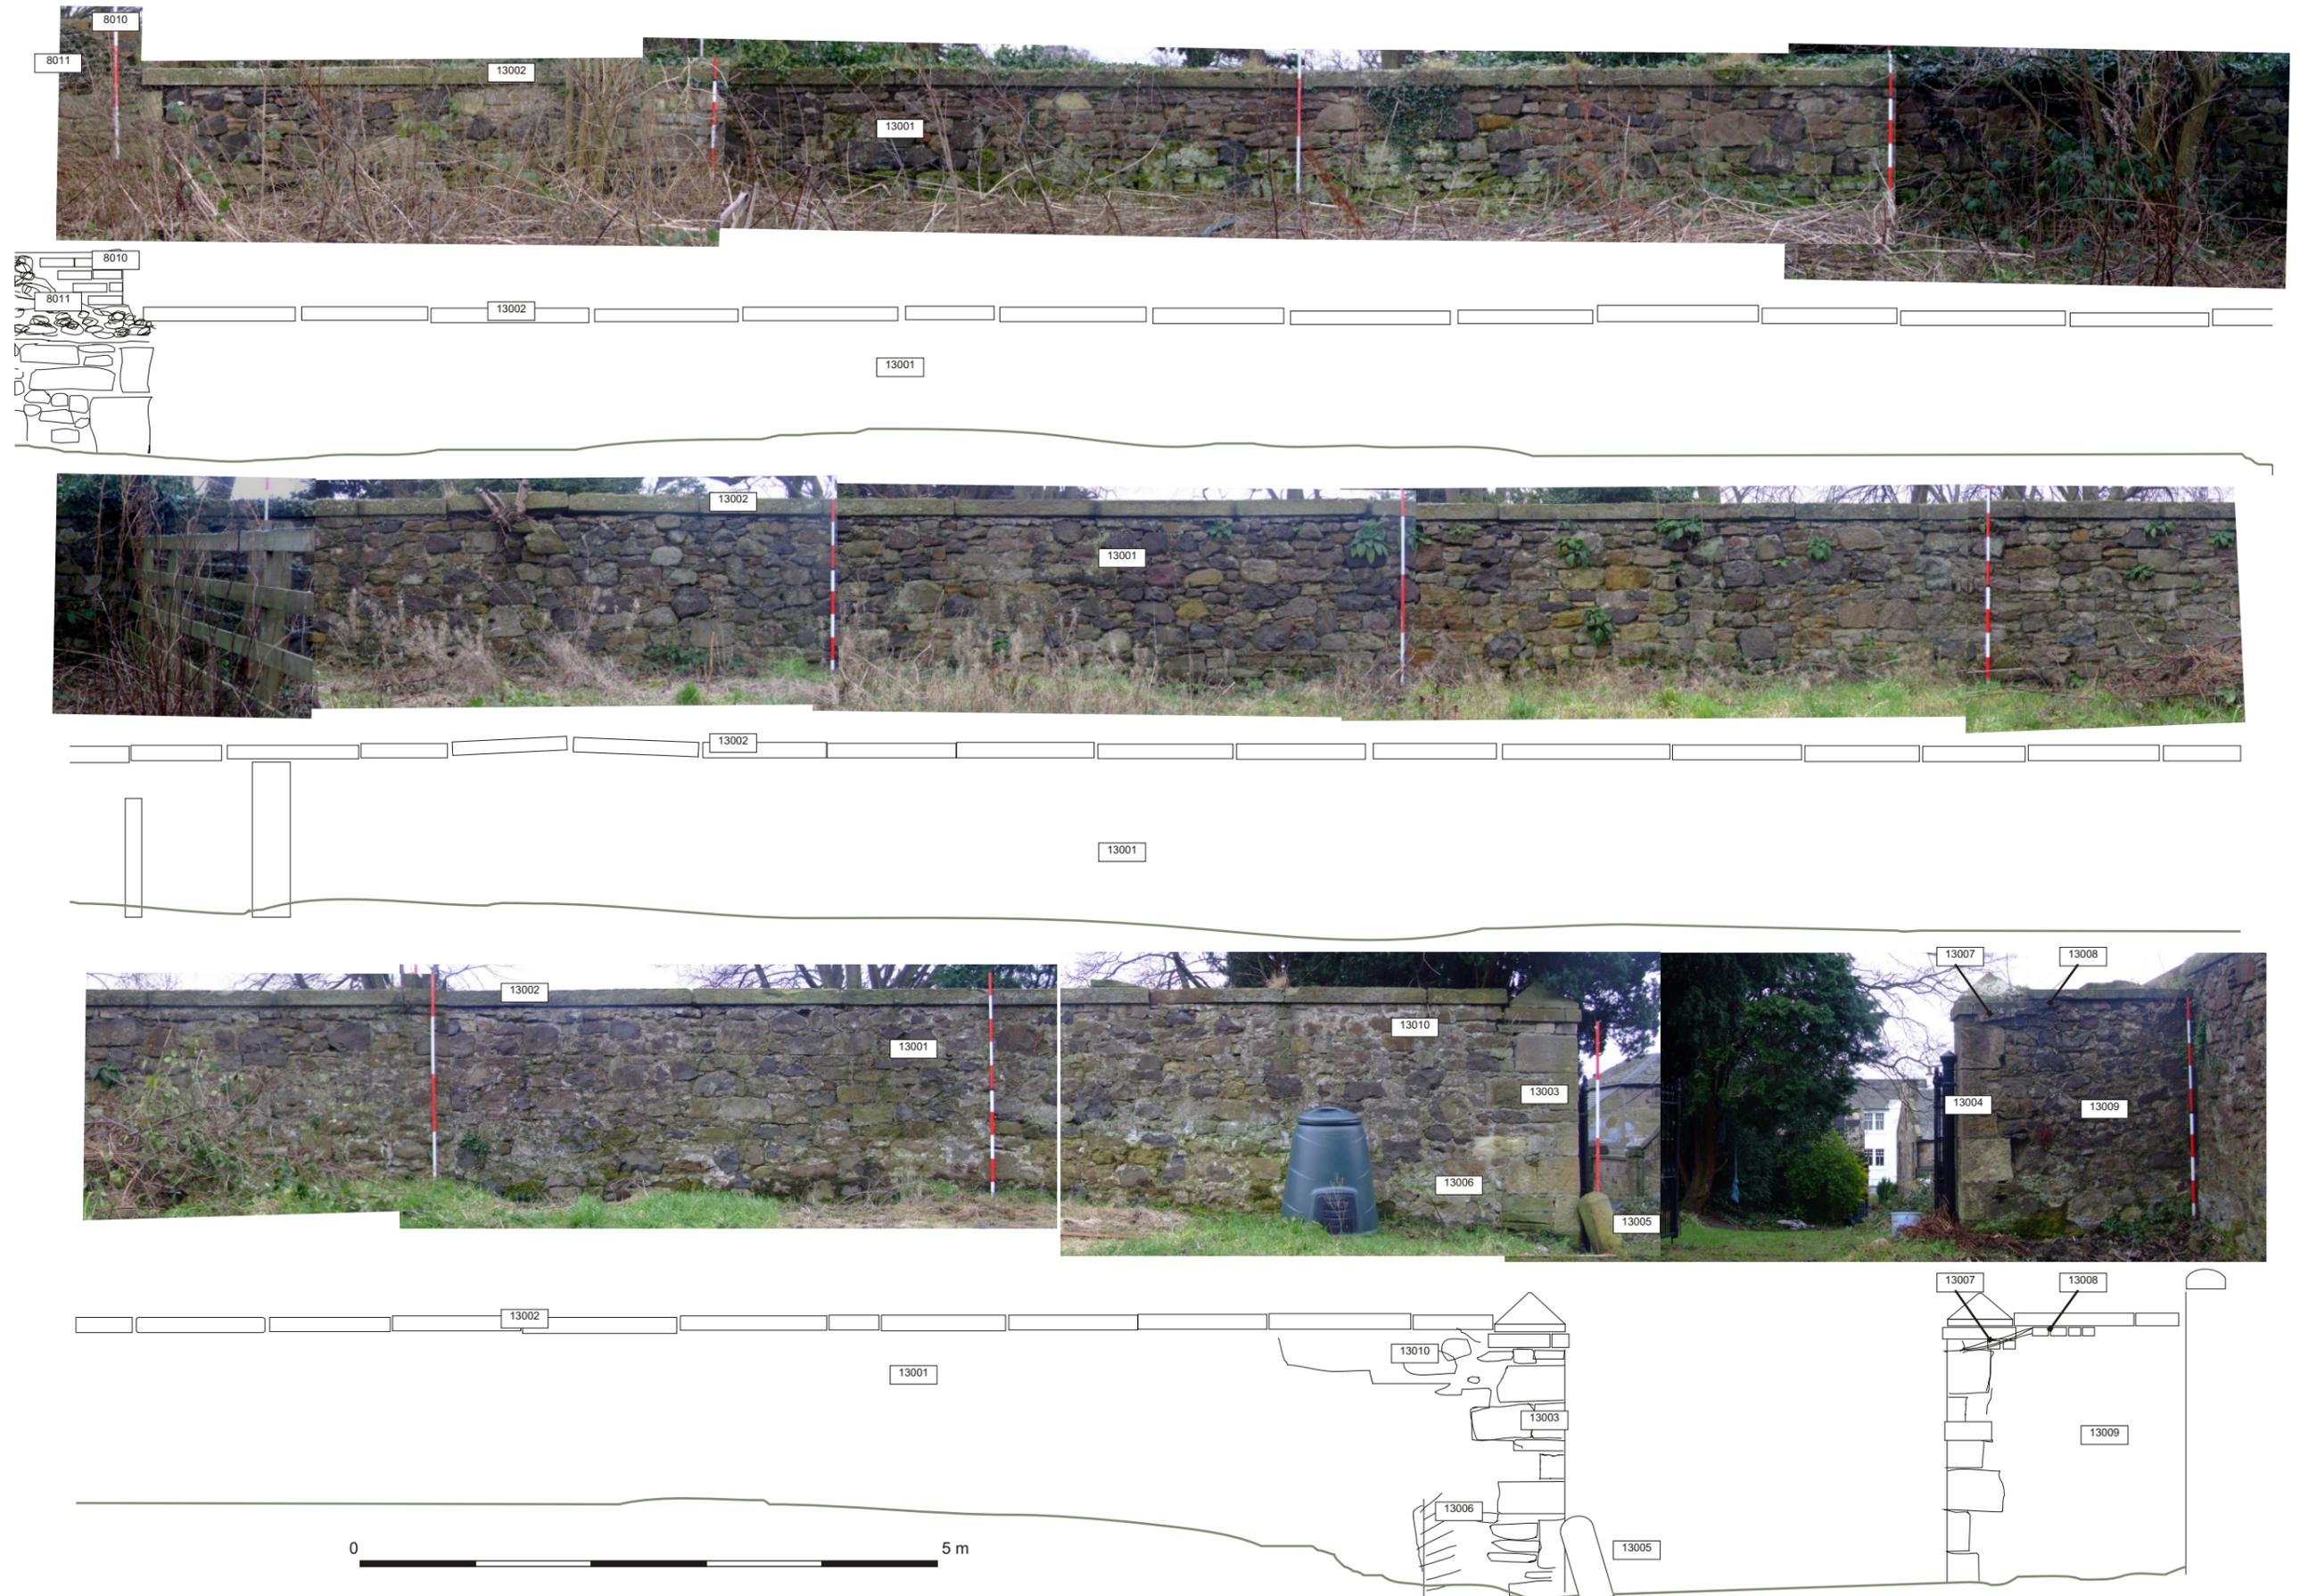
Figure 14: Wall 13 north facing elevation

Dividing Level 2 from Level 3, this retaining wall is all one phase of random rubble build consisting of mainly whin with occasional sandstone [13001]. The large flat quartzite sandstone copes run the entire length and over lye the industrial waste [8011] that faced the property boundary of Hawthorn Brae. Two well dressed sandstone gate piers with pyramidal caps [13003 & 13004] have been inserted into the wall to allow access for carts up to Level 3. Further evidence for the vehicular use of the gate way is provided by a stone bollard [13005] on the east side of the gate way which would indicate the direction that carts would have taken. A cement raggle line [13006] is visible just to the east of [13003] on the north facing elevation. A further cement raggle line [13007] with a slight slope overlies gate pier [13004] and leads to a line of bricks [13011] directly beneath the coping stones. Evidence for the insertion of the gateway can be seen to the east with a rough rubble work repair [13010] and to the west with what appears to be a complete wall re build [13009] as the coping stones are slightly higher on this side. Further evidence that the gateway is an insert is provided by the presence of earlier gate hangers set into the sandstone piers that do not relate to the current wrought iron gates that have been strapped with metal bands to the gate piers. It seems the wrought iron gates defined the size of the new gateway.

Wall 13 clearly marks until the 20th-century a northern limit to the site and it may only be in the later 19th or more likely 20th-century that the wall is breached to provide access to the stables beyond. The re-use of the cast iron gates at the entrance to Level 3 is of interest though a provenance for this feature is unclear.

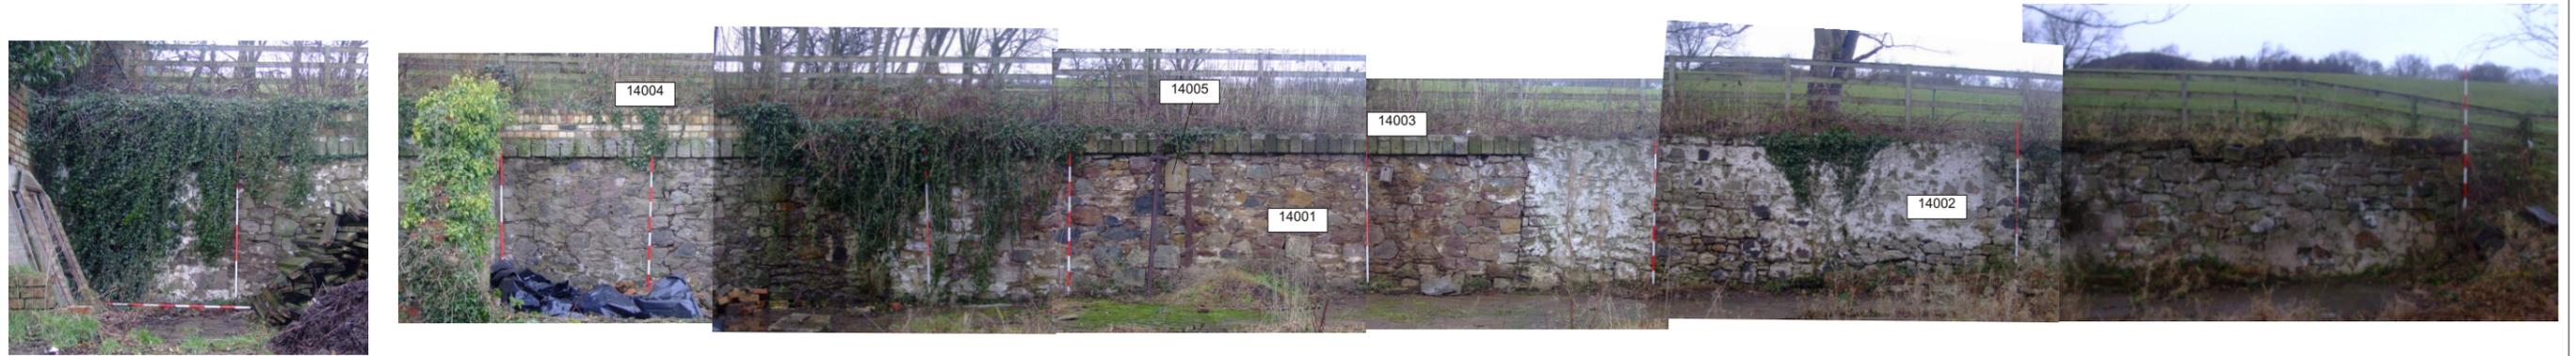
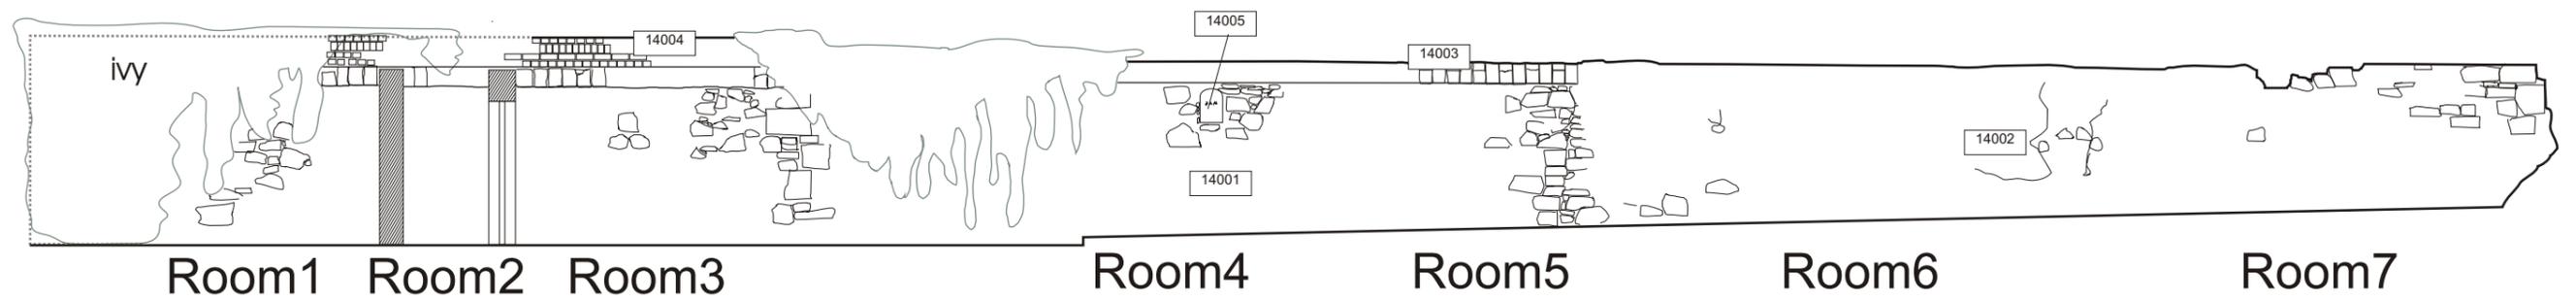
Figure 15: Wall 14, south facing elevation

A random rubble sandstone and whin retaining wall [14001] which has been extended to the east by similar sandstone and whin rubble work wall [14002]. Wall [14001] is topped with a castellated sandstone cope [14003] that itself is raised by a recent brick work construction [14004] at the west end. This brick heightening relates to the construction of building 4, rooms 1 – 3. Within room 5 set into wall [14001] is a small sandstone gravestone with the inscription ‘SAM’.

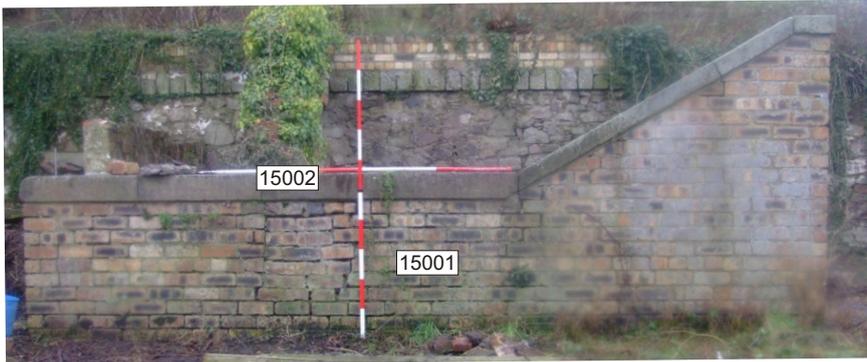
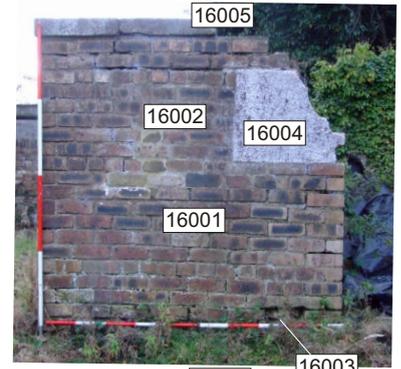
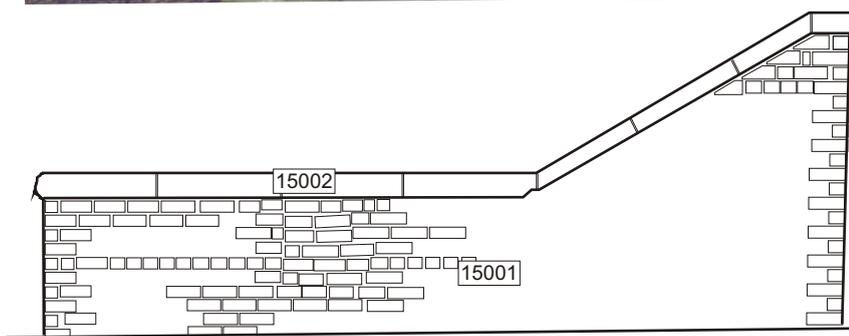
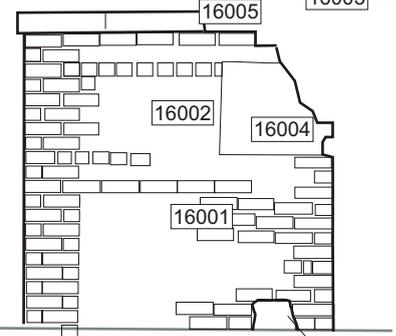
A 20th -century industrial brick wall 1.20m high which then rises steeply at the east end to 2.10m [15001]. The entire wall head is capped with a cement cope [15002].

A 20th -century industrial brick wall forming the west end of room 4/4 rising 2.10m high [16001]. A possible opening has been blocked with brick of a similar type [16002]. At the north corner, at the base of the wall there is a small opening [16003] which has been hacked through for drainage purposes. A small squared section of quartz chipped harling [16004] approximately 0.70m square is located to the north of this elevation and is of unknown function. The wall head is capped with a cement cope. This structure {Room 4/4} has no evidence of being roofed.

Figure16: Wall 15, south facing elevation

Figure17: Wall 16, east facing elevation

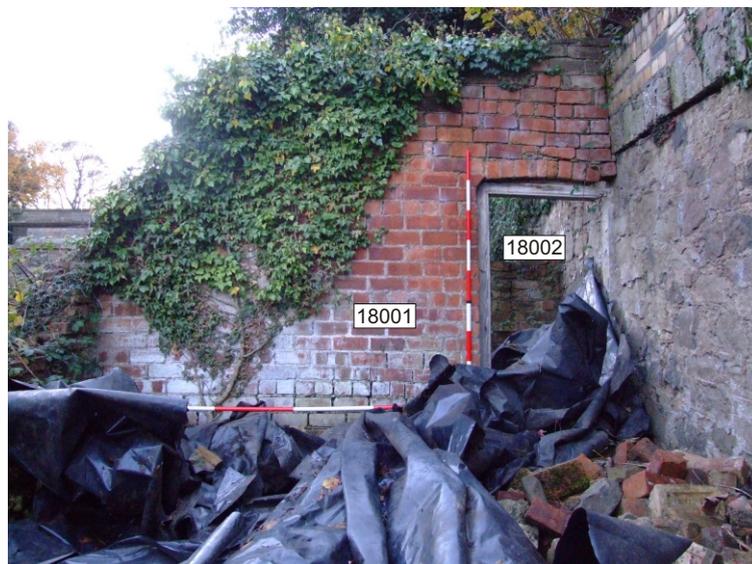
Figure18: Wall 18, east facing elevation

This dividing wall between rooms 4/3 and 4/2 is constructed of a mix of 20th and 18th -century bricks [18001]. It is penetrated by a door way [18002] with a segmental arched lintel. A wooden door frame survives. This wall butts up against the retaining wall [14001] and matches the height of the brick work [14004]. This suggests that the entire building of 4 post dates the construction of retaining wall [14001].

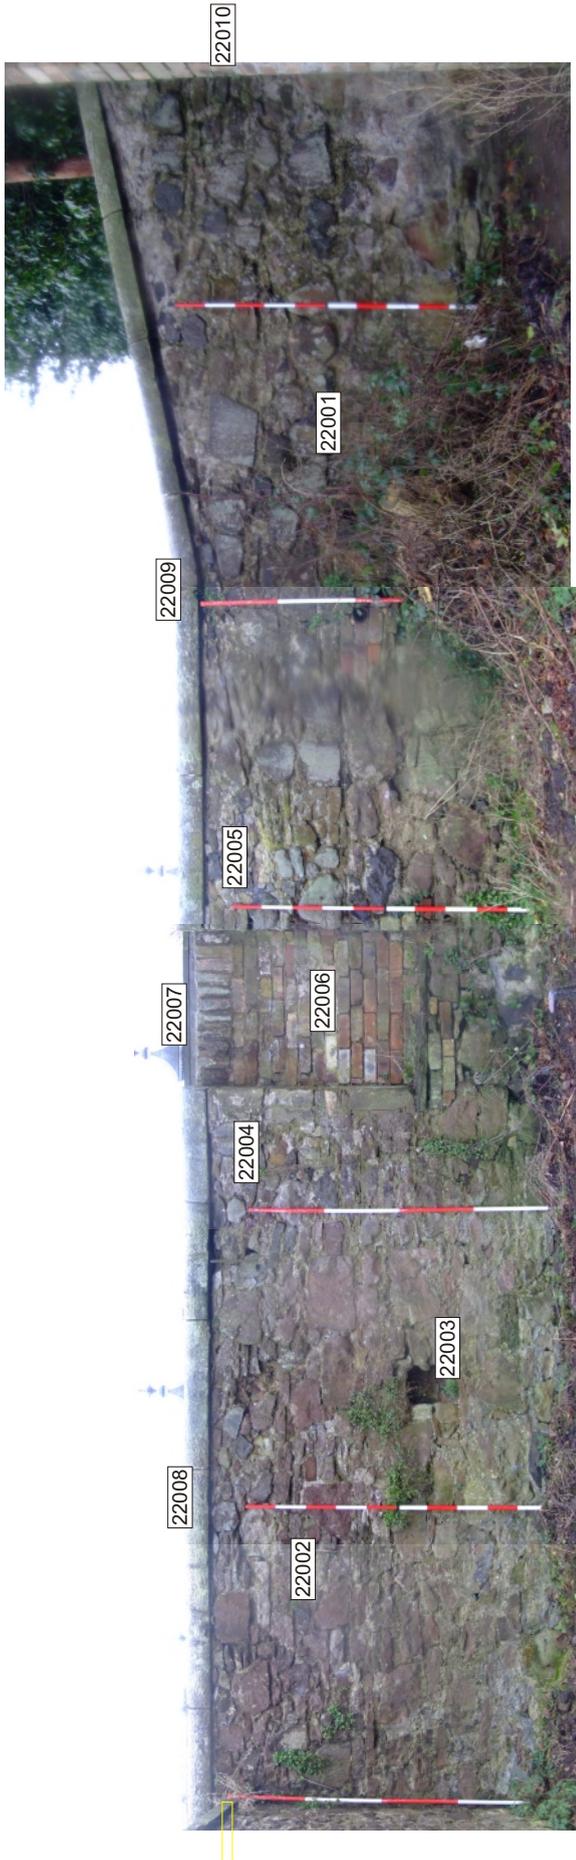
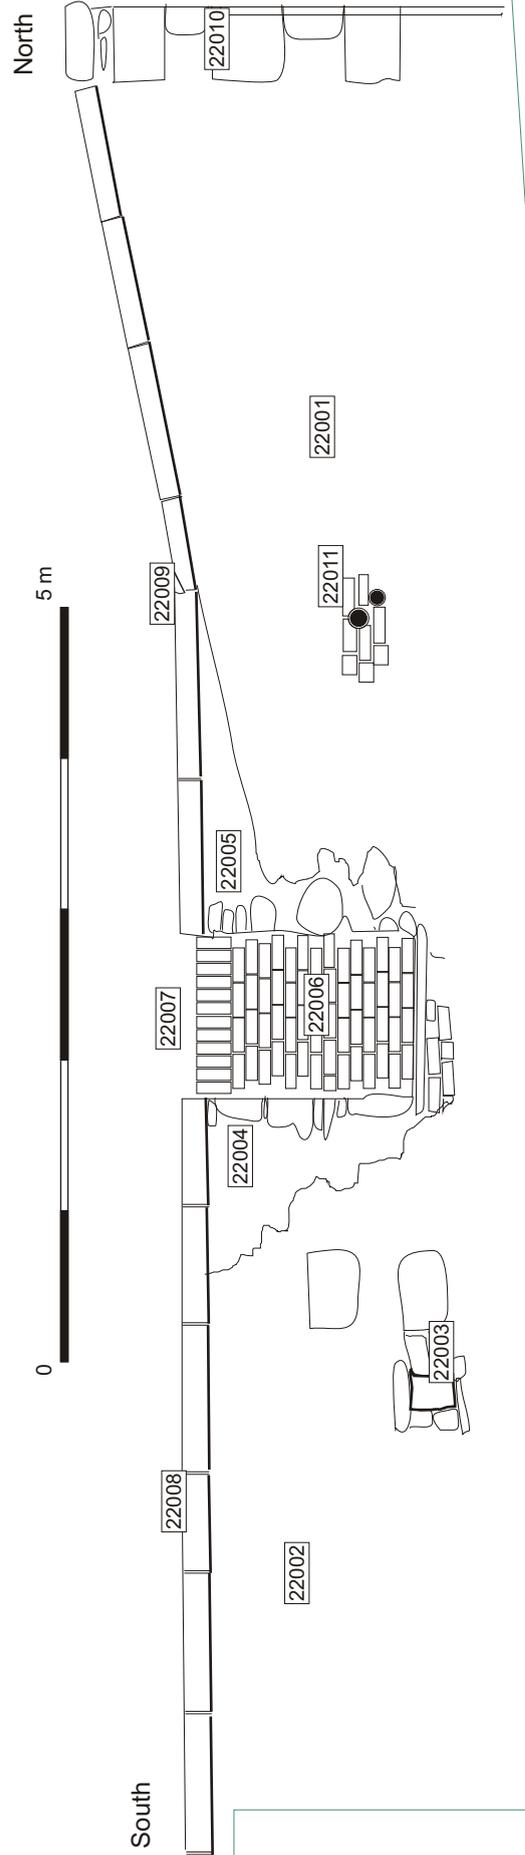
Figure 19: Wall 22, west facing internal elevation

Forming the boundary between the site and Bella Vista, wall [22001] is constructed of random whin rubble and mirrors the angle of the original slope. To the south the wall is of random sandstone rubble [22002] and is horizontal. There is a small inset to the wall [22003] 0.80m above ground level. Penetrating the wall is a gateway [22007]. To the south the jambs [22004] are of rough blocks of sandstone. There is a flat sandstone threshold resting upon bricks and to the north the original wall [22001] has been raised by a rough rubble and brick work infill [22005] to bring the height to the same as that on the south. The rounded coping [22008 & 22009] must have been re used from the original phase of the boundary wall. The gateway [22007] has been blocked with modern bricks [22006]. A further feature of unknown function is a brick blocked hole with two cast iron pipes penetrating the wall. At the extreme north their corner is constructed of well dressed sandstone blocks with a chamfer to approximately 1.60m in height. This provided access to a rear vennel behind Bella Vista.
