The Yards, Duddingston Village , Edinburgh

A National Trust for Scotland Report

April 2008

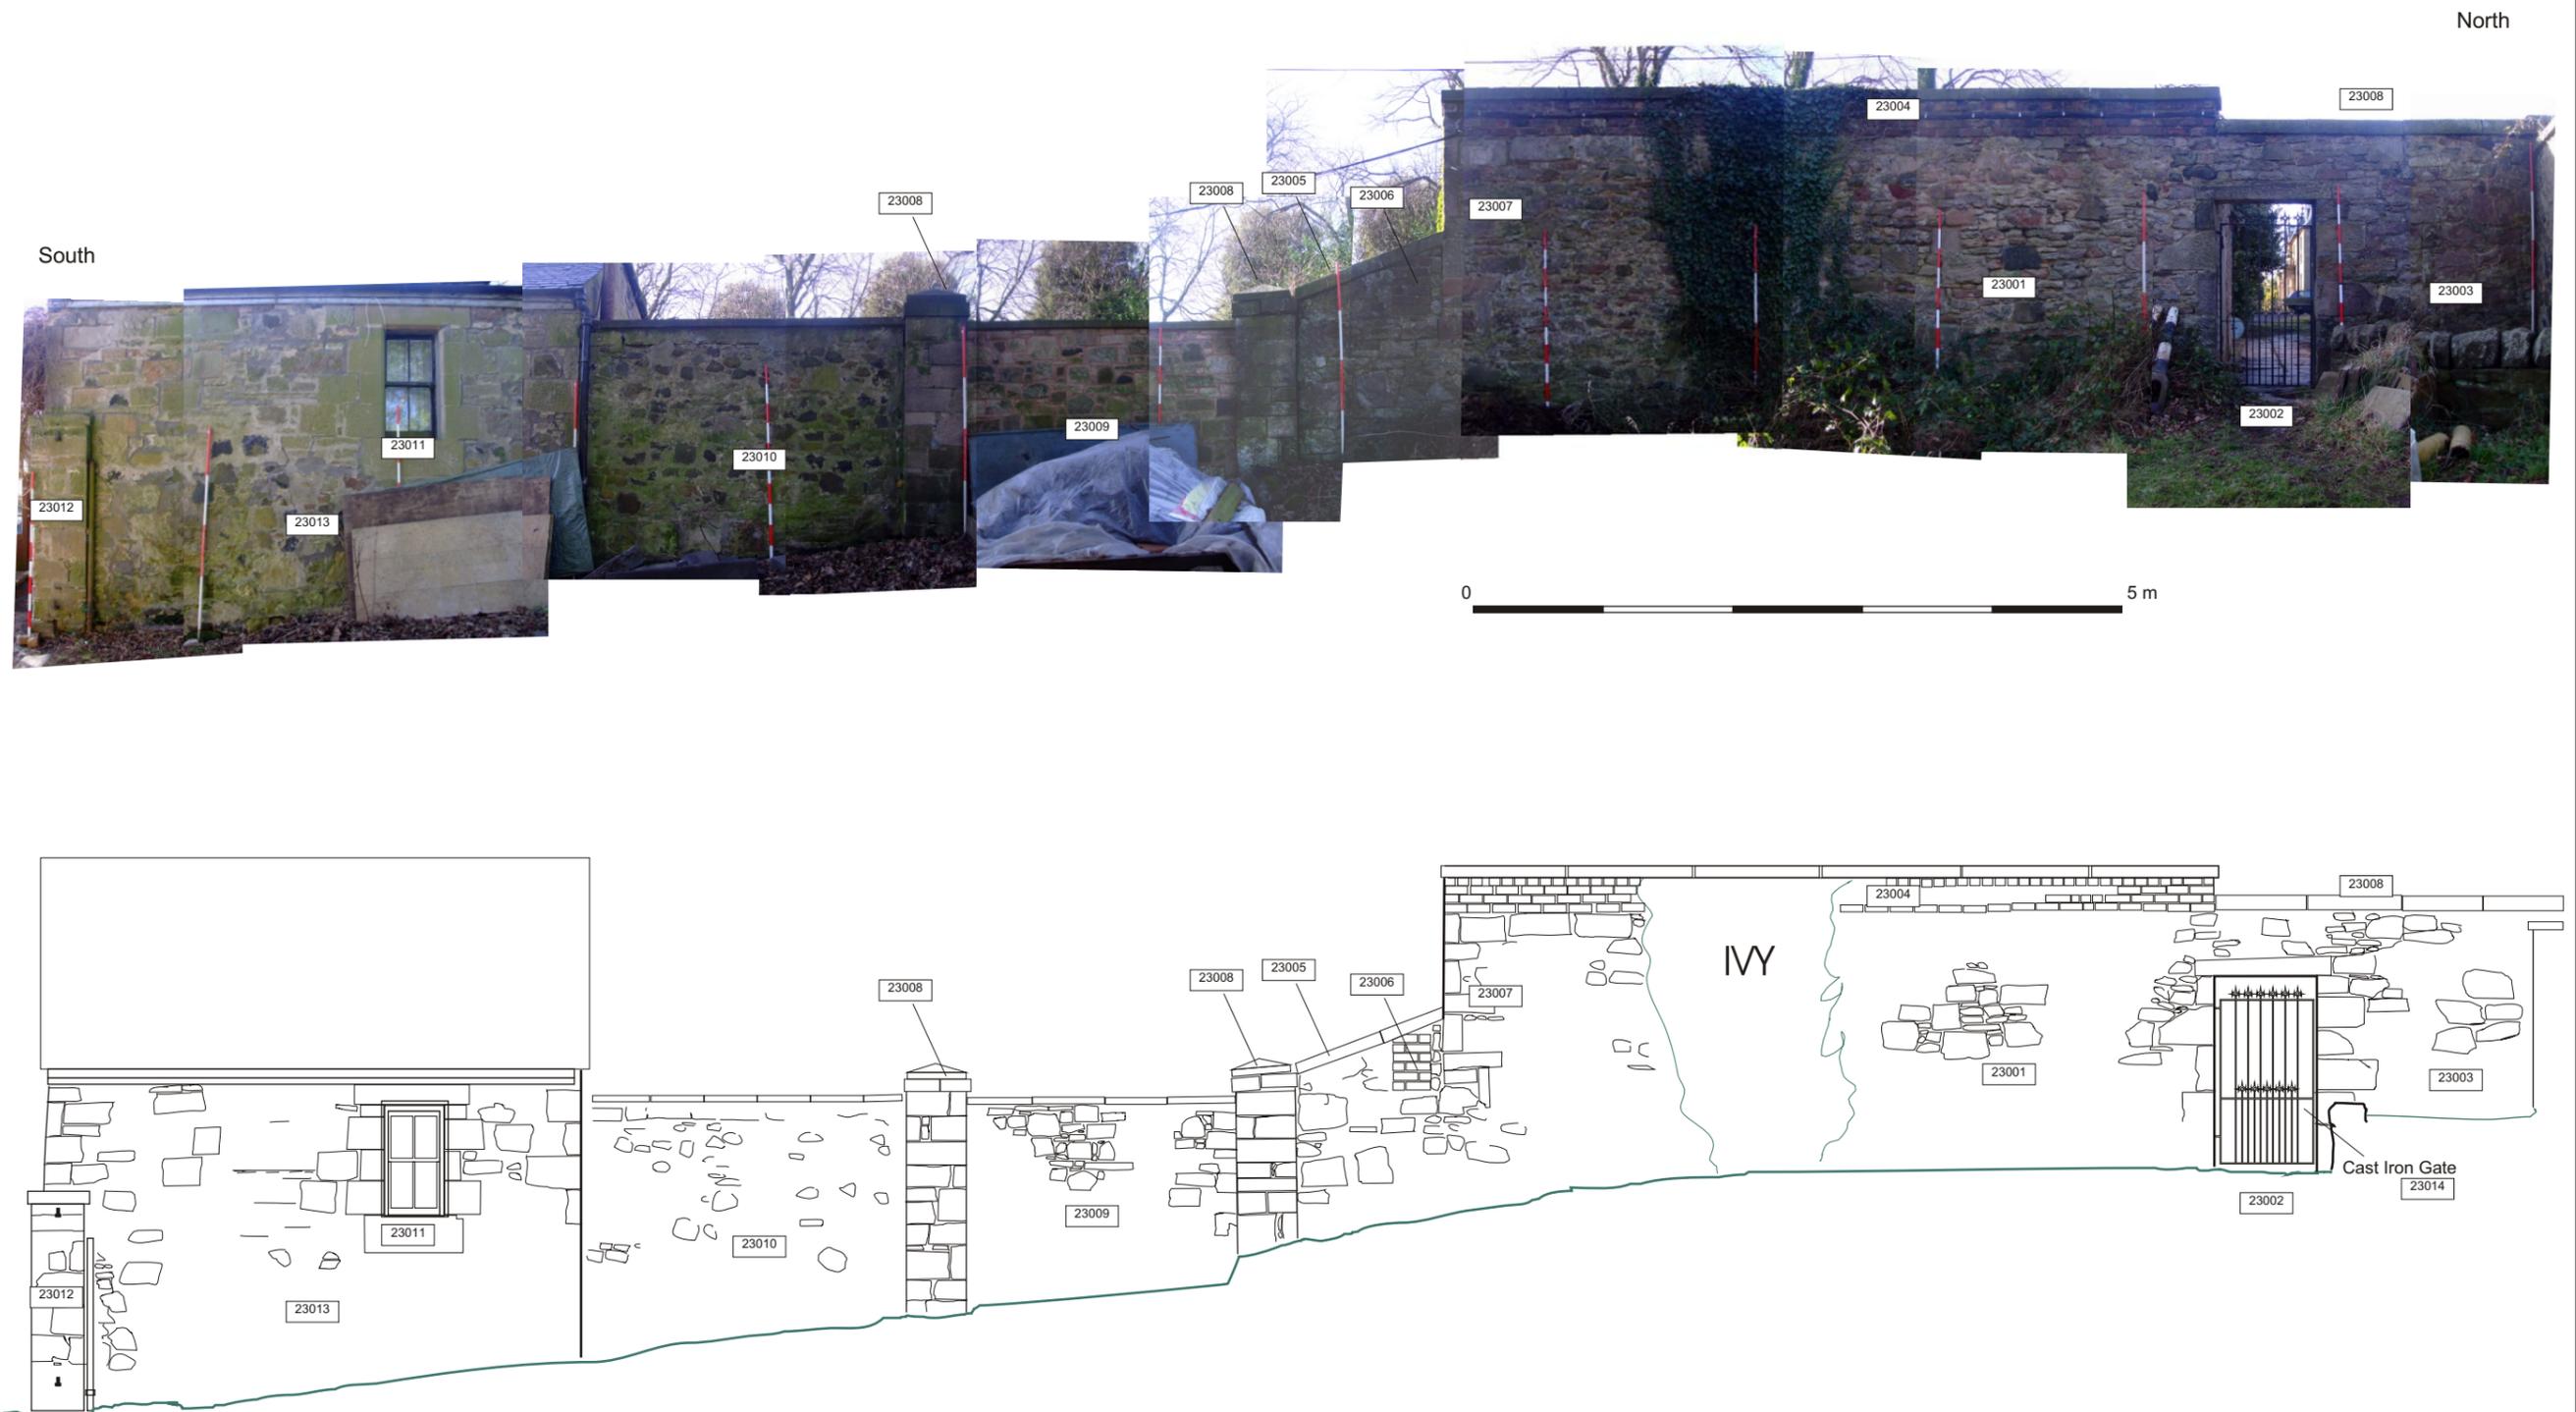
Figure 20: Above Wall 23, east facing elevation

Wall [23001] is of roughly coursed sandstone and occasional whin, forming the east elevation of a structure within the Bella Vista property to the west. This is surmounted by four courses of brick with a concrete cope that has raised the structure [23004]. The south corner of this structure has a series of quoins [23007] of quartzite sandstone. To the north the wall [23003] of random sandstone rubble {which equates to 23002 in Level 3} has been built over during the construction of the structure previously mentioned above. The rounded sandstone copes [23008] equate to [22008] in Level 3. A gateway with cast iron gate has been formed with the south jambs being the northeast corner of the Bella Vista property structure. Gate piers [23008] are of well dressed sandstone ashlar blocks with pyramidal caps of similar design and form to those seen in wall 13. This has now been filled with well coursed rubble sandstone and whin blocking and flat sandstone copes, effectively closing access to the Bella Vista stables from the access vennel. To the north of the gate piers the wall [23001] has been raised on a slope rising to the north and the coping stones [23005] have pushed the cap stone of the northern gate pier off centre. A small aperture has been formed in this raised wall and is now filled with bricks [23006], this represented a small sloping lean to structure to the north of the Bella Vista outbuilding. The wall [23010] of rubble build sandstone and whin with flat sandstone coping connects the southern gate pier to a further structure in the Bella Vista property to the south. The pitched roof stable block in the Bella Vista property is represented in this elevation by a roughly coursed sandstone wall [23013] penetrated by a single window [23011] of 2x2 pane, sash and case design, the surrounding margins are of well dressed sandstone with chamfered corners. The slate roof slopes away from the elevation to join the rest of the stable structure. Gate pier [23012] which matches gate pier [2007] to the east is of sandstone block work with a flat cap stone and bears evidence of being re-built into this location.

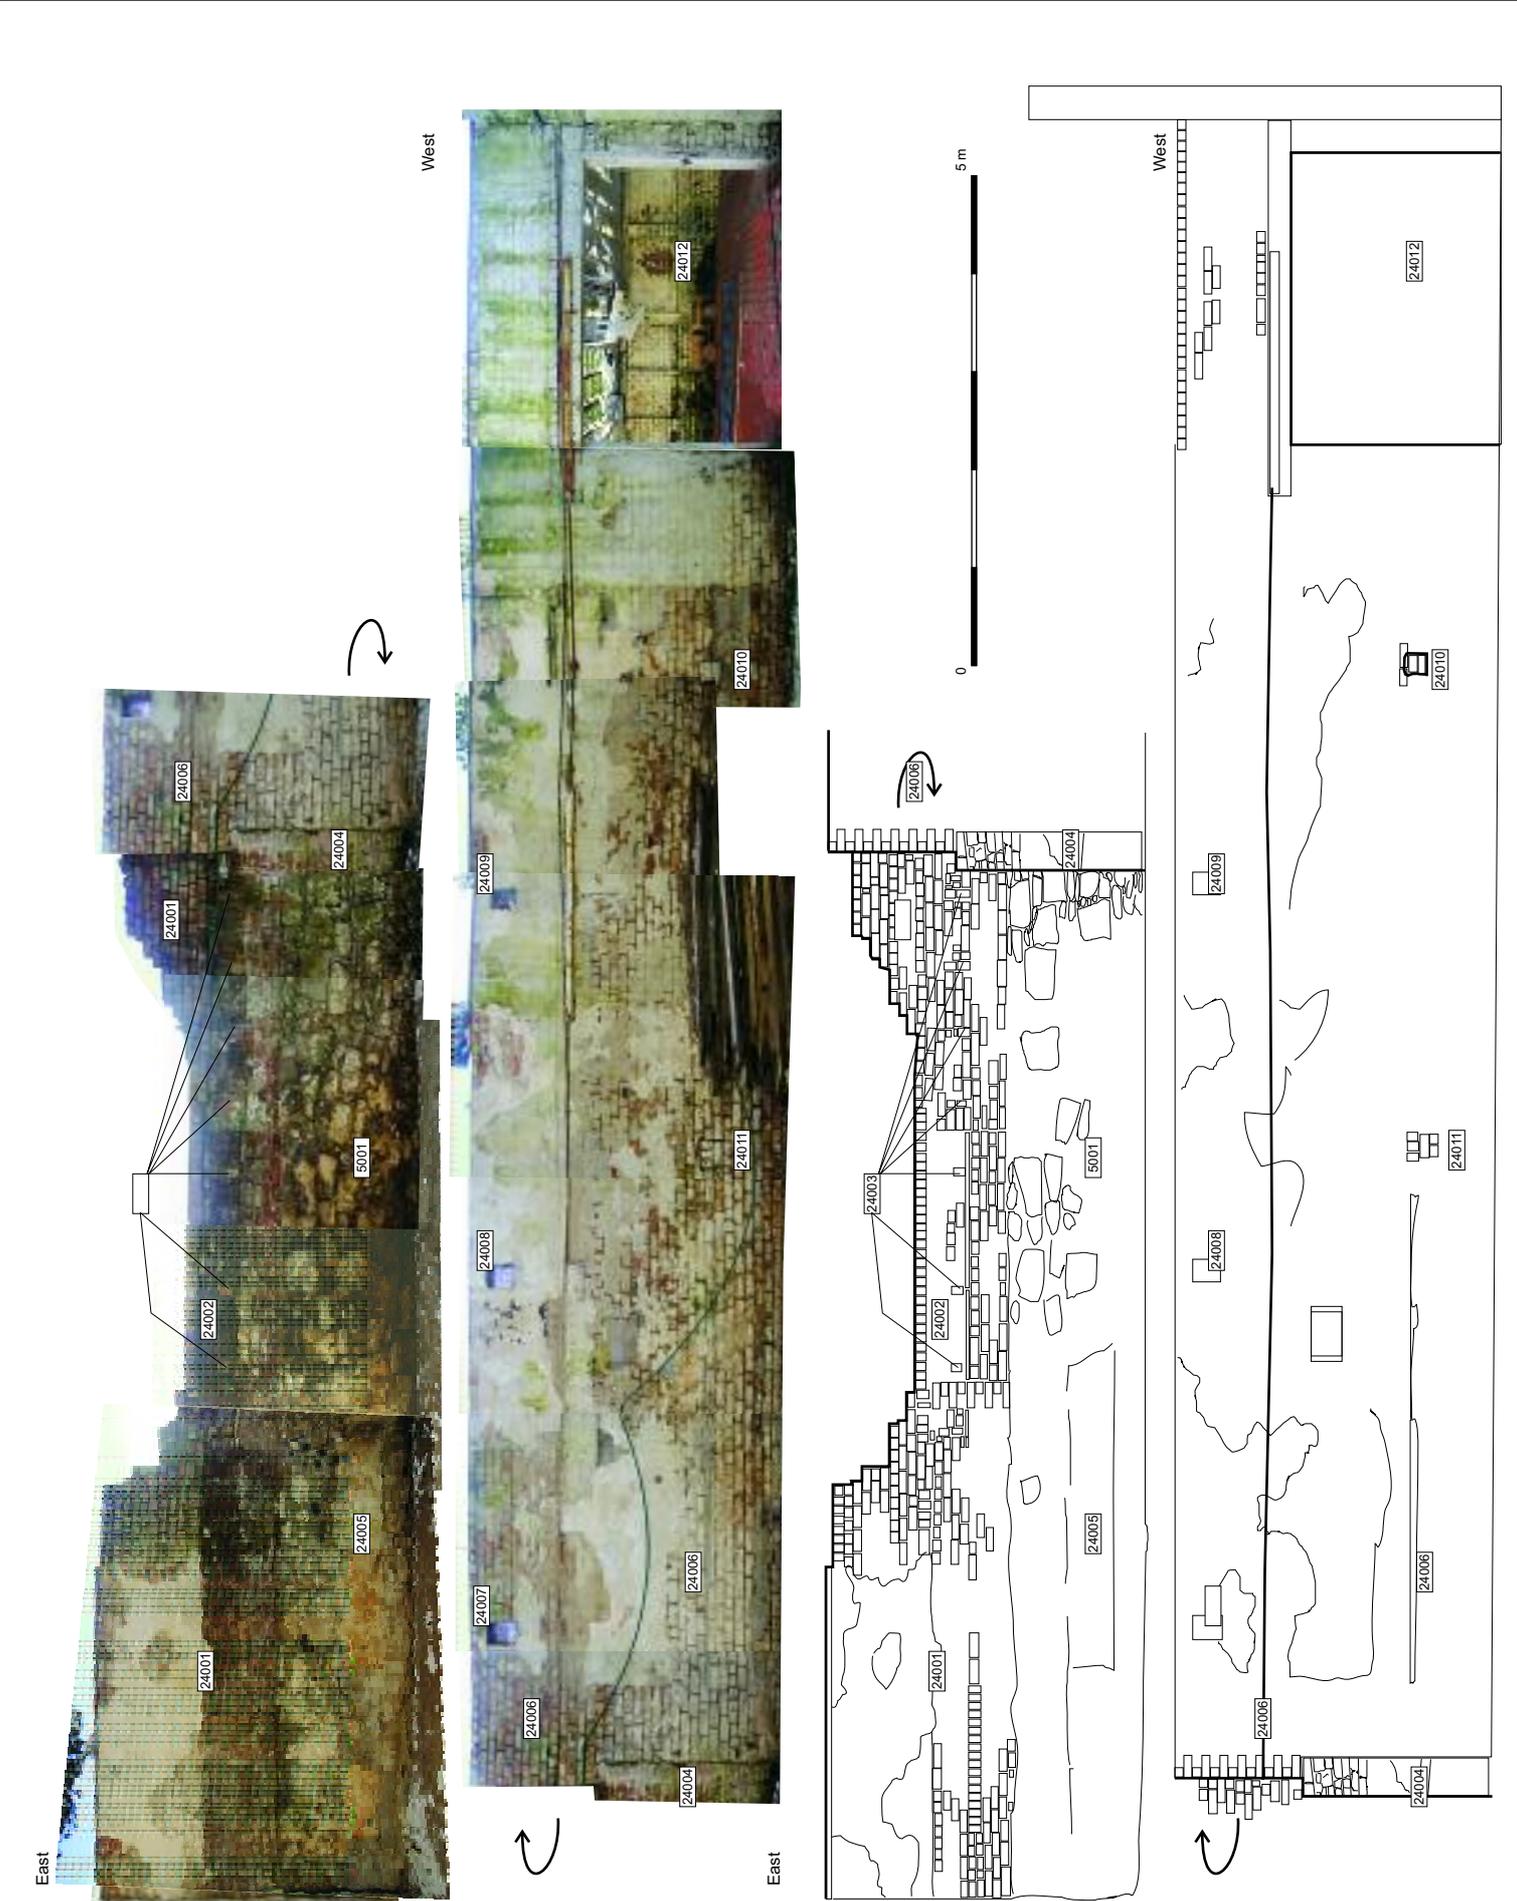
Figure 21: Wall 24, north facing internal elevation

The lower stone wall of this elevation is formed of roughly coursed sandstone blocks [5001] and was originally the terrace retaining walls between Levels 1 & 2. Formed of industrial brick [24001] this section of walling raises the elevation to a height where the area to the north can be enclosed as a structure. Off centre to this brick walling is an unusual feature [24002] with definite defined sides that itself is a brick infilling and brick header course/lintel. Its function is unknown. A series of joist holes [24003] can be recognized along this section of elevation, possibly representing a first floor platform. Due to the irregularities in the east/west boundaries of the properties, this section of elevation is set slightly further to the south than that to the west, which necessitated an angled join [24004] of brick. Patches of cement render can be found on the wall [24005] to a height of 2m. The rest of the elevation is of a single build of industrial brick [24006] which is penetrated with three air vents with cast iron grills [24007, 24008 & 24009] at wall head height. Two further small blocked openings are found nearer ground level [24010 & 24011]. At the extreme west end of this elevation there is a large opening with massive wooden beam lintel and the remnants of a sliding door mechanism.

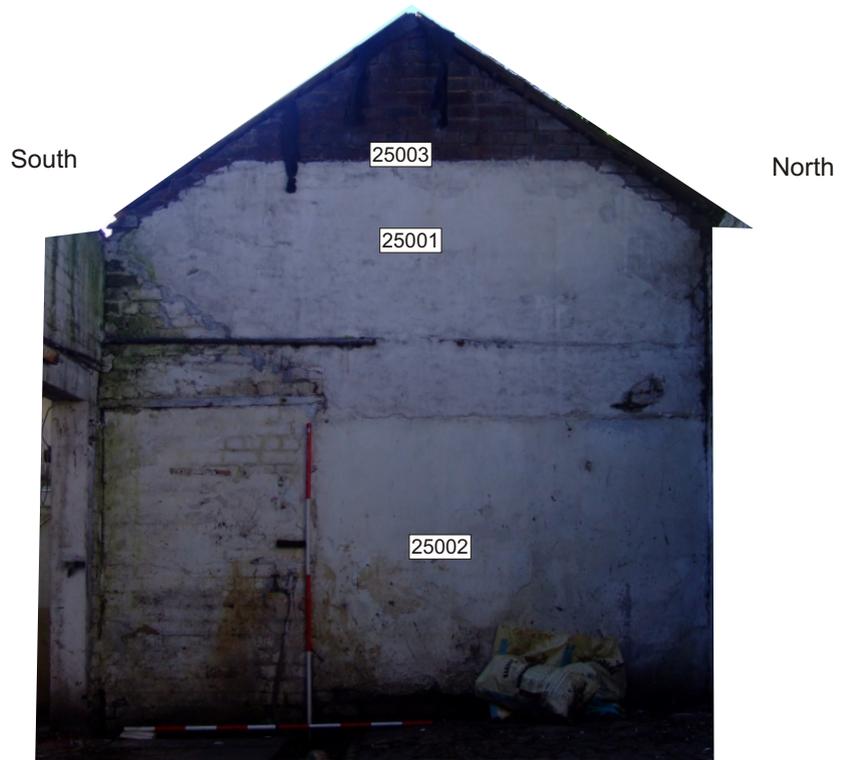
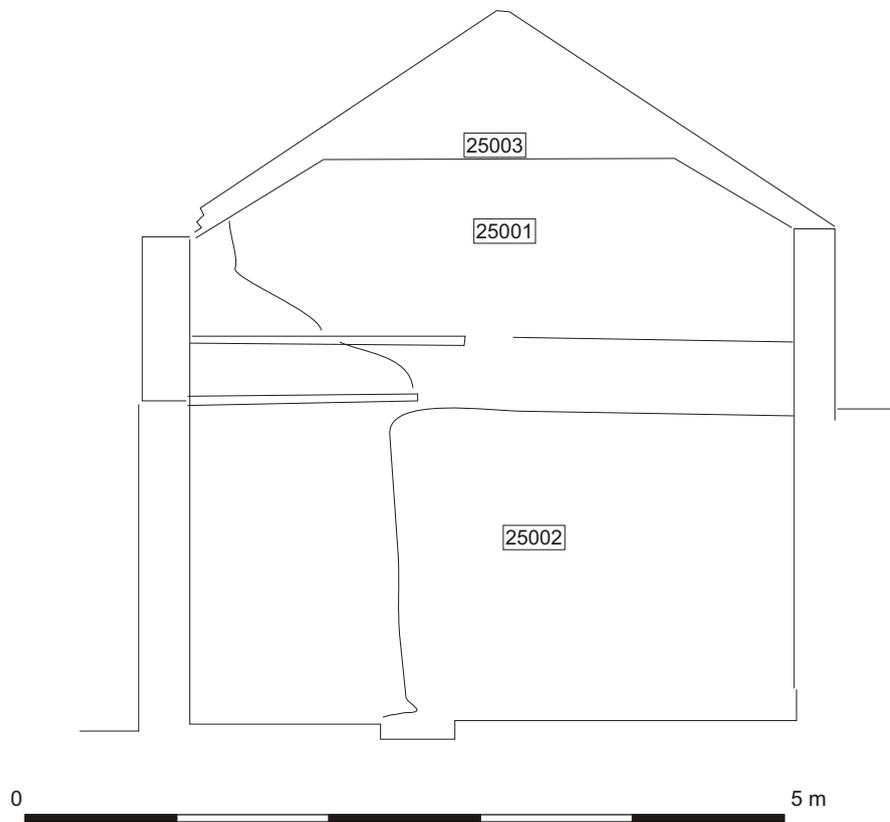
Figure 22: Wall 25, east facing internal elevation

[25001] is the gabled west end of room 1/2 and is built of industrial brick. This is rendered in cement [25002] and white washed. The scar of an A – framed roof truss is visible in the gable.
