**A Report to  
J. A. Andrew & Son/  
Metheringham Construction**

February 2011

**Cuthbert's Yard,  
land between 21 & 23  
Burton Road, Lincoln**

Buildings Recording (Level 1 Photographic Survey)

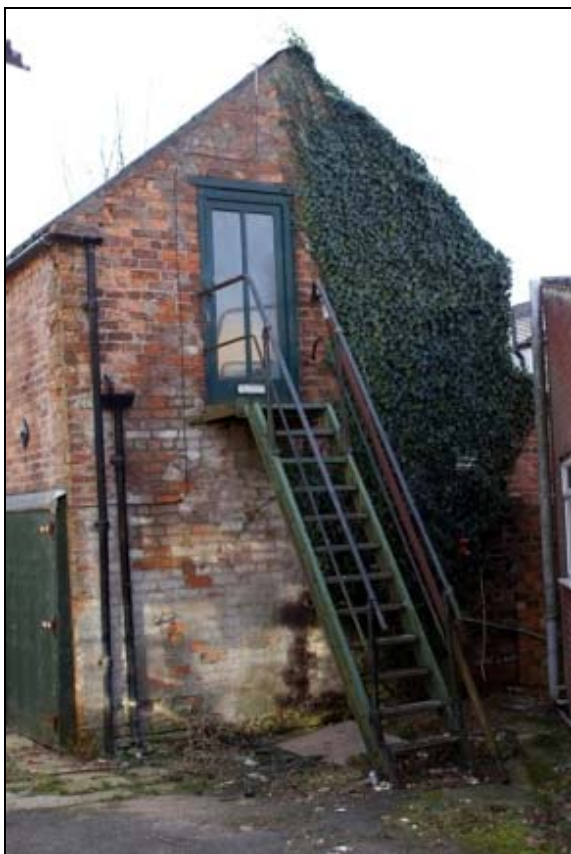
**Plate 1:** Building 3, north end - looking south (Digital image 1)

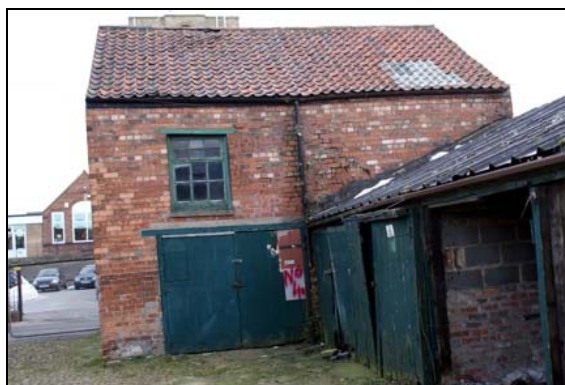
**Plate 4:** Building 1, west side - looking east (Digital image 9)

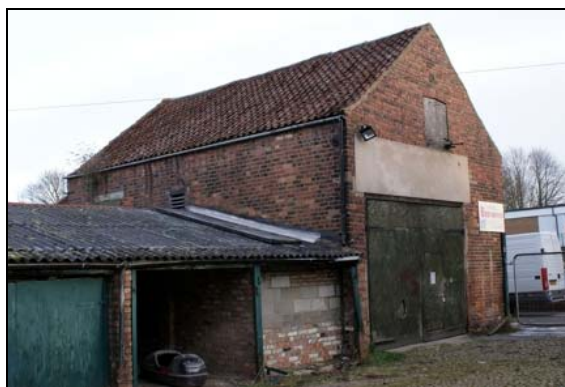
**Plate 5:** Building 2, south & west sides - looking north-east (Digital image 11)

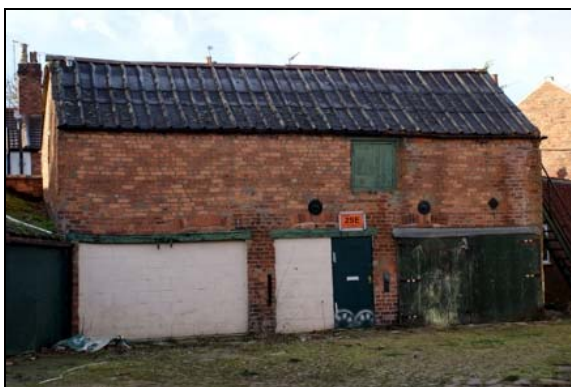
**Plate 2:** Building 3, east side - looking west (Digital image 2)

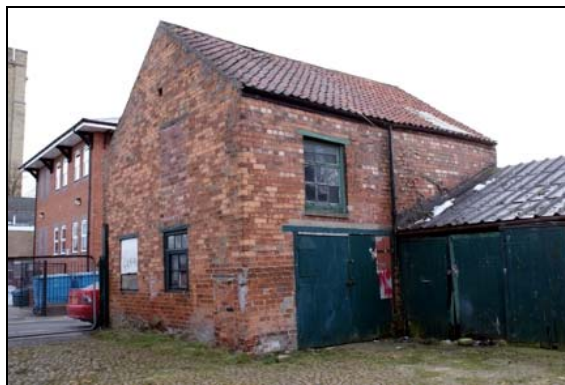
**Plate 6:** Building 1, north & west sides - looking south-east (Digital image 18)

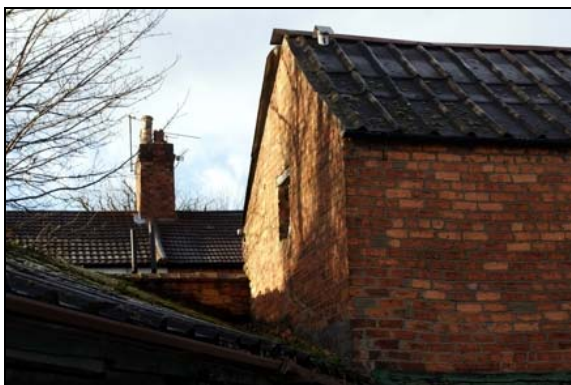
**Plate 3:** Building 3, south end - looking west (Digital image 6)

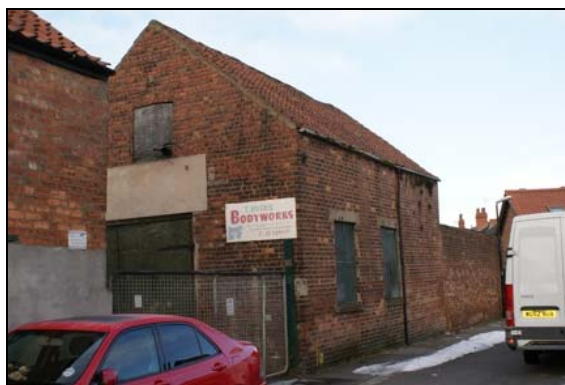
**Plate 7:** Building 2, south & east sides - looking north-west (Digital image 21)

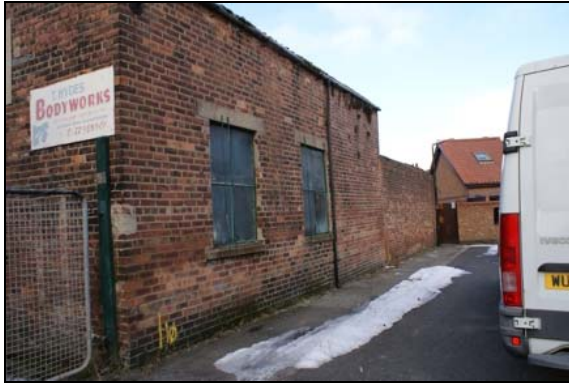
**Plate 8:** Building 2, east side - looking north-west (Digital image 25)

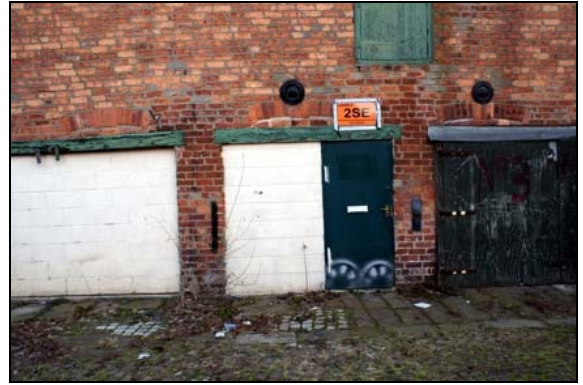
**Plate 12:** Building 3, east side (close up view) - looking west (Digital image 31)

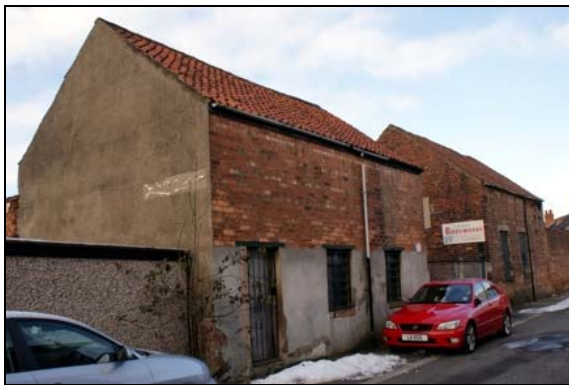
**Plate 9:** Building 1, south & east sides - looking north-west (Digital image 23)

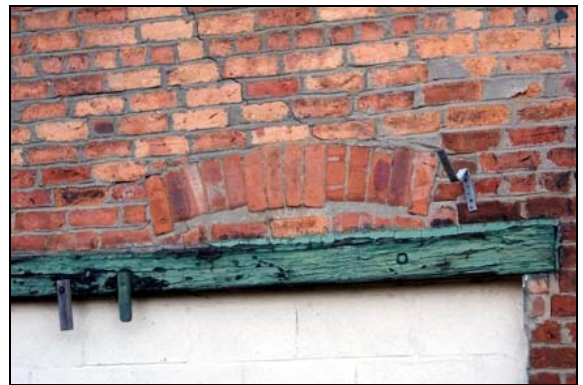
**Plate 13:** Detail view of original door/window arch (1), Building 3, east side - looking west (Digital image 32)

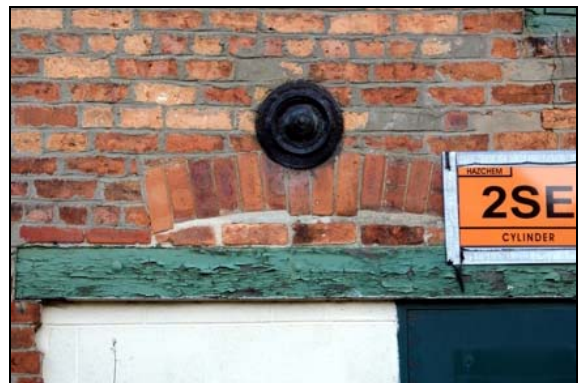
**Plate 14:** Detail view of original door/window arch (2), Building 3, east side - looking west (Digital image 33)

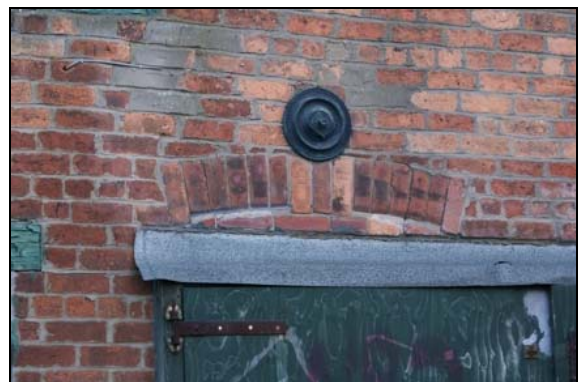
**Plate 15:** Detail view of original door/window arch (3), Building 3, east side - looking west (Digital image 34)

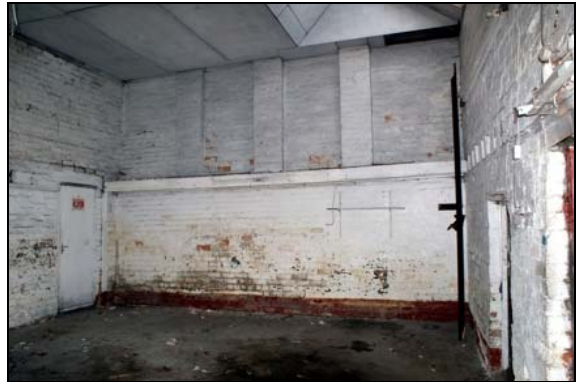
**Plate 21:** Building 1, interior - looking south-east (Digital image 46)

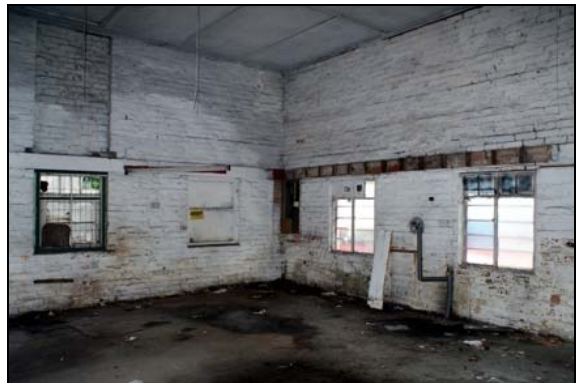
**Plate 22:** Building 1, interior - looking north-east (Digital image 47)

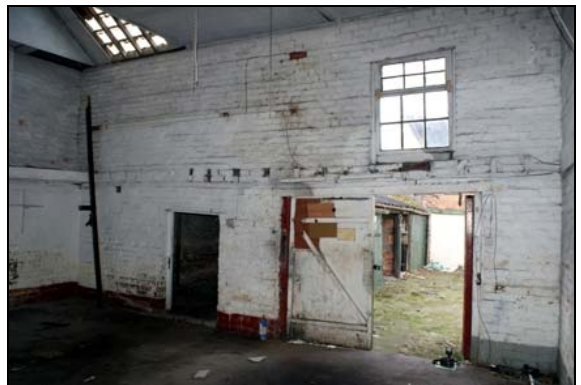
**Plate 23:** Building 1, interior - looking west (Digital image 48)

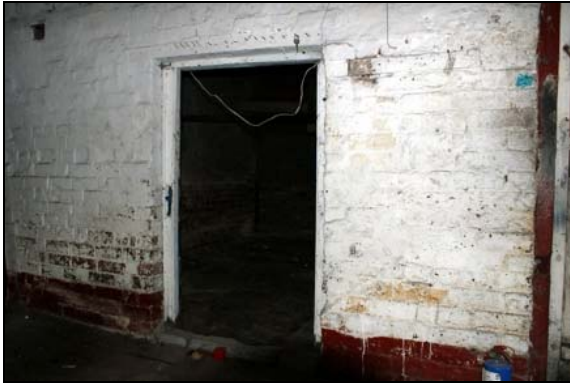
**Plate 24:** Building 1, interior doorway to adjacent garage - looking south-west (Digital image 49)

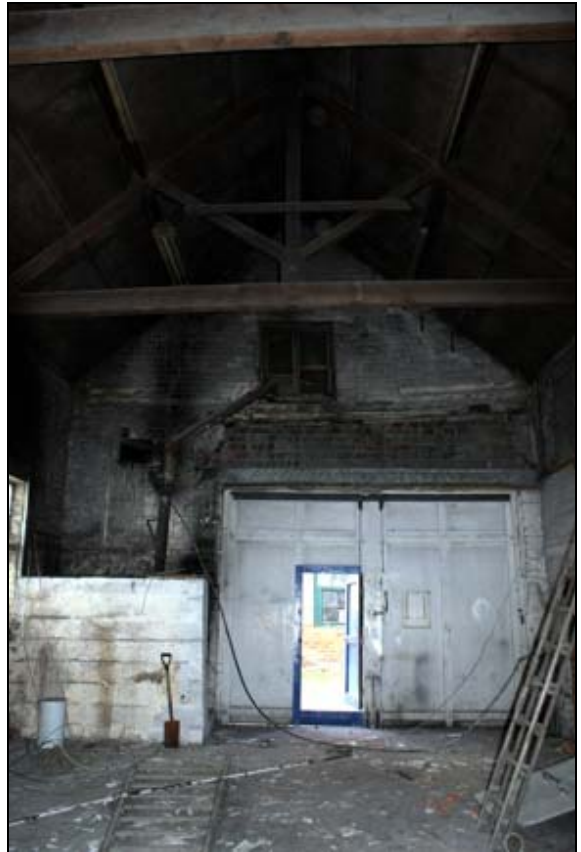
**Plate 28:** Building 2, interior (showing roof truss) - looking south (Digital image 56)

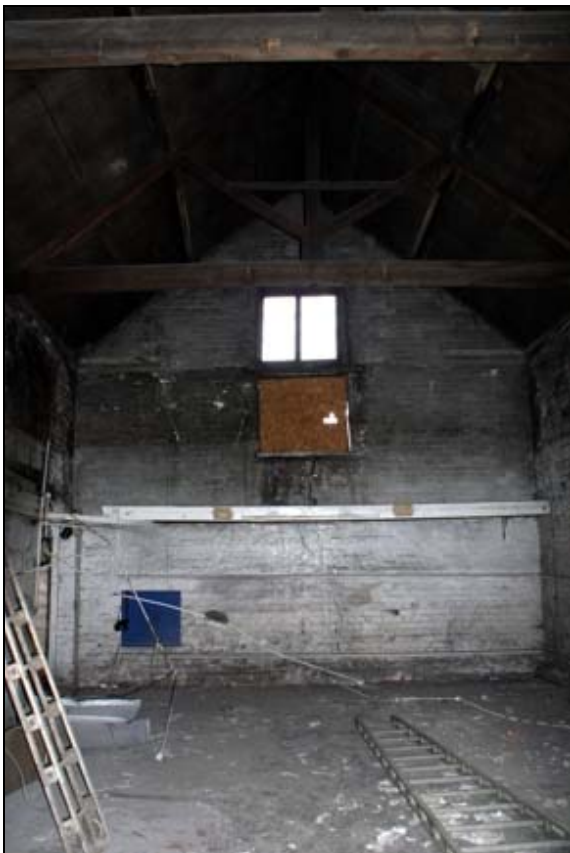
**Plate 26:** Building 2, interior (showing roof truss) - looking north (Digital image 52)

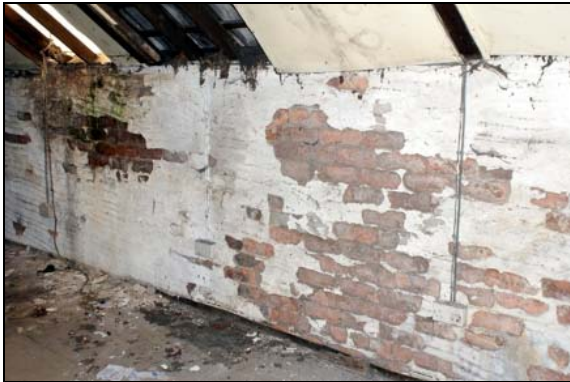
**Plate 31:** Building 3, first floor interior (showing revealed brickwork) - looking south-west (Digital image 59)
